**Archaeological observation, investigation
recording and analysis of land at the
Church of St Mary, Ringstead
Northamptonshire
November-December 2014**

Report No 14/266

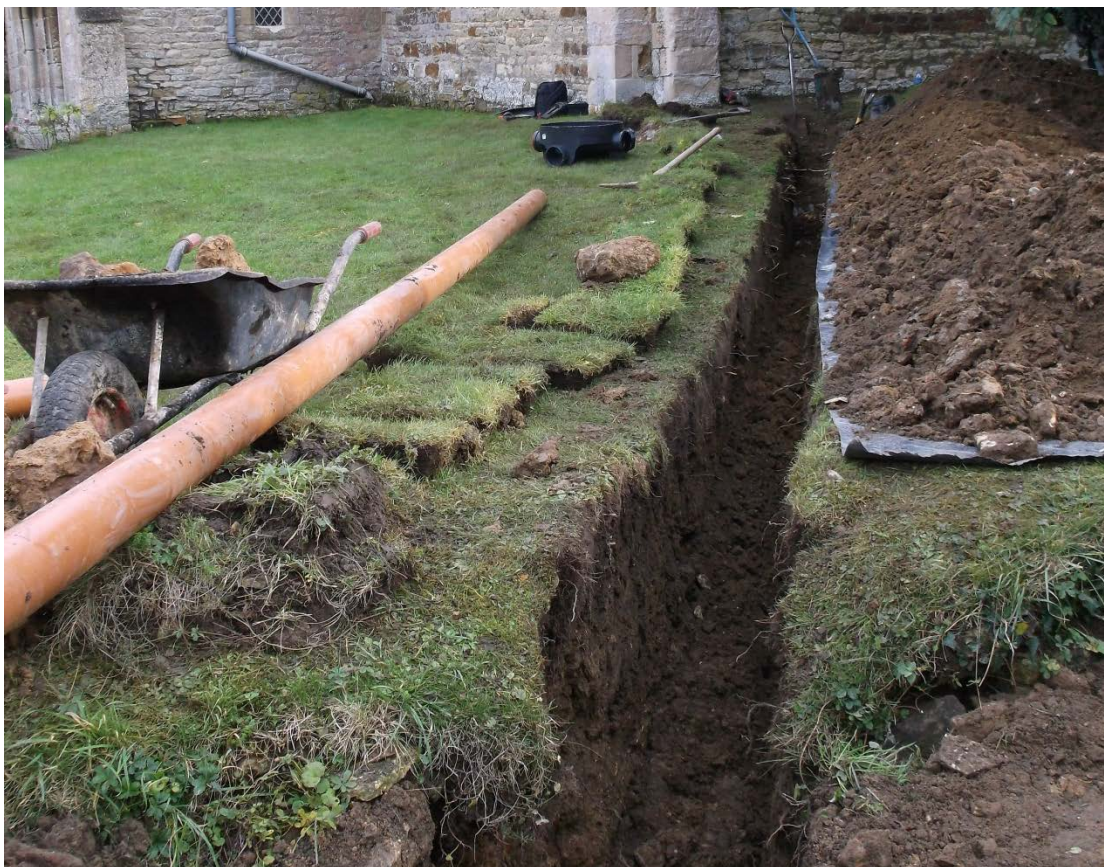
Fig 3

This trench was excavated by hand from the north-west corner of the church nave, to where it joined Trench 2 south of the north-west corner of the churchyard (Figs 2 and 3). The trench was aligned south-east to north-west, approximately 10m long by 0.4m wide and 0.6m deep.

Trench 1, looking south-east

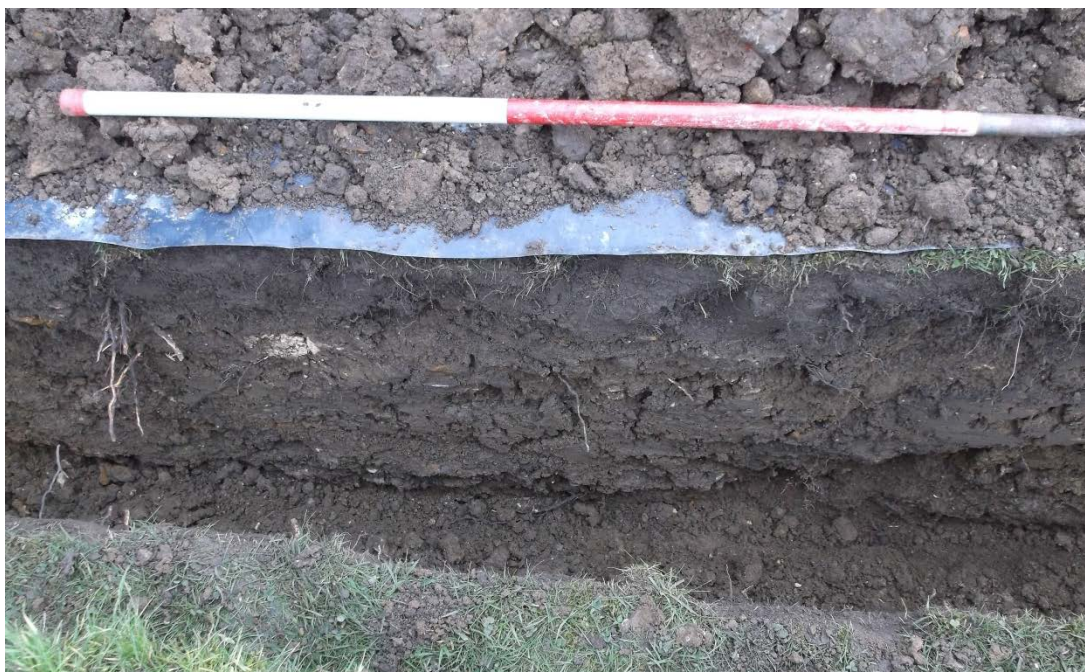
Fig 4

The natural substrate was not observed in this trench. The subsoil comprised a layer, 0.35m deep, of dark yellowish-brown sandy clay loam subsoil with numerous small to medium-sized fragments of limestone and ironstone together with some fragments of brick and tile (Fig 4). The topsoil, 0.25m deep, was a dark brown loam with a few small limestone inclusions (101).

Trench 1, section showing stratigraphy, looking north-east

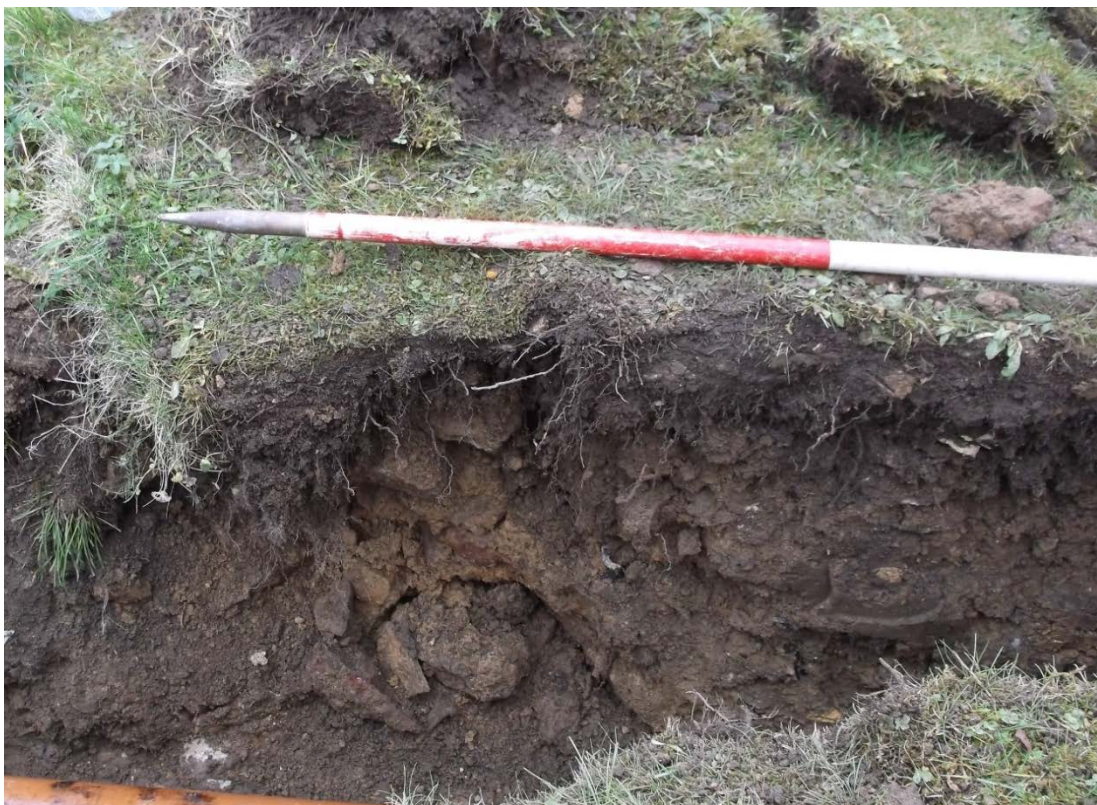
Fig 5

At the western end of this trench the remains of the former western wall of the churchyard (103) were observed (Fig 5). The remains consisted of approximately three courses of rough-hewn limestone overlying approximately five courses of rough-hewn limestone and ironstone blocks. At least one large fragment of dressed limestone masonry was observed. Four sherds of post-medieval pottery and one fragment of clay tobacco-pipe stem were noted in the spoil heap.

Former churchyard wall (103), looking north-east

Parts of the wall along the western boundary of the churchyard were still extant in places, but had largely been demolished in the area of observation. The footings of the western wall of the churchyard were cut through and exposed during monitoring of the service trenches. Although the footings largely consisted of large coarse blocks of limestone or ironstone, some dressed blocks of stone may be indicative of the re-use of medieval masonry suggesting that the footings could be late medieval or post-medieval. The surviving portions of wall along the western churchyard boundary appear to be post-medieval.

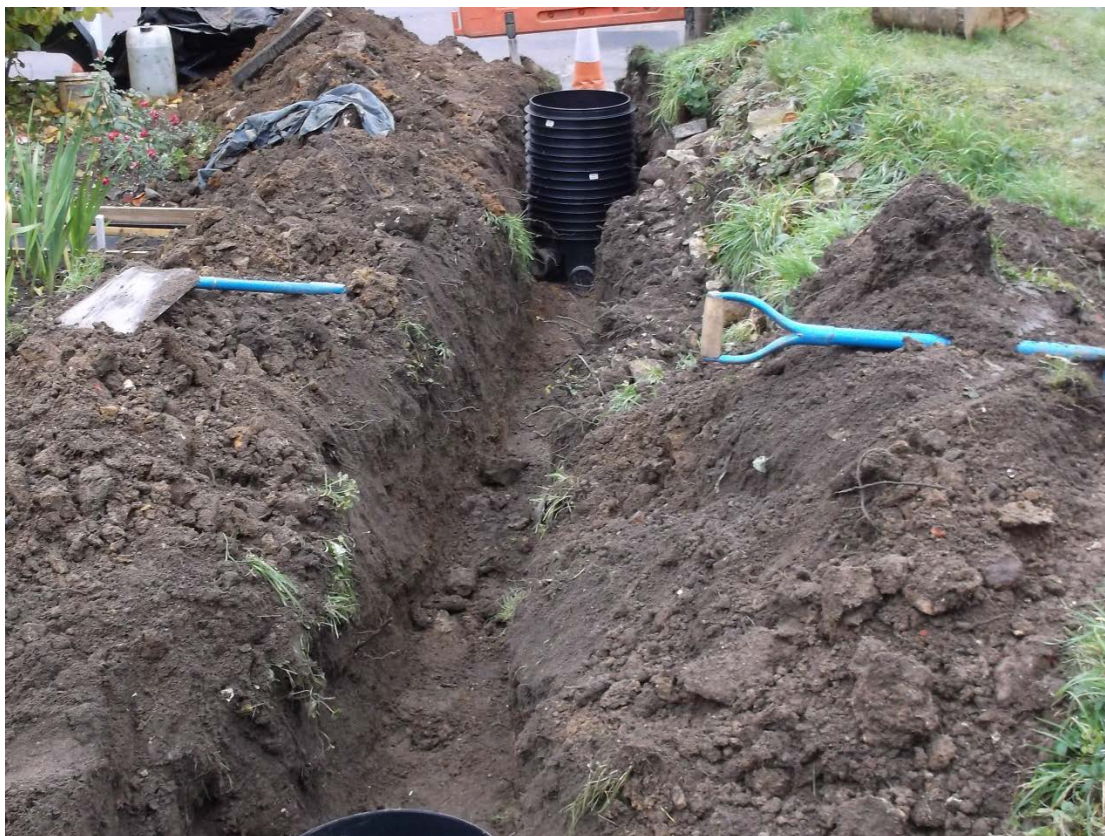
This trench was excavated by machine immediately outside of, and parallel with, the western wall of the churchyard, from the edge of Church Street southwards to join trench 1 (Fig 2). It was 8m long by 0.4m wide by 0.6m deep (Fig 6). This trench was dug to link the subsequently installed foul waste pipe to a sewer in Church Street.

The natural substrate (202) was observed c 0.5m below ground level and consisted of a yellowish-brown sandy clay with a few large fragments of limestone. Overlying this was a layer, 0.5m deep, of dark brown loam topsoil with a few small limestone inclusions. No obvious subsoil layer was apparent in this trench. However, as the trench had largely been dug through an allotment, it is possible the stratigraphy may represent made-up ground due to frequent composting or manuring.

Trench 2, looking north Fig 6

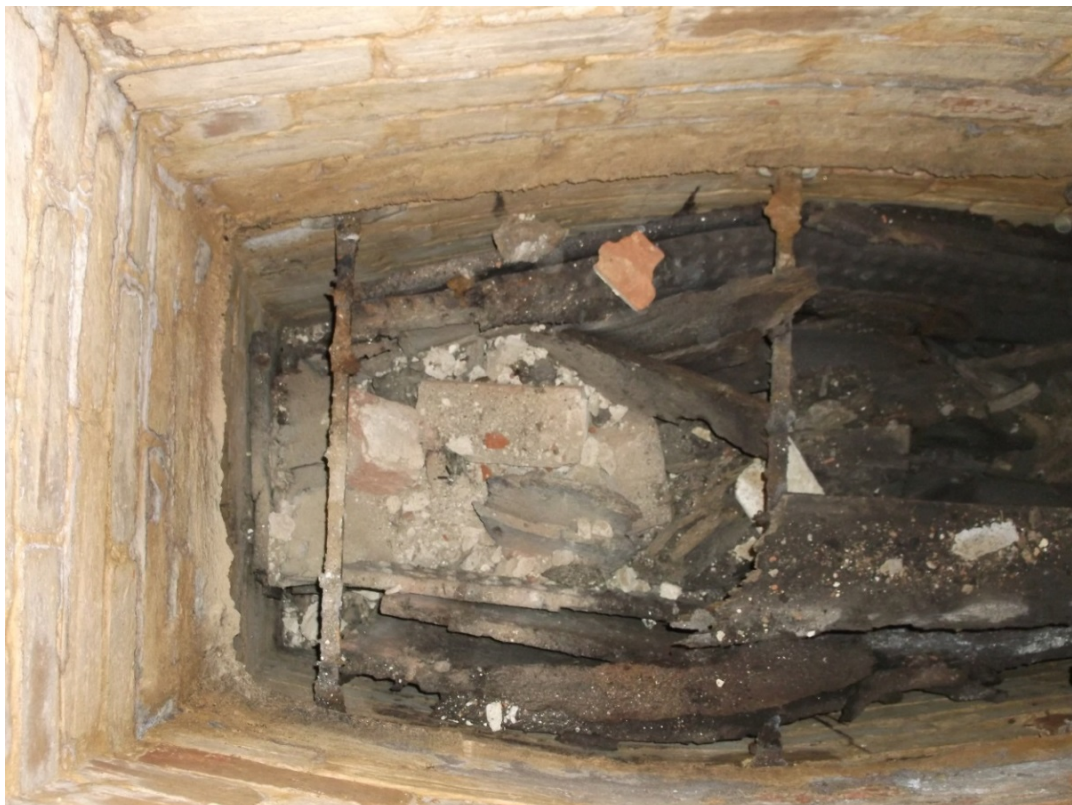
An inspection of the resulting void revealed that a brick-lined vault (103) lay beneath (Figs 7, 8 and 9). On the floor of the vault, approximately 2m below the barrel-vaulted roof, lay a timber coffin. The sides appeared to be intact but the lid had collapsed, especially where debris from the vault roof had fallen in at the west end of the vault. Above the coffin were four iron support bars fixed to the vault walls ready for the insertion of another coffin.

Vault (303), west end of interior showing debris from damaged vault roof Fig 8

The grave vault uncovered within the north-west corner of the nave probably dates to the 18th or 19th centuries. The grave vault incorporated four evenly-spaced, iron bars immediately above the coffin to support a future interment which did not occur. The vault pre-dates the current timber floor which replaced an earlier stone or tiled floor. The date for the laying of the current timber floor is unknown, however, within the church porch a plaque records a grant of £80 being made in 1863 towards 're-seating' within the church and the provision of additional seating (Fig 10). It is likely that new pews installed as part of this work, were placed on a new floor at the same time.

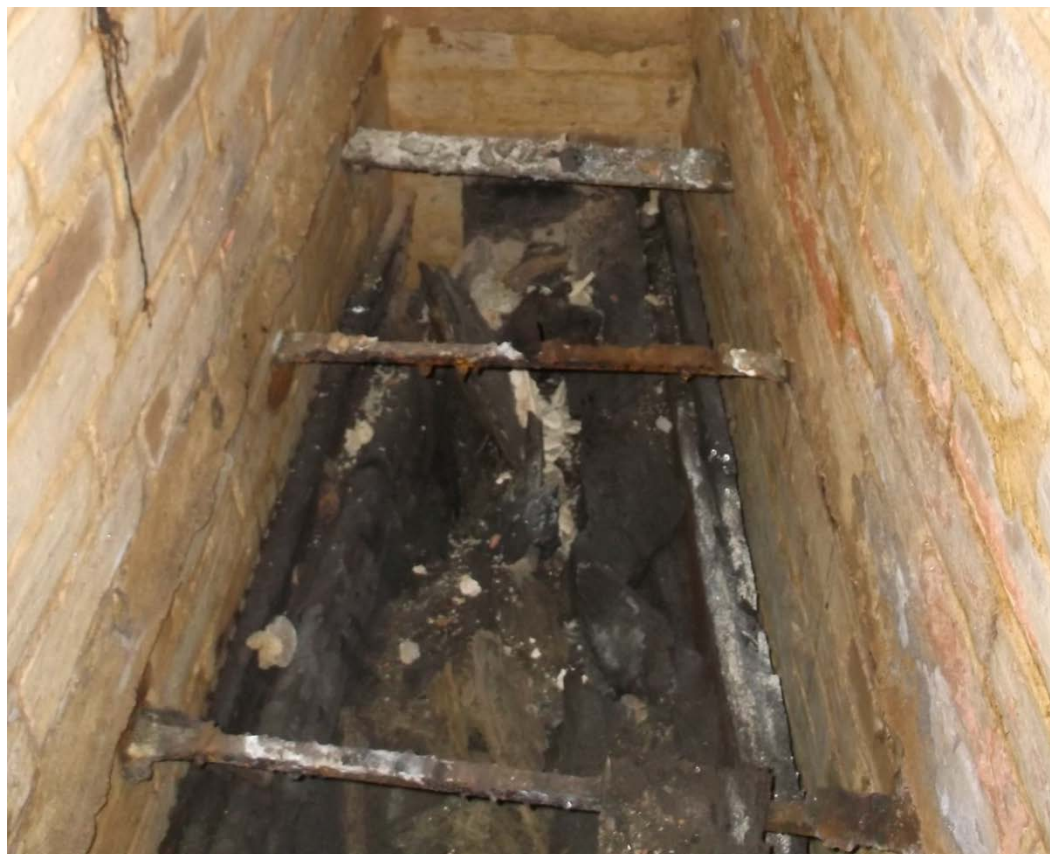
Vault (303), interior looking towards east end of vault Fig 9

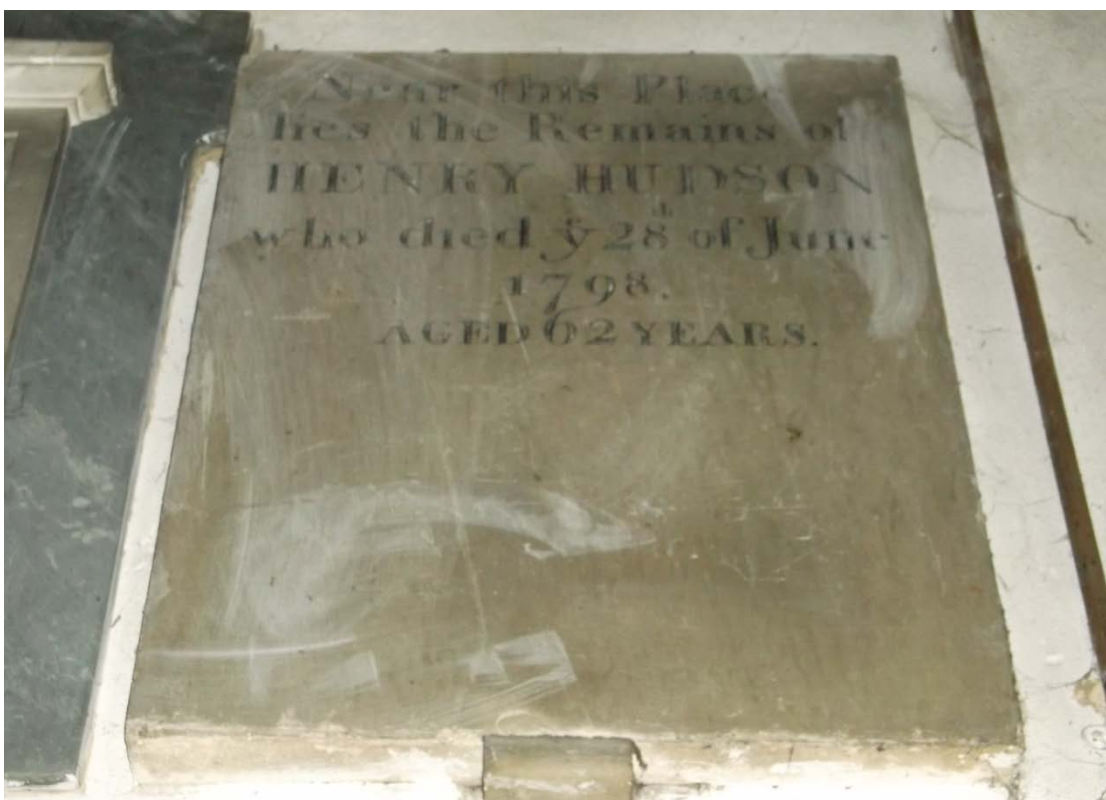
Stone memorial slab with space left for future inscription Fig 11

The identity of the occupant of the vault will probably never be known or why provision was made for another burial above. However, within the church tower a series of wall and floor memorials have been relocated to the interior walls, probably as a result of refurbishment of the nave interior. One relocated floor memorial had an inscription on the upper portion only, the lower portion left blank possibly in anticipation of a spouse who never was interred in the same place. The inscription reads: *Near this place lies the remains of Henry Hudson who died y 28th June 1798 aged 62 years* (Fig 11). It is tempting to suggest that the inscription is related to the grave vault, but as further examination of the vault interior is no longer possible, this may never be proven unless perhaps the opportunity arises for further documentary research.
