**Archaeological investigation within the  
Elizabethan garden area  
Kenilworth Castle, Warwickshire  
2004-2008**

Report No. 15/53

Authors: Brian Dix, Stephen Parry and Claire Finn

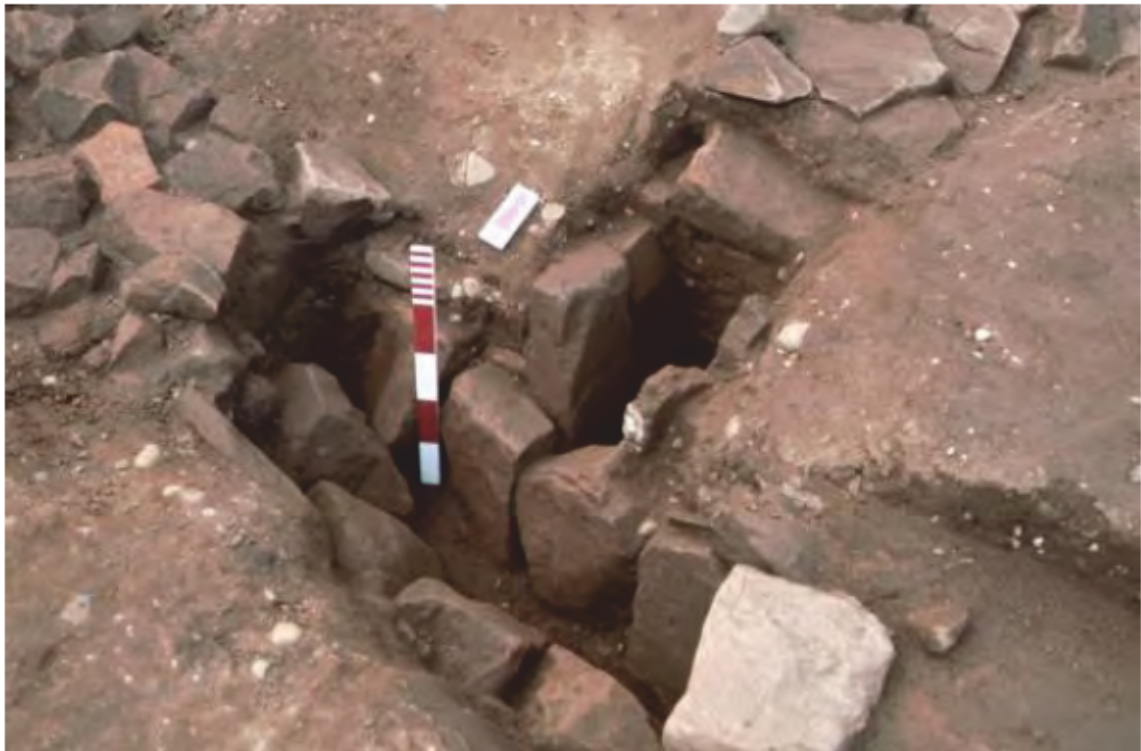
Medieval drain Fig 18

Part of a square-sectioned drain built of loose sandstone blocks was located towards the west end of the garden. It was constructed with walls of vertically-placed rough slabs of sandstone with a horizontal slab above to form the capping (Fig 18) (556/553-559). The whole was set within a wide construction trench closely filled with densely packed small sandstone fragments. There was no lining at the base of the drain and it is not clear in which direction it flowed since only a short section was exposed. It cannot be closely dated beyond its stratified position, which shows that it is earlier than the sixteenth century. The fact that it was made of unmortared stone and without a lined base, indicates that it was a drain and not a culvert carrying a water supply.

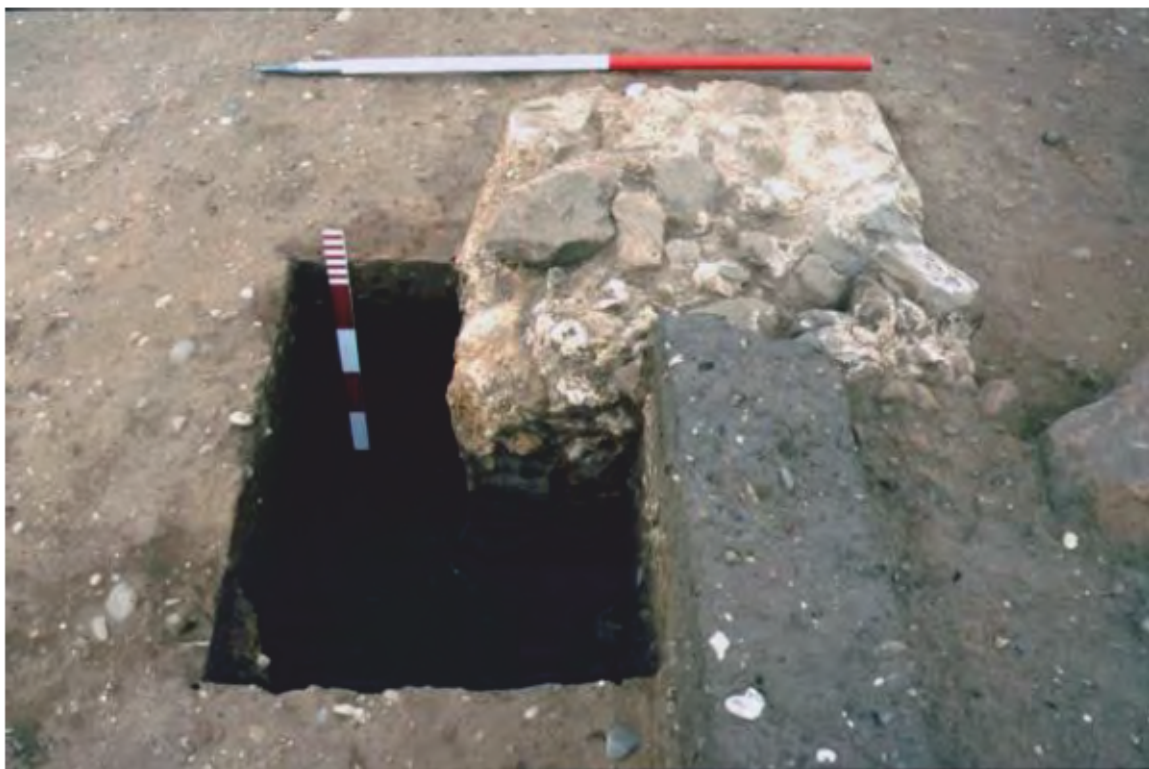
Sandstone and mortar base (5362) Fig 27

A further undated sandstone-and-mortar rectangular base (5362) was located in the north-west quarter of the garden, probably intended for an upstanding structure such as a plinth (Fig 27). The base was well constructed, trench-built and deeply founded (0.7m x 0.6m x 0.6m deep). Its construction does not resemble any of the other bases and it is therefore uncertain how, if at all, it relates to the Elizabethan or later gardens. It has no corresponding pair in any other quarter plot and therefore cannot easily be equated with a centrally-placed structural element such as one of the obelisks. Its size and depth of construction does, however, imply that it supported a substantial object.

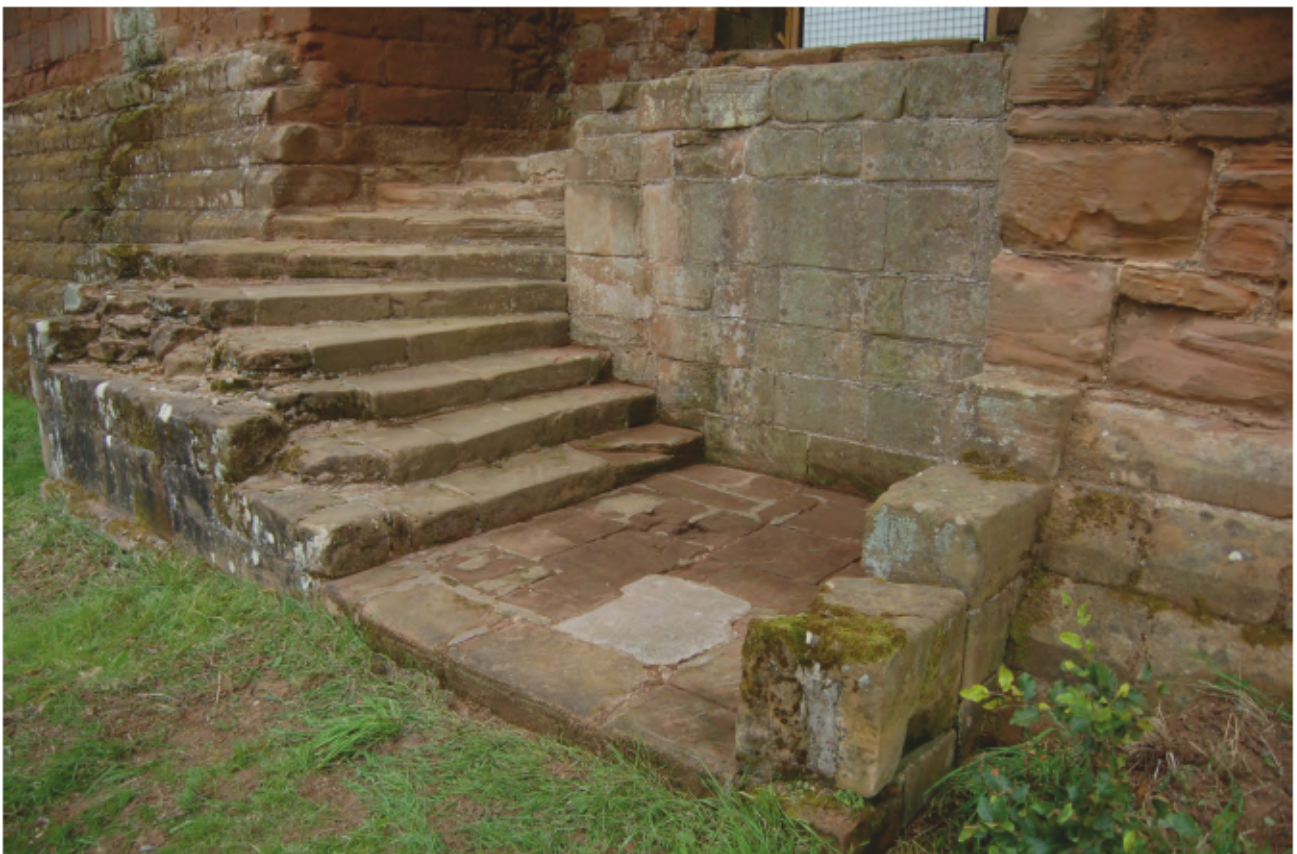
Sandstone stairs and platforms leading from the forebuilding arch Fig 38

A flight of sandstone steps formerly led down from the forebuilding onto the terrace. Whilst perhaps in part of sixteenth century or earlier date, almost all of the lower section appears to have been constructed during the twentieth century. They remain *in situ* beneath the wooden steps by which the new garden is entered but were fully recorded in advance. The outer surface of the steps comprised dressed red sandstone blocks, mostly cut from single pieces of stone, but with occasional onsets where they had become damaged or worn. The joints appeared to be pointed with cement. From their start beneath the forebuilding arch, the steps curved in an anti-clockwise direction down to a quarter landing directly below and giving out onto the terrace (Fig 38). Both the steps and lower landing projected beyond the north face of the forebuilding and butted up against the chamfered blocks of the keep, showing them to be of later construction (Fig 39).

Trench 2 extended as far as the base of the steps and showed that the flight sat directly on top of the upper soil layer of the terrace with hardly any foundation. It appears therefore that the projecting section, if not the entire whole flight of steps, is modern and presumably inserted after the castle came into the care of the Office of Works.

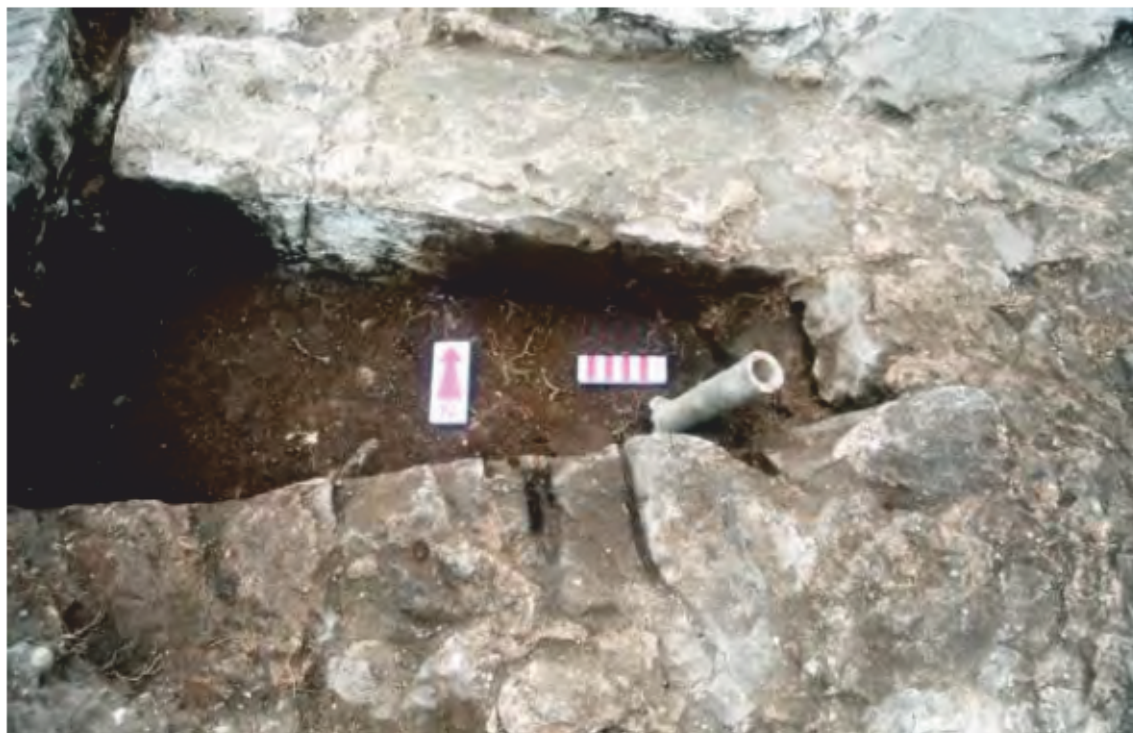
Lead pipe fragment, found *ex situ* in the fountain foundations Fig 47

Given the nature of the site, there are few finds which can be directly associated with the use of the Elizabethan garden. In total 39 finds were recovered from deposits relating to around this period. The majority were recovered from the garden make-up layer (501), with lesser numbers found in drains (557, 5291, 5292), the fountain (560, 565) and packed foundations (5107, 5370); most appear to be residual finds of medieval date. Among finds which probably date to use of the garden is the fragment of lead waterpipe from the fountain (560). The seamless lead tube is 5mm-9mm thick and 38mm in diameter, and has a cut length of 165mm (Fig 47, SF 139).

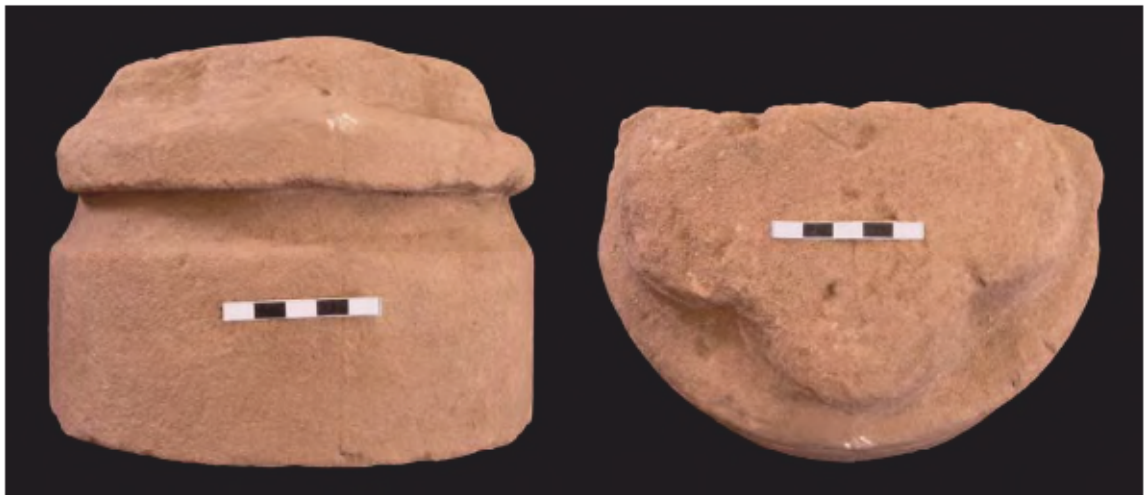
The base of three shafts, early fourteenth century, T1001 (SF129) (5392)  
(Scale 50mm) Fig 54

From the topsoil is the base for a group of three shafts and seems to have been originally part of an ashlar block (Fig 54). The circular plan of the base, the tooling, and the vertical profile suggest a date of the early Decorative Period (c1290-1325). The shafts have a small diameter (c80mm) suggesting a fixture or fitting, such as a church sedilia. It most likely originated from Kenilworth Priory.

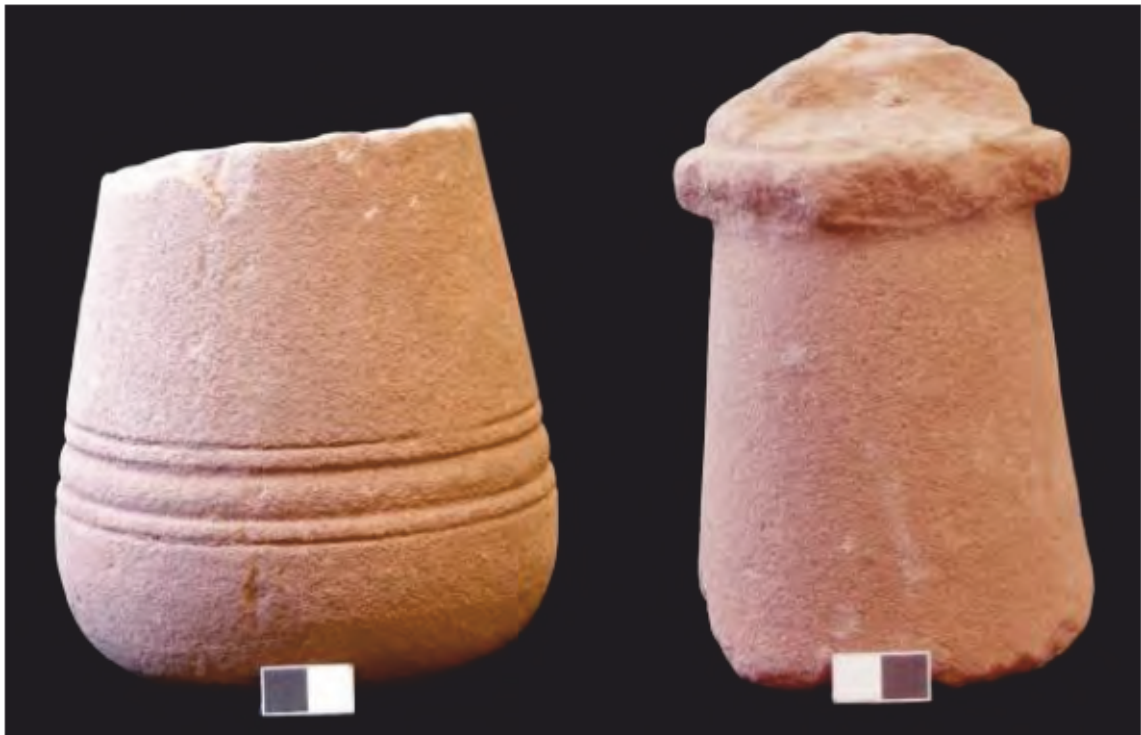
Stone baluster T1002 (SF2) (407/109) (left), and upper baluster found previously (right), (Scale 20mm) Fig 55

The only carved stone considered to be from the Elizabethan or Jacobean garden period is a fragment of a double-bulb baluster made from New Red Sandstone which had been discarded in the upper fill of the Civil War ditch (407/109) (Fig 55). It has typological similarities to another fragment found previously at the castle and which was formally held in the English Heritage store (see below section 13, T1002).

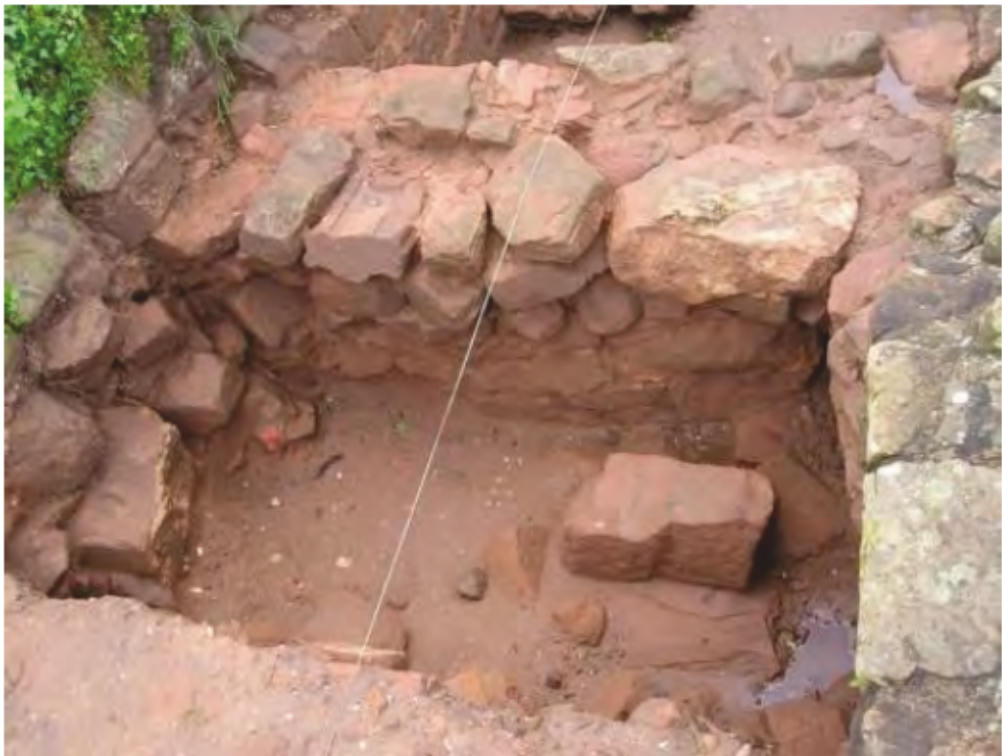
Vousoir stone T1007 *in situ*, reused in wall (602) Fig 57

This thirteenth-century voussoir was reused in the wall foundation (602) near the west end of the terrace (Fig 57). It originally had roll, hollow and fillet mouldings. Almost identical parallels are to be found among the material in English Heritage storage (88112667), and a piece preserved in the Lapidarium Wall at Kenilworth Priory site. Piece T1007 probably originated from an elaborate door or window arch at the priory.

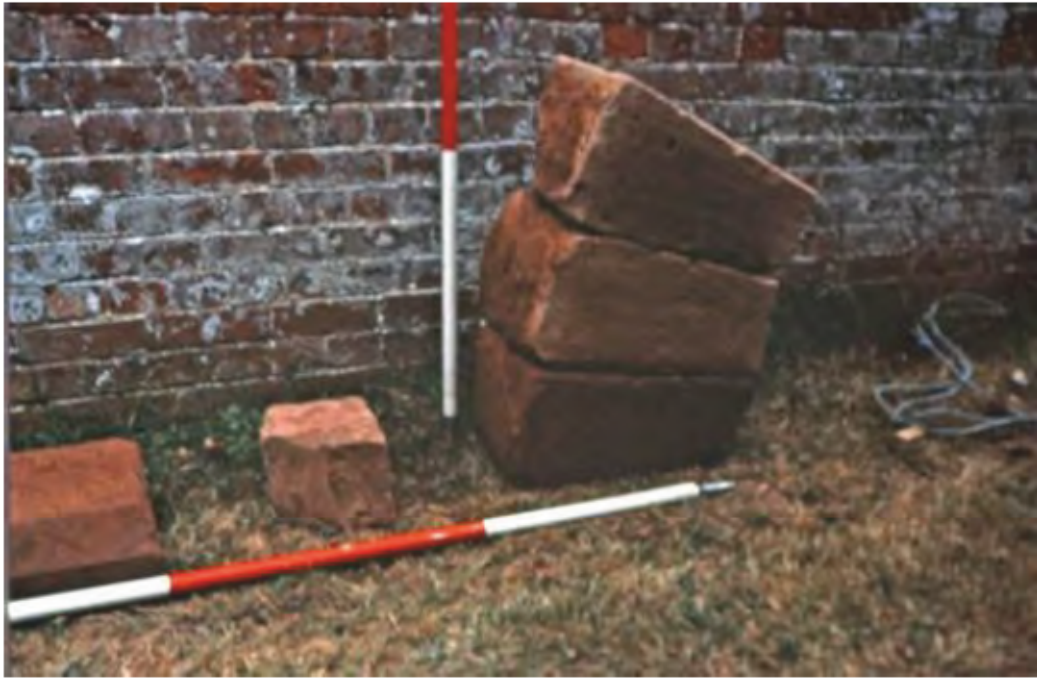
Voussior stones from the postern tower (1111) (scale interval 0.5m) Fig 59

A quantity of large worked stones from demolition layer (1111) around the foundations of the postern tower is probably debris from when the tower was slighted in 1650. Three types can be noted, all displaying diagonal linear tooling diagnostic of the twelfth and early thirteenth centuries. T1011 (SF121) and T1012 are voussoirs from large apertures, the former with chamfer moulding and the latter plain (Fig 59). T1013 is a length of plinth with a 75mm chamfer moulding. No exact parallels can be drawn with extant stonework in the castle although the similarity with the De Clinton fabric of the keep suggests that the stones are twelfth century rather than later. This in turn implies that the postern tower, from where these stones originated, was constructed in the twelfth century probably during the reign of Henry II, and therefore predating the later parts of the north curtain wall.
