**Historic Building Recording  
and Archaeological Observation at  
Holywell Hall Stable,  
Lincolnshire  
January 2015**

Report No. 15/74

<b>PROJECT DETAILS</b>		OAS/S molanort1-210076	
Project title	Historic Building Recording and Archaeological Observation at Holywell Hall Stable, Lincolnshire. January 2015		
Short description	<p>MOLA carried out a programme of historic building recording and archaeological observation at the Palladian style stable block located within the Holywell Hall estate. The stable is Grade II listed and dates to the early 18th century, showing evidence of a large scale program of enlargement and re-facing in the mid-18th century. In addition there have been internal alterations and partitioning relating to its most recent use as offices. Holywell Hall itself is Grade II* listed and also dates to the early 18th century, perhaps replacing an earlier medieval structure.</p> <p>The archaeological observation was carried out during ground works. Two trenches were observed and three archaeological features were identified, comprising post-medieval brick-lined drains.</p>

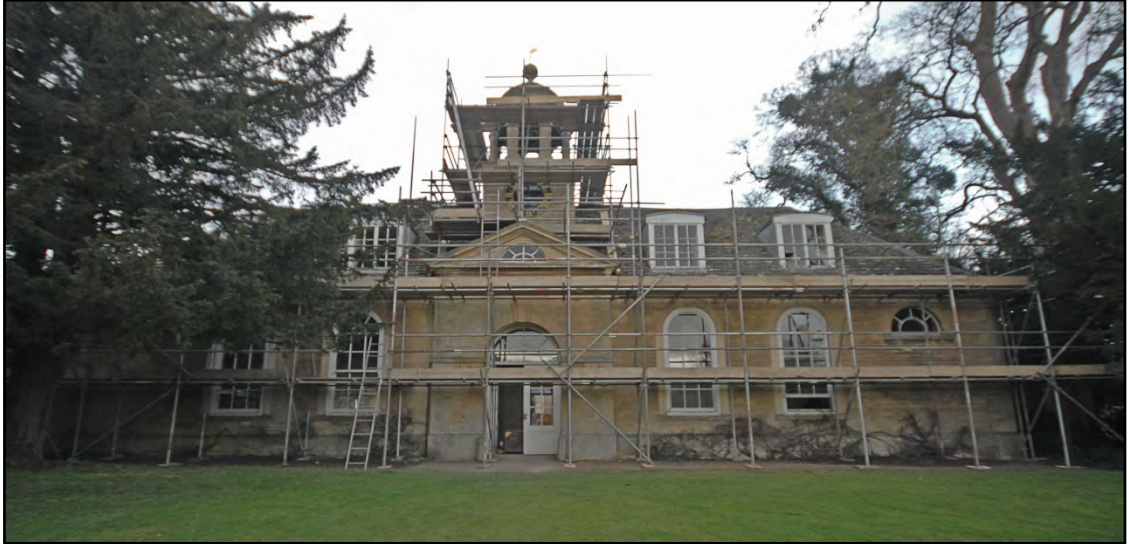
The south elevation, looking north Fig 2

The south elevation has a central pedimented entrance, projecting from the elevation, flanked by pairs of tall, arched windows with sliding sashes (Figs 2 & 3). The pediment has a semicircular light inserted. The entrance can be described as a *Gibbs doorway*, in which the architrave is interrupted by blocks of stone with a large keystone over. The doorway encloses a large fanlight over a white painted double door. A string course runs level with the bottom of the fanlight. A plinth course runs the full length of the elevation.

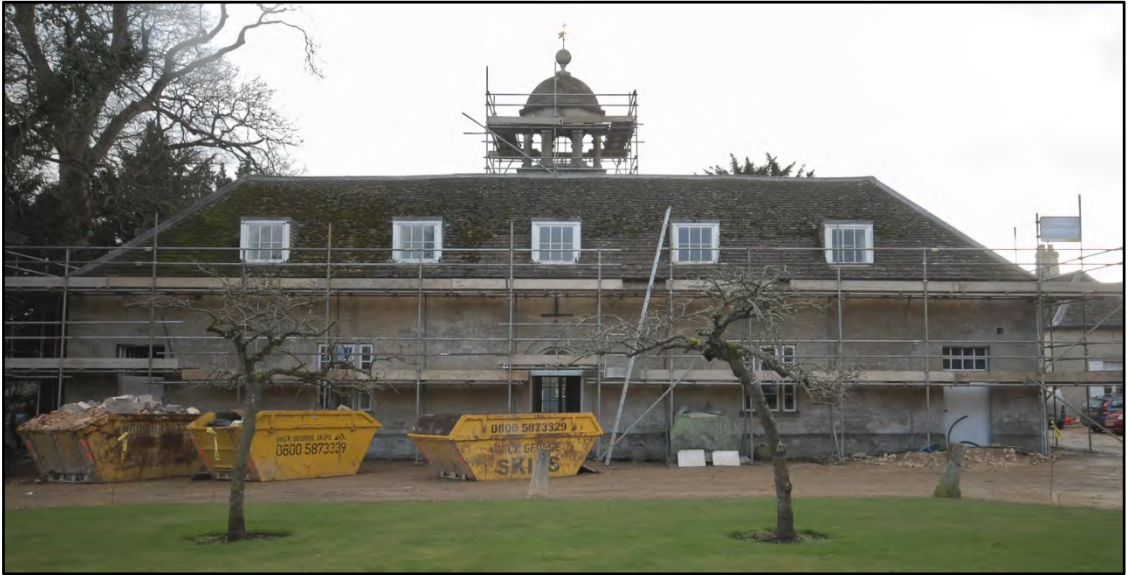
The north elevation, looking south Fig 4

The north elevation also follows the palladian rules of symmetry with a central door flanked by square windows with doors located at the far ends of the wall (Figs 4 & 5). The central doorway has double doors with a fanlight over. The architrave is plain with a keystone at the centre. A wrought iron bracket survives *in-situ* directly over the door, below the eaves. The windows are square with two mullions separating three units, each of four lights. Plain, rectangular stone lintels are presented externally, with timber on the inside face. The doors at the east and west ends of the elevation are fairly plain plank and batten doors with strap hinges, rim lock and latch. These doors each have a rectangular transom window over. There are five equally spaced dormer windows looking north. These are smaller than those on the opposing side of the building and are side hung with six lights.

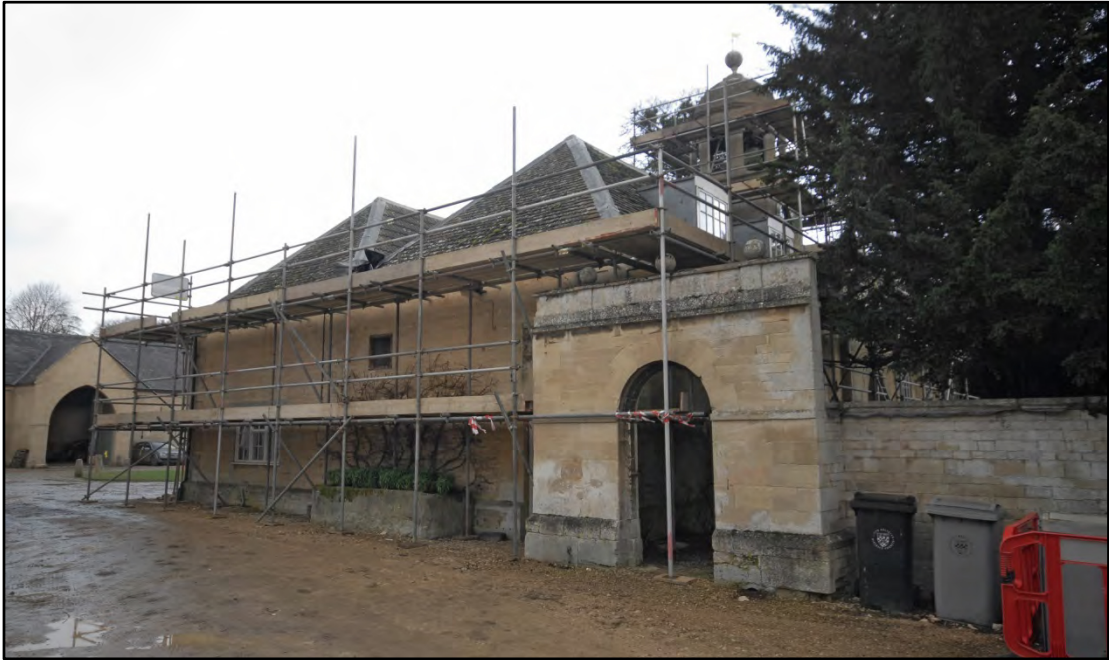
The west elevation with side entrance, looking north-east Fig 6

The west elevation is plain with a single window and a door opening (Fig 6). The door opening is original to the wall but the window is likely to be contemporary with the modern use of the building. Two square holes have also been cut into the wall to accommodate modern ventilation ducts. The plinth course continues around this side of the building.

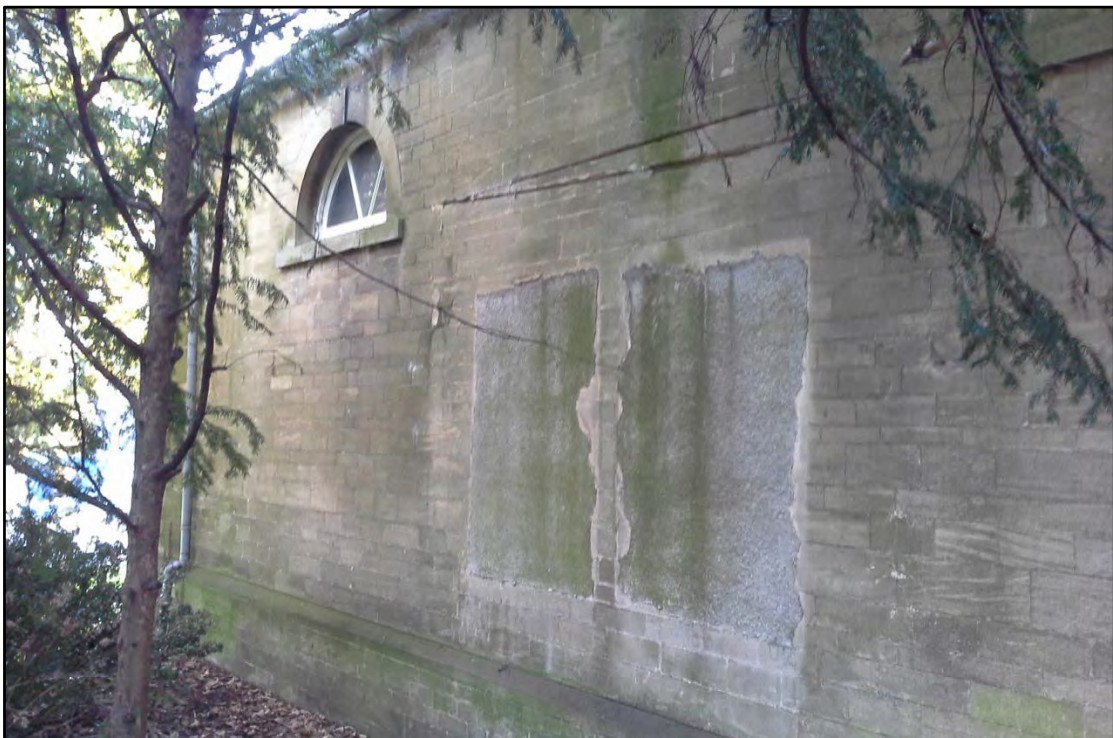
The east elevation, showing the rectangular blockings, looking south-west Fig 7

The east elevation is also plain with two high level semi-circular windows, one of which is blocked in stone. Dormer windows look south from each face of the hip, either side of the valley. Two rectangular blockings can be seen on the external face of this wall, adjacent to each other (Fig 7). These are unlikely to be window openings as no evidence of quoins or lintels are evident. The blockings are not visible from

within the structure and it is likely that a smaller structure was formerly joined to the east elevation at this point. The plinth course continues uninterrupted across this area.

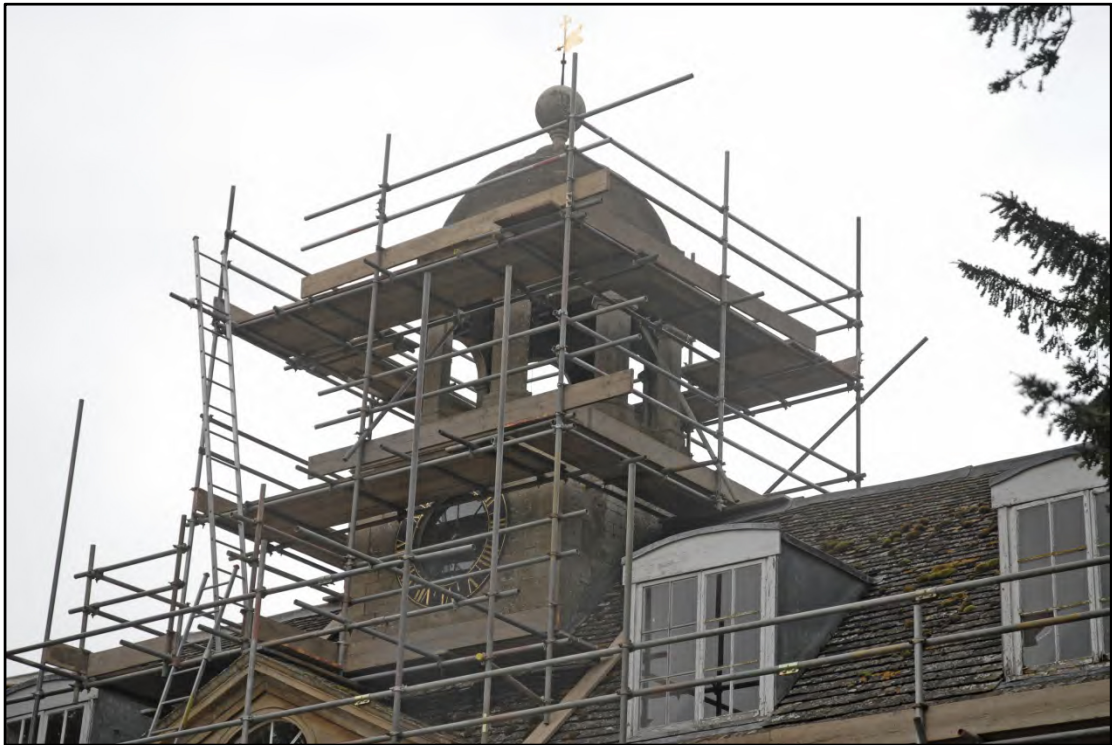
Detail of the lantern and clock, looking north-west Fig 8

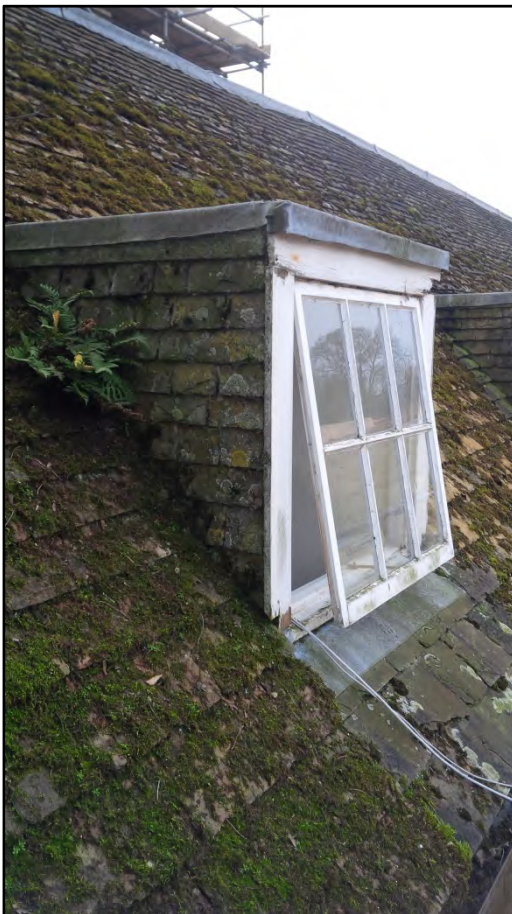
The roof is hipped at the east and west with a valley running east-west, central to the building. The exterior faces of the roof, including the hips are of locally available, squared, collyweston slate tiles whereas the inward facing sides of the central valley are of more modern ridged tiles.

Detail of the dormer windows and roof valley Fig 9

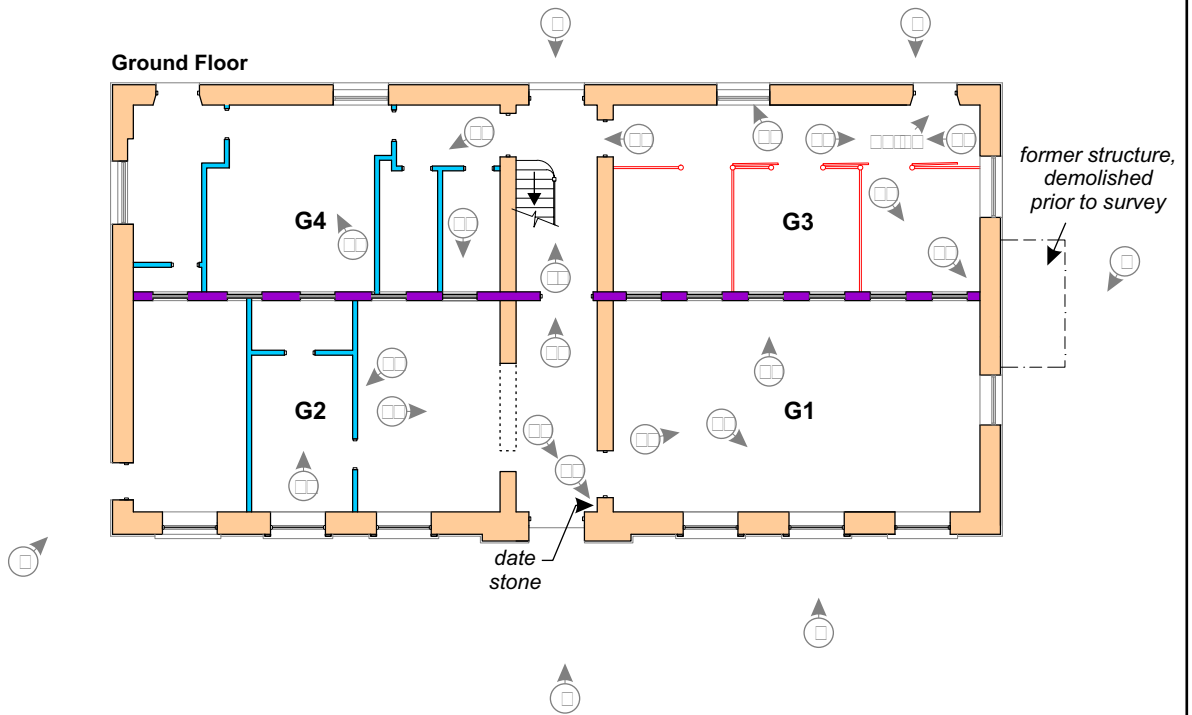
**Room G1** is located in the south-east corner of the building (Fig 10). It retained no fittings relating to its function as a stable save for iron tether rings on the north wall (Fig 16). The room measures c9.7 x 5.m and has a modern concrete floor. A modern suspended ceiling had been removed by the time of this survey. There is a single doorway in the south-west corner and two tall windows look south with a single semi-circular window adjacent. The main windows are recessed with splayed reveals and have pronounced ashlar quoins of varying sizes (Fig 18). The clerestory semi-circular window of the south wall is also set within a full height splayed recess. A clerestory, semi-circular, Diocletian style window looks east, central to the east wall. From the base of the window, the sill slopes downward at a steep pitch. The north wall of the room has a number of blind, arched recesses (Fig 17). The recesses have angled sills which are mirrored on the opposing side of the wall. Small iron tether rings survive in-situ between each recess. Square holes for modern ventilation ducts have been cut into the western wall of the room.

**Room G2** forms the western half of the southern range and measures c9.7 x 5.5m (Fig 10). The original doorway to the hall has been enlarged in modern times to accommodate a wide, arched opening which was knocked through prior to this survey (Fig 19). An RSJ supported by breeze blocks was inserted over this opening. The layout of this room is essentially the same as Room G1 with tall windows looking to the south, flanked by a clerestory semi-circular window (Fig 20). An additional doorway provides access to the west from the south-west corner of the room. The north wall presents a number of blind, arched recesses though no tether hooks survived in this room (Fig 21).

**Rooms F1 and F2** flank the central hall and landing (Fig 10). They are of an equal size, each measuring c9.7 x 5.5m. The first floor rooms are essentially a former hayloft serving the stables below. It was a common feature for there to be a gap around the edges of a hayloft so that hay could be pushed into the mangers from above, though due to the re-flooring of the stables no evidence of this survives. The rooms are primarily within the pitch of the roof with approximately 1m of vertical wall to the eaves. The roof construction is of interest with well-made arched collar trusses spanning the room (Figs 40,41 & 46,47). The west wall of room F1 and the east wall of room F2 incorporate arched collars within the wall, spanning over the door openings. Rather than continuous purlins, the roof structure incorporates staggered butt purlins throughout (Fig 42). Both rooms feature dormer windows, looking south, which are positioned within the butt purlins without interrupting or cutting them. Room F1 has an additional dormer looking to the east. Low stud partitions around the edges of the rooms shrink the interior space away from the outer walls. The facing of the partitions had been largely removed by the time of this survey, leaving only the studwork. The removal of the partitions has exposed two pairs of equally spaced substantial oak tie beams, two per room, which have been cut short (Figs 10, 43, 44 & 48). These beams protrude from the south walls of the two rooms. They are roughly squared with chamfered edges and measure c0.25m x 0.25m. Square peg holes, some empty and some plugged can be seen on two of the beams. On the north wall of the rooms, opposing the beams, blocking or patchings in stone can be seen, indicating where the tie beams formerly attached to the north wall (Figs 10, 45 & 49). As at ground floor, the detailing around the first floor door openings have been picked out with blue paint. A secondary door in the north-east corner of room F2 allows access to room G4 (Fig 50). There is evidence of an earlier, slightly higher floor in the two rooms, in the form of defunct floor joists which are to be positioned

**Rooms F3 and F4** form the northern half of the stable and are accessed primarily from the central landing at the north of the building (Fig 10). Room F4 has a secondary door opening to room F2 in its south-eastern corner. These rooms are near identical in layout to rooms F1 and F2, with dormer windows facing to the south and a roof structure comprising collar trusses and staggered butt purlins (Figs 53-56). The carpentry seen on the roof timbers over rooms F3 and F4 is of a poorer quality than that seen in rooms F1 and F2 where the collar trusses are well made with curving edges. The roof structure here appears to be an imitation of that in the southern rooms though constructed of poorer quality timbers with less skilled joinery. The remains of tie beams seen in the south rooms is not repeated in the north rooms and no earlier, chopped floor joists were evident.

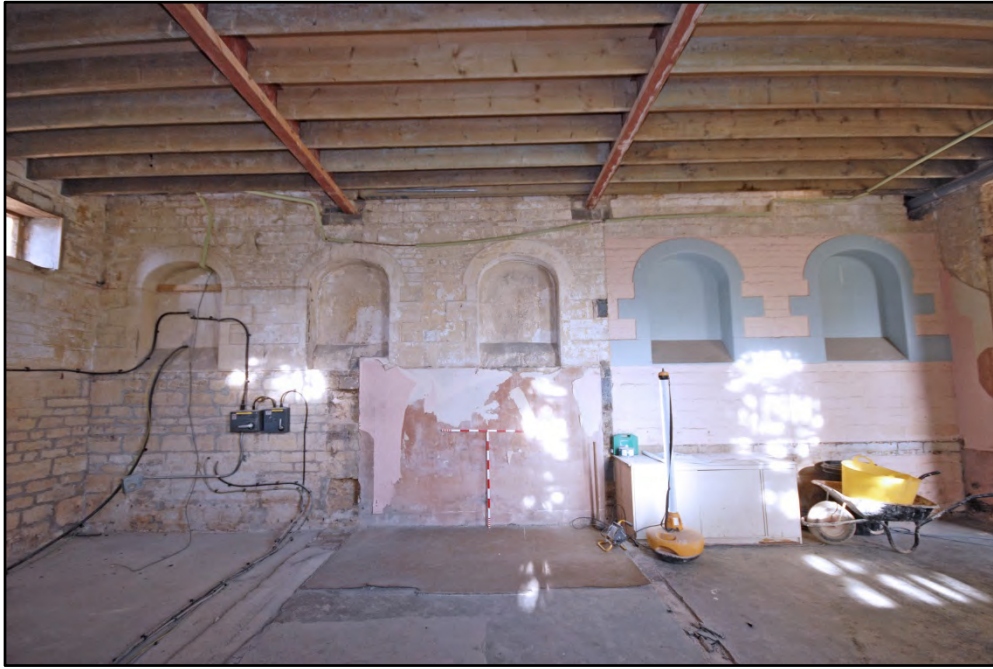
The north wall of room G2, showing the arched recesses, looking north Fig 21

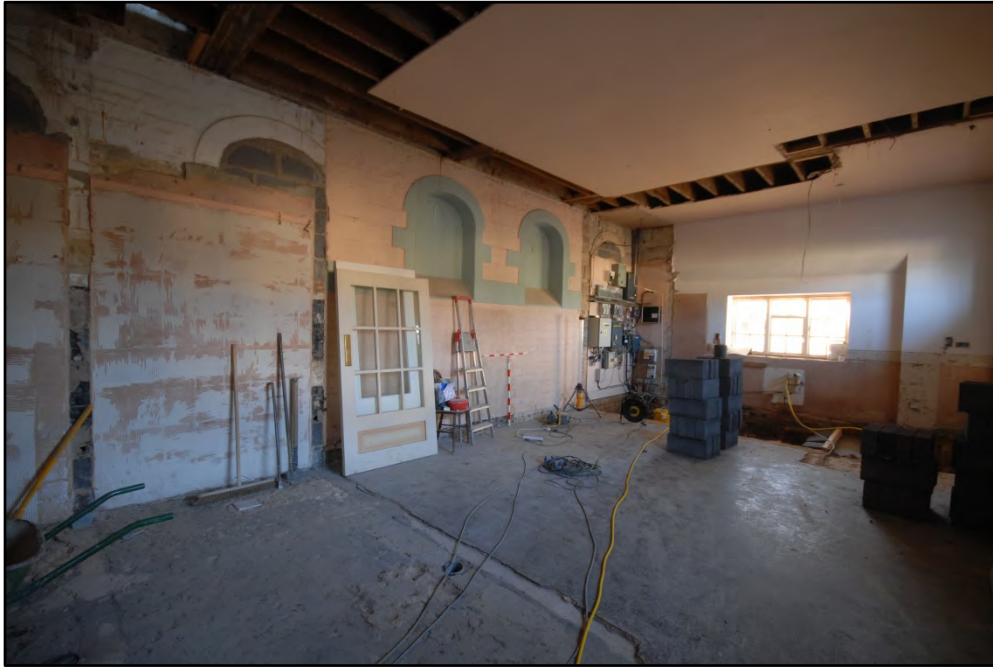
**Room G4** had, until recently, been partitioned for use as a kitchen, toilet, shower, and sitting room. These brick partitions had been removed by the time of this survey. As a result of this partitioning, several of the arched recesses of the south wall of the room had been filled in with modern breeze blocks (Figs 29 & 30).

General view of room G4, looking west Fig 29

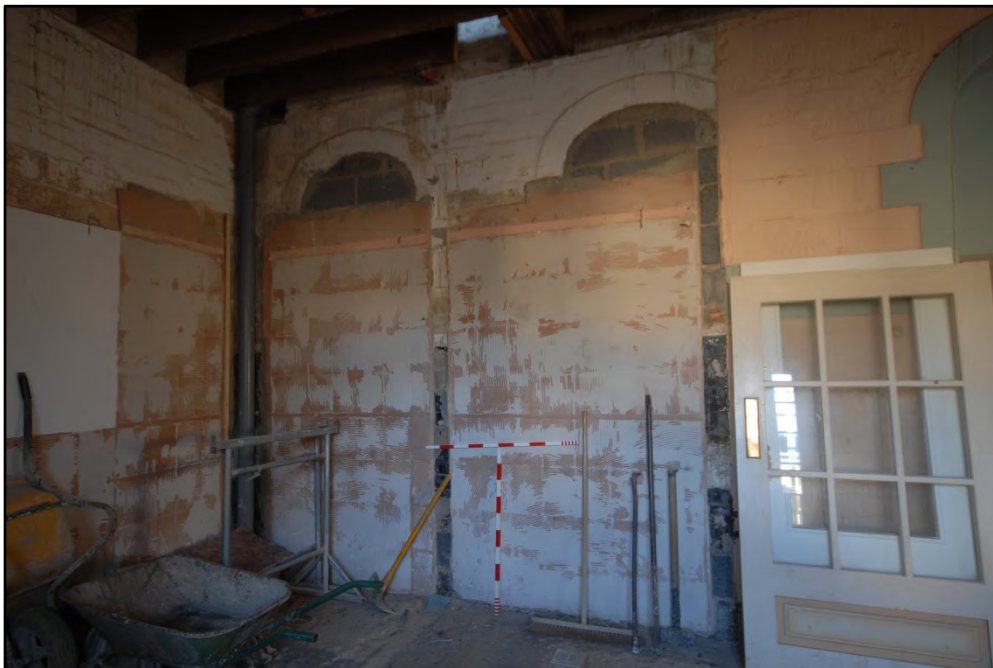
Room G4, detail of the blocked arched recesses Fig 30

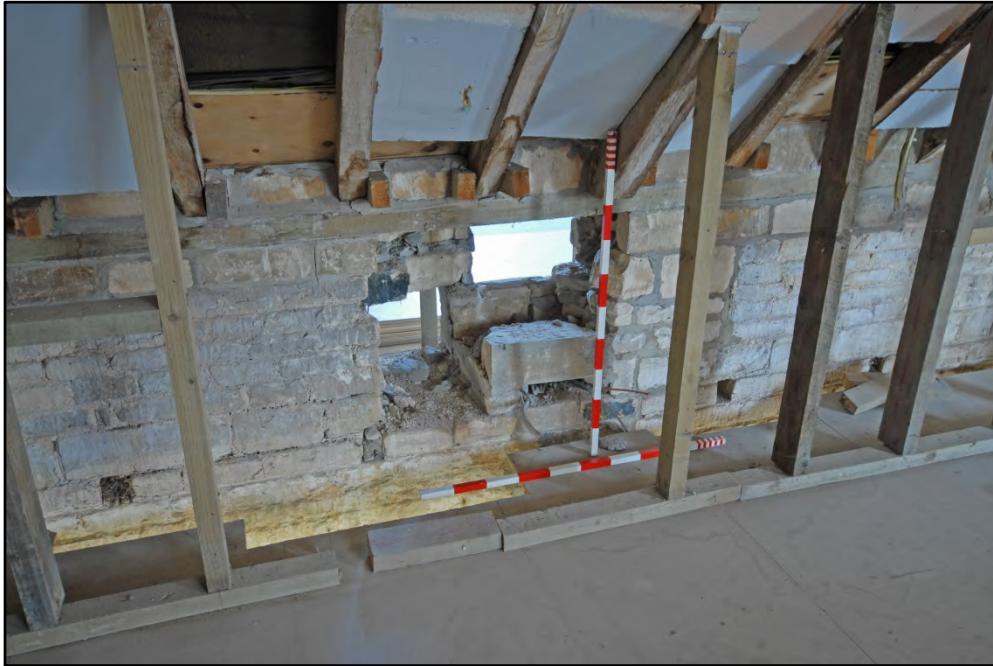
with regular spacing around the full extent of both rooms (Fig 49). The majority of the joists have been cut short, flush with the wall though in places only the joist sockets remained.

Detail of blocking opposite to the tie beam, also showing defunct joist slots, looking north Fig 49

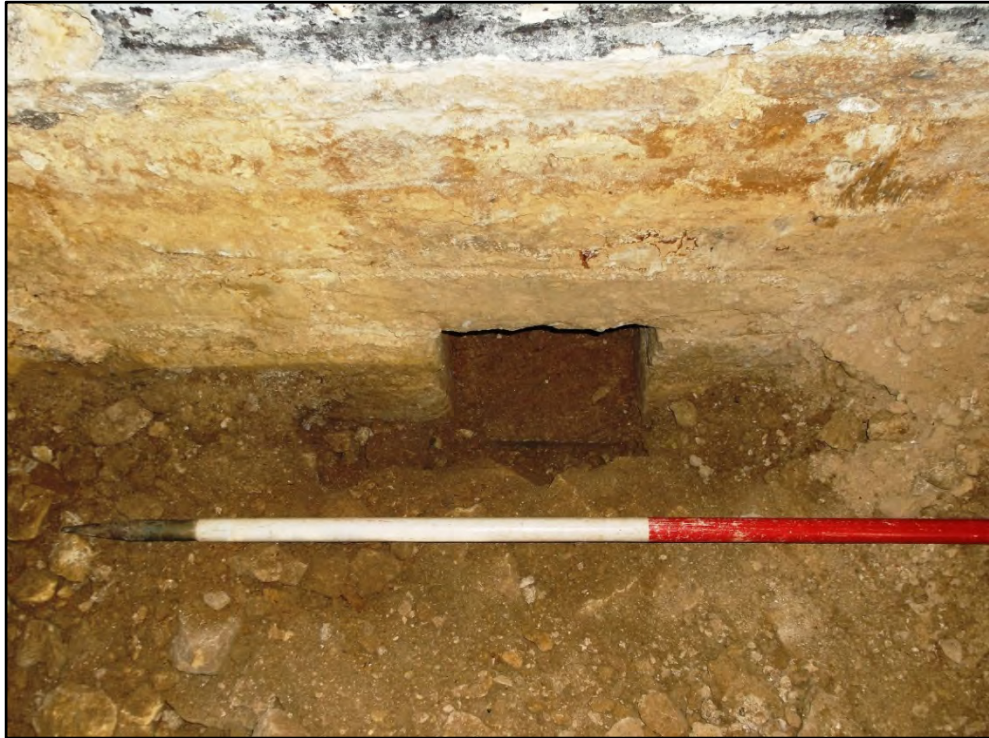
The natural substrate was not observed in this trench. At a depth of between 0.3m and 0.6m below floor level, a compacted layer of limestone rubble and yellowish brown sandy clay loam (103) was found throughout the length of the trench overlying the base. This layer appeared to have been cut by the foundation trench of the east wall of the building. At a point roughly 2m to the north of the south eastern corner of the room, a possible square-sectioned, weep-hole was noted within the eastern wall foundations (Figs 57,59, 63)

Trench 1, possible weep hole in foundations of east wall. Fig 59

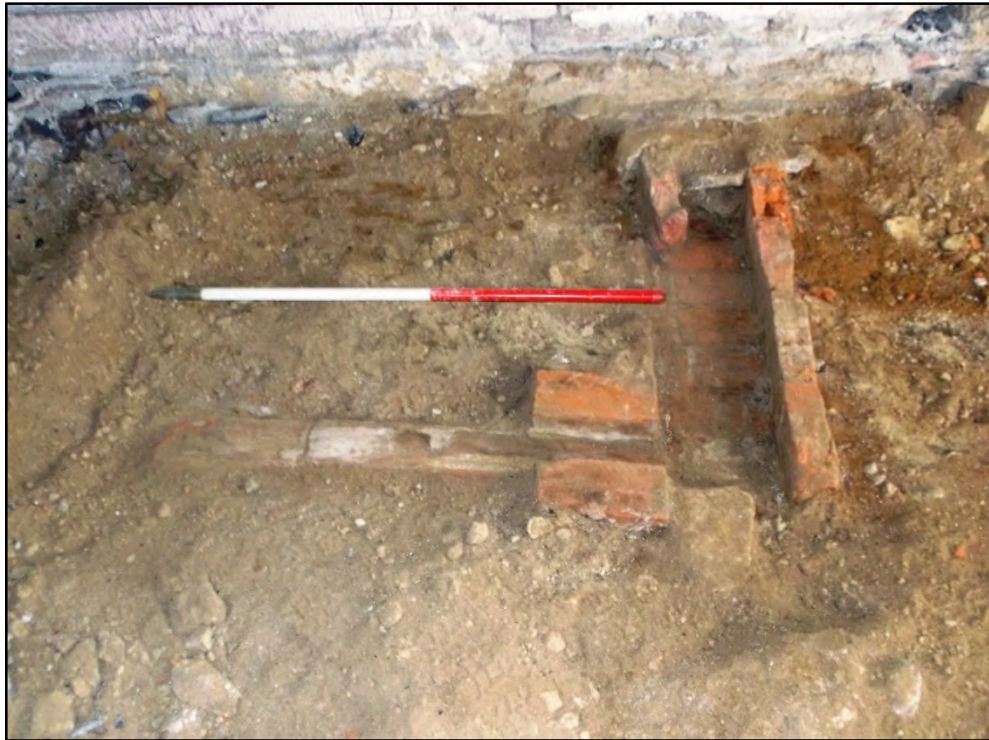
Drain 104 was aligned in an east to west direction in the northern part of the trench (Figs 57, 60). The drain floor comprised horizontally laid bricks the width of a brick stretcher, the walls consisted of two lines of vertically laid bricks, which were capped by horizontally laid bricks. The drain had been badly damaged close to the western side of the trench. Drain 104 was approximately twice the width of the other drains (105, 110) and appeared to be a 'main drain'.

Drain 105 joined 104 at a right-angle and was aligned in a north to south direction towards the north end of the trench (Figs 57, 60). It comprised a narrow base of horizontally-laid bricks, the width of a single brick header, with walls formed by a single layer of horizontally-laid bricks. The drain had been badly damaged with only two bricks surviving from the walls, the capping having been entirely removed.

Trench 1, drains 104 (right), 105 (left) looking east. Fig 60

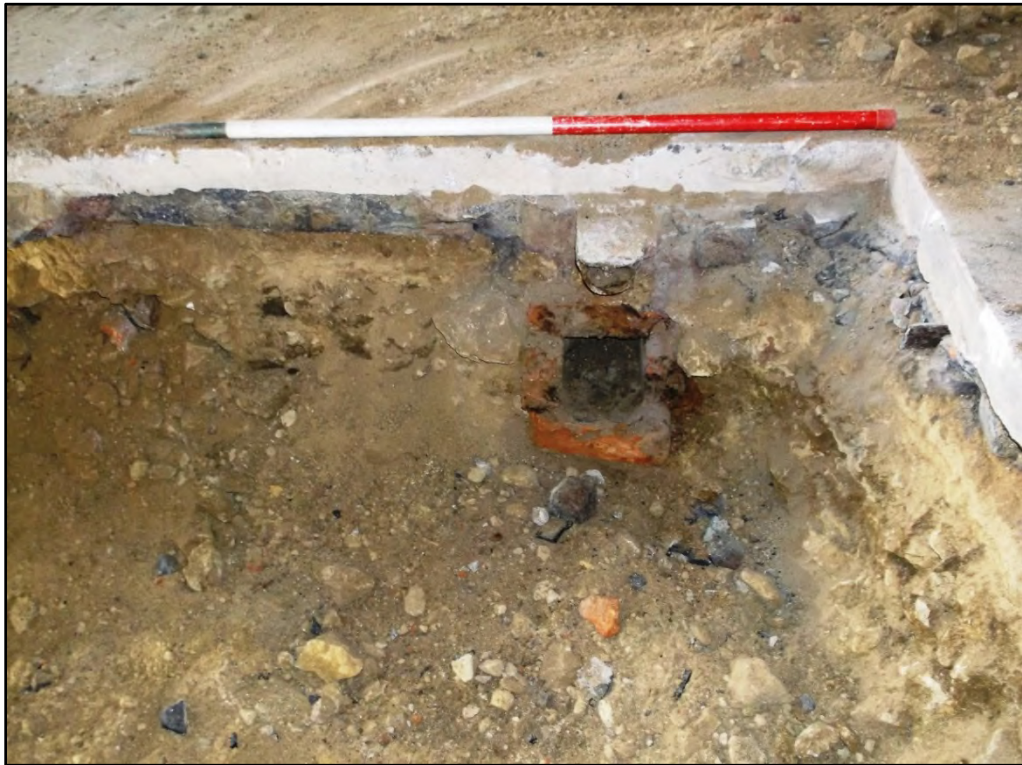
In the extreme north-west corner of the trench, drain 110 was aligned in an east to west direction running parallel with the course of drain 104 approximately 1m to the north. Drain 110 survived in good condition in the east facing section of the trench (Figs 57, 61). It is likely that 110 and 105 may have been linked, however the eastward continuation of drain 110 is uncertain.

Trench 1, drain 111 overlying drain 110 looking west. Fig 61

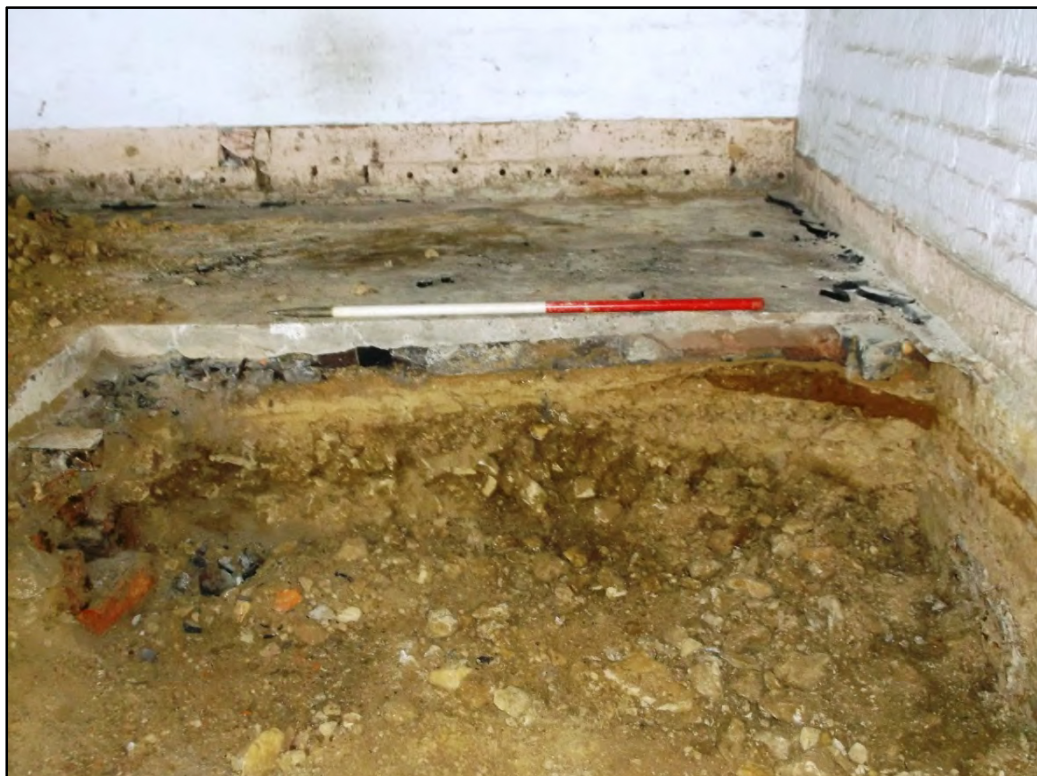
Trench 1, south facing section. Drains 110, 111 on left. Fig 62

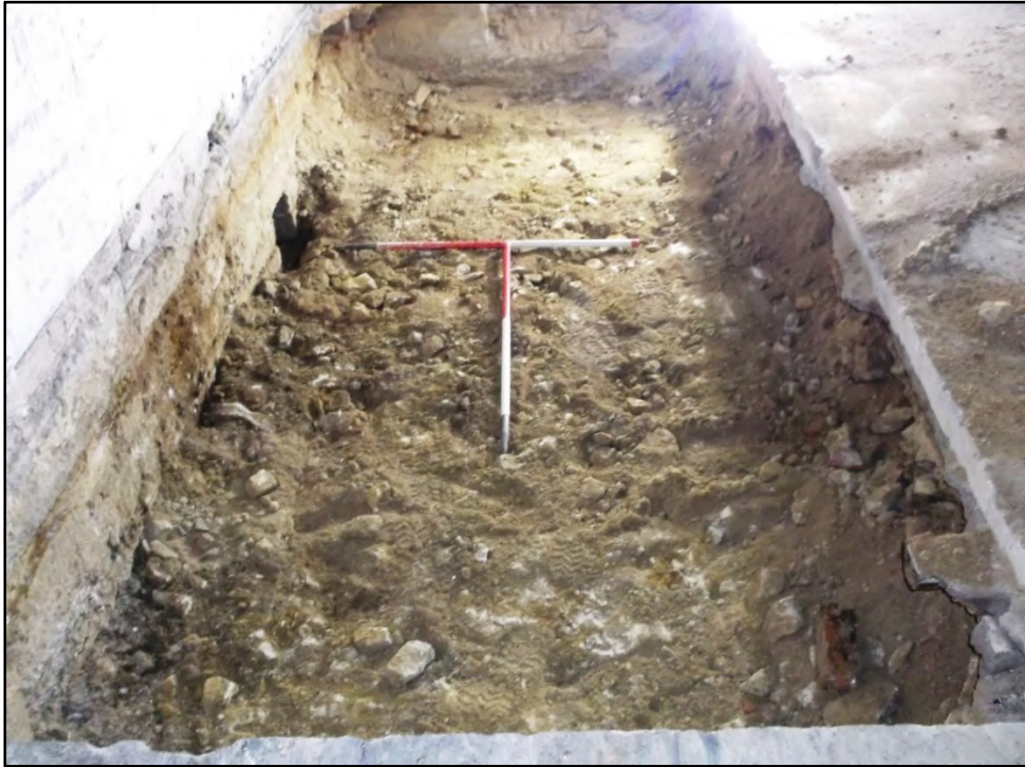
Trench 1 (Figs 57, 63) was excavated by machine in the south-east corner of the stable block, the trench measured 4.5m long by 1.9m wide by 0.6m deep and was aligned north to south. The eastern and southern sides of the trench were formed by part of the east and south wall foundations respectively, of the stable block. The western and northern sides of the trench were cut through the later concrete floor of Room G1 within the building.

Trench 1, looking south after removal of drains. Weep hole on left. Fig 63

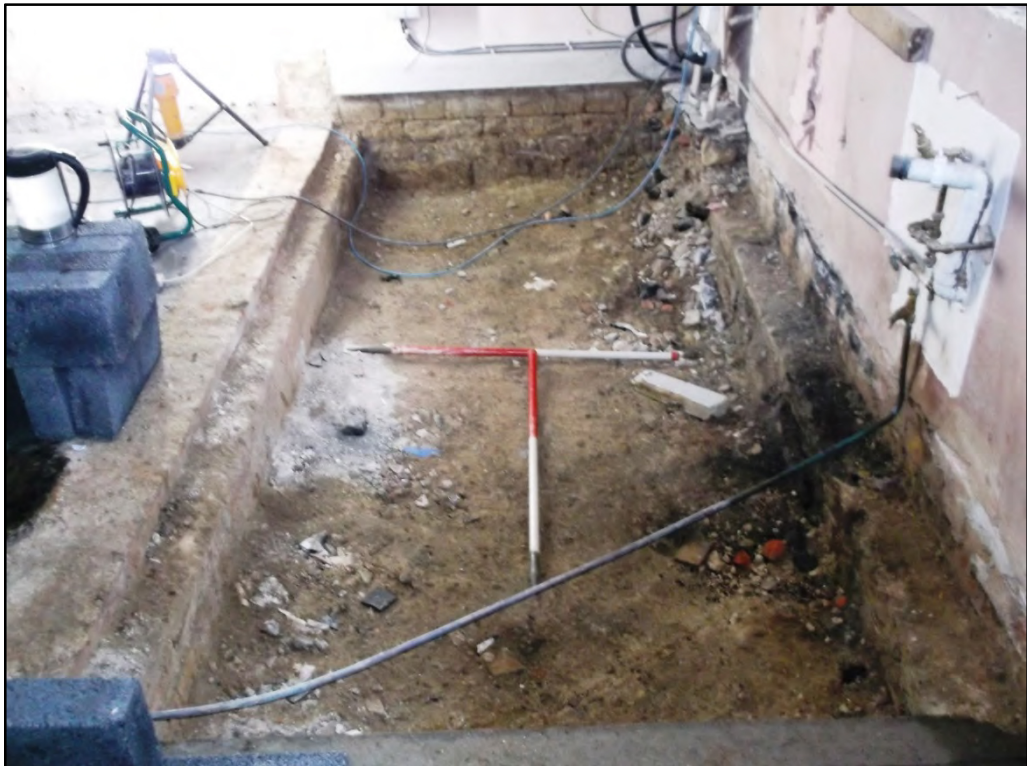
Trench 2 (Fig 58) had been excavated on a previous occasion, within the former kitchen area in the north-west corner of the stable block. Trench 2 measured 5m long by 2m wide by 0.6m deep and was aligned in a north to south direction (Figs 58, 64). The sides of the trench were formed by the external and internal wall foundations of the later kitchen area.

Trench 2 had been deepened to a depth of approximately 1m below the floor level at the north end adjacent to the external kitchen door. The natural substrate was observed at a depth of approximately 0.5m below floor level. The natural substrate consisted of solid, compacted limestone. Overlying this natural substrate were the stable block wall foundations. Within Trench 2, no archaeological features were observed.

Trench 2, looking south. Fig 64
