**Archaeological observation, investigation
and recording on land at
Stanford Hall, Stanford-on-Soar
Nottinghamshire
February-March 2015**

Report No 15/84

A programme of archaeological observation, investigation and recording was undertaken on land at Stanford Hall DNRC, Stanford-on-Soar, Nottinghamshire, prior to excavation works for the installation of electricity sub-stations and associated underground cables. A brick-lined drain, road surfaces and a kerb were recorded. There were no finds.

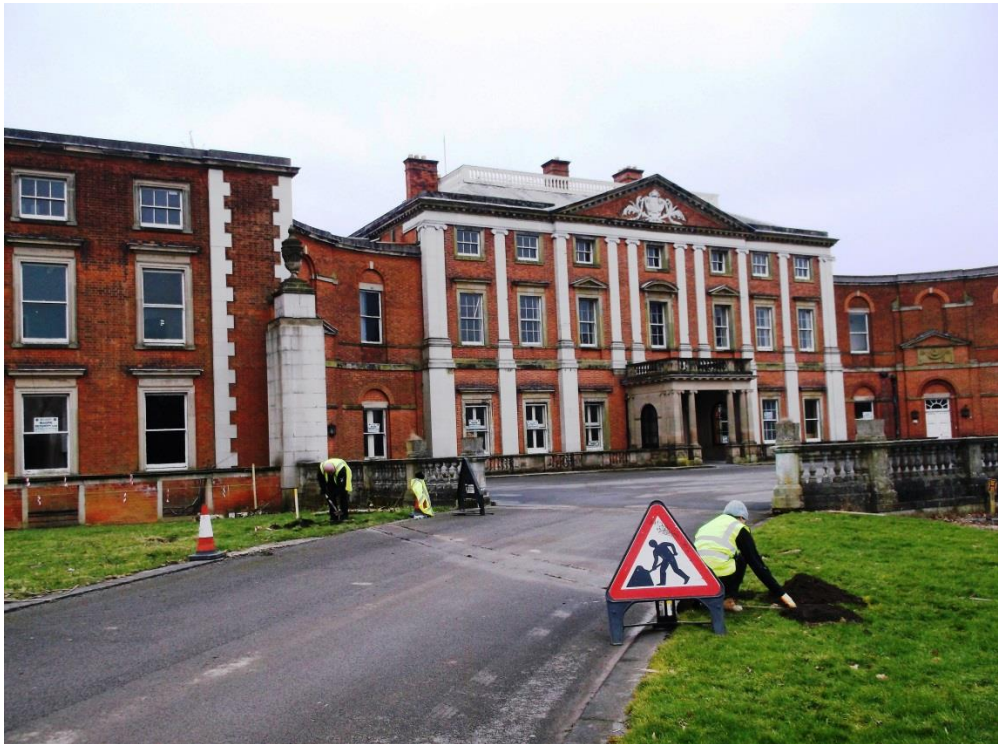
Front cover: Excavation of test pits (TP7-8), Stanford Hall looking south-west
Back cover: North elevation of the Hall

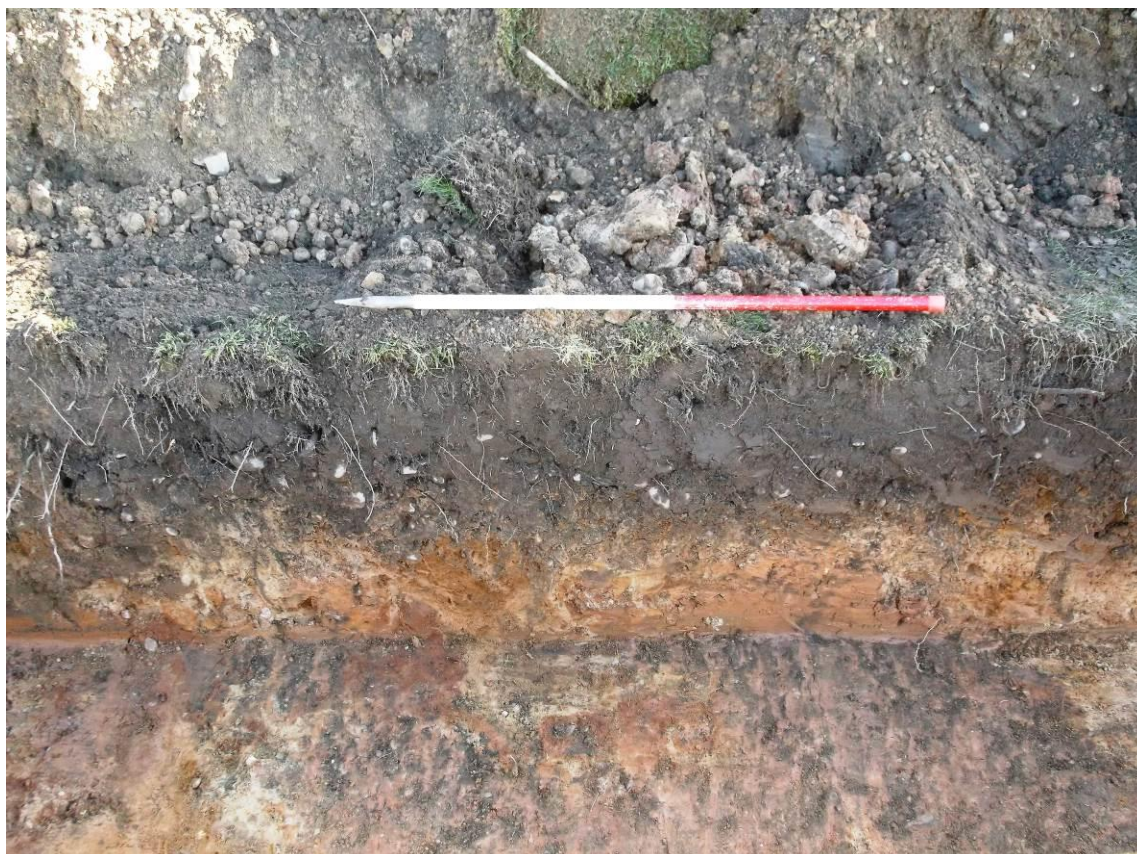
Fig 4

In the eastern area of observation, the natural substrate in the four excavated trenches (T1-4) generally consisted of a mid orange-brown sand and sandy clay with small to large stones and was approximately 0.60m deep from the surface (103, 203, 303, 403). This was overlain by 0.25m thick layer of dark yellowish sandy loam subsoil (102, 202, 302, 402) above which was a 0.3m thick dark grey-brown sandy loam topsoil (101, 201, 301, 401).

Trenches 1, 2 and 3 were generally excavated to c0.6m below the surface. Trench 4 was excavated to approximately 0.8m below the surface (Fig 4). Trench 1 was excavated in order to locate an existing underground live electricity main. This was found on the floor of the trench at c0.6m below the surface, together with two other buried electricity cables, both of which were also encountered in the electricity sub-station trench (T4). No archaeological features were encountered in Trenches 1 and 3, however, in Trench 2, the remains of a badly damaged, brick-lined field drain of post-medieval date was noted in the base of the trench (Fig 5). The drain (204) consisted of un-mortared hand-made red bricks aligned north-west to south-east.

Trench 4, section looking east

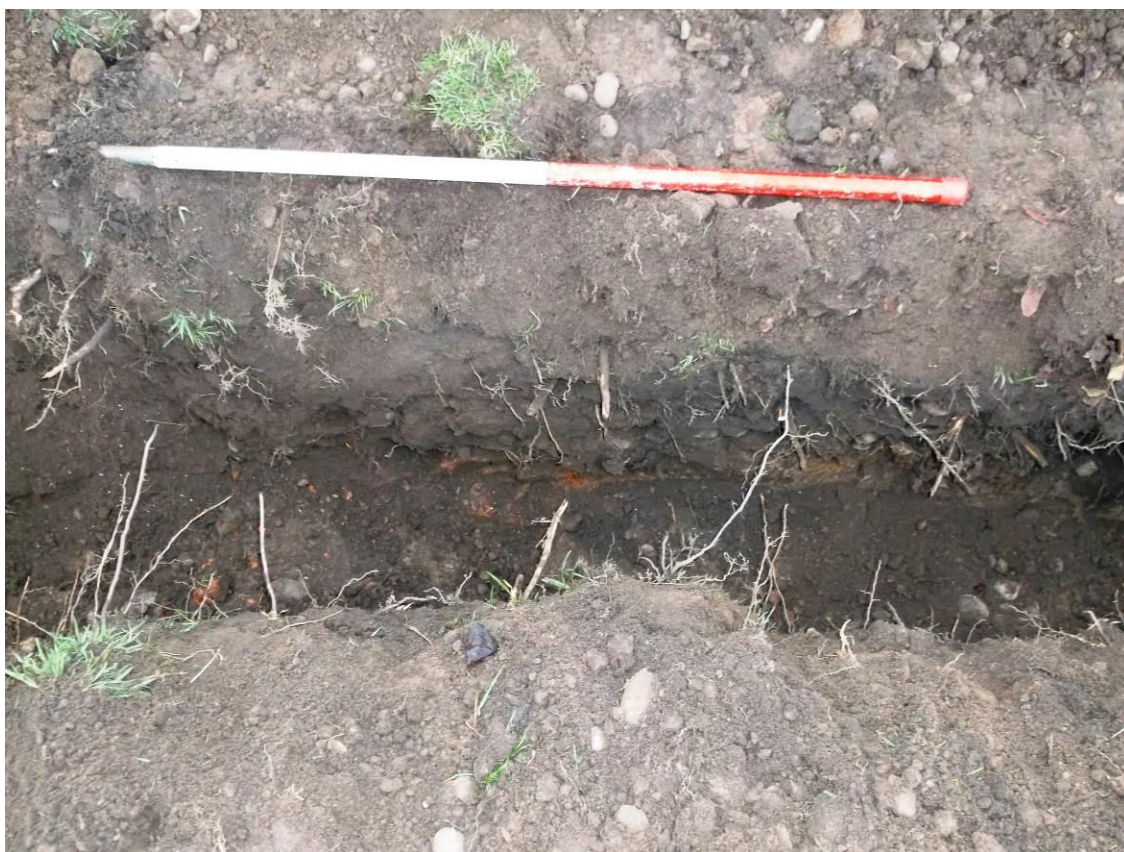
Trench 2, possible brick-lined drain (204), looking south-east Fig 5

The possible brick-lined field drain noted in Trench 2 could be evidence of a 17th or 18th-century drainage system within the park. Within Trench 7, there was evidence for possible post-medieval or modern road surfacing layers. In Test Pit 7 the mortar and brick foundation may represent some form of kerb stone or edging to an earlier, possibly post-medieval or modern access road.

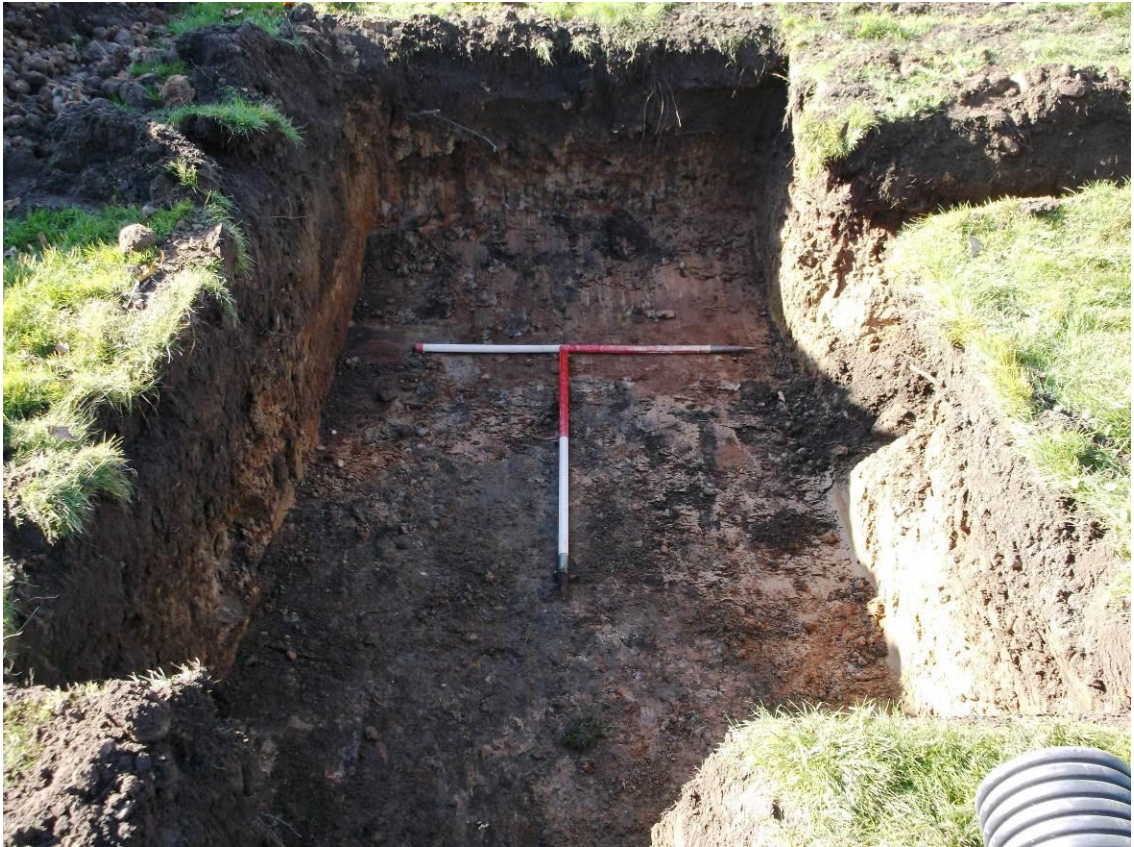
Fig 6

A rectangular trench (T5) measuring 3.0m long by 1.5m wide by 0.8m deep was excavated for the installation of an electricity sub-station at a point 120m to the north of the Hall and 70m west of the former Lido pool (S2 and Fig 6). The natural substrate was a yellowish-brown sand with patches of orange and grey clay at c0.6 below the surface (503) and was overlain by a 0.25m deep, greyish-brown sandy clay loam with numerous small pebble inclusions (502), above which was a topsoil consisting of a 0.3m deep dark grey-brown sandy loam (501). No archaeology was encountered in this trench.

Trench 5, looking west

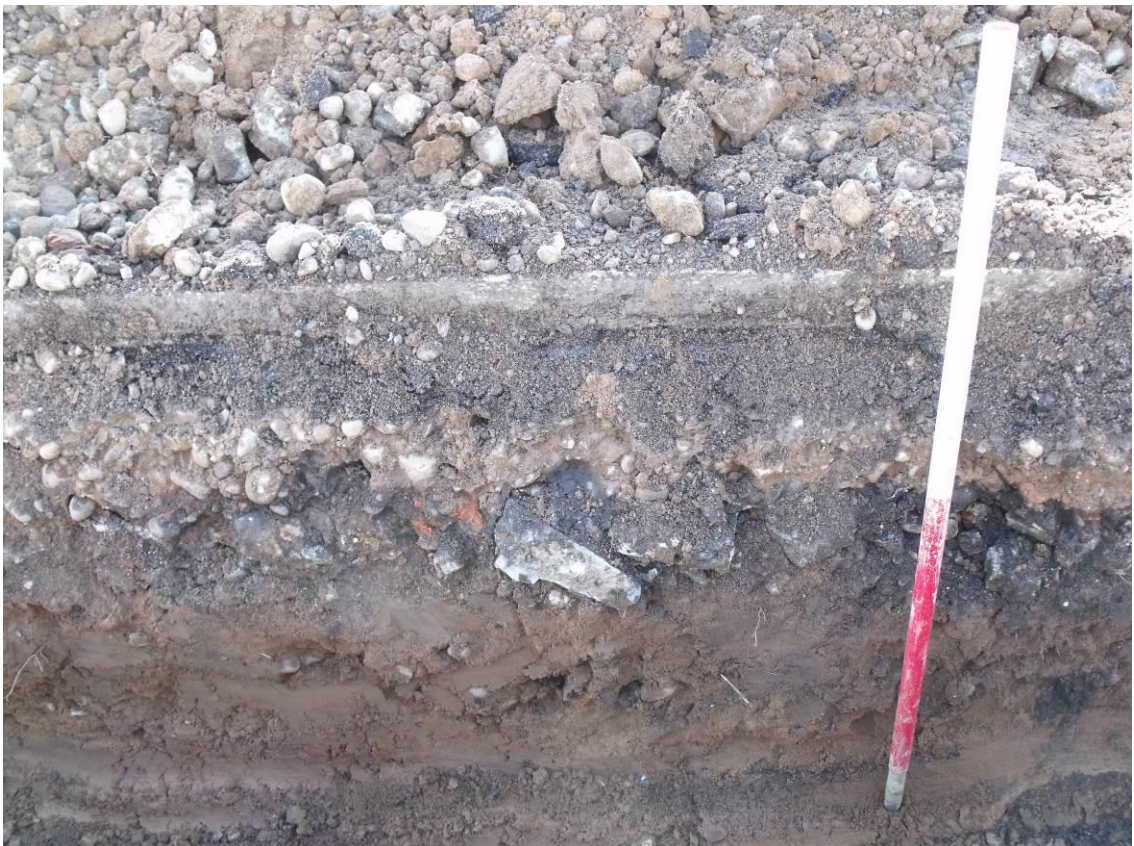
Fig 7

Trench 6, section looking north

Within Trench 6 the natural substrate was a mid-brown sandy clay (606) and was approximately 0.6m below the surface. This was overlain by a 0.25m deep layer of mid grey-brown sandy clay subsoil (605), above which was a 0.14 m deep layer of dark grey-brown gravel with brick and concrete fragments (604), this was overlain by a 0.1m deep layer of sandy gravel with frequent inclusions of small stones (602), above which were two layers of tarmac (601-2), a total of 0.12m deep. No archaeological features were noted in this trench.

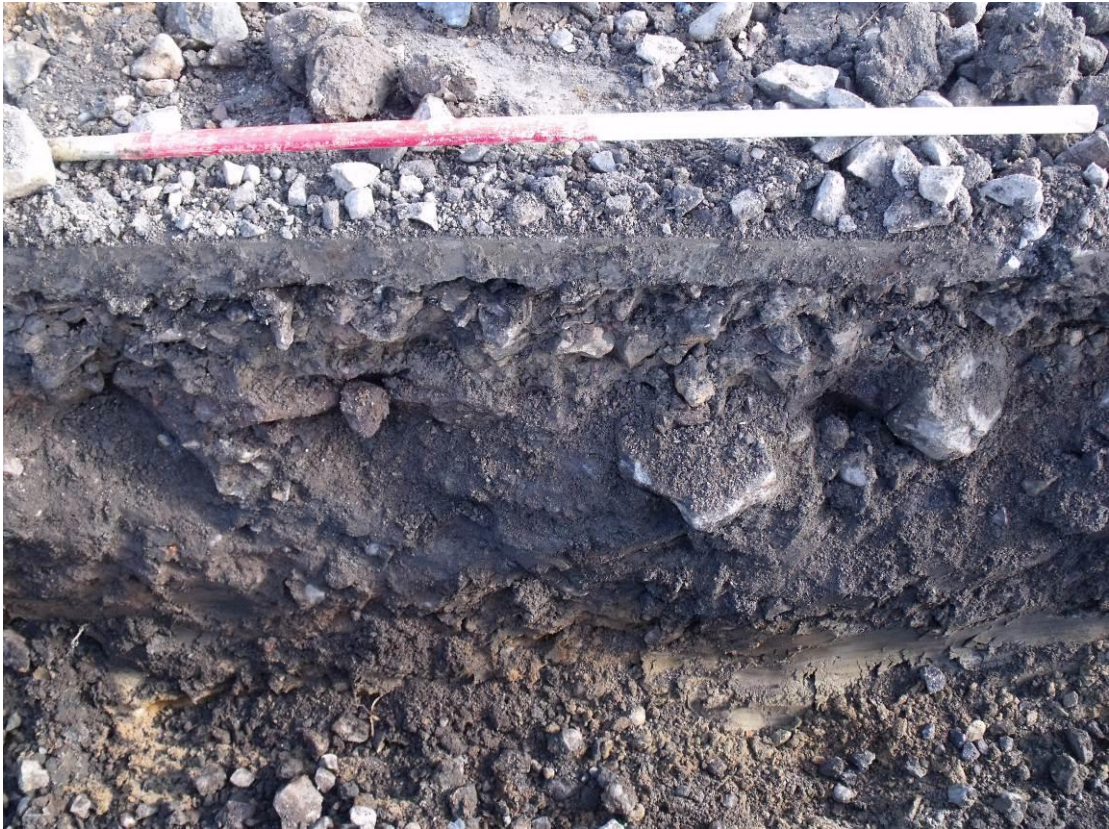
Two small hand-dug test pits (TP3-TP4) were excavated either side of the east-west access road at a point 130m to the north of the Hall and 70m to the west of the former Lido pool. The test pits were completely removed at a later date by a machine-dug trench (T7), aligned north-south, and cutting across the east-west access road (Figs 8-9). The trench extended a further 10m southwards to join with the sub-station trench (T5). The natural substrate within the trench (705) consisted of an orange-brown clay with greyish sandy patches at a depth of approximately 0.65m below the road surface, this was overlain by a 0.21m deep layer of dark greyish-brown clay with gravel and building rubble inclusions (704) above which was a 0.2m deep layer of large stones (703) some of which were more than 0.3m in length. Above this was a 0.18m deep layer of gravel (702) which was overlain by a 0.07m deep layer of tarmac (701). No archaeology was observed in this trench apart from layers (704), (703) and (702) which may represent post-medieval road layers (Fig 8).

Trench 7, section looking west Fig 8

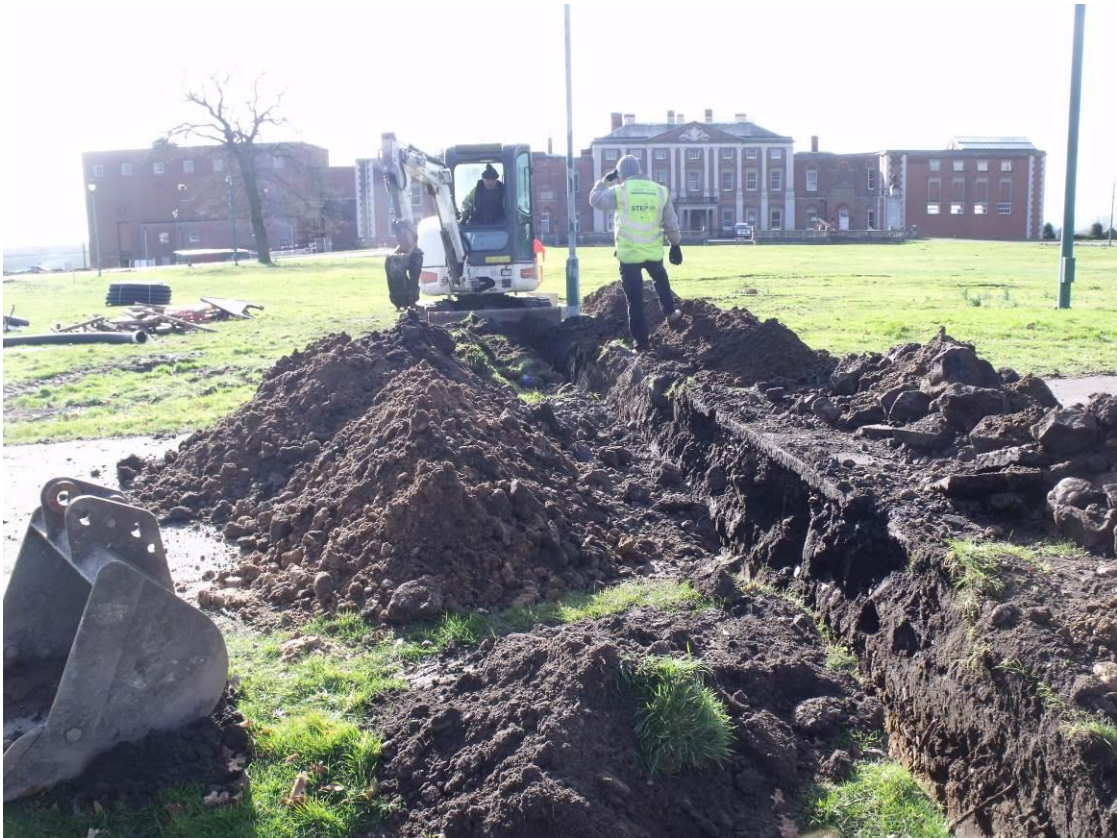
Trench 7 looking south Fig 9

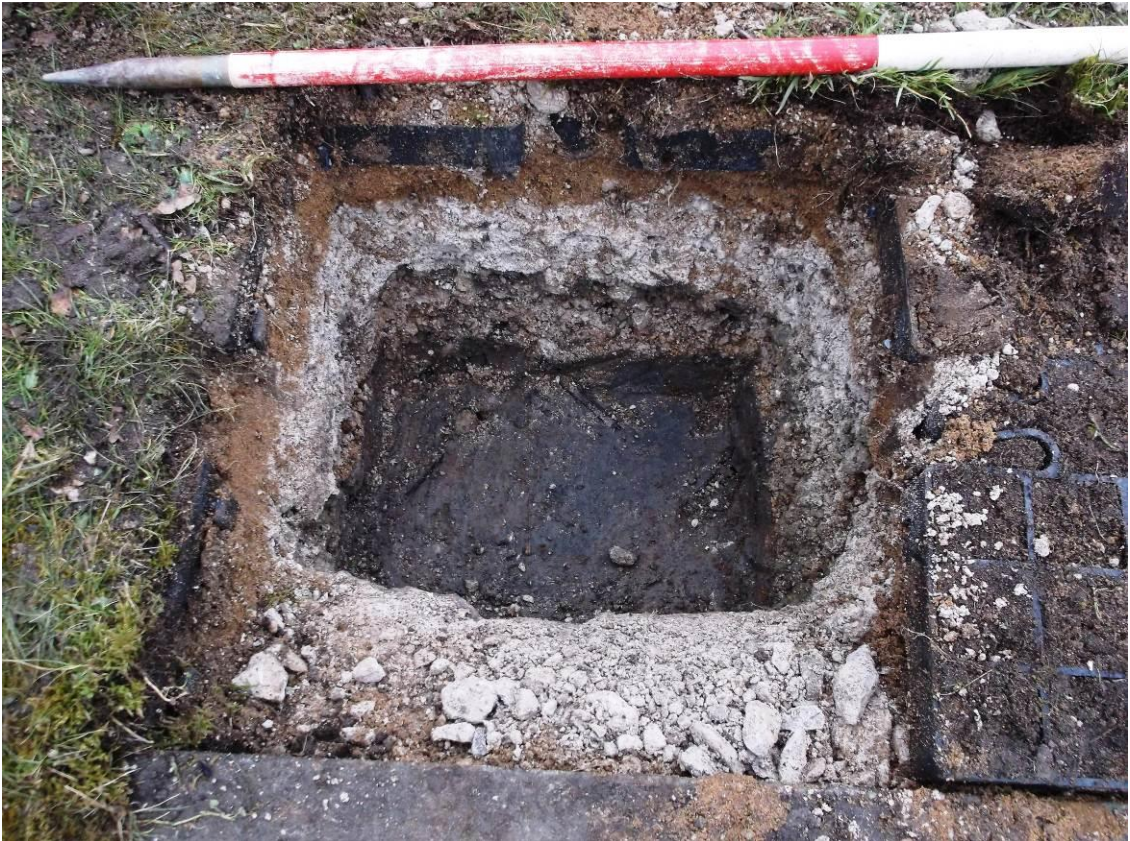
Two test-pits (TP5-TP6) were excavated by hand either side of the eastern approach road to the Hall at a location 70m to the north of the Hall. The test pits were each 0.5m square by 0.35m deep. In one test pit (TP5) a former buried topsoil was noted at the base of the trench which had been overlain by successive layers of modern roadmaking material (Fig 10). In the neighbouring test pit (TP6) the natural substrate of a yellowish-brown sandy clay was noted in the base of the trench, overlain by two thin layers of greyish-brown sandy loam, above which was a thin veneer of modern mortar and some topsoil (Fig 11). No archaeology was found in the test pits. Both test pits were completely removed during the excavation of Trench 8, aligned east to west, across the road, which was not observed.

Test Pit 5, showing buried soil, looking west Fig 10

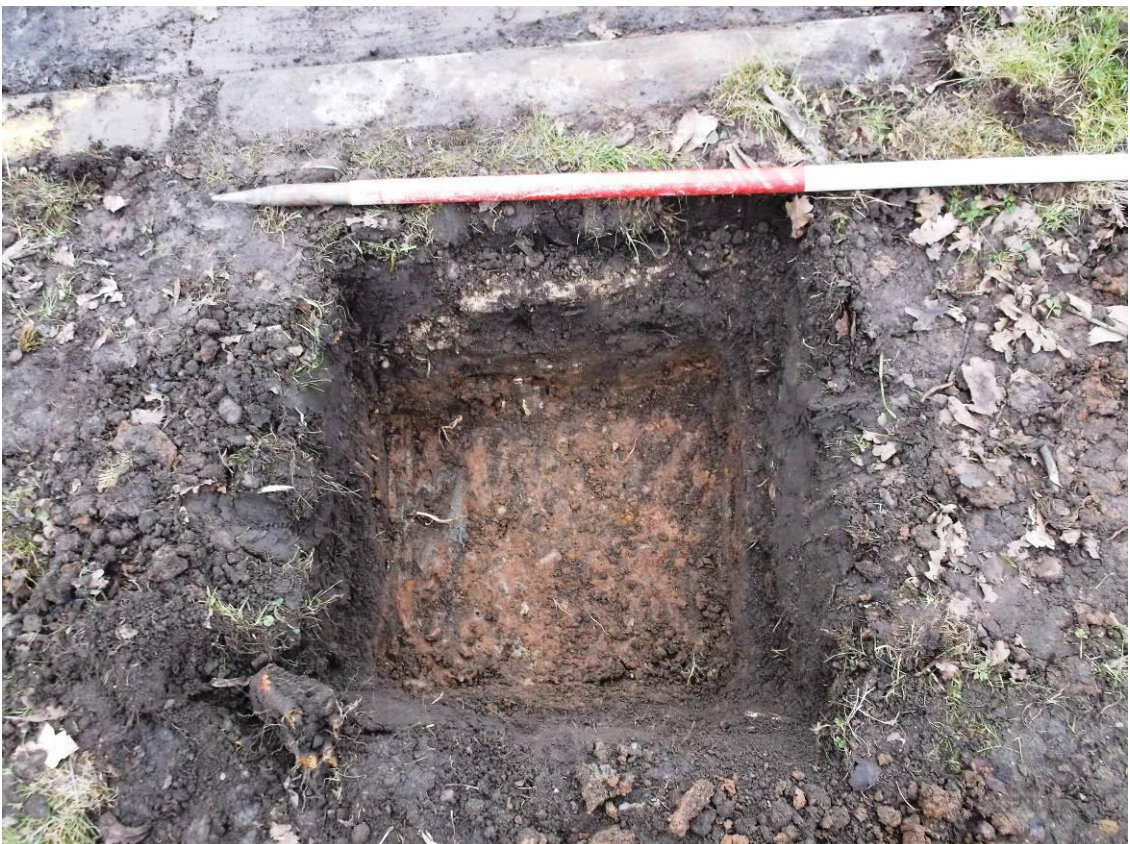
Test Pit 6, showing natural substrate, looking west Fig 11

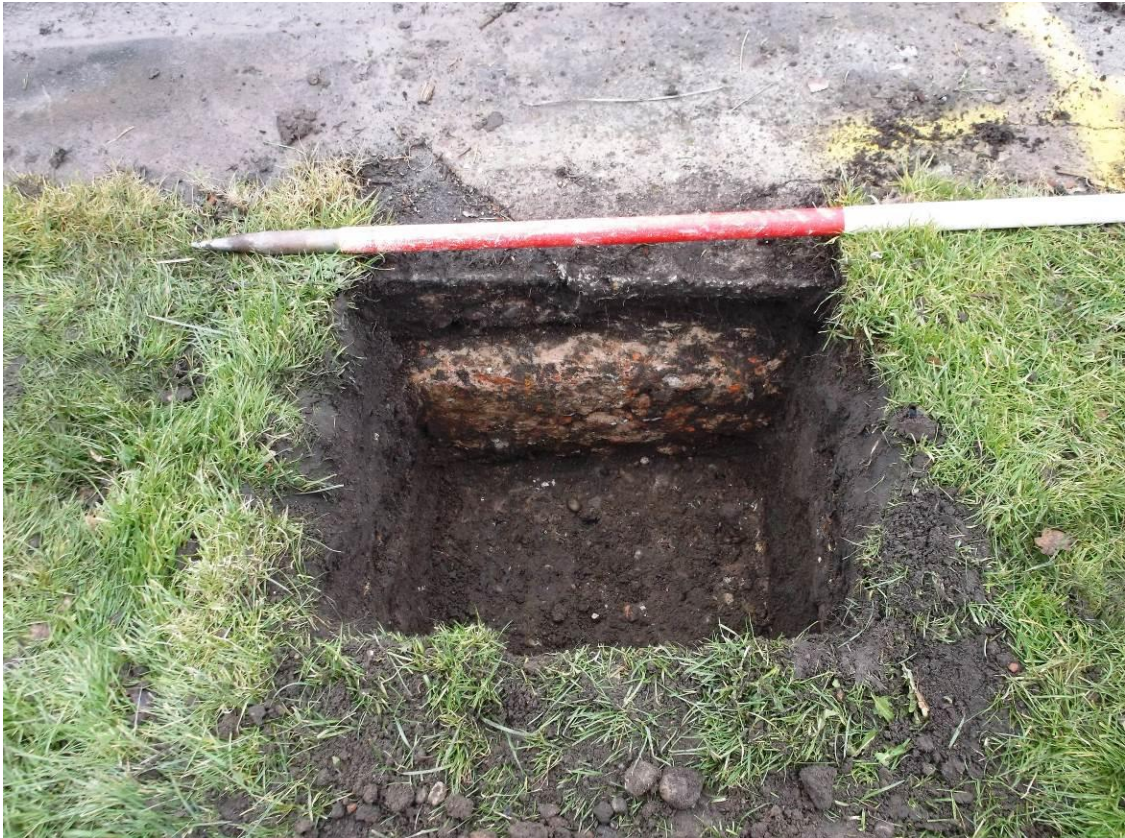
Two test pits (TP7-TP8) were excavated by hand, either side of the eastern approach road at 20m to the north of the Hall. The test pits were each 0.5m square by 0.35m deep. Within the northernmost test pit (TP7) a mortar and crushed brick foundation, underlying the modern concrete road edge, was noted in the north facing section of the test pit (Fig 12). The stratigraphy below the dark brown loam topsoil consisted of three layers of sandy clay loam subsoil, the lowermost of which was mixed with brick rubble and pebbles. In the neighbouring test pit (TP8) two layers of sandy loam subsoil were noted. A sherd of modern "willow pattern" pottery was noted in this test pit. Both test pits were removed completely by the excavation of a narrow service trench (T9), which was aligned north to south, and was not observed.

Test Pit 7, showing mortar and brick foundation, looking south Fig 12
