**Gazetteer of mid-late 20th-century buildings at
Bucknall Hospital, Stoke on Trent
Staffordshire
April 2015**

Report No. 15/85

PROJECT DETAILS		OASIS molanort1-211236
Project title	Gazetteer of mid-late 20th-century buildings at Bucknall Hospital, Stoke on Trent, Staffordshire, April 2015	
Short description	MOLA carried out a Gazetteer level programme of historic building recording of post-1940s buildings at Bucknall Hospital, Stoke on Trent, Staffordshire. The surveyed buildings largely comprised extensions to earlier buildings, detached boiler houses and store rooms and sheds. These primarily dated to the 1980s and 1990s.	
Project type	Historic Building Survey	
Previous work	Historic Building Survey	
Future work	Trial trench evaluation	
Monument type and period	Post 1940s buildings and extensions	
PROJECT LOCATION		
County	Staffordshire	
Site address	Bucknall Hospital, Eaves Lane, Stoke on Trent	
NGR	SJ 9106 4801	
Area	c4.3 hectares	
PROJECT CREATORS		
Organisation	MOLA Northampton	
Project brief originator	Keepmoat Home	
Project Design originator	MOLA Northampton

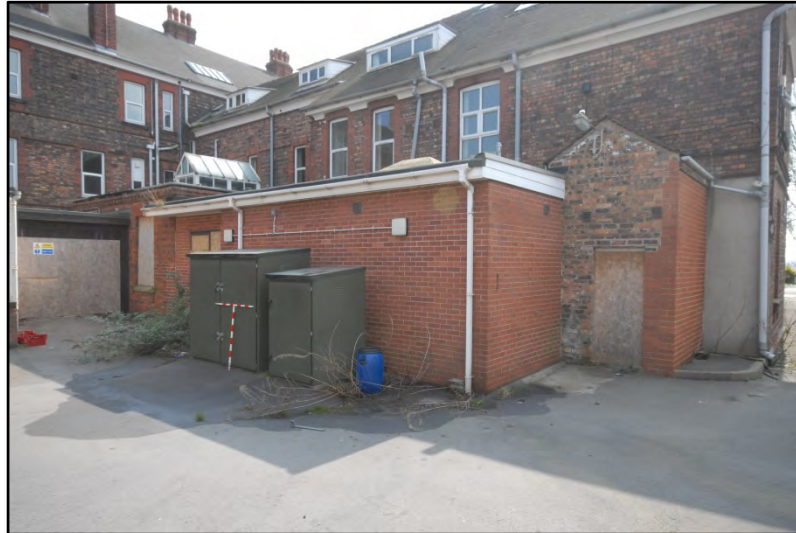
The western arm of the building was extended northward by a single storey brick structure which housed WCs. The construction is of hard fired red brick in stretcher bond with a flat roof of roofing felt with timber soffits and fascia boards as well as PVCu rainwater goods. To the north of the extension, junction boxes are housed in two secure steel boxes, bolted to the ground and wall. The western wall of the adjacent, late 19th-century store room has been completely re-built in modern red brick.

Administration, WC extension, looking south-east Fig 3

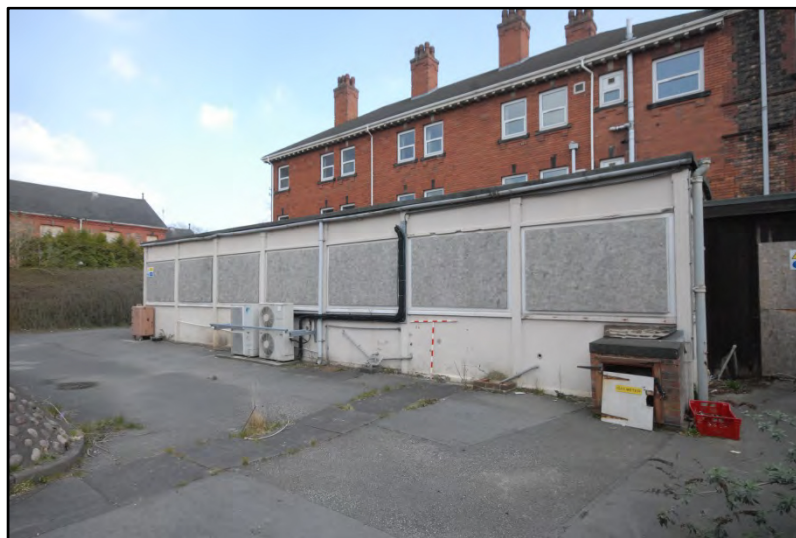
Administration, Kitchen extension, looking north-east Fig 4

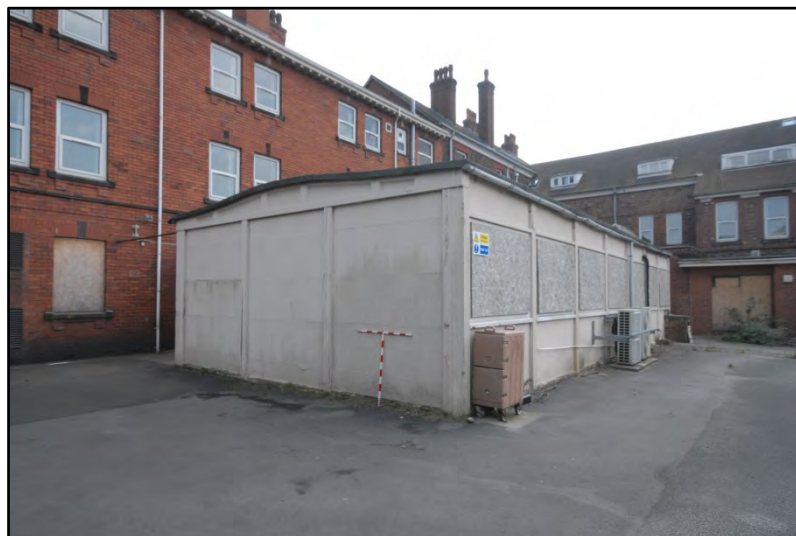
Administration, Kitchen extension, looking south-east Fig 5

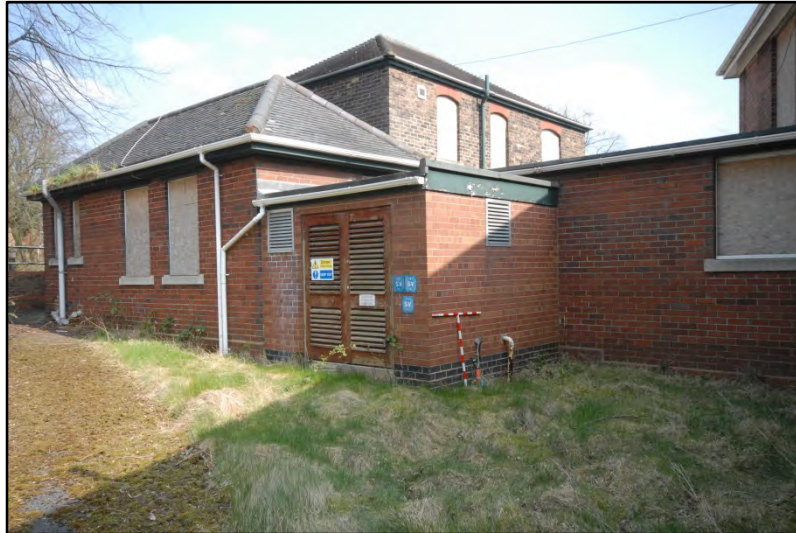
The boiler house is a single storey structure on a square plan, sharing the north and east walls with the adjacent, earlier, structures. Access is through a double door with ventilation louvers which faces west. Two louvered ventilation panels are located in the west and south elevations. It is of brick in stretcher bond with red brick forming the main structure and dark blue-black brick at the base of the walls. It has a flat roof of felt with PVCu water furniture and timber fascia boards at the west and south.

Ward Block 2, boiler house, looking north-east Fig 6

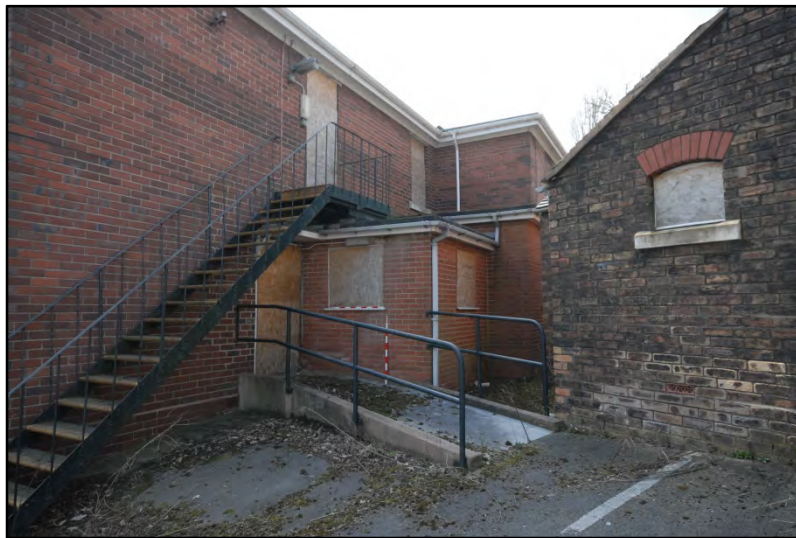
To the north of the ward block is a post-1980s single storey extension, part of the service range which includes a WC and kitchen. It is of red brick in stretcher bond with two square window openings in PVCu surrounds looking north and east. The main part of the extension is a projecting square plan with a slightly taller extension which wraps around the north-east corner of the earlier northern service range, projecting it outward.

Ward Block 2, extension, looking south-west Fig 7

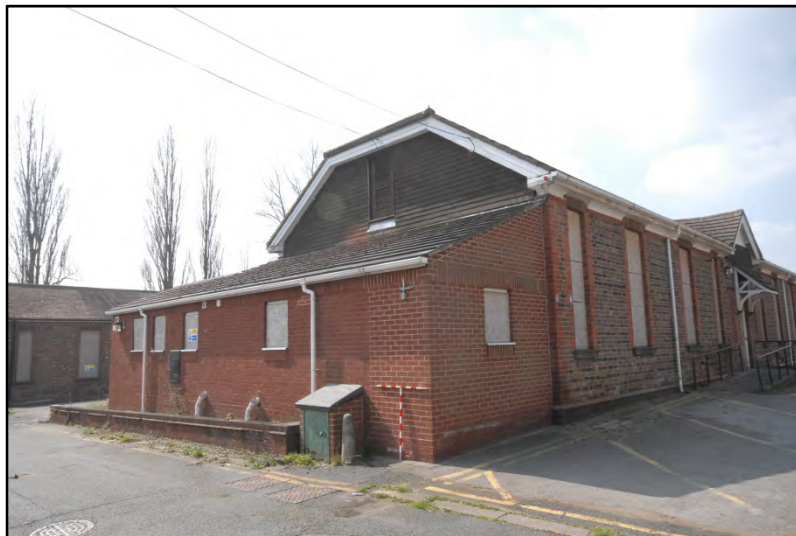
The east extension/ day room is aligned north-south, abutting the east wall of the Ward. It is identical in design and construction to the south and west extensions.

Ward Block 3, east extension, looking south-west Fig 8

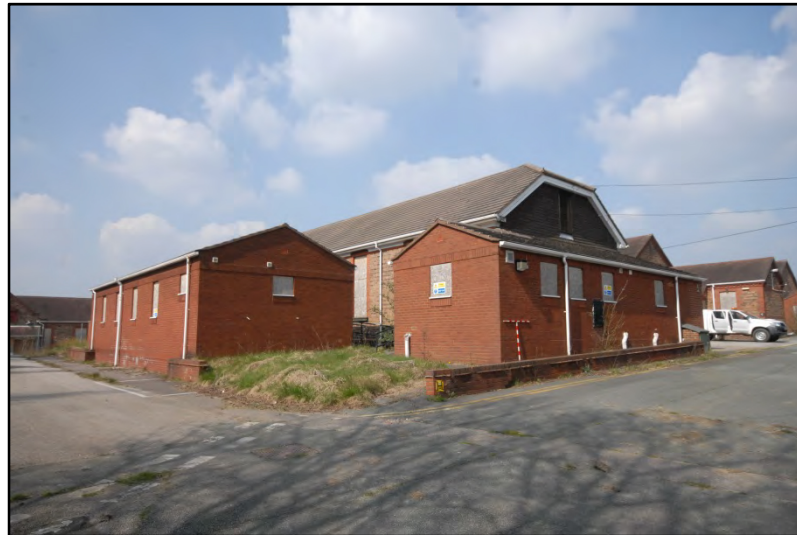
The south extension/entrance block is set away from the main ward, with a connecting block between the two. It is aligned east-west and is constructed of red brick in stretcher bond. A number of windows open from the main elevations. These have sills of soldier edge brick and the window openings extended to a soldier edge brick course at eaves level. The building has a tiled gable roof with the ridge aligned east-west. PVCu rainwater goods are located at the north and south elevations.

Ward Block 3, the east and south extensions, looking north-west Fig 9

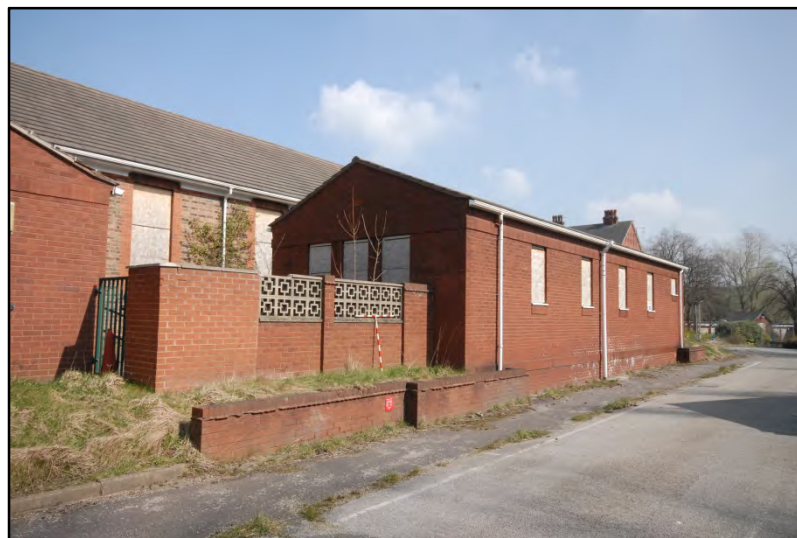
Ward Block 3, the south extension and enclosure wall, looking north-east Fig 10

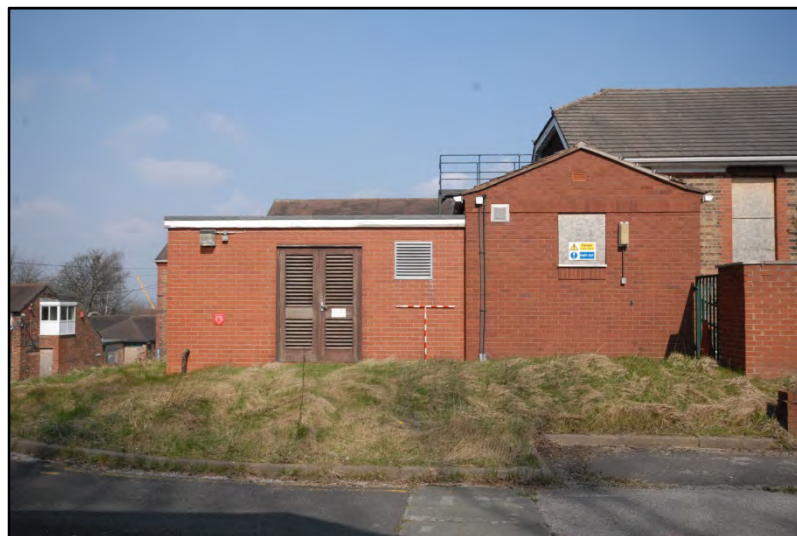
Ward Block 3, boiler house, looking north Fig 11

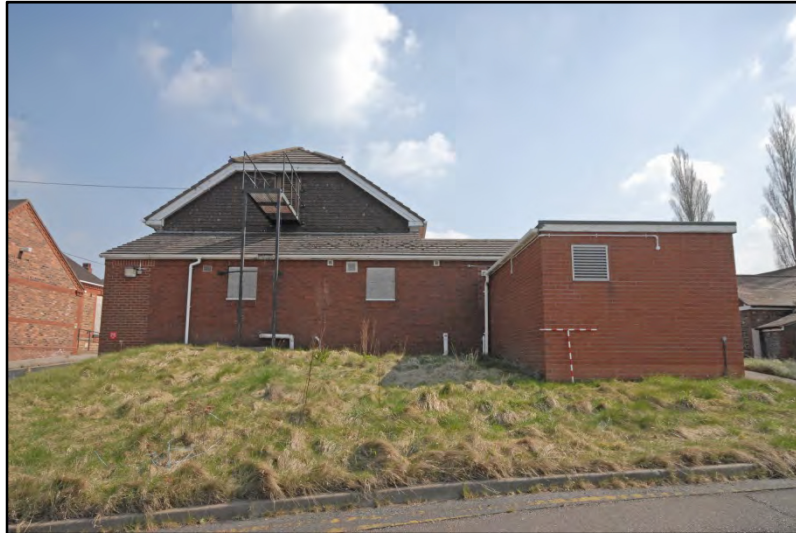
The historic core of Ward 3 dates to 1885. Late 20th-century extensions were appended to the east, west and south of this building. These comprised day rooms and entrance block, as well as a smaller, post-1994 boiler house to the east. A small, square yard was created in the space between the west and south extensions, enclosed by a brick wall. The boiler house comprises a single room and is built to the south-west of the west extension. Access is via a louvered double door which opens to the south. A square, louvered ventilation panel is located adjacent to the door. The roof is flat and comprises roofing felt with timber fascia boards. The west extension/day room is single storey, aligned north-south. It is constructed of red brick in stretcher bond, with no decorative embellishments. The brickwork at the north-west corner of the building has been re-pointed. The roof is of tiles, part gabled and part cat-slide where it adjoins the west wall of the historic core of the Ward Block.

Ward Block 3, the west extension, looking east Fig 12

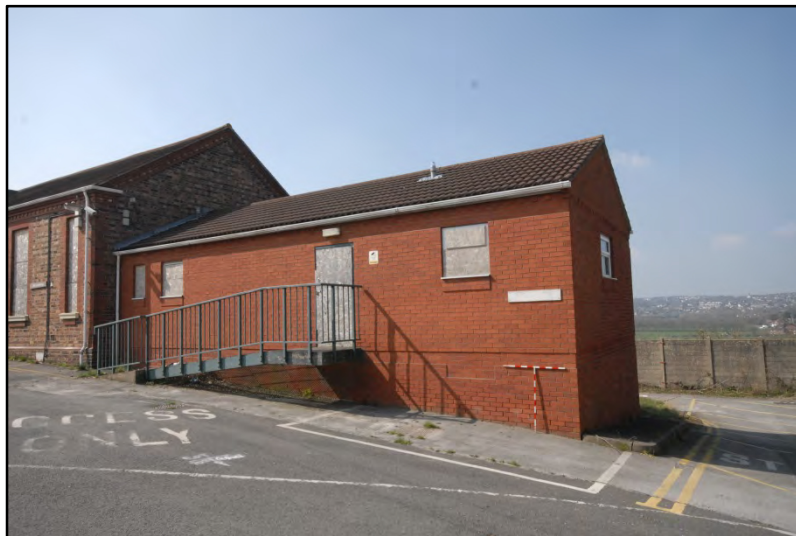
To the north is a rectangular extension, aligned north-south, which is of textured red brick in stretcher bond with a brick dentil course at the eaves. The structure is plain

with no decorative embellishments, even at the window and door openings. The building comprises a main ground floor, level with that of the original ward, and a sub-floor level housing a boiler room, located in the space formed by the sloping topography of the site. External entry is from the east where a steel ramp with railings rises to an elevated doorway. The boiler house is entered through a double, louvered door to the west. Internally, the structure can be accessed from the south, through the main ward.

Ward Block 4, the north extension, looking west Fig 13

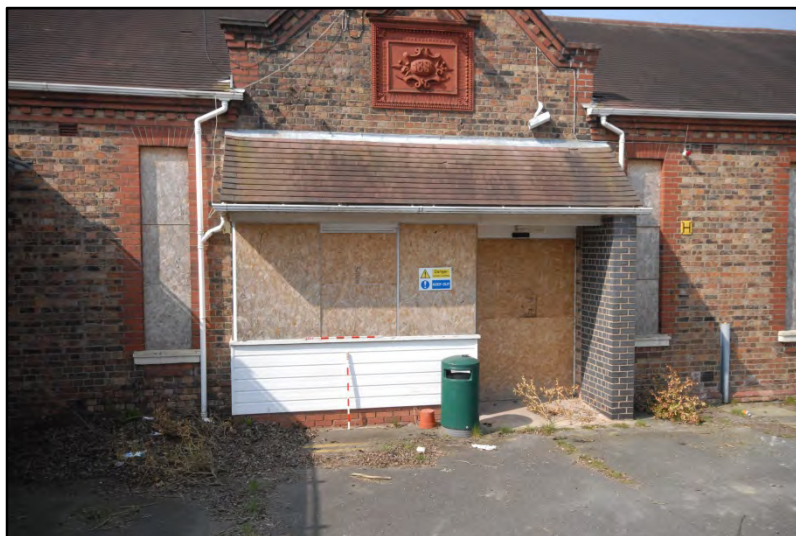
Central to the east elevation of the ward is a 1980s entrance way. This is constructed of both red and dark blue-black brick and projects from the original entrance way, with a tile-clad, cat-slide roof with lead flashing. Within the entrance are windows, flush with the brickwork and set within white painted timber cladding, and a doorway set to the rear.

Ward Block 4, 1980s entrance, looking west Fig 14

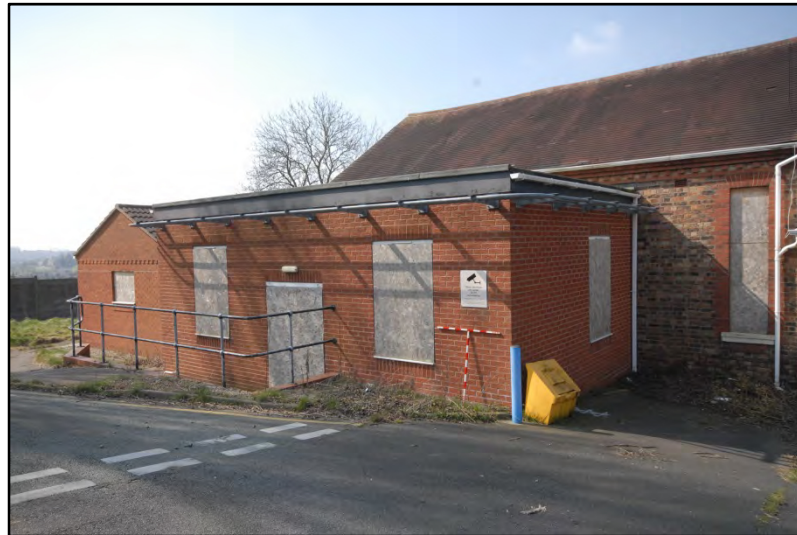
At the south-east corner of the ward is a post-1994, single-storey extension constructed of textured red brick in stretcher bond. This is entirely plain, lacking even a dentil course. The door and window openings have sills and lintels of soldier lain brick. It has a flat roof of roofing felt, with grey painted timber fascia boards and PVCu rainwater goods. Steel railings held at a distance from the building by steel brackets are located around the perimeter of the building, just below eaves level. The purpose of this rail is unclear. External entry to the structure is from the east via a central double door set below road level, which is flanked by a pair of windows. The building can also be entered from the west, through the ward.

Ward Block 4, east extension, looking south-west Fig 15

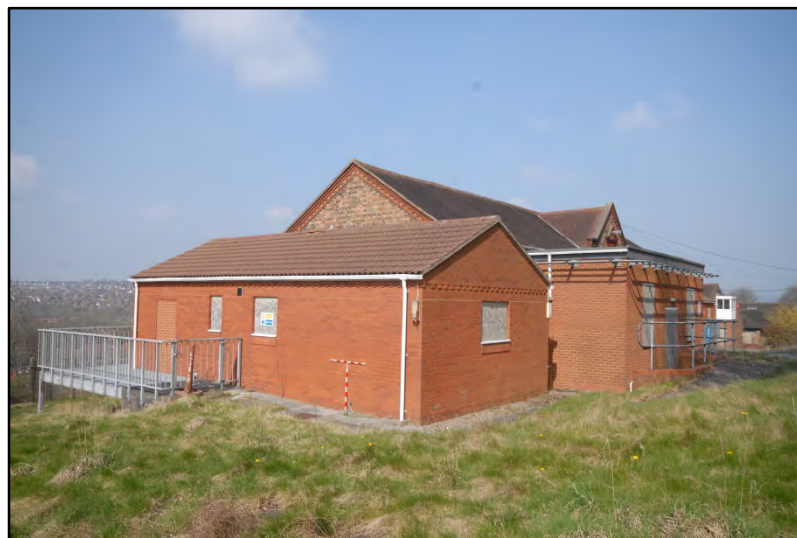
To the south of the ward is a rectangular extension, aligned east-west, located on the site of a former primary sanitary block. This extension dates to the 1980s, pre-dating the extension to its north. The main part of the extension is set back from the earlier ward, with a linking passage between the two. The structure is of textured red brick in stretcher bond, with a dentil course below the eaves. It has a tile-clad, open gable roof with the ridge aligned east-west. The topography drops sharply to the south and west from the ward, so that the south and west portion of the extension is much taller than at the east. A steel walkway with railing is located around the south and west sides of the building, providing level access around the perimeter. A doorway in the south elevation has been blocked in brick. The building can also be accessed from the north-west, from the walkway and internally from the north, through the ward

Ward Block 4, south extension, looking north-west Fig 16

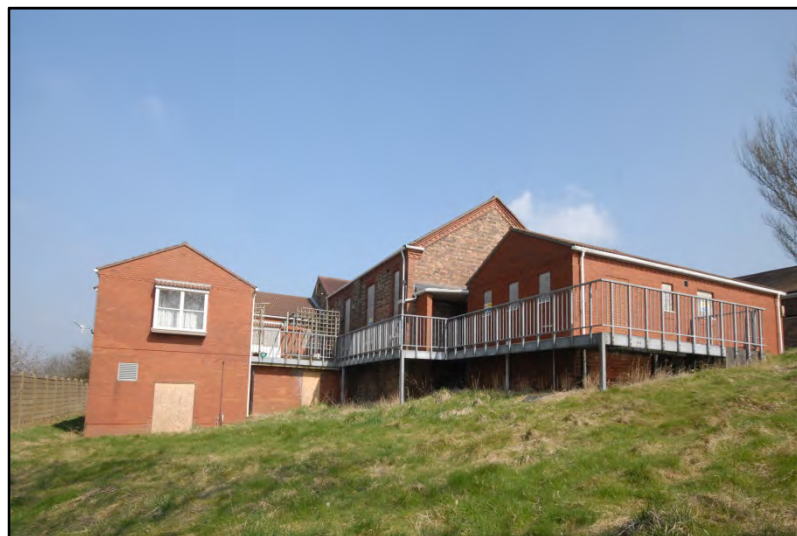
Ward Block 4, the south and west extensions, looking north-east Fig 17

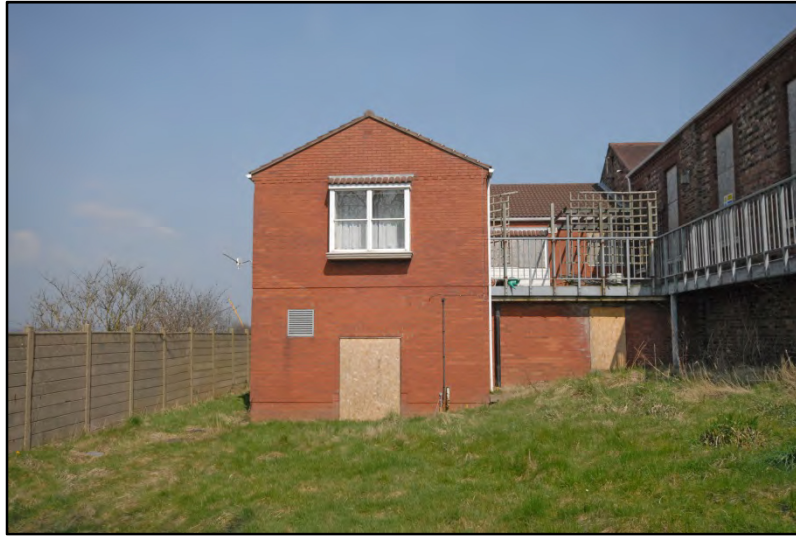
The largest of the extensions is located to the east of the ward and is on an L plan, connecting to the central portion of the ward and projecting to the south. It is contemporary with the north and south extensions, constructed of textured red brick in stretcher bond, with a dentil course below the eaves. It has a tile clad, T-intersection, open gable roof with lead flashing at the joins. The lower level houses plant and boiler rooms. The upper level is divided into bedrooms and WCs/showers.

Ward Block 4, the west extension, looking north Fig 18

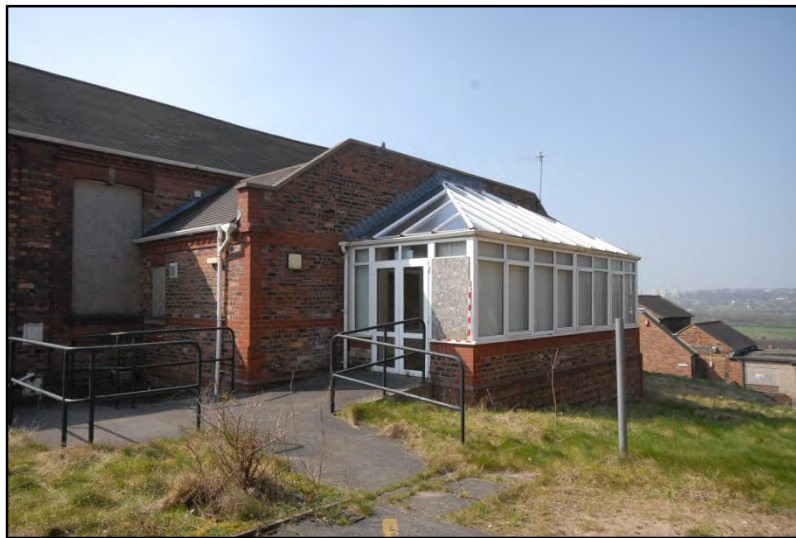
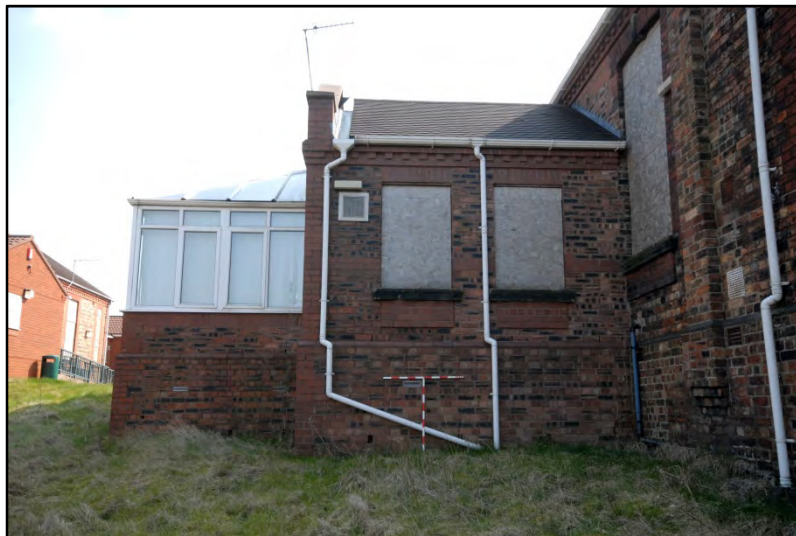
The ward is extended north by a mid-1990s brick structure which served as a day room, with a conservatory extending further still. These are constructed of multi-buff brick and retain the detailing of the original structure such as dentils and window surrounds. The conservatory is of modern PVCu resting on dwarf walls. The ground level slopes sharply to the west and the western side of the extensions are heightened to match. The roof of the day centre is of square roof tiles and is pitched to the east and west and flat at the centre. The north elevation forms a short parapet over the roof.

Ward Block 5, the north extension and conservatory, looking south-west Fig 19

Ward Block 5, the north extension and conservatory, looking east Fig 20

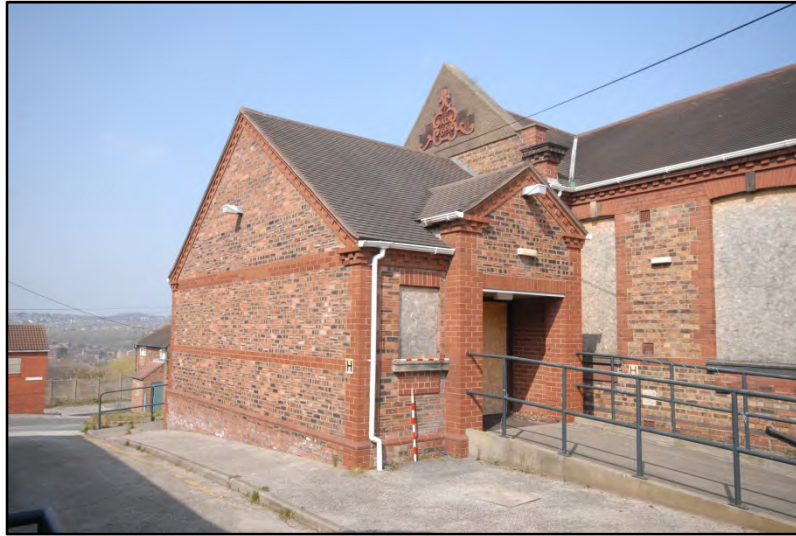
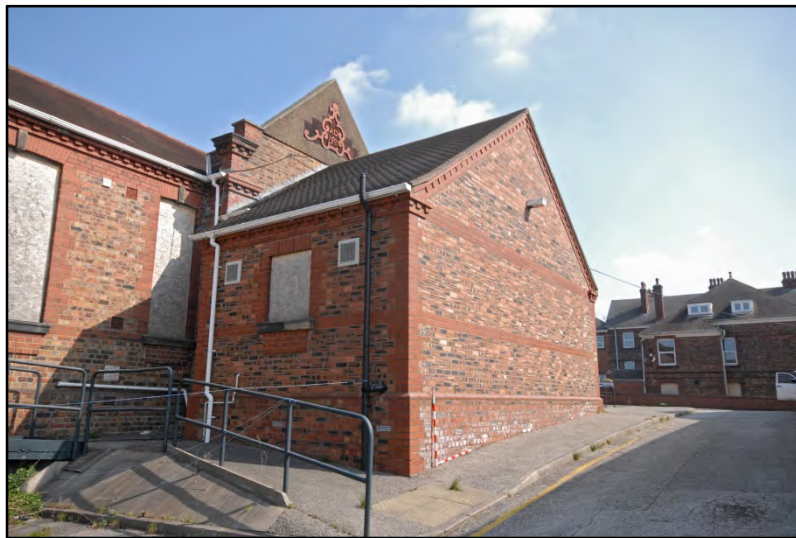
The core of Ward Block 5 dates to 1901 and remained unaltered until the mid-1990s when an entrance block and conservatory were appended to the north and south. These are constructed of brick and are blended into the original structure by the use of similar coloured brickwork as well as retaining detailing such as dentils, window surrounds and continuing of the original building's plinth course. To the south, a concrete ramp leads to the doorway which is held within a slightly projecting, pedimented portico flanked by a single window. A plinth course and decorative brick courses run the full perimeter of the entrance block and the opening surrounds and wall corners are picked out with red brick. The southern gable elevation is plain with decorative red brick courses at the eaves and midway up the wall. The structure has an open gable roof of square roof tiles with flashing at the join to the earlier structure.

Modern PVCu rain water goods are located at the east and west elevations. The survey drawing shows the entrance block to be subdivided into five small rooms surrounding an L-plan corridor that leads into the main Ward Block.

Ward Block 5, the south entrance, looking north-west Fig 21

Ward Block 5, the south entrance, looking north-east Fig 22

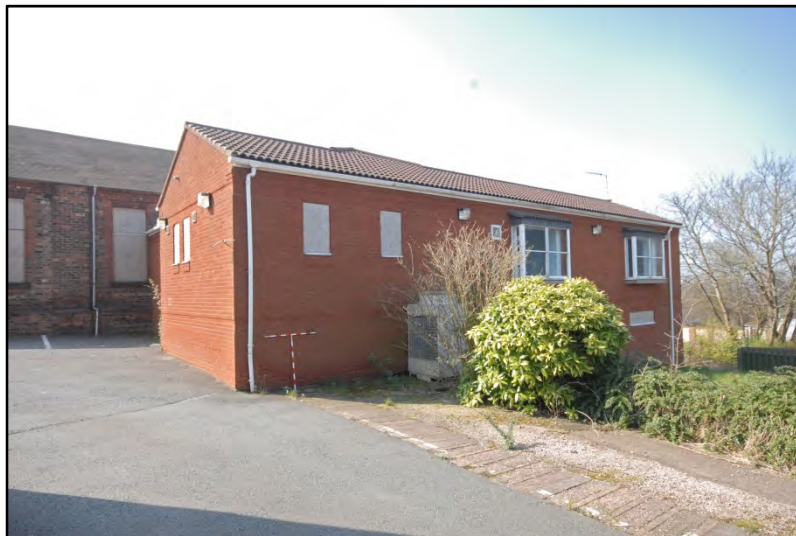
The northern extension is the largest and is laid out on an L plan with entry from the south, through the main Ward. The ground slopes westward and the western sides of the extensions are built taller to match. The northern extension presents windows to the north, east and west and has a secondary entrance from a raised terrace to the west. Three of the windows are of a larger, oriel type, projecting slightly from the face of the wall with sliding sashes within wooden frames. These have stone sills and angled roofs of rounded tiles. To the west, the lower level of the extension contains a plant room or boiler house which continues beneath the raised terrace.

Ward Block 6, the north extension, looking south-west Fig 23

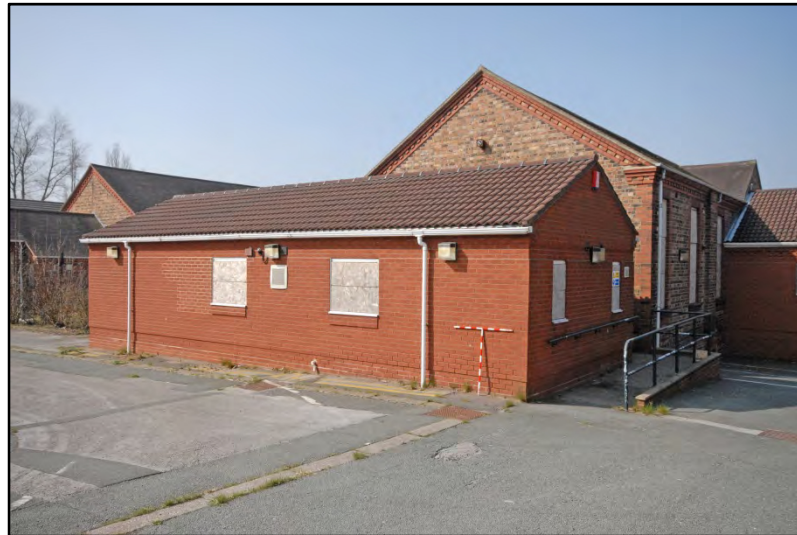
To the east of the Ward is a single storey extension, aligned north-south, with a narrow connecting bay to the earlier building. Entry is via a concrete disabled ramp to the north or through the connection bay from the ward to the west. The roof is an open gable type with the ridge running north to south. The windows were blocked at the time of the survey but likely comprise two light sashes in wooden frames. An area of repointing and repair was visible adjacent to the one of the windows of the east elevation. The survey drawing shows the interior to be subdivided into three rooms with a central hall, with a WC located within the connecting bay.

Ward Block 6, the east extension, looking west Fig 24

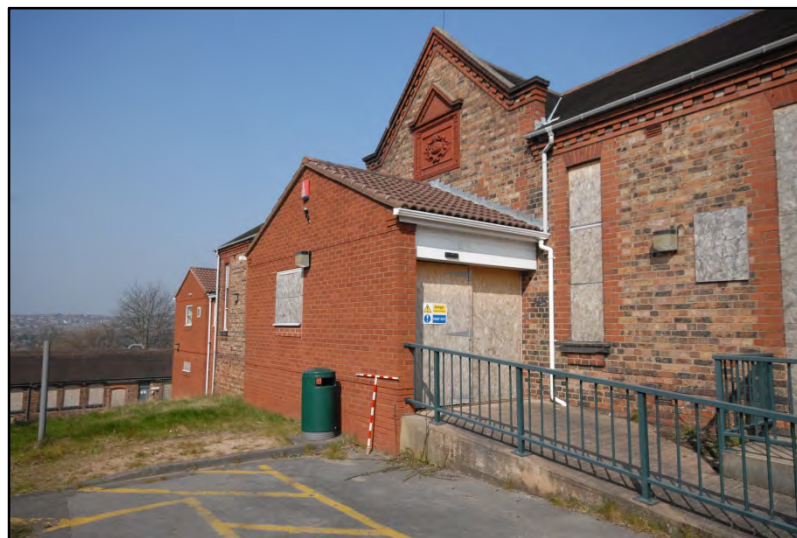
The south extension is an entrance hall with a concrete ramp with iron railings leading up to a sliding door. Inside is a hall or porch with two small rooms facing the entrance. These rooms are a later addition to the structure and their dividing wall bisects a former window, blocked in brick. The structure has a ridged roof of rounded tiles with lead flashing at the eaves.

Ward Block 6, south entrance, looking north-west Fig 25

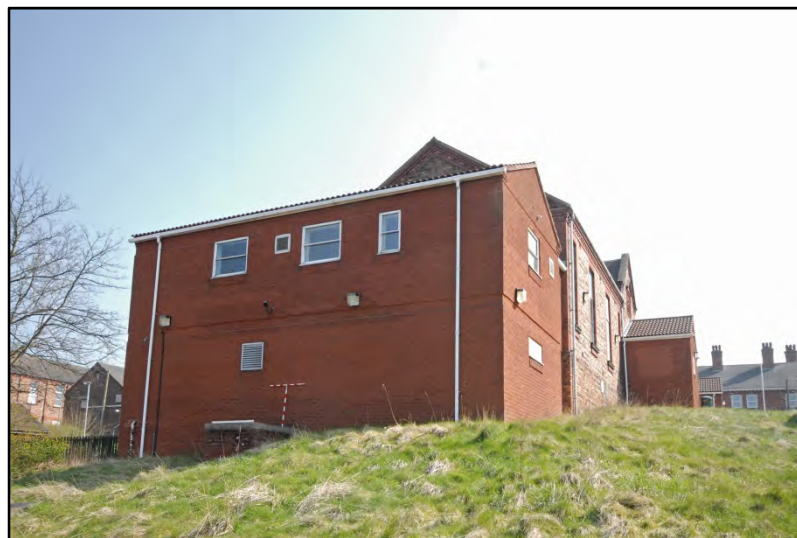
The western extension is of two storeys with a boiler house at the lower level which is entered from the north through a doubled, louvered door at ground level. A square, louvered ventilation panel is in the west wall and a fixed window looks south. The upper level comprises two rooms with primary entry through the main ward to the east. The windows here are two light sashes in wooden frames with brick lintels and sills. The structure has an open gable roof of square tiles with dentils at the eaves and PVCu rainwater goods. To the north, a steel fire exit stair and walkway allows access to the raised terrace and to the ground level. A raised brick and concrete manhole entrance is located adjacent to the west wall.

Ward Block 6, the west extension, looking east Fig 26

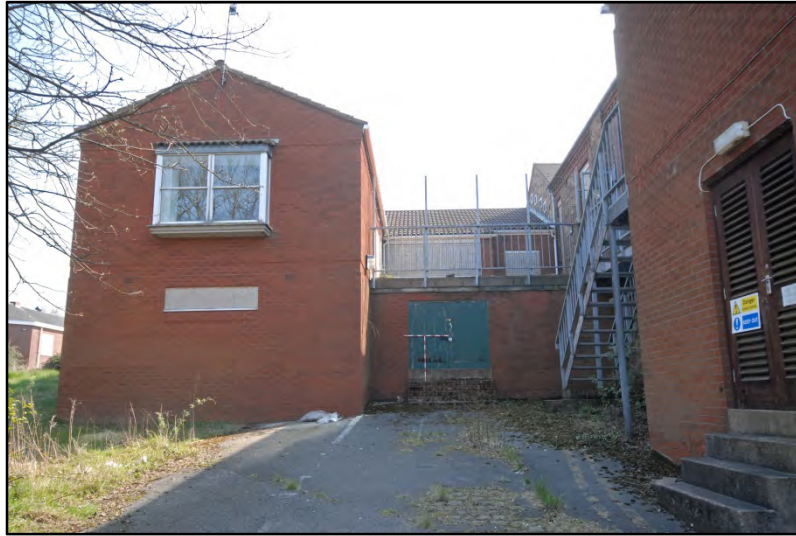
Ward Block 6, the north and west extensions, looking east Fig 27

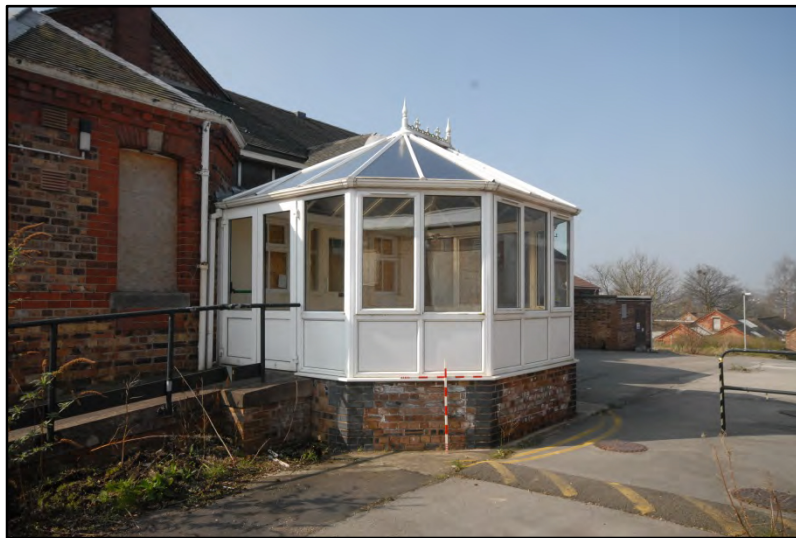
Ward Block 7 dates to 1904 and is on a linear plan, aligned east-west. It largely retains its historic layout, both internally and externally. Small mid-1990s extensions are constructed to the north and west of the building. To the north, filling in the space between the primary isolation rooms, is a modern PVCu conservatory on brick dwarf walls. This is of a fairly standard conservatory design of five sides, with French doors opening onto a concrete ramp to the east. It is a single room with access to the main ward.

Ward Block 7, the north conservatory entrance, looking south-west Fig 28

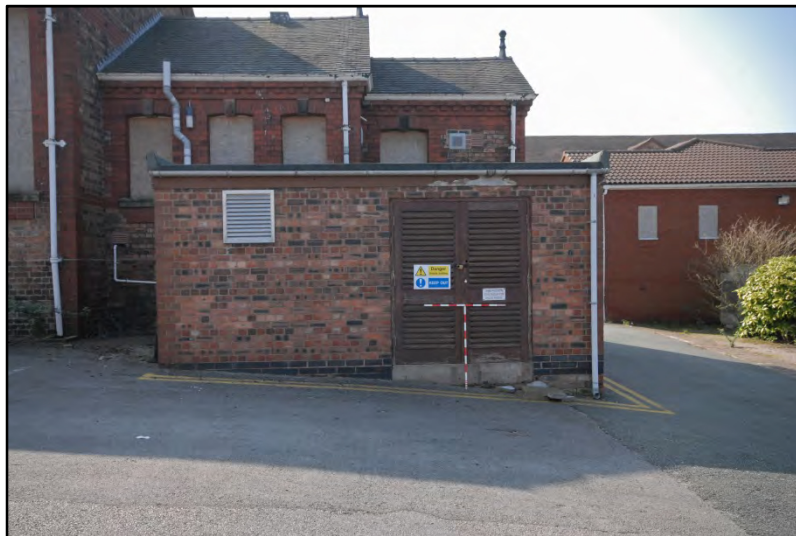
To the north-east is located a single storey boiler house on a rectangular plan. Entry is via a louvered double door to the north and square, louvered ventilation panels face north and west. It is constructed of multi-buff brick in English Bond, with courses of blue-black brick toward the base. It has a flat roof of roofing felt with wooden fascia boards and PVCu rainwater goods.

Ward Block 7, north boiler house, looking south Fig 29

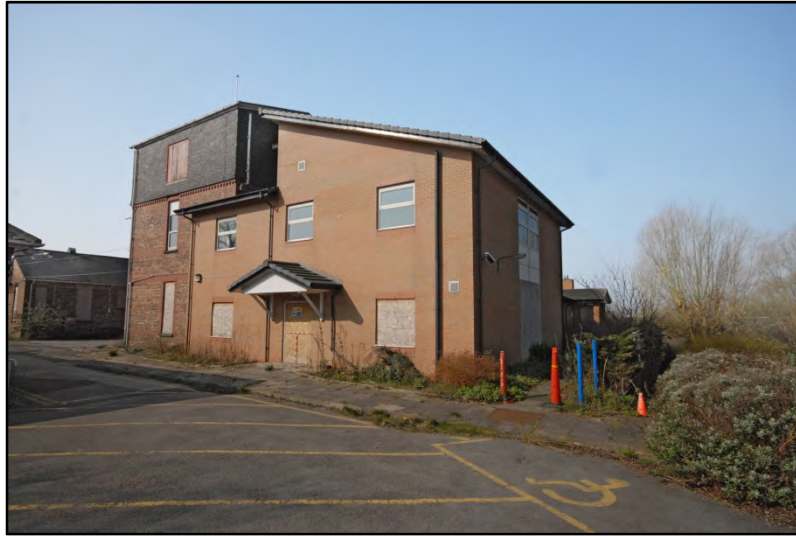
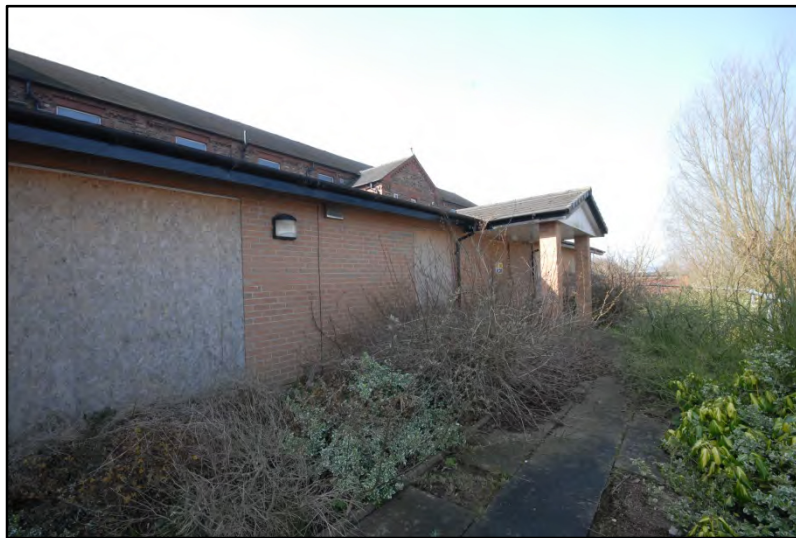
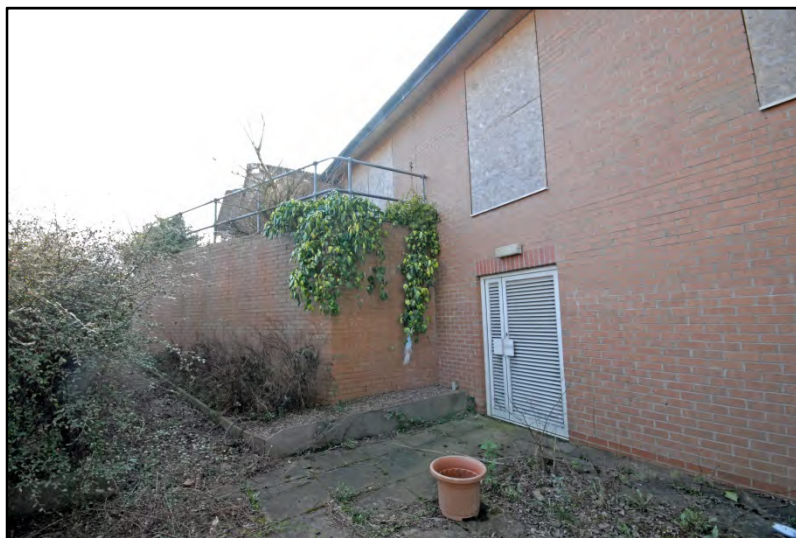
These are located at the northern extent of the hospital site, to the north of the day centre. The main structure is a two-storey building constructed in 1915, extensively enlarged in the mid-1990s with the addition of a large extension to the north. This extension is of a single phase and is constructed of buff-red brick in stretcher bond, fairly plain with no decorative embellishment, and with no attempt made to blend the extension into the earlier building.. The windows are mainly PCVu double glazed, of two lights with the upper top hung. The sills and lintels are of red brick solid courses. The easternmost extent of the extension is of two storeys with a stair in the south-east corner. The east elevation is of three bays, with the south bay having a flat roof of rounded tiles. The roof level rises at the middle bay to the height of the adjacent, earlier building. From here it descends to the north, with its eaves level with the flat roof. Facing north there is a central, full height bay of large windows over panels.

The main stretch of the extension is also of two storeys, but at a lower level, following the topography of the site which slopes down to the west. A concrete ramp is located along the northern side of the extension, creating a level path to a simple brick portico which serves as the northern entrance. The ground floor level is utilised as a boiler house with its entrance located adjacent and below the concrete ramp.

The central portion of the extension is set away from the building so that an open yard is formed by the western return. A conservatory allows covered movement between the yard and the building, opening onto a corridor that runs the length of the extension, from east-west, with doorways opening onto the various rooms within. At the west, the extension wraps around the earlier, primary sanitary block which projects north from the main Ward block. A door has been inserted in the north extension of the ward, adjacent to the primary sanitary block, allowing for movement between the ward and the extension.

Wards 10 & 11, the north extension, looking south-west Fig 30

Wards 10 & 11, the north extension entrance, looking south-west Fig 31

Wards 10 & 11, the north extension, looking south-east Fig 32

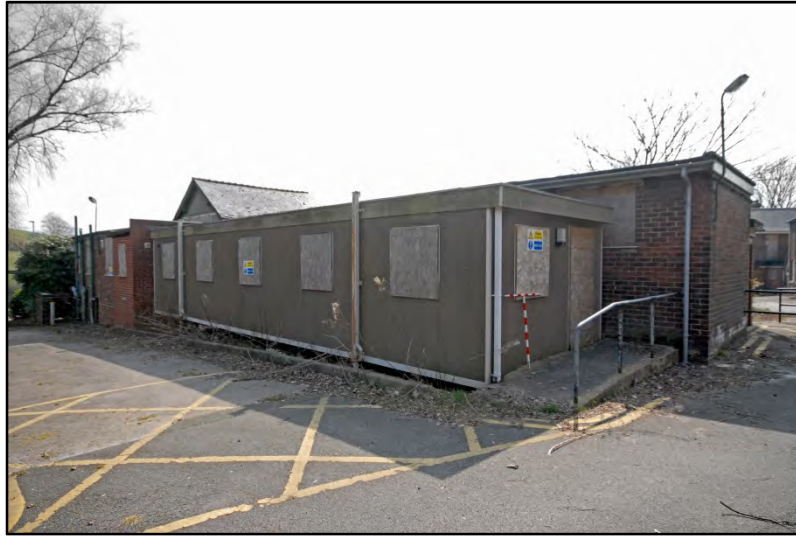
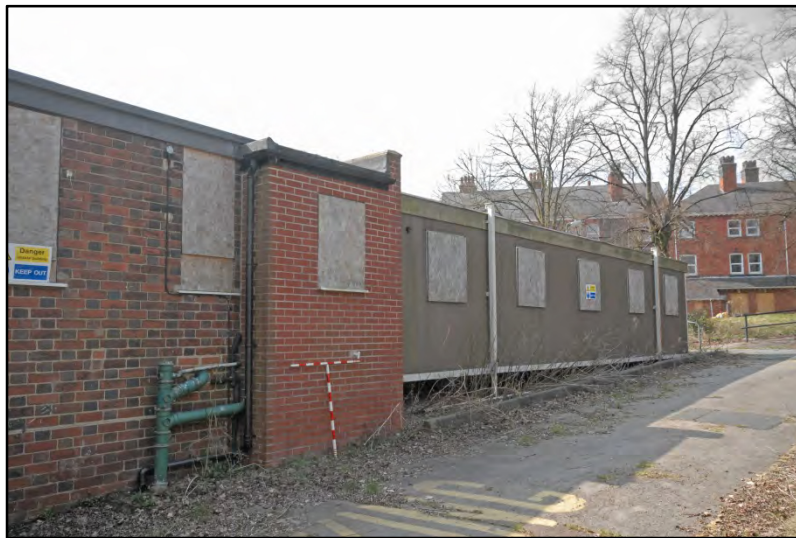
A post-1980s, free standing, pre-fabricated structure was located to the north of Ward 12, which is a 1920s, brick-built, cubical isolation ward. This structure was not entered. The structure is typical of its type, located on a rectangular concrete base and made level with raised supports. Constructed of panels, with a flat, tarred roof, it has one entrance located to the west, at the top of a concrete ramp with iron rail. A number of windows are positioned in the north elevation and a single window faces to the west. Given the nature of the structure, it is likely that identical window openings,

though unusable, are located to the south and east. Adjacent to the pre-fabricated structure is a small, brick extension which projects slightly from the earlier wall line. This extension is of a single bay, with a single window looking north. The eastern wall forms a short parapet above the surrounding roof line. It is constructed of hard fired red brick in stretcher bond.

Ward Block 12, pre-fabricated unit, looking south-east Fig 33

Ward Block 12, brick extension and pre-fabricated unit, looking north-west Fig 34

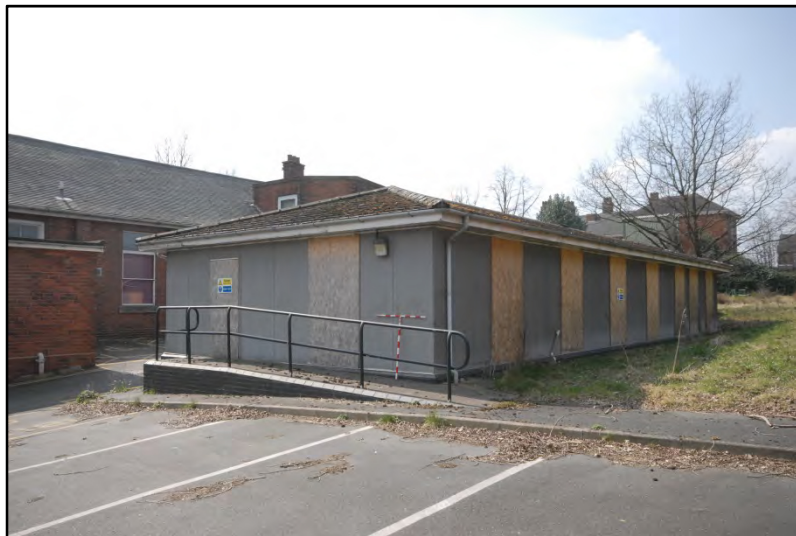
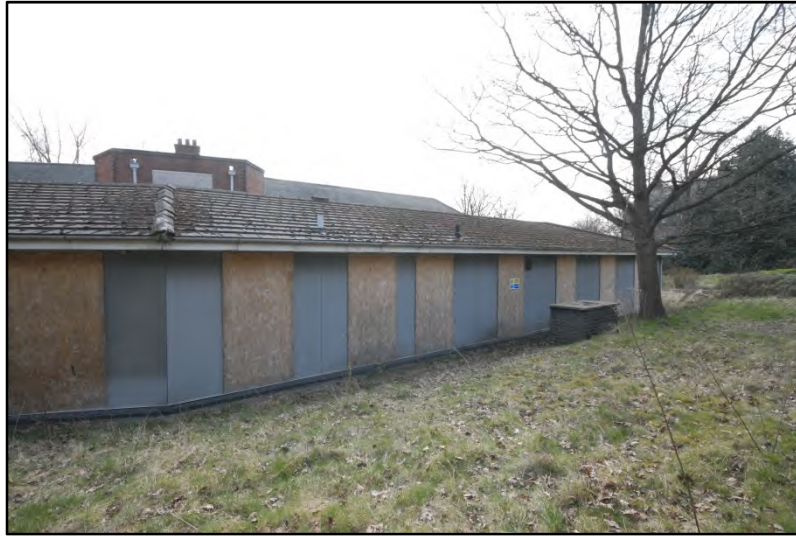
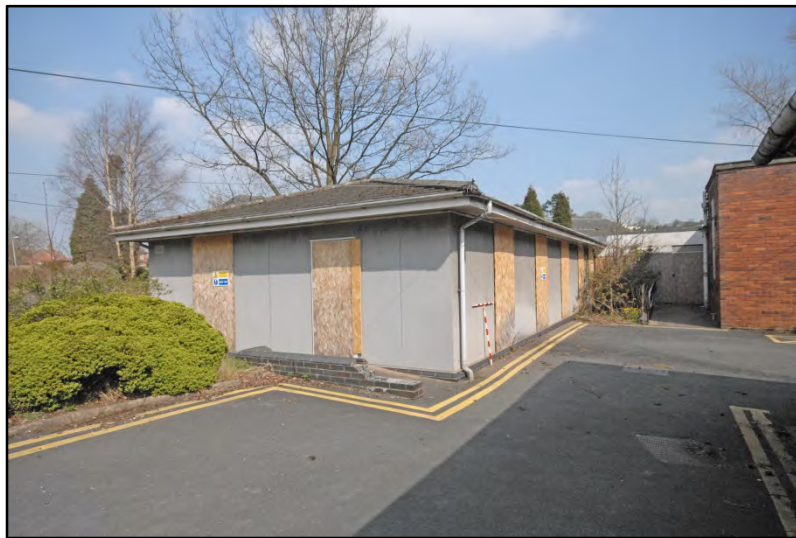
This is located to the east of the site and comprises a 1920s brick structure of two angled wings with a post-1994 extension, also of two wings, situated to the north of the earlier structure. The extension and the larger ward were not entered. The extension is constructed of lightweight panels and purple brick with large windows (boarded up at the time of this survey), positioned at regular intervals around the principal elevations. Primary entrance to the extension is through a short linking corridor from the main ward but secondary doors, likely fire escapes are positioned at the east and west of the extension, opening onto ramps with safety rails. The structure is roofed with square slate tiles and angled ridge tiles, with timber soffits and fascia boards at the eaves. PVCu rainwater goods were present around the full length of the structure. A number of circular ventilation flues could be seen projecting through the roof. A brick-built, raised manhole entrance was positioned to the north of the extension.

Ward Block 19, east wing of north extension, looking south-west Fig 35

Ward Block 19, west wing of north extension, looking south-west Fig 36

Ward Block 19, west wing of north extension, looking north-east Fig 37

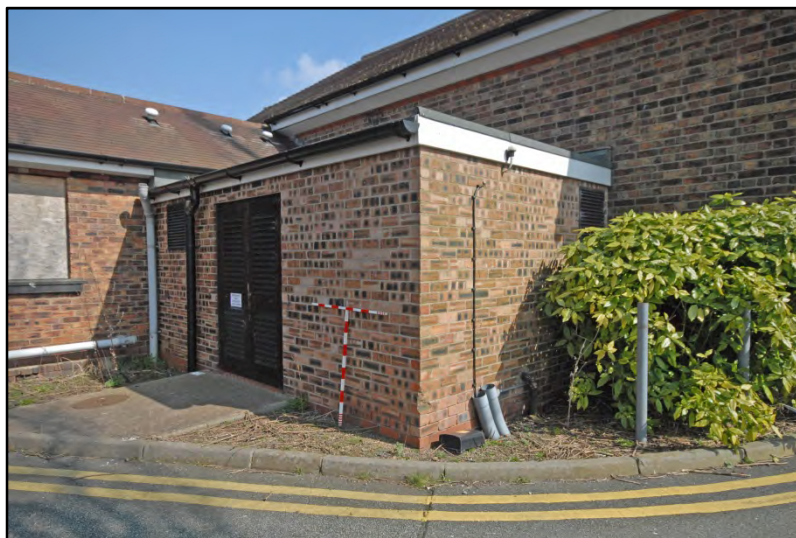
The Laundry is located at the south-east of the site and is of a linear plan, aligned east-west. The structure is of two phases, being originally constructed in 1885/6 and later extended in 1898 with smaller additions in the early-mid 20th century. A single storey, rectangular boiler house of buff, multi-buff brick in stretcher bond was located to the west of the main building. The lowest courses of the brickwork were of hard fired red brick, also in stretcher bond. The boiler house utilises the walls of the adjacent, earlier building. Access was through a louvered double door with a concrete ramp rising up from the ground level. A square, louvered panel was located adjacent to the door. The roof is flat and covered with roofing felt, with timber fascia boards to which PVCu rainwater goods are secured.

Laundry, the east boiler house, looking north-east Fig 38

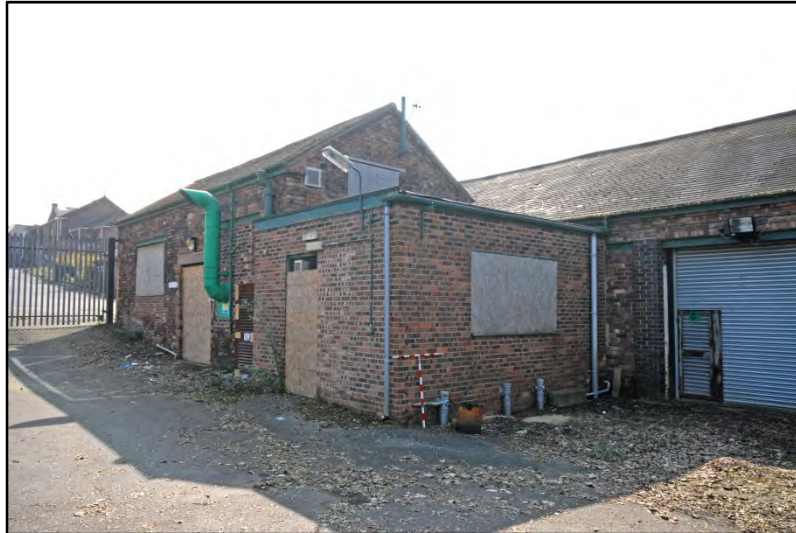
The toilet block is constructed of multi-colour brickwork in stretcher bond. It has a flat roof of roofing felt with timber fascia boards. A double door to the north has been partially blocked and reduced to a single door opening.

Workshops, north WC extension, looking south-east Fig 39

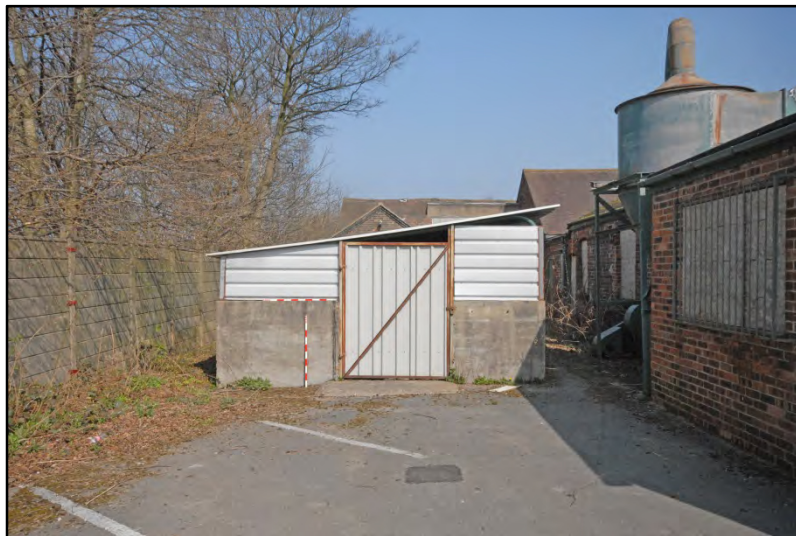
To the rear (west) of the workshops is a detached, single storey garage or shed. This comprises a single room, rectangular in plan, on a north-south alignment. The construction is of steel sheets supported over concrete dwarf walls. The roof is of a cat-slide type, sloping to the west and is also of steel sheets. Opposing doorways were located in the north and south elevations.

Workshops, detached garage/shed, looking north Fig 40

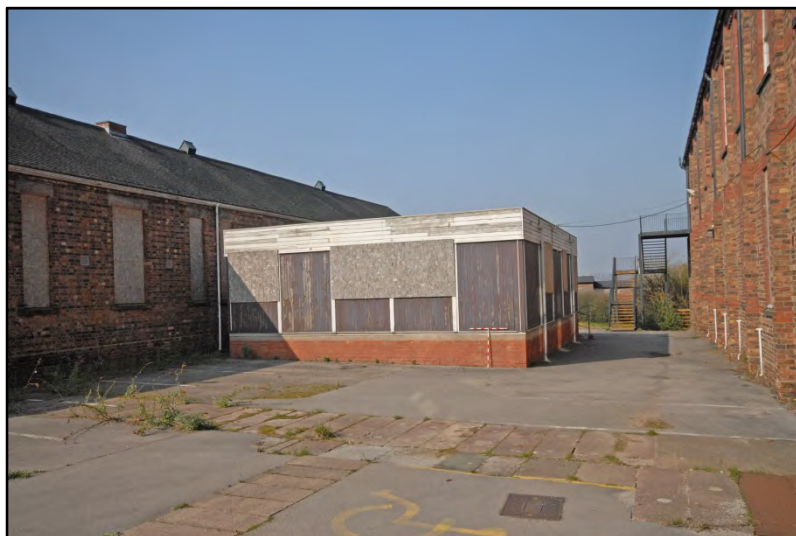
To the north is a square, single storey structure, largely detached from the main building, with a connecting passage linking to the ward. The structure comprises a timber structure with timber posts and vertical cladding supported over a red brick dwarf wall in English Bond capped with cement. The flat roof is constructed of roofing felt with white painted timber fascia boards at the eaves. Internally there is an L plan central corridor flanked by a number of rooms, leading to a secondary entrance or fire exit to the west.

Day Hospital, brick and wood extension, looking west Fig 41
