**Gazetteer of mid-late 20th-century buildings at
Bucknall Hospital, Stoke on Trent
Staffordshire
April 2015**

Report No. 15/85

PROJECT DETAILS		OASIS molanort1-211236
Project title	Gazetteer of mid-late 20th-century buildings at Bucknall Hospital, Stoke on Trent, Staffordshire, April 2015	
Short description	MOLA carried out a Gazetteer level programme of historic building recording of post-1940s buildings at Bucknall Hospital, Stoke on Trent, Staffordshire. The surveyed buildings largely comprised extensions to earlier buildings, detached boiler houses and store rooms and sheds. These primarily dated to the 1980s and 1990s.	
Project type	Historic Building Survey	
Previous work	Historic Building Survey	
Future work	Trial trench evaluation	
Monument type and period	Post 1940s buildings and extensions	
PROJECT LOCATION		
County	Staffordshire	
Site address	Bucknall Hospital, Eaves Lane, Stoke on Trent	
NGR	SJ 9106 4801	
Area	c4.3 hectares	
PROJECT CREATORS		
Organisation	MOLA Northampton	
Project brief originator	Keepmoat Home	
Project Design originator	MOLA Northampton

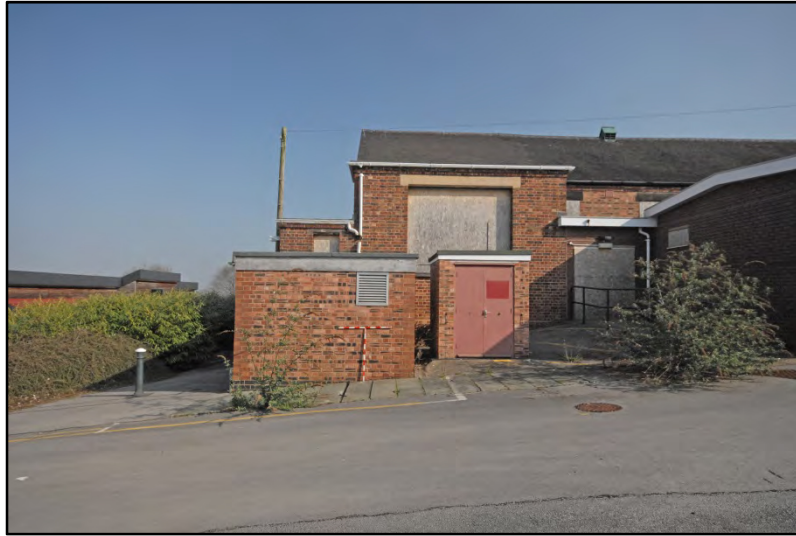
A small, rectangular boiler house is located at the south-west of the main building with a double louvered door opening to the west and a louvered ventilation panel to the south. This is constructed of multi-buff brick in English Bond with blue-black brick courses at the base, and has a flat roof of roofing felt with timber fascia boards. Immediately to the east of the boiler house is a small detached electrical room, identical in fabric and construction to the boiler house, though much smaller.

Day Hospital, boiler house and electrical room, looking north Fig 42

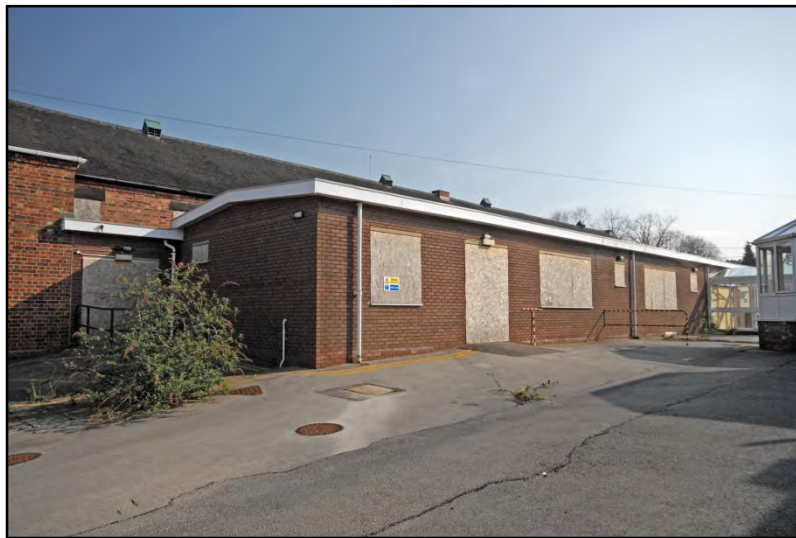
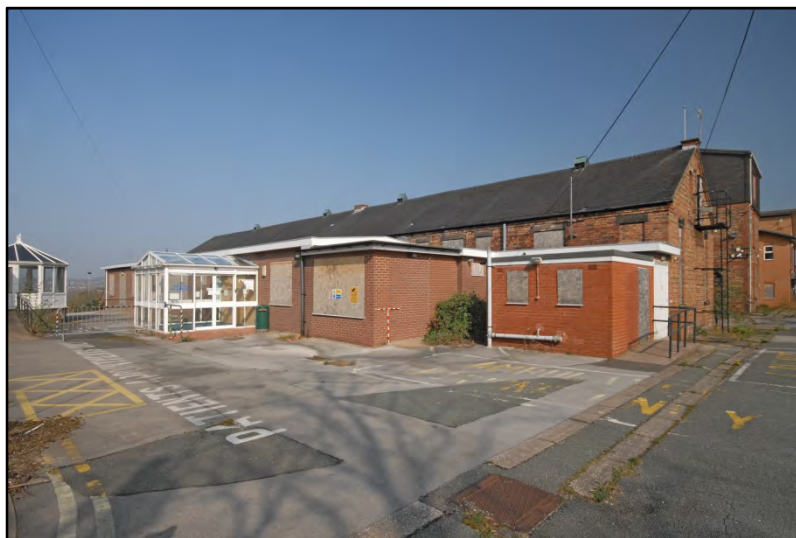
The full southern extent of the original building was extended southwards post-1970s with a long corridor running alongside the original south wall, providing access to a brick extension which is almost the length of the original building. This is extended further south with a modern entrance block. The corridor and main extension is constructed of dark red, textured brick in stretcher bond. The structure is plain with no decorative embellishment. The corridor has a flat roof of roofing felt and the extension has a shallow ridged roof of roofing felt, with white painted timber fascia boards and soffits at the eaves. Internally, the extension comprises a single large room accessed from the corridor, with a number of small rooms such as WCs and storage, flanking an entrance hall with access to the entrance block. The entrance block is a glass and aluminium / PVCu structure on a brick and concrete base. It has an automatic sliding door opening onto a small ramp to the east. A mid-1990s extension fills in the south-east corner of the larger post-1970s structure and comprises a single room with a window facing south and a double door, blocked in brick, formerly opening eastward.

To the south-east, adjacent to the corridor, is a single storey, square plan extension, bisected into two equal-sized rooms which formerly functioned as WCs. This is of red brick in stretcher bond with concrete ramps leading to doors that open to the east and west. Each room has a single window looking south. The flat roof is of roofing felt with white painted timber fascia board. Also present are PVCu rainwater goods and drainage pipes.

Day Hospital, the south extension, looking north-east Fig 43

Day Hospital, the south extensions and entrance, looking north-west Fig 44

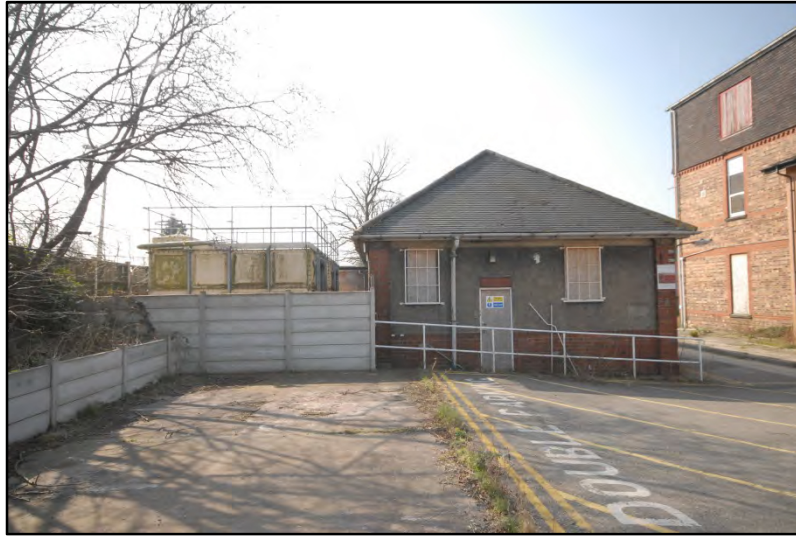
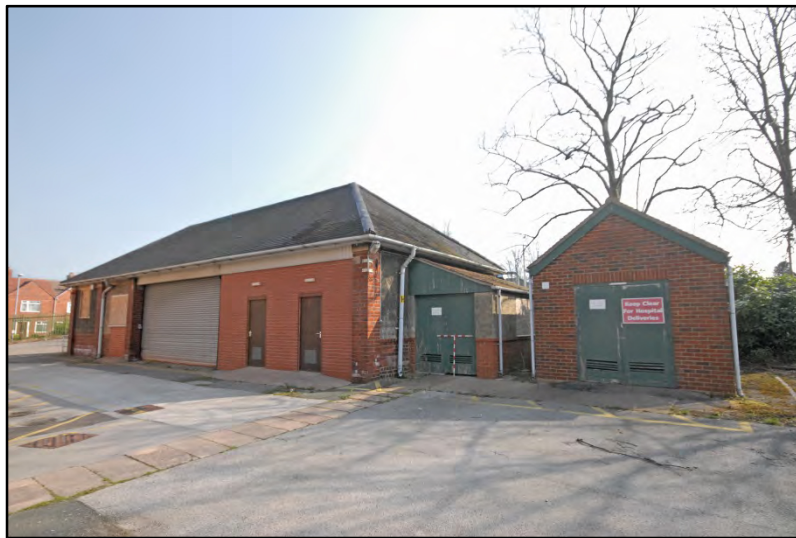
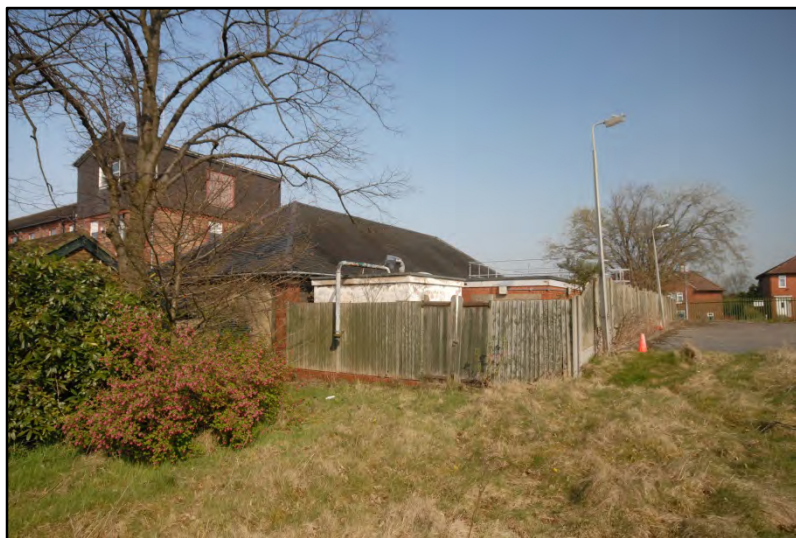
The main part of the garage building dates to the early 20th century and was constructed by 1937. It is located to the east of Ward Block 10/11, at the north-eastern corner of the site. Two small gas store rooms were constructed to the south of the garage, one abutting the southern elevation and the other being free-standing and detached. The garage is constructed of multi-coloured brick, both red and grey, laid in English Bond. The main part of the west elevation is of a later construction indicating that originally the structure was open fronted to the west. A large, upward opening garage door and two wooden doors are located within the later wall. The upper portion of this area has vertical timber cladding below the eaves.

The north elevation has an off centre door, flanked by two windows with steel security grills. The south elevation is obscured by a later gas store which abuts the building. This has a large double door to the west and has red brick dwarf walls in stretcher bond, with the upper part of the structure being in concrete. A single window is located within the south wall. The store is covered with a cat-slide roof which descends from eaves level of the garage. The garage itself has a tile-clad hipped roof with rounded ridge tiles and PVCu rainwater goods. The adjacent, free-standing gas store is a square structure with a single double door opening to the west. It has a tile-clad open gable roof with rounded ridge tiles, with the ridge aligned east-west. The Walls are constructed of red and grey textured brick in stretcher bond, with a soldier brick lintel over the door

Garage, looking south Fig 45

Garage and stores, looking north-east Fig 46

Garage, looking north-west Fig 47

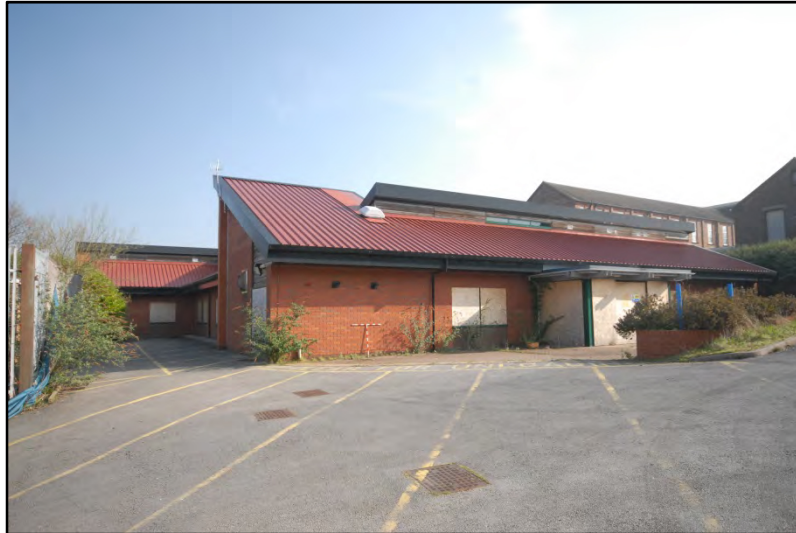
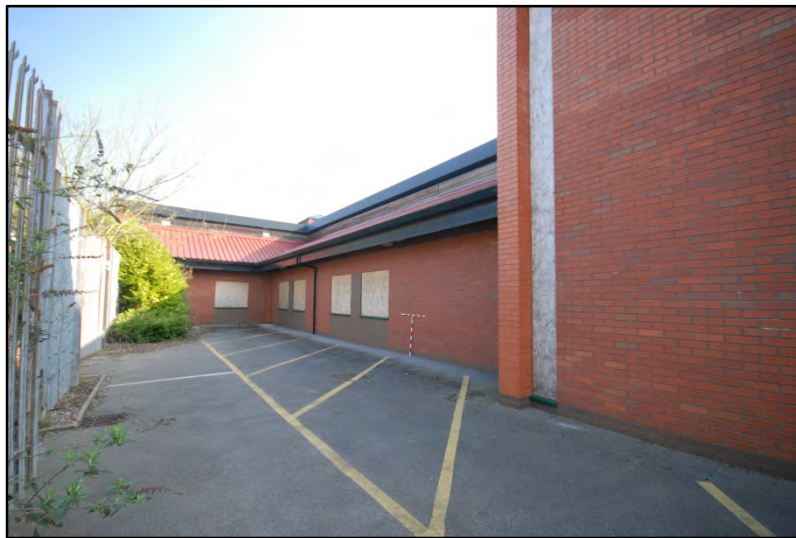
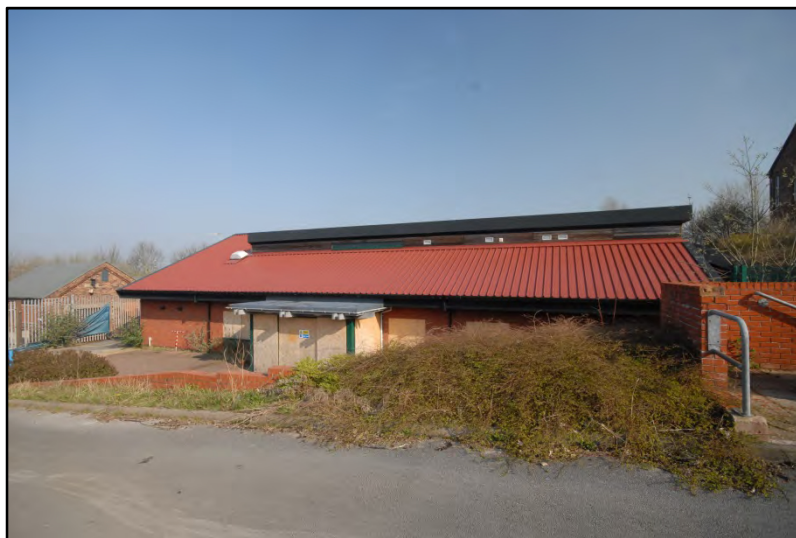
Meadow Croft, south elevation, looking north Fig 48

Meadow Croft, west elevation, looking north Fig 49

Meadow Croft, south elevation, looking north Fig 50

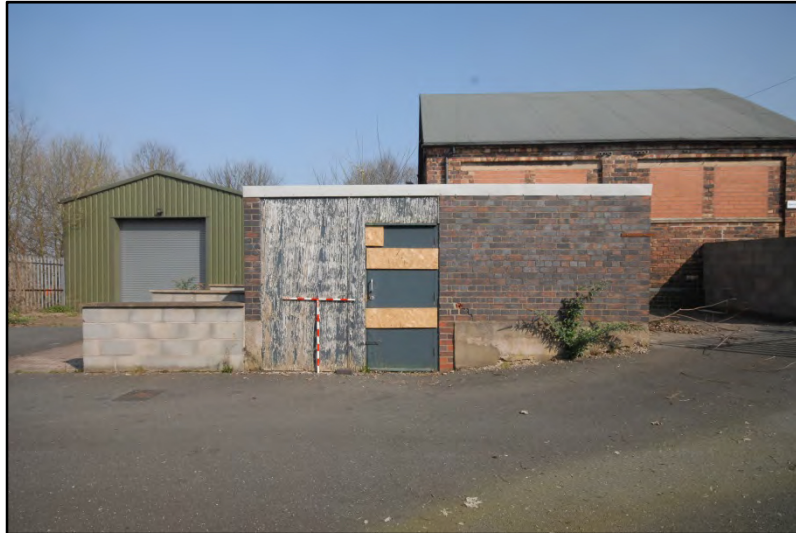
A free standing shed of box profile steel panels is located west of the group. This is aligned north-south and comprises a single room with access from the south through a large steel garage door. The structure has a gabled roof of steel sheets.

Store room and Shed, looking north Fig 51

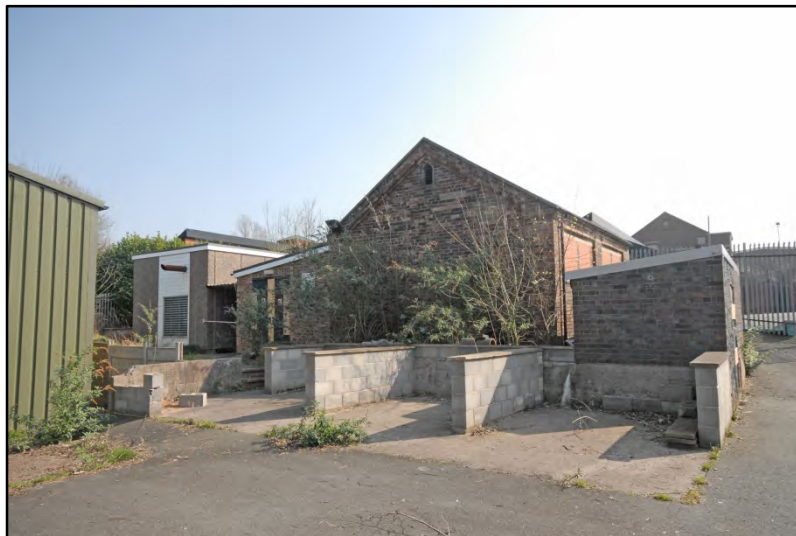
Breeze block bays, looking north-east Fig 52

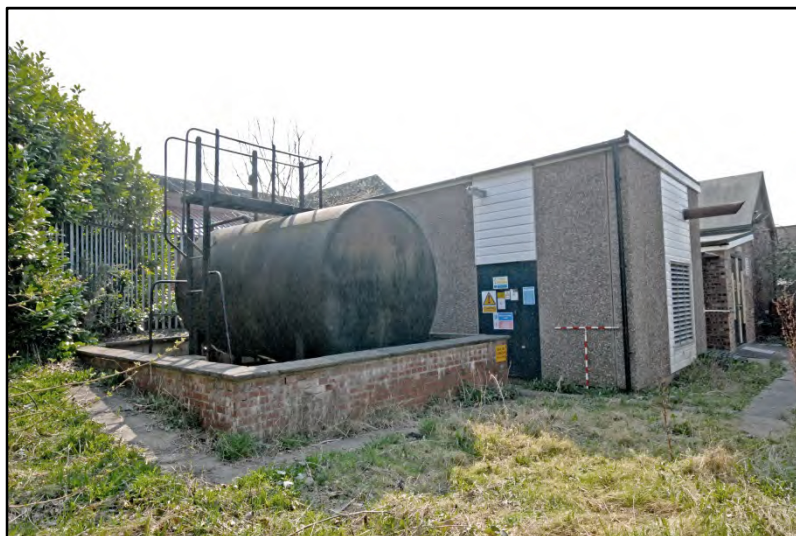
A pre-fabricated concrete with pebble dash render generator room is located north of the extension. This is rectangular in plan, aligned east-west and comprises a single room with entry from the north. A large ventilator panel with exhaust pipe over is located in the western elevation. It has a flat roof of roofing felt with timber fascia boards. Adjacent to the generator (north) is a cylindrical fuel tank which is housed within a brick enclosing wall.

Generator and tank, looking south-east Fig 53
