Archaeological trial trench evaluation at Bucknall Hospital, Stoke-on-Trent April 2015

Report No. 15/92

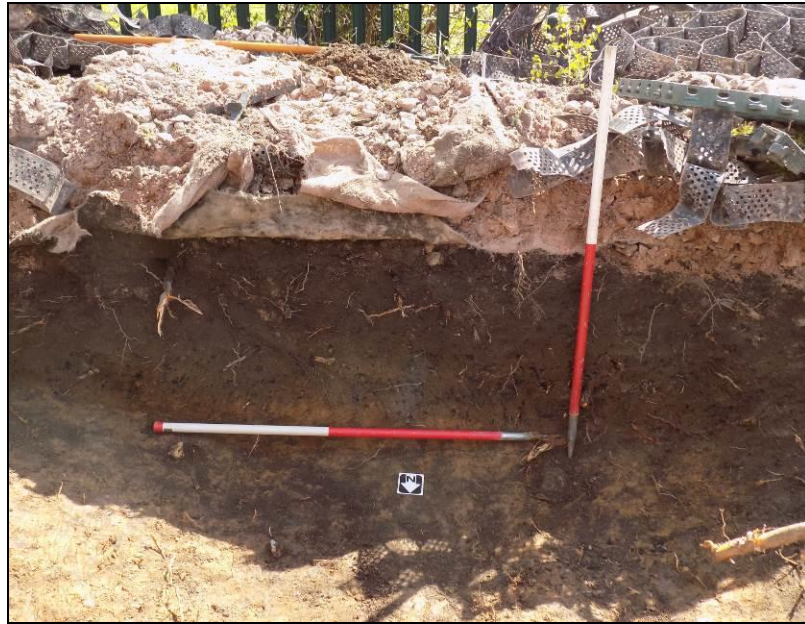
Trench 1, north-facing section Fig 3

The lower made-ground layer was 0.30m thick and comprised firm dark black-brown silty clay with fragments of post-medieval pottery, brick and charcoal (102). This was overlain by a thin layer of compact light pink-yellow sand and gravel mix, 0.05m thick, over matting (101). Layer (103, located towards the northern end of the trench, comprised modern disturbance, up to 0.60m thick.

This trench was located to the west of the current building on site, aligned north-north-west to south-south-east, and was positioned to target the former yard to the north of the farmhouse. No structural evidence of the yard or farmhouse remained, with only fragmentary post-medieval pottery and brick being found in the made-ground layers (Fig 3 and Fig 4).

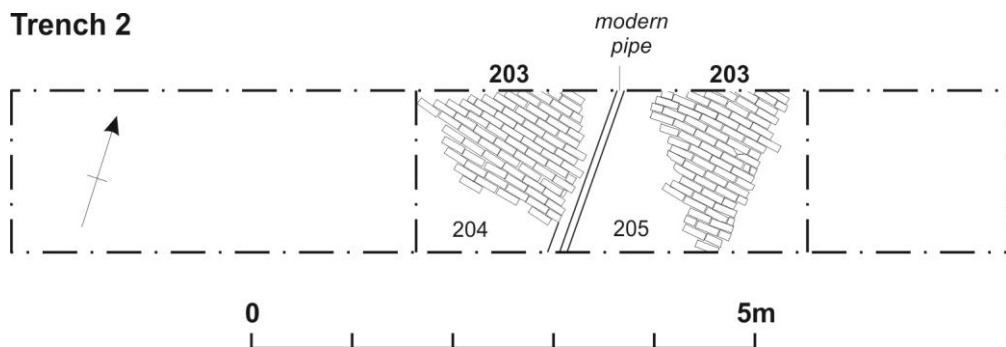
Plan of brick surface in Trench 2, extension not shown (Scale 1:75) Fig 5

Made-ground deposit (204), extended across the trench, was 0.34m thick and comprised compact dark black-brown clayey-silt contained small fragments of brick. It was overlain by the remains of a brick surface (203), which was 3.5m wide and comprised hand-made, yellow/brown-red bricks measuring 0.23x0.1x0.07m laid on edge and end-to-end (Fig 5-7). The brick surface was truncated by a modern plastic pipe. No wall foundations were present.

At the request of the Senior Planning Officer, the trench was extended to the north in order to assess the extent of the brick work and to determine the presence/absence of wall foundations. The brick surface did not extend beyond the original limit of the trench and no walls were identified (Fig 5-7).

The brick surface in Trench 2 was the only evidence for the farmhouse and is likely to have been the remains of a floor at the south end of the building. No walls or wall footings were located. The truncated nature of the floor and absence of walls/footings indicates that the farmhouse was almost completely demolished when the hospital grounds were expanded to allow for the construction of Verity House.
