**Archaeological watching brief and  
trial trench evaluation on land off  
Coventry Road, Coleshill  
Warwickshire  
January 2014 to February 2015**

Report No. 15/99

# Archaeological watching brief and trial trench evaluation on land off Coventry Road, Coleshill Warwickshire January, October 2014 and February 2015

Report No. 15/99  
Accession code: CCR14/15

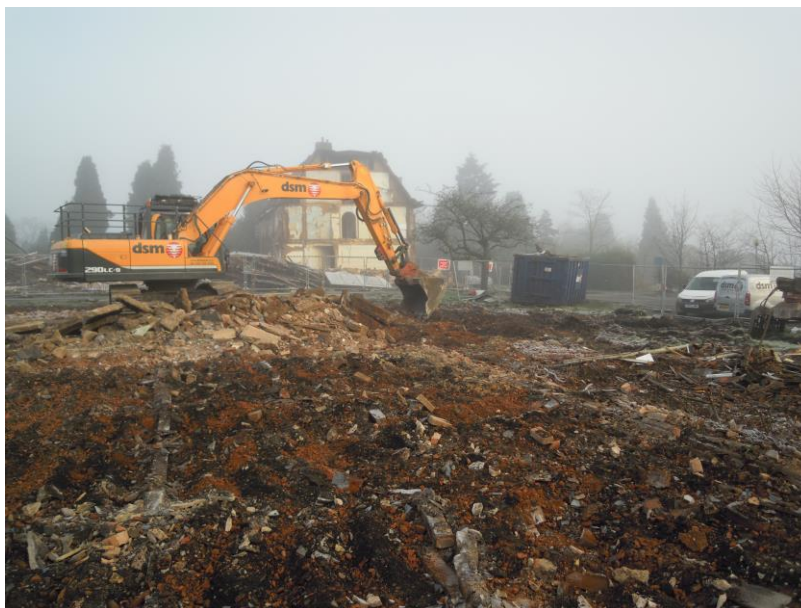
Fig 3

Area of watching brief, pre excavation

This took place in February 2014 during the demolition of existing buildings and excavation of an area in the south-west of the site (Fig 2 and 3).

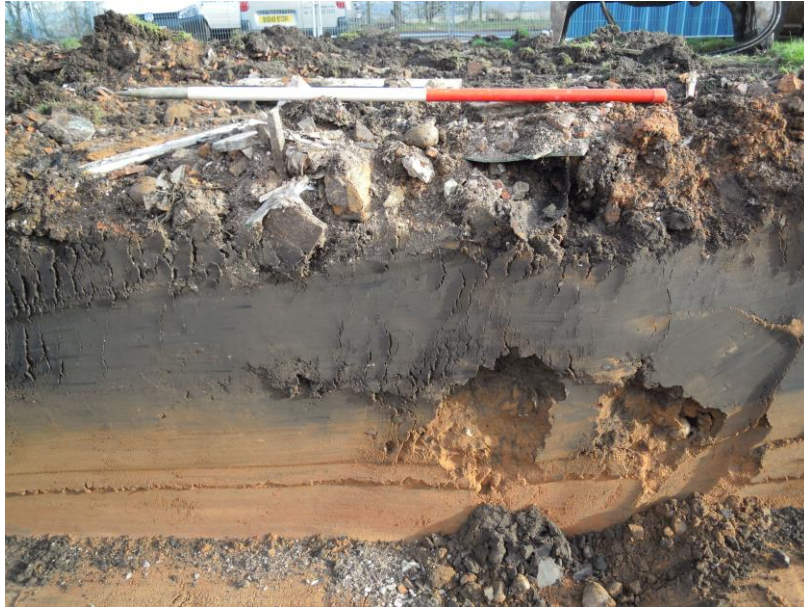
Heavily disturbed ground in watching brief area Fig 4

The natural sub-stratum uncovered in the watching brief area was consistent with that uncovered during the trial trench evaluation and comprised red-brown and orange sands with occasional gravels and occurred 0.40-1.0m below the present ground surface. Heavily disturbed ground and make-up layers were also identified (Fig 4).

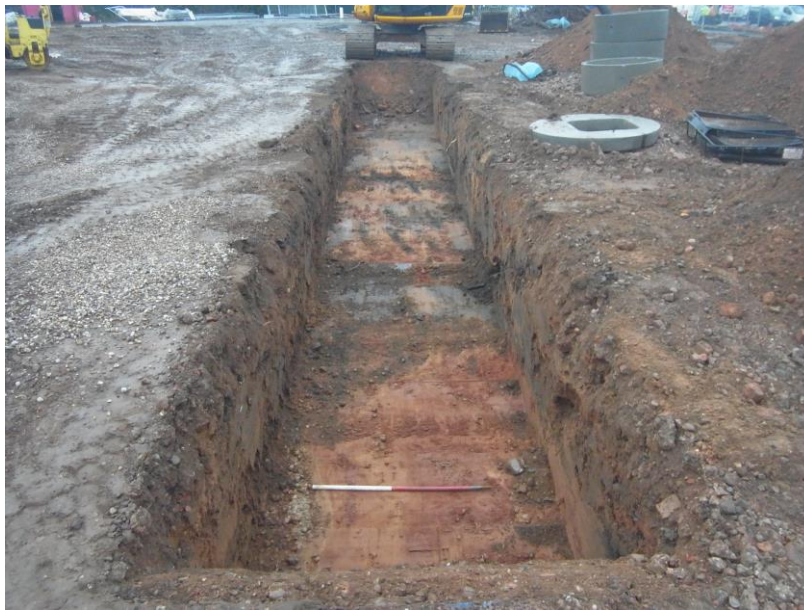
Fig 5

Trench No.	Length, width & alignment		Surface height (aOD)	Depth & height of natural (aOD)
2	2.0m x 20m N-S		?	1.20m ?
<i>Context</i>	<i>Context type</i>	<i>Description</i>	<i>Dimensions</i>	<i>Artefacts/ Samples</i>
201	Made ground	Layer of crush rubble	0.30m thick	-
202	Made ground	Mixed brick rubble, stone and silty sand	0.90m thick	-
203	Natural	Friable red-brown and orange sands with occasional gravels	-	-

Trench 2, looking north

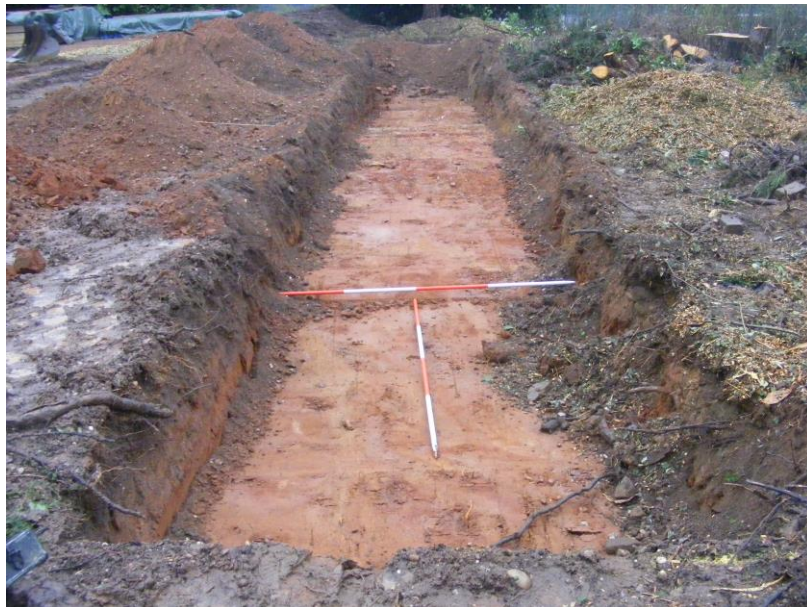
Fig 6

<b>Trench No.</b>	<b>Length, width &amp; alignment</b>		<b>Surface height (aOD)</b>	<b>Depth &amp; height of natural (aOD)</b>
<b>3</b>	<b>2.0m x 20m E-W</b>		<b>102.86m</b>	<b>0.70m 102.16m</b>
<b>Context</b>	<b>Context type</b>	<b>Description</b>	<b>Dimensions</b>	<b>Artefacts/ Samples</b>
301	Made ground	Friable mid grey-brown sandy silt with brick and small stone inclusions	0.70m thick	-
302	Natural	Friable red-brown and orange sands with occasional gravels	-	-

Trench 3, looking east

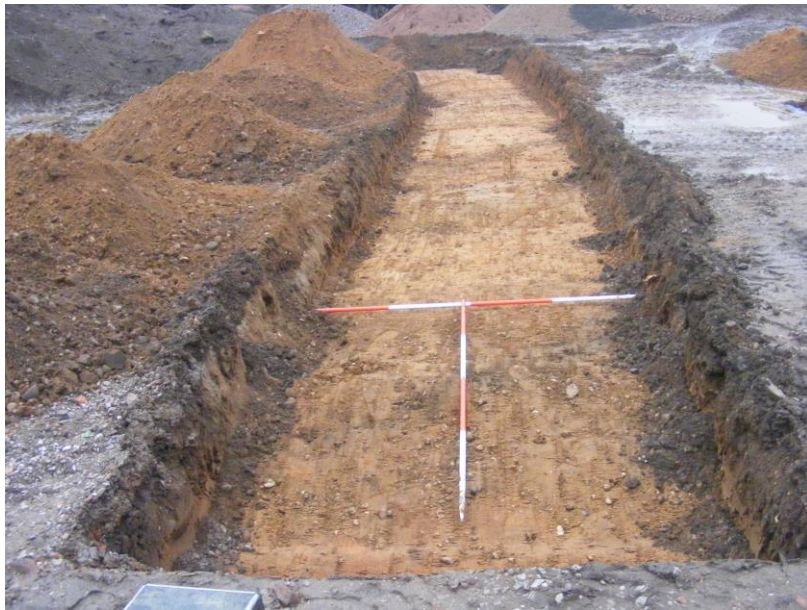
<b>Trench No.</b>	<b>Length, width &amp; alignment</b>		<b>Surface height (aOD)</b>	<b>Depth &amp; height of natural (aOD)</b>
4	2.0m x 20m E-W		103.59m	0.80m 102.79m
<b>Context</b>	<b>Context type</b>	<b>Description</b>	<b>Dimensions</b>	<b>Artefacts/ Samples</b>
401	Made ground	Friable mid grey-brown sandy silt with brick and small stone inclusions	0.80m thick	-
402	Natural	Friable red-brown and orange sands with occasional gravels	-	-

Trench 4, looking west      Fig 7

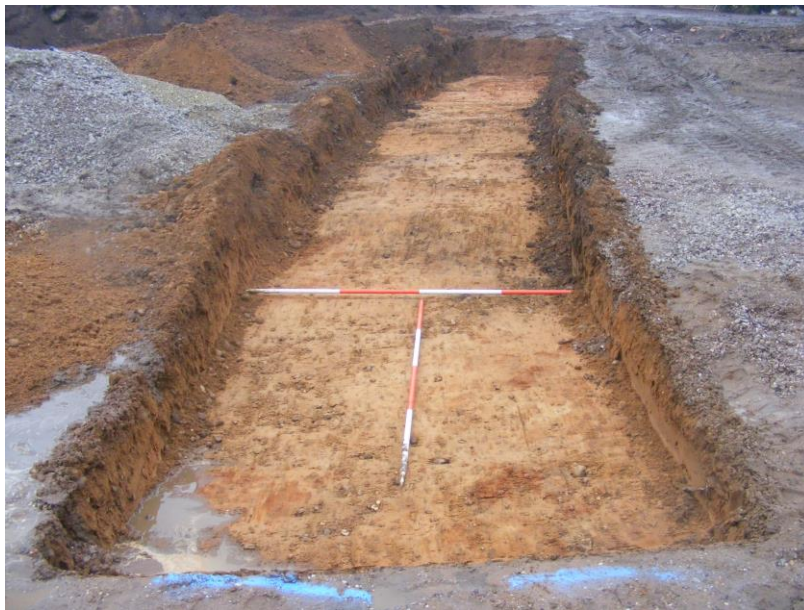
Fig 8

Trench No.	Length, width & alignment		Surface height (aOD)	Depth & height of natural (aOD)
5	2.0m x 20m NE-SW		102.0m	0.55m 101.55m
<i>Context</i>	<i>Context type</i>	<i>Description</i>	<i>Dimensions</i>	<i>Artefacts/Samples</i>
501	Tarmac	-	0.05m thick	-
502	Made ground	Friable mid grey-brown sandy silt with brick and small stone inclusions	0.50m thick	-
503	Natural	Friable red-brown and orange sands with occasional gravels	-	-

Trench 5, looking south-west

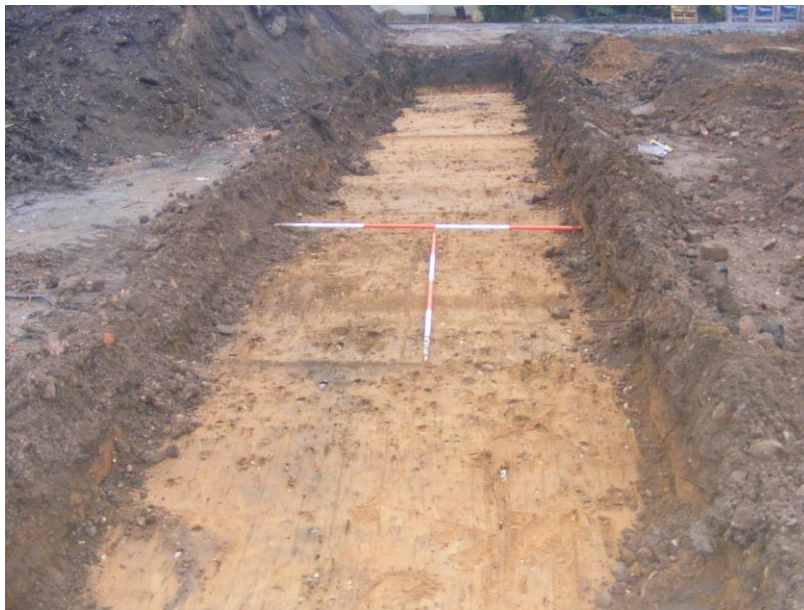
<b>Trench No.</b>	<b>Length, width &amp; alignment</b>		<b>Surface height (aOD)</b>	<b>Depth &amp; height of natural (aOD)</b>
<b>6</b>	<b>2.0m x 20m NW-SE</b>		<b>102.45m</b>	<b>0.70m 101.75m</b>
<b>Context</b>	<b>Context type</b>	<b>Description</b>	<b>Dimensions</b>	<b>Artefacts/ Samples</b>
601	Made ground	Mixed gravels, sand and brick rubble	0.50m thick	-
602	Re-deposited natural	Friable yellow-brown silty clay with frequent brick fragments and small stones	0.20m thick	-
603	Natural	Friable red-brown and orange sands with occasional gravels	-	-

Trench 6, looking north-west Fig 9

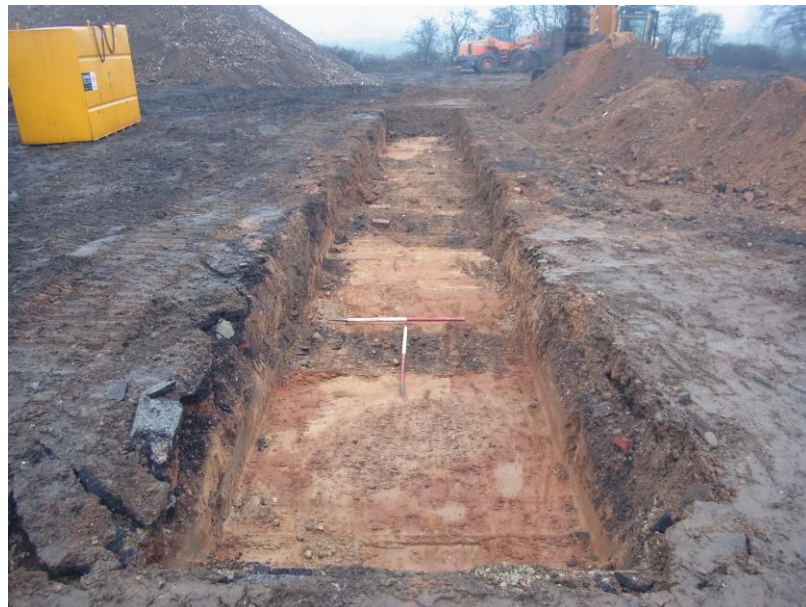
Fig 10

<b>Trench No.</b>	<b>Length, width &amp; alignment</b>		<b>Surface height (aOD)</b>	<b>Depth &amp; height of natural (aOD)</b>
<b>9</b>	<b>2.0m x 20m NE-SW</b>		<b>?</b>	<b>0.70m ?</b>
<b>Context</b>	<b>Context type</b>	<b>Description</b>	<b>Dimensions</b>	<b>Artefacts/ Samples</b>
901	Made ground	Mixed crush and sand	0.30m thick	-
902	Made ground	Mixed stone, brick rubble and sand	0.40m thick	-
903	Natural	Friable red-brown and orange sands with occasional gravels	-	-

Trench 9, looking east

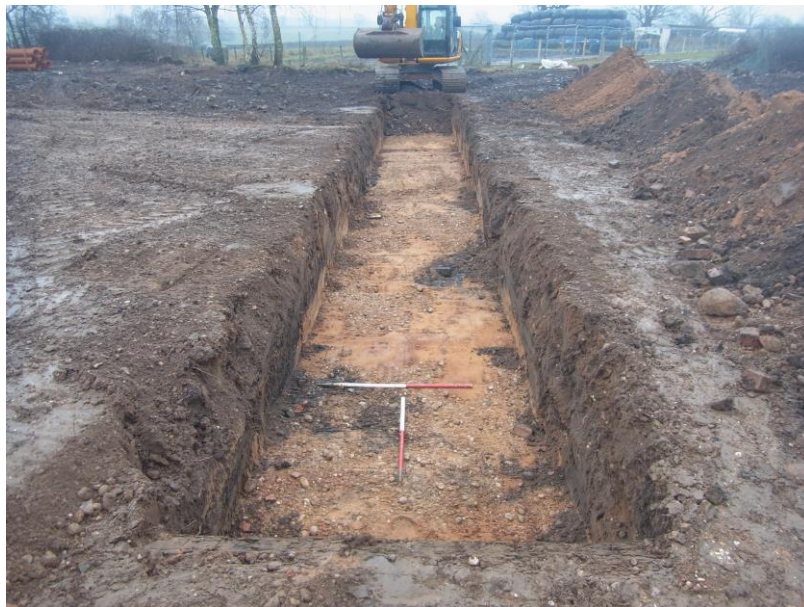
Fig 11

<b>Trench No.</b>	<b>Length, width &amp; alignment</b>		<b>Surface height (aOD)</b>	<b>Depth &amp; height of natural (aOD)</b>
10	2.0m x 20m NW-SE		?	1.05m ?
<b>Context</b>	<b>Context type</b>	<b>Description</b>	<b>Dimensions</b>	<b>Artefacts/ Samples</b>
1001	Made ground	Mixed crush and sand	0.30m thick	-
1002	Made ground	Mixed stone, brick rubble and sand	0.75m thick	-
1003	Natural	Friable red-brown and orange sands with occasional gravels	-	-

Trench 10, looking south-east

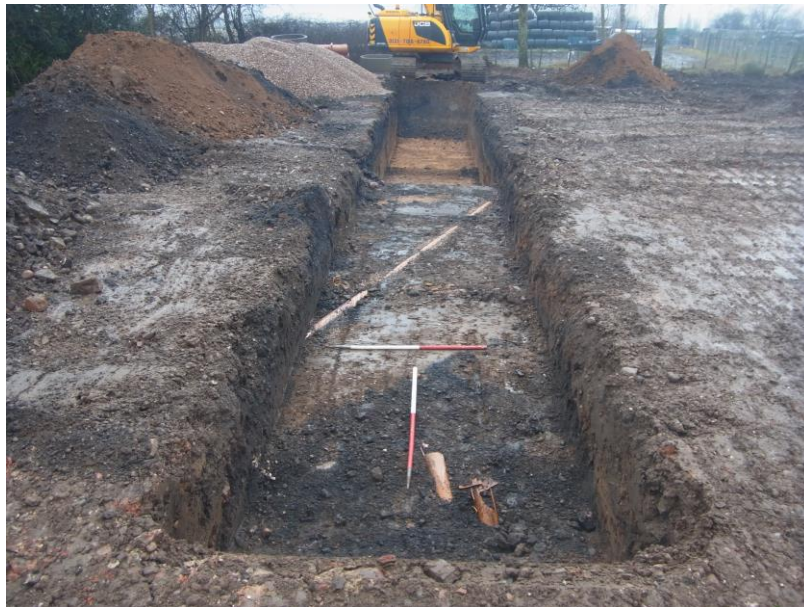
Fig 12

Trench No.	Length, width & alignment		Surface height (aOD)	Depth & height of natural (aOD)
12	2.0m x 20m N-S		?	1.16m ?
<i>Context</i>	<i>Context type</i>	<i>Description</i>	<i>Dimensions</i>	<i>Artefacts/Samples</i>
1201	Made ground	Mixed crush and sand	0.30m thick	-
1202	Made ground/clinker	Dark grey clinker-coal	0.40m thick	-
1203	Made ground	Mid brown stony deposit	0.30m thick	-
1204	Natural	Friable red-brown and orange sands with occasional gravels	-	-

Trench 12, looking south
