# **An Archaeological Investigation of the Historical Development of Cathedral Square, Peterborough November 2008 to August 2011**

Report No. 16/105

Site Codes: PCSWB09, PCS09, PCSF09, CATSP08

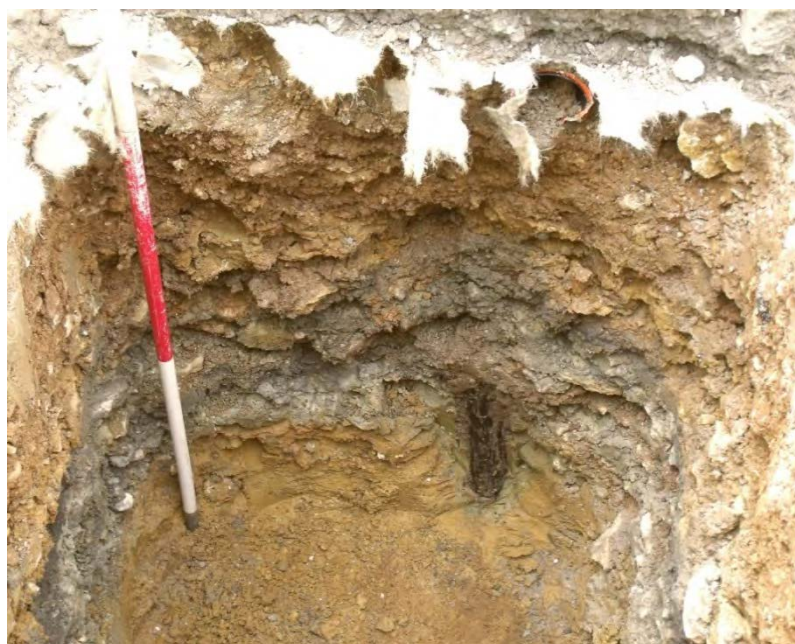
Posthole with *in situ* wooden post, east end of Cathedral Square Fig 3.1

Two features, a wooden post (not retrieved) in its posthole, at the east end of Cathedral Square (Figs 3.1 and 3.2) and a large pit to the west of the church of St John the Baptist, both sealed below the market square stone surface that probably dates to De Bec's 'New Town'.

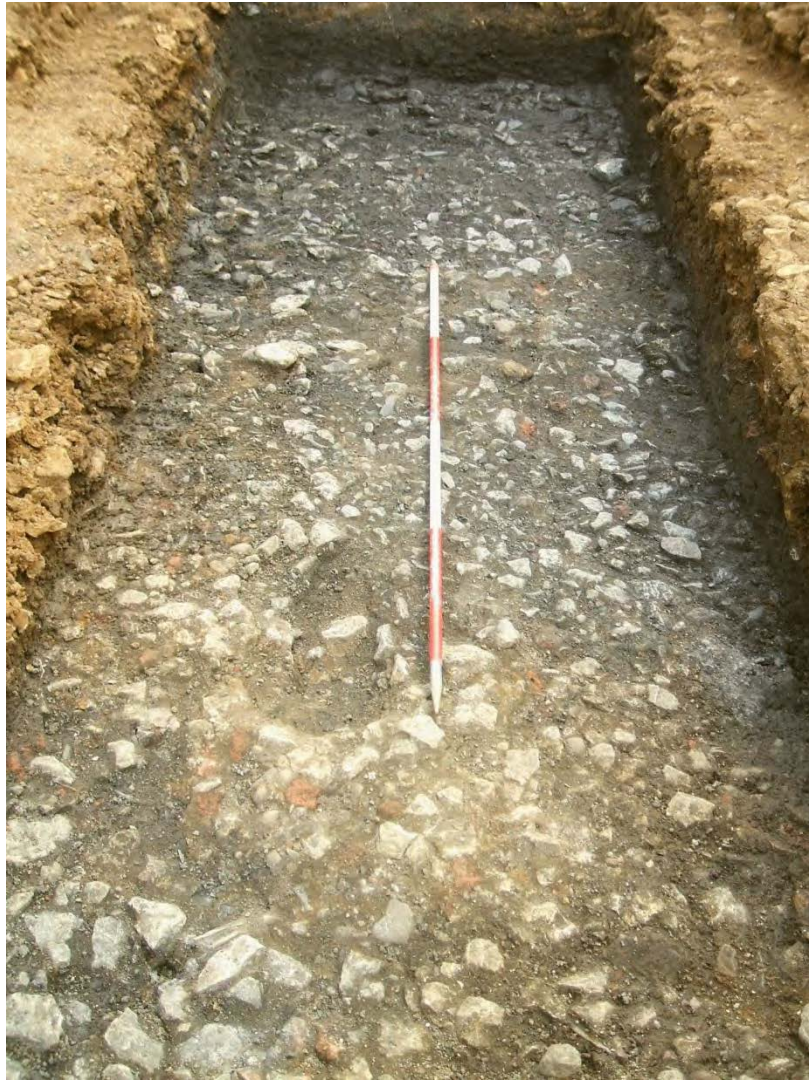
De Bec's market square surface, sealed by dark silt of the 12th to 17th centuries, Cathedral Square, looking west Fig 3.3

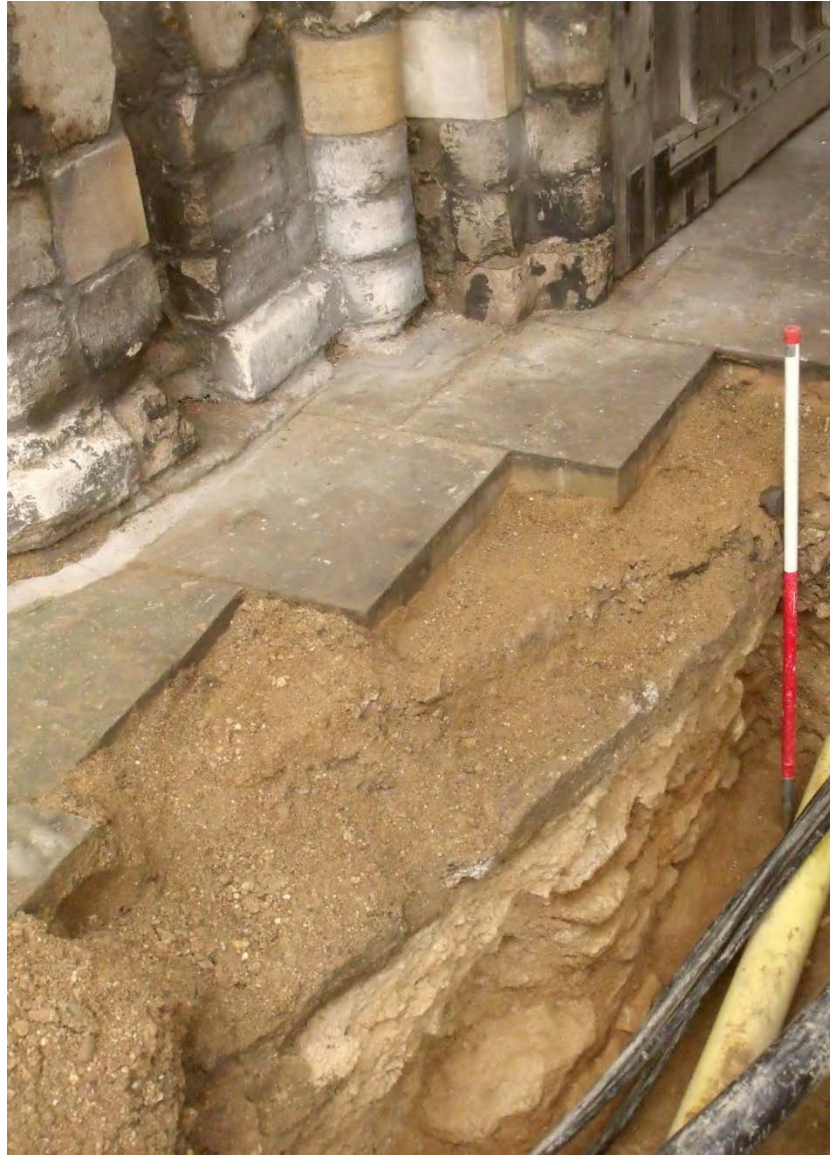
Gas trench at the Cathedral West Gate, showing stone foundations of the 12th to 14th centuries, looking north-east Fig 3.4

The stone foundations of the 12th- and 14th-century gateways were exposed during reopening of the gas main trench that passed through the gateway into the Cathedral precincts (Fig 3.4). The foundations for the supporting 14th-century turrets were exposed during the groundworks in the 1.0m-deep trenches. The foundations on the north side had been partly replaced with concrete, probably in the 1930s, during widening and construction of new Bridge Street (Fig 3.5).

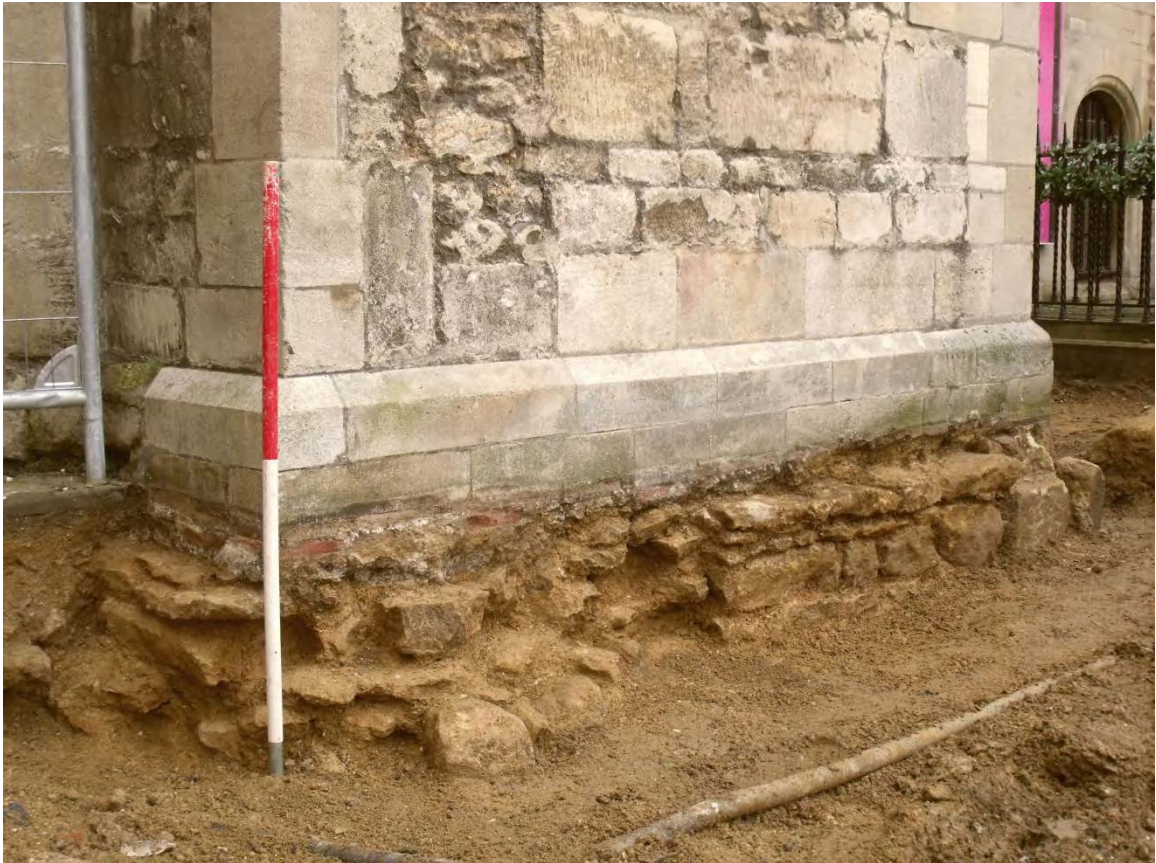
Foundation of the south turret of the 14th-century West Gate, partially disturbed by early 20th-century services, looking south-east Fig 3.5

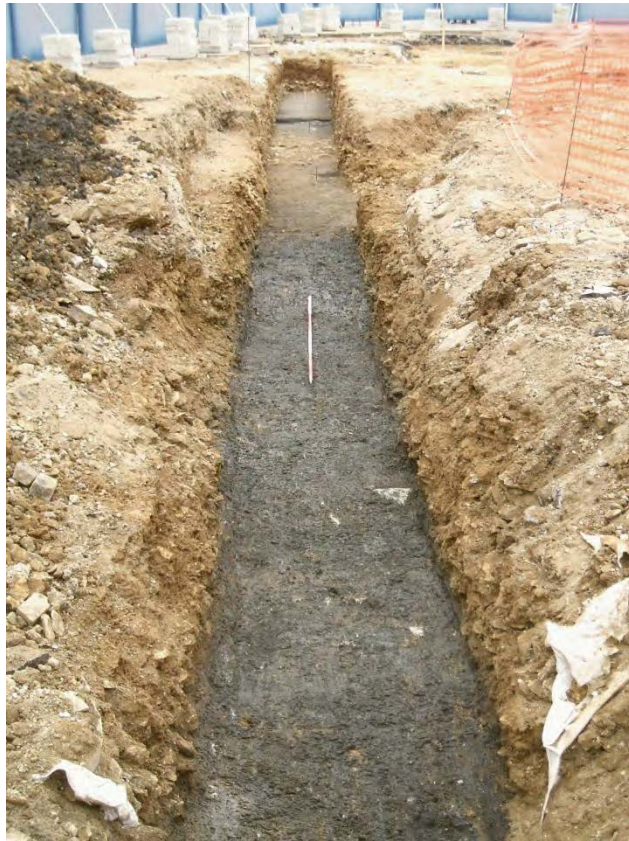
Dark silt over de Bec's market square surface,  
north side of Cathedral Square Fig 3.8

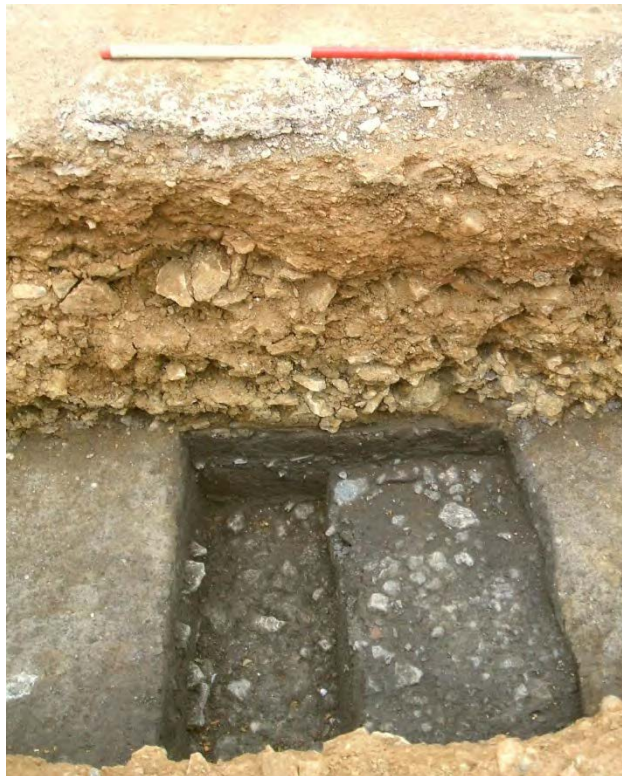
De Bec's market square surface, with overlying dark silt,  
showing later resurfacing Fig 3.9

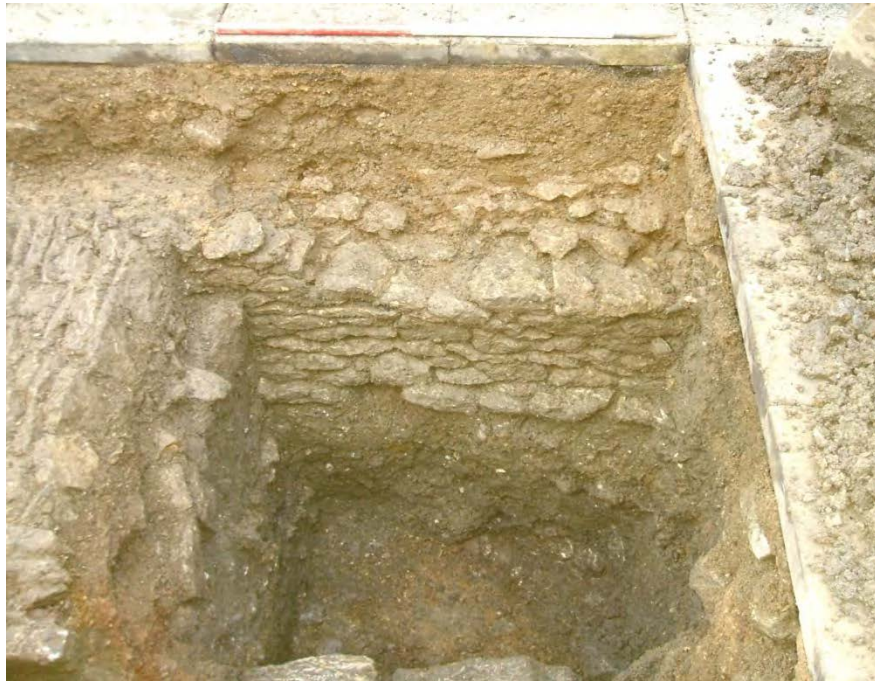
Fig 3.10

Early churchyard wall, north side of Church Street, looking north

To the south and west of the church the remains of a contemporary stone churchyard wall was evident, lying parallel to and about 6.0m away from the church façade (Figs 3.10 and 3.11). No evidence of an early corresponding wall was observed on the north and east sides of the church. Slightly green organic rich soils appear to have been introduced to level up the ground around the church. On the surface of the lower soil layer there was a thin spread of gravel, which may have been an early churchyard surface. Pottery recovered from these layers dates from the 15th-16th centuries. Similar soil layers were not present on the north side of the church.

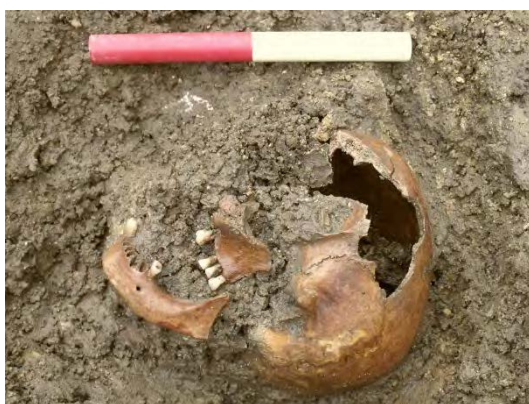
The skull of burial HB1 Fig 3.12

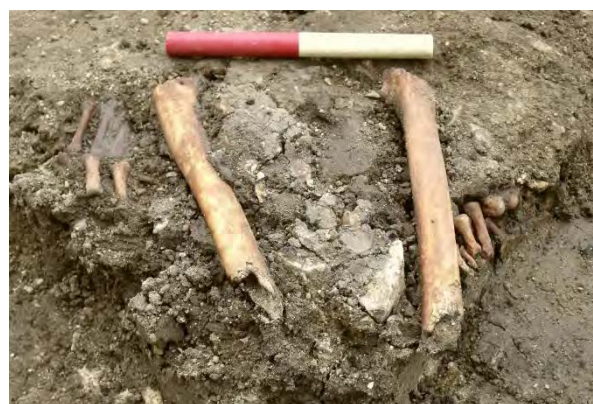
The femurs of burial HB6 overlying the feet of one or two earlier burials, HB 7 Fig 3.13

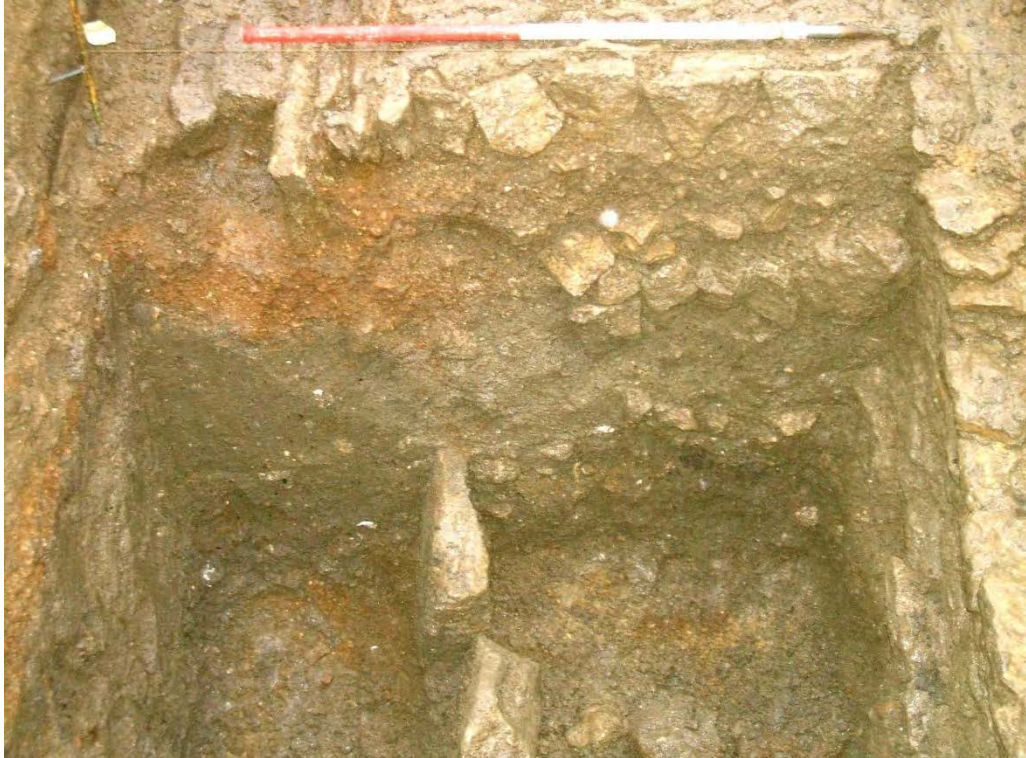
Kerb stones forming the edge of a 15th-century pathway against the stone churchyard wall (right) with the road at a lower level to the left, Trench 6 Fig 3.14

A trench to the south of the church revealed a street level probably contemporary with the construction of the church. It was composed of a roughly metalled road and path separated by large upright stone slabs that formed a kerb, adjacent to the south churchyard wall. A single sherd of Bourne B ware pottery of 13th to 15th century date was recovered from the path (Figs 3.14 and 3.15).

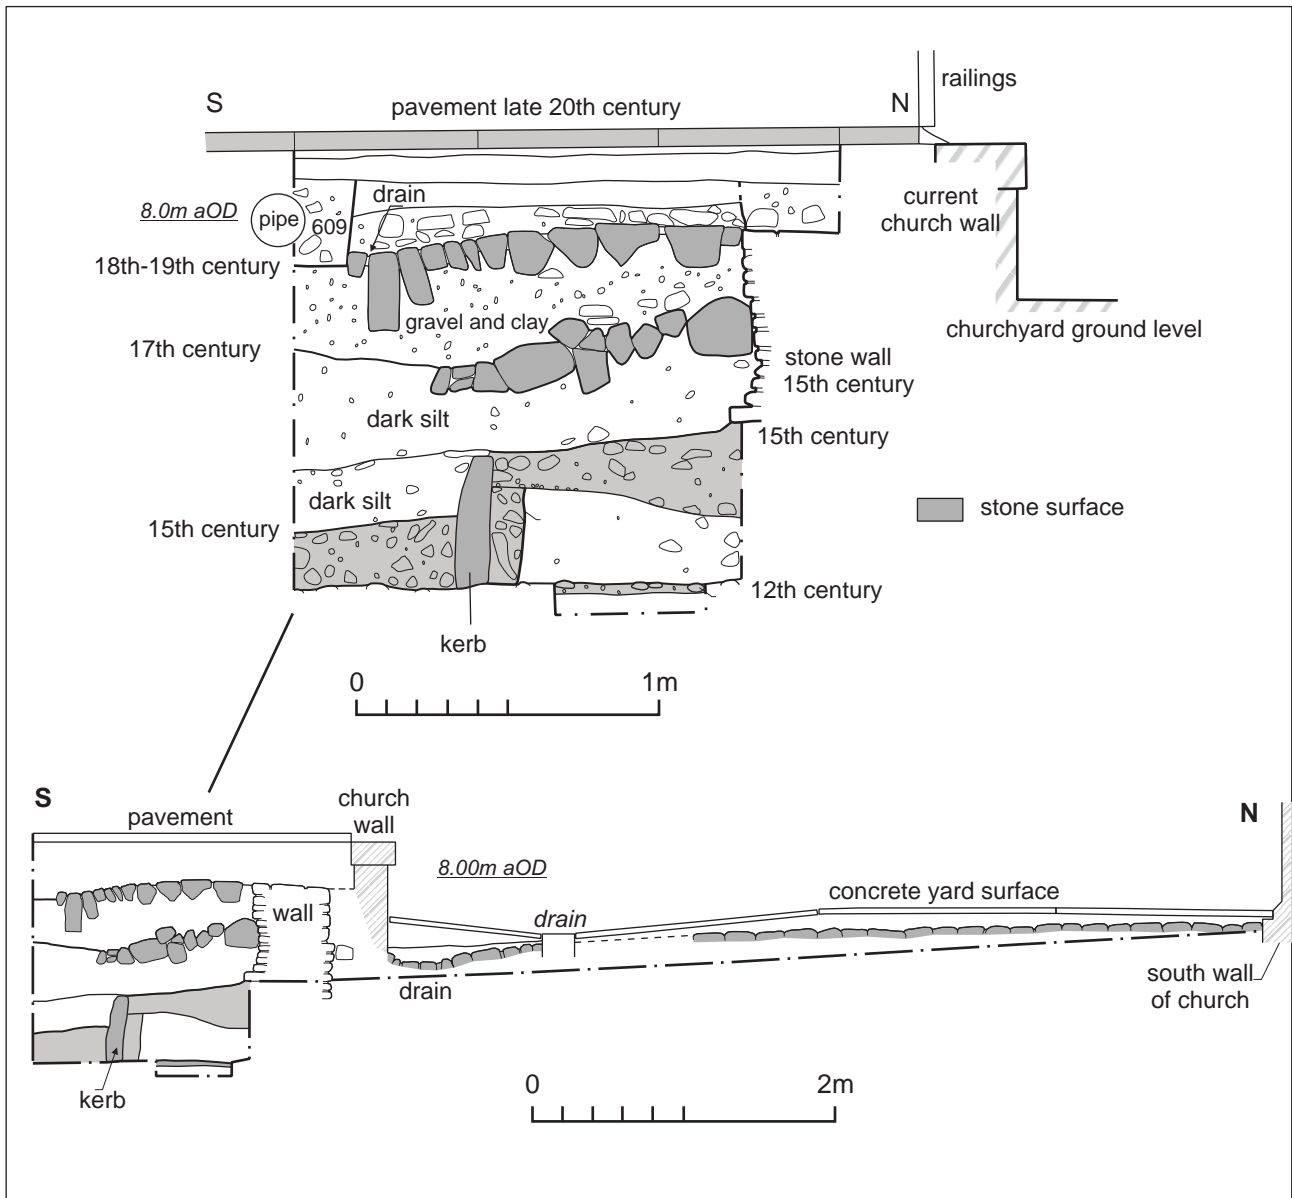
The pavement surfaces in Church Street from the 12th-20th centuries (top), and the pavements in relation to the sunken churchyard (bottom) Fig 3.15

A pitched-stone path 1.0m wide ran along the length of the churchyard wall on the north side of Church Street (Figs 3.15 and 3.27). The path had a slight incline into the street that had lost its stone surface exposing the dark silt deposit beneath. It is possible the churchyard wall may have been reconstructed at the same time or at some stage post-dating the laying of the pitched surfaces, as the wall appears to be slightly offset to the south at the new ground level.

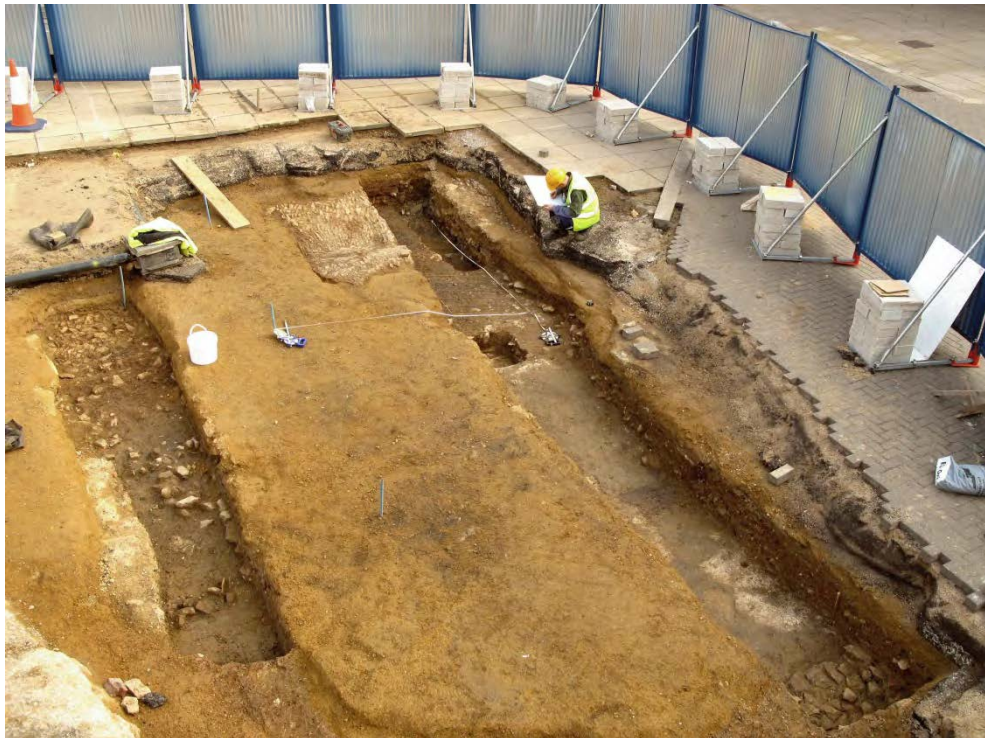
The fountain array area with the two deeper trenches containing walls and floors of Building 3, looking north-east Fig 3.16

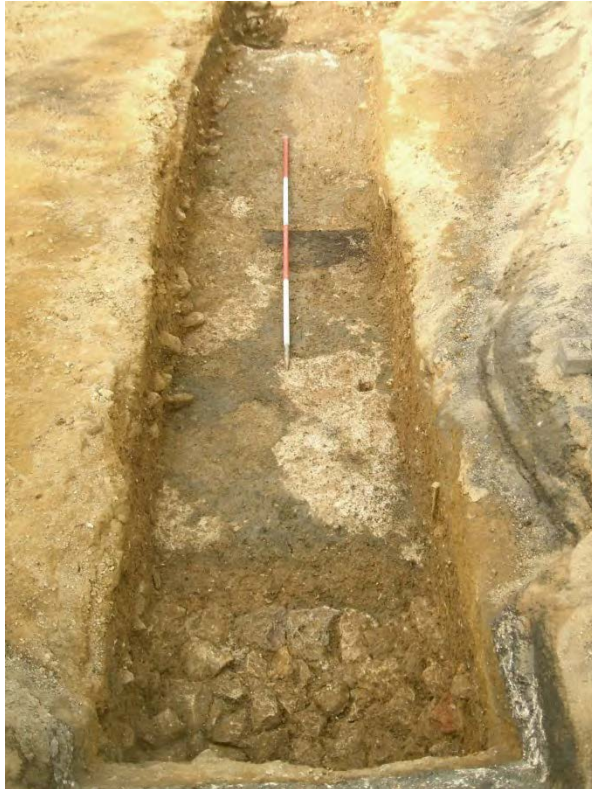
Extant stone wall of Building 3 (foreground) with robbed wall and floors behind, looking north Fig 3.17

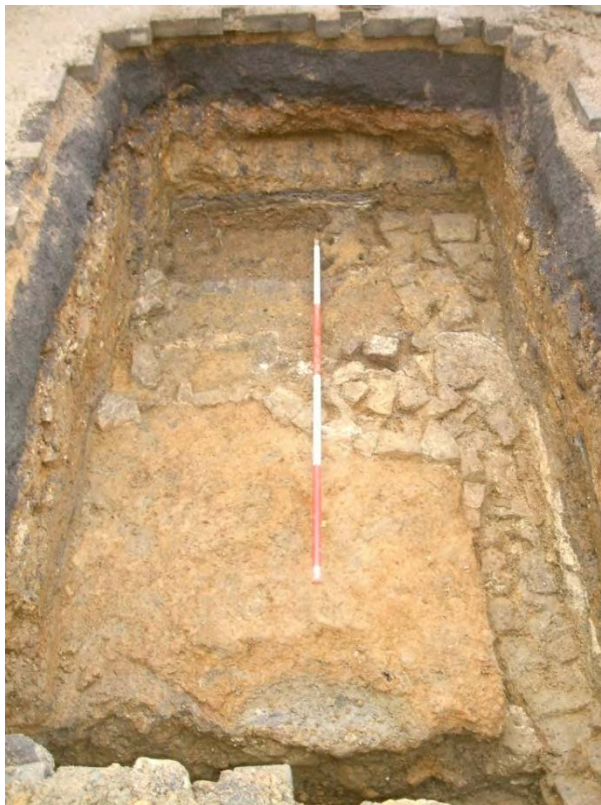
Building 3, the east wall foreground, and narrow internal walls and floors behind, built over the levelled remains of Building 1, looking west Fig 3.18

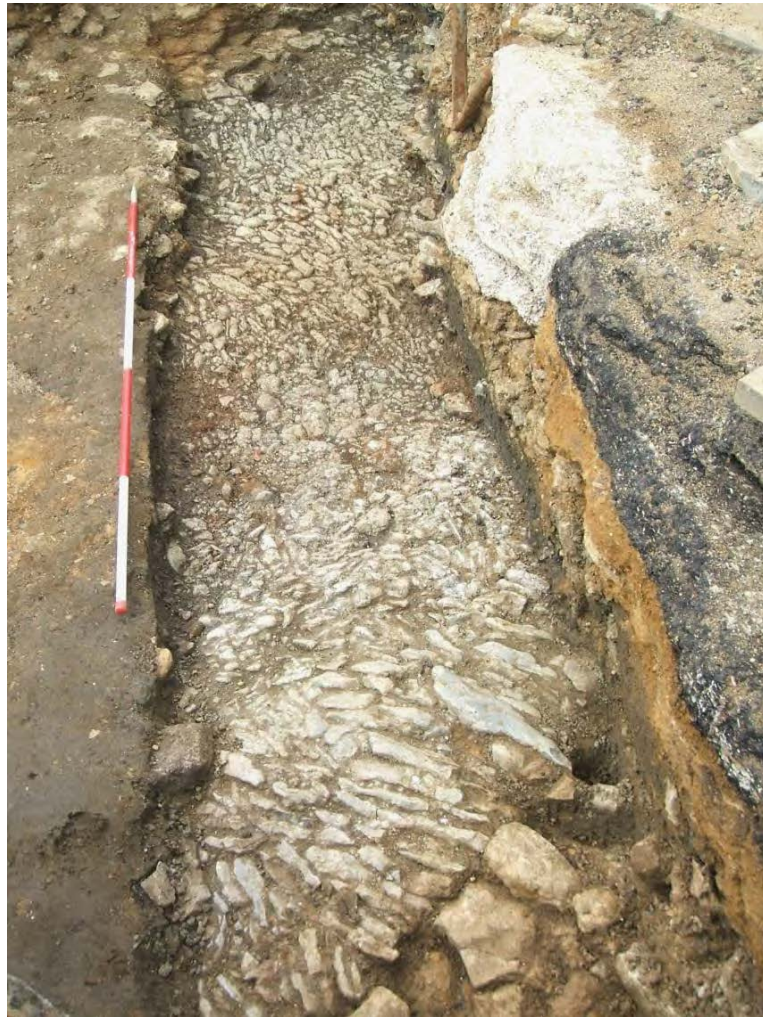
Pavement and street surface on the west side of Building 3 Fig 3.19

Inside the stone step was a make-up layer or packing of limestone rubble. At the approximate centre of the feature there was a pile of roughly-laid ashlar blocks and at least one piece of fine moulded stonework dating from the late 13th to early 14th centuries, likely derived from the demolition of the 'old' parish church or the Chapel of St Thomas the Martyr (Thomas Becket). Overlying the stone was a deposit of gravel and a soil and rubble dump, forming a mound at least 1m high. This feature may have been the plinth for the market cross mentioned in town books of 1614 and 1649, but it had apparently disappeared by 1699. The date of its construction is unclear, but the first documentary evidence of a market cross appears to be from the early 15th century (Fig 3.20). The soil mound appears to have remained as a feature in the square since the street silting was allowed to accumulate against and partly over it.

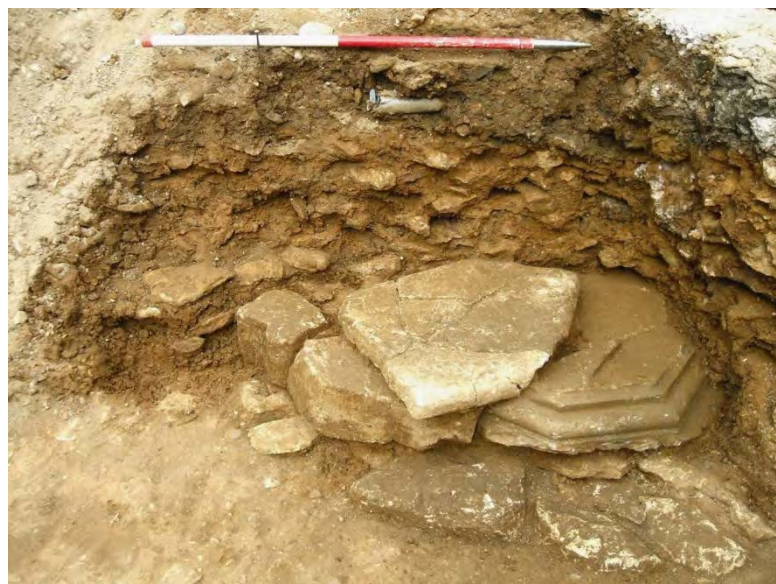
Remains of a street monument, possibly the market cross of the 15th and 16th centuries, Cathedral Square Fig 3.20

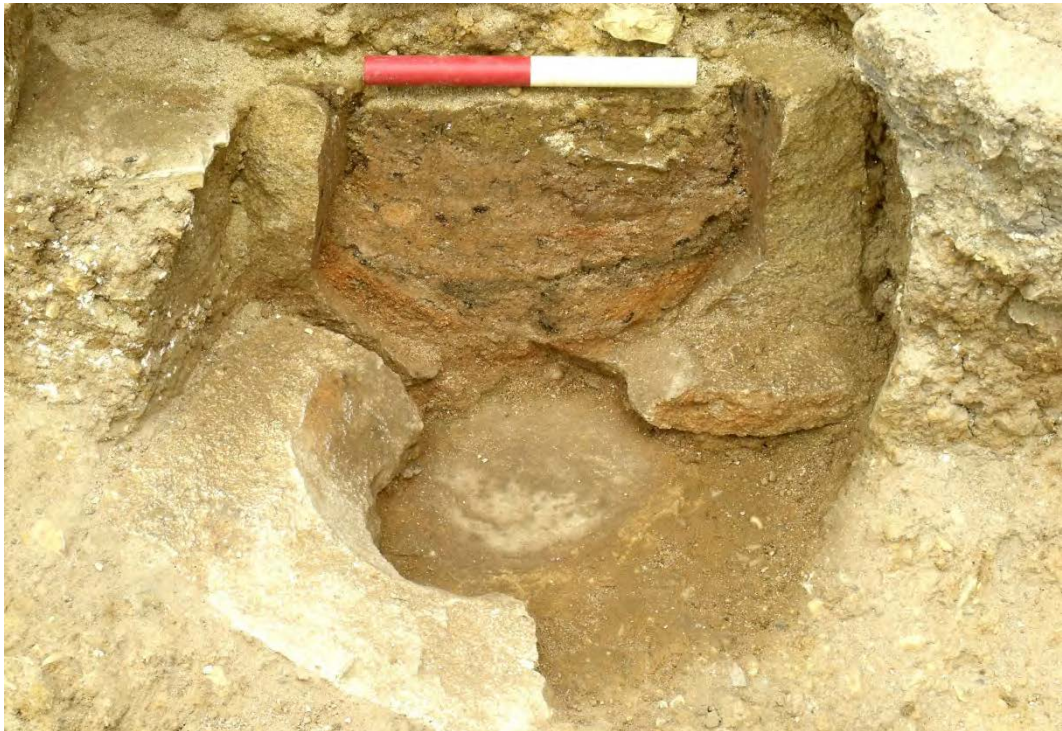
Re-used stone mortar set in the floor of building in Butchers Row,  
possibly to serve as a urinal Fig 3.21

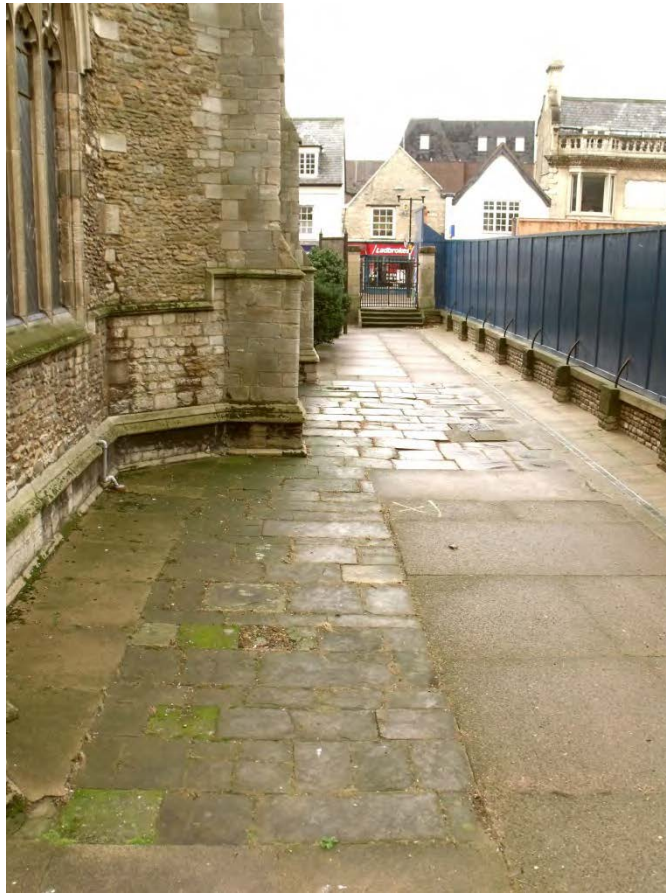
Flagstones at west end of churchyard may outline the location of the Sexton's house at the north end of Butchers Row, looking south towards the surviving burgage tenement buildings on Church Street Fig 3.23

The outline of the Sexton's building in the churchyard may have been defined by the remains of a flagstone path in the churchyard, but no remains of the building had survived (Fig 3.23).

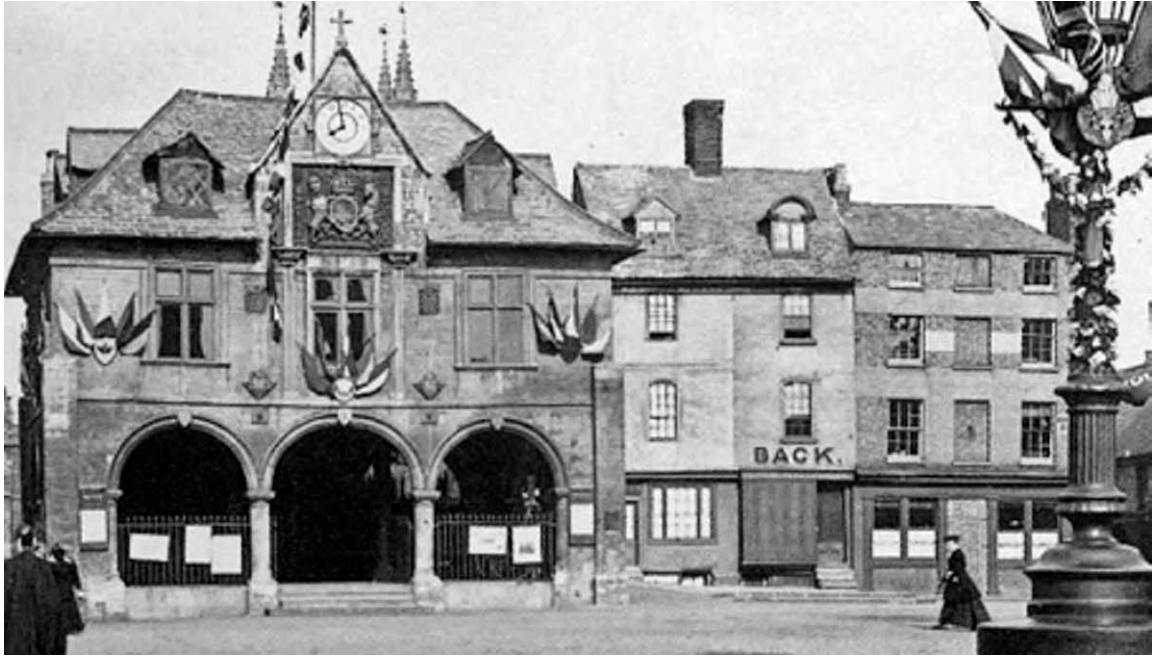
The Guildhall in 1896, looking west, showing the row of buildings between the Guildhall and the church Fig 3.24

This development created a marked change in the look of the square, with the construction of the Guildhall forming the centre piece, a public building consisting of a large chamber supported on open arches, forming a covered market space. A public subscription was started in 1669, with the completion of the structure in 1671, which in its formative years was known as the Chamber over the Cross. It was located in the market square to the east side of the church (Figs 3.24 and 3.25).

This area was the site of many buildings from at least the 17th century through to the 20th centuries. A length of stone wall to the south was a rare surviving element of an early building, and an area of brick floor was part of a later building, both listed as Building 5 (Fig 3.34). There were more substantial remains of stone and brick foundations and cellarage of several of the later buildings (Buildings 6, 7 and 8; Figs 3.34-3.36). The buildings at the northern end of the row, Buildings 7 and 6, were photographed in the late 19th century (Fig 3.24).

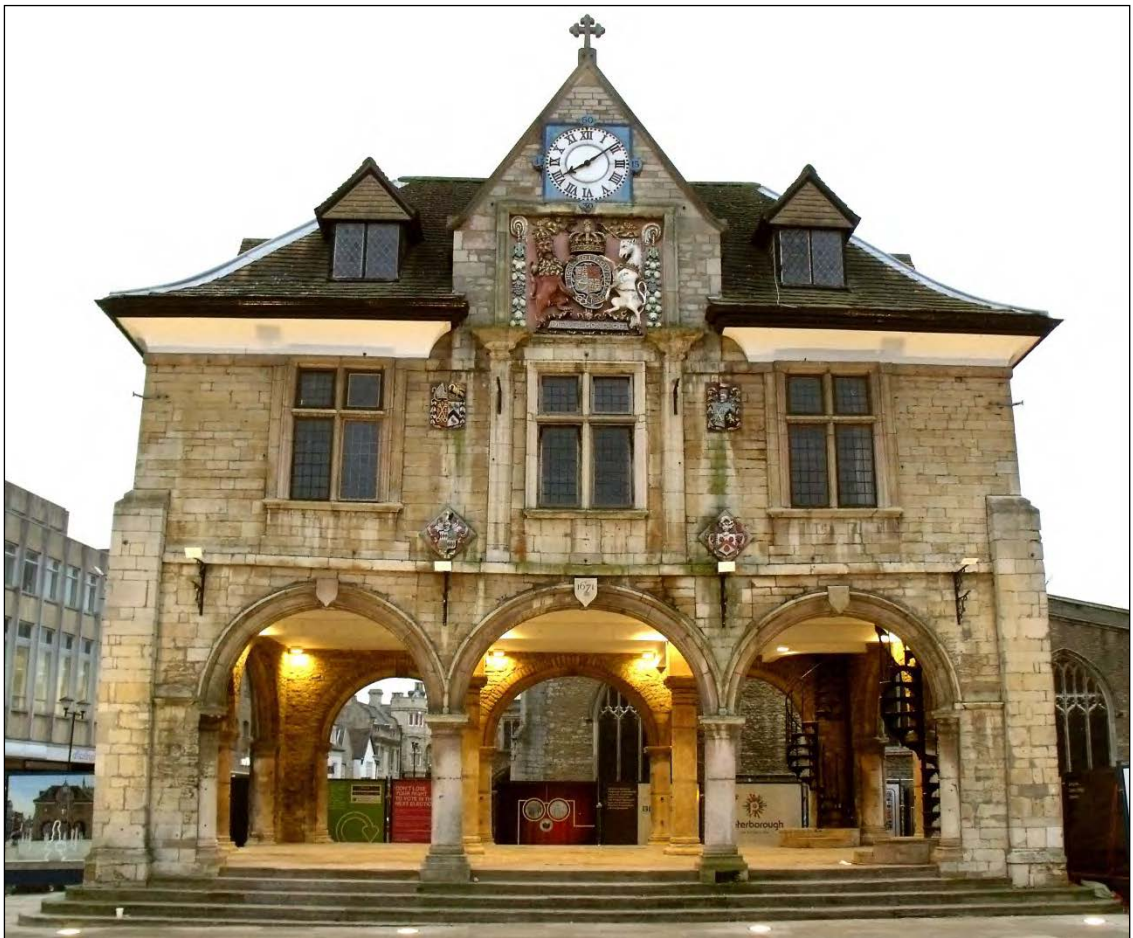
The eastern facade of the Guildhall Fig 3.25

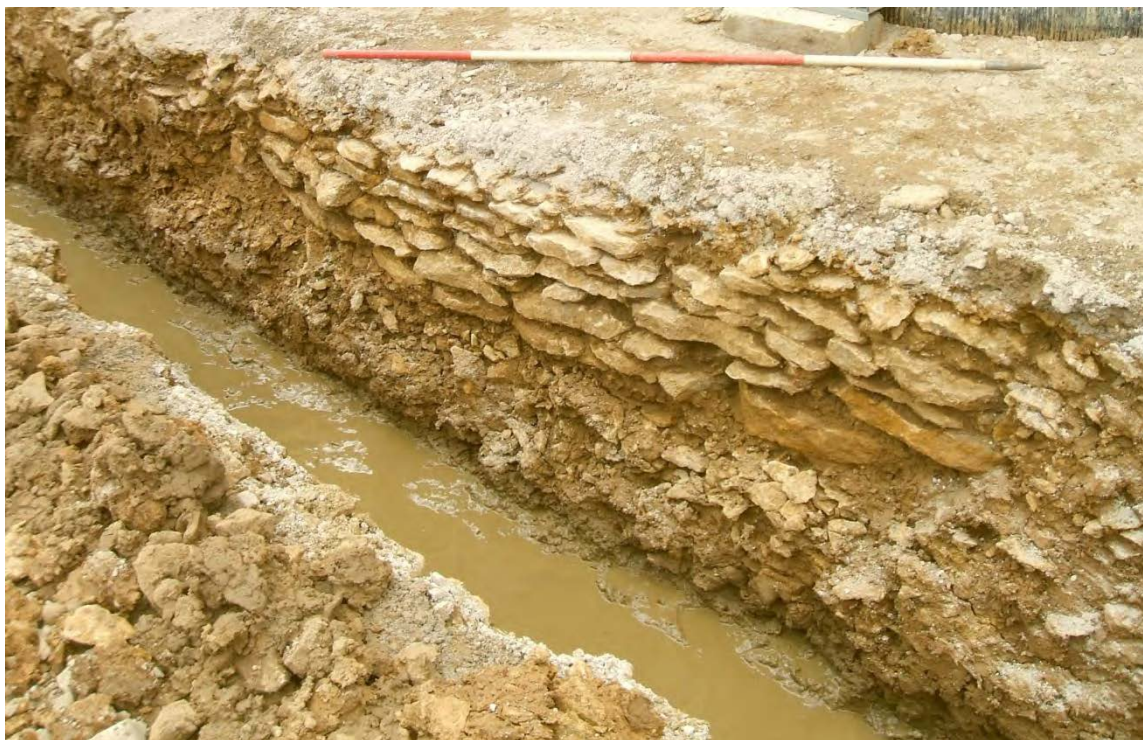
Guildhall stone foundations in fountain drain trench on the east side of the building, Guildhall to right, looking south-west Fig 3.26

Adjacent to the east side of the Guildhall, there was a 3.0m length of curving stone foundation, probably part of an estimated 17m circular structure on which the building is probably supported. The foundations were approximately 0.5m deep, constructed on a similar depth of clay and cornbrash rubble make-up overlying the dark silt deposit (Fig 3.26).

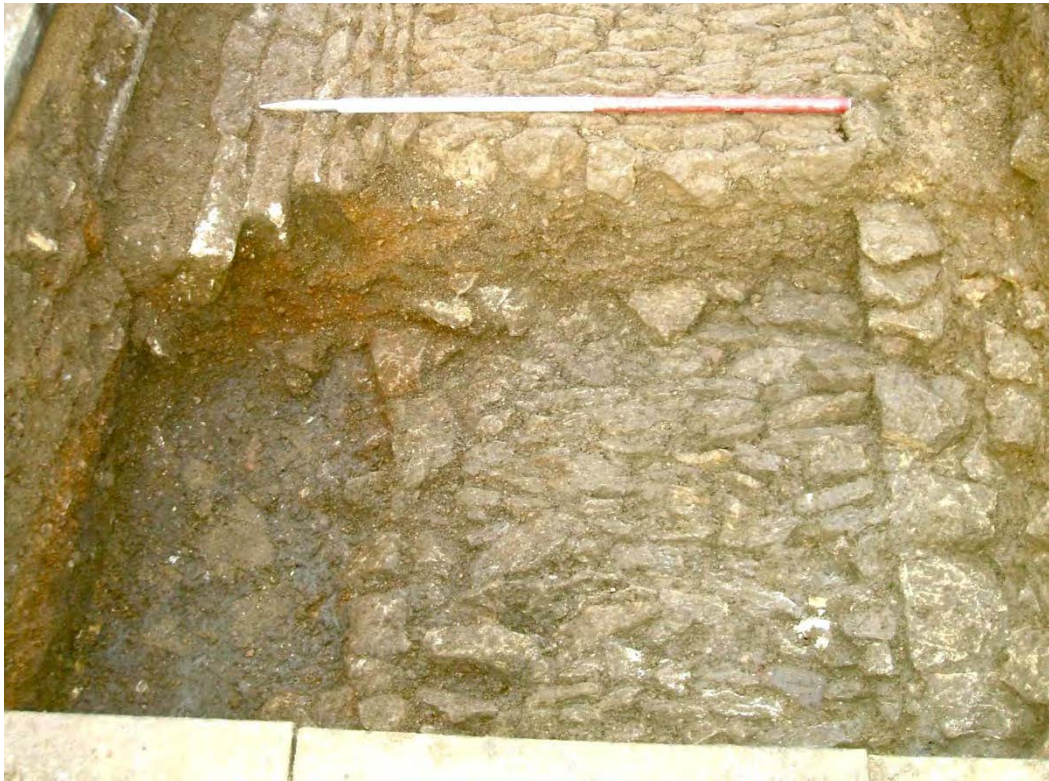
17th-century pitched-stone path overlaid by a late 18th to early 19th-century pitched-stone pavement, both abutting churchyard stone wall (right), looking west Fig 3.27

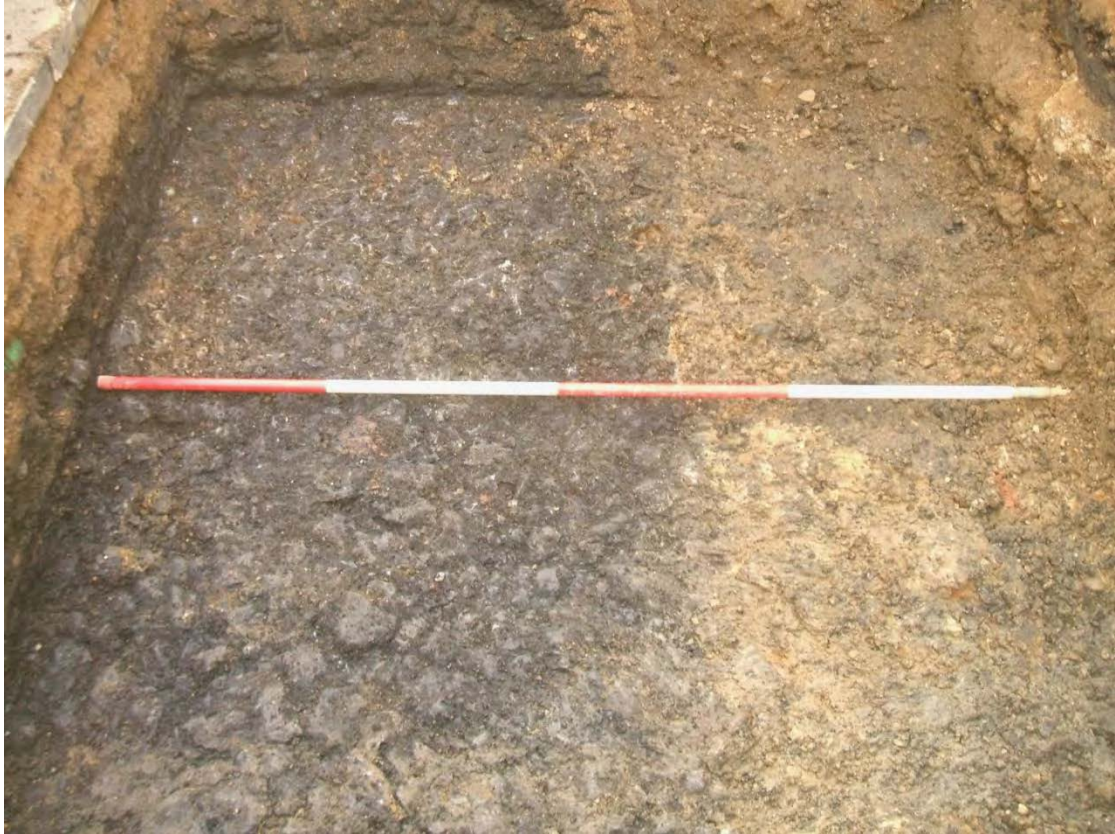
17th-century street surface overlaid by the dark silt, cut by a modern pipe trench to the right, Queen Street, looking south Fig 3.28

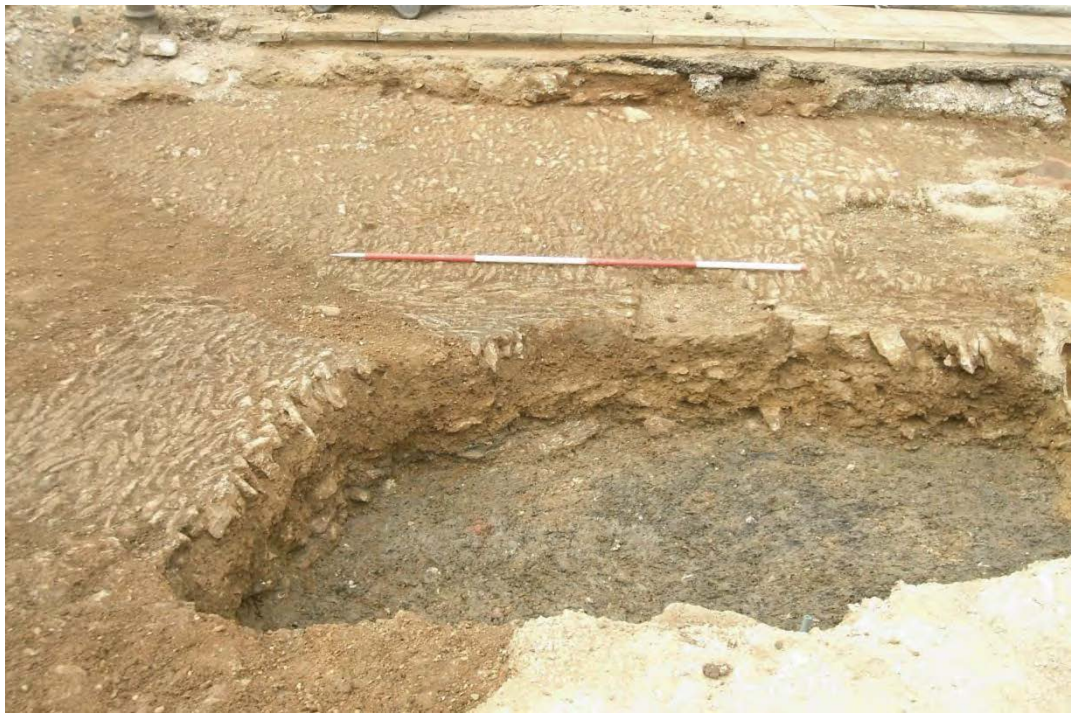
Late 18th- to early 19th-century pitched-stone surface, with underlying make-up layers, sealing the dark silt, under Cathedral Square in the east, looking north Fig 3.29

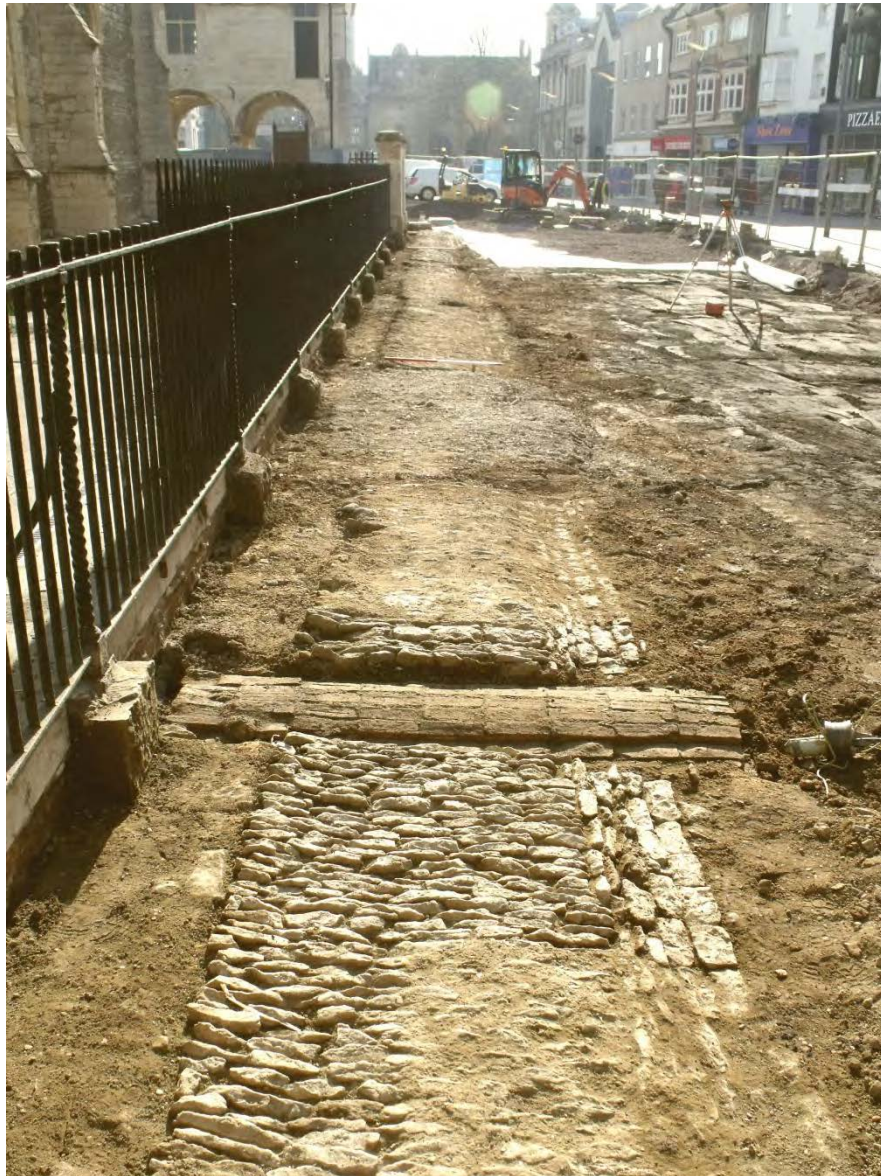
Pitched-stone pavement with an open gutter along its outer edge, to the south of the church, cut by a Victorian brick culvert, looking east Fig 3.30

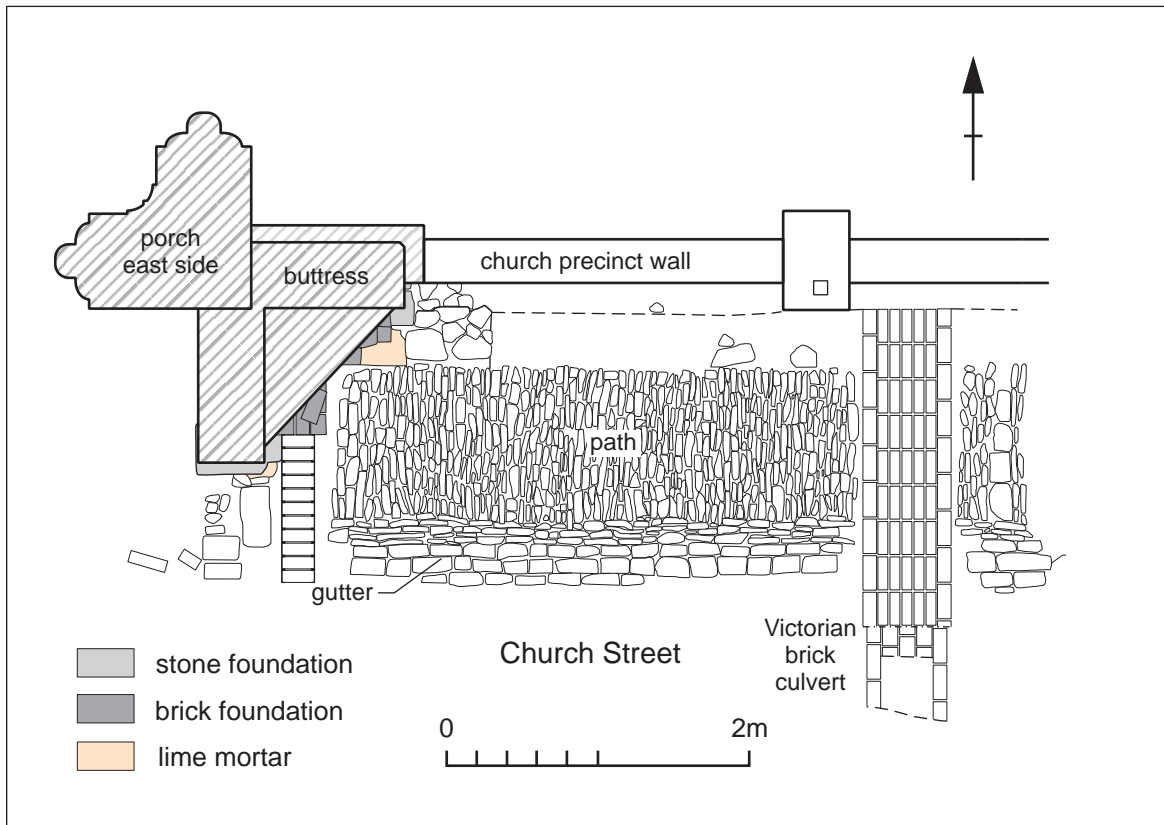
The 18th-century pitched-stone pavement, cut by a 19th-century brick culvert, south of the church Fig 3.31

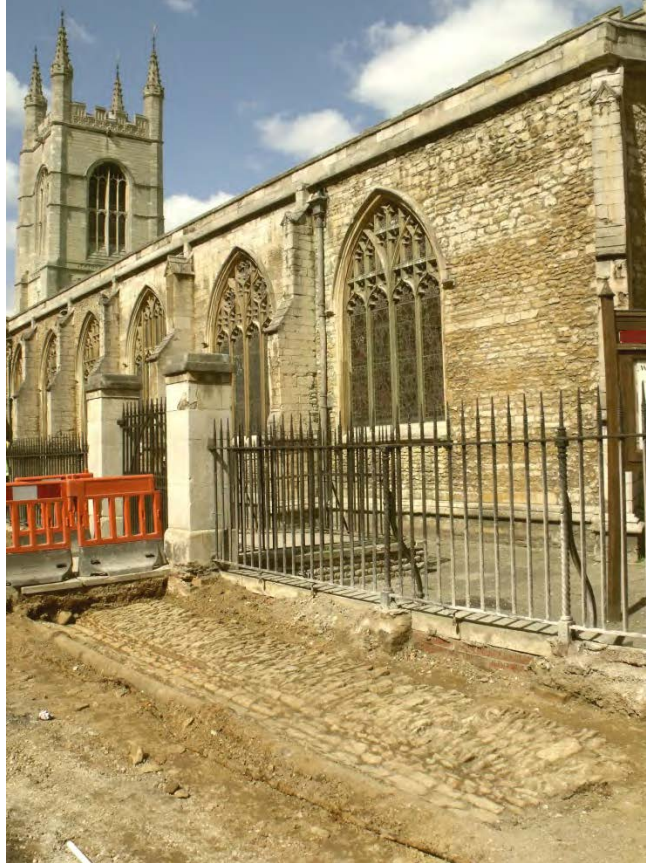
Pavement at the east end of the churchyard wall, looking west Fig 3.32

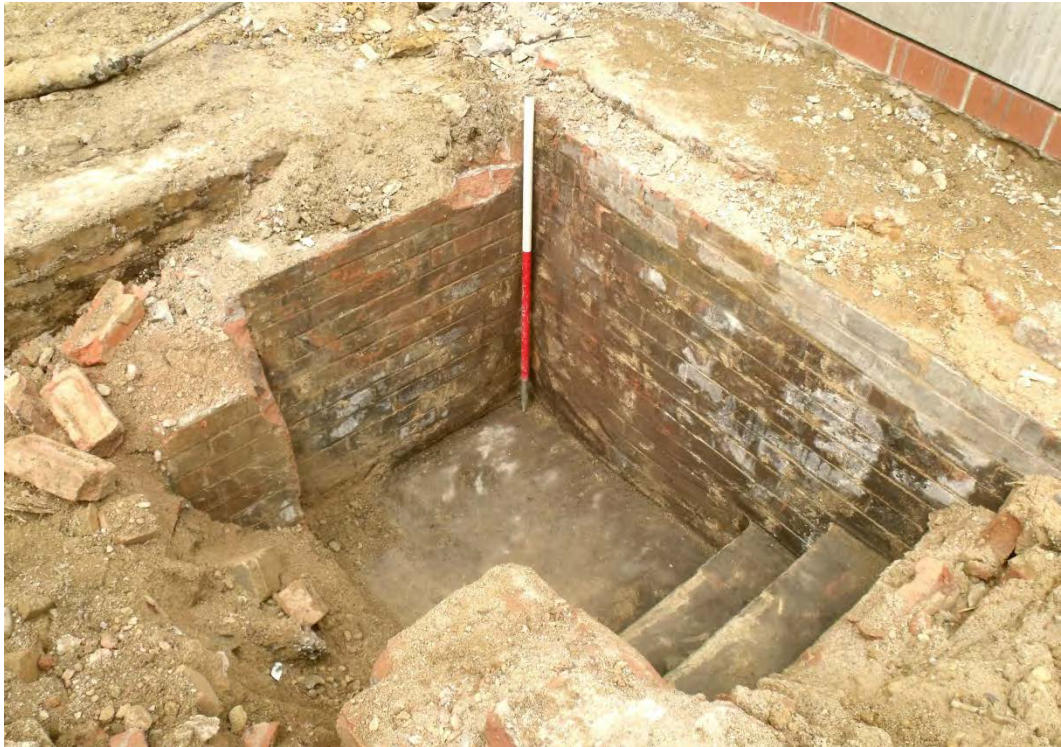
Stairwell with steps down to cellar threshold, Building 8, Cellar 4,  
west of the Guildhall Fig 3.35
