# **An Archaeological Investigation of the Historical Development of Cathedral Square, Peterborough November 2008 to August 2011**

Report No. 16/105

Site Codes: PCSWB09, PCS09, PCSF09, CATSP08

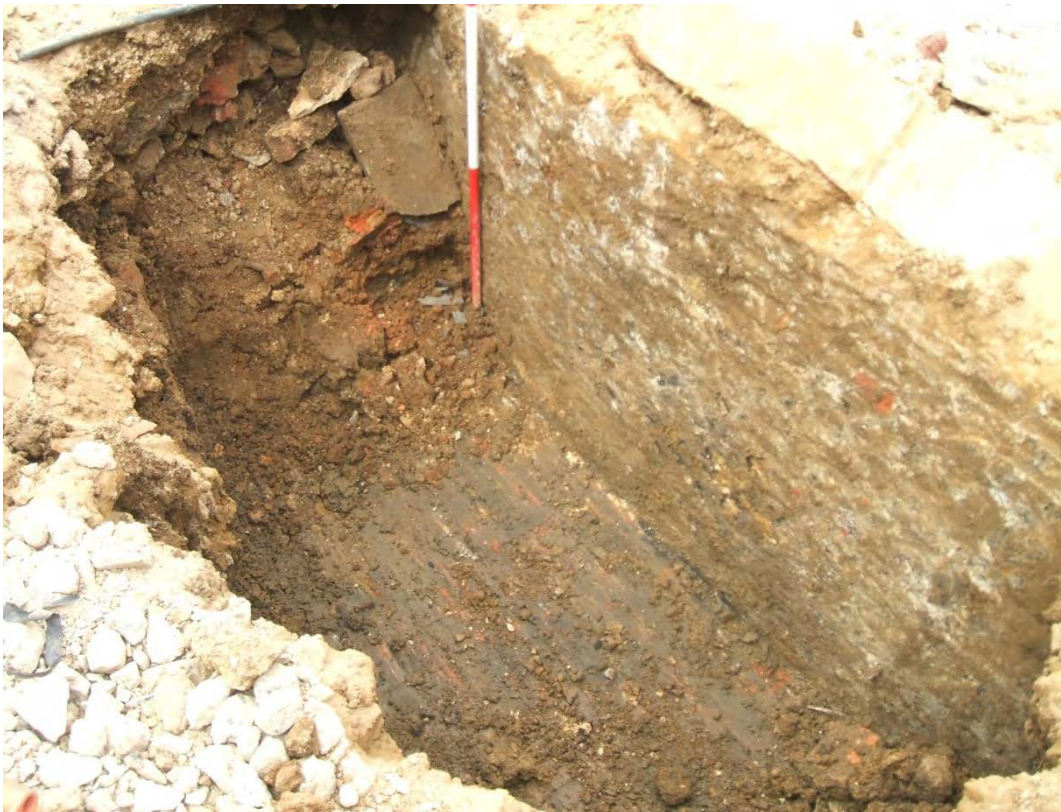
Stone cellar wall and brick floor, Building 7, Cellar 2,  
north-west of the Guildhall Fig 3.36

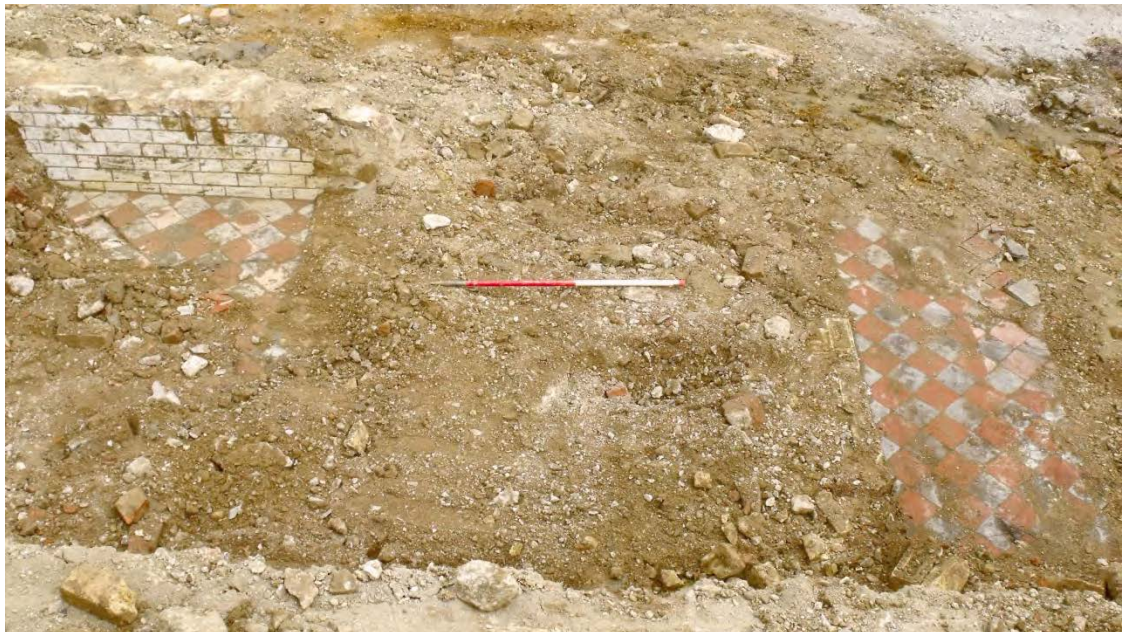
Corn Exchange; remains of wall and floor of the subterranean toilet, looking east Fig 3.37

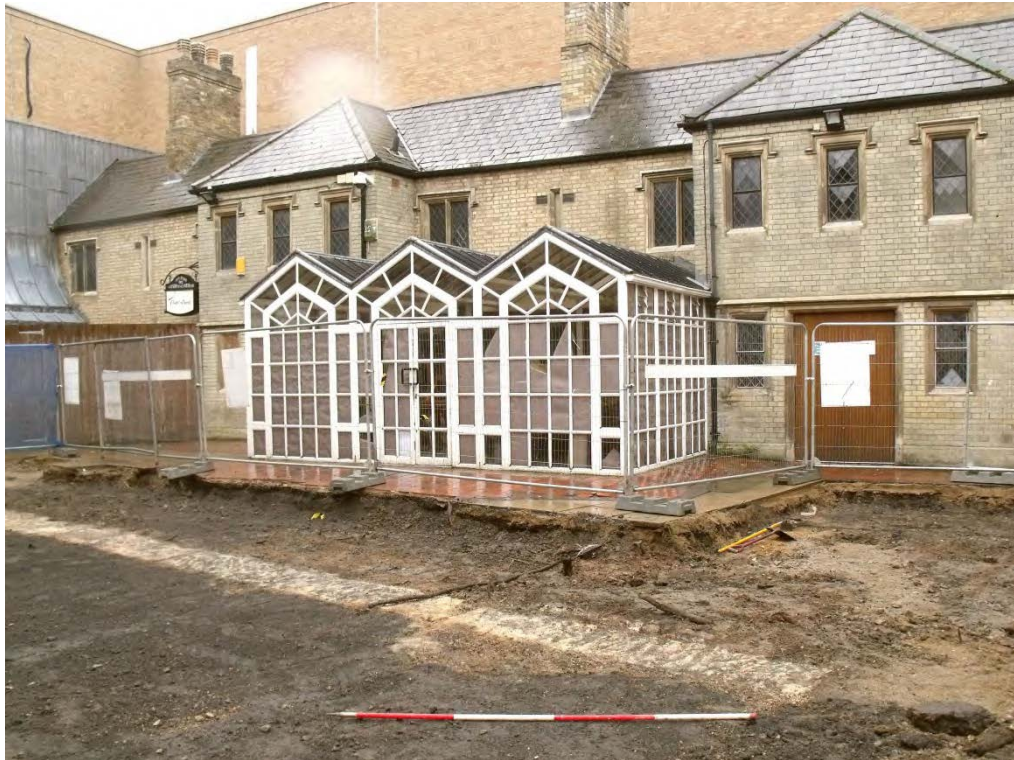
Miss Pears' Almshouses with garden brick wall foundations (foreground), looking north-east Fig 3.38

The street area in front of the building was the Almshouses garden, walled off from Cumbergate, of which a 14m length of the foundations, aligned approximately south-west to north-east, with street and building frontage survives (Figs 2.6, 2.7 and 3.38). Adjacent to the east side of the wall was a short 2.0m length of stone wall. Although this has been attributed an early medieval date, it may be part of the probably 18th- or 19th-century almshouses that fronted the street. A remnant of a garden soil and a possible bedding feature was present to the east side of the wall.

There was a disturbed stone cobble street surface, cut by the wall foundations, from which 17th- or 18th-century pottery was recovered.

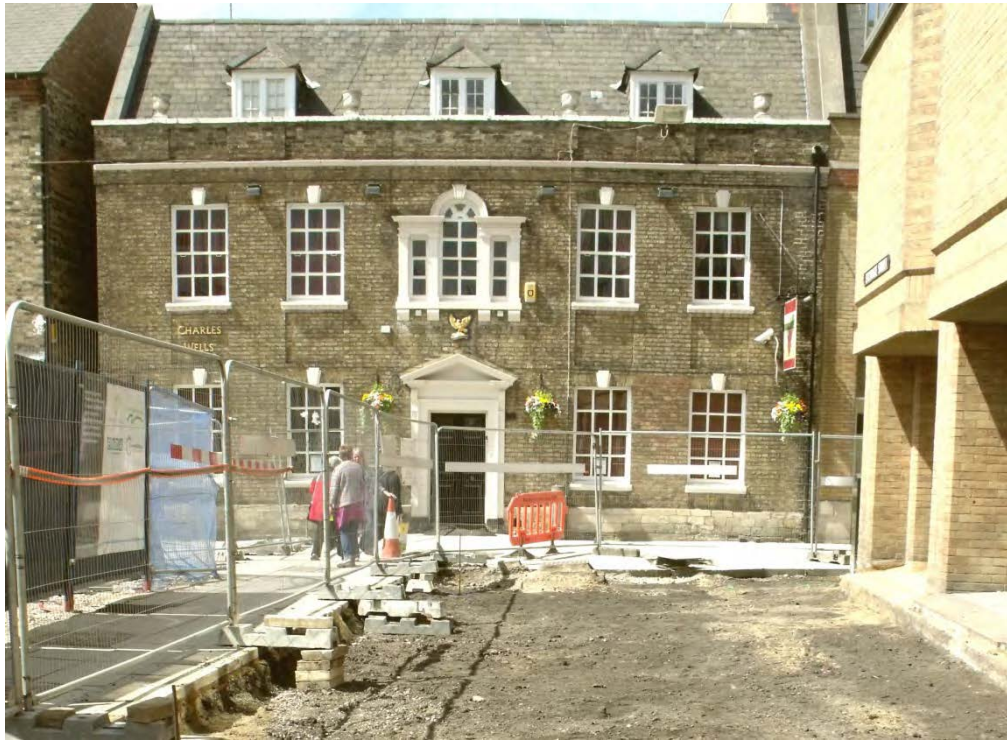
Former 18th-century town house on Queen Street, now The Grapevine public house, looking west, from Exchange Street Fig 3.39

On the west side of Queen Street stands a mid-18th century brick town house of quality, with a central Venetian window and entrance. It is presently in use as a public house, called The Grapevine (Fig 3.39), though not the historical Grapevine public house which was on a different site, now gone. The reduction in the street level and the excavation of the service trenches prior to the new resurfacing gave opportunity to record the foundations of the building, and a partly obscured wall cavity for a boot scraper, adjacent to the north side of the entrance. The presence of a boot scraper in the 18th-century city centre appears to be a clear indictment to the conditions of the pavements at this late date, even after all the previous street improvements.

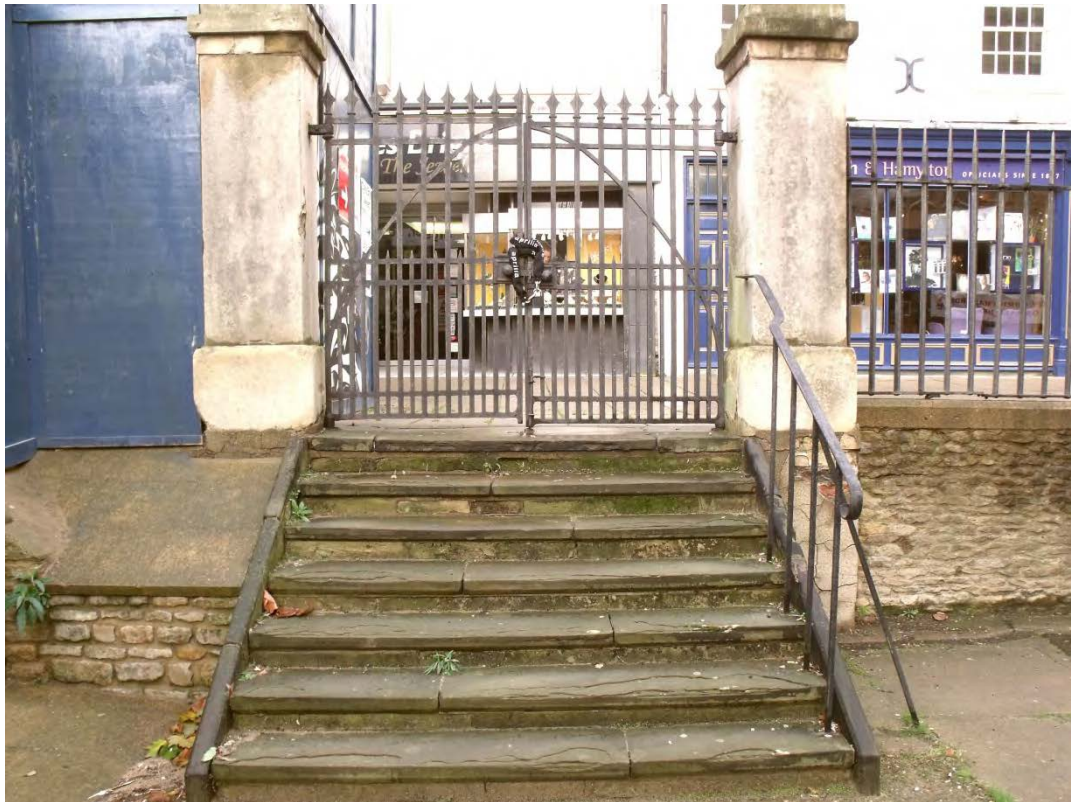
Church gateway, north-west corner of the churchyard, looking north onto Exchange Street Fig 3.40

In the latter part of the century the medieval stone churchyard wall was demolished and replaced, with a 'new' low wall topped by wrought iron railings, opening up the lower part of the church to street view. The new wall extended around the entire churchyard with the exception of four new entrances comprising stone clad plinths and iron gateways. Stone steps led from these entrances into the churchyard (Figs 3.40 and 3.41).

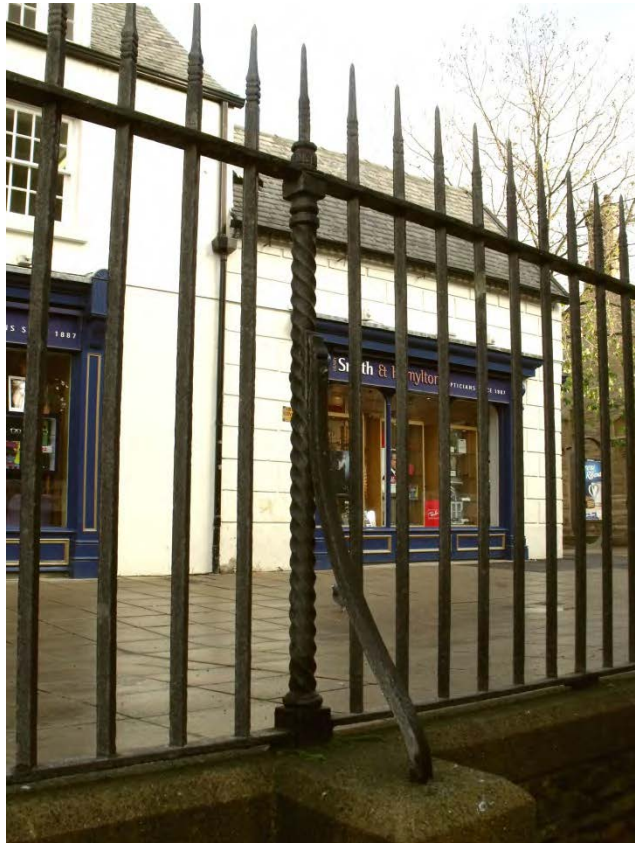
Churchyard railings on the north side of the church Fig 3.41

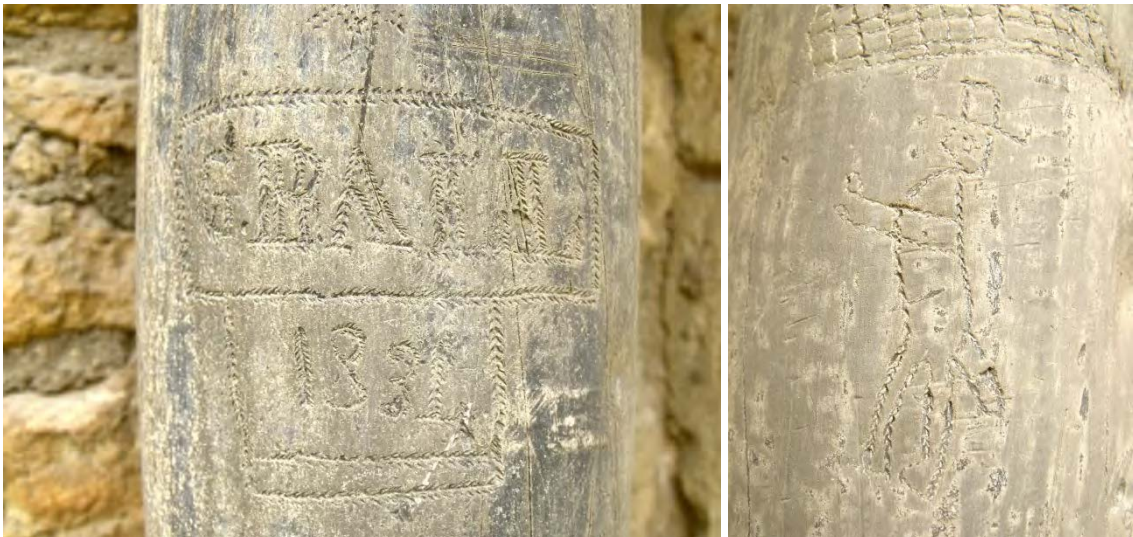
The name, Grail, and a date of 1831 (left) and a figure in top hat and tails in a pugilist pose (right) on 19th-century lead piping on the church of St John the Baptist Fig 3.42

Part of the early work included the existing lead downpipes of the church, which were officially marked 1819 on their chute outlets at the roof level. Some of the pipes at the churchyard level displayed interesting graffiti, the handiwork including people's initials, surnames, decorated gloves and a figure wearing top hat and tails in a pugilist pose, including a date of 1831. The graffiti appears to have been created by scoring or a succession of indents from the point of a knife (Fig 3.42).

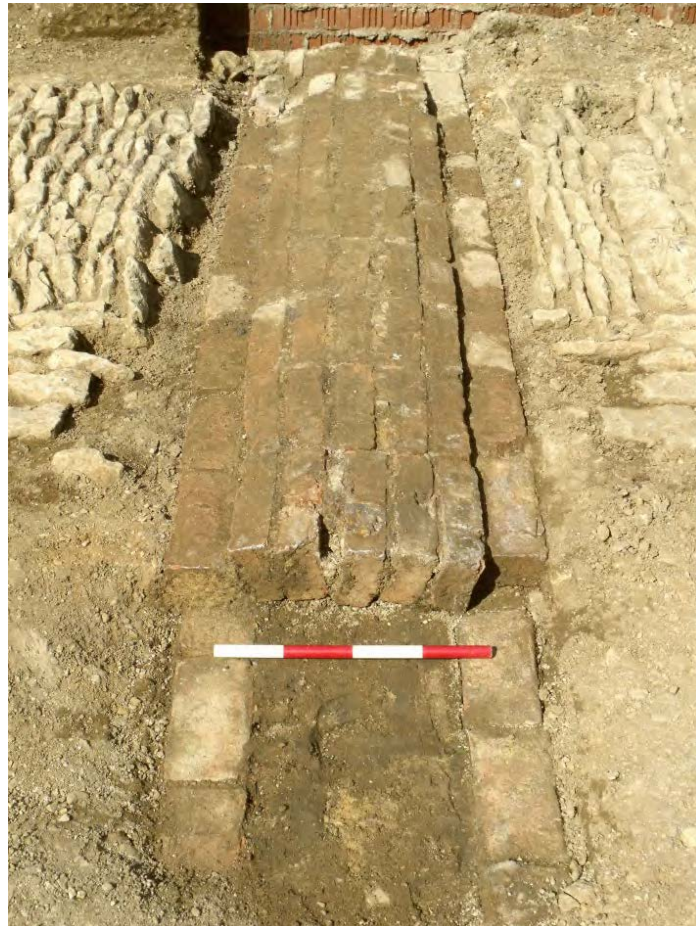
Victorian brick culvert, cutting late 18th to early 19th-century pitched-stone pavement, on the north side of Church Street Fig 3.43

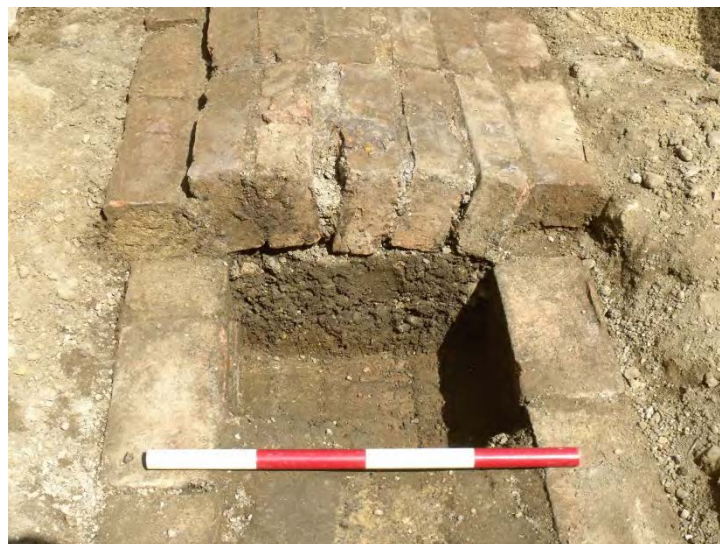
Excavated section through culvert, looking north Fig 3.44

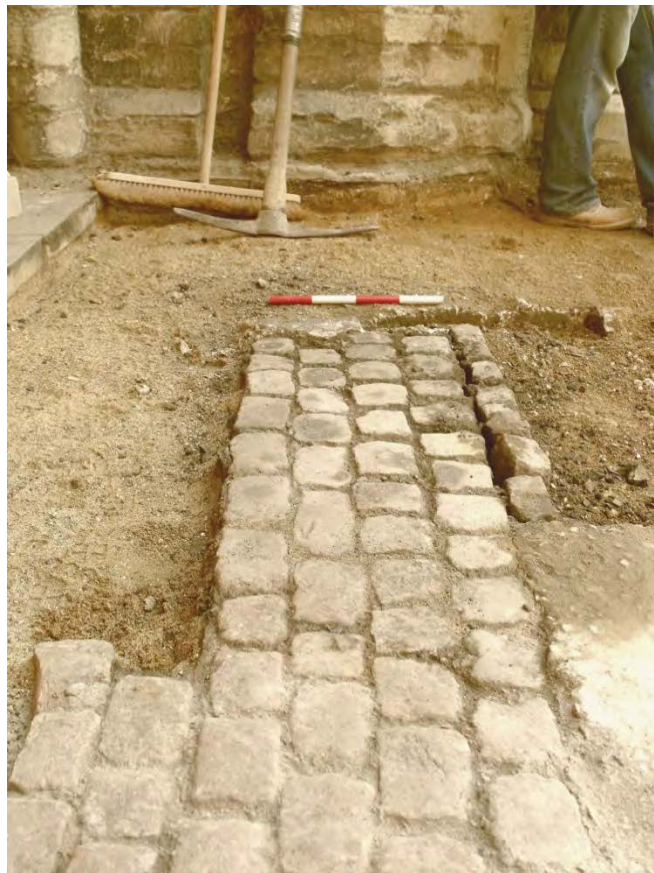
Remnant of late 19th to early 20th-century granite setts under the Cathedral West Gate, looking south Fig 3.45

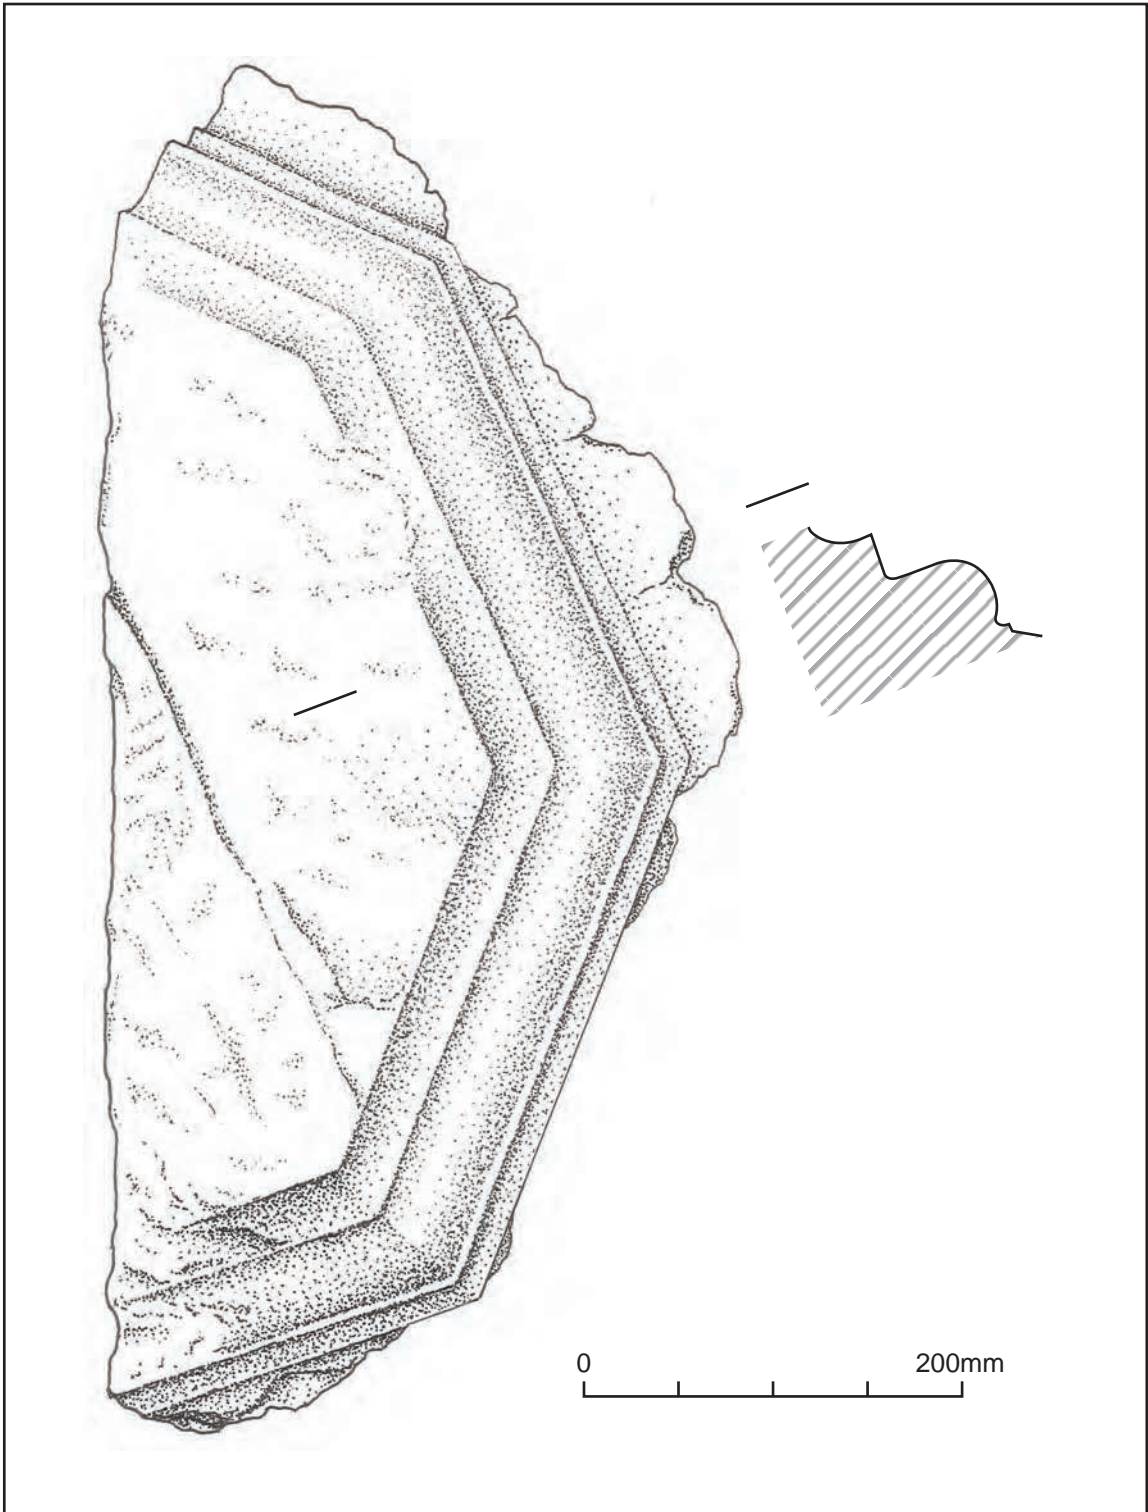
Octagonal capital or base in Alwalton marble (SF58) Fig 4.2

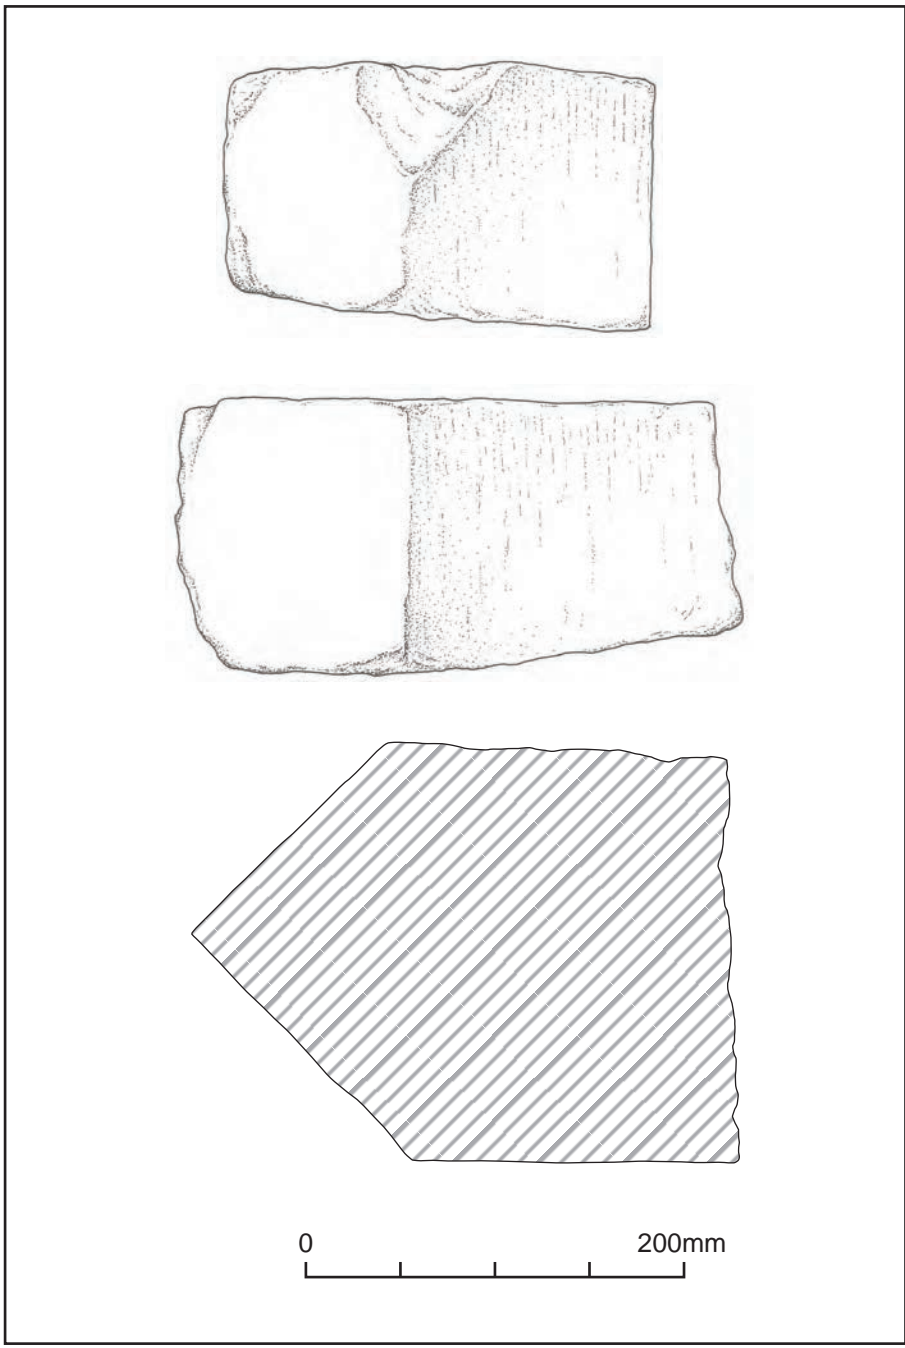
Part of respond/jamb (SF60) Fig 4.4

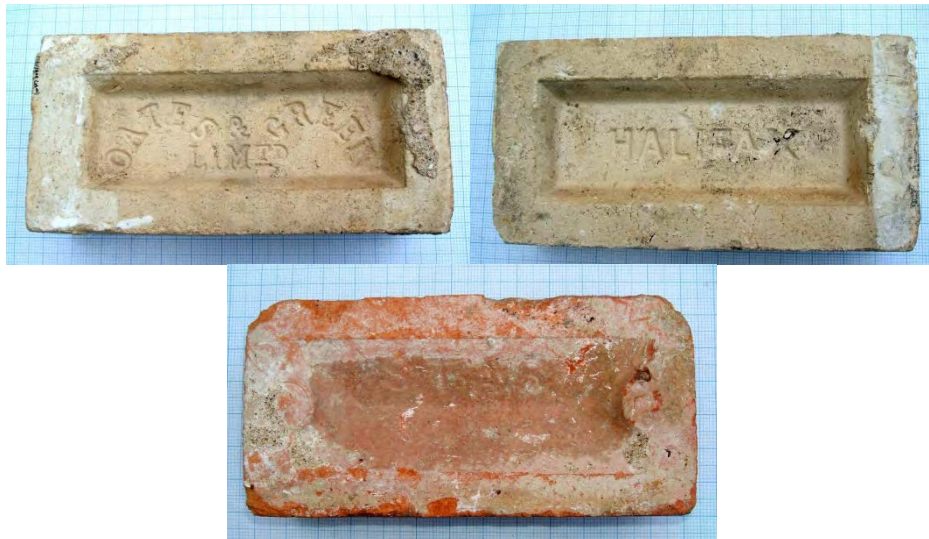
OATES & GREEN brick left, HALIFAX right, local STAR brick below Fig 4.8

There are also two white glazed bricks from the toilet block in the 1893 extension of the Corn Exchange building. They come from Halifax, one stamped with HALIFAX, and the other stamped HALIFAX on one side and the other side with OATES & GREEN LTD, a company specialising in urinals and the construction of toilet blocks (Fig 4.8).
