**An Archaeological Investigation
of the Historical Development of
Cathedral Square, Peterborough
November 2008 to August 2011
Appendices: The Excavated Evidence**

Report No. 16/105

Site Codes: PCSWB09, PCS09, PCSF09, CATSP08

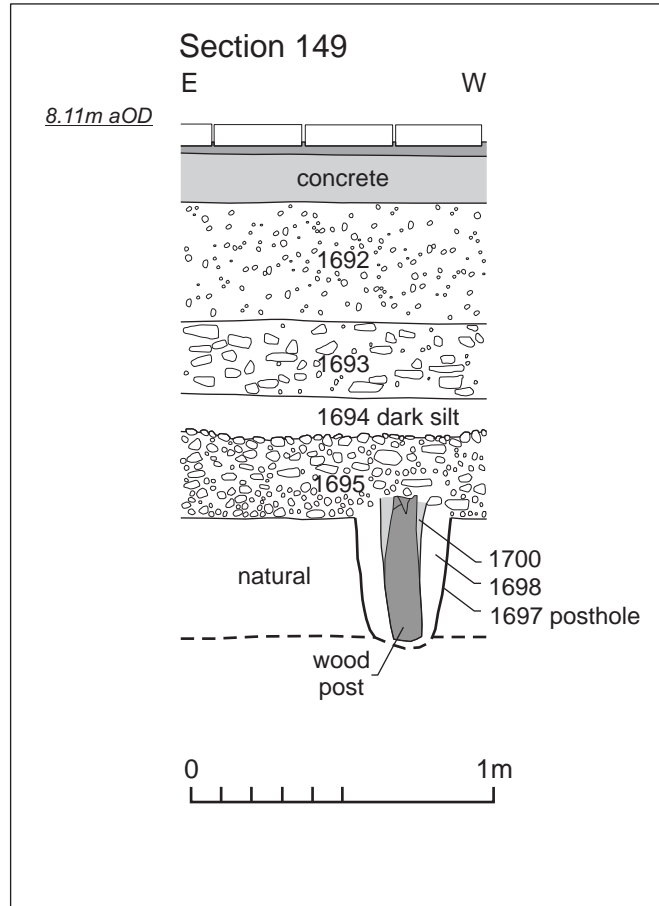
Fig A1.2

The wooden post (1699) was 470mm high and 80m-100mm in diameter, narrowing towards the point which remained concealed in the base of the posthole. It was black in colour, either due to staining or it had become carbonised. The post was not quite straight, with a slight angle to the east at the base and a bend at the top slightly to the west. There was bark visible on the post, but vague flat tool cuts could be seen along its length.

Wooden post in posthole beneath 12th-century market place surface, Trench 31, Area 1

The top of the post showed an uneven break and protruded slightly above the natural clay level (6.8m aOD). There was no obvious wear to the break, suggesting its removal was most likely contemporary with the layer of the market place surface (1695).

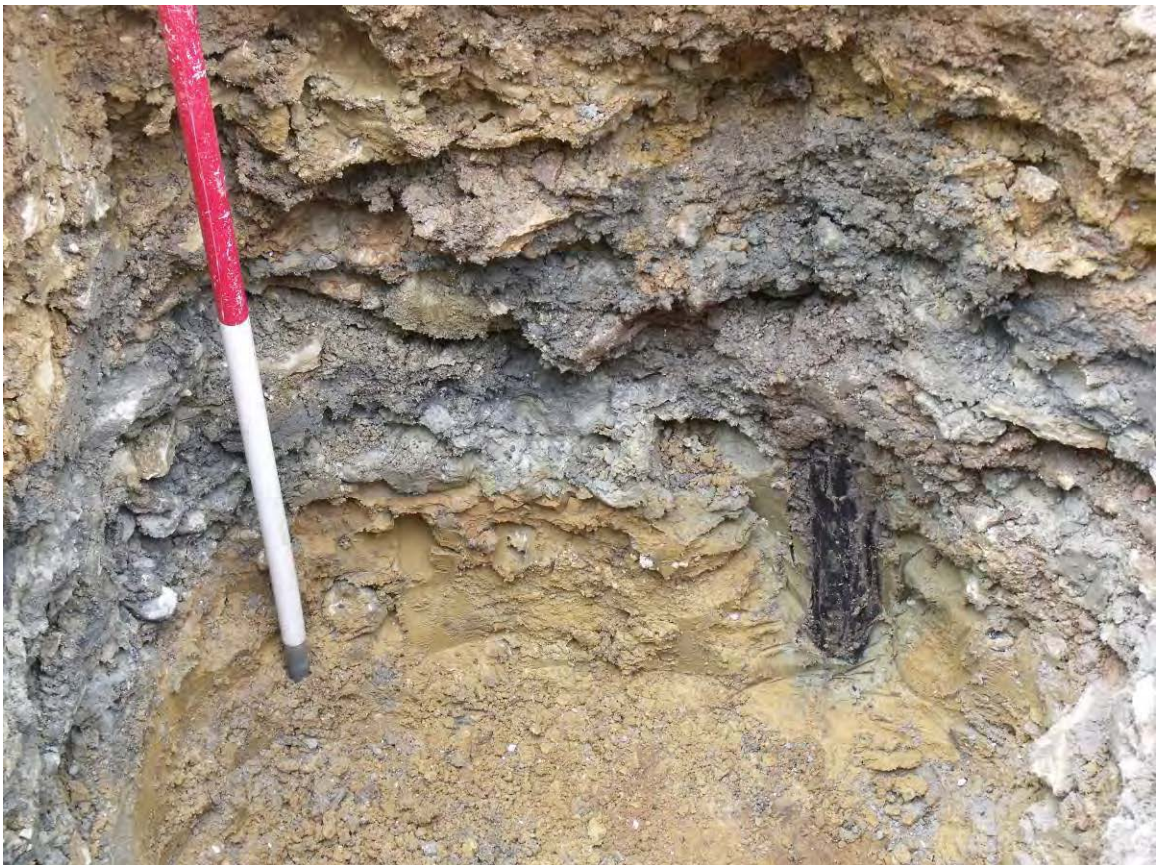
Fig A1.3

Posthole [1697] with *in situ* wooden post, Trench 31, Area 1

The post would have been a substantial feature, probably pre-dating De Bec's market place, and it is not possible to say what its function was, whether this was a single post or part of a larger structure. This was one of only two pre-market features identified. The action of stripping off the soil horizons that may have contained evidence of pre-12th-century activity, combined with the limited exposure of pre-market place levels during the development, much reduced the opportunities of identifying Anglo-Saxon or earlier activity in this area.

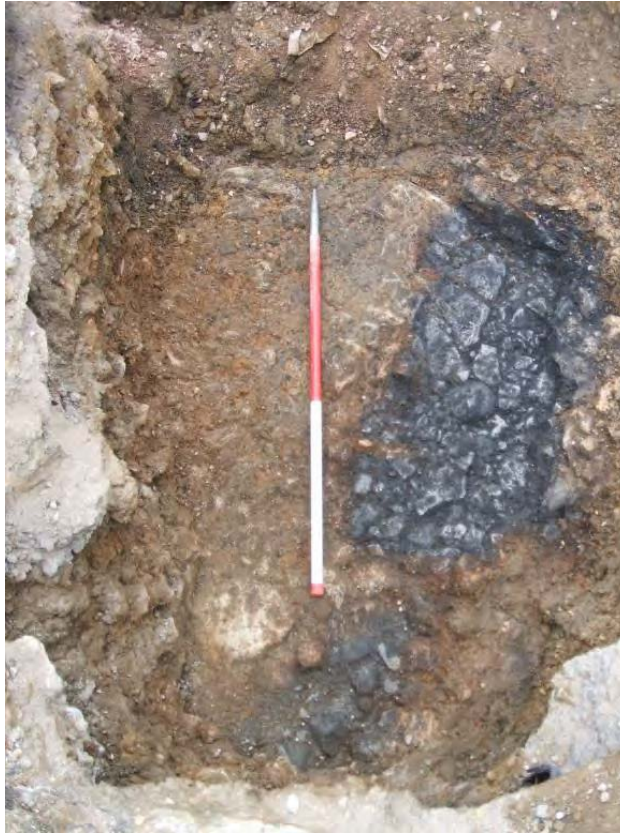
De Bec's 12th-century market place surface, Trench 32 Fig A1.6

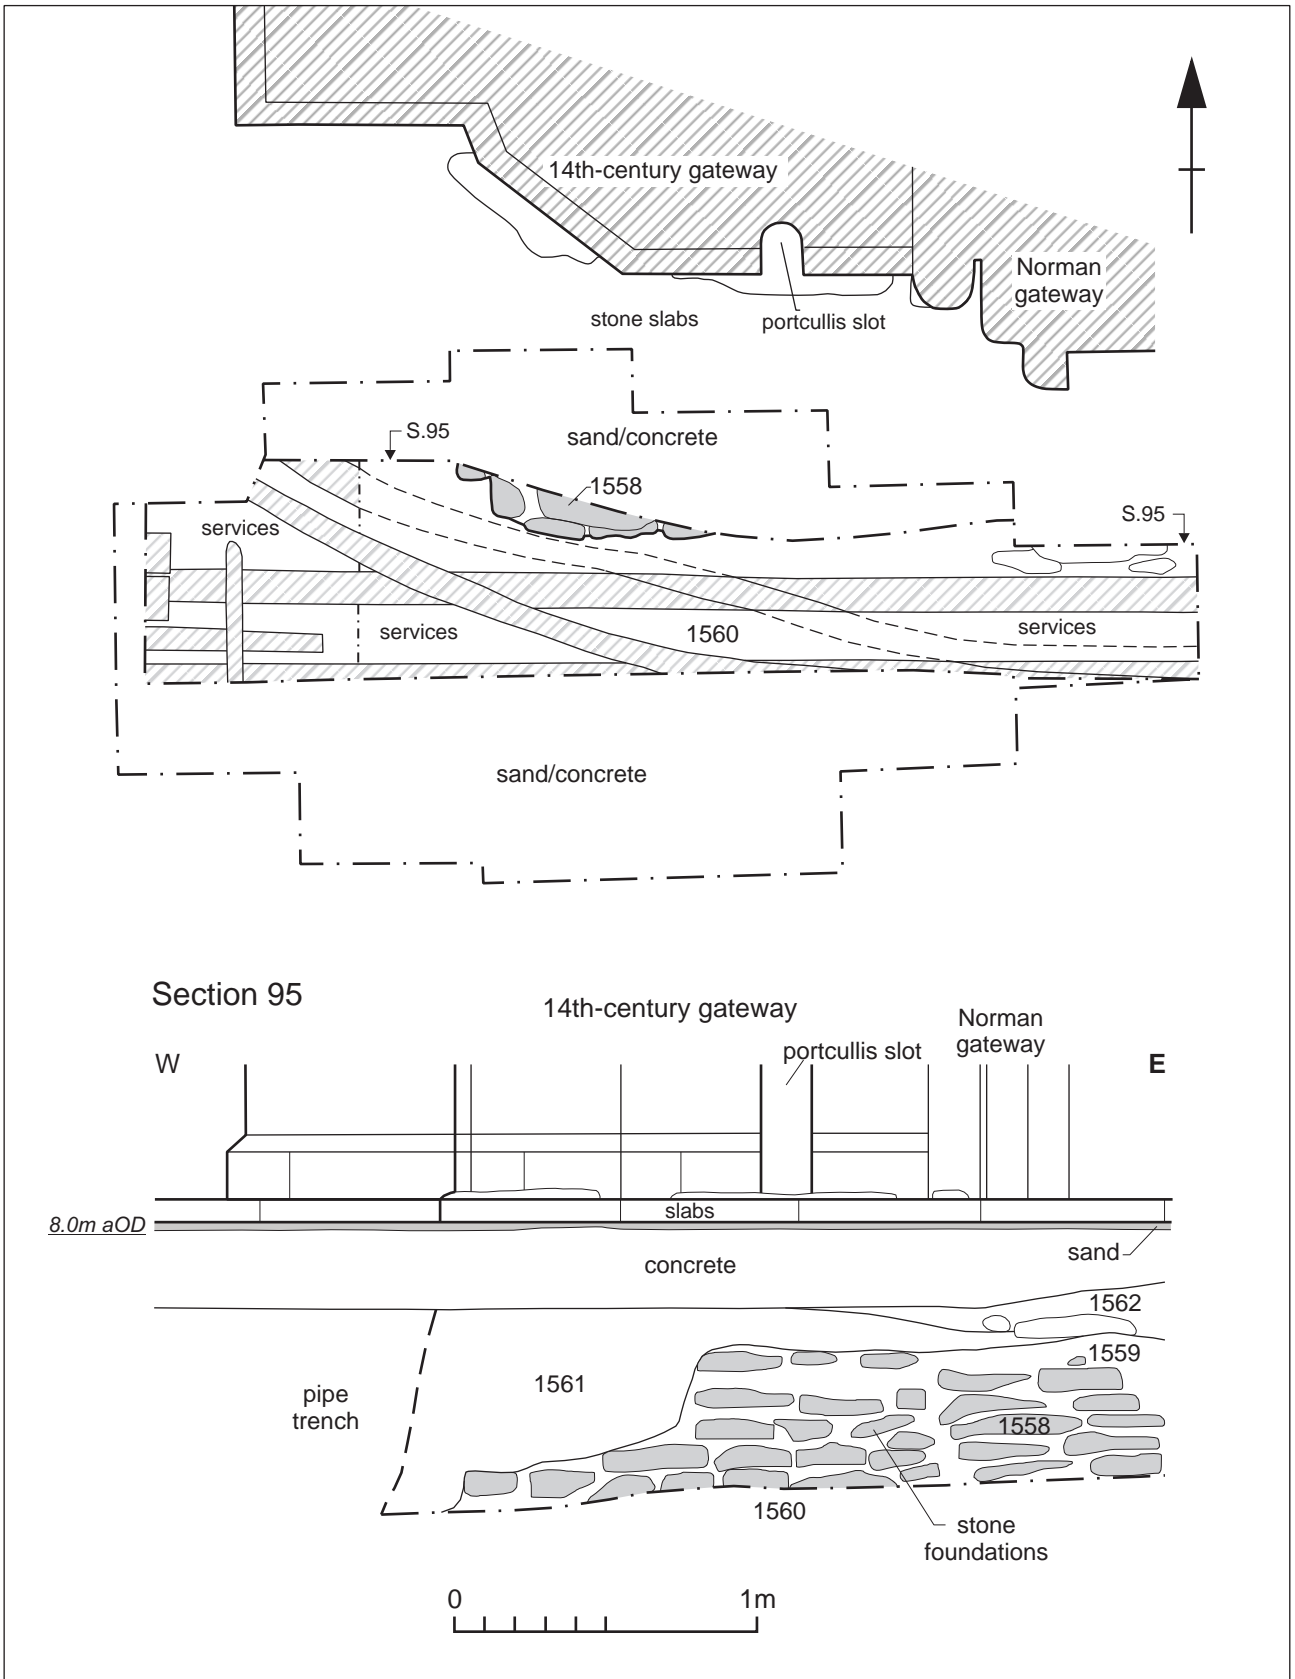
Cathedral West Gate foundations, north side, Trench 34, Area 1 Fig A1.7

The foundations (1588) were south facing, with an uneven vertical face, composed of large roughly-worked limestone slabs, 100-400mmx50-80mm, laid flat in approximately five level courses. The thickly applied bonding, up to 100mm thick, was compact orange-brown very sandy-gravelly mortar, with occasional small rounded pebbles (1559).

A narrow near vertical slot, 0.06m-0.10m wide and 0.02m-0.30m deep, in the face of the foundations probably demarks the 12th from the 14th-century construction, which aligned with the junction of the Norman and later gateway superstructure. The mortar bonding was the same throughout the foundations, suggesting re-pointing of the earlier stonework during the 14th-century remodelling. The proposed foundations for the Norman gateway may have had slightly longer limestone blocks; however, this cannot be conclusive as only a small section of the foundations were exposed.

In the north side of the gas main trench, the stone foundations (1558), aligned east-west, for the north side of the West Gate were exposed. They were offset from the ornamental archway by 0.70m to 1.30m, but parallel to the gateway access, with a height of 0.50m from the base of the trench and at least 2.30m long. The foundations continued below the base of the trench and beyond the edge of excavation to the east, the west side and the upper part of the foundations appear to have been truncated, probably by later activity (Figs 3.4 and A1.7).

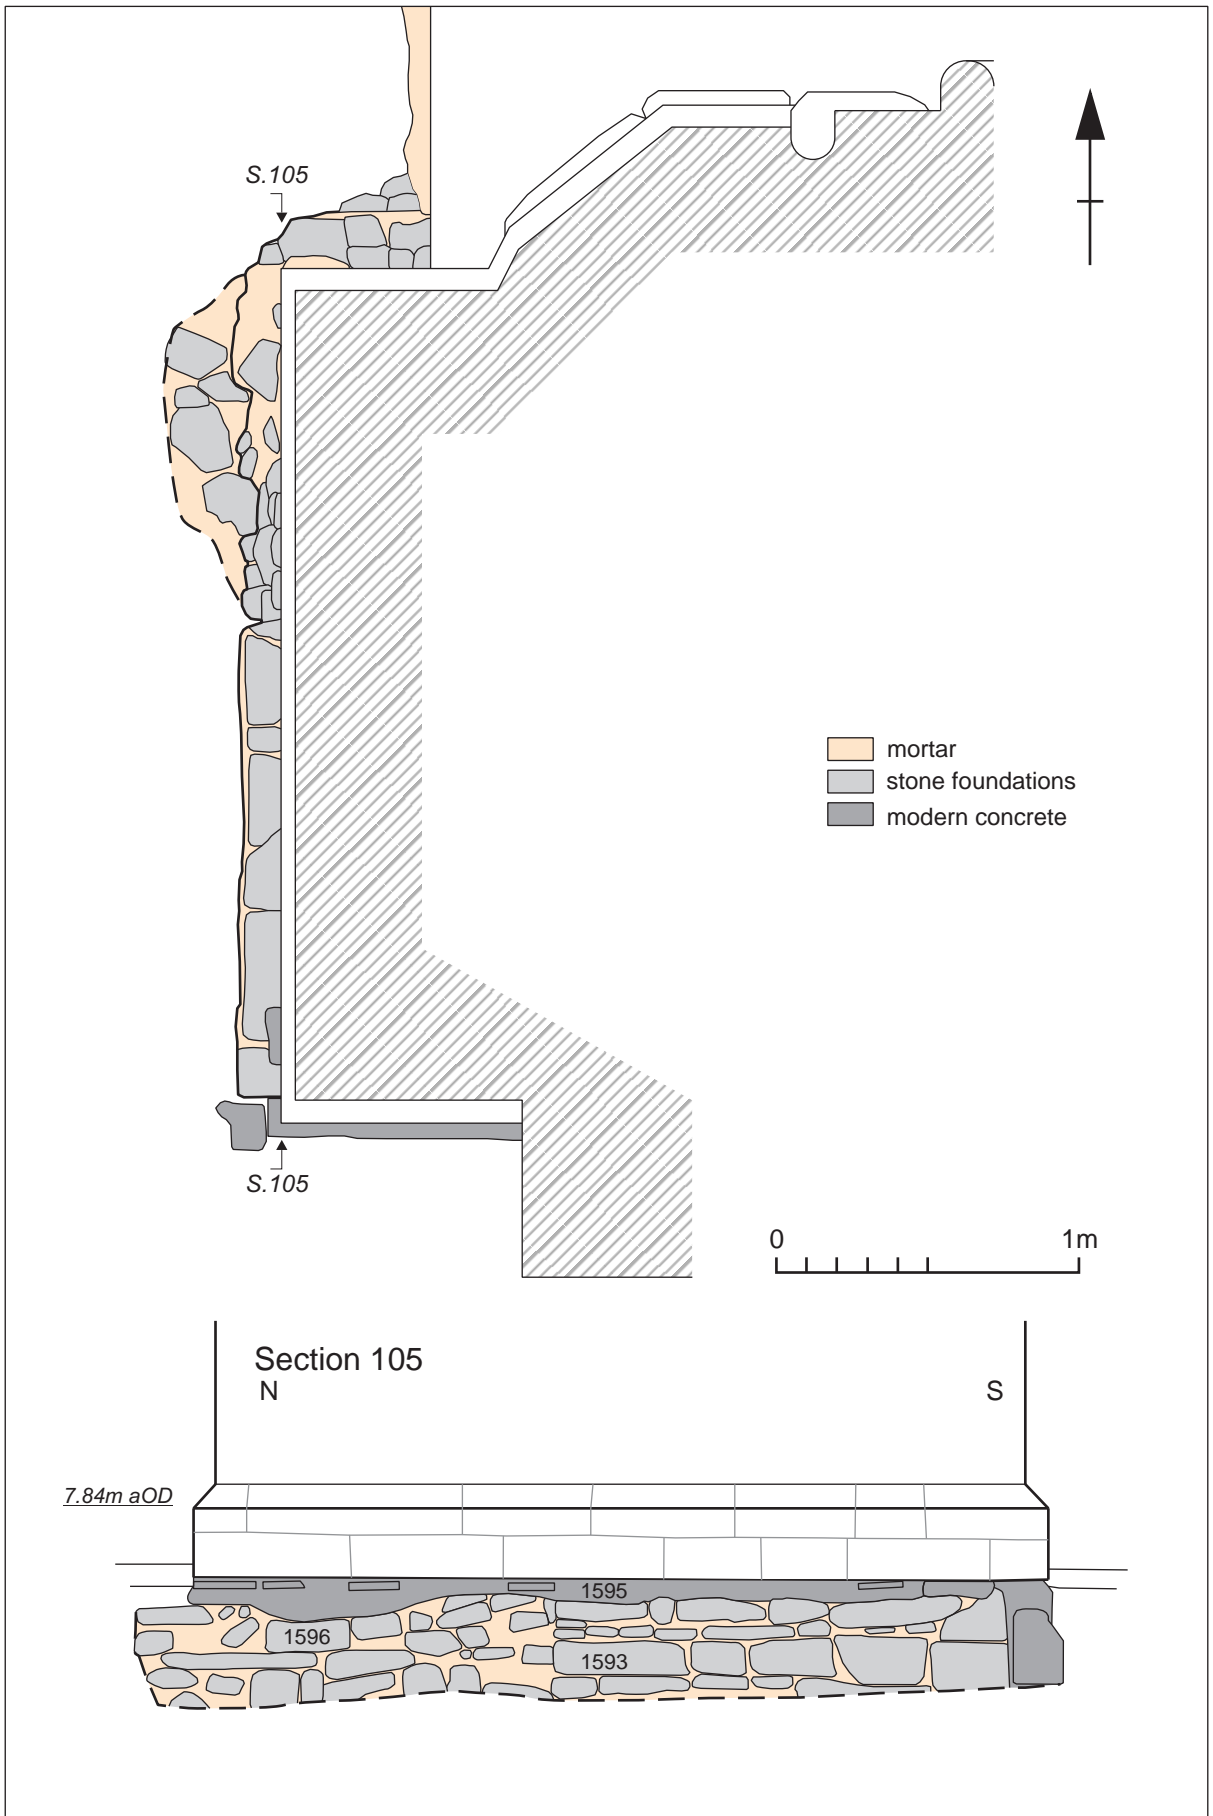
The southern half of the foundations along the west face of the tower comprised a 2.0m length of well-constructed stone footings (1593) aligned north-south. The foundations were composed of four coursed layers of alternate roughly-faced limestone blocks, 200-420mmx80-180mm, and slabs, 80-300mmx30-60mm, up to 0.40m high with an offset of 0.15m. Two ashlar stone blocks at the south end of the foundations probably formed the original corner at south end of the tower. The foundations were heavily bonded with a with a soft to firm yellow-orange-brown very sandy mortar, with the occasional small grit and chalk fleck.

The northern half of the foundations (1596) showed considerable disturbance, from either dismantling or damage, and had been replaced in a very jerry-built manner without regular coursing and were roughly mortared. Disused stone rubble and mortar abutted against these foundations, and were visible for up to 0.3m, tipping away westwards in a gentle slope from the wall. This irregular rebuild was probably part of some recent activity, possibly during the 1930s redevelopment of Bridge Street.

Cathedral West Gate foundations, south turret, Area 1 Fig A1.8

The two ashlar stone blocks at the south end of the foundations (1593) have been refaced on the south side tower by recent brick and concrete footings (1595), supporting a refurbished stone wall on the south side of the tower, which was probably part of the 1930s redevelopment of Bridge Street. The brick and concrete foundations and refurbished stone wall on the south side of the tower extends around to form a contemporary foundation and wall of the adjoining stone building, on the west facing Bridge Street frontage. This adjoining building, now a commercial premises, was formerly a building housing the 'abbots gaol', that was contemporary with Great Gateway, although like the south wall of the south tower the frontage wall was also refurbished in the 1930s development.

The open stripping, undertaken as part of the general groundworks (to a depth of 0.4m) around the west side of the 14th-century towers to the north and south sides of the West Gate, exposed the foundations to this structure. Many of the footings excavated had been replaced by 1930s brick and concrete refurbishment, but on the west face of the south tower a length of the probable early tower foundations (1593) was still intact (Figs 3.5 and A1.8).

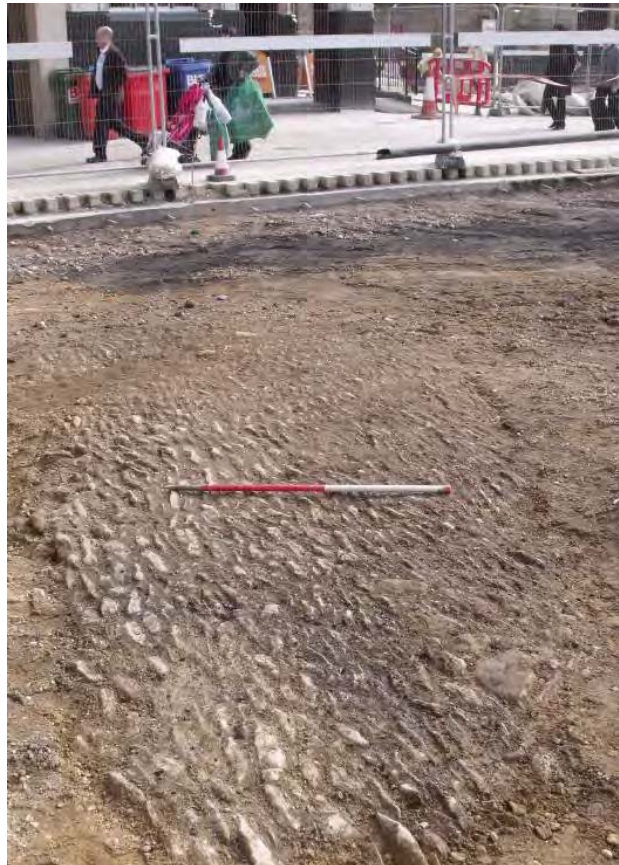
Late 18th- to early 19th-century pitched-stone surface, east side of Cathedral Square, looking east Fig A1.10

Although most of the exposed stone surfaces of this phase were pitched north-south, with narrow pitched-stone drains aligned east-west, area (1625) was too flat and wide to be a drain. An area 2.0m wide of pitched-stone surface (1564), aligned east-west, was also present in the northern half of the surface area, 10.0m to the south of (1625), suggesting that a pitched-stone surface aligned east-west was quite extensive in this part of the square. There may have been areas of similarly aligned stone surfaces in other parts of the square, possibly in some form of alternating pattern or patchwork.

On the south side of surface (1564) the stone was aligned north-south, 2.0m wide, abutting stonework aligned the east-west, with a level at 7.46m aOD. The smaller surfaces to the south of this area also had pitched-stone aligned north-south and also designated with context (1564). The most southerly of the group had a surface level at 7.43m aOD, which demonstrates a slight gradient from the northern most surface (1625) to the southern area (1564) of 0.15m.

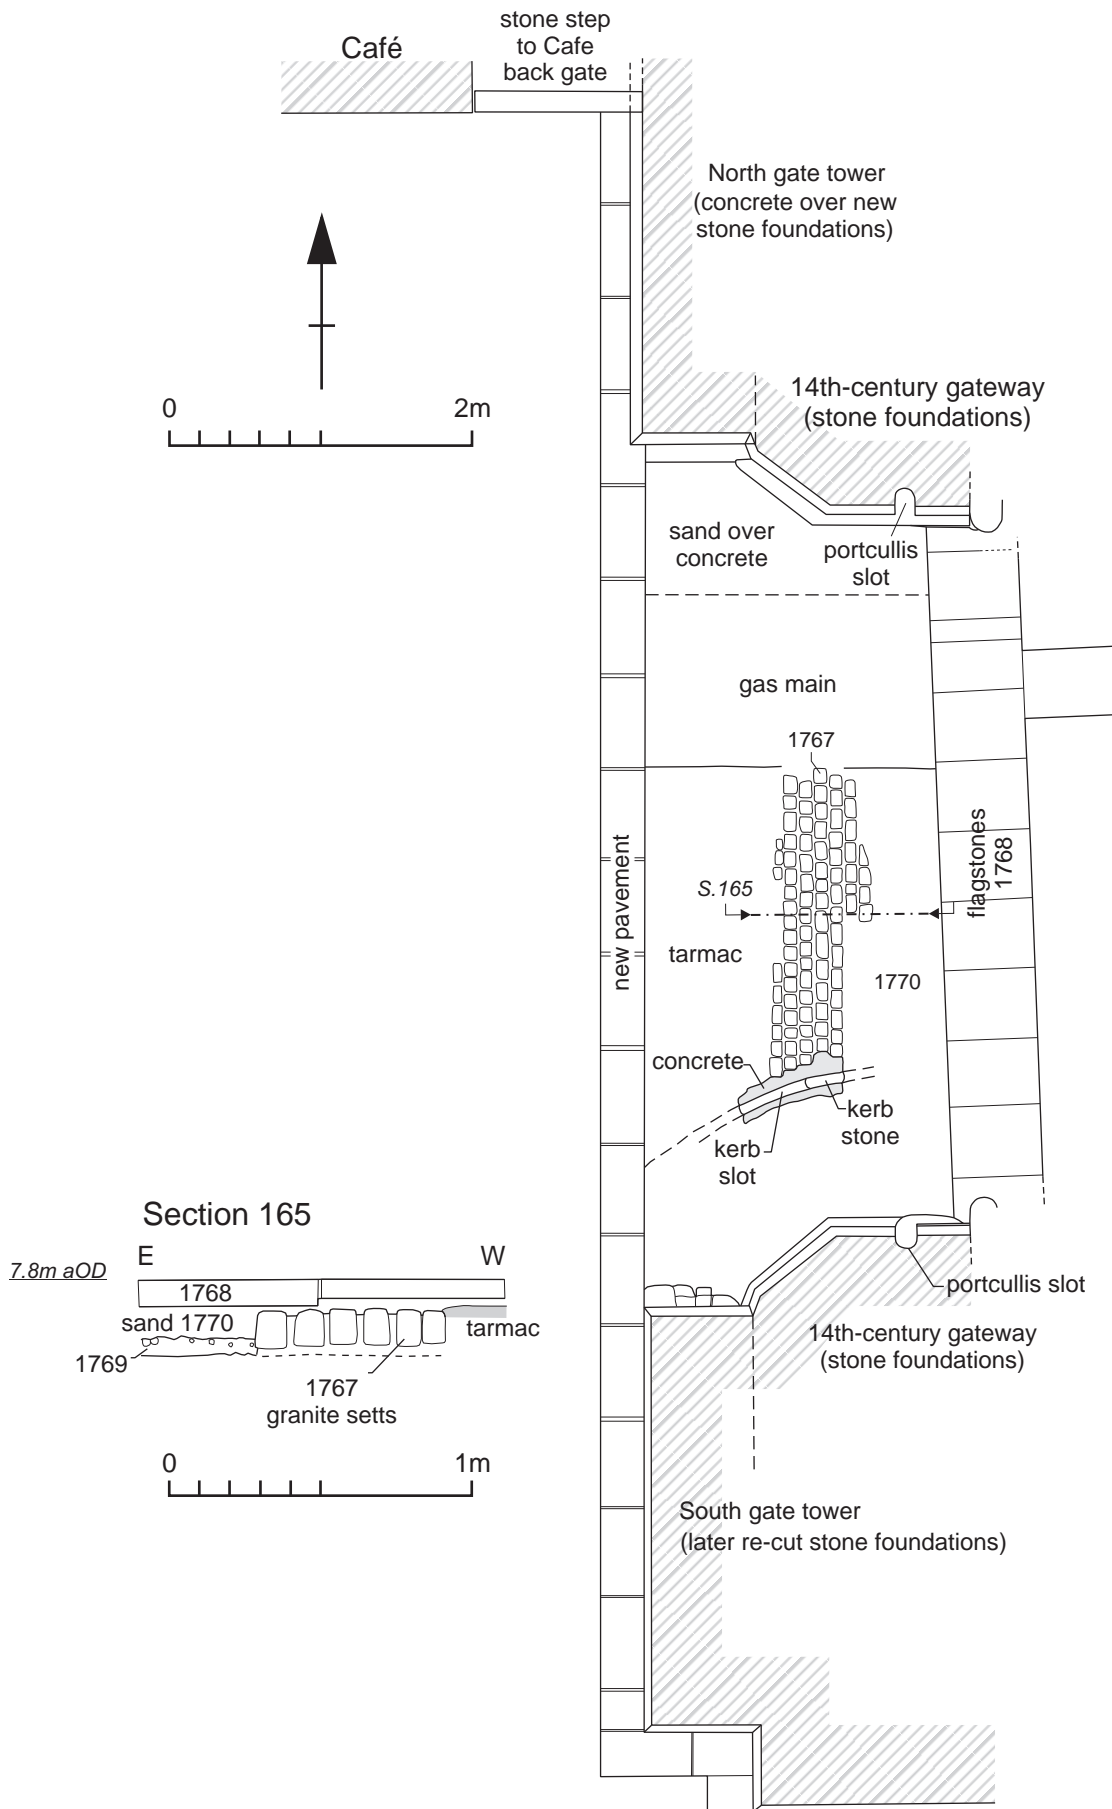
There were the remains of at least seven lines of setts laid out in an approximate north to south orientation, forming an area 0.65m wide. The surface was flat and level, but slightly uneven, with a level at 7.72m aOD. The surface of the setts were worn flat by much use, and between the granite setts there was evidence of a pitch/bitumen bonding material which may have at one time entirely coated them, but had been worn away or removed.

19th-century granite sett surface, Cathedral West Gate Fig A1.11

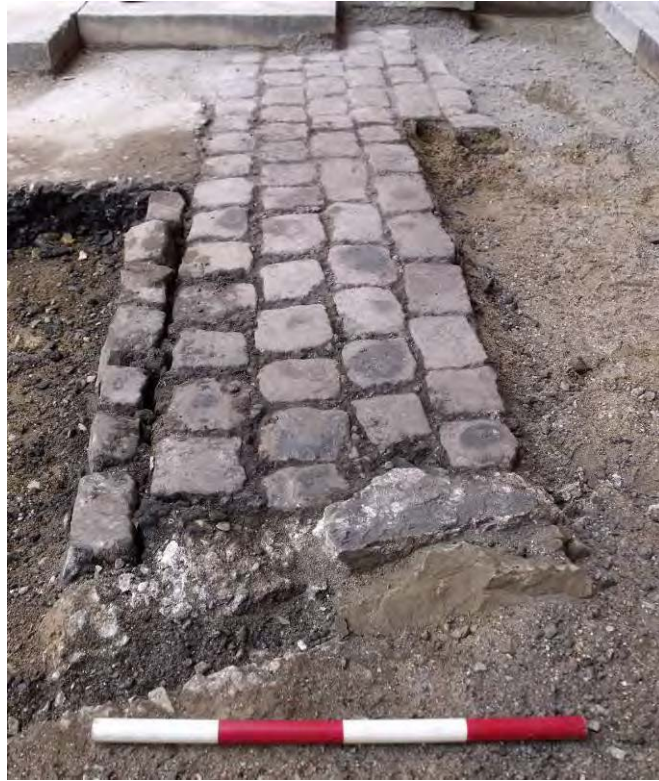
Remnant of late 19th- to early 20th century granite sett market square surface and stone kerb at the Cathedral Gateway, looking north Fig A1.12

The west side of the granite surface (1767), was abutted by a 20th-century tarmac road surface and the north side had been truncated by the gas mains trench that revealed the foundations for the north side of the 12th- and 14th-century gateway. To the east side of the granite surface (1767), it had been removed and replaced with a coarse yellow sand (1770), 0.04m to 0.1m thick, which also overlaid stone surface (1767) as a sub-base for the flagstones (1768) at 7.8m aOD. The rectangular Yorkshire flagstones, 250-450mm by 600-70mm, were probably a late 20th-century installation, extending through the Cathedral Gateway into the east side of the square and remained the street surface until the present development in 2010.

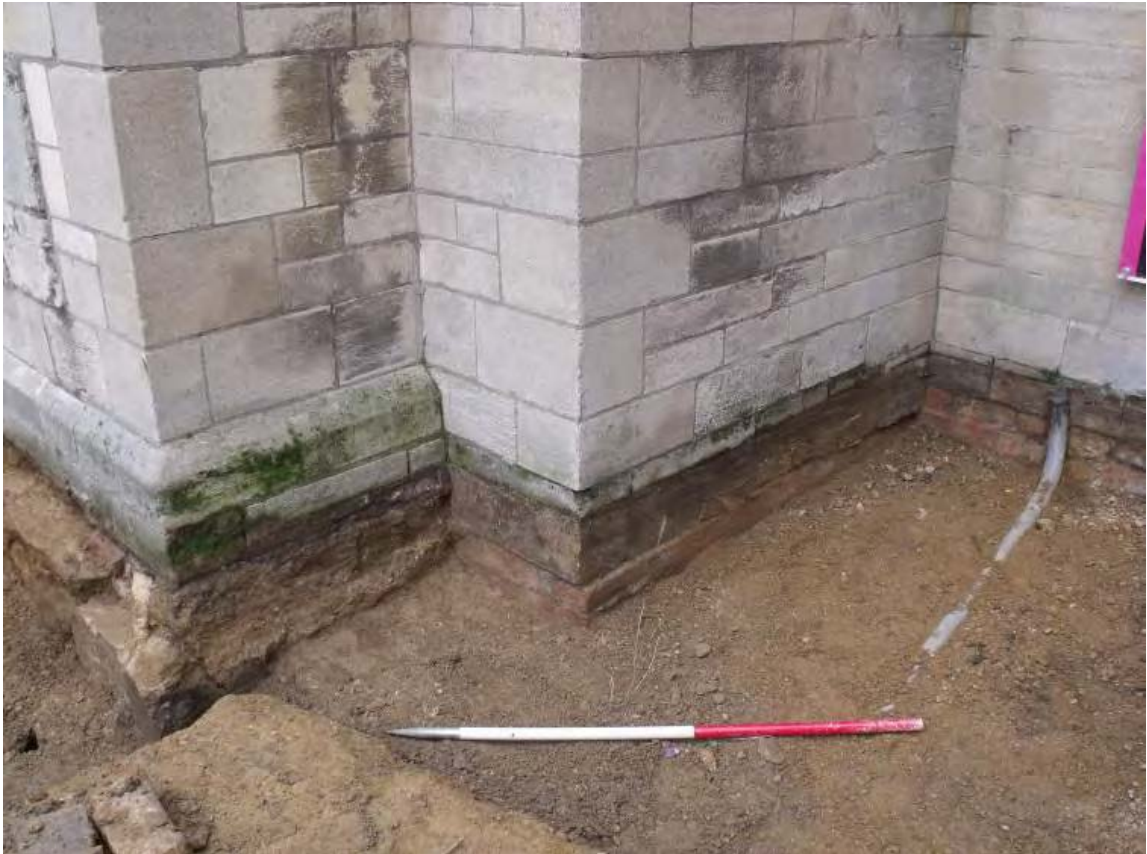
If this make-up layer (1561) was a protective layer for the tower foundations it succeeded in part, but it was cut by the service trenches, exposing the towers footings. Layer (1561) was sealed below a concrete levelling layer 0.18m to 0.26m thick, overlaid by coarse yellow sand (1770) and flagstone surface (1768).

South turret of the 14th-century gateway, showing 1930s refurbishment, with brick and concrete foundations (1595), looking north-east Fig A1.14

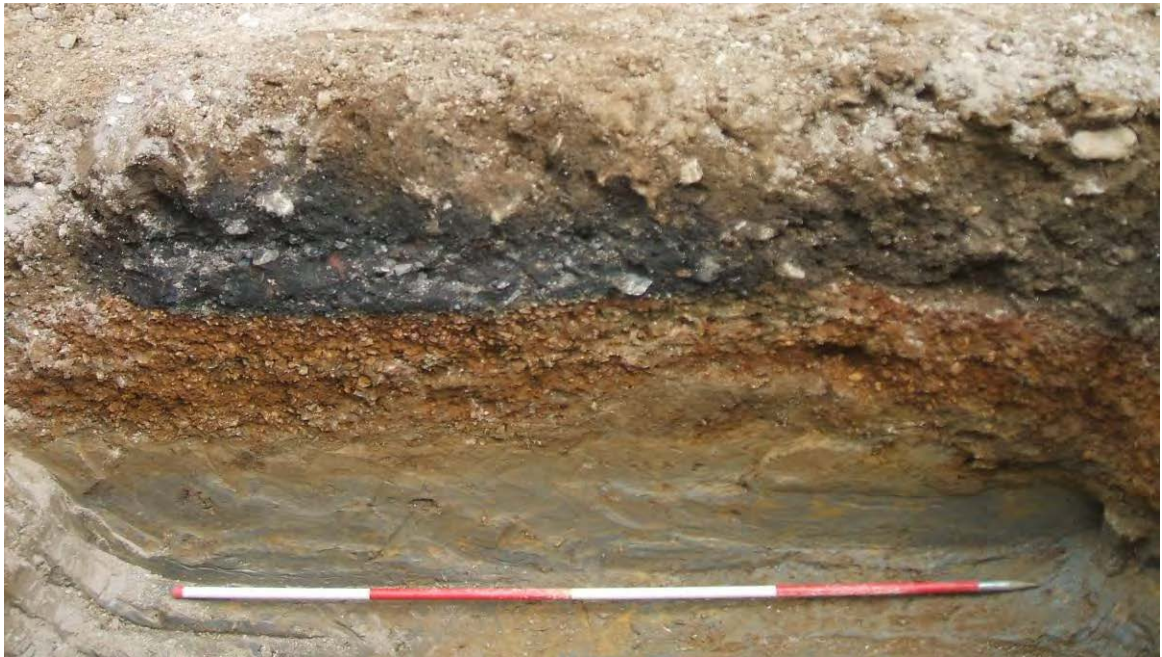
The natural blue-grey clay (1371), east side of toilet block, Trench 55 Fig A2.2

The compact blocky blue-grey clay (1371), formed a base layer for the drift deposits and was least 0.4m thick, with fairly flat surface at c.6.5m aOD. The natural alluvial sand and gravels formed a series of overlying layers, composed of yellowish and orange-brown coarse sand and small gravel (1374), overlaid by (1373) a layer of very compact orange-brown sub-rounded gravel, with thin clay bands (Fig A2.2). The upper layer was a compact greeny-grey silty-sandy gravel (1191)/(1372), which was probably levelled off to form a relatively flat base for the overlying 12th-century market surface (1189), (1190) and (1495) at 6.80m aOD. A gradual drop eastwards in the natural of 0.4m from Trenches 54 and 55 to Trench 7 was apparent.

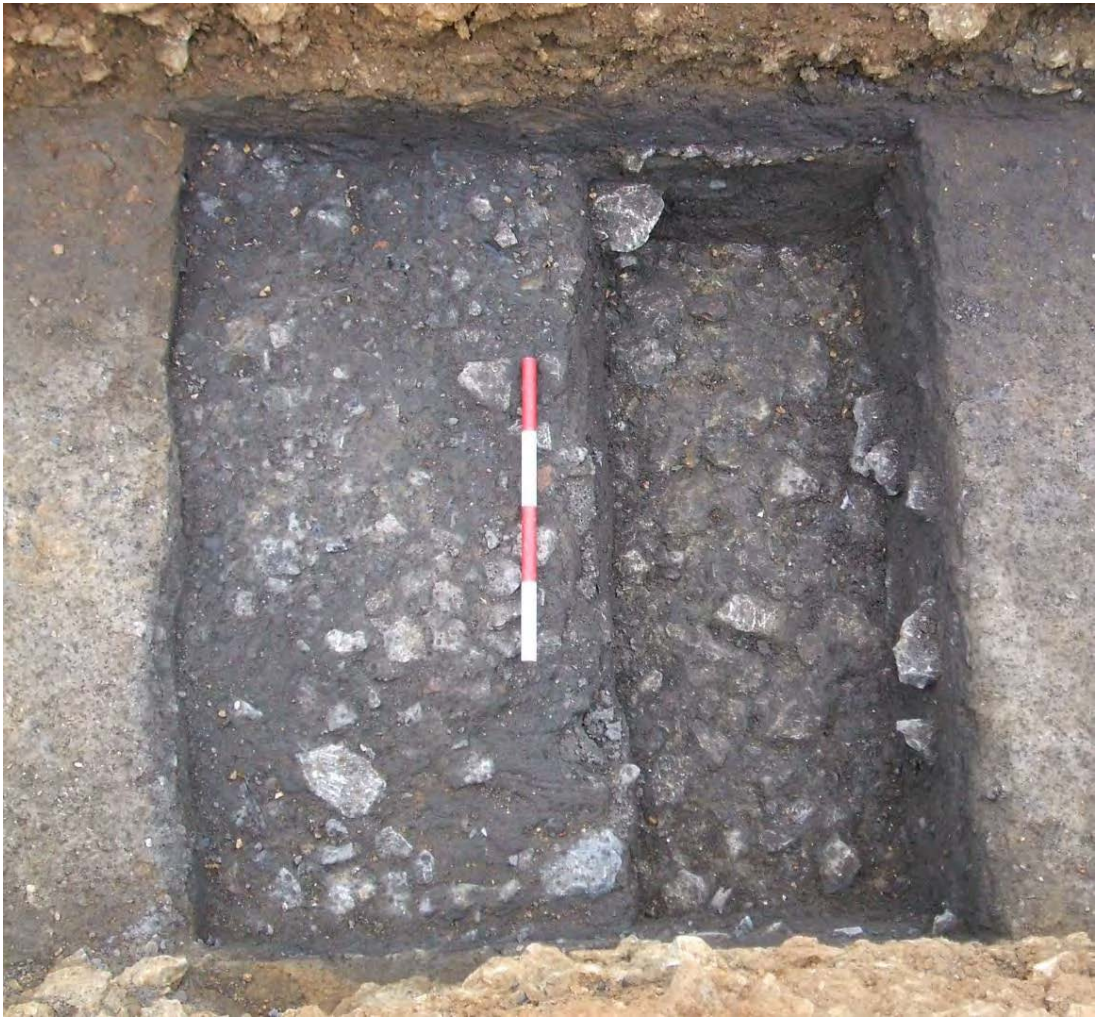
De Bec's market surface (1223) at base of sondage, overlaid by dark silt (1222),
Trench 52, looking south
Fig A2.6

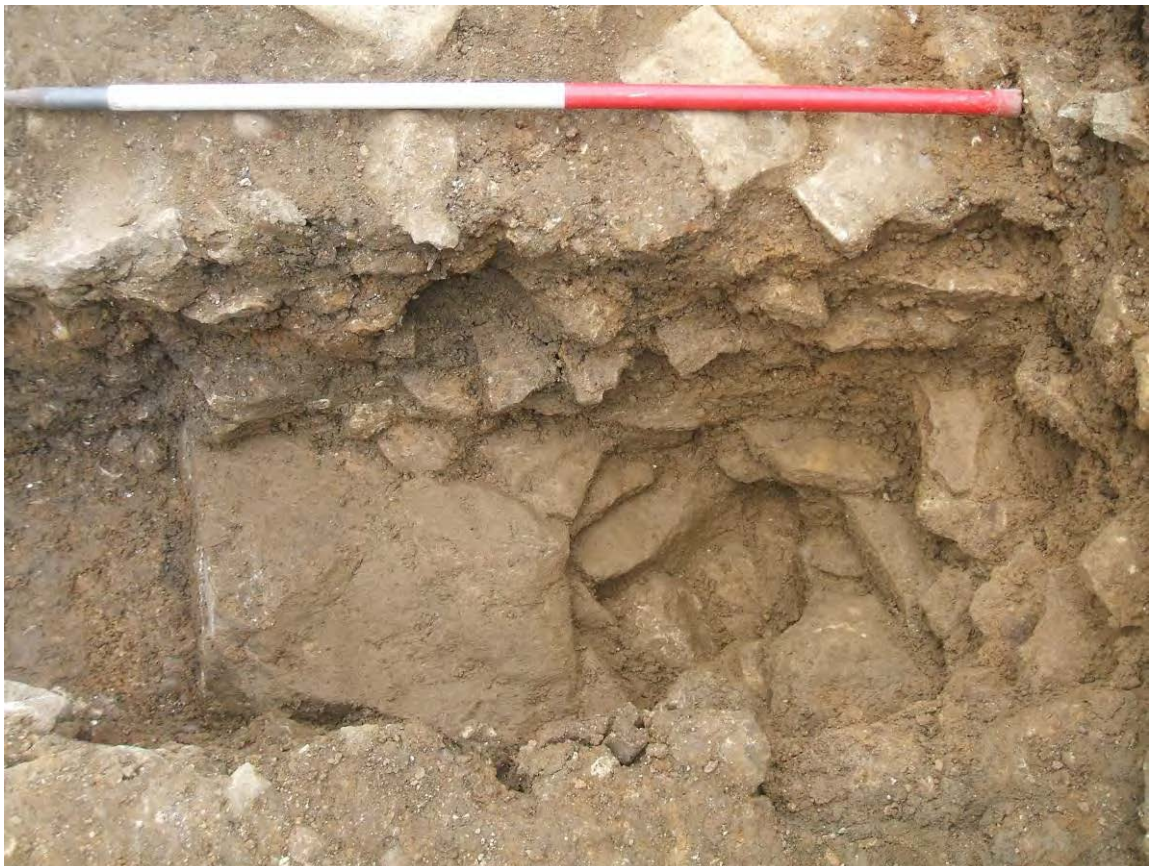
Market Cross; stone kerb/step abutted by probable 16th-century market place surface (1036)/(315), Trench 43, looking north Fig A2.9

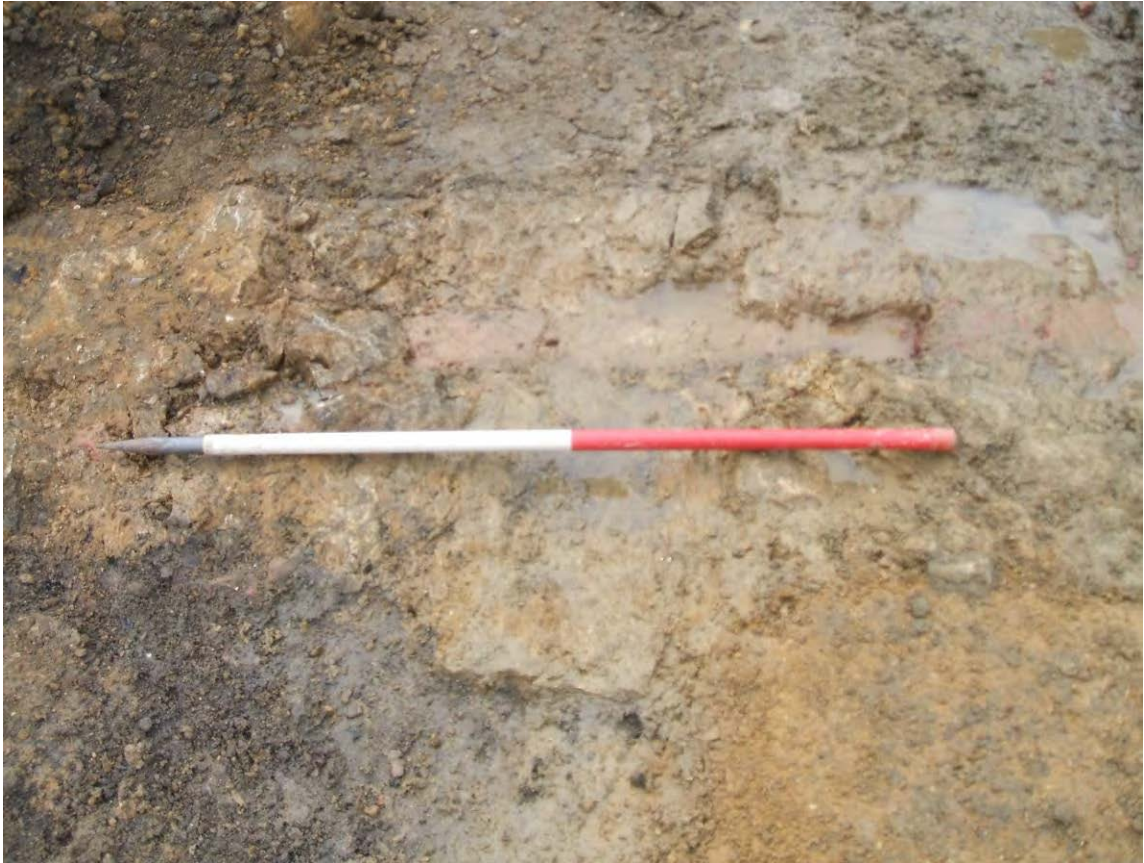
Internal stone wall (1482) in Building 3, with possible brick threshold between Rooms 4 and 5, Trench 45, looking west Fig A2.12

Approximately 6.0m to the east of wall [1481] there was the remains of a parallel stone wall [1482], 2.0m long in the open area strip and 0.5m long across Trench 45. The wall was faced with roughly-hewn limestone slabs, 200-300mm long and up to 100mm thick, with central packing of smaller limestone fragments, 50-200mm. There were only two courses of the wall visible, 0.15m high, but it was plainly bonded with firm, blocky yellow-orange-brown clay. The wall was 0.8m to 0.9m wide, with the top of the wall between 7.39m and 7.59m aOD.

The south end of the wall had a line of five handmade bricks, 240x110x60mm, laid header to header, c.0.3m behind and parallel to the east face. There were at two courses of brick set in white lime mortar, forming a flat and level alignment 1.2m long, and this possibly represents a threshold between rooms. The east side of the wall broadened opposite the threshold, where a single faced limestone block survived, which may be the remains of a step into the room.

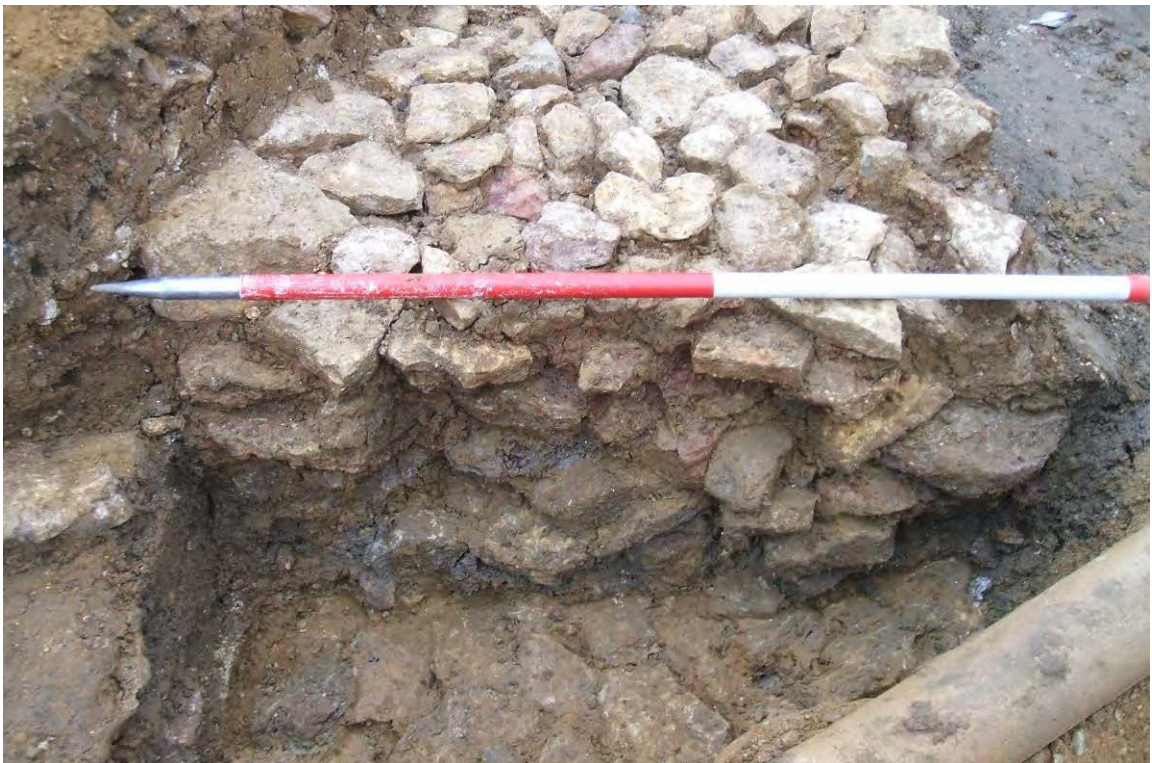
The substantial and broad foundations suggest it supported a large ground floor wall, with a possible wooden superstructure for any upper floors. John Speed's map of 1610 appears to show a large building at least a single storey high.

Section through building wall [1055], aligned east-west, in construction trench [1120], Trench 56 looking east
Fig A2.16

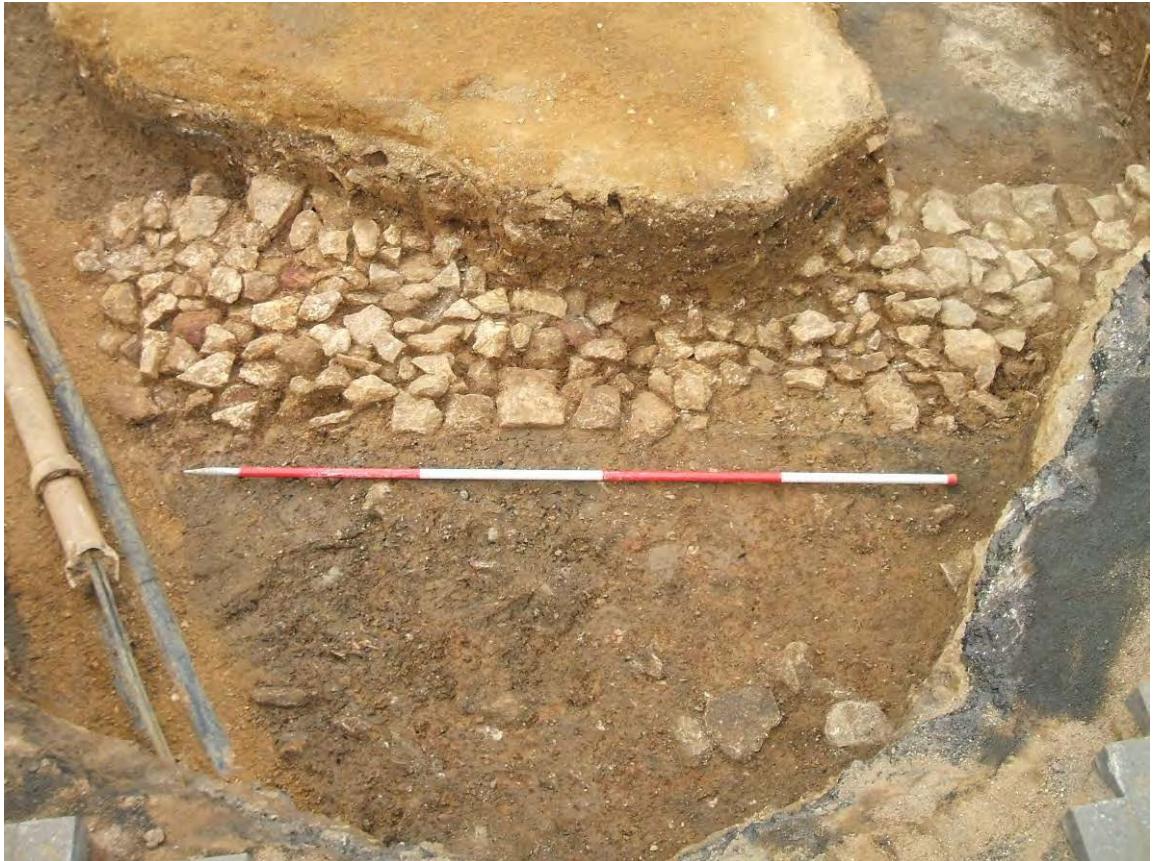
Fountain service Trench 56 showing building wall [1055], aligned east-west Fig A2.17

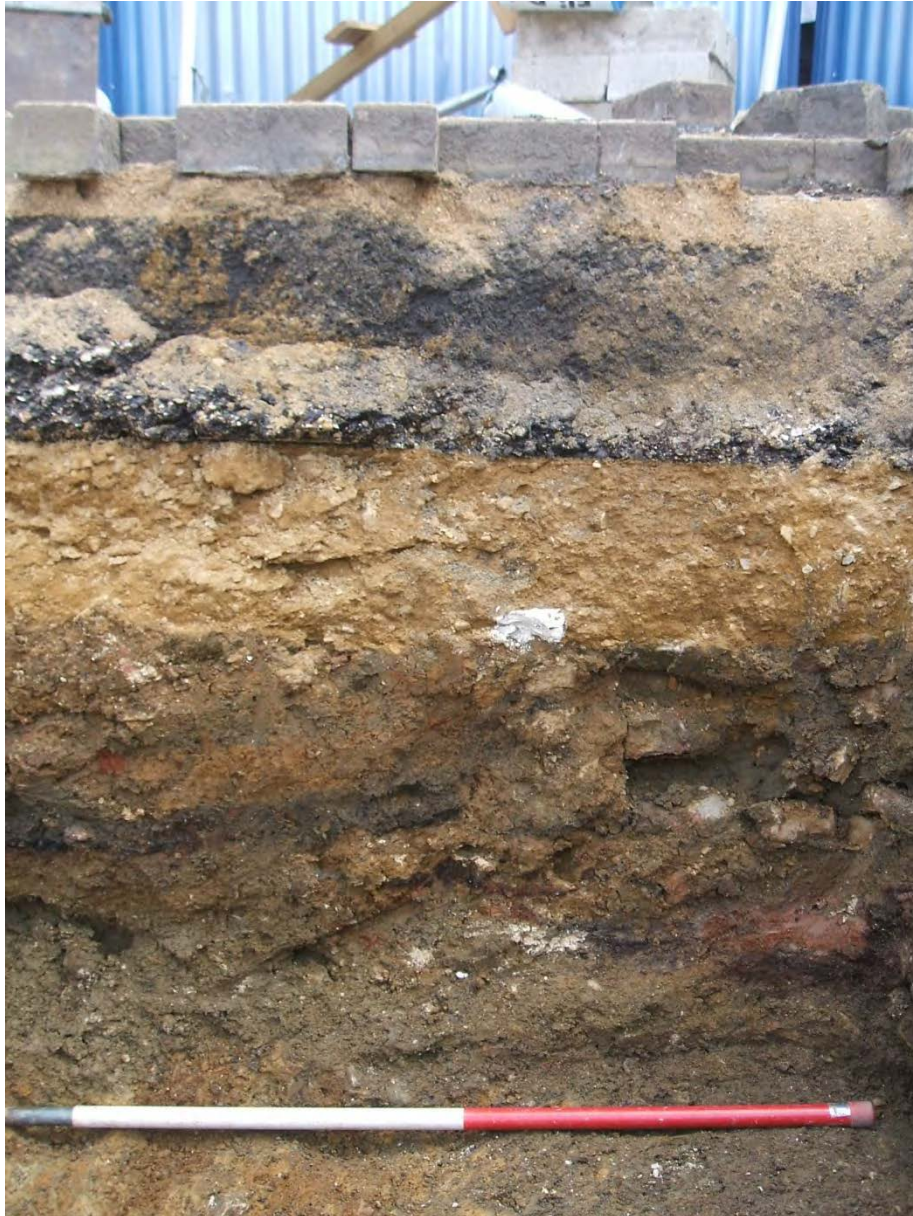
Trench 58, showing building wall [1309], aligned east-west, and a series of overlying internal clay-based floor surfaces for Room 14, looking north-west Fig A2.18

There was only a small area of layer (1300), probably forming a floor surface in Room 14 abutting the east side of wall [1301]. It comprised a firm, dark yellow-brown clay loam, containing a moderate number of limestone fragments, 50-100mm, and occasional smaller stone/gravel and charcoal flecks, with a level at 6.9m aOD. Two sherds of Bourne D ware were recovered from the layer, suggesting a probable 16th to 17th century date for the floor.

The surface and its level don't correspond to the surface layers adjacent to wall [1309], so it is possible that this layer lay within a separate room.

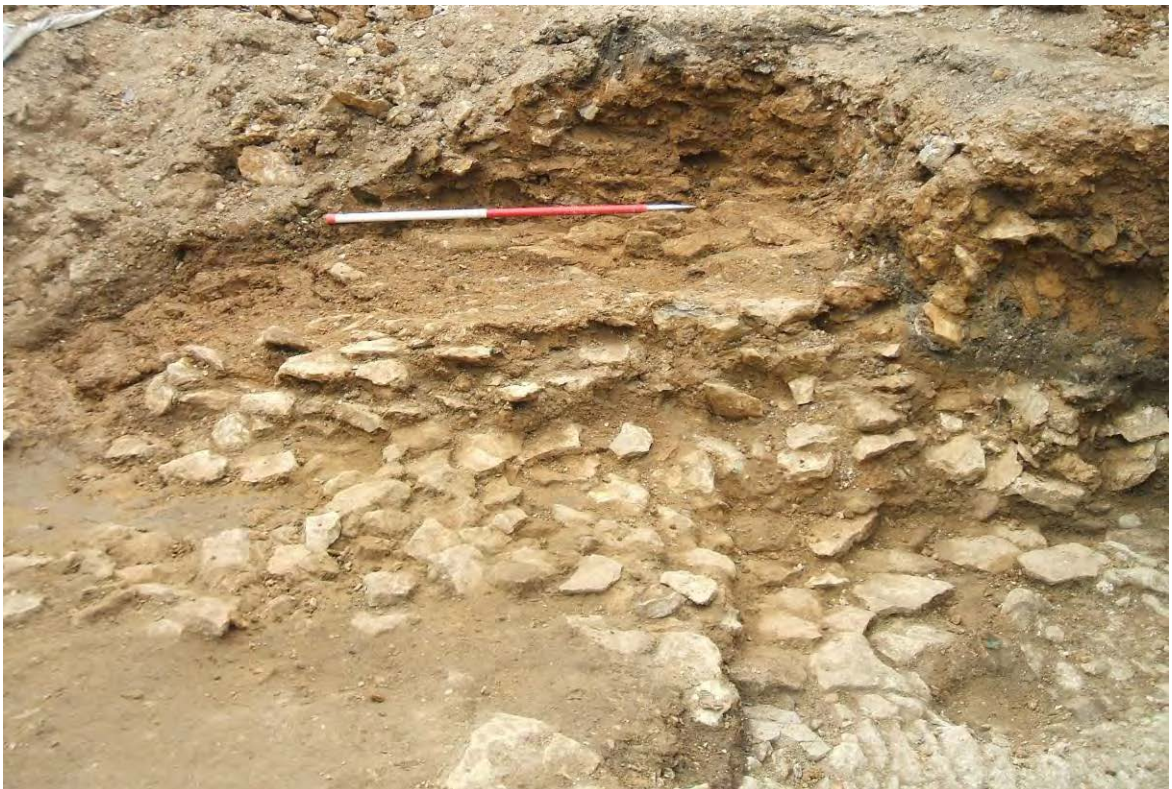
Street monument mound (centre), overlaid by mound soil limestone rubble make-up (1028), Trench 44, looking west Fig A2.21

The mound, created by gravel (1173) in the 15th century, was later overlaid by soil and rubble dump (1028), a compacted deposit of orange-brown silty clay, containing frequent limestone fragments, 50-300mm, and few pebbles. It was sub-circular in shape and at least 3.0m in diameter, with a slightly rounded top and moderately steep sides, sloping down to cover most of the remains of the former market cross (4.5m in diameter). The thickest part of the make-up was at least 0.85m, raising the mound to 1.2m above the street level, between 7.65m and 7.85m aOD.

The addition of this make-up on the mound probably occurred in the 16th century, possibly to raise it above the incursion of the dark silt (1014)/(1016)/(1027)/(1101), which was allowed to abut and partially overlay it, which may have been the result of trample. This apparent market place monument probably continued through into the late 18th century. Whether the mound retained a religious significance it is not known, but it would have formed a prominent oration platform, visible across most of the market place.

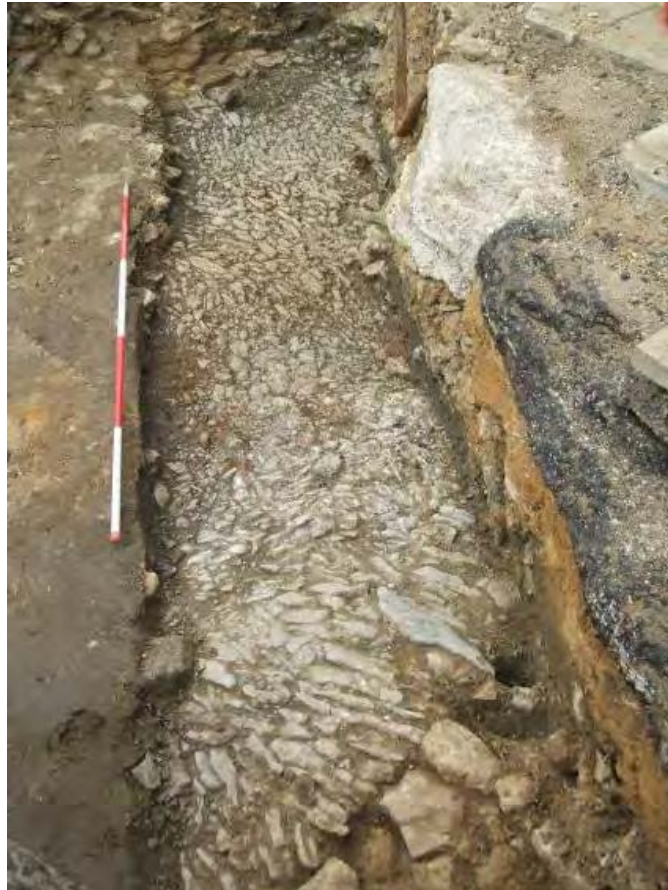
Pitched-stone pavement (1092), abutting wall [1090] on the west side of Building 3, Trench 44, looking north-west Fig A2.23
