**An Archaeological Investigation
of the Historical Development of
Cathedral Square, Peterborough
November 2008 to August 2011
Appendices: The Excavated Evidence**

Report No. 16/105

Site Codes: PCSWB09, PCS09, PCSF09, CATSP08

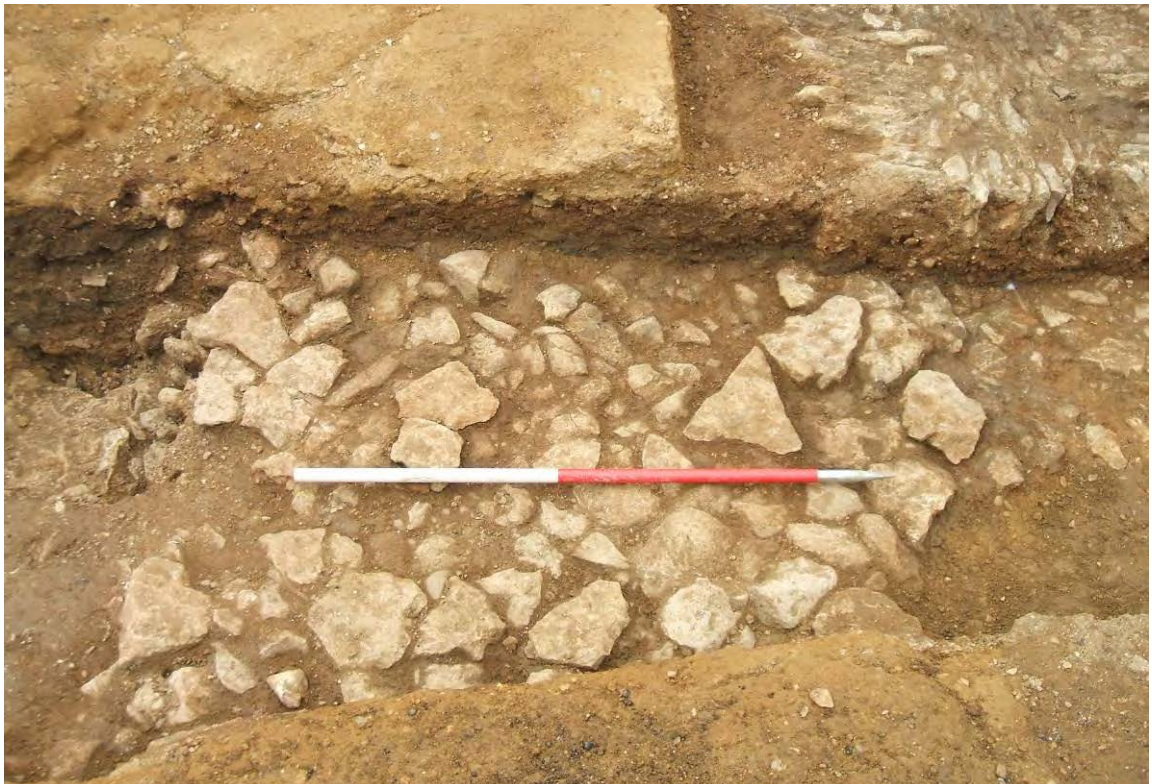
Flat-laid stone pavement (1050) (centre), adjacent to robber trench [1054] and wall [1058] (left) on north side of Building 3, Trench 47, looking west Fig A2.24

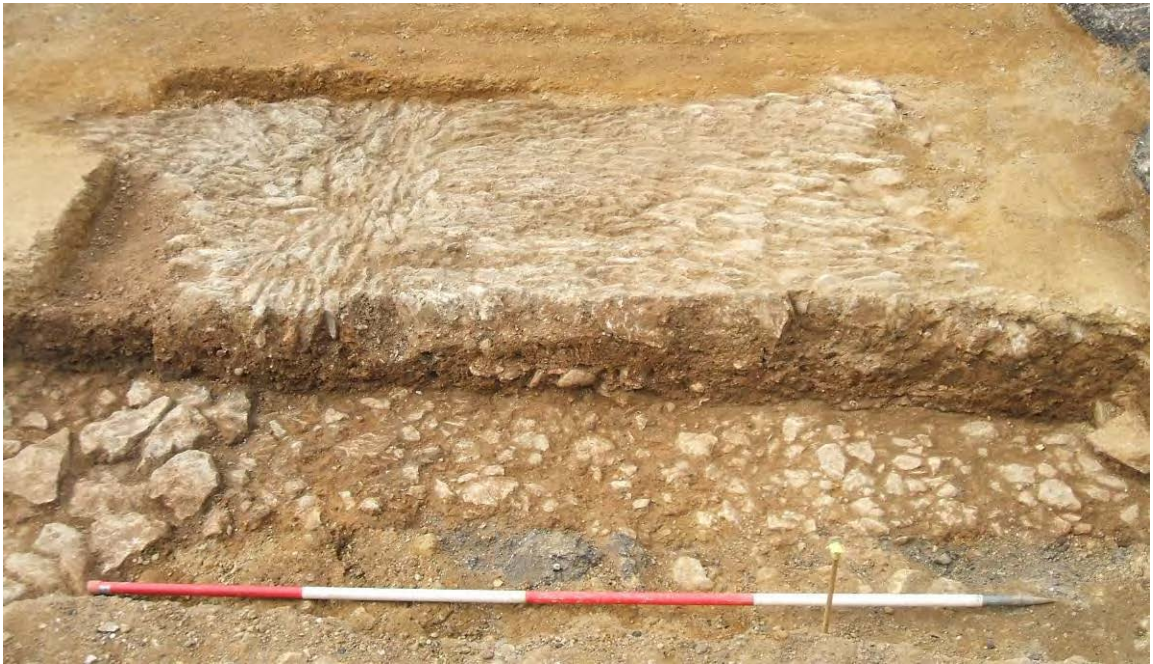
Flat-laid stone pavement (1050), adjacent to wall [1058] on north side of Building 3, overlaid by 18th-century pitched-stone surface and drain (1039), Trench 47, looking west
Fig A2.25

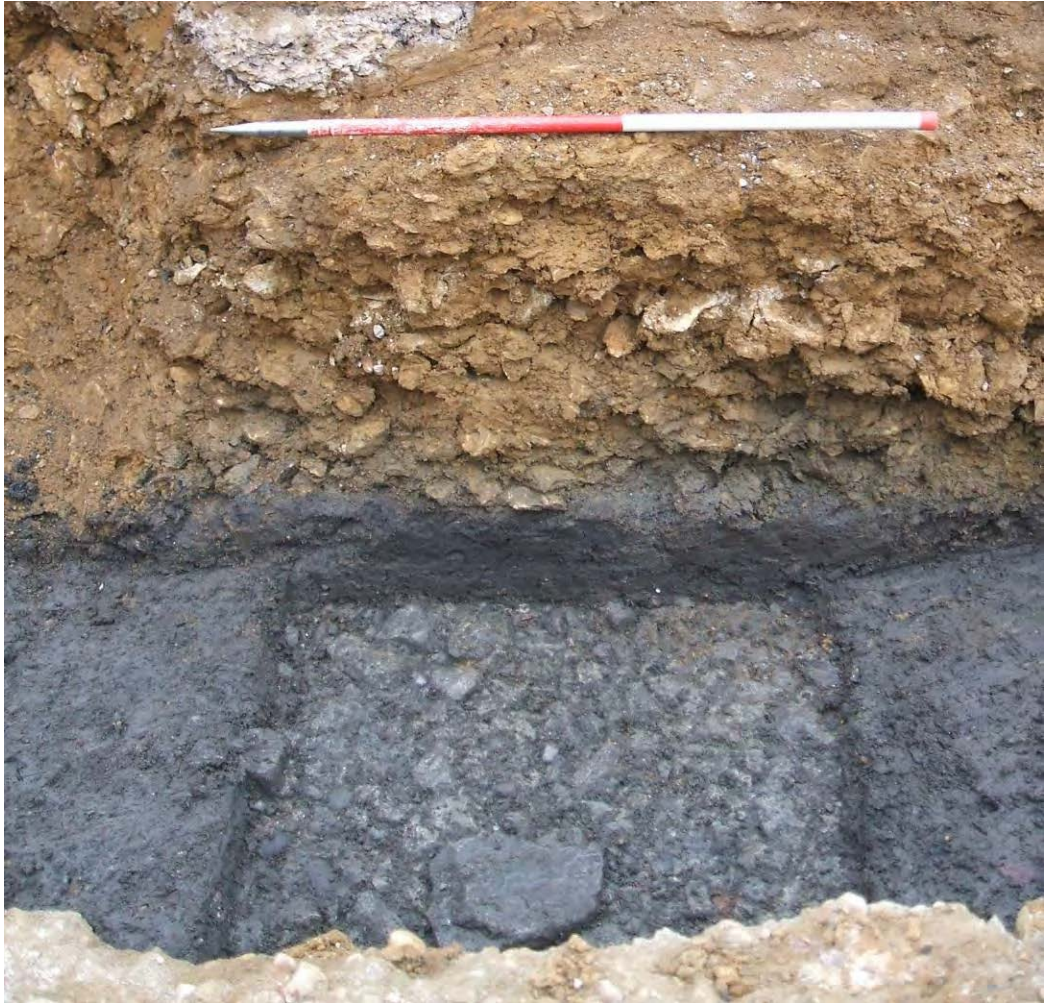
The layer was mixed with a dark grey-black silt, 0.05m to 0.15m thick, comparable with overlying silt (1186), which gradually increased to the west. It contained Bourne D ware pottery of 15th to 17th century date, including a piece of a possible lead badge and an iron strap fragment.

Market place surface (1193), overlaid by dark silt (1186)/(1214), sealed by 17th-century limestone and clay make-up deposits (1224) and (1225), Trench 52, looking north Fig A2.26

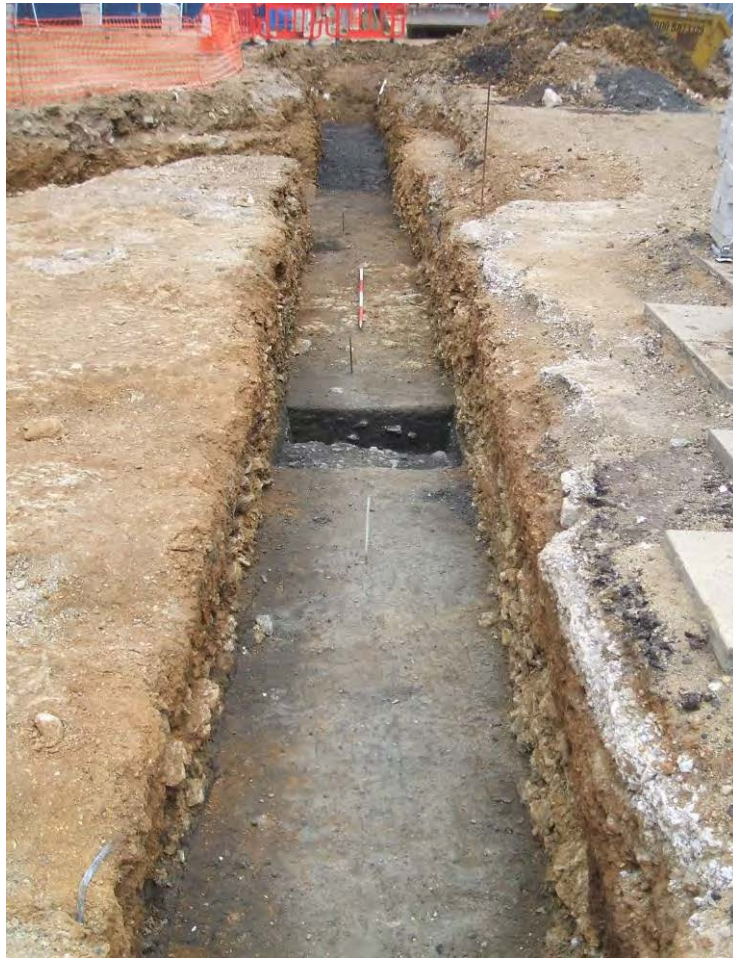
The extensive dark silt (1186)/(1214), overlying market place surface (1193) and sealed by 17th-century limestone and clay make-up deposits, Trench 52, looking west Fig A2.27

Overlying both surface (1187) and (1193) was dark silt (1186), 0.3m thick, which in turn was overlaid intermittently by dark grey-brown silt (1185), which may have been trampled into the surface of the underlying layer. Deposit (1185) was similar to (1186), but with small patches of mottled green-brown cess and an increased amount of grit and small gravel up to 0.22m thick. Together they formed a fairly level layer at least 0.3m thick.

Layer (1186) contained a large amount of Bourne D ware pottery of 16th to 17th century date and a few sherds of Cistercian/Midland Black ware pottery. Brick, roof and floor tile pieces and fragmented animal bone were also recovered. Some interesting household objects and general loses were also retrieved, such as a copper spur rowle (Fig 4.6,15), purse bar (Fig 4.6,9) and thimble (Fig 4.6,14), an iron key (Fig 4.6,12) an iron candle holder (Fig 4.6,11) and buckle, nails and other sundry metal pieces and leather fragments. Layer (1185) had fewer finds than (1186), but the pottery was of a similar type and date though fewer sherds, although this may have been the result of the finds being designated to the early layer (1186), until the later deposit (1185) had been defined.

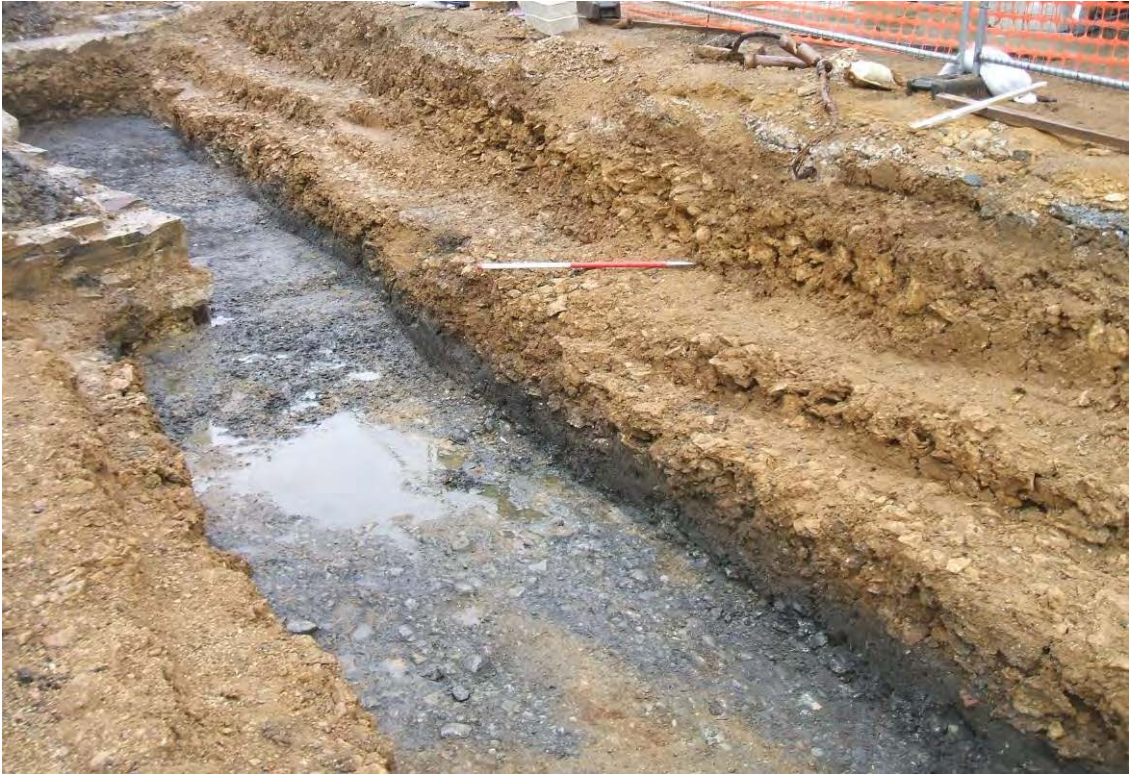
Fig A2.28

De Bec's market square surface (1189) sealed by dark silt (1187)

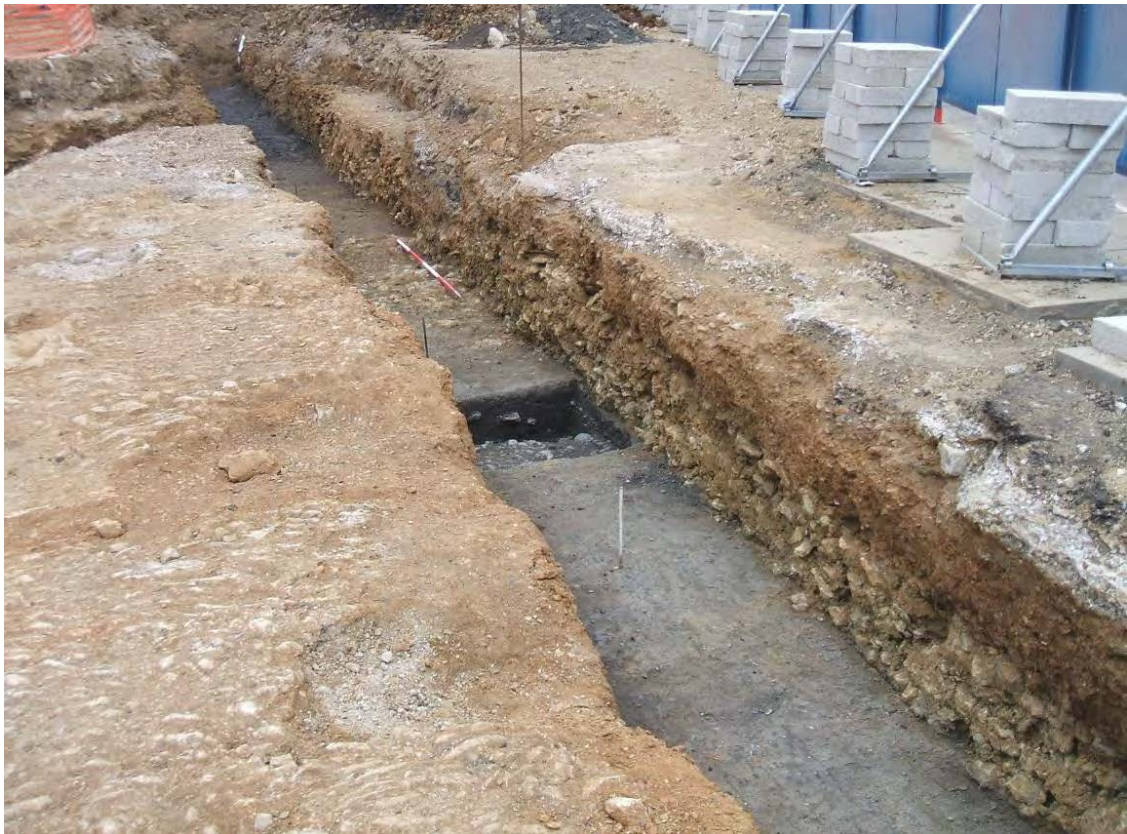
The clay and rubble make-up layer (1336) overlay the dark silt (1341). It was up to 0.4m thick at the north end, narrowing and petering out towards the south end of the trench. The overlying cornbrash rubble layer (1337) extended the length of the trench, 0.15-0.25m thick at the south end, increasing up to 0.5m at the north end.

Late 17th-century limestone rubble and clay make-up deposits tipping east, Trench 52, looking north-west Fig A2.31

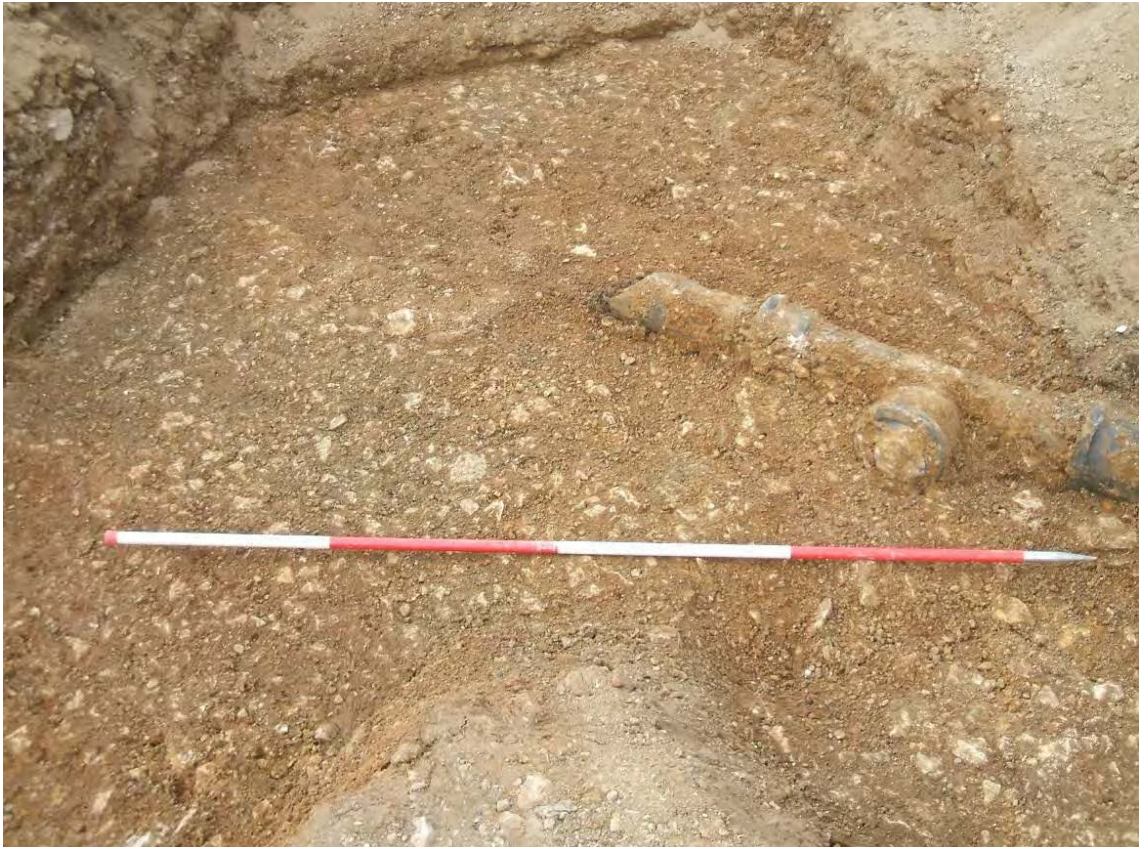
Late 17th-century market place stone chip surface (1212) at the junction of Trenches 50 and 52, truncated by Victorian gas main, looking west Fig A2.32

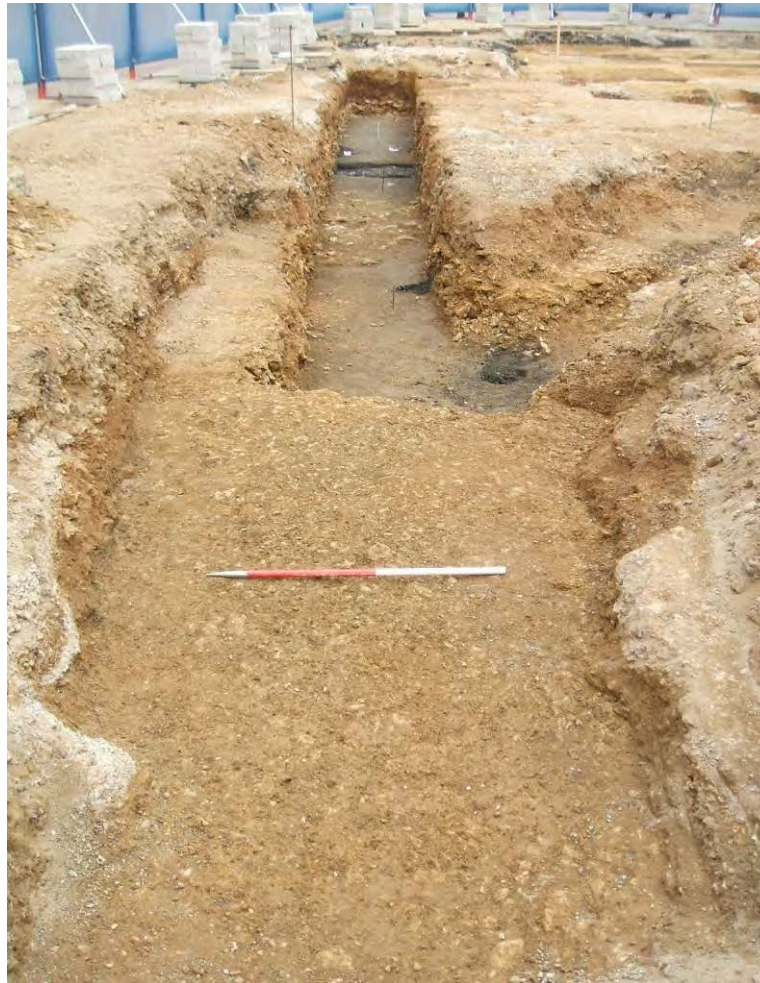
Late 17th-century market place stone chip surface (1212) overlying limestone rubble and clay make-up deposits in Trench 52, looking east Fig A2.33

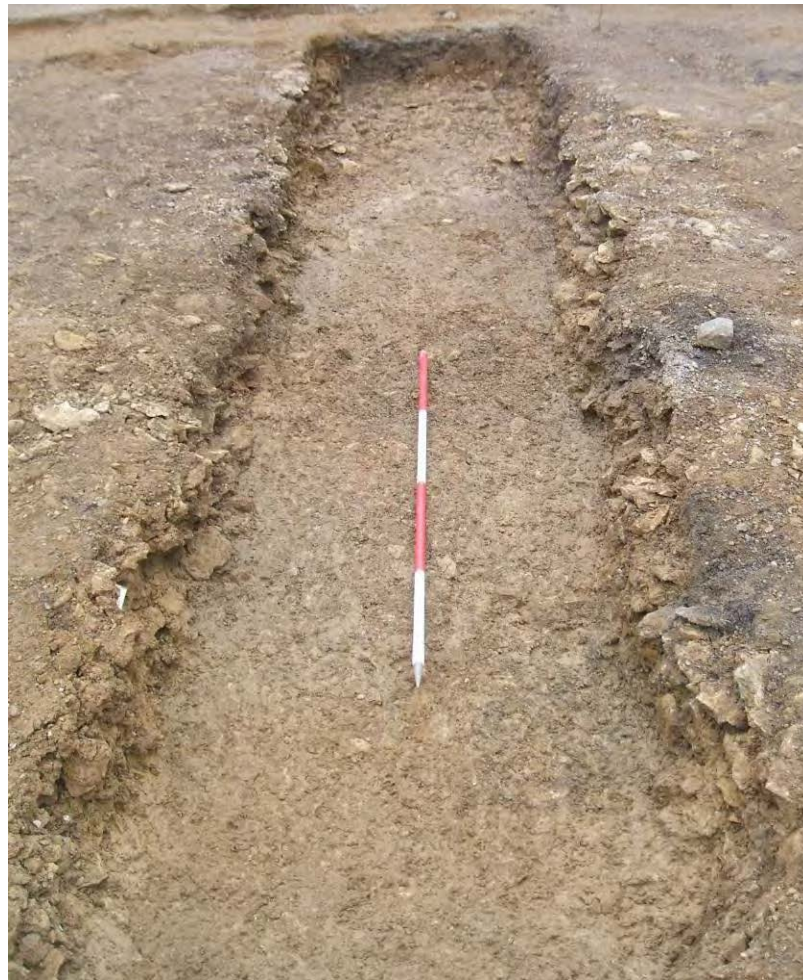
Late 17th-century market place stone chip surface (1020) overlying limestone rubble and clay make-up deposit (1021), Trench 42, looking south Fig A2.35

This roughly square area of the market place surface, 3.0m x 3.0m, was truncated on its north, south and west sides, probably by 20th-century road development, with Trench 5 cutting the east side, although the surface appeared to continue beyond the east side of the trench (Fig A2.35). The stone surface displayed a gentle camber from 7.64m aOD, sloping into the shallow pitched-stone drain at 7.55m aOD, that traversed the length of the south side of the surface. No finds were recovered from the surface, which was overlaid by silt deposit (1040).

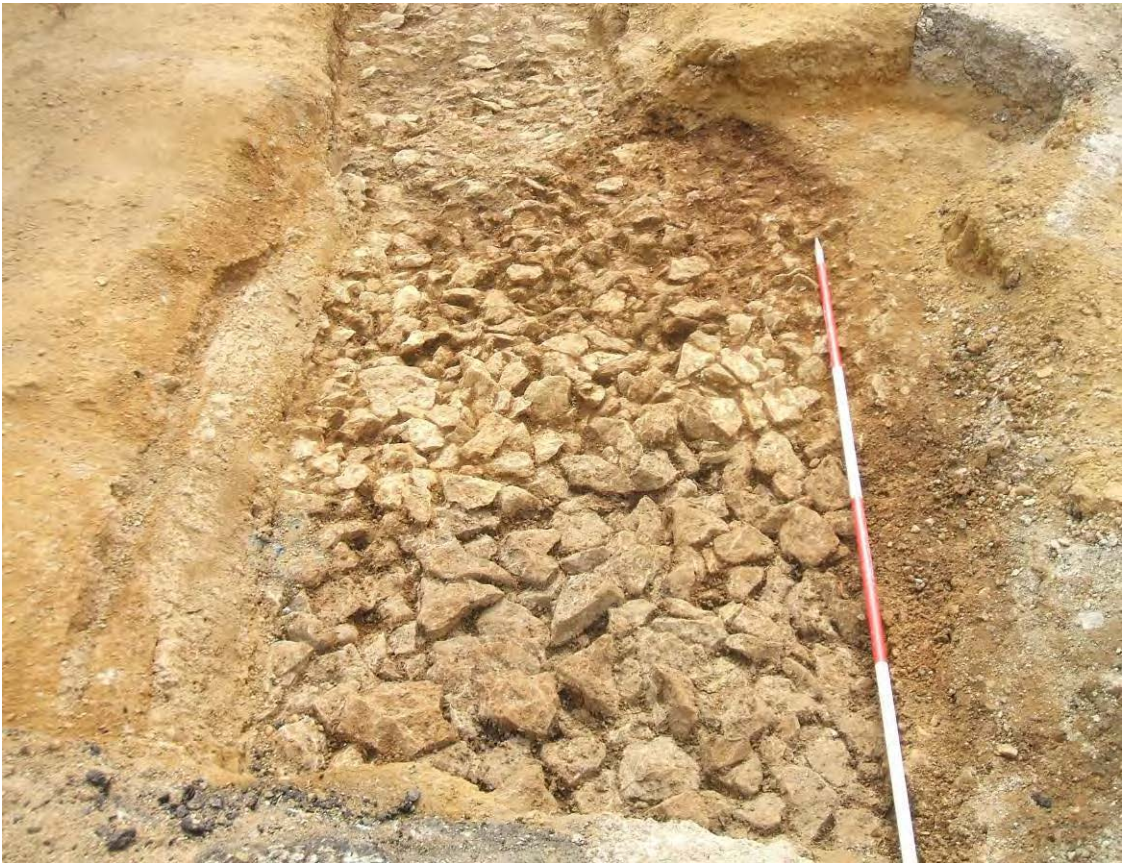
Late 17th-century limestone rubble make-up deposits (1059), Trench 48, looking south
Fig A2.36

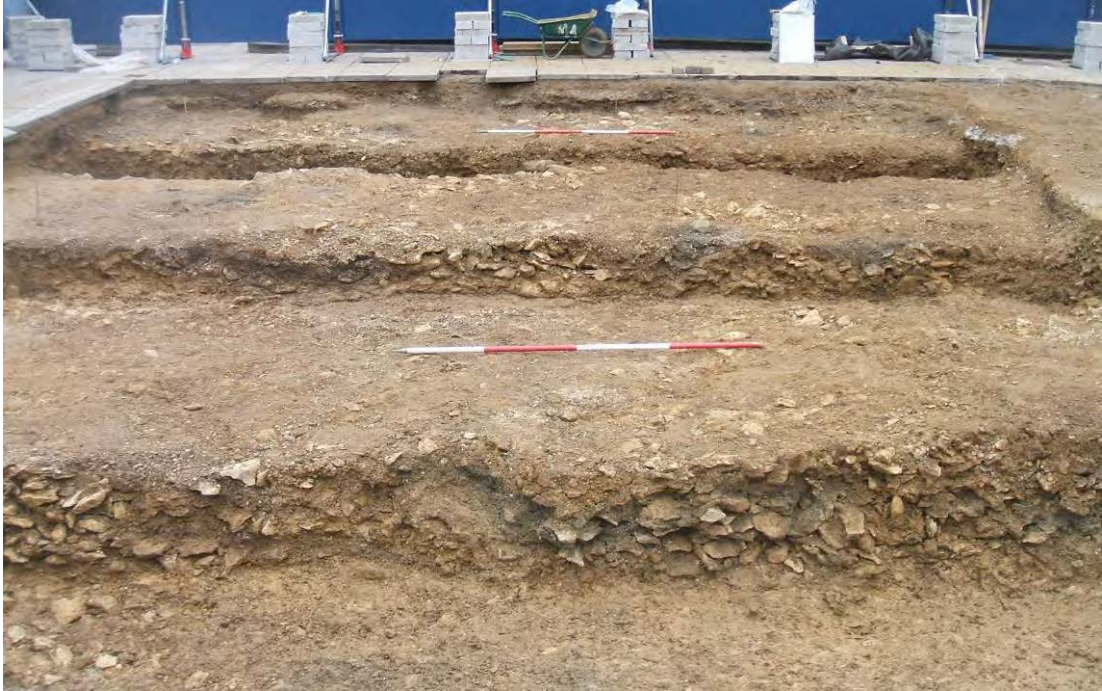
Late 18th-century make-up layers, Trenches 41 (background), 42 and 43 (foreground), looking west
Fig A2.39

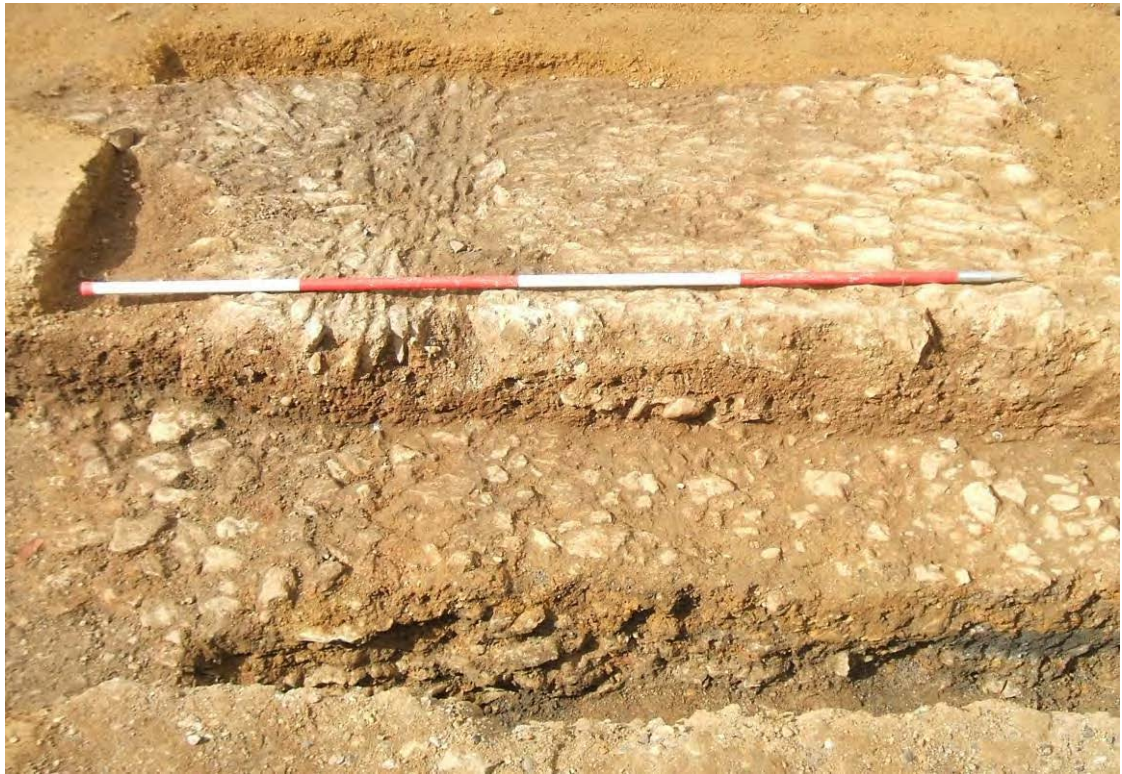
Late 18th-century pitched-stone surface (1039), and drain aligned east to west, with underlying make-up layers and dark silt, Trenches 5 and 47, looking west Fig A2.40

Overlying part of the linear drain in surface (1039) was a thin dark grey clay silt deposit (1040), with the occasional small pebble, stone and grit up to 20mm thick. No finds were recovered from the deposit. The silt was overlaid by a compacted bright orange sand sub-base layer (503)/(1048), 0.15-0.20m thick, for the 20th-century road construction.

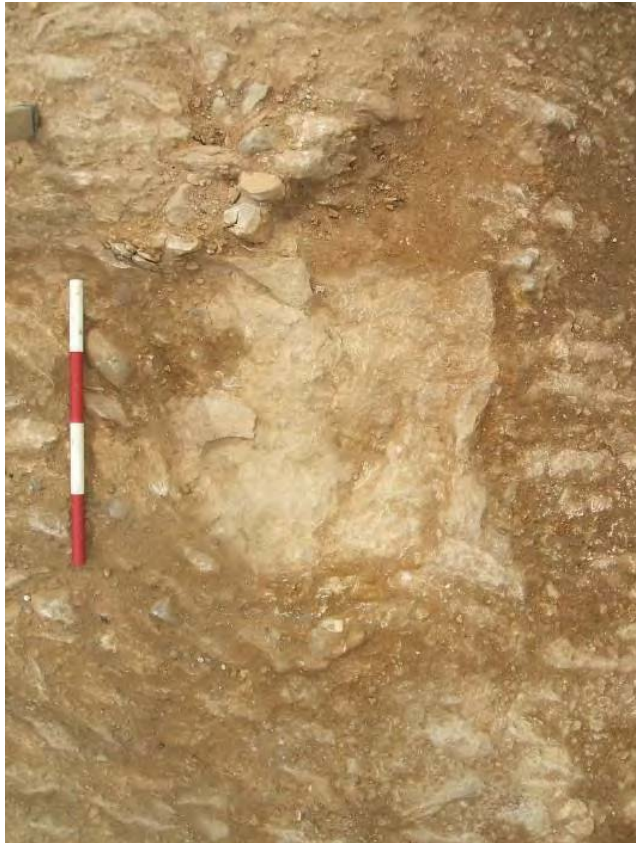
About 1.0m north from the centre of the star-shaped feature lay the base of a roughly-square, limestone plinth or post-base (1133), set square with the pitched-stone surface. The stone post was probably hewn from a single block 0.5m square, that had been broken off at ground level, leaving a fractured and cracked surface, with rounded and damaged sides. The post would have formed a piece of the late 18th-century market place furniture, possibly for tethering animals, that was probably removed prior to the resurfacing in the late 19th century. The top of the post base was at 7.83m aOD.

Late 18th-century pitched-stone surface (1075),
with stone post base (1133), looking west Fig A2.41

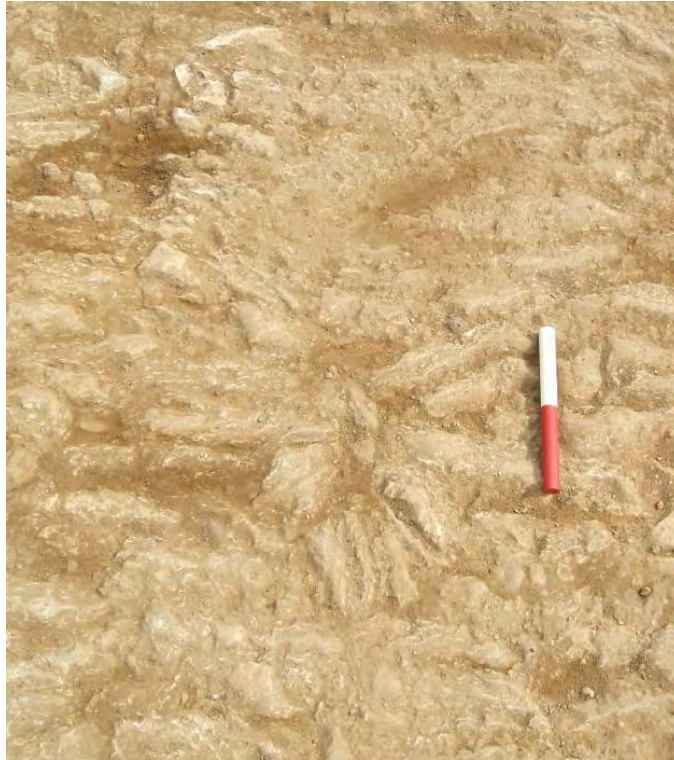
Late 18th-century pitched stone surface (1075), with star-shaped feature (right), looking east Fig A2.42

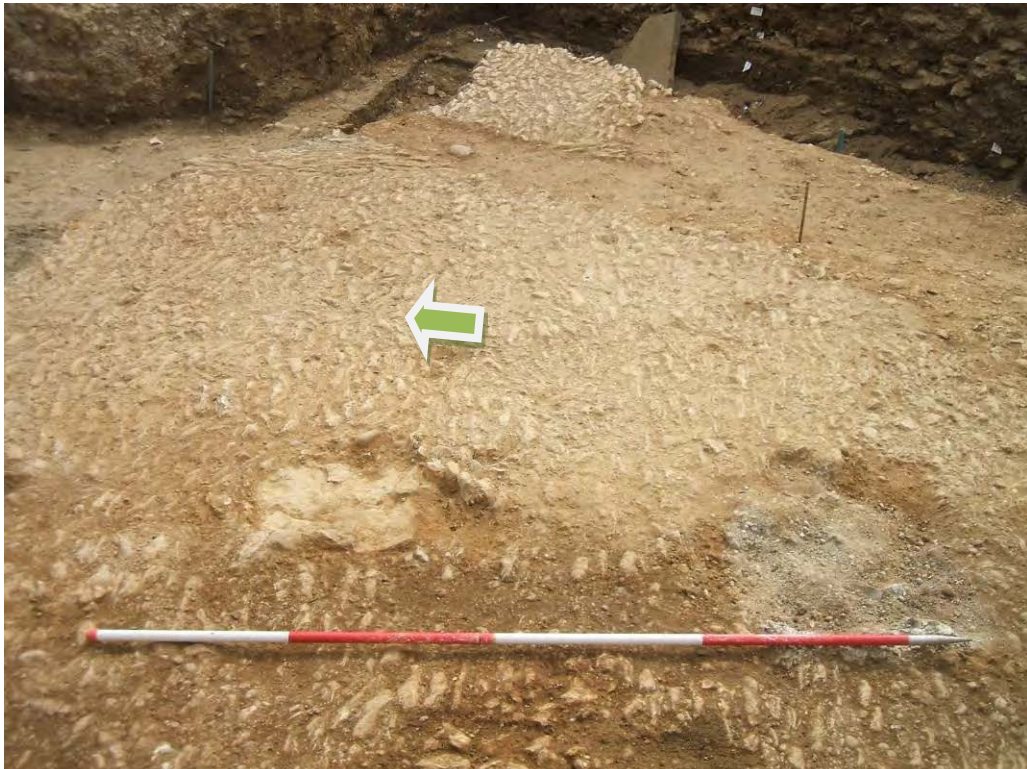
Late 18th-century pitched-stone surface (1075) and drain, with stone post-base (1133) (foreground) and star-shaped feature (background arrow), central area, looking south Fig A2.43

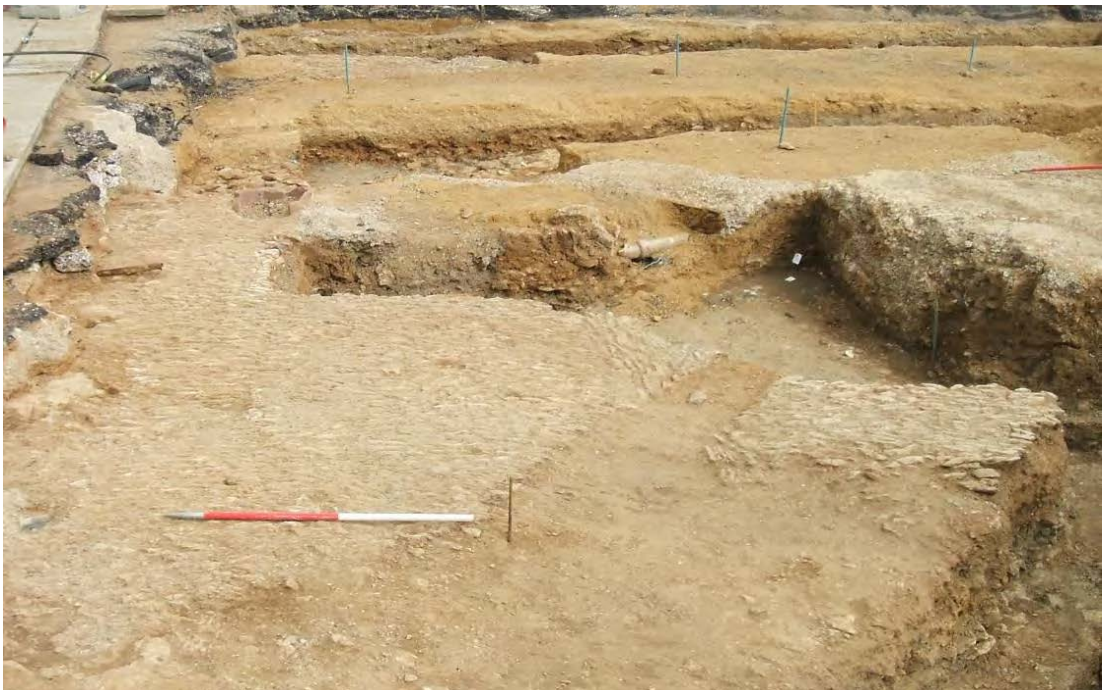
Late 18th-century pitched-stone surface (1075) and drain orientated east to west (centre), cut by construction trench [1069], exposing concrete foundation for the late 19th-century Gates Memorial fountain, looking east Fig A2.44

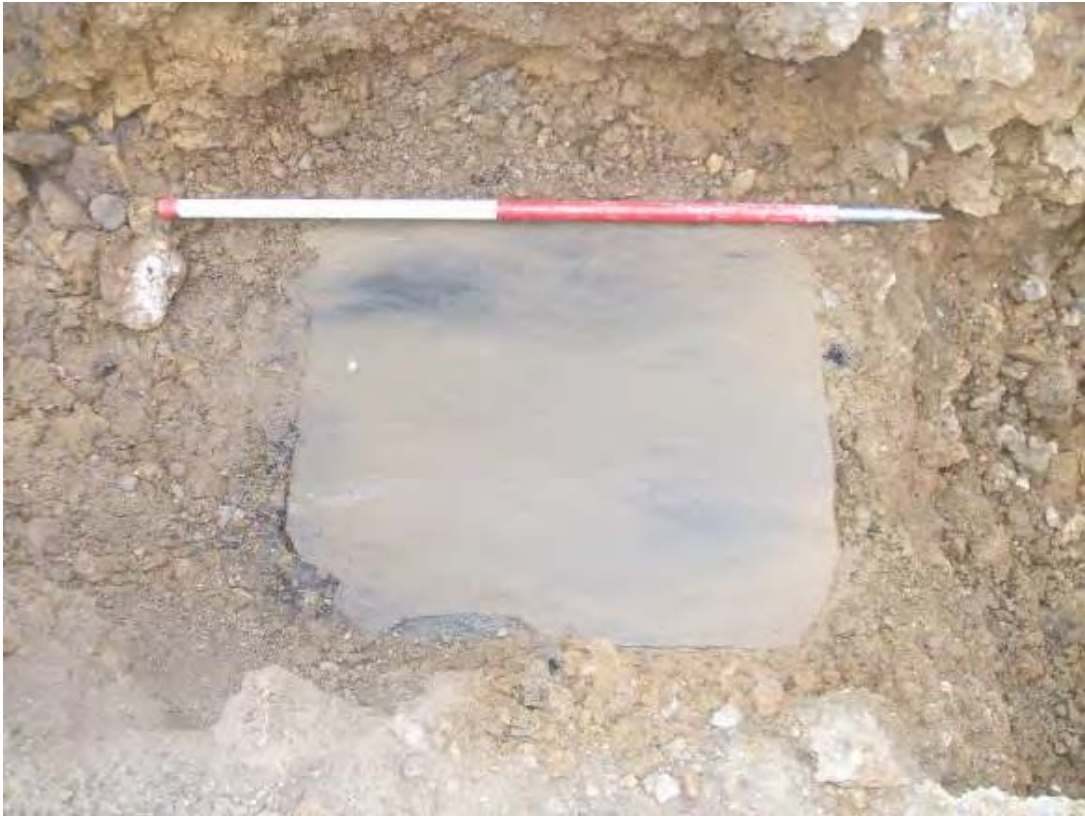
It can only be assumed these were bases to support some form of superstructure, relating to the Guildhall. The pits were unlikely to be for scaffold posts for the Guildhall, as they lay too far from the building and too distantly spaced (Fig A2.46). They may have been used to support a temporary decorative structure to celebrate Queen Victoria's jubilees in the late 19th century, when the city was lavishly decorated and illuminated (Tebbs 1979).

Probable Victorian slab base in pit, set in concrete for temporary structures
north end of Trench 40, looking west Fig A2.46

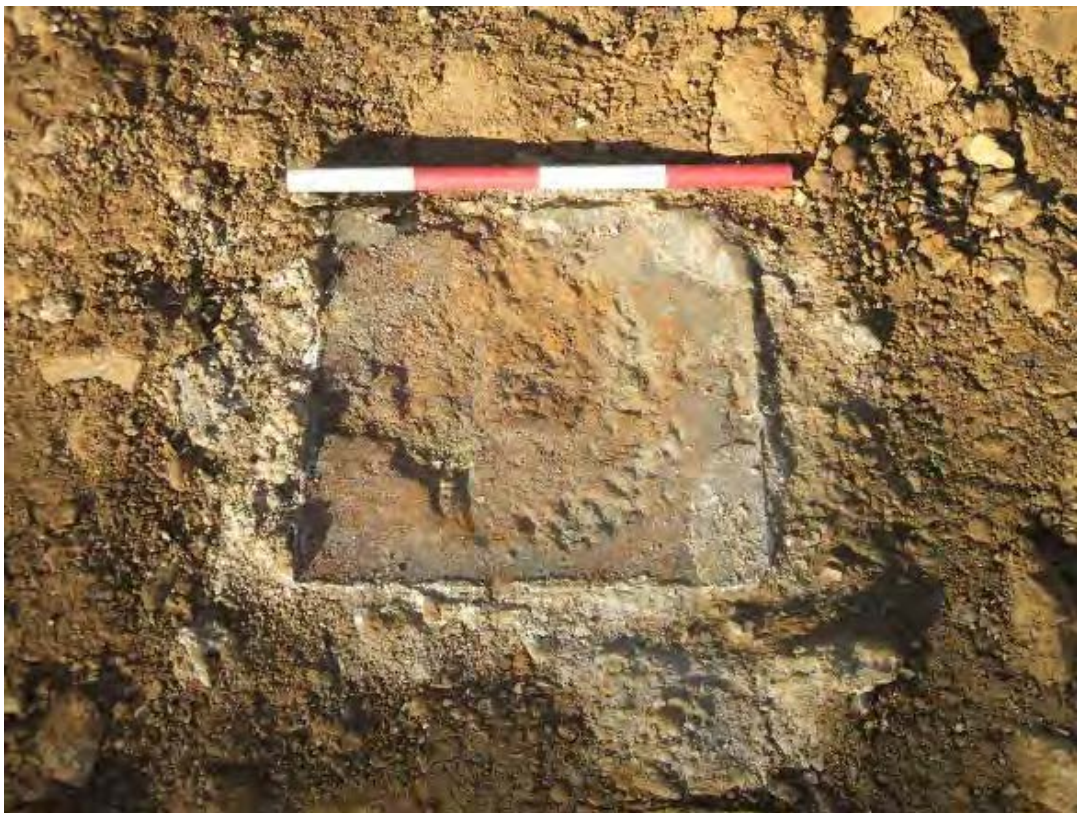
One of the ten square bollard bases forming a line adjacent to the east side of the Guildhall, probably dating to the early 20th century and set in 18th to 19th-century make-up deposits Fig A2.48

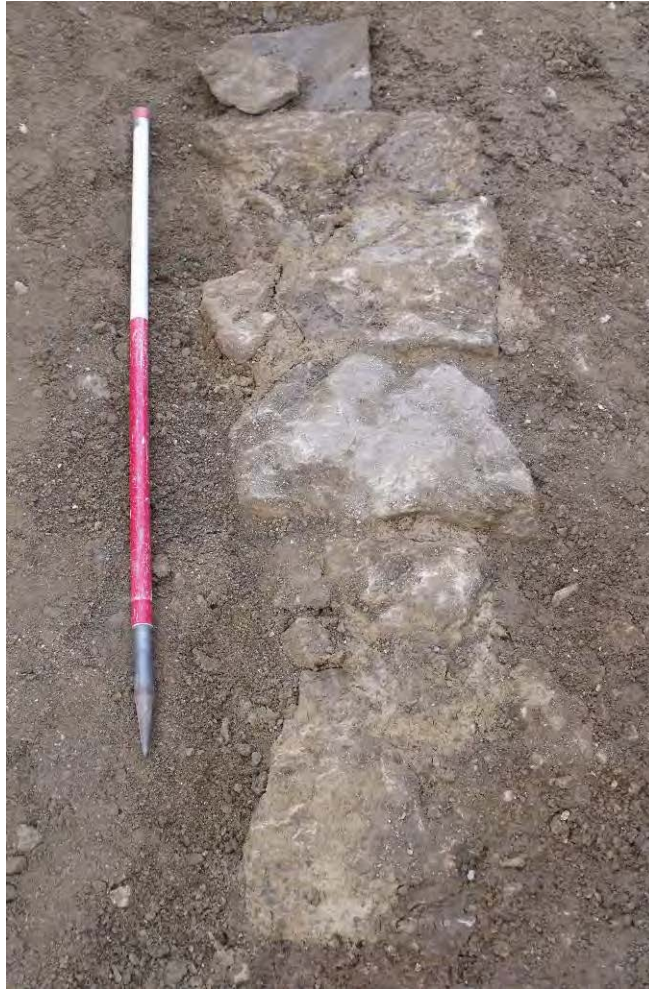
Building 5, Stone wall [1779], overlaid by recent gravel make-up (1780),
looking north Fig A3.4

Stone wall [1779] was 3.0m south-east of brick floor [1772] and 4.0m from the churchyard wall on a similar north-south alignment. The wall was 1.7m long and 0.3-0.5m wide, with facing stones on the east side, but truncated on the west (Fig A3.4). It was composed of roughly-worked blocks/slabs, 250-450mm, with smaller sub-angular packing stones, 50-200mm, mainly along the west side. There were at least three courses of wall stone, bonded with a firm yellow clay. The wall was bounded by a 0.4m thick layer of red-brown gravel mixed with sandy clay (1780), overlaying a thin grey clay loam layer (1783), 0.10-0.15m, sealing the top of an orange sand/gravel deposit (1784). Layer (1783) contained a single sherd of common industrially produced 19th-century pottery, suggesting these were backfill or make-up layers, most likely of recent origin.

The wall was possibly the remains of one of the early buildings that survived the later 19th-century brick structures and cellar construction.

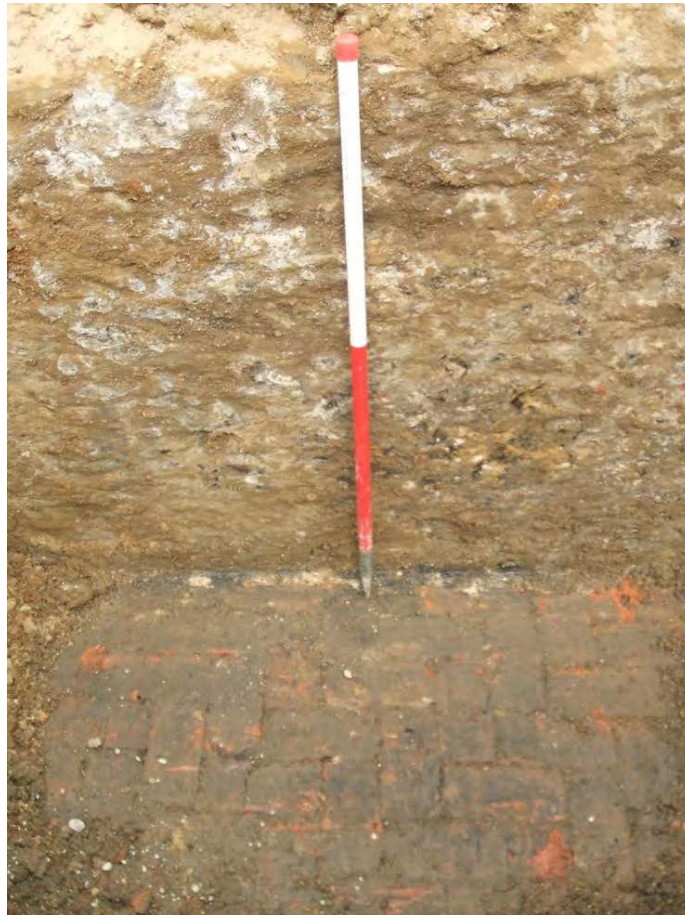
North stone cellar wall [1368] and brick floor [1369], laid in herringbone style, Building 7, Cellar 2 , looking north
Fig A3.10

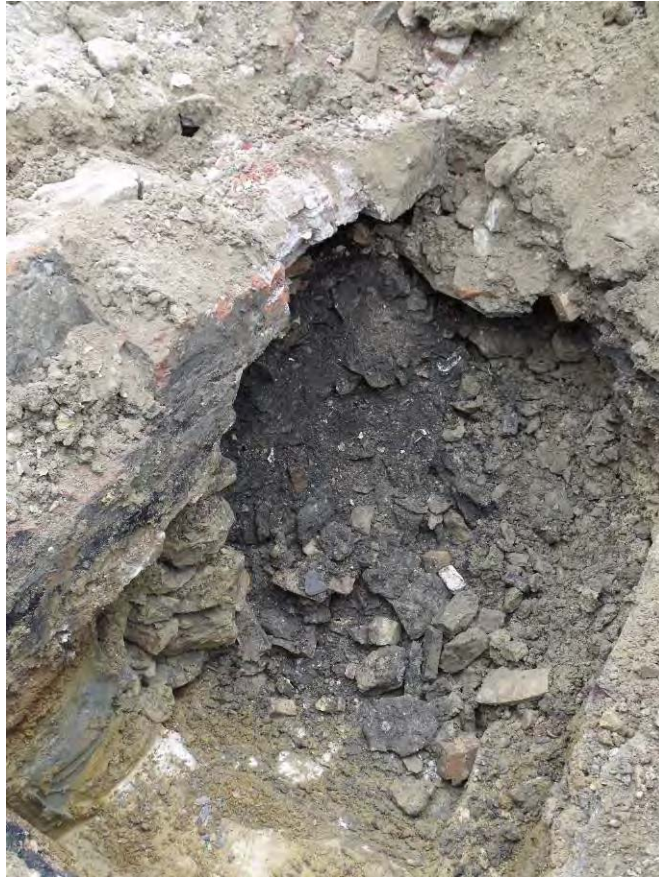
Brick cellar wall [1786] undermined by quarry cut [1785]; wall is supported on the natural gravels and clay, but also by a column of quarried limestone blocks (1787). Building 7, Cellar 3, Trench 55, looking north-east Fig A3.11

The lower part of the brick wall had been broken through, with the extension of the quarry into Cellar 2 creating a hole at least 1.6m wide and 0.6m high, no doubt to

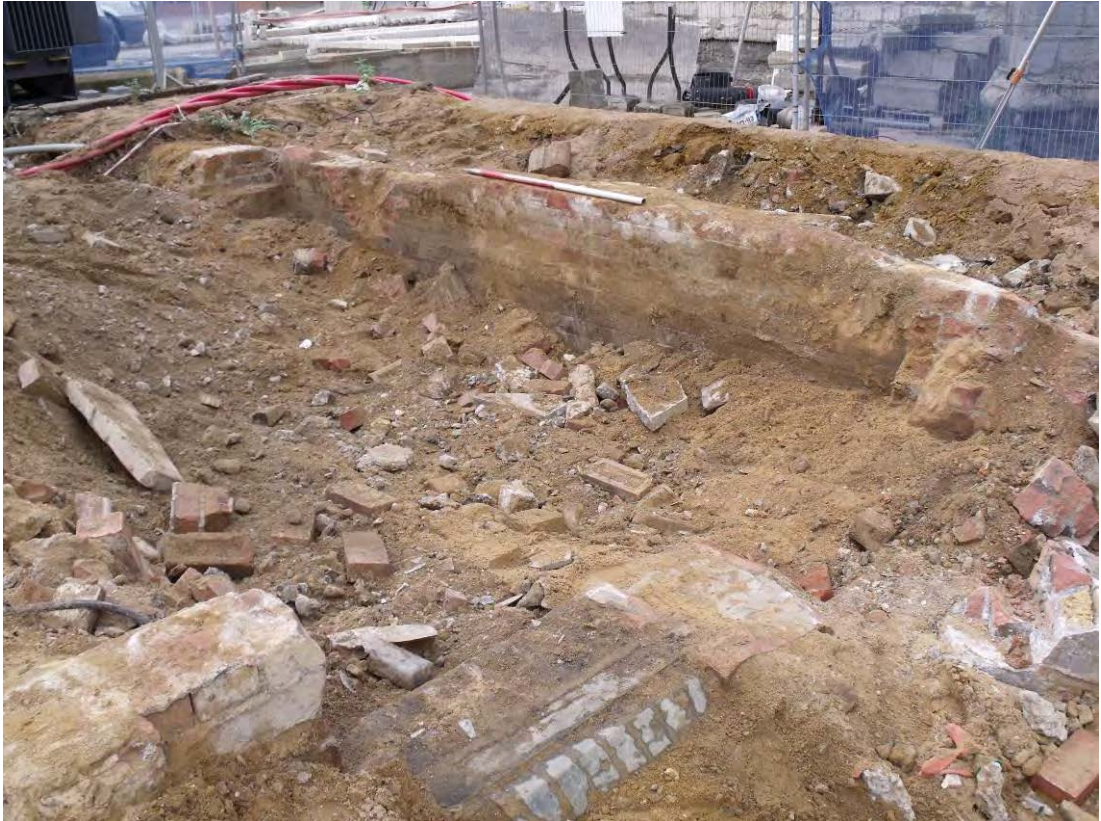
West brick cellar wall and north cellar wall/stairwell wall [1771]/[1776], with the brick window ledge [1775] (foreground), Building 8, Cellar 4, looking south-west Fig A3.12

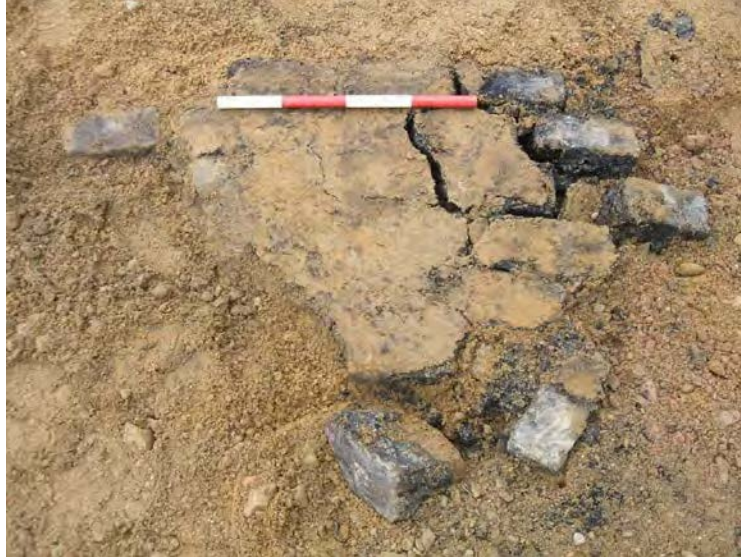
East side of the toilet block, 19th-century granite sett surface (1473), surfaced with tarmacadam, looking west Fig A3.13

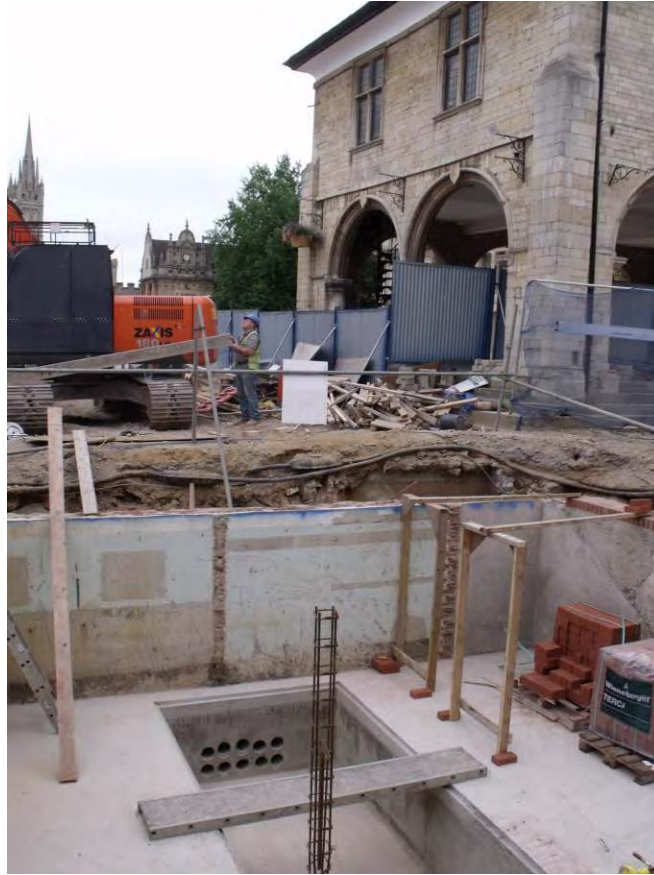
Underground toilets, during conversion into the electricity sub-station; the floor deepened to accommodate the transformer, looking south-east Fig A3.14

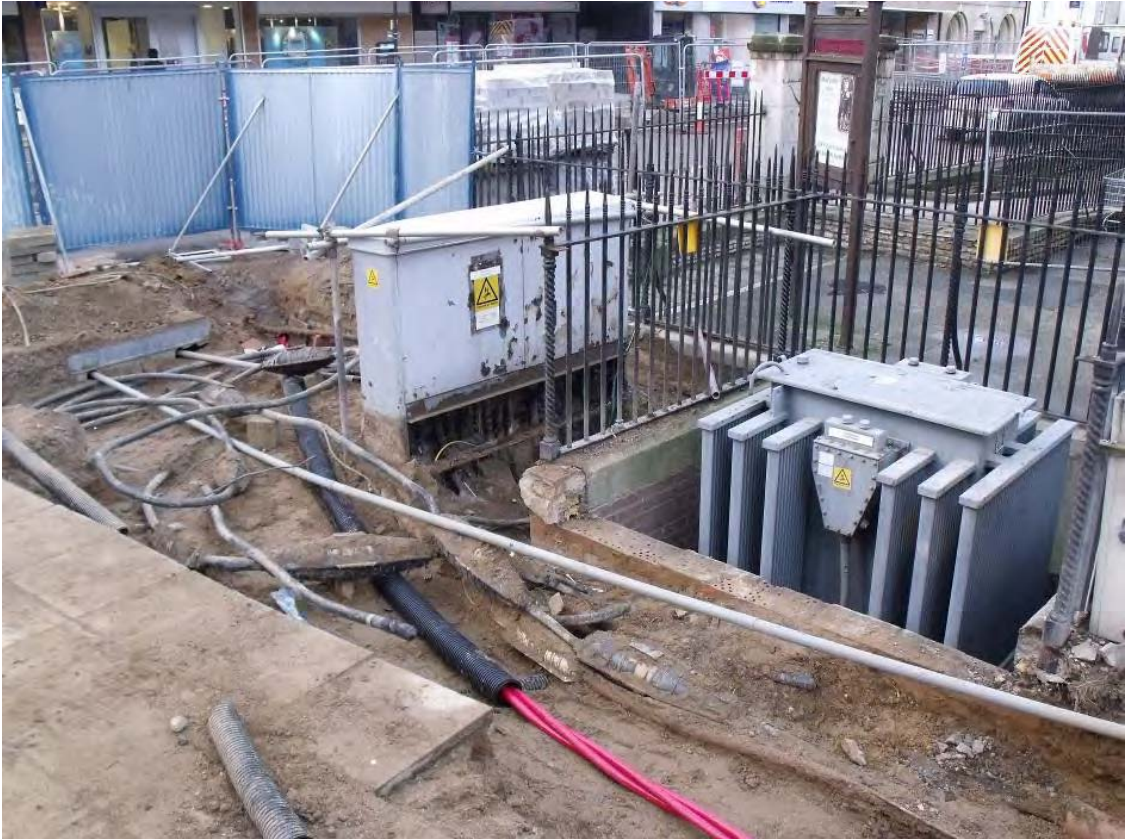
Sunken electricity transformer, before its relocation to the converted toilet block, looking south-west
 Fig A3.15

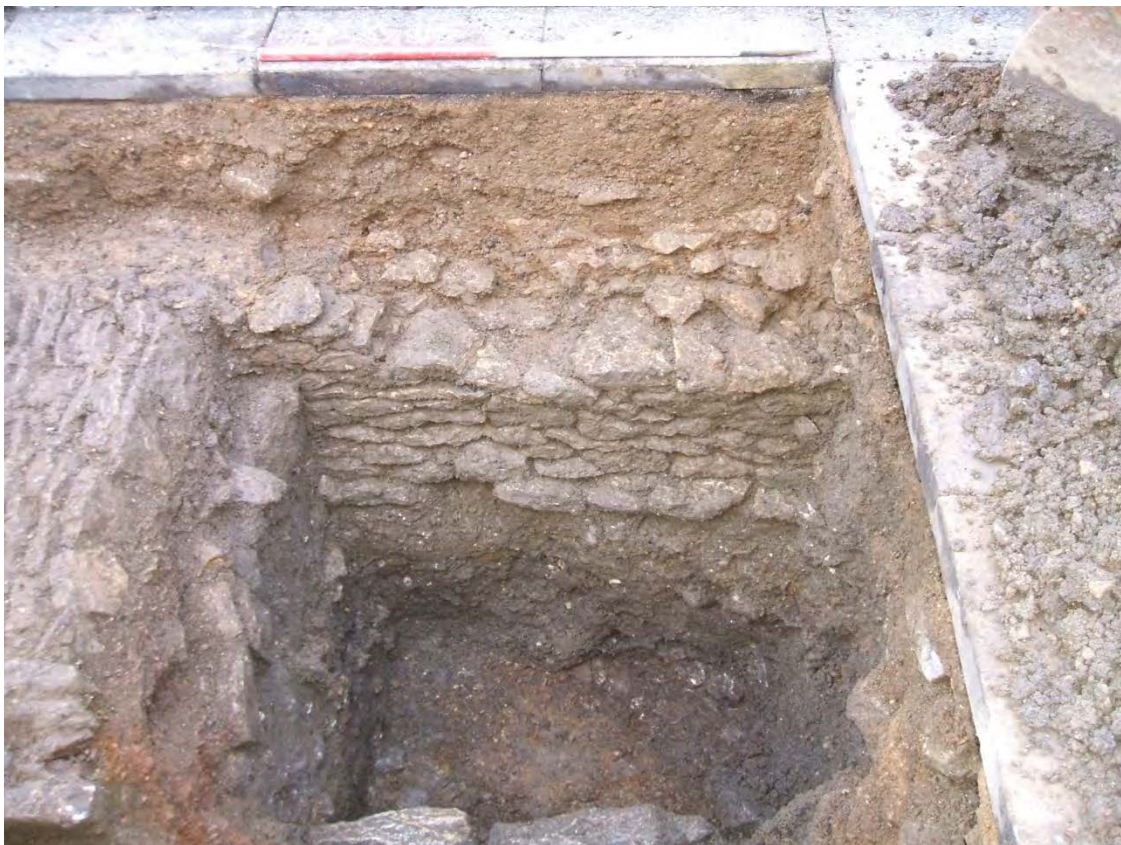
Fig A4.3

Early churchyard wall [611], Trench 6, looking north
