**An Archaeological Investigation
of the Historical Development of
Cathedral Square, Peterborough
November 2008 to August 2011
Appendices: The Excavated Evidence**

Report No. 16/105

Site Codes: PCSWB09, PCS09, PCSF09, CATSP08

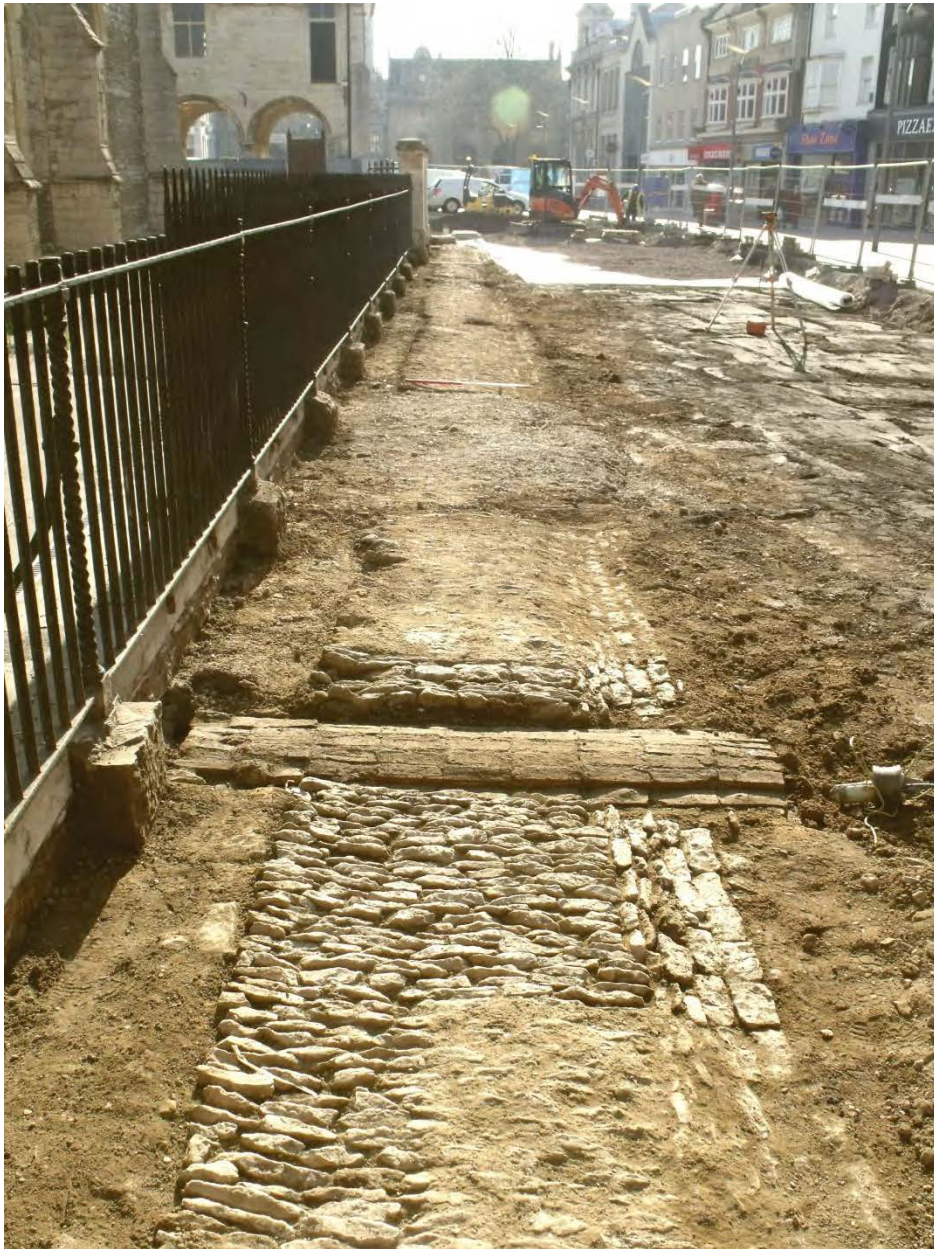
Fig A4.5

18th-century pitched-stone surface cut by brick culvert, looking east

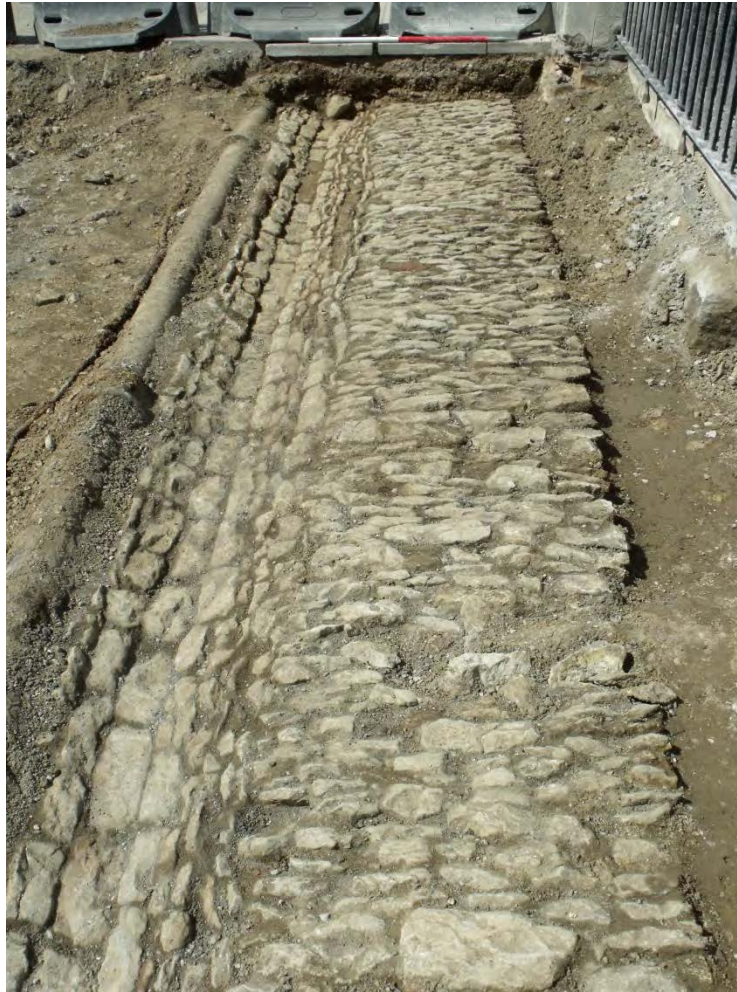
The late 18th-century pitched-limestone pavement [1642] and gutter [1643], abutted by the robber trench fill (1651) of the 15th-century churchyard wall [1650], looking west Fig A4.6

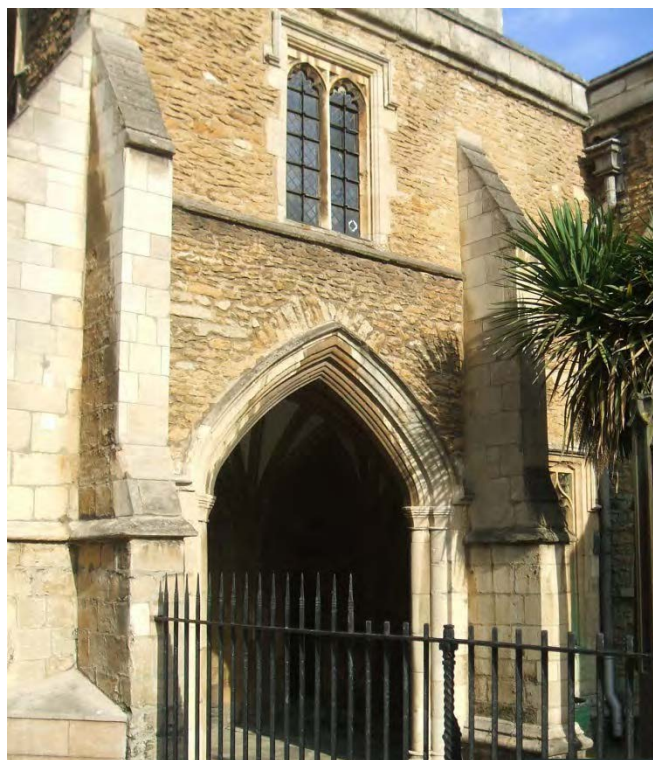
The 15th-century church porch, with the 19th-century buttresses at the south-east corner, looking south-east Fig A4.9

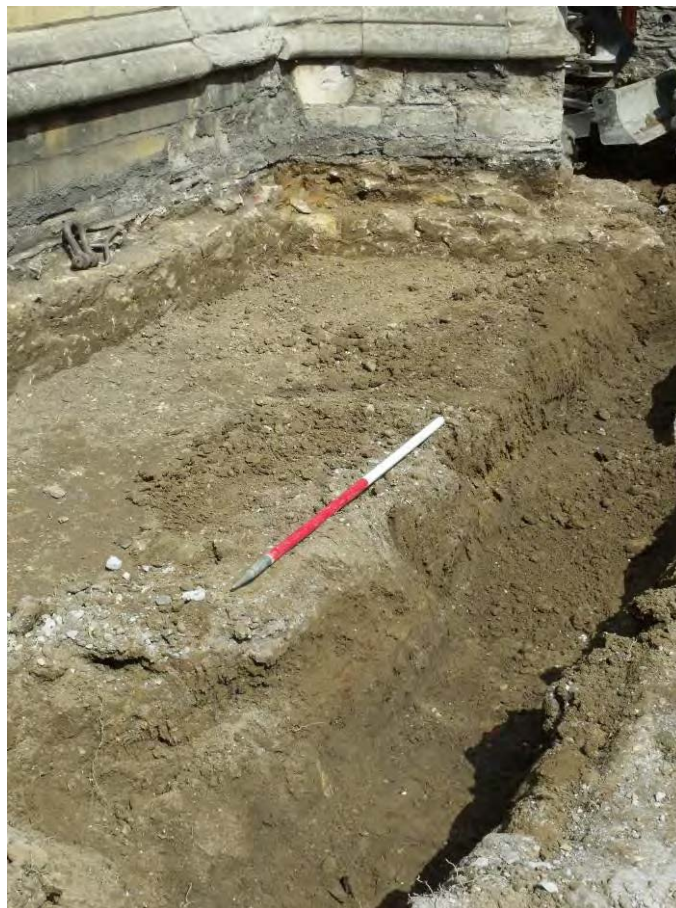
Late medieval and post-medieval make-up soils (1673), (1674) and (1675) in Trench 105 on the east side of the church, looking north-west Fig A5.4

Make-up layer (1674) was located around the south and east sides of the churchyard in Trenches 92, 93, 99, 100, 101, 102, 105 and 106 (Figs A5.2, section 136, and A5.4). It comprised a similar firm, cess-like grey-green, loamy silt, 0.10-0.28m thick, as layer (1672), including the occasional small pebble, sub-angular limestone chip, >50mm, small gravel/grit and charcoal fleck. It overlay layer (1673) and was sealed by make-up/levelling layer (1675). It was also present in Trench 82 as layer (1533), overlaid by make-up deposit (1536).

As mentioned above this layer was introduced to raise the churchyard surface to an equitable level, although it appeared to slightly undulate, from the east of the porch in Trench 99 at 7.35m aOD to 7.48m aOD in Trenches 92 and 102 close to the south-east corner of the church, dropping to 7.23m aOD in Trench 105 on the east side.

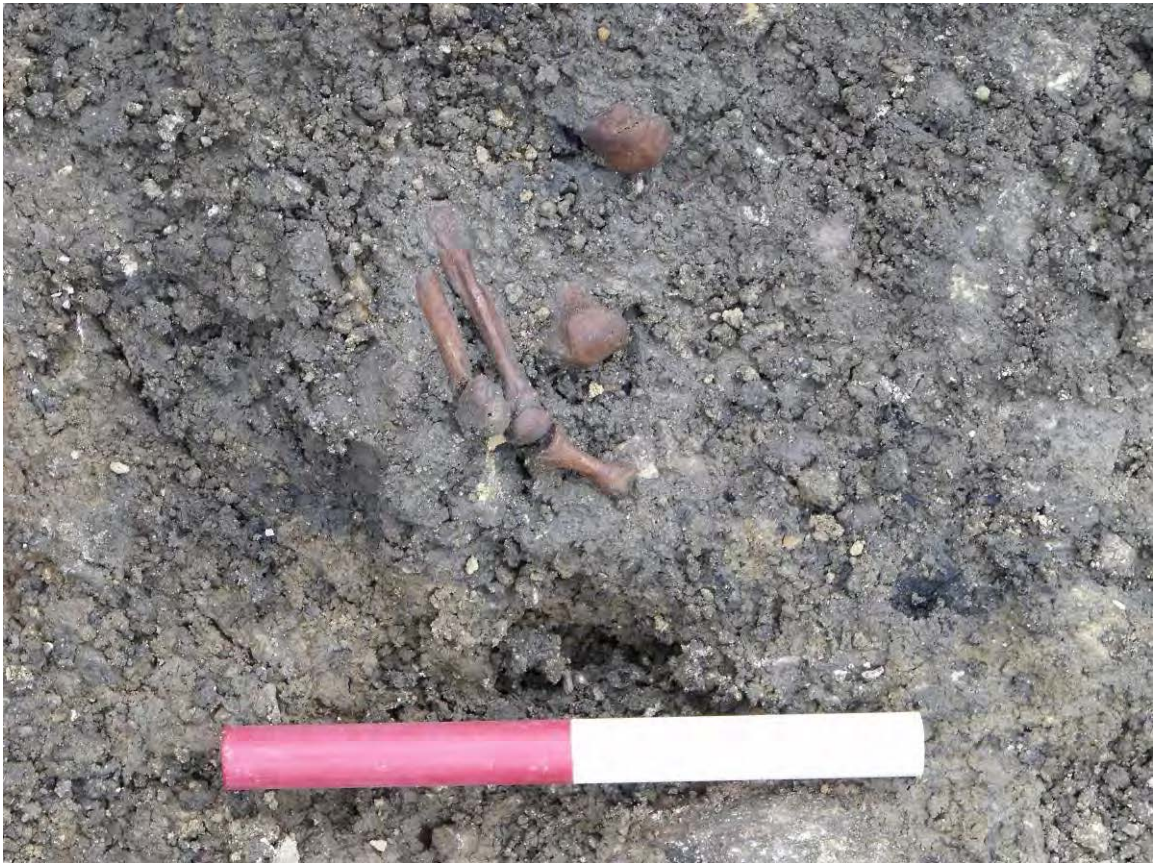
Burial HB2, looking west, showing foot bones (Scale 20mm) Fig A5.6

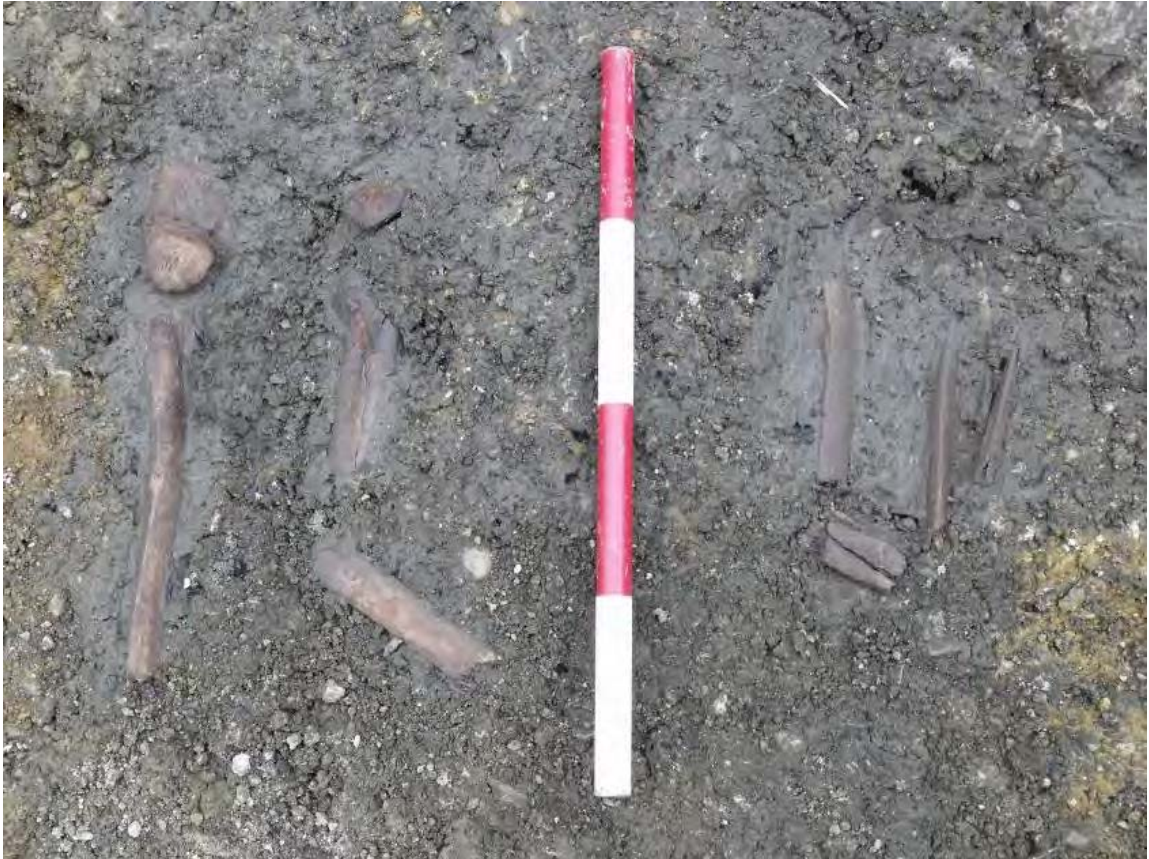
The tibiae of burials HB3 (left) and HB4 (right), looking west Fig A5.7

Burial HB4 comprised the upper part of the left and right tibias and left fibula, 150-220mm long, truncated just below the knees (Fig A5.7). The legs lay parallel, but the right tibia was broken in two and the lower piece was disturbed, similar to Burial HB3.

The surviving bone in both burials were in good condition, but there was some possible trauma to the back of the right knee in Burial 3. The small size of the bone for both burials suggests they were juveniles and as they were buried together they were probably siblings, that had died under similar circumstances.

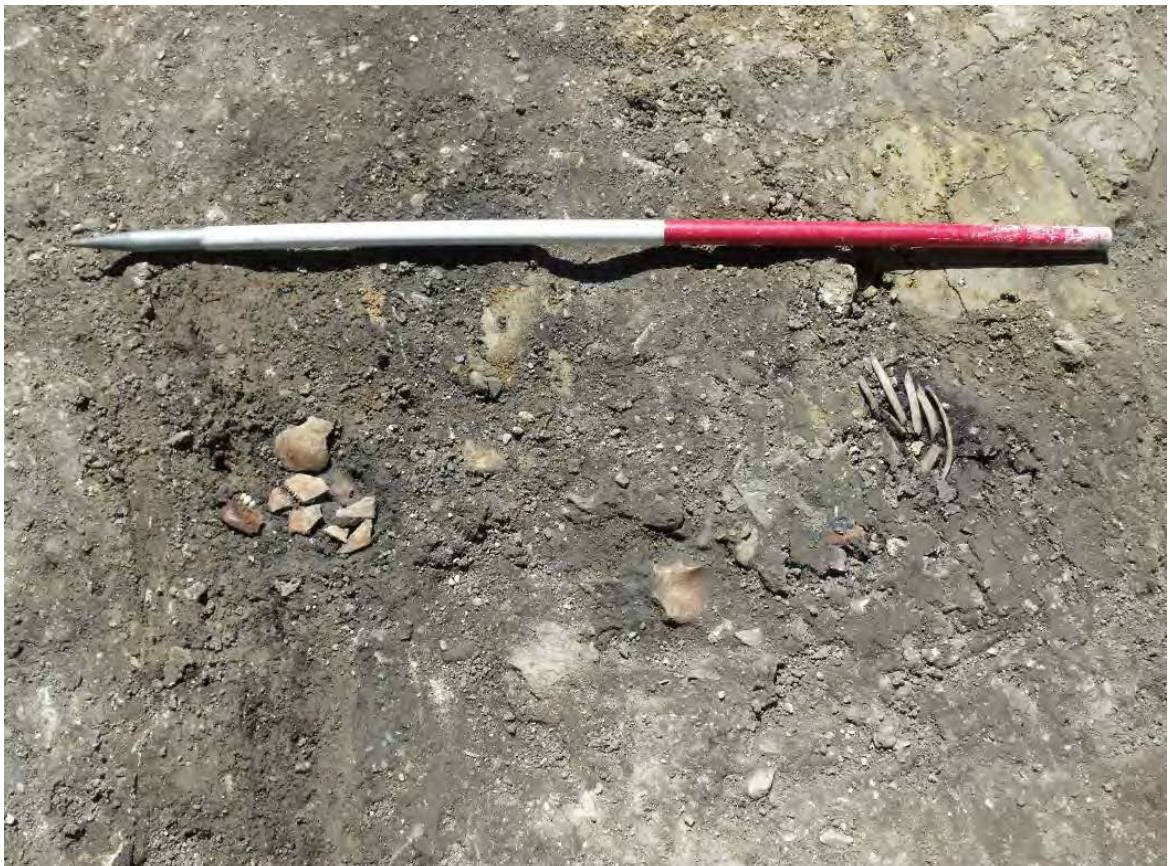
The in-situ ribs (right) and pelvis (centre) of burial HB5, with displaced and relocated skull fragments in the area of the legs, looking south Fig A5.8

Approximately six of the right ribs, the left pelvis and fragments of the skull and lower jaw were exposed during the excavation. The ribs and the pelvis lay *in situ* and in fairly good condition, but the skull and jaw were fragmented and lay in the approximate position of

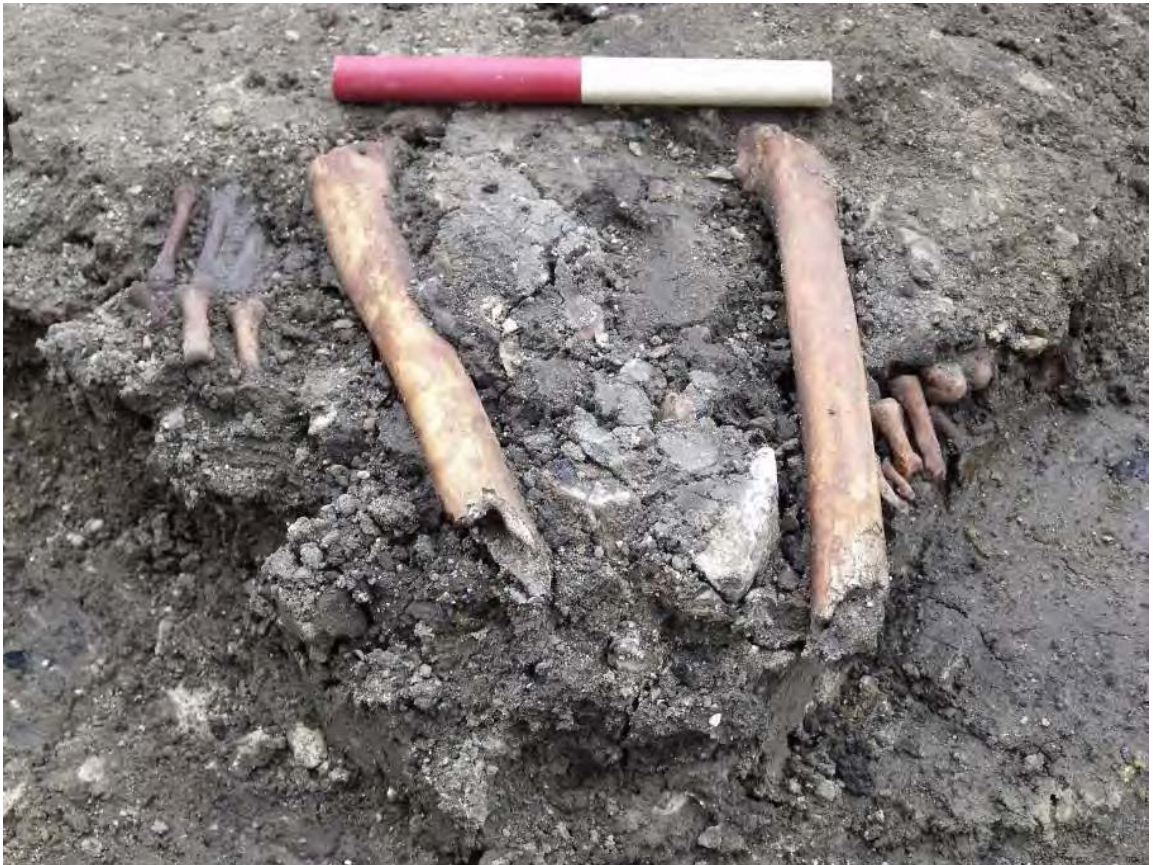
The femurs of burial HB6 and the underlying feet of burial HB7, looking west Fig A5.9

The burials directly overlaid one another on the north edge of the grave area (1739), but no grave cuts for either could be discerned. Upper Burial HB6 only consisted of the left and right femur, laid in a supine position, lying at 7.63m aOD, but truncated below the hip joints by service trench cut [1547] and above the knee joints by the modern church wall trench. The remaining bones were 220mm long and 30mm in diameter, converging towards knee joints. The bone was in good condition and their short length and close proximity to each other suggests this was also a juvenile burial (Fig A5.9).

Only the left and right feet of Burial HB7 were visible, 0.25m apart at 7.48m aOD, appearing on the respective sides of the femurs of overlying Burial HB6 (Fig A5.9). The metatarsals and the phalanges of the feet could be seen and appeared to be in good condition. It was possible the feet were from two separate burials.

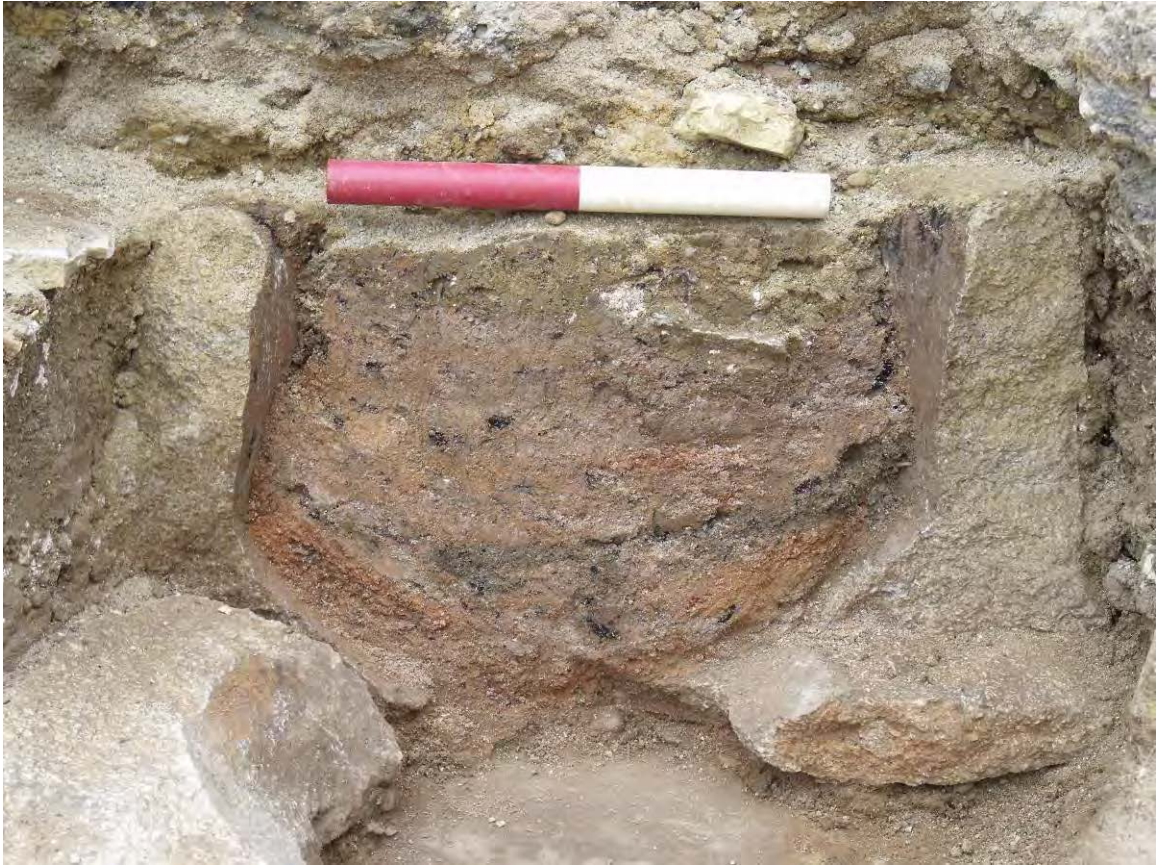
Fig A5.11

Pit [1763] containing reused medieval mortar (1762)

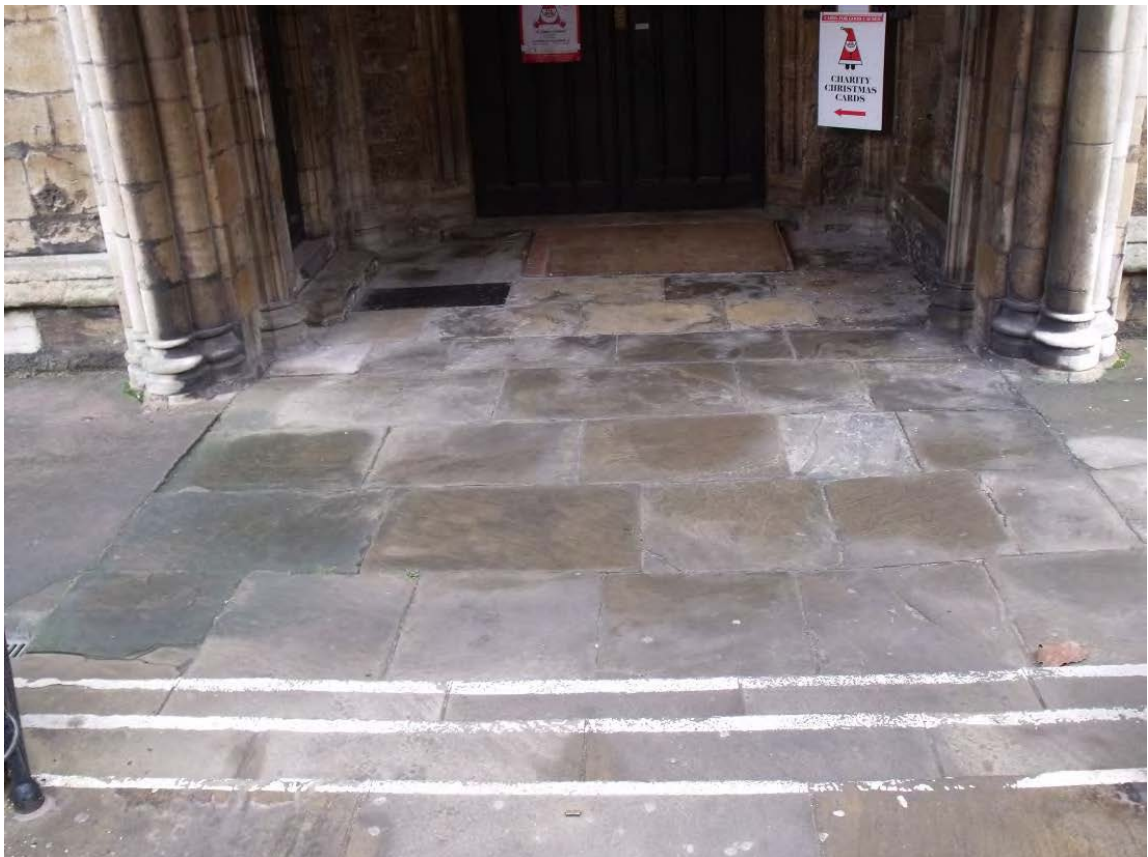
The steps from Church Street on to the flagstone surface, below the south church porch, looking north Fig A5.12

The flagstone surface below the south church porch formed an area 4.0m by 5.5m (22m²) at 7.86m aOD while the smaller north porch area was 1.5m by 3.5m (5m²) at 7.71m aOD. The flagstone pavement at the west door of the church extended west across towards the churchyard wall, 6.0m by 6.5m, with a path to the north-west corner of the churchyard, 2.0m by 7.0m, leading to the steps and the gateway. The flagstones occupied an area of 54m², at 7.79m aOD in front of the west door to 7.88m aOD at the north end of the flagstone path. At the north-eastern corner of the churchyard the flagstones enclosing the coal hole cover were less than 1.0m² and lay at 7.84m aOD.

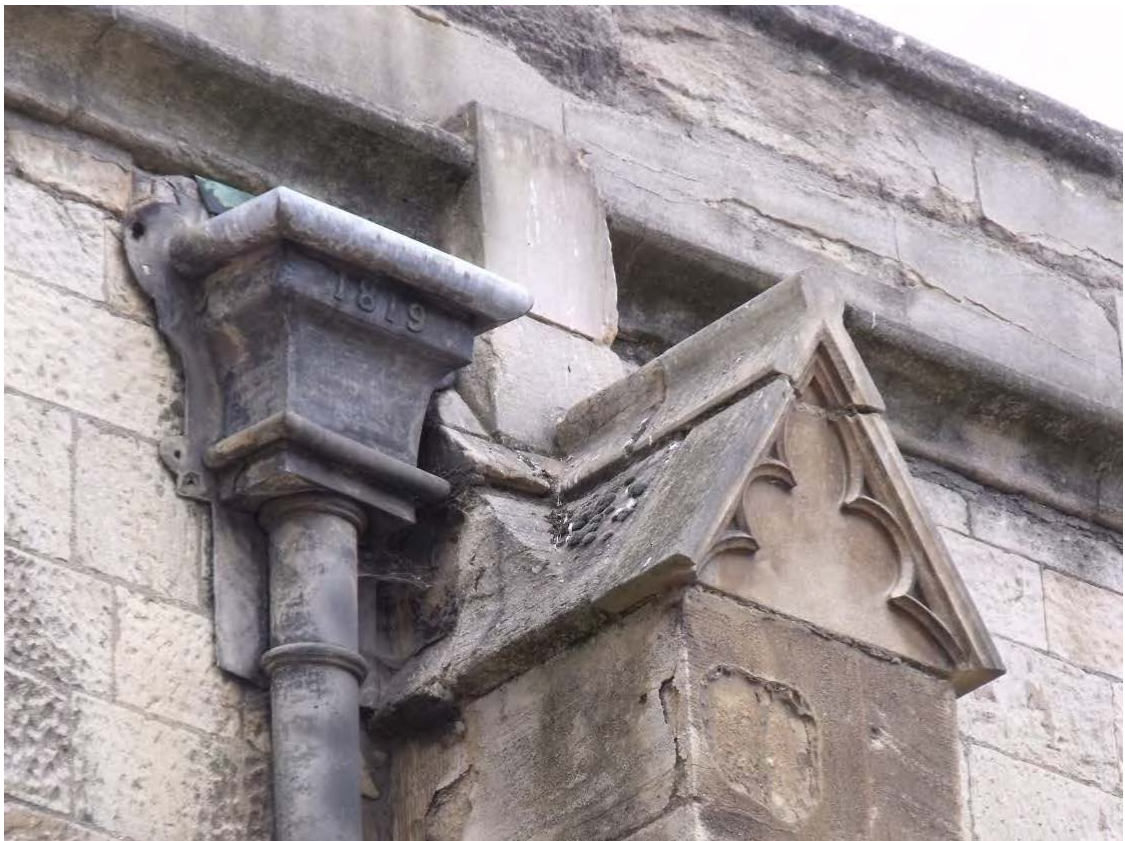
Fig A5.13

One of the 1819 lead rainwater chute outlets, located along the south side of the church, looking north-east

Part of the early work included the existing lead downpipes of the church, which were officially marked 1819 on their chute outlets at the roof level. Some of the pipes at the churchyard level displayed interesting graffiti, the handiwork including people's initials, surnames, decorated gloves and a figure wearing top hat and tails in a pugilist pose, including a date of 1831. The graffiti appears to have been created by scoring or a succession of indents from the point of a knife.

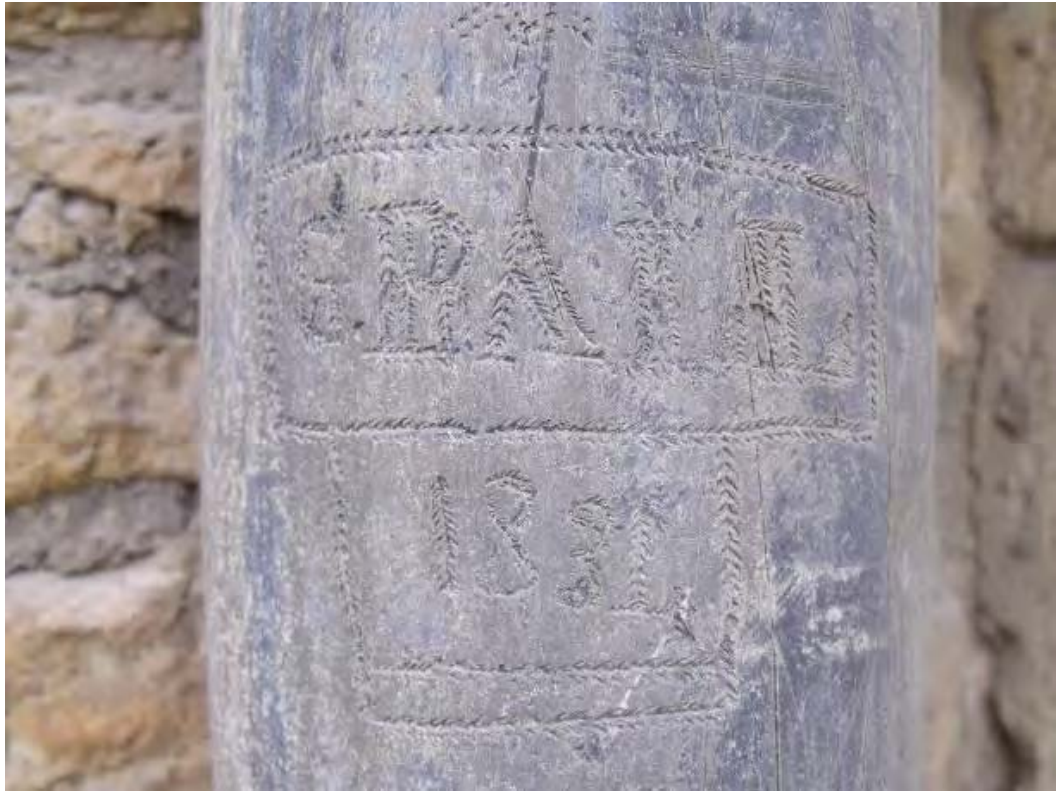
Graffiti on 19th-century lead piping on the church, with name Grail and a date of 1831 Fig A5.14

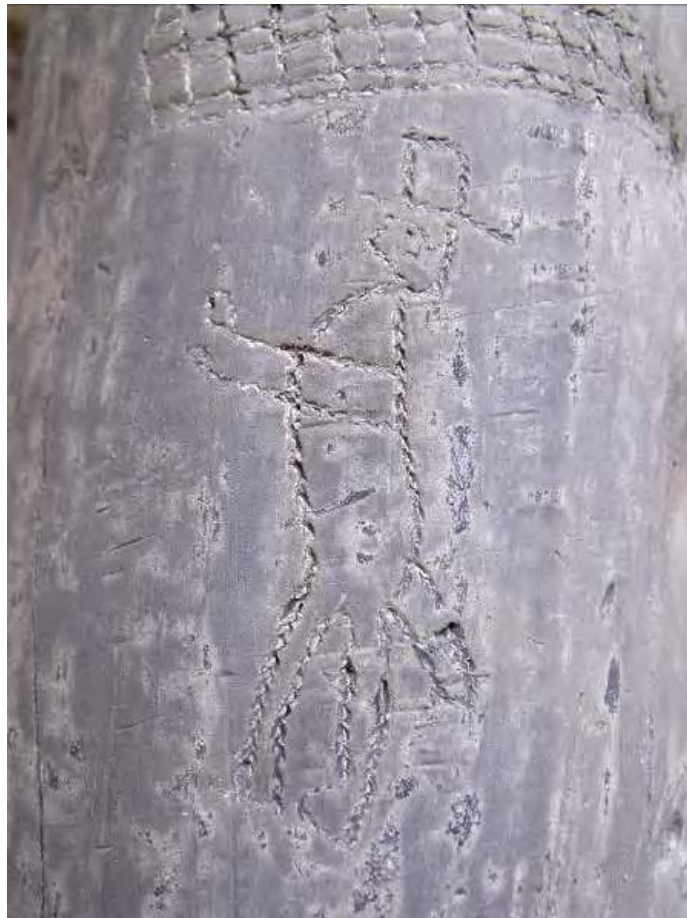
Graffiti on 19th-century church lead piping of a figure in top hat and tails, in a pugilist pose Fig A5.15

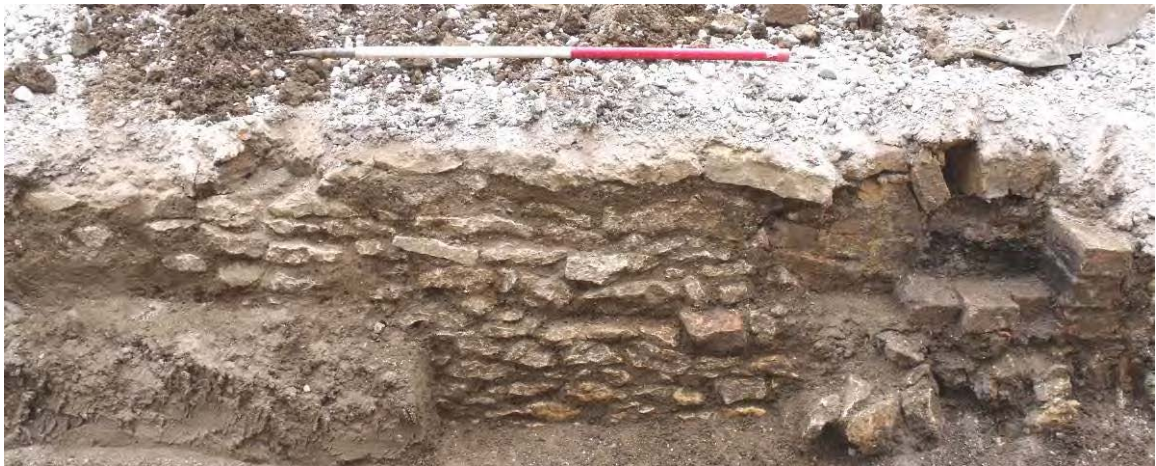
North face of churchyard walls [1706] and [1705], cut by Victorian brick culvert [1707], which overlaid the 17th-century pitched-stone churchyard surface [1684]/[1686], looking south
Fig A5.16

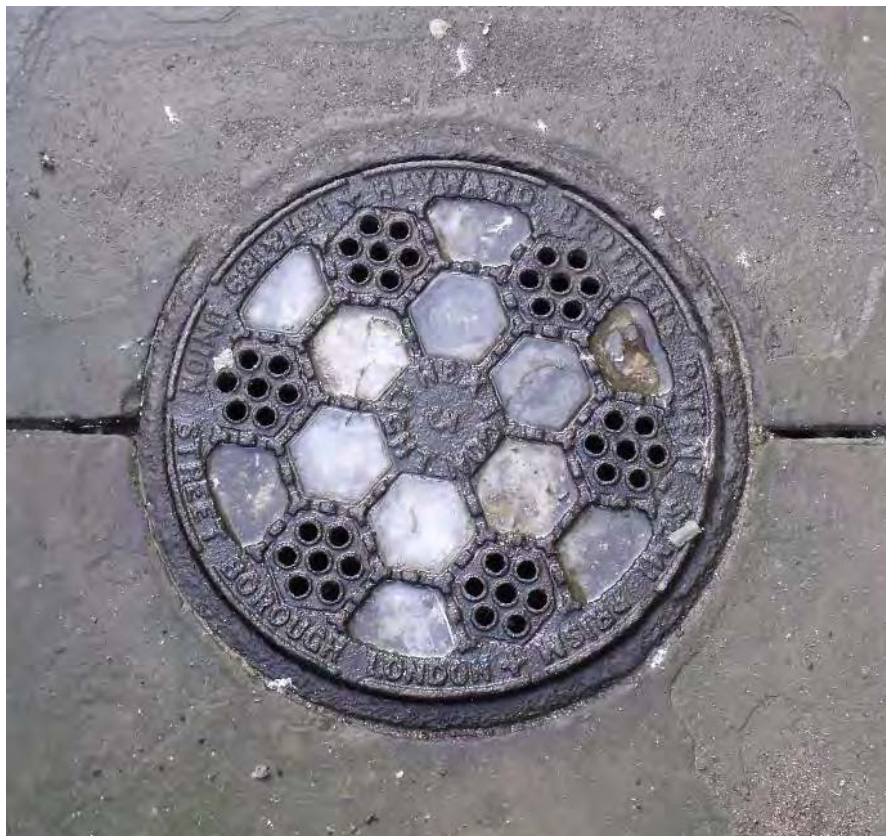
The 19th-century cast iron coal chute cover, located to the east side of the church
Fig A5.17

The boiler room and coal bunker are subterranean structures excavated in the north-east corner of the churchyard. The ground was made-up with (1766) and then capped with a concrete surface, extending at least 10.0m and 12.0m south and west respectively. There was a concrete staircase access to the boiler room adjacent to the corner of the church and a concrete ramp was constructed on the north side (a possible later construction). The coal bunker lay to the east side, which had a 19th-century cast iron and glass coal chute cover cut through two flagstones, the remains of the 18th-19th-century churchyard surface. The circular iron coal cover was cast with the maker's name of Hayward Brothers and their address of the Union Street foundry in London. The cover also had their 1871 patent for hexagonal prismatic glass fixtures that allowed light to be dispersed into dark spaces (Fig A5.17).

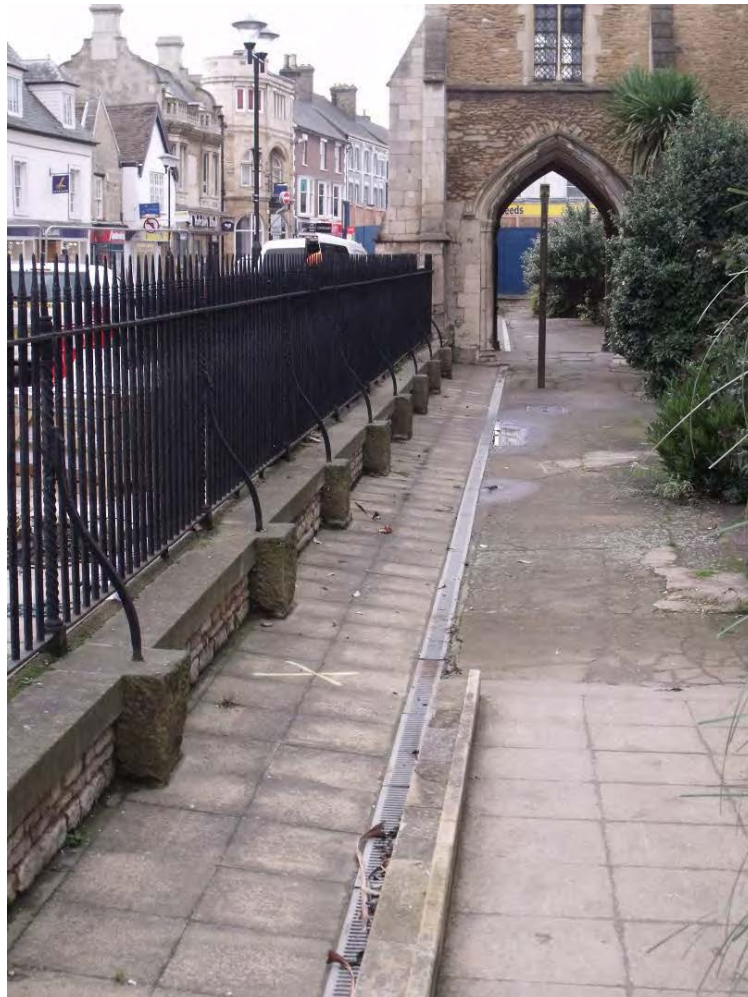
A view of the churchyard on the south side of the church, displaying the 1980s replacement churchyard wall [1516], with the limestone plinths supporting the 19th-century iron railings, looking west
Fig A5.19

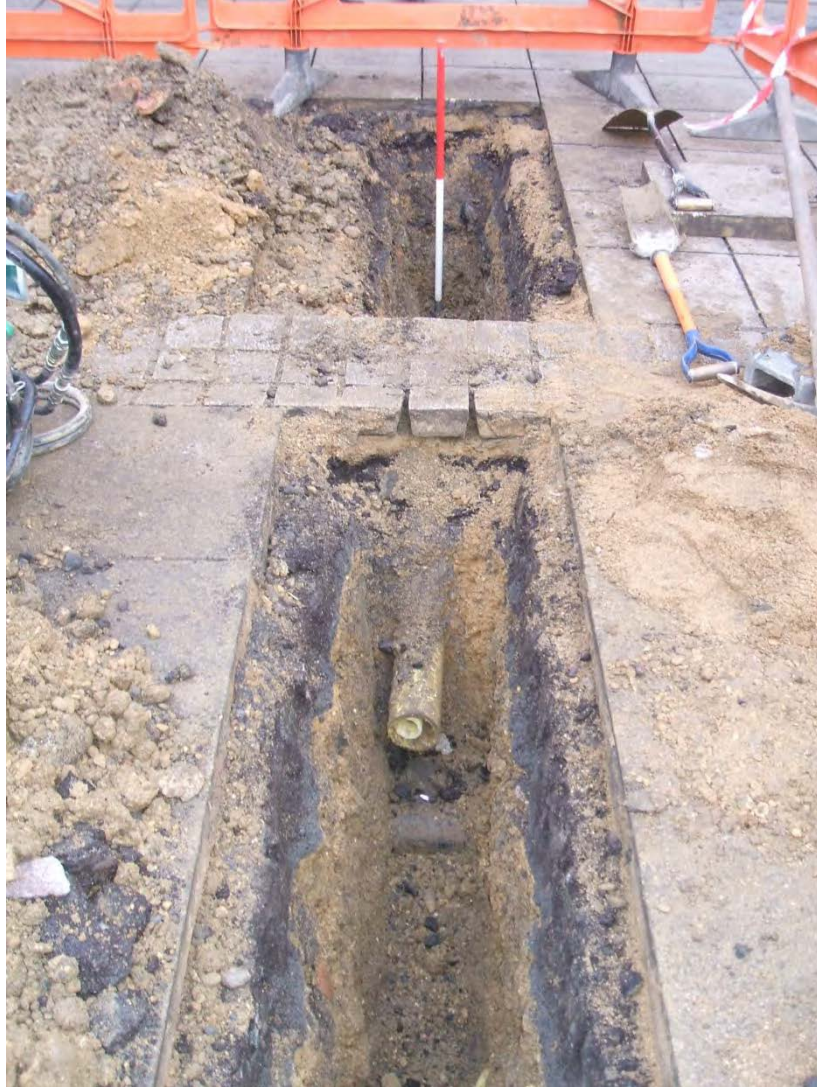
Fig A6.2

Services and dark fuel ash layer, Trench 13

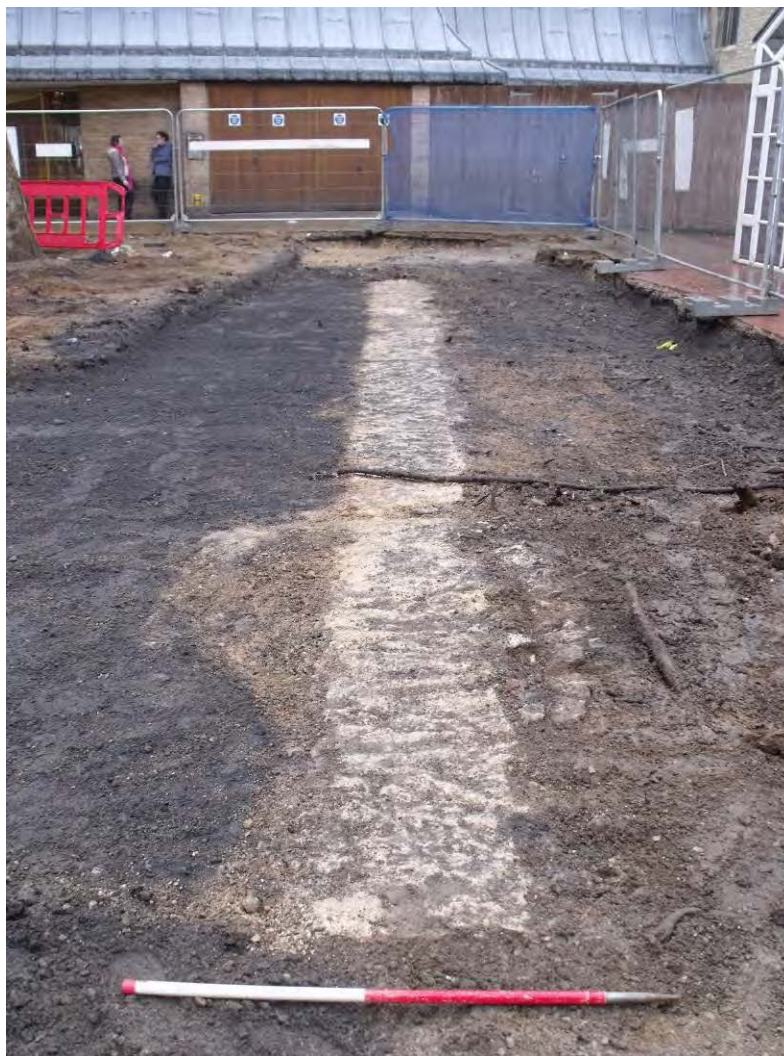
Wall foundation [1577] looking north-east, with wall [1578] visible to the right Fig A7.7

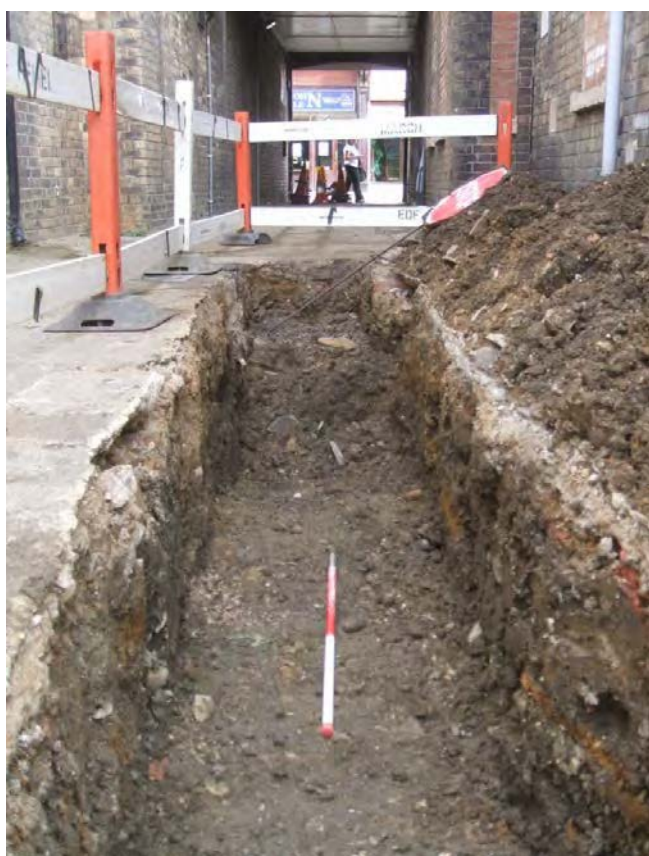
The alleyway trench looking north towards Cowgate,
with the covered frontage in the background Fig A10.1

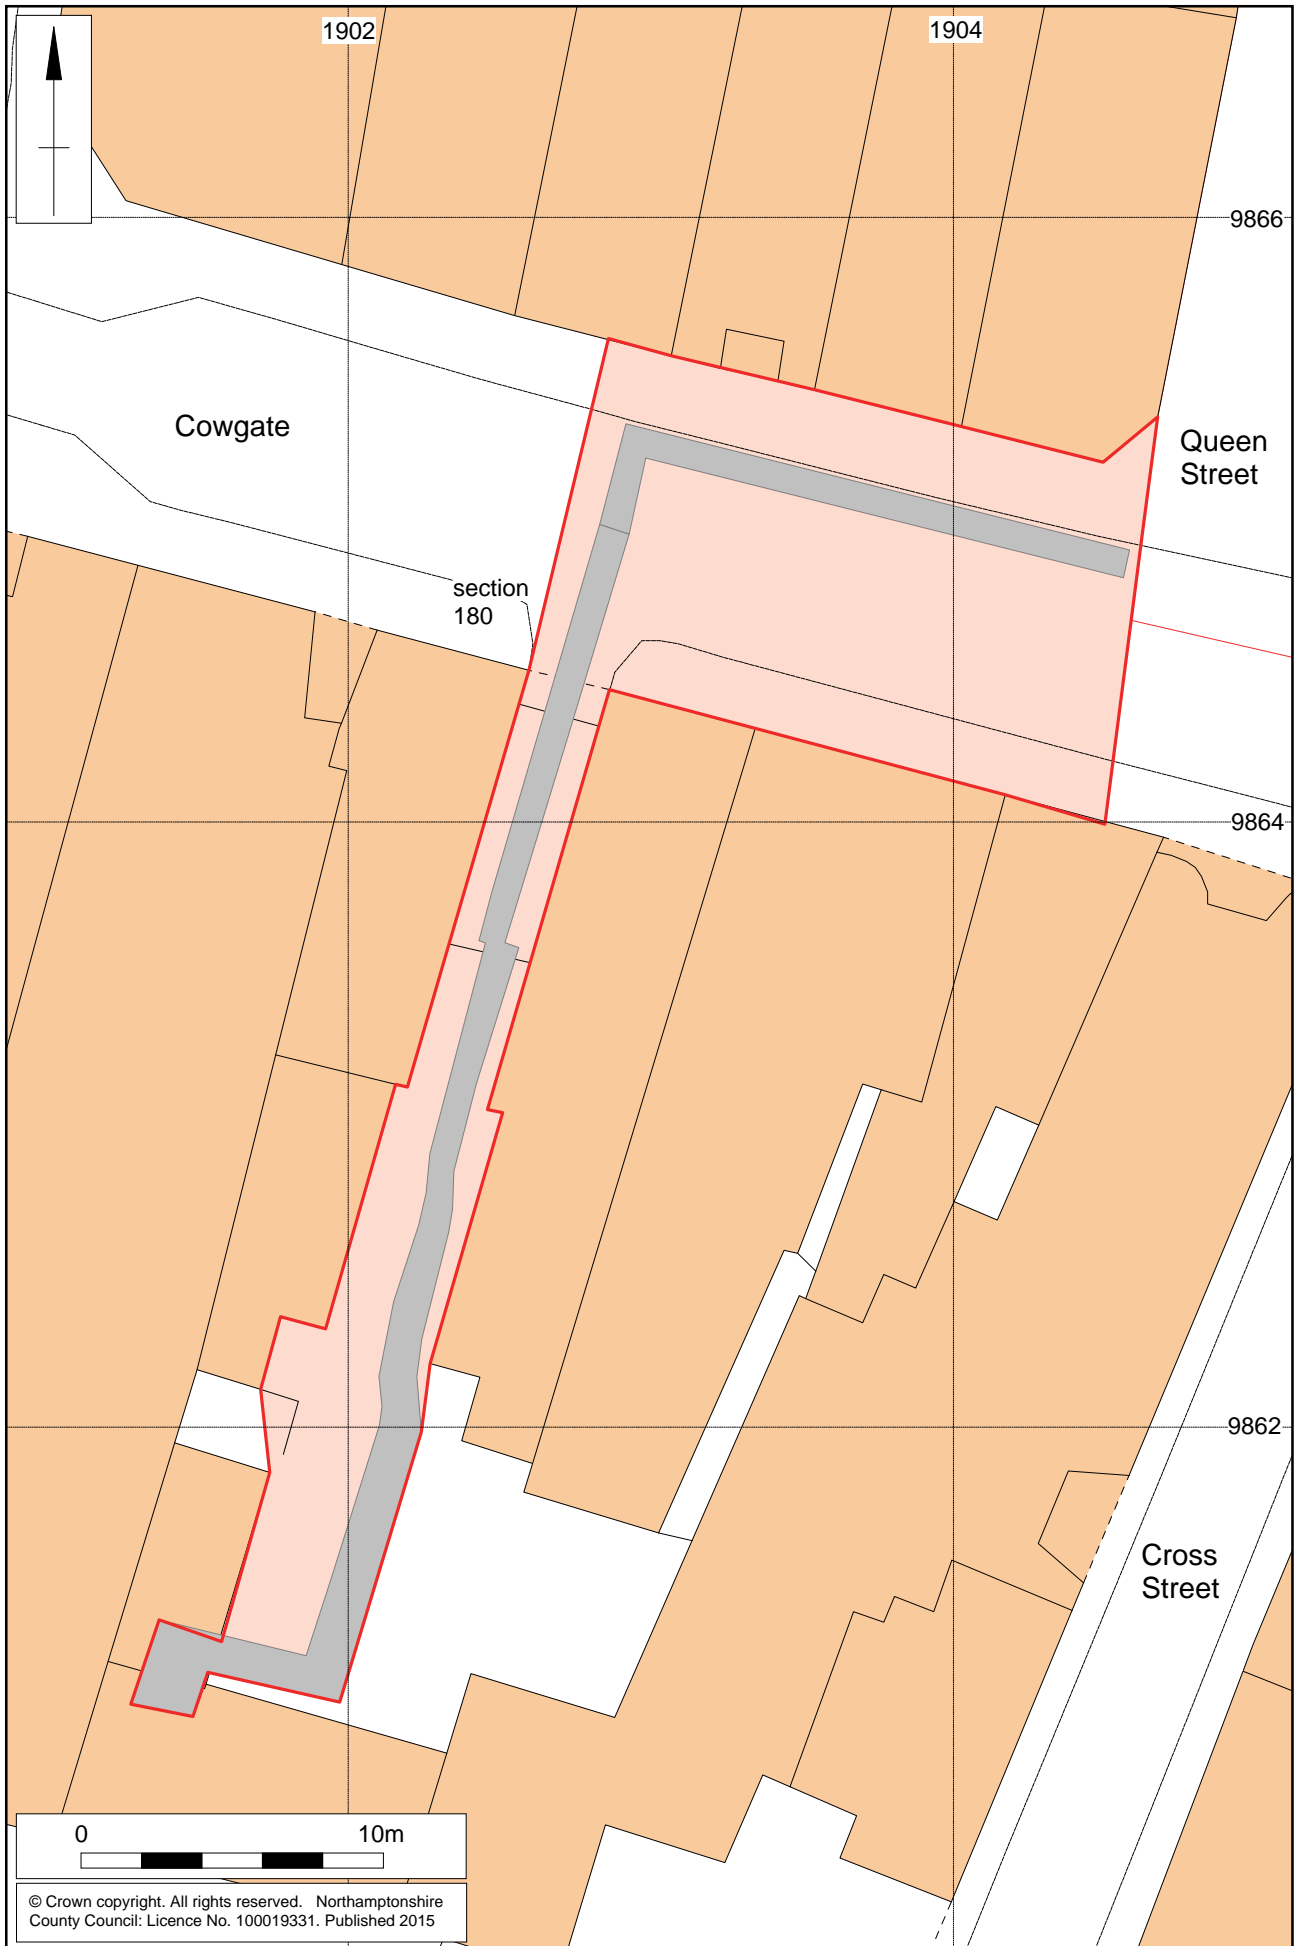
The Cowgate trench Fig A10.2

Scale 1:250
