**Archaeological observation at  
the Church of St Laurence  
Stanwick, Northamptonshire  
August 2015**

Report No. 15/160

*MOLA Northampton was invited to undertake a programme of archaeological observation at the Church of St Laurence, Stanwick, during groundworks associated with the installation of a new heating system within the church. The works comprised the lifting of stone floor slabs at the west end of the church, the reduction of ground level within these areas and the excavation of pipe trenches and inspection chambers. A number of disarticulated and disturbed human remains, a stone-capped drain and brick flues relating to a previous heating system were identified and recorded.*

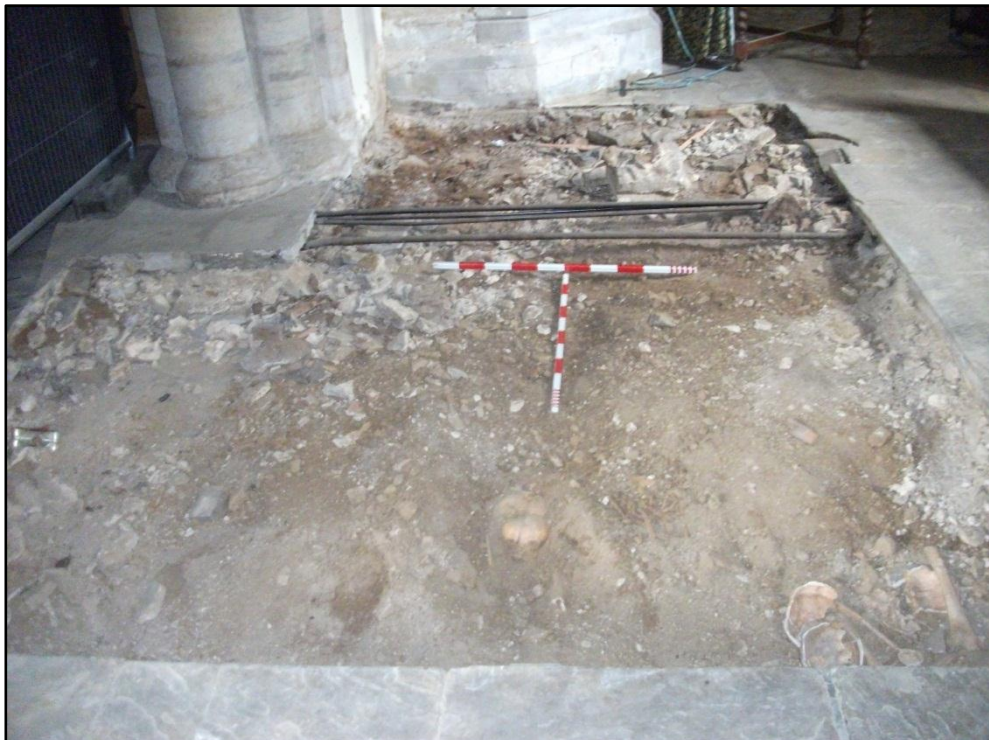
Area A pre-excavation, looking west Fig 3

Area A was positioned to the south-west of the tower (Figs 3-5). Underlying the stone-floor surface and mortar bedding was a layer of mixed limestone rubble and pale grey-brown sandy gravel, which served as a make-up / levelling layer for the floor. The area was bisected by four cable pipes crossing north to south across the western arm of the area. The area was excavated to a depth of 0.2m.

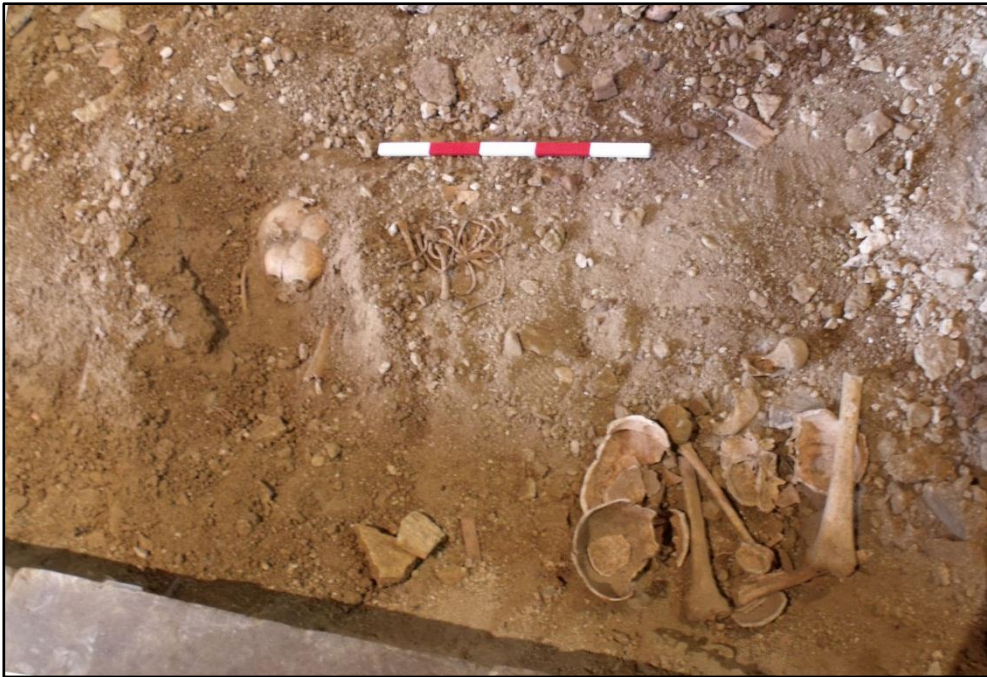
Disarticulated human remains had been identified at the start of the groundworks, and several clusters of disarticulated bones were located in the north-east corner of Area 1. These mainly comprised pieces from at least four craniums and several long bone fragments (Fig 4).

Towards the eastern end of the opened area the disarticulated remains of a juvenile burial were visible, including parts of the cranium, mandible, ribs and long bones. The age of the individual has been estimated at 11-12 years using dental eruption.

Disarticulated skeletal remains including juvenile cranium, Area A Fig 4

No other archaeological features were visible and no finds were recovered from Area A. The skeletal remains were removed from the areas of excavation for re-interment elsewhere in the church.

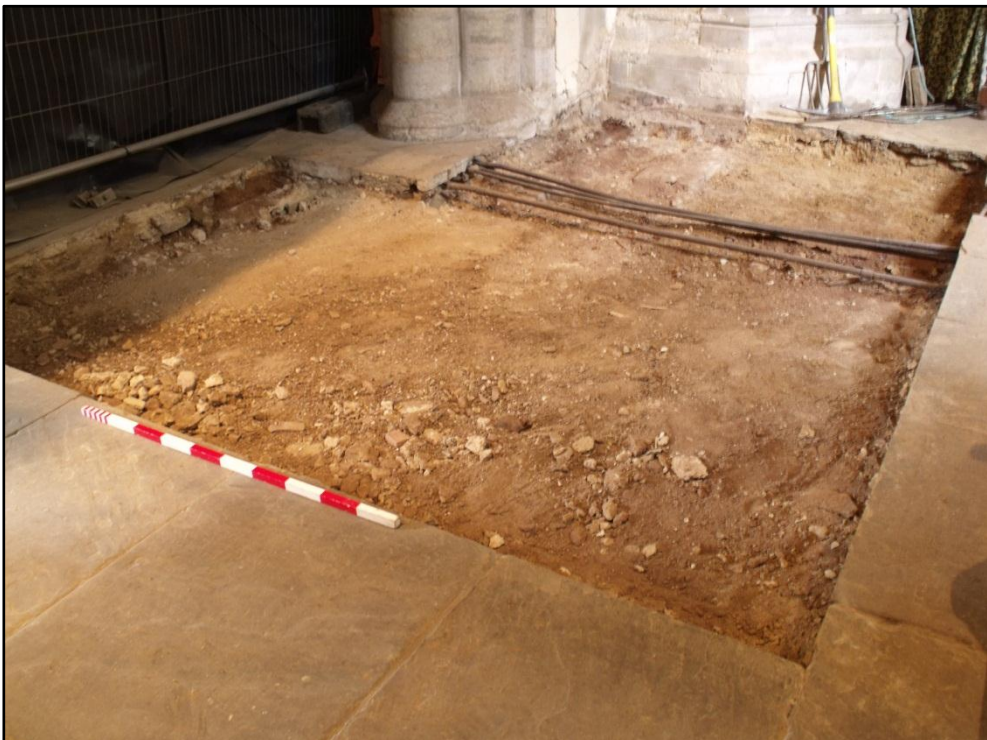
Area A post-excavation, looking south-west Fig 5

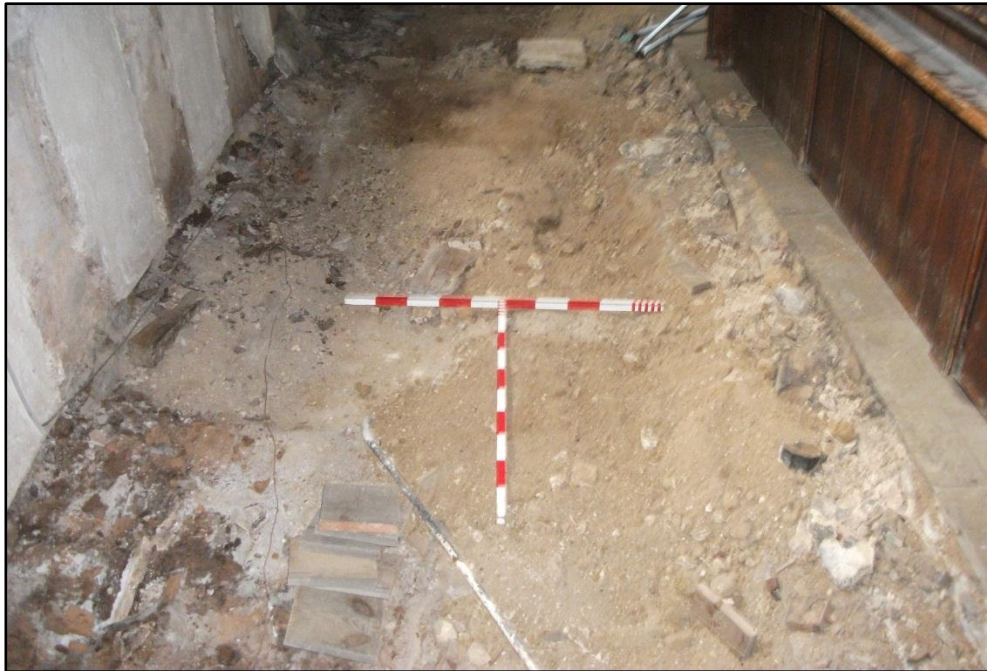
Area B was situated against the north wall of the nave. Below the flagstones and mortar bedding was a similar substrate of mixed limestone rubble, sand and gravel (Figs 6-10). The area was excavated to a depth of 0.2m. A quantity of disarticulated human skeletal material was mixed with the substrate layer, particularly in the central east end of the trench, where remains comprised a mandible, long bone and pelvis fragments (Fig 7).

Area B pre-excitation, looking east Fig 6

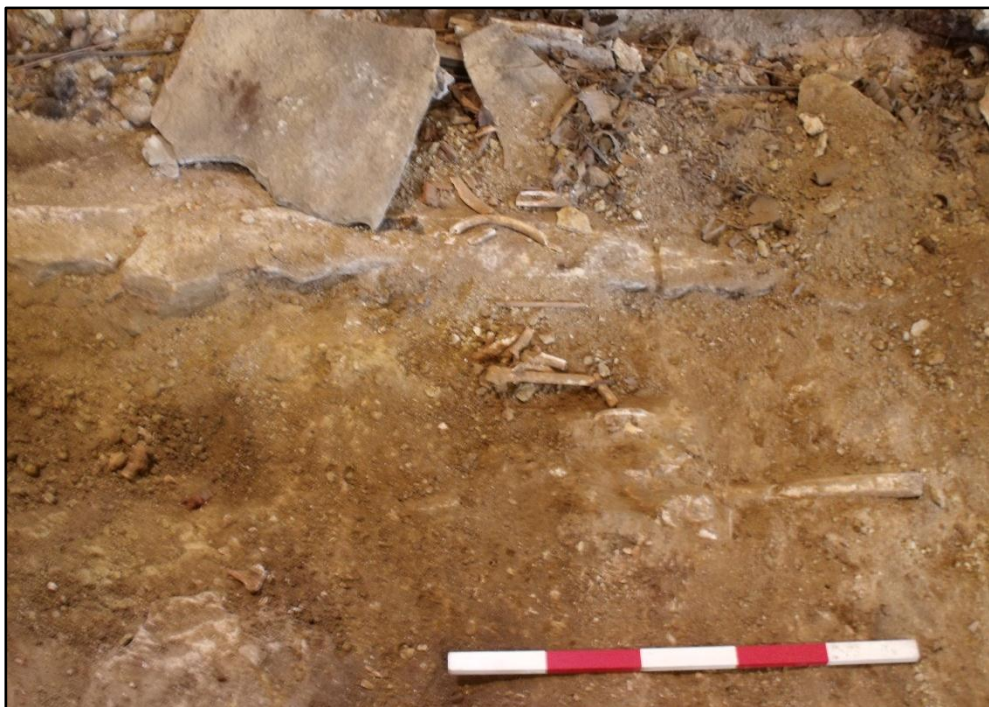
Disarticulated skeletal remains lying beside stone sill, Area B Fig 7

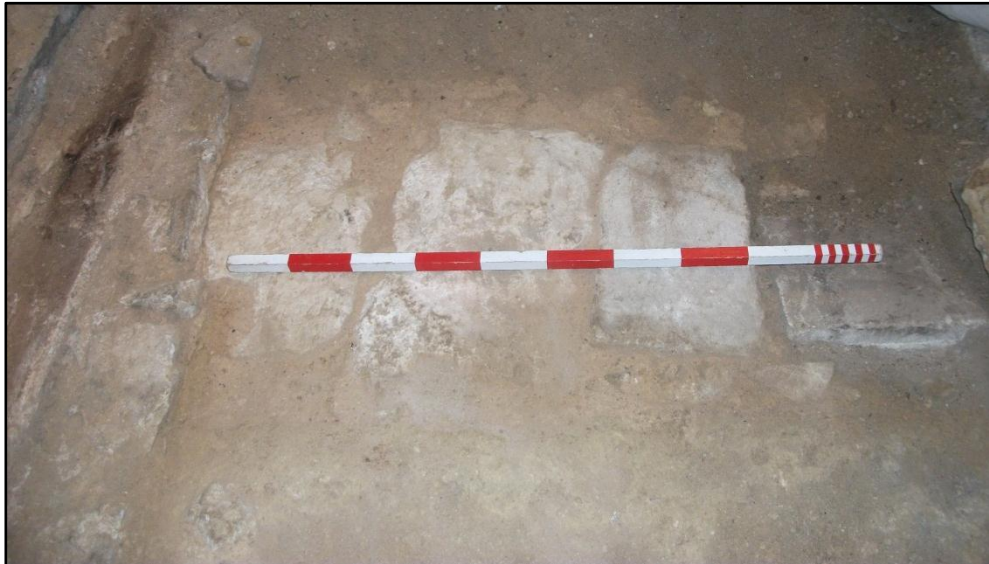
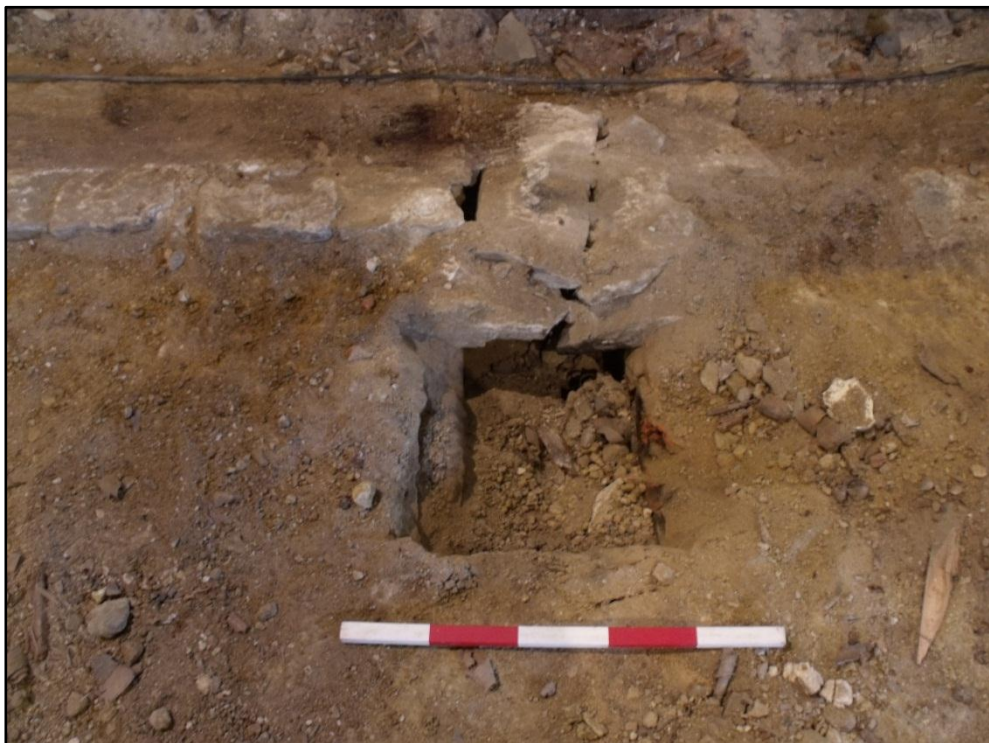
Around 1.2m from the eastern end of the area was a stone-capped drain 0.6m wide, aligned north-south (Figs 8-9). The drain was capped by dressed ashlar slabs. As it was overlain by the stone sills for the Victorian pews, the drain would seem to predate this period of church activity, and may be late medieval, or early post-medieval. No dating evidence was found.

Stone-capped drain, Area B, looking west Fig 8

Stone-capped drain, Area B, looking north Fig 9

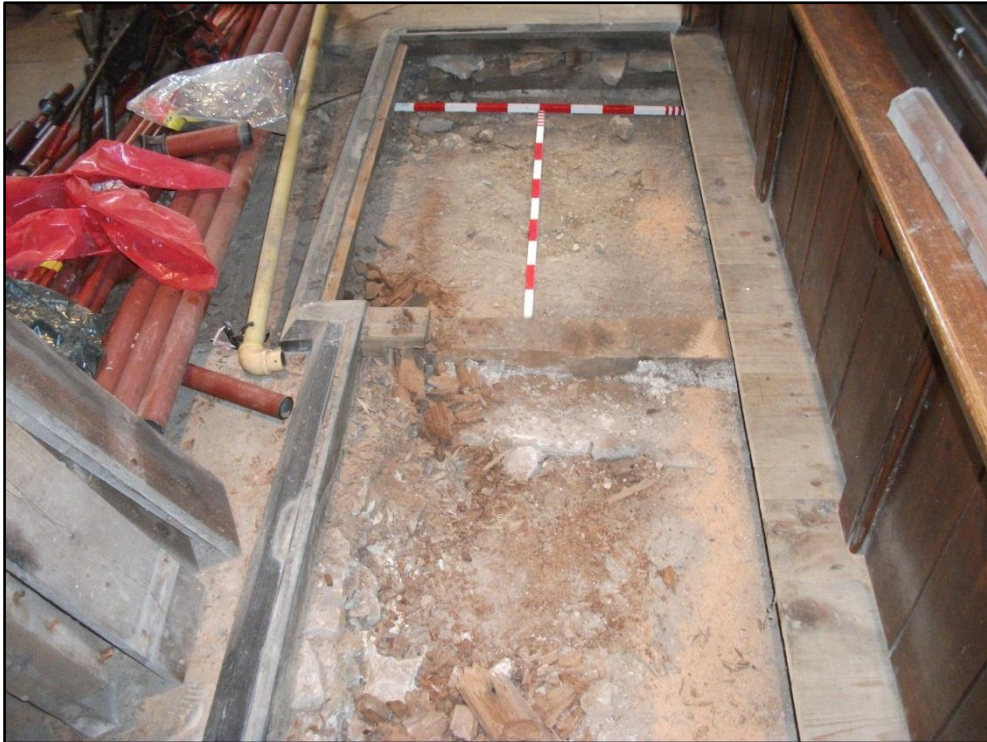
Area C was crossed and bordered in several places by timber sills which formerly edged the area of pews (Figs 11-12, 16). The floor surface in these areas was formed by timber floorboards which overlay timber joists below. When the boards were lifted, the mortar, gravel and crushed limestone substrate below was shown to be scattered with large and medium chunks of wood (Fig 11) and wood plane shavings, indicating the shaping of the wooden joists and sills may have been done in situ (Fig 12). The southern end of the area was also crossed by a metal pipe.

Area C central section, looking north Fig 11

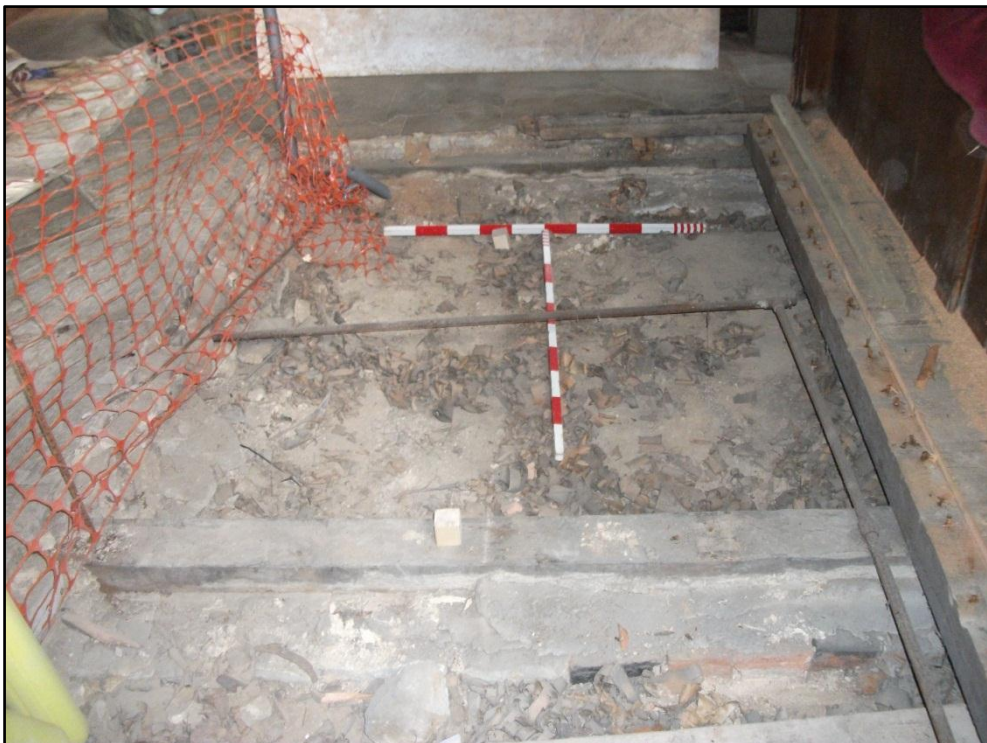
Area C southern section, looking north Fig 12

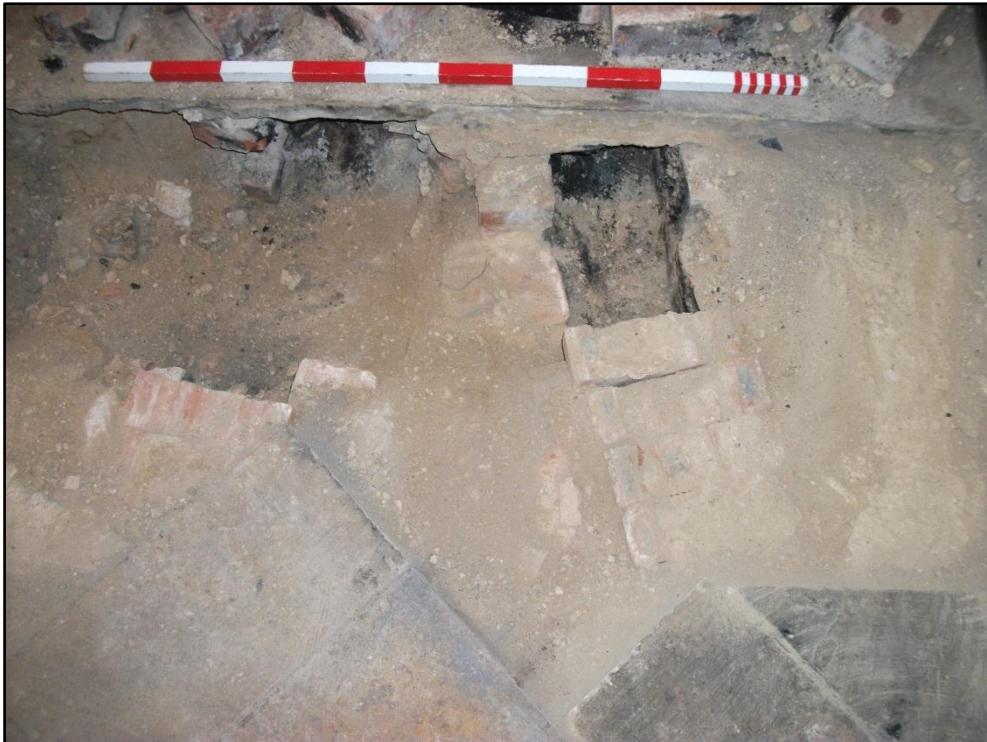
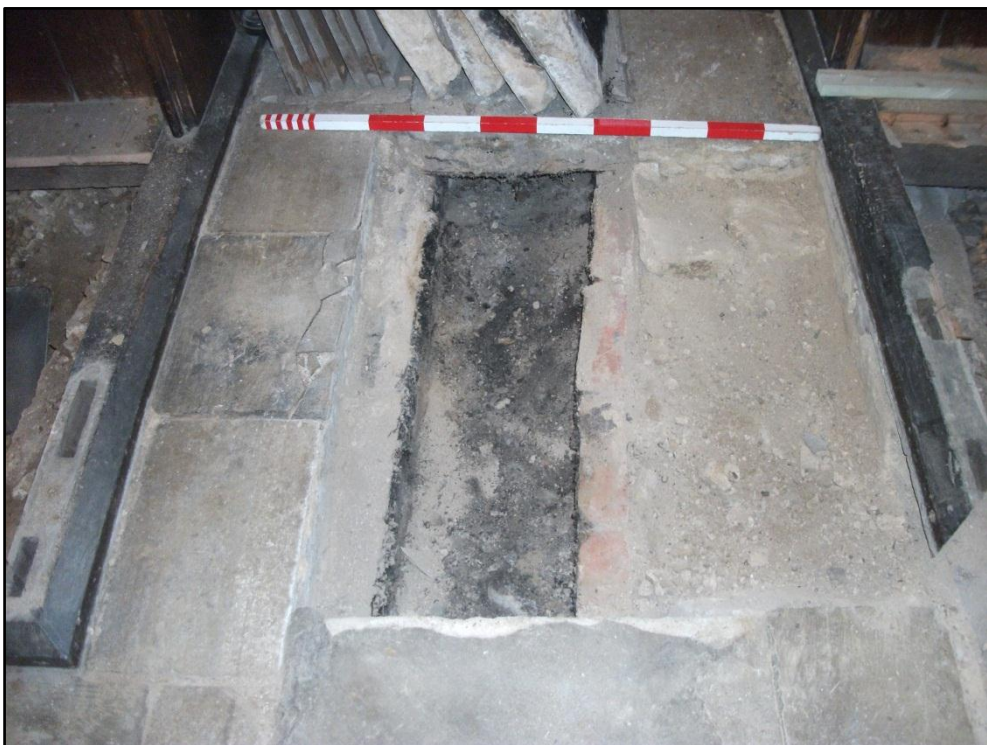
While excavating Area C, three brick-built heating flues were uncovered (Figs 13-15). These ran under the flagstones in the aisles between the pews, and were constructed of short walls formed of two bricks laid flat or on the side. The capping was either formed of brick or utilised the flagstones laid above.

The flues were constructed in a loosely-packed mortar and rubble layer which was overlain by the flagstone floor. All of the flues were heavily sooted and are probably the remains of the Victorian-era heating system. In the northern aisle, two of the flues converged.

Brick-built flues, northern aisle Area C, looking east Fig 13

Brick-built flue, southern aisle Area C, looking west Fig 14
