# Archaeological Recording at Beauvale Priory Nottinghamshire July 2015

Scheduled Monument: 1002920

Report No. 15/164

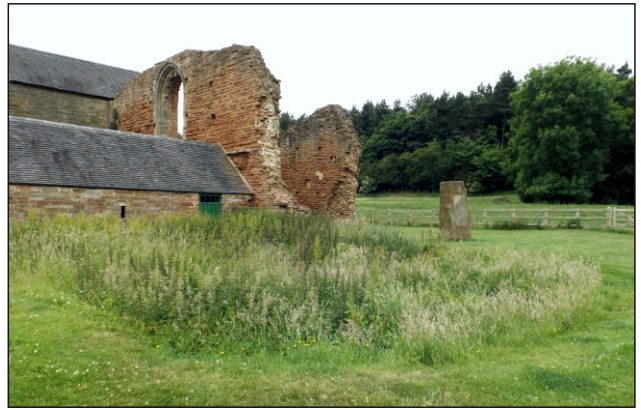
(a) Area A, prior to archaeological works, looking north-west

Vegetation including long grass and nettles as well as topsoil were removed to expose the extent of loose masonry rubble. Following this the rubble was removed to allow for the recording of the extent and condition of the walls (Fig 5, a to d). Across both areas the average depth of removed soil/rubble was c0.20m.

After the 1908 excavation the trench was partially backfilled with a layer of loose dark yellow-brown sandy loam (103). The outline of the trench was clearly visible as a rectangular depression measuring 10.8m north to south by 7.4m east to west. Both the chapel and church walls were overlain with loose masonry blocks and the occasional 20th century brick (100, 101 and 102). These deposits were recorded and photographed prior to removal (Fig 5a & b).

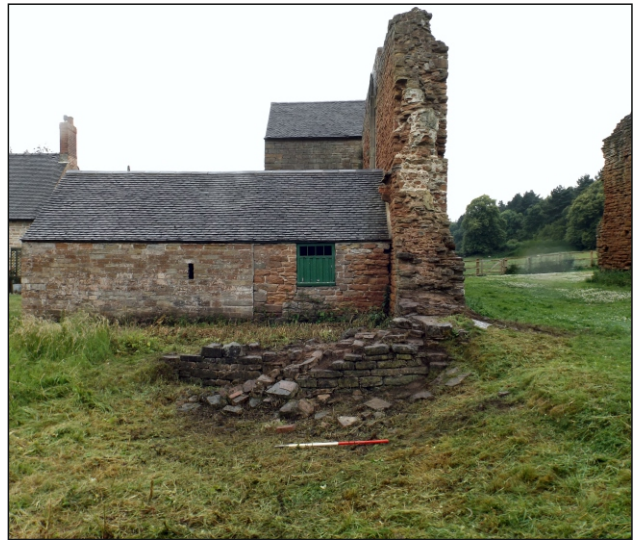
(b) Area A, after clearance of surface rubble, looking west

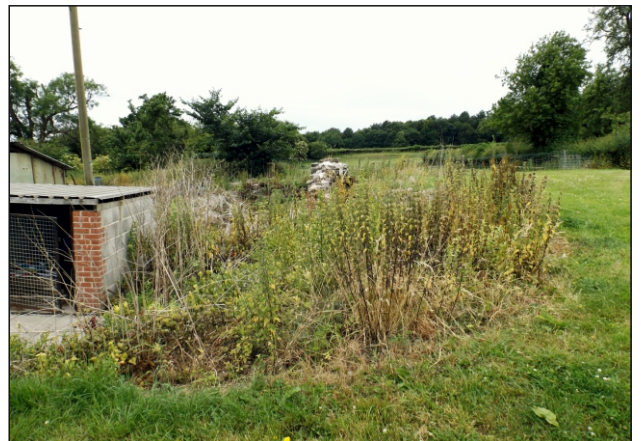
(c) Area B, prior to archaeological works, looking west

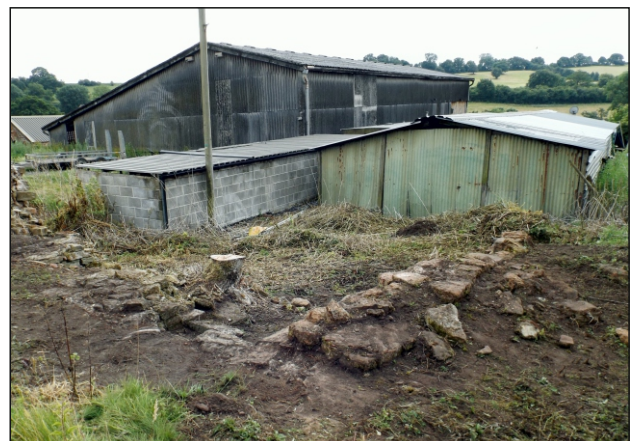
(d) Area B, after clearance of surface rubble, looking south-east

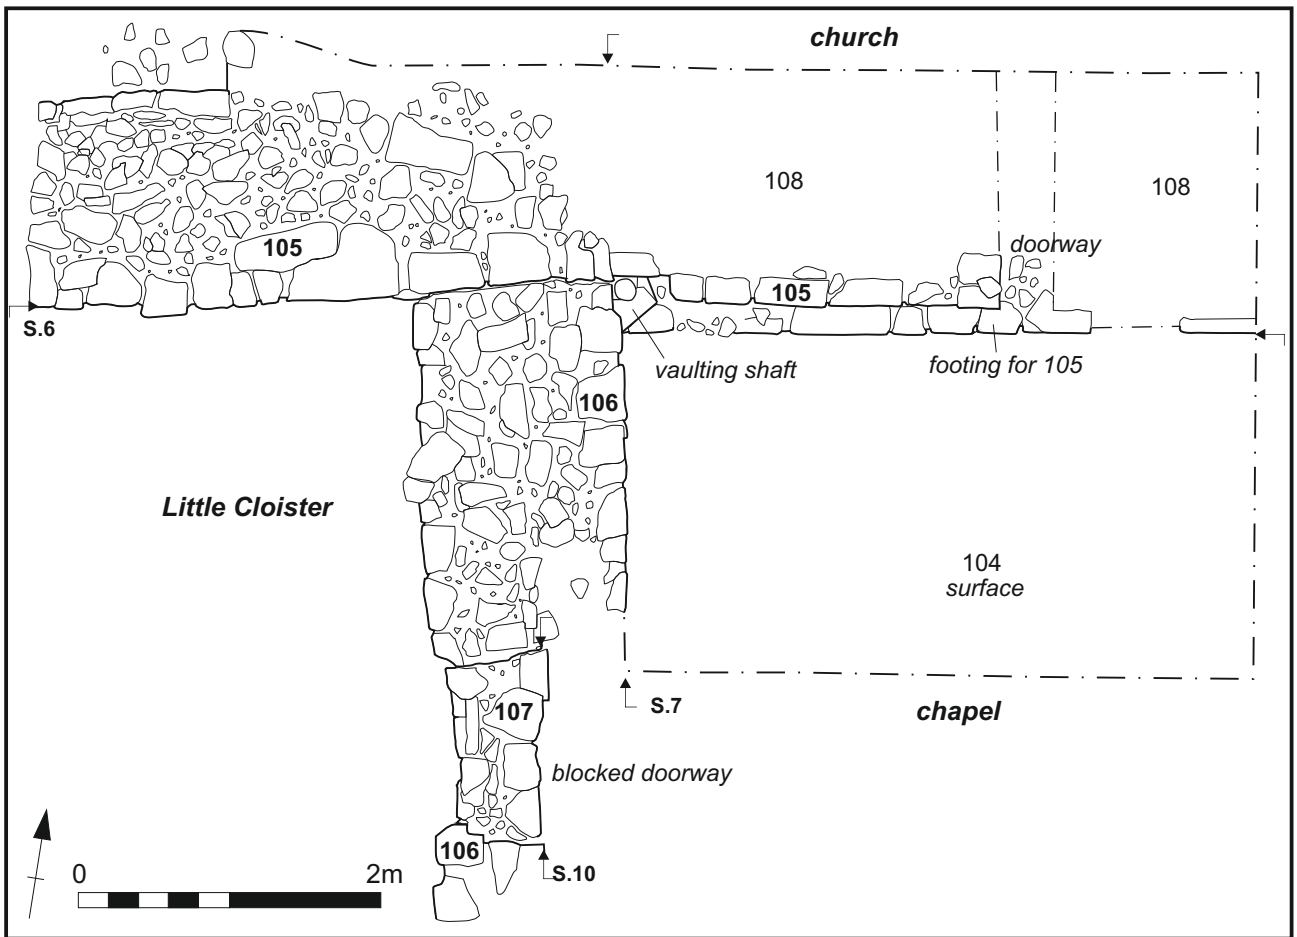
The recorded walls in Area A Fig 6

The clearance of Area A identified three clear structural phases (Figs 6-7). These comprise the south wall of the church [105]; a later chapel [106] accessed from the west via the Little Cloister and from the Church and a subsequent phase of blocking [107] of the doorway between the Little Cloister and the Chapel. A layer of rubble and mortar (108) covering the church wall is post-suppression in date.

Within Area A the southern wall of the church [105] was up to 1.2m high and 1.4m wide (Figs 6, 7, 8, Sections 6 & 7 and Fig 9 a & b). The wall was constructed on a roughly dressed stone footing c0.15m high. It comprised a rubble sandstone core and dressed stone on the north and south faces. It was thought that the church had at least two phases of building although this could not be confirmed during this phase of works.

The northernmost chapel was rectangular, although its full size was not determined in this phase of works. It is recorded as being '11ft. 6in. wide' (de Boulay Hill and Gill 1908) or 3.53m wide. The southern and eastern walls lay outside of the trench. The western wall [106] was substantial, being 1.34m thick and with a surviving height of 1.30m (Figs 6, 7 and 8, Sections 6 & 7). The western side of the wall was not fully exposed to depth and there was no obvious footing level on the eastern side of the wall. The wall was of massed wall construction with the outward facing sides of the stonework dressed and a rubble and mortar core. The blocks were of varying size but of a similar height (90mm). The chapel wall abutted the church wall and was not keyed in (Fig 8, Section 7). In the north-western corner and inserted into the church wall was the lower portion of a vaulting shaft with a square sub-base and round shaft, 0.28m high.

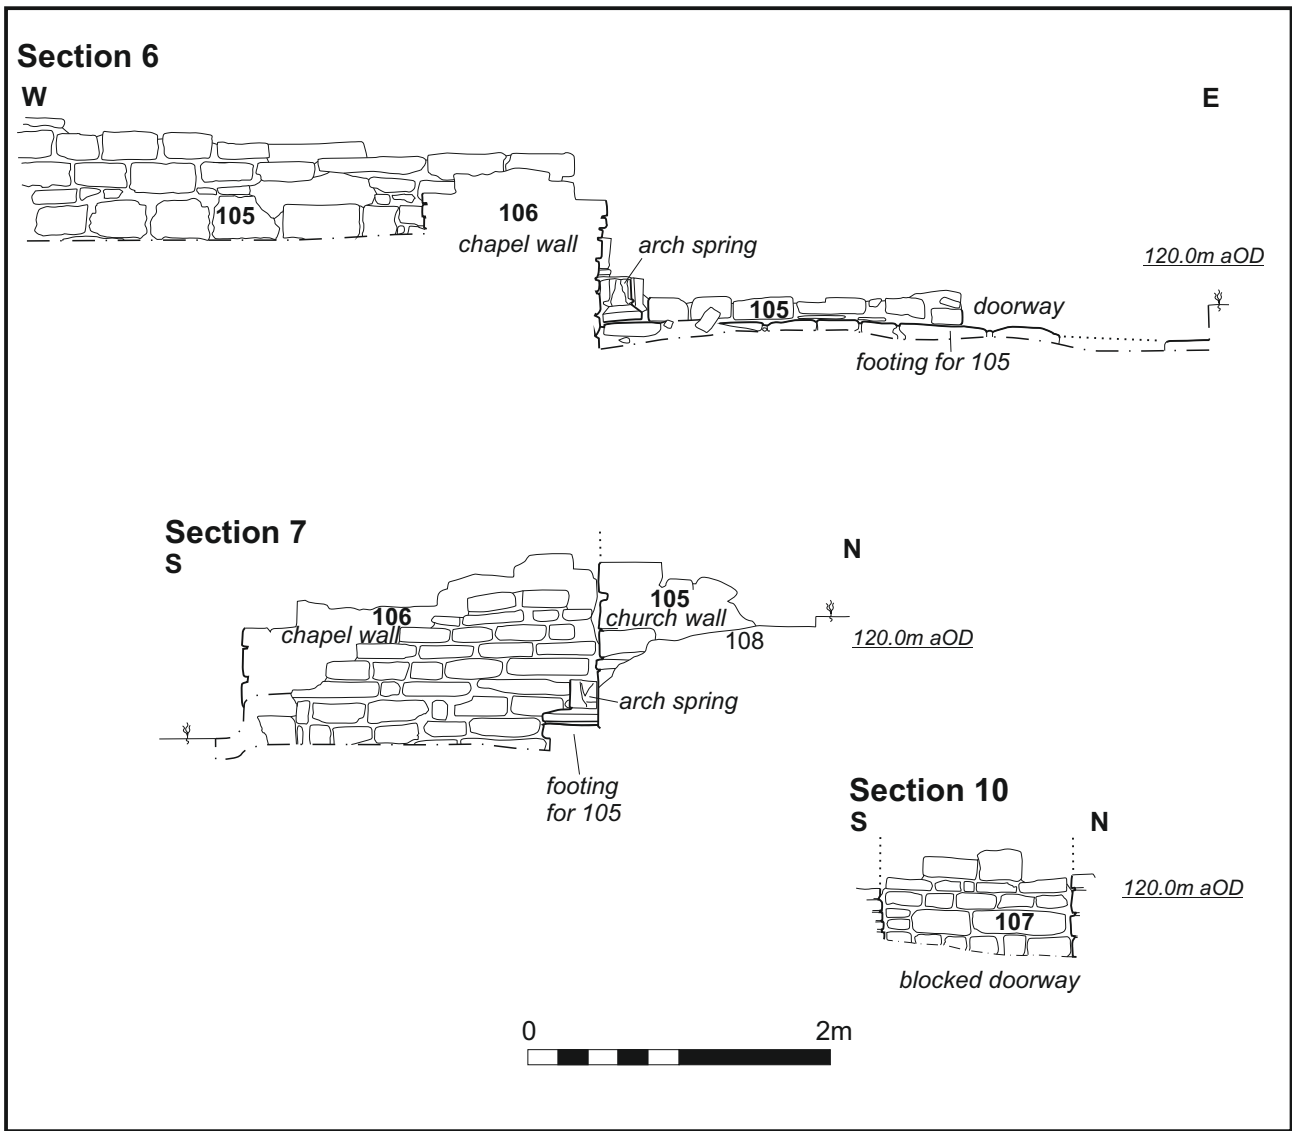
Area A, sections 6, 7 and 10 Fig 8

The western doorway (Figs 6 & 7) was 1.22m wide with shaped tapered door jambs. At a later date this doorway fell out of use and was blocked [107] with masonry comprising a rubble core and roughly dressed outward faces (Fig 8, Section 10). The blocking wall had at least five surviving courses and was 0.54m thick and at least 0.7m high.

Covering the church wall [105] was a layer (108) (Figs 6, 7, 8, Section 7 and Fig 9a & b), 0.50m thick, of friable of yellow-white sandy mortar with frequent fragments of sandstone. No artefactual material was recovered from this although in order for the full width of the door between the chapel and church to have been noted by de Boulay Hill and Gill this layer would not have been present. It is therefore likely that it related to the first stage of backfilling of the trench.

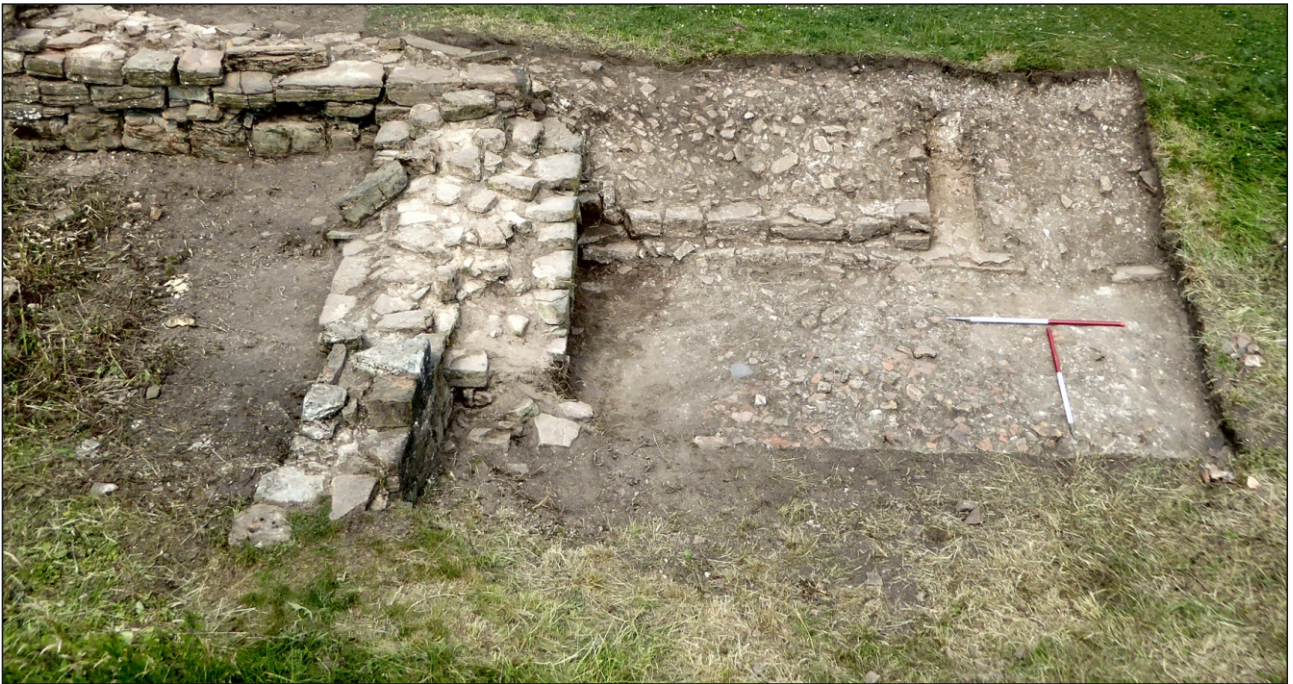
(a) General view of Area A, looking north

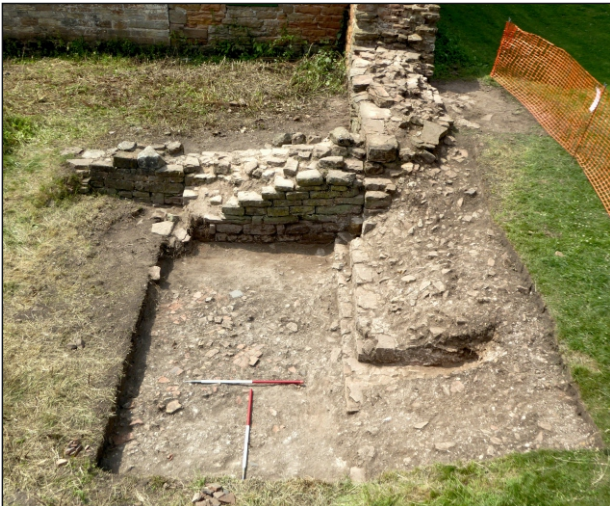
The archaeological recording of two of the 1908 excavations succeeded in elucidating the plan and the sequence of a small portion of the priory (Fig 14). For the southern wall of the church and northernmost chapel (Area A) the sequence and descriptions of the 1908 excavations were broadly correct although it was clear that the eastern range of the Little Cloister post-dated the church. In addition the chapel wall was not keyed in; rather it abutted up against the southern wall of the church.

(b) The chapel wall abutting the church, looking west

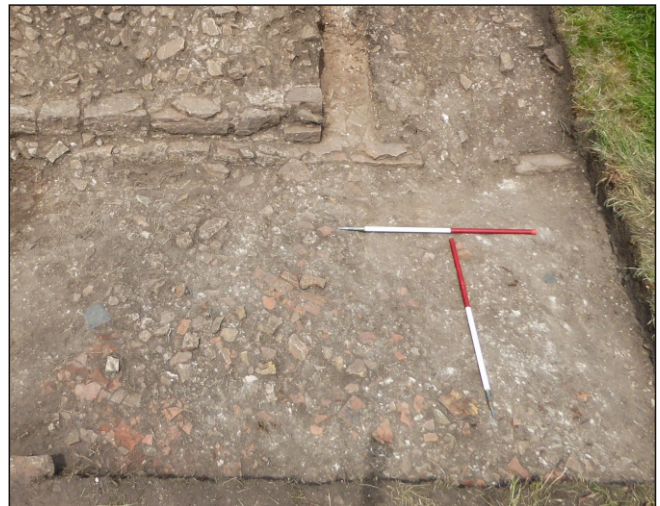
Within the chapel and bounded by walls [105] and [106] was the remains of a surface (104) found during 1908 excavations. This comprised a pale yellow-white/pinkish-white mortar with some decorated and plain floor tiles *in situ* (Figs 6, 7 & 9 a-c). The exposed area measured 3.30m east to west by 2.0m north to south and the surface was at a height of 119.3m aOD. Once it had been recorded the surface was covered over with lightly compacted topsoil.

(c) The remains of the surface 104, looking north

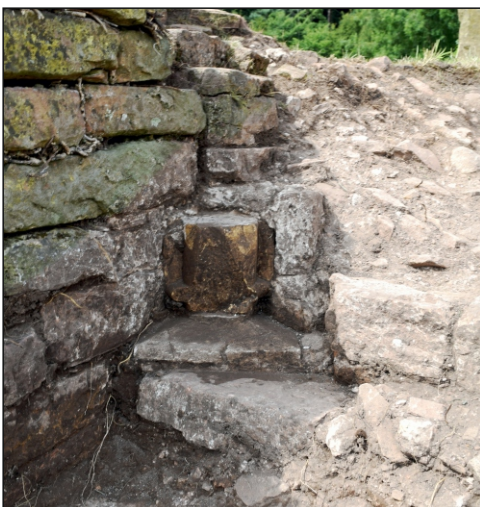
(d) The vaulting shaft, looking north

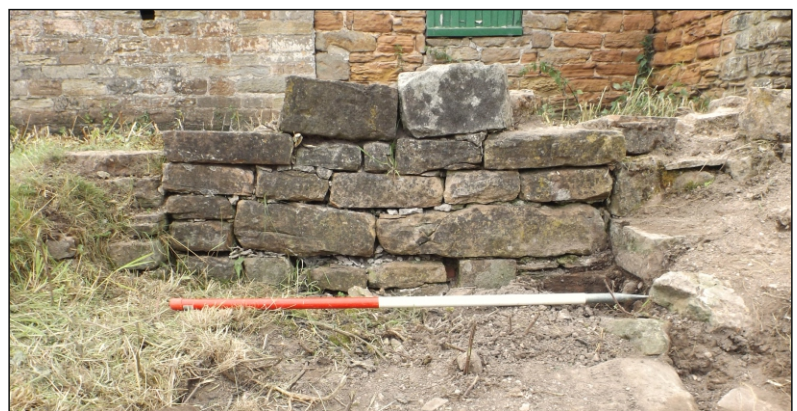
(e) The blocked doorway 107, looking west

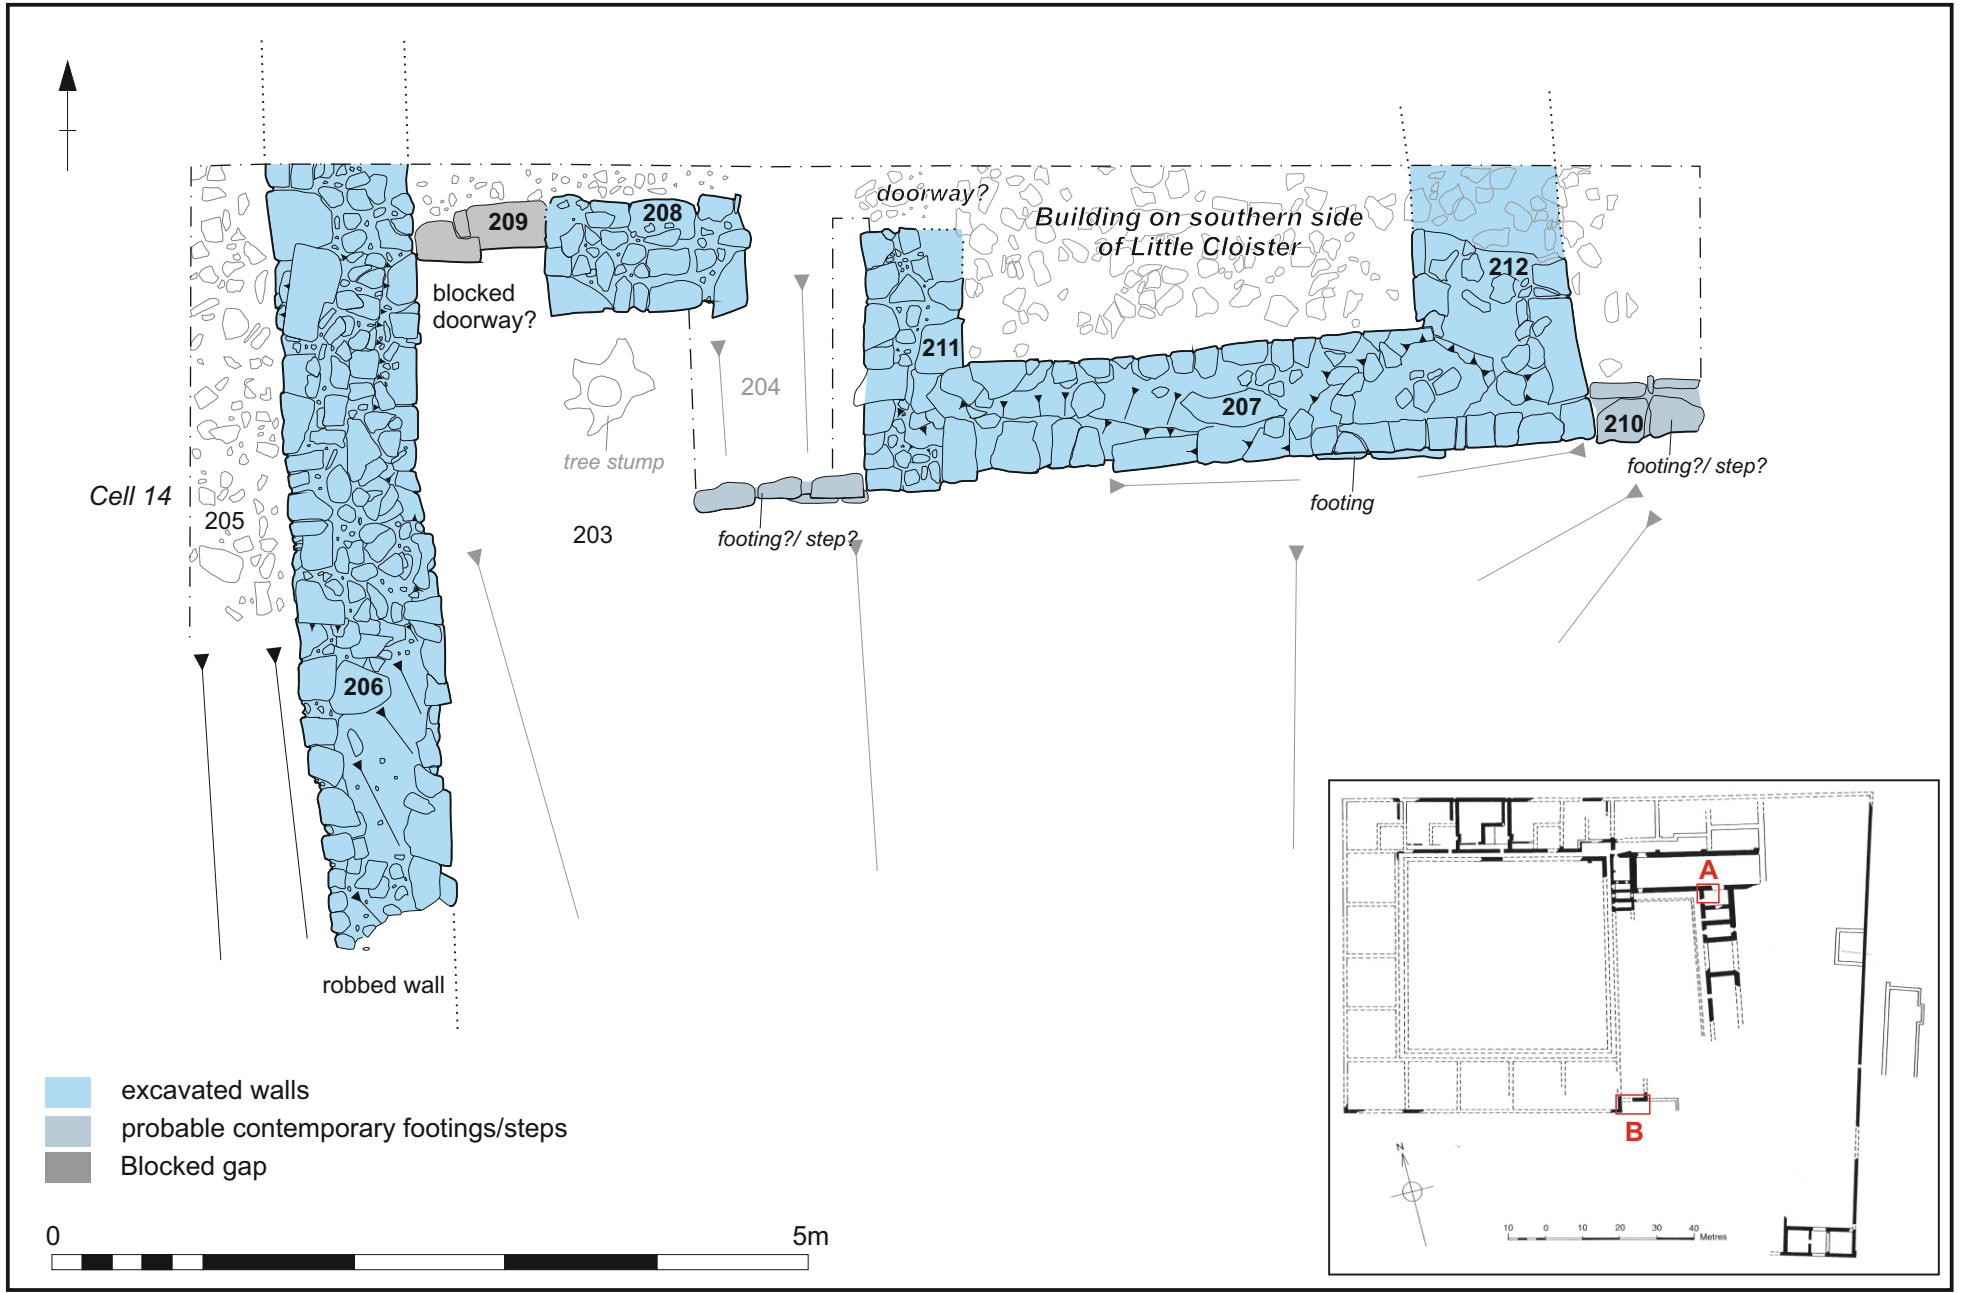
The walls in Area B Fig 10

Area B (Figs 10-13) recorded the eastern wall [206] of cell 14 as well as the southern wall [208] and [207] of a building on the southern side of the Little Cloister. There was no obvious physical relationship. The walls, particularly the southern end of [206] and the southern face of [207], had been heavily and systematically robbed. Ascertaining standing remains and surfaces to the south of wall [207] was not possible as the ground level had been reduced to enable a flat platform for the 20th century farm buildings to the south.

The remains of the southern wall [207] of a small building with return walls at the east [212] and west [211] ends was present in Area B (Figs 10 & 11). This contrasts with the 1908 plan (Fig 3) where a straight length of wall is recorded. Wall [207], aligned east to west, was 4.80m long and 1.74m high and 0.84m thick. The wall was constructed on a roughly dressed stone footing (Fig 12, Section 2) and the superstructure comprised a rubble and mortar core encased in roughly-dressed sandstone blocks of varying sizes. Although the lower five courses were generally even the upper portion of the stonework was much rougher with uneven courses of roughly-dressed stones and tile fragments. The eastern return [212] appeared to extend beyond the northern limit of the trench. It was at least 1.44m long, 1.03m thick and at least 0.40m high. There were at least two courses (visible at the southern end) of dressed sandstone blocks with a rubble core. The western arm [211] was 1.70m long, 0.66m thick and at least 1.1m high (Fig 12, Section 1). The wall appeared to terminate at the northern end although it is unclear whether this forms the door jamb of a doorway or other feature such as a window. There were 10 visible courses of rectangular roughly dressed blocks of sandstone of varying sizes with the occasional fragment of tile. The bonding material for walls [207], [211] and [212] was a loose, crumbly yellow-white sandy mortar.

The excavation of the trench uncovered the upper horizon of rubble layers (203), (204) and (205) probably associated with the initial backfill of the 1908 excavations (Fig 10). With the exception of a sondage exposing the western face of wall [211] (Figs 10 and 11) these deposits remained unexcavated. The final sequence of accumulated soils (201) and (202) is likely to be more recent.

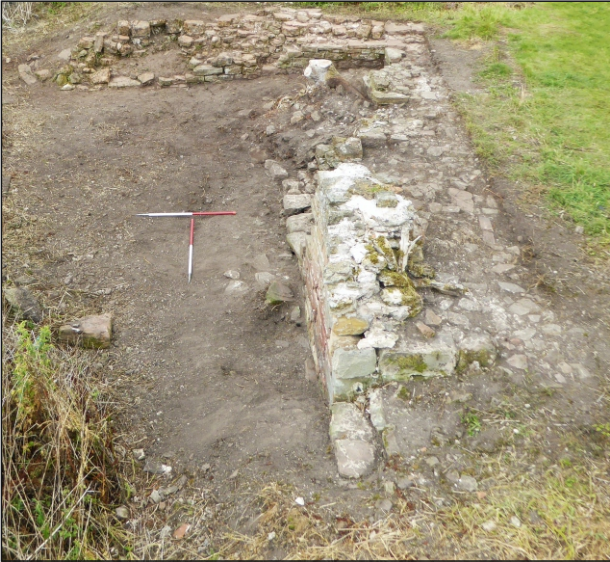
(a) The exposed walls in Area B, looking west

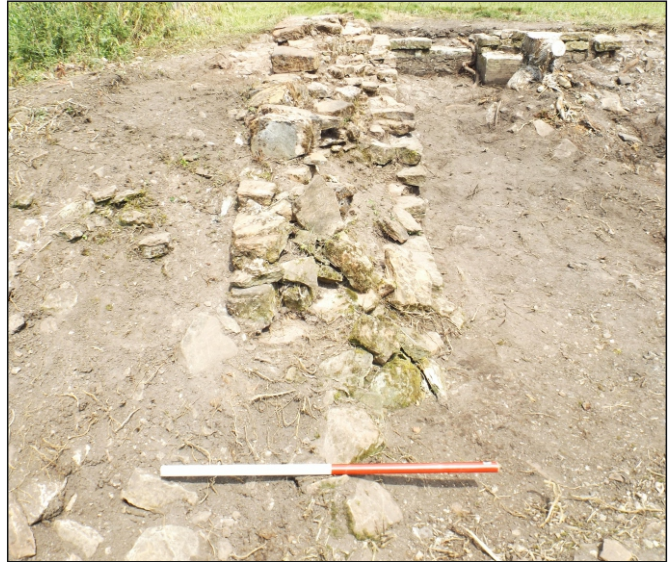
The eastern wall of cell 14, [206], lay within the excavation area and extended northwards beyond it as a very low earthwork bank. Within the trench there was a 5.0m length of wall, which was 0.96m wide and at least 0.70m high. The wall was better preserved at its northern end as the southern end had been heavily robbed (Figs 10, 12, Sections 11 and 12 and Fig 13b). It was of massed wall construction with a rubble and mortar core and roughly dressed faces. The dressed stonework was narrow rectangular blocks of variable size.

(b) The robbed remains of wall 206, looking north

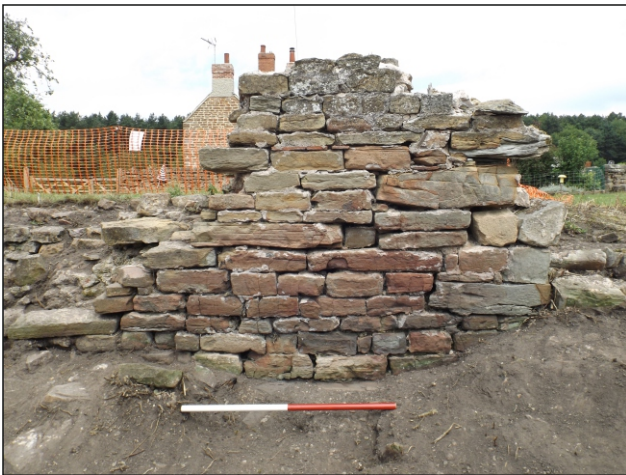
(c) Wall 207, looking north

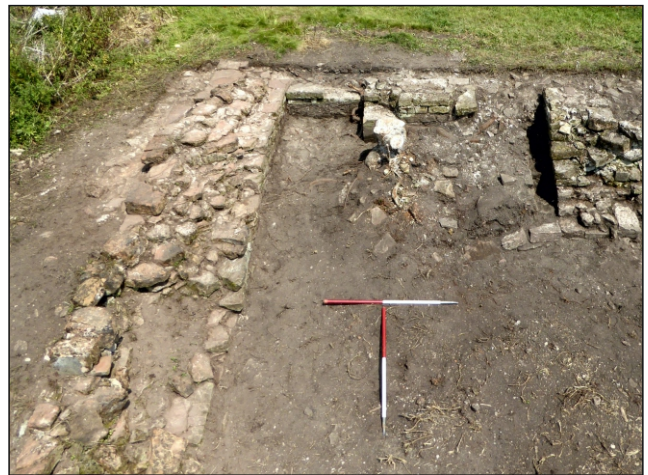
Between walls [206] and the western arm of [207] was a short length of wall [208], 1.18m long, 0.76m wide and at least 0.48m high (Figs 10, 11 and 12, Section 13). There were four visible courses of dressed masonry with a rubble and mortar core.

(d) Walls 207 and 208, looking north

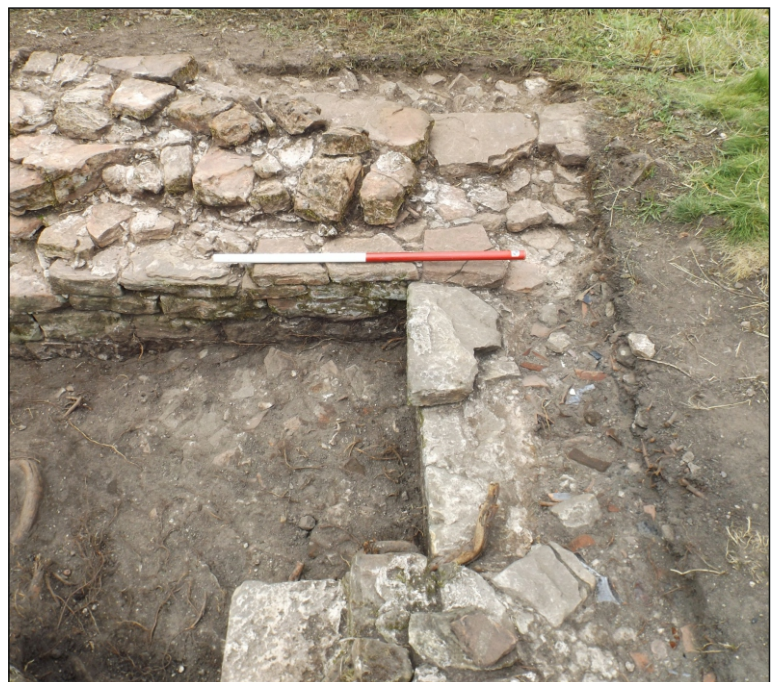
Any structures to the south of walls [207] and [208] appear to have been accessed through two possible entrances. The westernmost entrance was defined by a gap, 0.80m wide between walls [206] and [208]. This was blocked by a single width of masonry [209] with a dressed south face (Figs 10, 11 and 12, Section 14). The easternmost entrance was defined by two courses of masonry steps [210] at the side of wall [212]. Between walls [208] and [211] was a gap which was 0.80m wide. It is unclear whether this was a doorway or another feature.

(e) Blocked doorway 209, looking west
