**Historic Building Recording at
Rectory Farm, Great Addington
Northamptonshire
September 2015**

Report No. 15/183

© MOLA Northampton 2015
Project Manager: Amir Bassir
Planning ref: 13/00066/FUL
Planning ref: 14/00648/FUL
Planning ref: 14/01336/FUL
NGR: SP 95245 75420

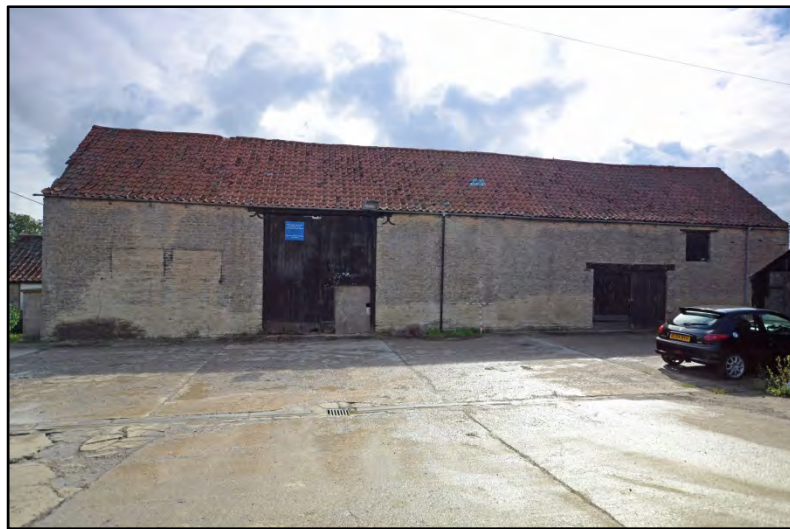
The north elevation of the north range Fig 9

This building fully occupies the northern extent of the recording area and comprises two large rooms, Rooms 1 and 2 (Fig 7). It is aligned north-east to south-west and has a rectangular footprint measuring c27m by 26.5m. It has a gabled roof of red clay asymmetric pantiles with semicircular ridge tiles. The primary construction material is of regularly-coursed, shaped blocks of the locally-sourced shelly limestone with lime pointing between. To the north, the building presents a continuous, plain elevation interrupted by a full-height double door to Room 2 and a shorter double door and adjacent window to Room 1 (Fig 9).

Modern uPCV rainwater goods have been fitted to the north and south walls of the building. There were formerly two diesel tanks for refuelling farm machinery fixed to the wall to the east of the full height doors, which have since been removed, leaving cleaner marks of their former location (Fig 9).

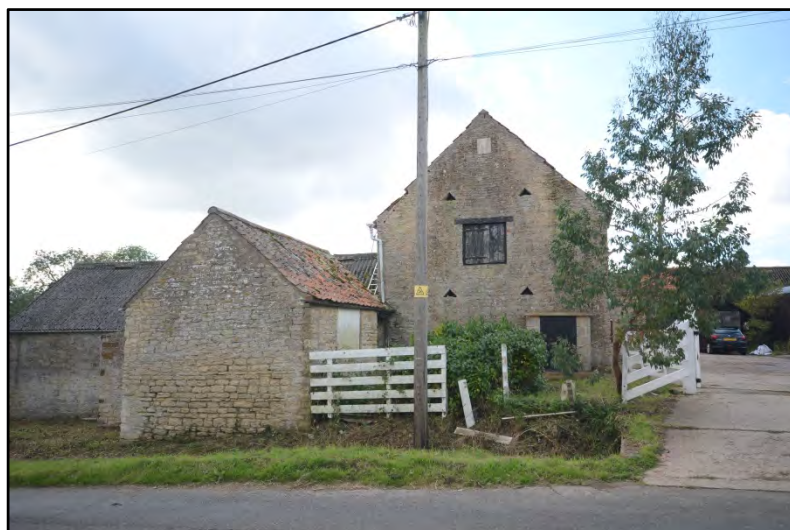
The east elevations of the north range and Room 4 Fig 10

A square doorway or hatch is positioned central to the east elevation, its timber lintel level with the eaves (Fig 10). It is constructed of black painted timbers with cast iron strap hinges and is set within a stone surround with red tile sill internally to the room. There are a number of cracks and structural weaknesses radiating from the opening (Fig 25). It is uncertain if this is a later addition or original to the building with repairs to address cracking. This doorway allowed the loading of material onto a former hayloft which is evident from a number of defunct joist slots on this side of the room. The door opening is surrounded by four stone-lined, triangular ventilation slots. A date stone bearing the inscription *J.T 1816* is located central to the elevation, below the ridge (Fig 11).

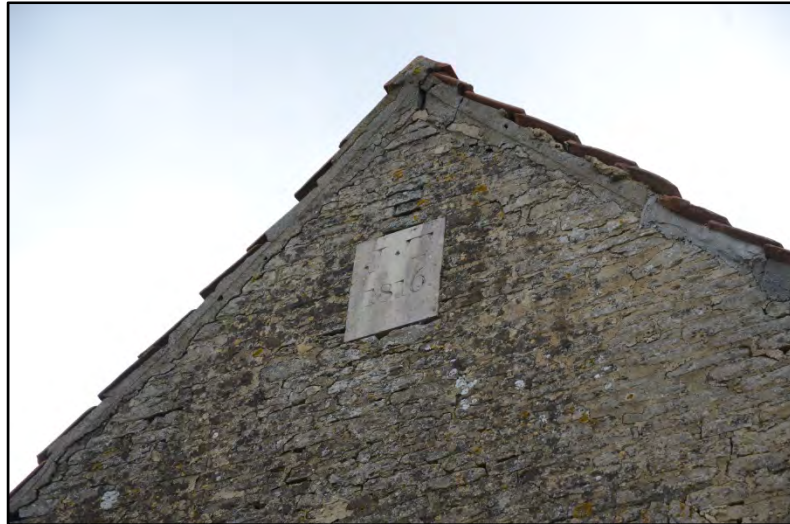
Detail of date stone on the east elevation of the north range Fig 11

Historic mapping obtained during research for this work is sadly lacking in detail prior to the late 19th century. The date stone of 1816 on the east gable of the north range provides a good starting date for the development of the surveyed buildings though this date cannot with certainty be applied across the whole recording area. Analysis of the buildings suggests an early layout may have comprised an L-plan range formed by the north and eastern buildings with an enclosing wall encircling the yard to the south and meeting the smaller building, Barn B. The yard was enclosed to the west by a mid-height stone wall. It is possible that the east range has always been open-fronted to the west, certainly it is depicted as such in 1885. The arched red brick openings are a later addition to the building, perhaps contemporary with the re-roofing of the structure. The earlier roof was probably of asymmetric pantiles and connected with the pantile roof of the milk room.

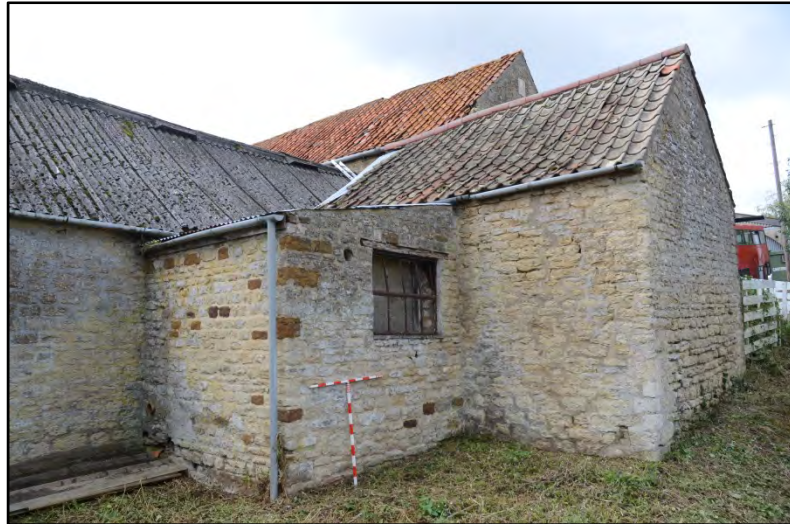
Room 4 and Room 5 Fig 14

Room 5 is a small square room adjacent to Room 4 and the east range (Fig 7). It has a lean-to roof of corrugated sheets. Externally, the walls are of stone but have been faced internally in red brick and CMU blocks. The construction date of the room is hard to determine: historic mapping up to at least the 1970s depict this area as comprising only a single room projecting from the east elevation, rather than the stepped plan comprising Rooms 4 and 5. Externally, the building seems in keeping with the surrounding structures and there is no obvious change in fabric to indicate a later date of construction (Fig 14).

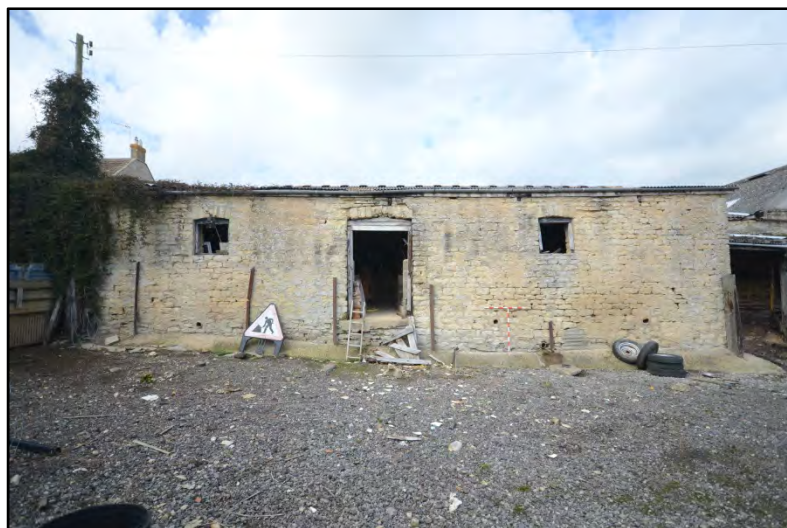
The south elevation of Room 7 / Barn B Fig 18

Barn B, or Room 7, comprises a fully enclosed stone-built barn or shed on a rectangular footprint measuring c15m by 6m (Figs 7 & 18). The building has a flat roof of corrugated sheets, supported by a simple structure of joists which leans slightly towards the yard to allow drainage in that direction. The interior of the barn is a single room fully open to the roof. Access is through opposing doorways in the north and south walls. The southern door was missing at the time of this survey but that to the north was a top and bottom opening stable door with timber lintel over (Fig 49). Two small, square window openings are located in the south facing wall to either side of the central door. Both openings have arched stone lintels and timber frames, though no glass was present within the frames.

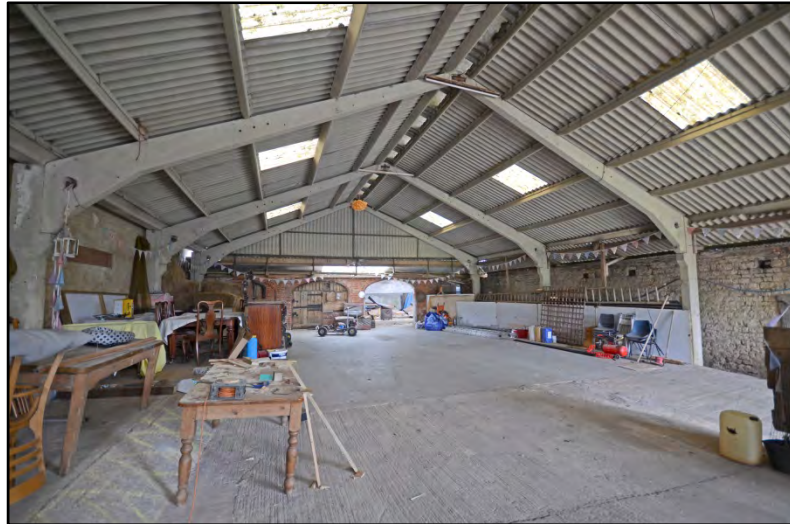
The modern central shed Fig 20

This is a modern structure dating to 1962. It fully occupies the space between the three ranges which was formerly an open yard. The skeleton of the structure is formed of post-tensioned concrete columns with attached truss members that carry a roof of corrugated sheets and corrugated roof lights (Fig 20). The room has a modern concrete floor which replaces the earlier yard surface. To the west the room is enclosed by a wall of coursed limestone, likely the former western enclosing wall of the central yard.

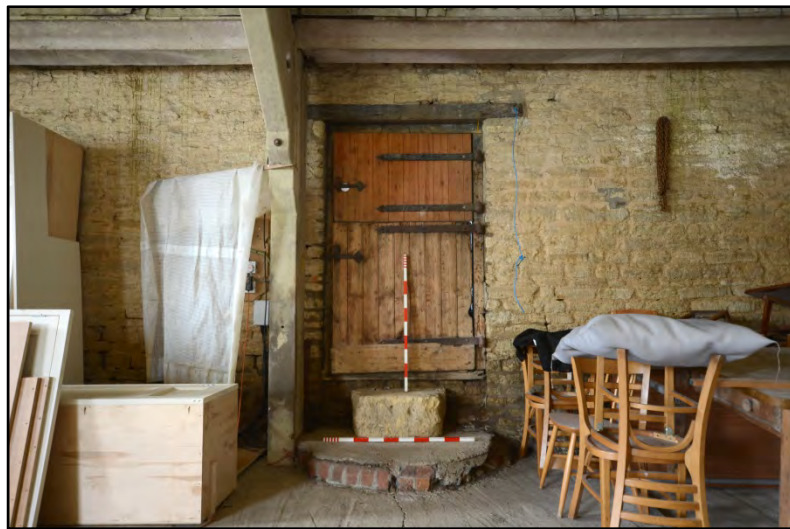
Door to Room 1 Fig 21

Room 1, the westernmost room of the north range, is fully open to the roof and has a rectangular footprint measuring c10m by 5m (Fig 7). The room can be accessed from the north by a double width doorway or from the south by a single-width plank, batten and braced door with top and bottom opening elements (Fig 21). The upper portion of the door is a modern replacement, utilising antique cast-iron door furniture, likely taken from the earlier door being replaced. Brick steps from the door lead to the lower floor level of the modern shed.

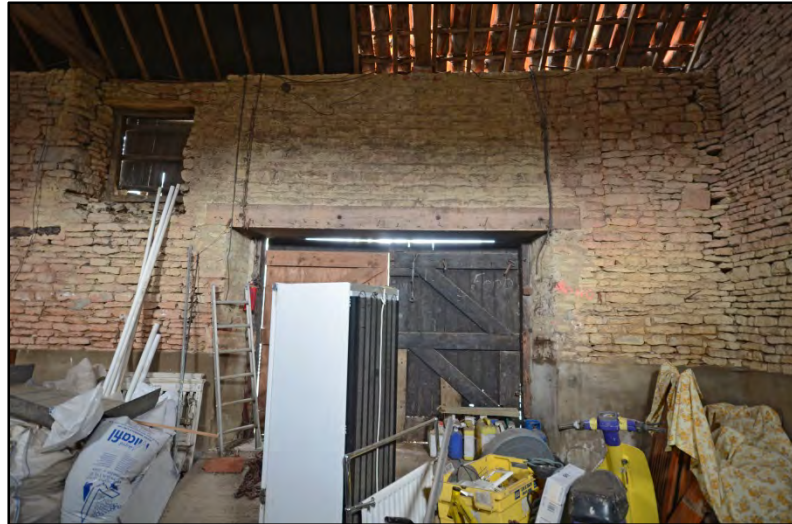
Room 1, detail of the north doorway Fig 23

The double door to Room 1, further to the west, is constructed of black painted timber planks with battens and internal diagonal bracing, and is within a splayed door opening (Fig 23). The western side door of the pair is a modern replacement in the same style as the original and the lower portion of the earlier door has undergone some repair and replacement of its original elements. Cast iron strap hinges are located externally at the top and bottom of both doors. While both hinges were contemporary with the original door timber, the lower hinge appeared to have changed position following repair work. The hinge straps of the replacement door are later additions and are of different styles to each other. Over the door is a timber lintel, painted black externally and fitted with iron bolts. The stonework above the door has been re-pointed and partly rendered on the internal face and a vertical joint is visible on the east side of the door. This joint cannot be seen on the external face of the wall and likely represents a repair to the stonework rather than a re-modelling of the doorway. Some re-pointing and repair work can also be seen on the west side of the external face of the door.

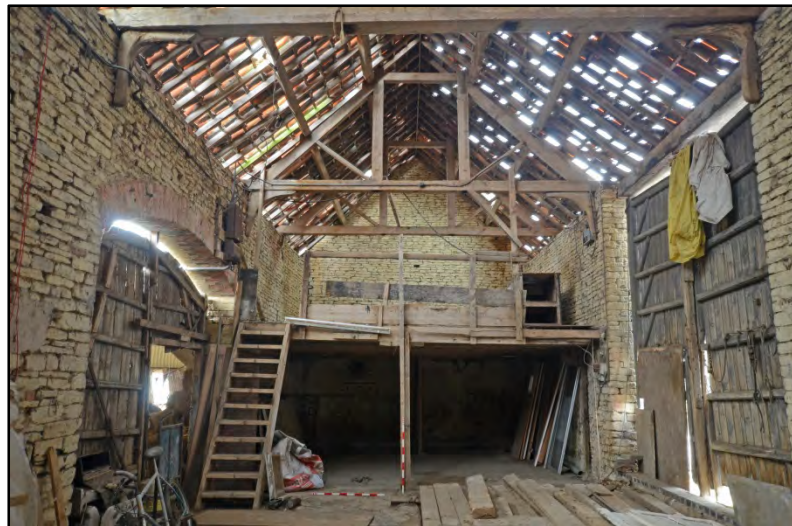
Room 2, looking south-west Fig 24

The western half of the room has an elevated platform supported over posts and joists which is accessed by a timber ladder adjacent to the south door (Fig 24). A timber safety rail is positioned at the edge of the platform and is attached to the overlying truss for stability. It is likely that a similar platform was formerly located at the opposing side of the room below the high level doorway or hatch.

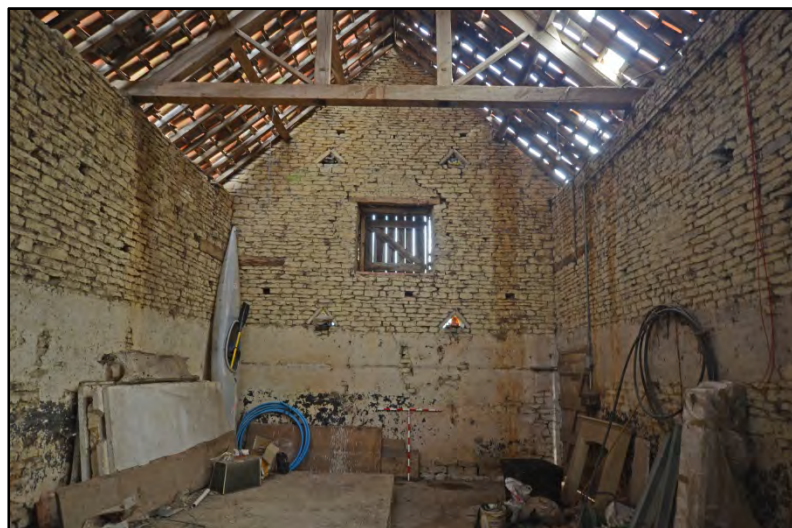
Room 2, looking north-east Fig 25

The room has a concrete floor and has a raised rectangular concrete platform, formerly for a grain tank in the north-eastern corner (Fig 25). This is positioned adjacent to a rectangular depression in the floor which functioned for discharging of grain from trailers.

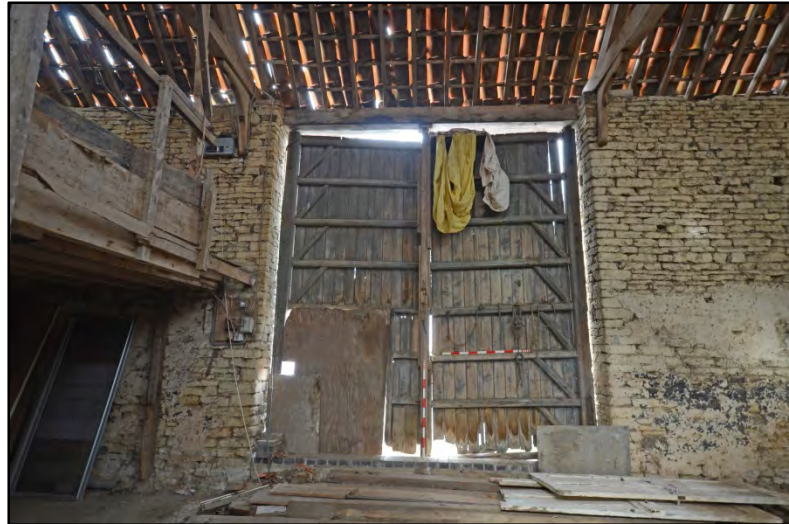
Room 2, detail of north doorway Fig 26

The full-height door is of black painted timber planks, with battens and bracing on the internal face, within a squared opening (Fig 26). The heel posts are likewise timber with cast iron straps at the top and bottom ends. The door elements retain their original wood pegs. Above the door opening, the roof is carried over a timber lintel. The underlying stonework below the far ends of the lintel has been strengthened with cast iron anchor plates. Within the room the floor level steps down from a purple brick sill.

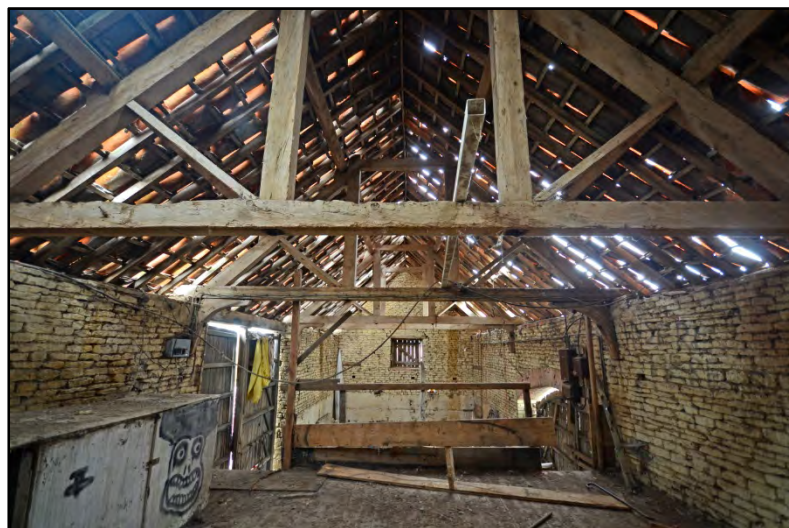
Room 2, detail of roof from the platform Fig 28

The roof structure of the northern range comprises queen post trusses with struts (Fig 28). The opposing pairs of purlins are held between the upper chords and common rafters and are supported by purlin cleats. The tie beams of the trusses rest atop the stone walls to the north and south. The trusses over Room 2 have additional supporting brackets which are not seen in Room 1.

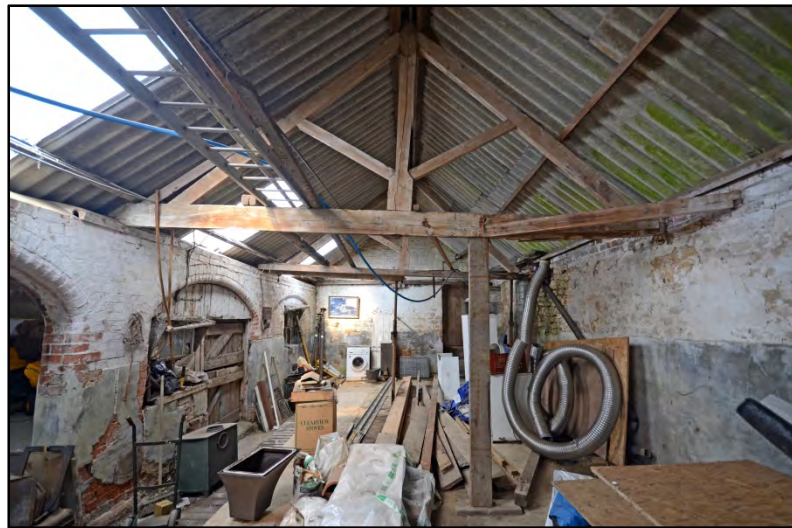
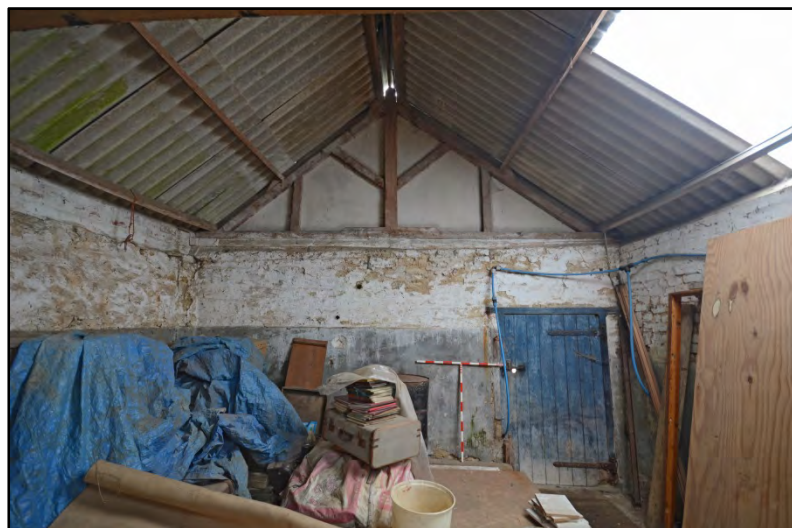
Room 3, the former Milking Parlour, looking north-west Fig 30

Room 3, detail of the south internal elevation Fig 31

The south elevation is constructed of coursed stone to the level of the stonework of the east elevation. Above this the gable partition is a king post truss with vertical struts, with plastered infill between the truss elements. The roof structure is carried over three king post trusses which are stylistically indicative of a mid-late 19th-century date though these continued in use throughout the early to mid-20th-century (Fig 30 & 31).

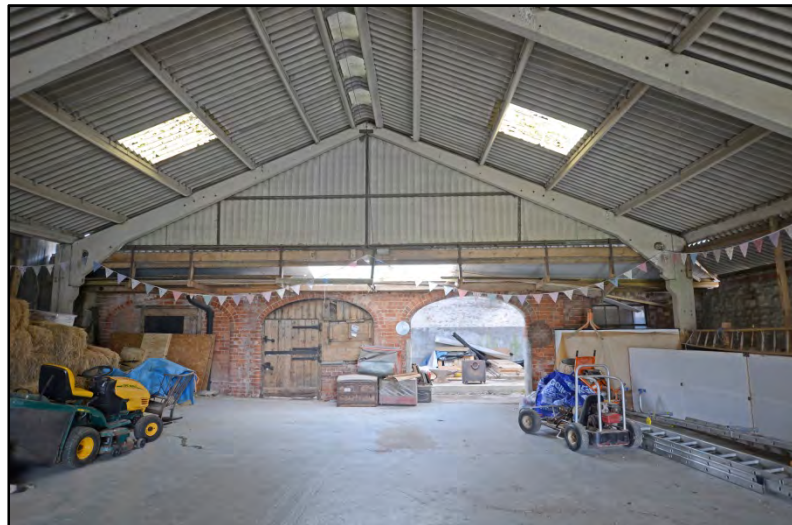
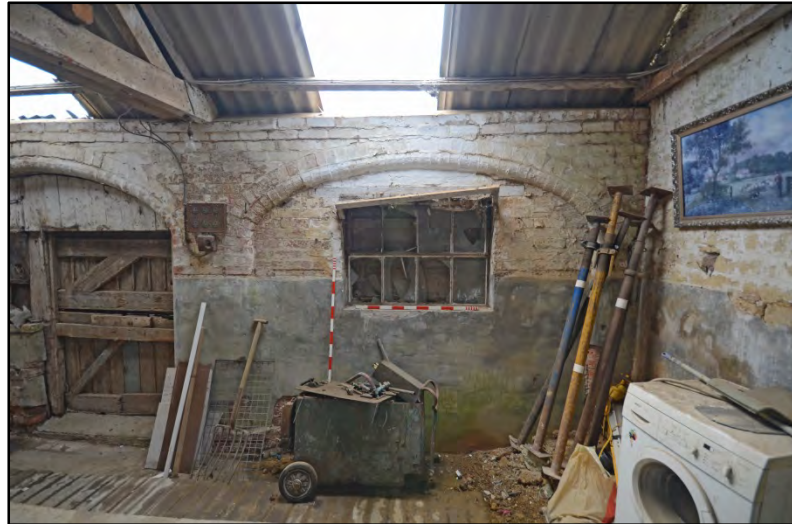
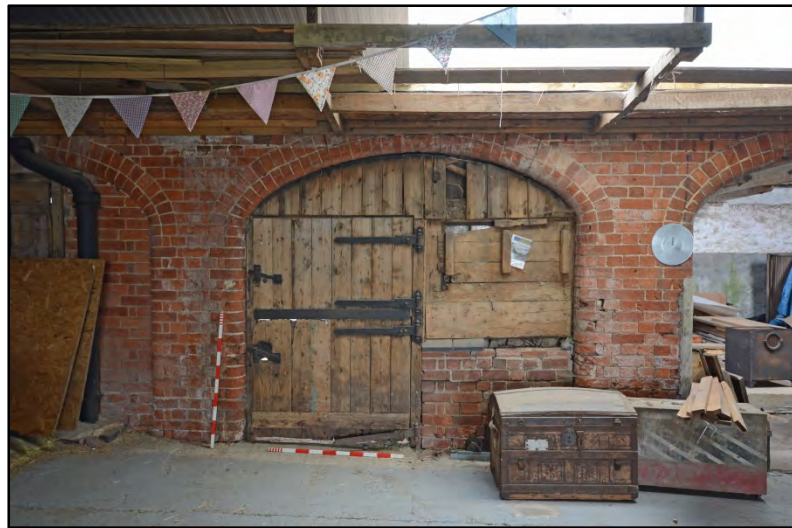
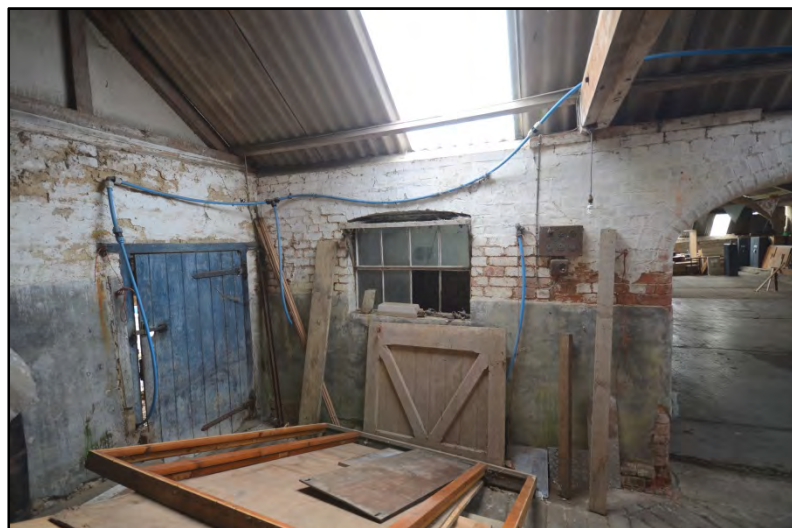
The west elevation of Room 3 Fig 34

Room 3, former arched opening with brick infill Fig 35

Room 3, former arched opening with timber and brick infill Fig 36

Room 3, former arched opening with brick infill Fig 37

into the modern shed or former central yard (Figs 34-37). These were likely formerly fully open but have been subsequently reduced or blocked entirely in brick. The north and south arches have been fully blocked in brick leaving rectangular window openings with steel framed eight light windows. The second arch from the north has had a timber partition inserted with a top and bottom opening stable style door adjacent to a small window. A small area of brickwork with a purple brick sill is located below the window. The third arch from the north has remained fully open. The internal face of the west elevation has been whitewashed and the lower portion of the wall and arches rendered.

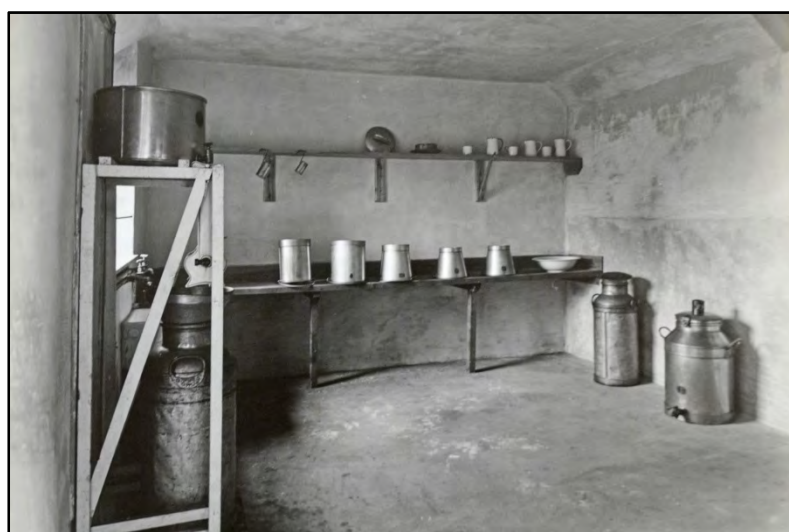
Room 4, the former Milk Room Fig 39

Undated photograph of the former Milk Room Fig 40

Room 4 latterly served as a store for milk from the milking parlour (Fig 7, 39 & 40). A historic photograph of the room shows shelving along the north and east walls with a number of milk containers in the room. The room is separated from the main range by a short corridor which leads to Room 5.

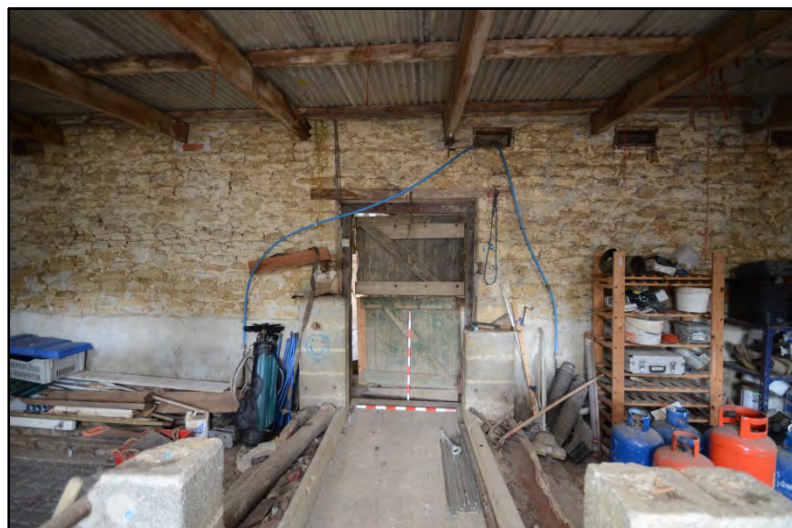
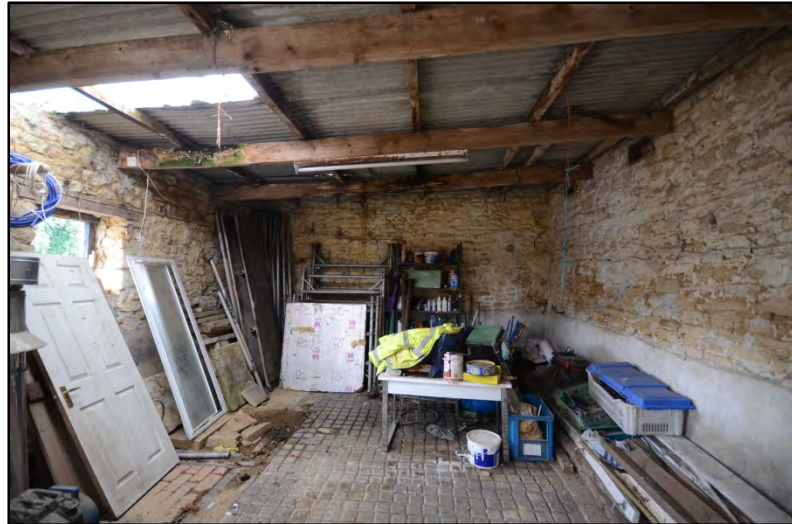
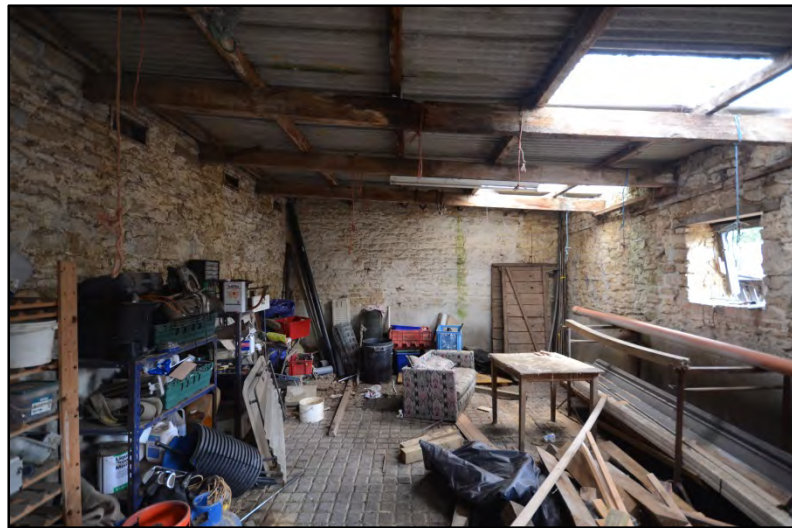
Room 7, the central walkway Fig 46

Room 7, looking south-west Fig 47

Room 7, looking north-east Fig 48

The east and west halves of the room are separated from one another by a central concrete walkway between the door openings (Figs 46-48). The walkway is raised slightly from the surrounding floor levels and is bound by modern CMU blocks with upright corrugated sheeting and rails over. The main room floor surface is of Staffordshire square pavers and the central walkway likely overlies this original flooring scheme rather than replacing it.
