**Archaeological observation, investigation  
and recording of groundworks at the  
Church of St. John the Baptist, Harringworth  
Northamptonshire  
October 2015**

Report No. 15/185

*In October 2015 an archaeological observation, investigation, and recording was undertaken by MOLA Northampton during groundworks relating to the installation of a trench arch for foul water drainage on the north side of the Church of St John the Baptist. The works revealed the top quarter of an in-situ burial and the foundations for the north aisle of the church.*

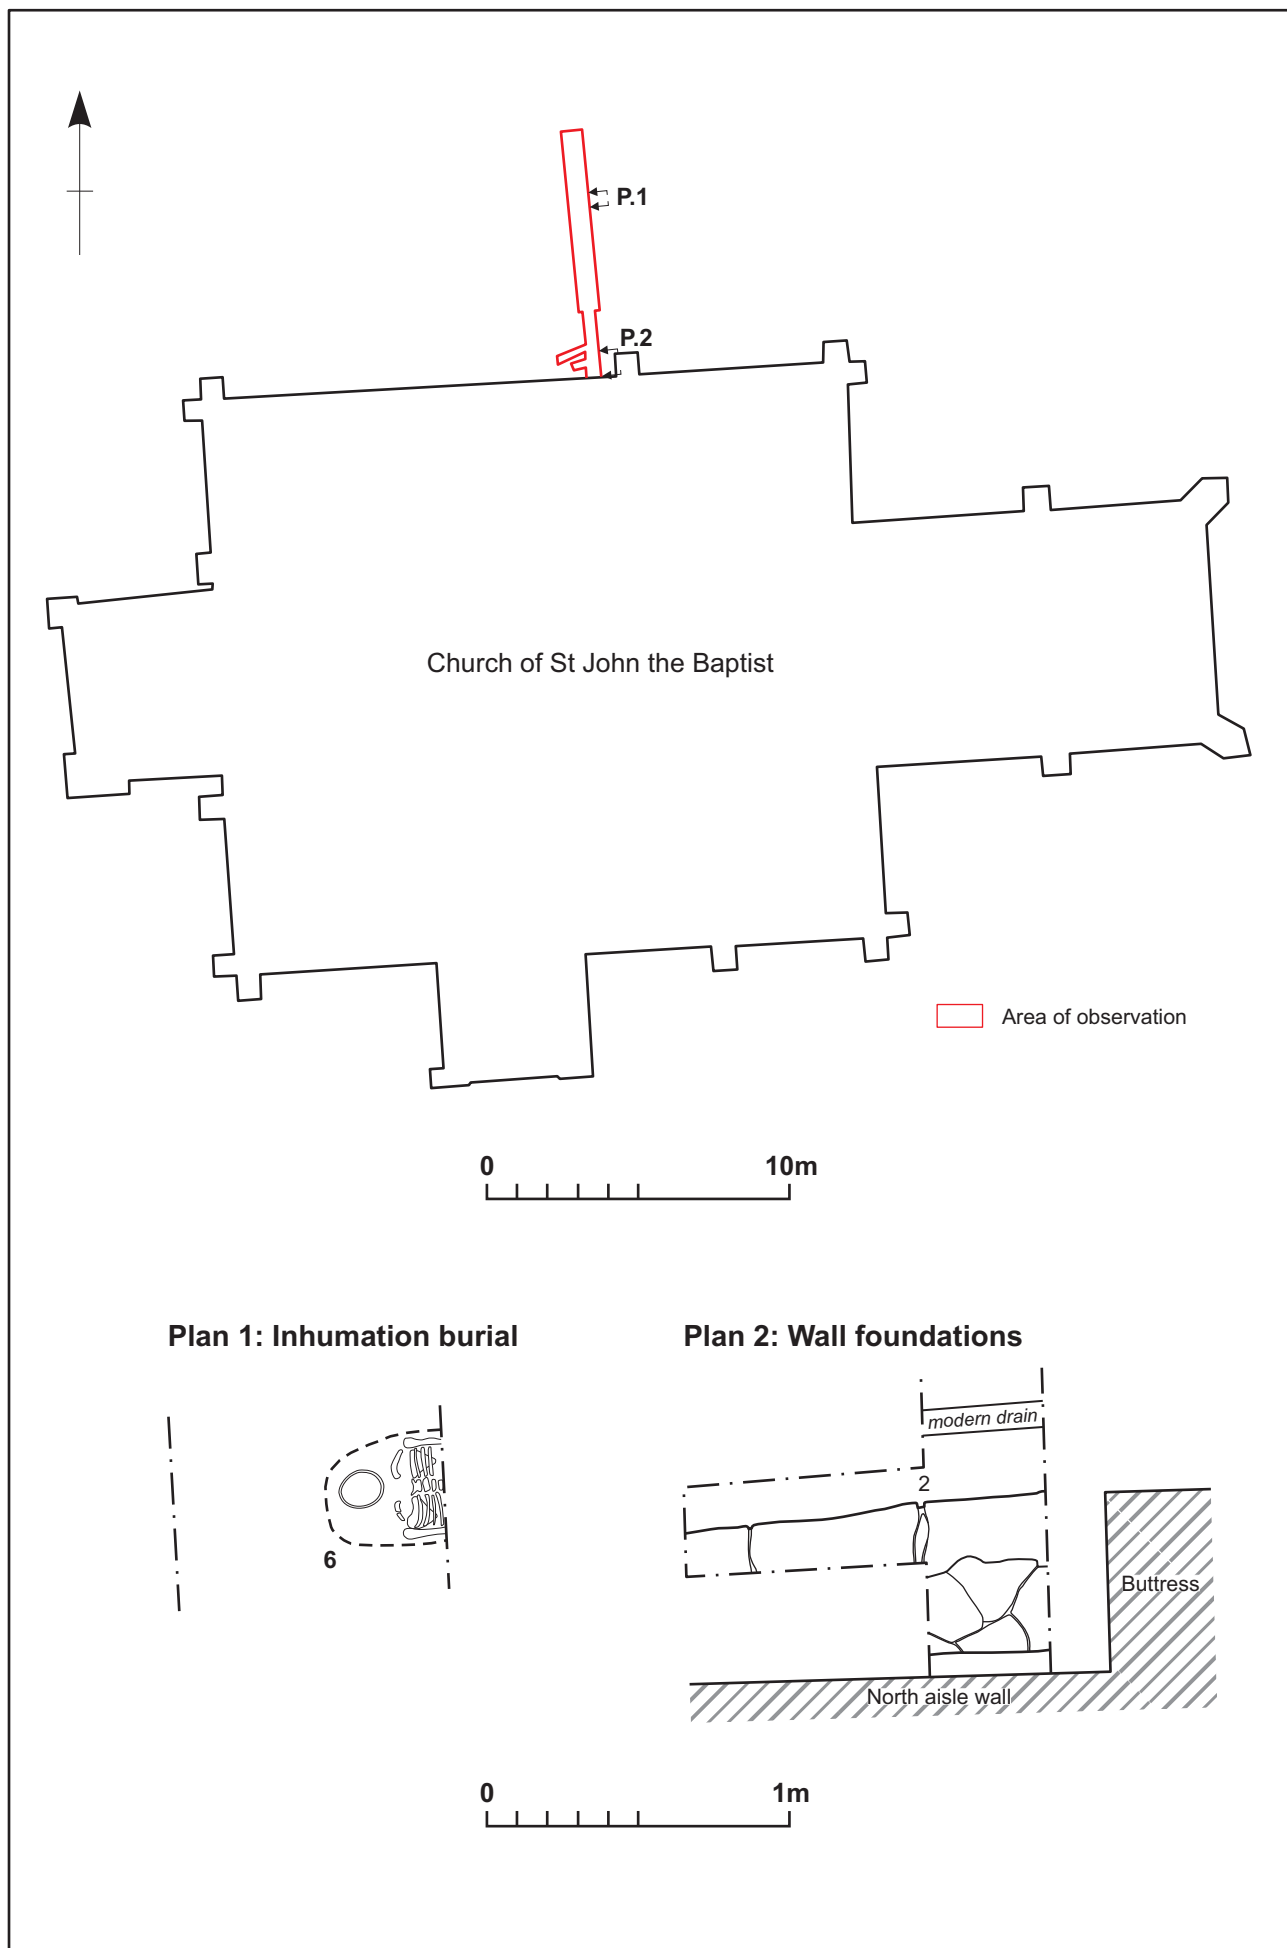
Fig 2: Area of archaeological observation and plans

All groundworks were undertaken by hand excavation, using mattock and shovels to remove topsoil, subsoil and other overburden within the area of the new trench arch drain and associated pipe routes (Fig 2). The area was cleaned sufficiently to enable the identification and definition of archaeological features.

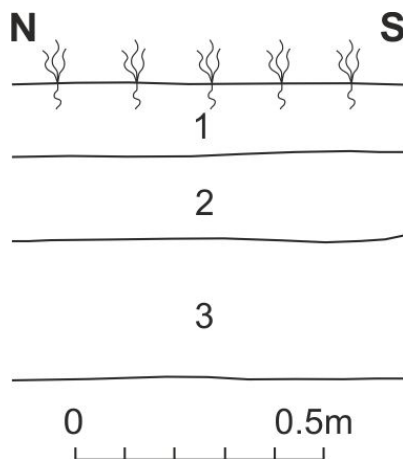
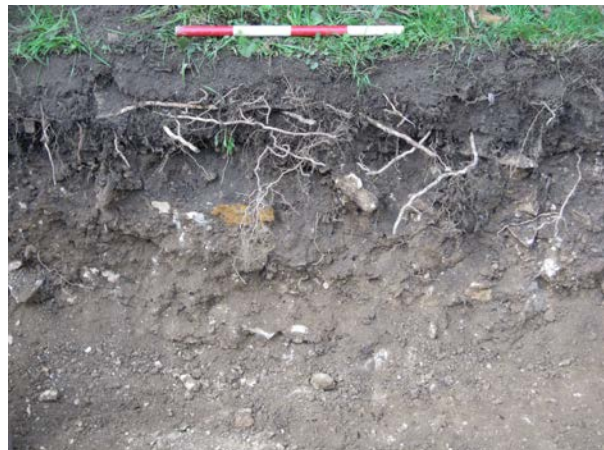
General sections of the graveyard stratigraphy Fig 3

The underlying geology was encountered at 0.60m below the modern ground surface. It comprised pale yellow to off white limestone with patches of light grey clay-loam. It was overlain by mid grey-brown loamy subsoil (3), 0.30m thick, containing fragments of limestone, and occasional fragments of disarticulated bone. This was overlain by dark grey-brown loam (2), 0.25m thick. It contained disarticulated bone fragments, modern tile and limestone roofing tile potentially relating to the late 19th-century restoration of the church. The topsoil/turf was dark grey-brown loam, 0.15m thick (Fig 3). All layers were disturbed by the high density of root intrusions.

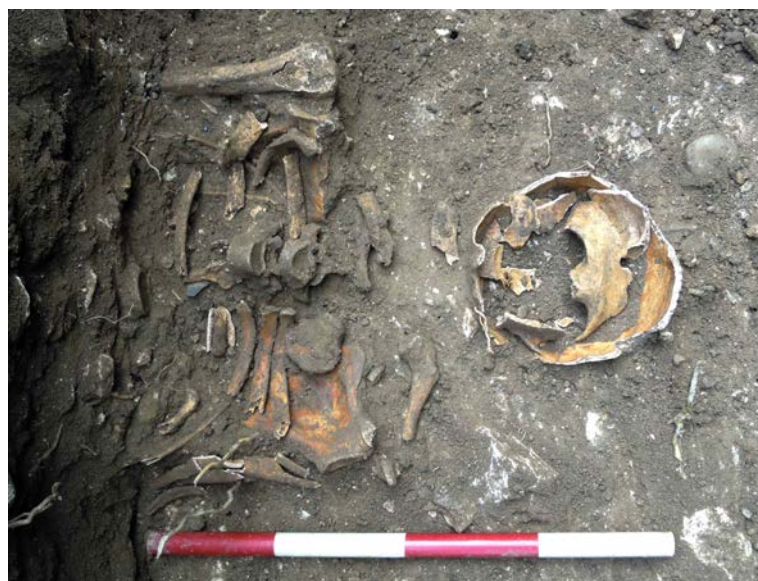
The burial in plan (scale 400mm) Fig 4

An *in-situ* inhumation burial was identified 2.10m from the northern end of the trench arch drain, 0.60m below the modern ground surface. The upper left and right humerus, ribs, clavicle, vertebrae, and skull were exposed. The lower remains extending east beyond the bounds of the groundworks (Figs 2 and 4). No cut was evident within the section due the highly root disturbed layers above. No finds were recovered.

An undated articulated inhumation burial lay partially within the area of the main trench arch drain. The burial was left *in situ* as it was below the base level required. Fragments of bone from disarticulated burials were also recovered from the overlying soils and were reburied within the trench.

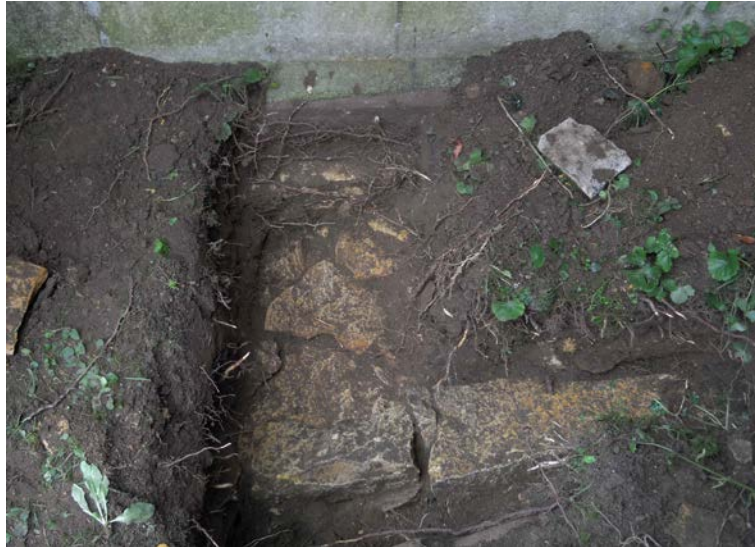
North aisle foundations, looking south Fig 5

Foundations for the north aisle of the church were identified in the pipe trench connecting the trench arch drain to the church. Large blocks of limestone, 0.60m long and at least 0.30m wide and 0.08m thick, were overlain by smaller limestone pieces 0.30m long, 0.30m wide and 0.05m thick (Figs 2 and 7). These were directly overlain by the main north aisle wall. The line of the stone was at a slight angle to the wall, likely widening to provide footings for the buttress (Figs 2 and 5).

The works exposed a small section of the north aisle foundation stones. In this area they appear to widen, likely to incorporate a buttress to the immediate east.
