**Historic Building Recording at
Holywell Spring Farm
Ashby de la Zouch
Leicestershire
August 2015**

Report No. 15/203

MOLA Northampton was commissioned by CgMs Consulting to undertake a Level 1 photographic survey of buildings at Holywell Spring Farm, Ashby de la Zouch, Leicestershire. Recording encompassed the farmhouse, barns and a granary which were still working buildings at the time of this survey. The farmhouse likely dates to the early 19th century whilst the adjoining barn may be of a later date and was expanded in the late 19th to early 20th centuries to include a western range and granary.

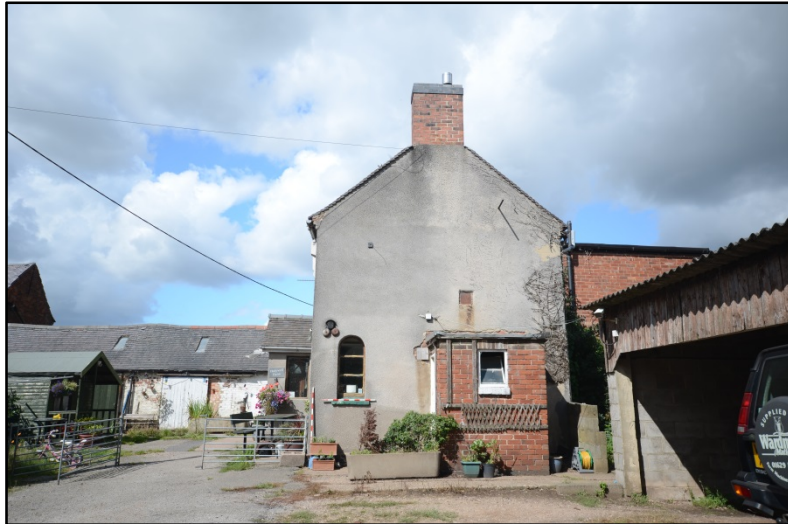
The east gable elevation is fairly plain with a narrow window opening into the kitchen. A later small brick outbuilding has been constructed against the north corner of the wall. The main south facing elevation is interrupted by a short covered passage between the farmhouse and the adjacent barn. The main part of the elevation is of

The Farmhouse, east elevation, looking north-west Fig 7

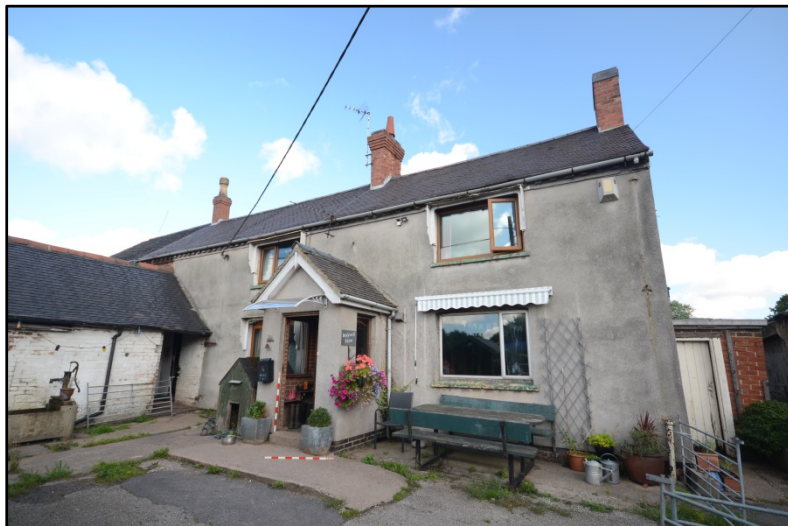
three bays with ground and first floor windows flanking a gabled brick porch. The windows are modern replacements within the original openings and have decorative wooden surrounds. The windows at ground floor level have green painted coping brick sills. Within the covered passage are opposing door openings. To the north is a single width door with bullnose brick sill which opens into a small utility room. The wall within the passage is white washed brick and has not been rendered. The opposing doorway has a sliding door on rails and opens into another small utilities room with washing facilities. The western portion of the farmhouse, beyond the western chimney, is an extension to the earlier building and dates to between the 1880s and 1920s. The farmhouse has a scheme of brick dentils at the eaves which is not continued onto the extension. The ground floor of the extension is a single room with access from the north through a simple single width door. This door was locked and the room was not accessed during the survey. The west elevation has two identical rectangular windows with purple coping brick sills. The windows have wooden frames and comprise side hung three light casements flanking a fixed central element with top hung ventilation pane. The ground floor window has a concrete lintel whilst a timber lintel is utilised at first floor. A small cross of protruding purple bricks is located above the first floor window. The north elevation of the extension is plain and a ground floor outbuilding or shed abuts the wall here.

The Farmhouse, main façade, looking north-east Fig 8

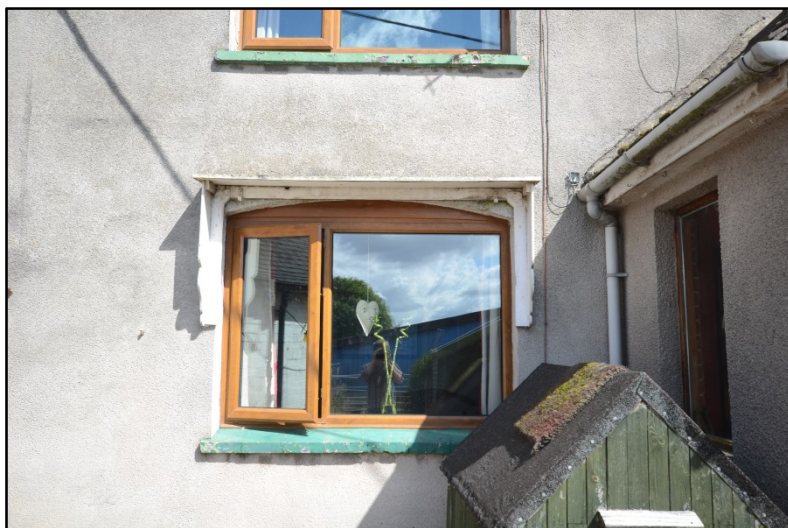
Detail of ground floor window Fig 9

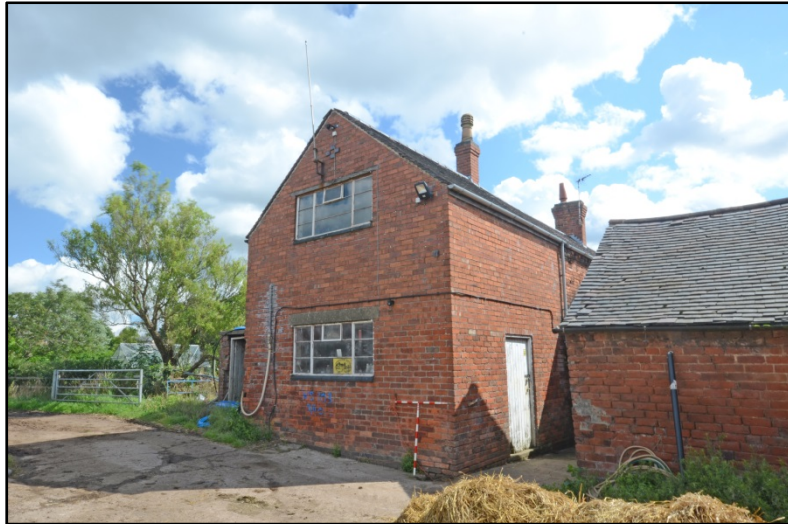
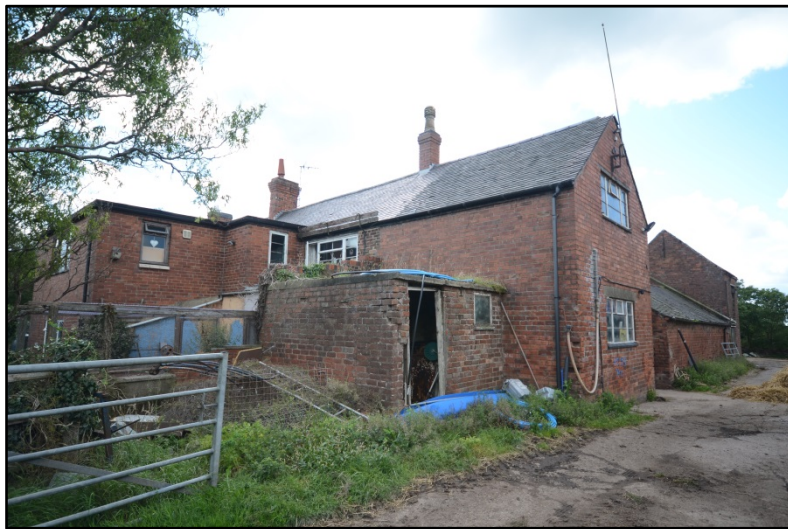
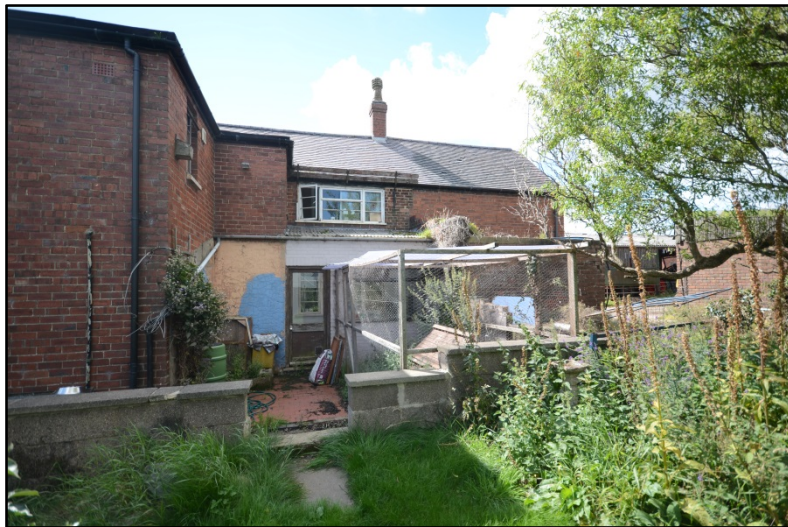
The large extension to the rear of the building was constructed between 1923 and 1961 and replaces a much smaller extension which was built between 1883 and 1923. At ground and first floor, facing north, are wide rectangular window openings, the lower of which is a modern double glazed replacement. At ground floor the extension comprises a pantry / laundry room. This room has a floor of square quarry tiles and a brick and tile work surface, similar to those utilised in dairy rooms, is located against the south wall of the room. The upper floor of the extension is occupied by a bedroom. A single storey brick porch with a catslide roof of corrugated sheets is located between the rear extension and the main farmhouse.

The western extension, looking east Fig 10

The west elevation and extensions, looking south-east Fig 11

The rear extensions, looking south-west Fig 12

The rear extensions, looking south-west Fig 13

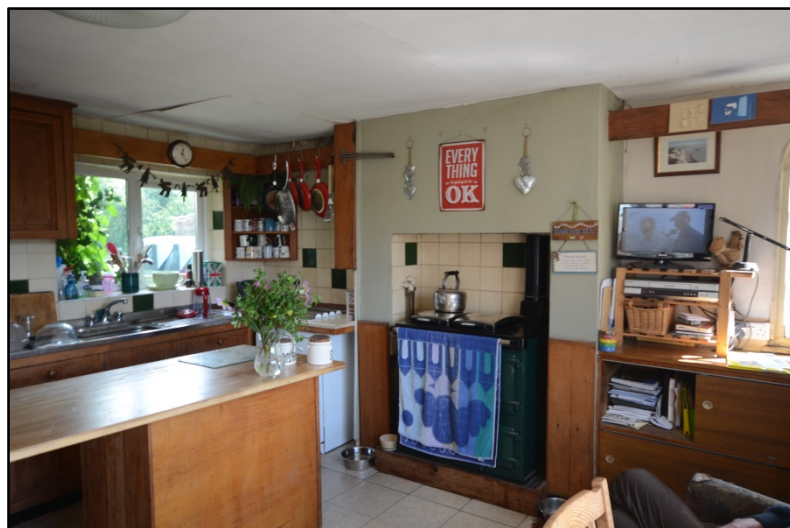
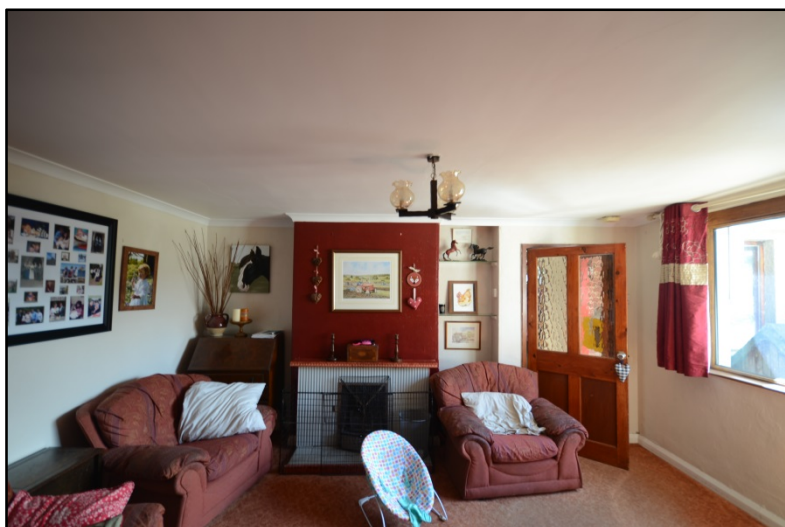
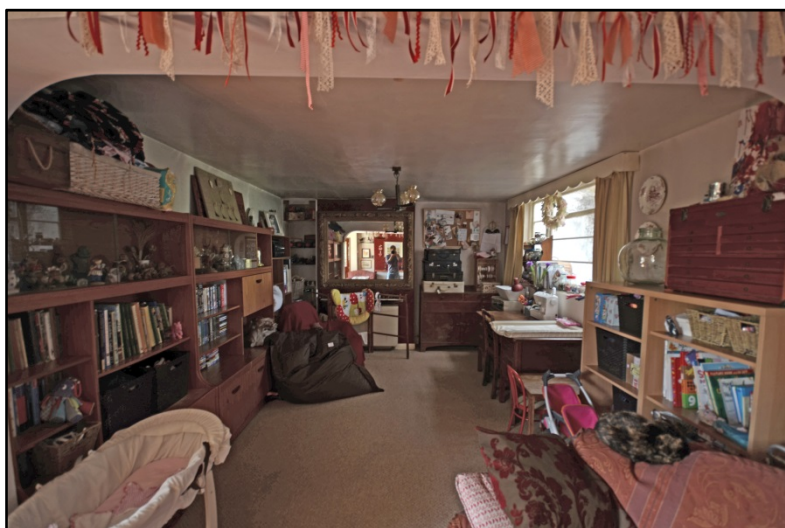
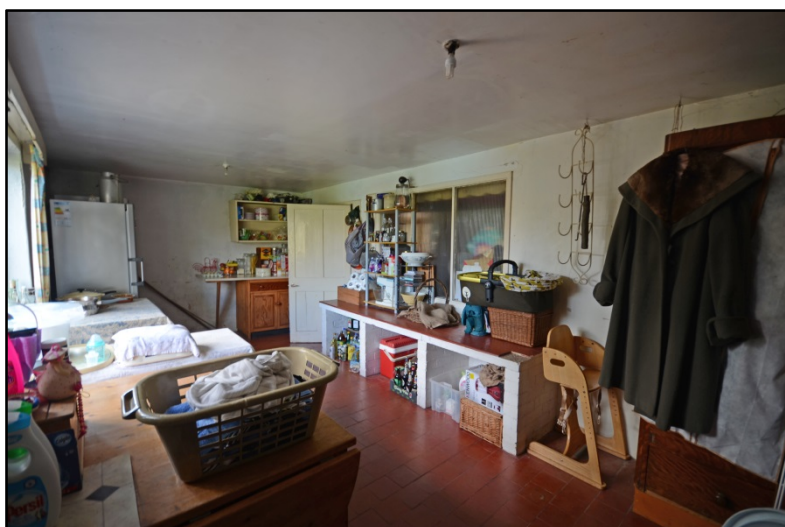
At ground floor the farmhouse contained a kitchen and living rooms. The staircase to the first floor is located directly opposite to the porch. The kitchen occupies the eastern side of the farmhouse and has modern utilities throughout. An Aga range has been installed in the fire opening on the eastern wall with its flue connected to the chimney breast. The remainder of the farmhouse at ground floor level which would originally have contained two rooms has been opened up into a single large sitting room. This room has been modernised and no historic features were visible. The first floor contains a number of bedrooms and bathroom all, of which have been fully modernised and no historic features were evident.

The Farmhouse kitchen Fig 15

The Farmhouse, the living room, looking south-east Fig 16

The Farmhouse, the living room, looking north-west Fig 17

The Farmhouse, pantry / laundry room, looking south-east Fig 18

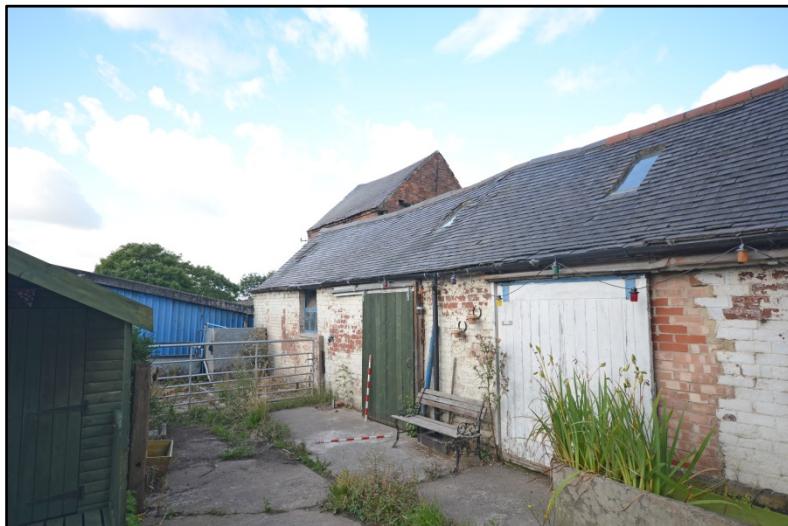
The west elevation has largely been lost or is obscured by the eastern range of barns. To the east the building faces onto an open, paved garden area with a small shed and seating. A concrete water trough adjacent to the building now serves as a water feature. The east elevation is constructed of whitewashed brick in an irregular Sussex

Bond, containing a mix of stretchers and headers. Sliding doors on iron rails allow access to the main rooms. A recessed six-light window with bottom hung upper element is located at the south of the elevation. An adjacent single-width door opening has been blocked in modern brick. A former window located at the western end of the building has been blocked in brick. The western door opening has undergone repair work on one side. The repair is fairly modern and utilises modern brick and CMU (Concrete Masonry Units).

The east barn, east elevation, looking north-west Fig 19

The east barn, east elevation, looking south-west Fig 20

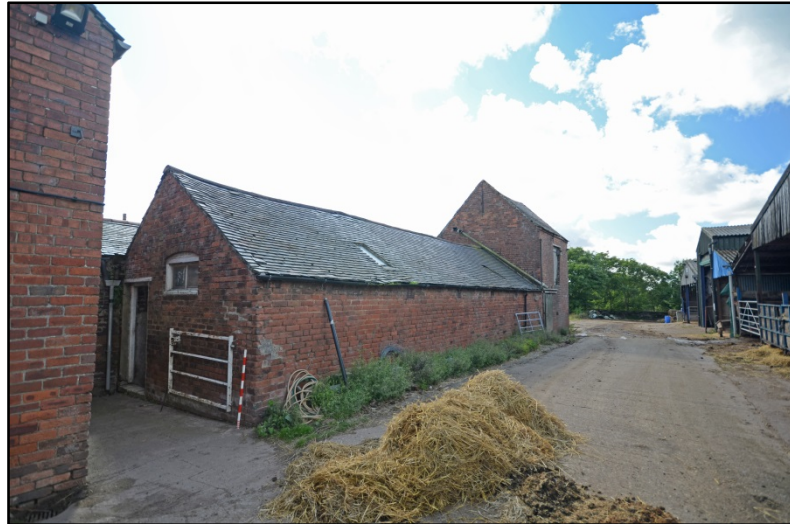
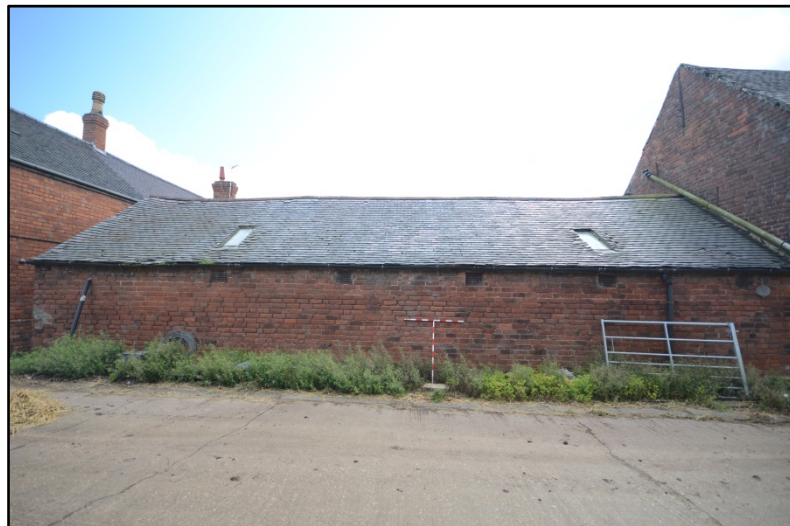
The western barn dates to between 1883 and 1923 and comprises a north-south aligned linear range measuring c20x x 4.5m. This range fully abuts the earlier range to its east and shares a common wall. The range is constructed of red brick, primarily in stretcher bond with occasional rows of stretchers and headers. The gabled roof is constructed of slate tiles with rounded ridge tiles and forms a valley with the adjacent roof. Pairs of roof lights have been added to either side of the roof. The internal roof structure comprises white painted timber king posts trusses with diagonal bracing and iron ties through the king post and lower member. The trusses support timber purlins, rafter and the battens which carry the roof tiles.

The building stops short of the farmhouse, in line with the covered passage, but its roof is not continued over the space between. The north elevation has an off-centre single-width ledged and braced door with simple wooden lintel, which opens into the northern room, and a small two-light window with arched brick lintel which is located beside the door. A simple iron gate is hinged to the north elevation and can be swung outward to close off the passageway when cattle are moved around the farm. The west-facing elevation is plain with no window or door openings. A number of equally spaced square vents with iron grilles are located below the eaves.

The west barn, looking south Fig 22

The west elevation of the western barn Fig 23

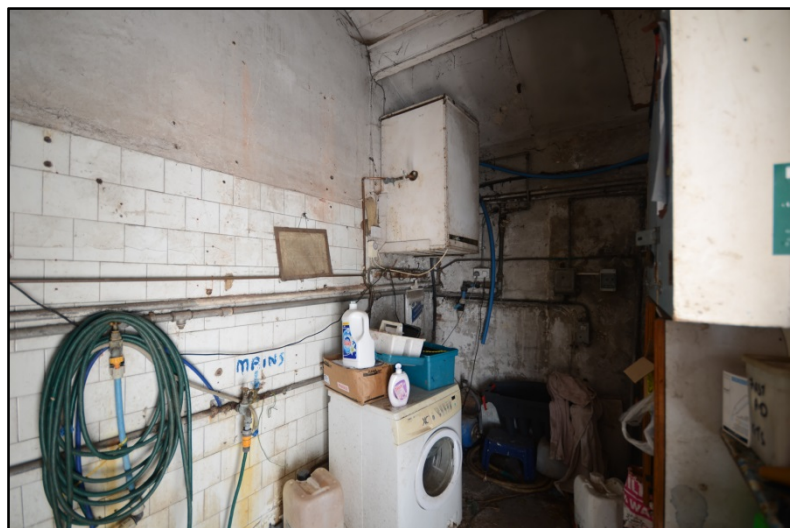
The northernmost room is a fairly small space serving as a utilities / washroom and is accessed from the passage. The door opening has bullnose brick jambs and a sliding door with iron rails. The underside of the roof has been covered with white painted planks and the internal walls have a mix of tile, render and white wash coverings. The middle room was utilised as a store at the time of the survey and the interior space was fairly cluttered. The room had a single access from the east and formerly had a window opening to the east, now blocked.

The east barn, northern room Fig 24

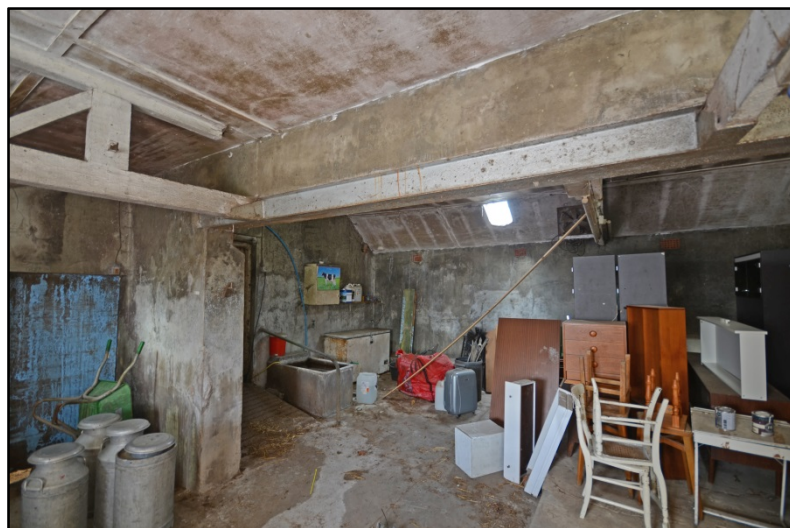
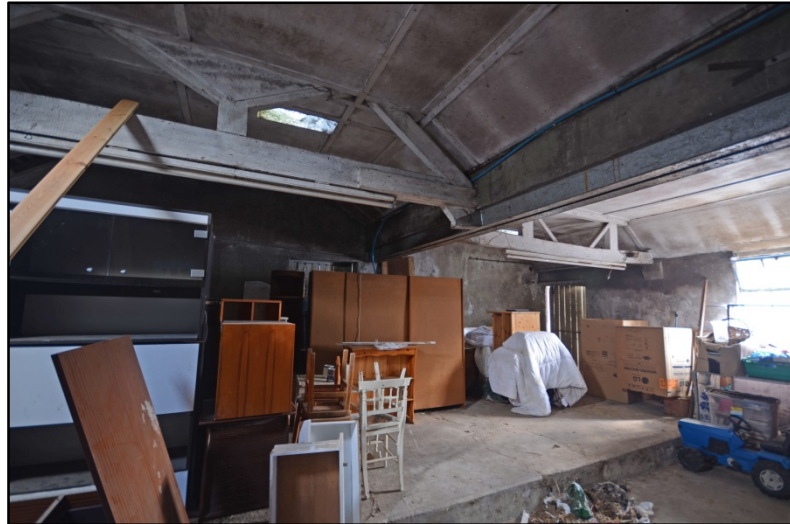
The south room was the largest of the three and the west wall had been partly removed to create a shared space with the later adjacent range. An RSJ (Rolled Steel Joist) spans the width of the opening between the two. The room has a concrete floor and the walls are plastered and painted. Two queen post trusses with diagonal bracing are exposed below the underside of the roof and are supported over the RSJ. At their eastern ends the trusses are supported over protruding brackets. A single-width, blue painted wooden door located in the south-western corner of the room allows access to the modern cowshed.

The remainder of the building is a single room, made larger by the removal of the west wall of the earlier barn. At the time of this survey, this space was used for the storage of large furniture which prevented a thorough inspection of the room. The floor of the room is on two levels with a timber plank platform at the northern half with a concrete surface adjacent. The ceiling of the room has been lowered so that only the lower portion of the trusses is exposed.

The south room of the east and west barns, looking west Fig 27

The south room of the east and west barns, looking north-east Fig 28

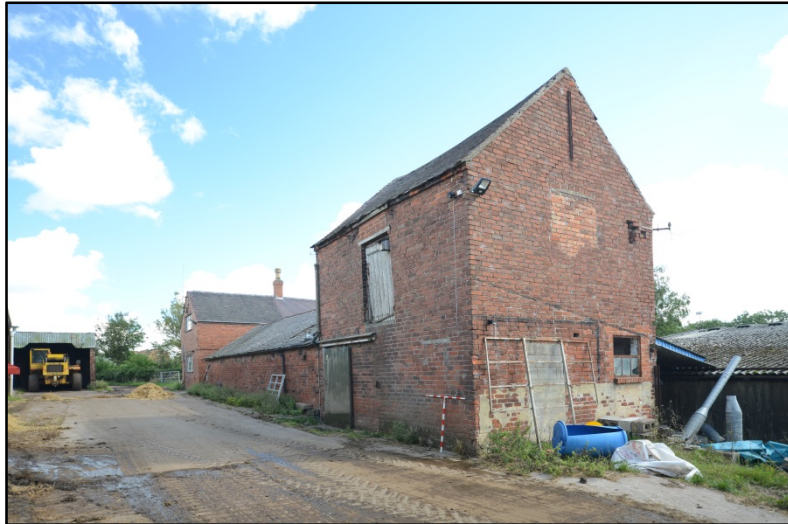
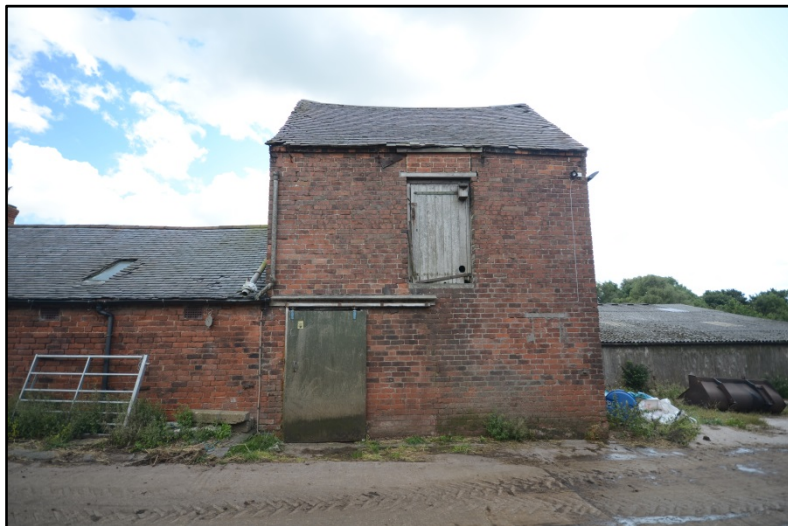
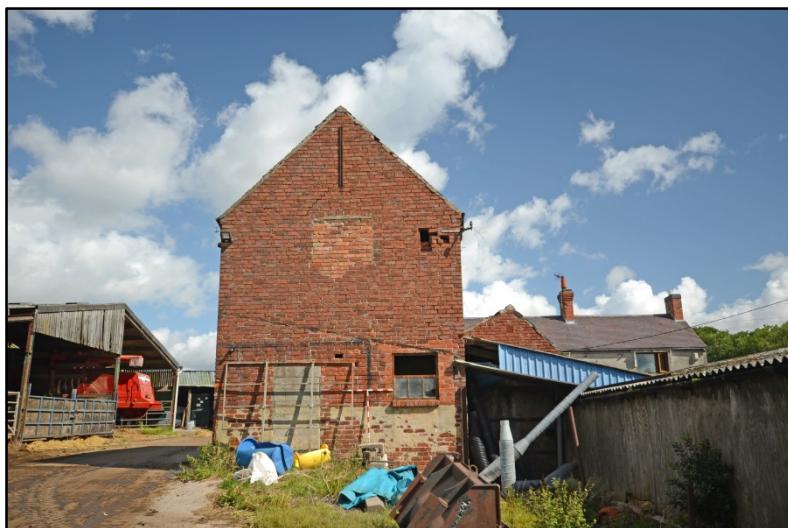
The Granary is contemporary with the western barn and is part of the same structure. It is a two-storey building on a square plan measuring c5 x 5m. It is constructed of red brick, primarily in stretcher bond with occasional rows of headers and stretchers, and has a gabled roof of slate tiles. A smaller structure with sloping roof formerly abutted with southern wall of the granary.

The west elevation is a continuation of the west wall of the barn and there is no join between the two. A single-width door opening with green-painted sliding timber door provides external access to the ground floor room. A small square vent with timber lintel is located adjacent to this door and has been blocked in brick. A loading door is located centrally at first floor level. A transom light above this door has been blocked with brick. The south gable elevation presents a former door opening, blocked with CMU, which formerly opened into a single-storey building, demolished prior to survey. Adjacent to this door is a square window opening with modern brick surround which is a later addition to the building.. An original window opening with arched brick and timber lintel is located centrally to the elevation and has been blocked in brick.

The Granary, looking north-east Fig 31

The Granary, west elevation Fig 32

The Granary, south elevation Fig 33

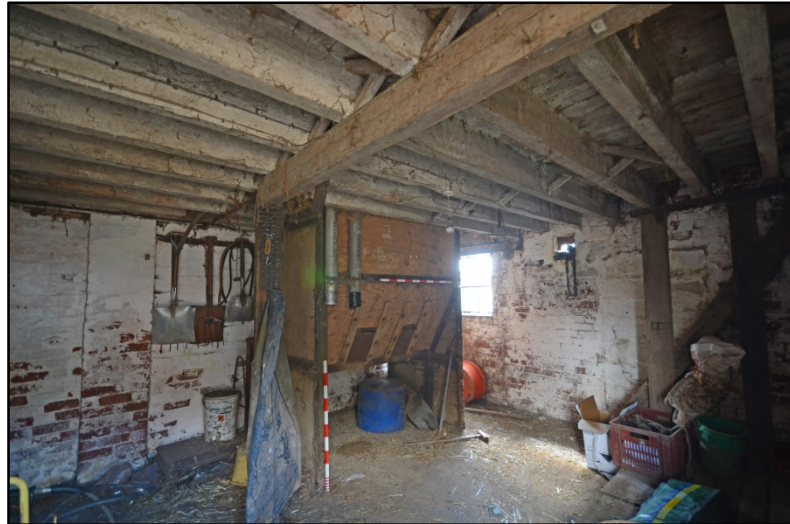
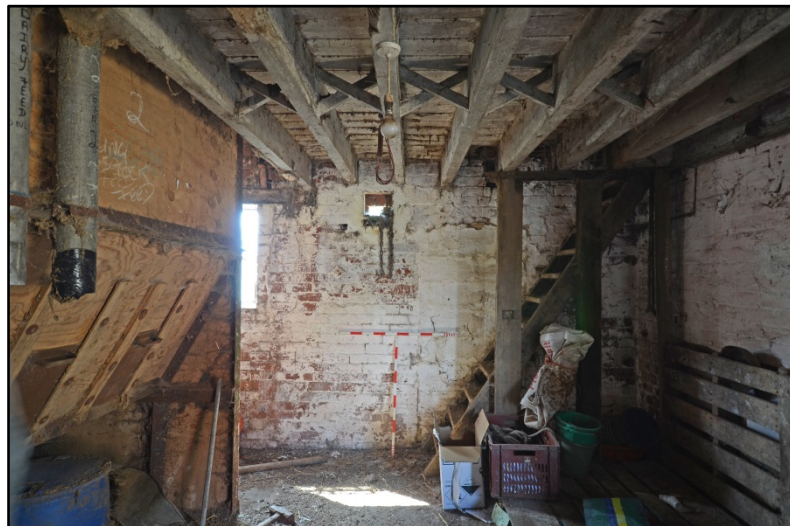
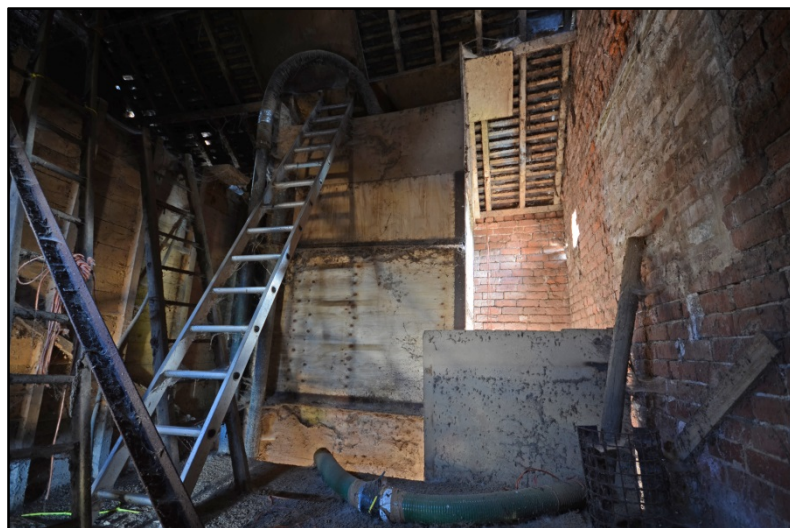
The ground floor space is a single square room with concrete floor and an exposed timber ceiling of joists supported by a central beam with cross-bracing. A ledged and braced door in the north-east corner of the room allows access to the south room of the barn. A wooden feed chute is located off-centre to the room and allows easy dispensing of feed from the upper floor which is accessed by a narrow stair in the south-west corner of the room. The upper floor is effectively a platform which occupies the western half of the room with the feed chute rising from the ground floor. A small crawl space has been created above the ceiling of the south room of the adjacent barn which can be accessed by ladders.

The Granary, ground floor room with feed chute Fig 34

The Granary, ground floor room with access to first floor Fig 35

The Granary, first floor room, looking south-east Fig 37
