**A programme of archaeological observation  
investigation, recording and analysis at  
Canons Ashby, Northamptonshire  
November 2015**

**Report No: 15/215**

Scheduled Monument Heritage List number: 1015534  
Registered Park and Garden Heritage List number: 1000488  
Planning application: DA/2015/0888

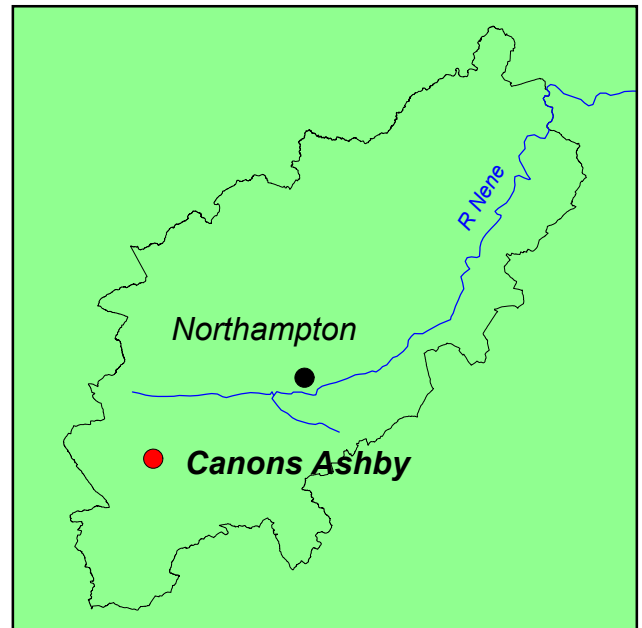
Site location Fig 1

MOLA was commissioned by the National Trust to undertake a programme of archaeological observation, investigation, recording and analysis on land at Canons Ashby House, Northamptonshire (SP 57517 50805, Fig 1). This was undertaken to fulfil a condition on the planning permissions for work relating to the replacement of a sewage treatment plant tank to the north of the car park with another tank in the same location (Planning Ref: DA/2015/0888).

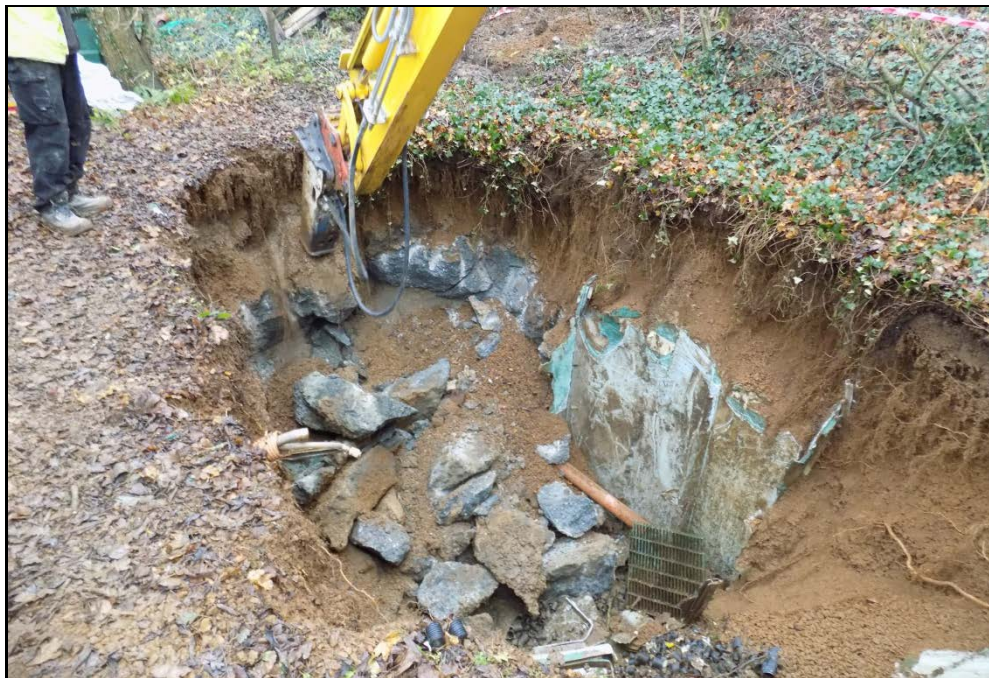
Removing the concrete footing, looking east Fig 2

After the removal of the former septic tank, the excavation works took place under constant archaeological supervision to the archaeological horizon. This included the mechanical removal of the concrete footings of the old tank (Fig 2), and the extension of the trench to the west to allow space for the siting of the new tank (Fig 3). The archaeological remains present were then fully examined, excavated and recorded. The stripped areas were hand cleaned as required to produce a sketch plan.

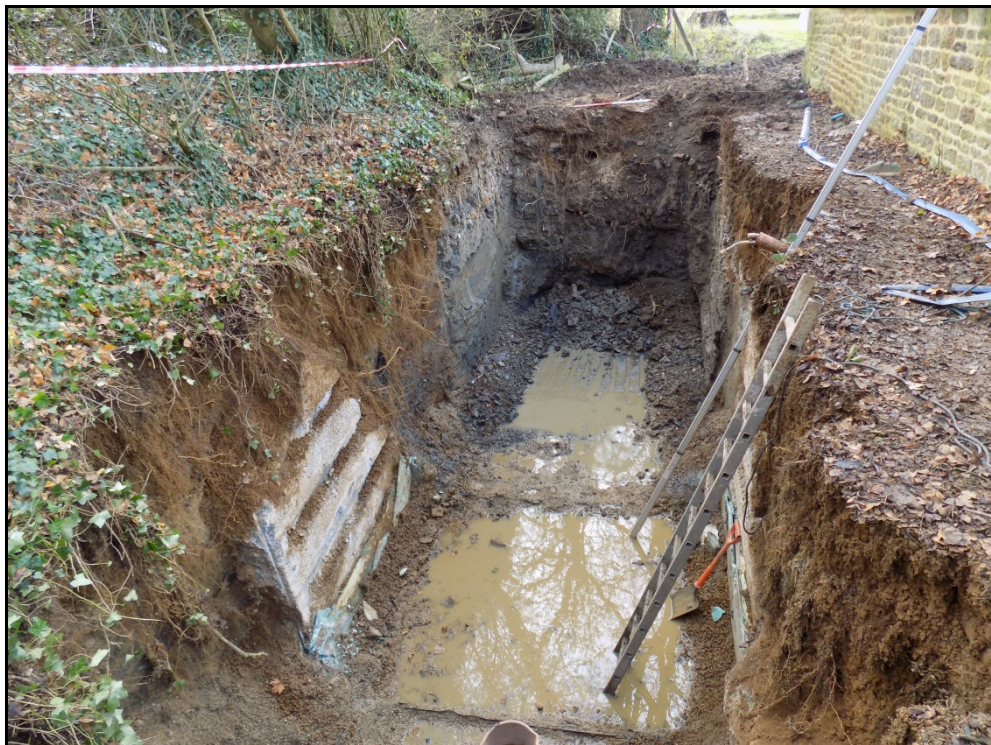
Site view showing the site after the removal of the tank and concrete, looking south-west Fig 4

At the same end of the trench, a modern pipe, presumably part of the sewage works infrastructure, was shown to cut into the natural clay. The pipe trench was straight-sided, and was filled with large deposits of crushed limestone gravel. This gravel was found to be spread throughout the area of the former tank. The pipe lay at c1.0m below the ground surface (see Figs 4-5).

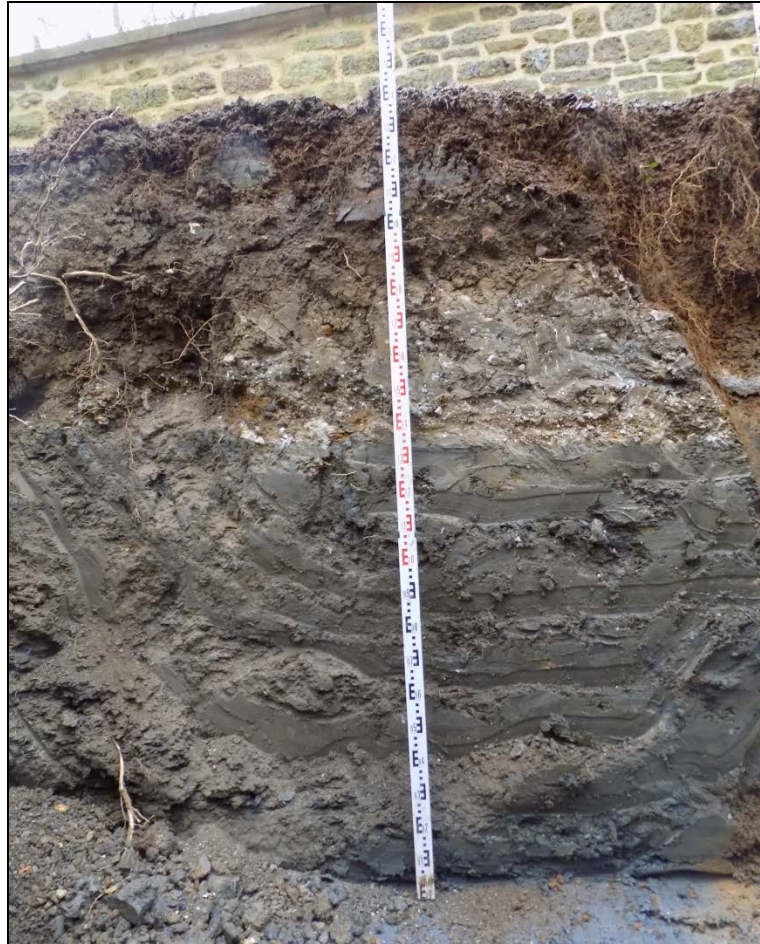
South-east-facing baulk showing natural clay and chalky-clay make-up layer, looking north-west Fig 5

The natural geology of the site was observed to be grey clay. The removal of the overburden showed that it comprised a c0.70m deep make-up layer of compacted clay and chalk (Fig 5). This was overlain by very thin organic topsoil with a high density of plant roots.

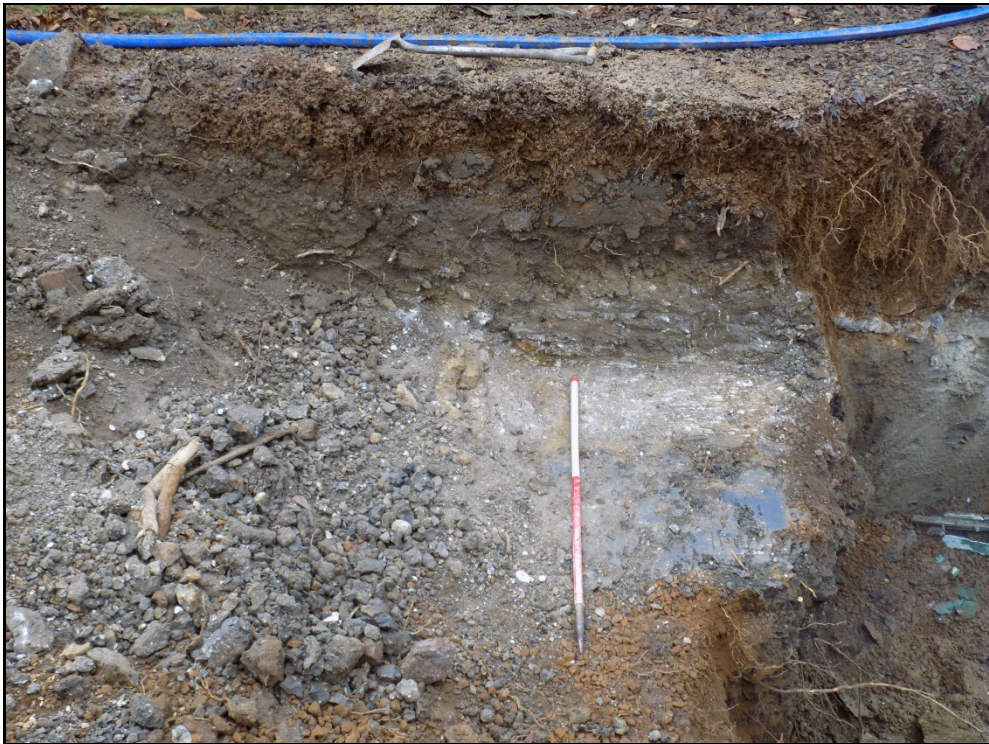
Possible footings trench, looking north-west Fig 6

At the south-west end of the trench, on the north side, a possible footing trench was observed. This feature was aligned east-west, and cut into the natural clay c1.0m below the ground surface (Fig 6). As it only partially appeared within the trench, the nature of this feature could not fully be defined, and it may have only been the lower edge of the make-up layer.

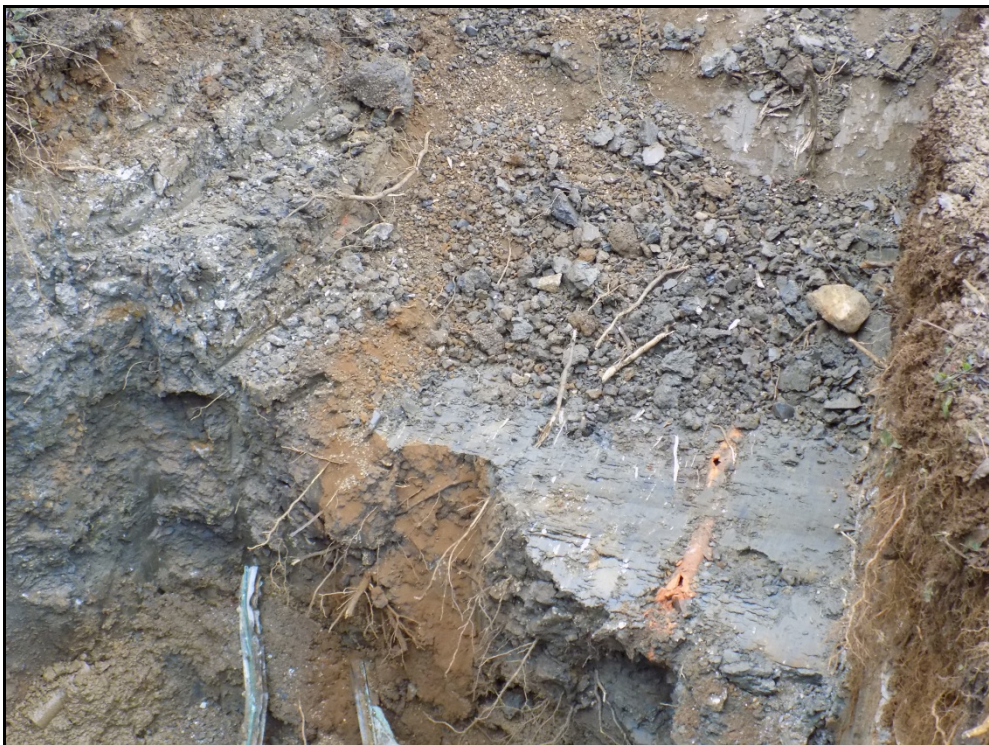
Ceramic land drain, looking south-west Fig 7

Also at this end of the trench was a 19th-century ceramic land drain, aligned east-west. It lay c1.20m below the ground surface (Fig 7).

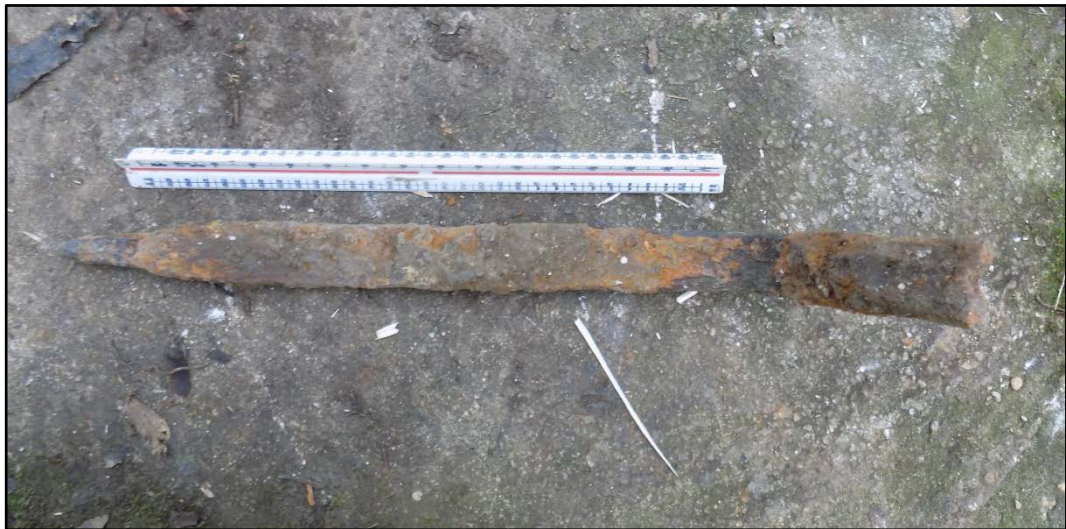
Iron fence spike Fig 8

An iron fencing spike was found in the chalky-clay make-up layer at the south end of the trench. It measured 10mm wide by c0.55m long. It was of modern date and was not retained (Fig 8).
