**Archaeological observation, investigation
recording and analysis of land
at Deene Hall, Deene Park
Northamptonshire
February 2016**

Report No. 16/34

Author: Adam Meadows

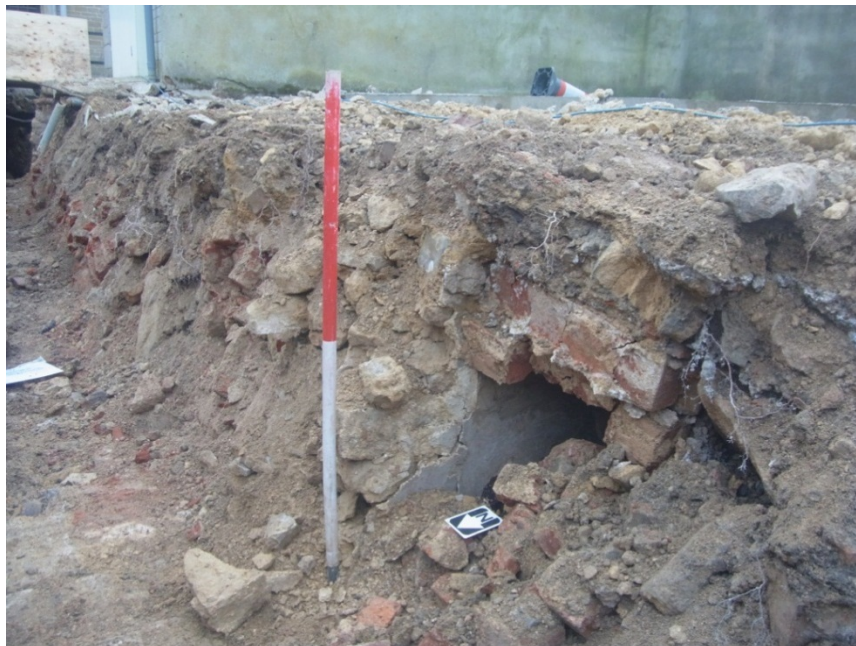
Plaster remains on wall [106] Fig 3

Three limestone walls were sectioned within this trench [104], [106] and [107]. They were all aligned north-south and constructed of square-cut limestone of an average size of c 200mm. The bricks were bonded with a poorly preserved sandy shelly mortar, and the walls were all c 80cm wide while their depth went below that of the excavated trench. The finish of the wall facings and the 10mm thick layer of plaster present upon the western face of wall [106] indicate that these represent potential cellarage below a substantial building (Fig 3).

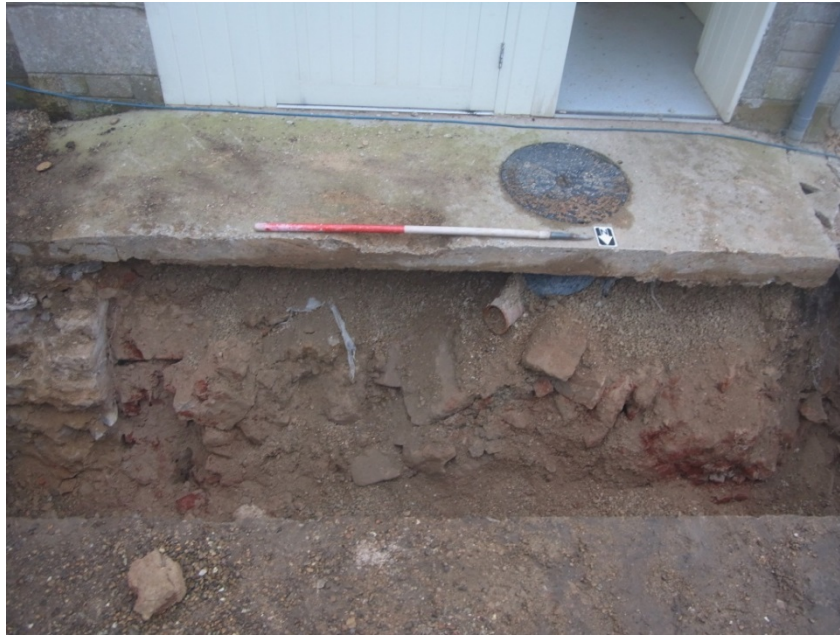
Brick rubble deposit (105) with wall [104] to the left Fig 4

The material found south of wall [108] and between walls [104] [106] and [107] comprised predominantly red brick rubble in varying states of preservation. This included whole bricks, fragmented bricks and some bricks that were still mortared

together in 'Running Bond' (105) (Fig 4). This deposit was only present within these walls, and is likely to represent demolition rubble dumped within the exposed cellar cavity prior to being covered to form the courtyard present today.

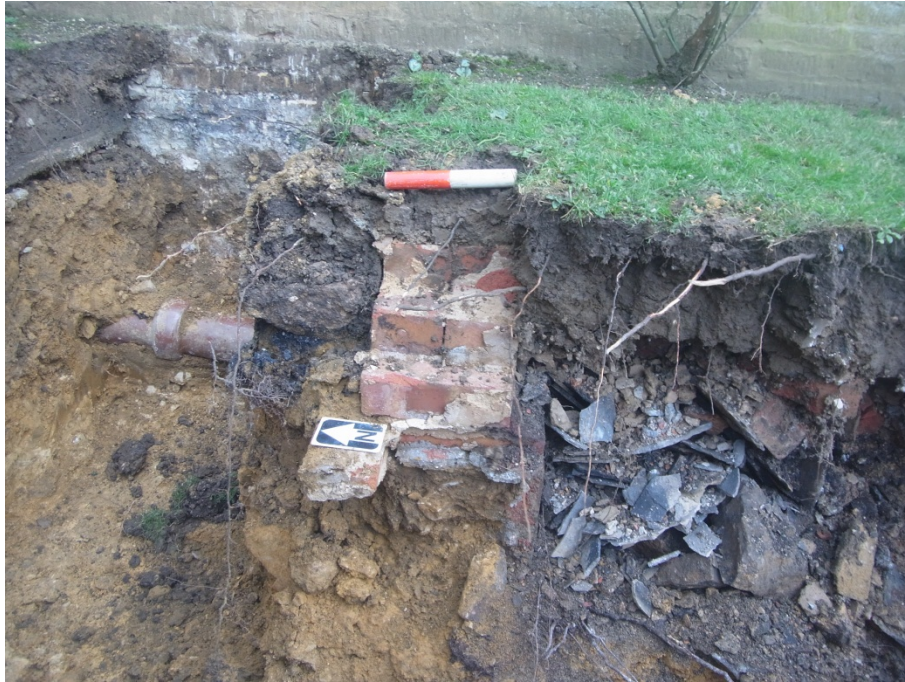
Wall [205] with roofing slate deposit (208) Fig 5

A further three walls were encountered in the northern portion of this trench running in an east-west orientation. One of these [207] was preserved through a linear concentration of limestone blocks that may represent packing within a foundation trench. The northern wall [205] comprised two courses of brickwork 0.34m wide and 0.43m deep constructed of well fired unfrogged bricks (Fig 5).

The area within walls [205] and [206] contain two deposits that are likely to result from the demolition of this ancillary building. This includes [204], a block of bricks nearly entirely enveloped by mortar and concrete which may have been a footing for this structure. Against the southern face of wall [205] there was a deposit of slate roof tiles

(208) which again are likely to have been left from this recent demolition. Within the slate deposit there was an iron framed thermometer which could indicate that this building once contained a boiler or other such machinery in need of temperature regulation (SF 1, Fig 15).

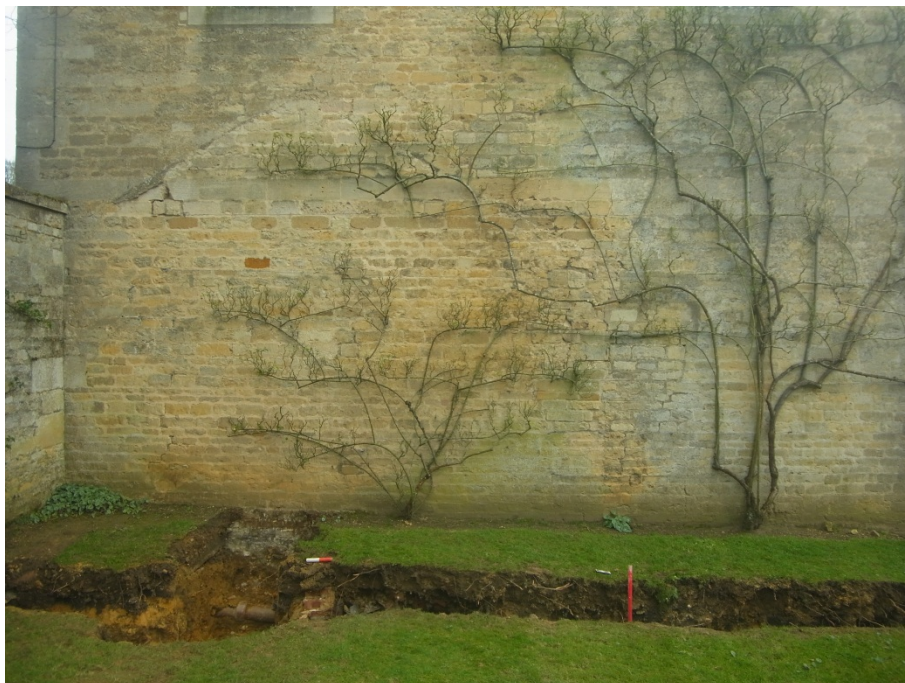
Wall [206] was a concreted mass of brick and limestone which is likely to be the remnants of a foundation wall footing. These features, particularly wall [206], appear to match a scar found on the side of the tea room at Deene Hall (Fig 6). This represents a recently demolished building that still features on current Ordnance Survey mapping.

Building scar upon Deene Hall, the left scale locating wall [205] and the right scale indicates wall [206] Fig 6

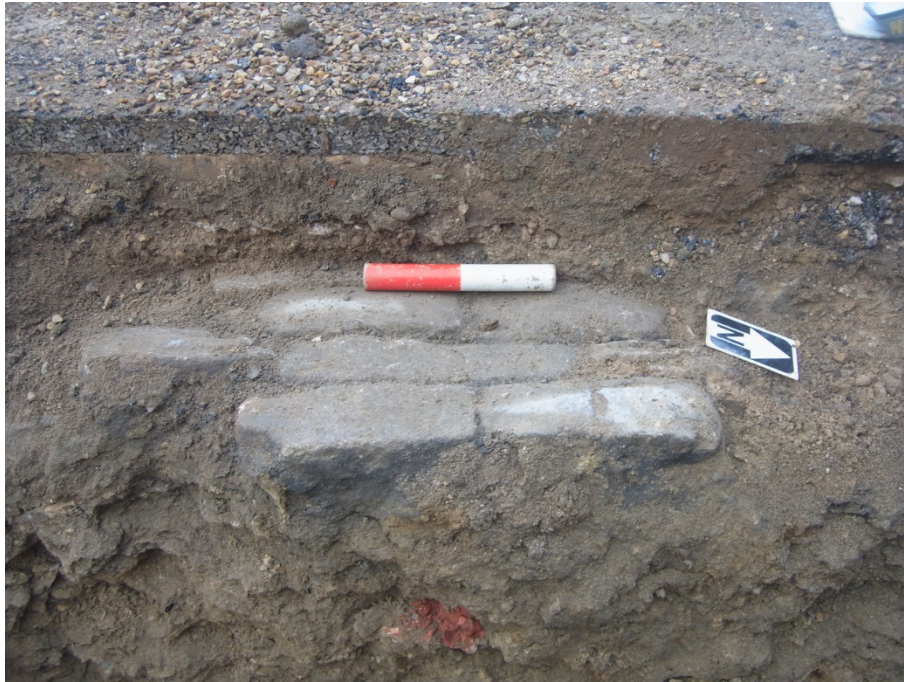
Trench 2, cobbled surface (212) Fig 7

There is evidence of a previous surface for this courtyard in the southern half of trench 2. This consists of some cobble stones found below the tarmac between walls [209] and [210] (Fig 7).

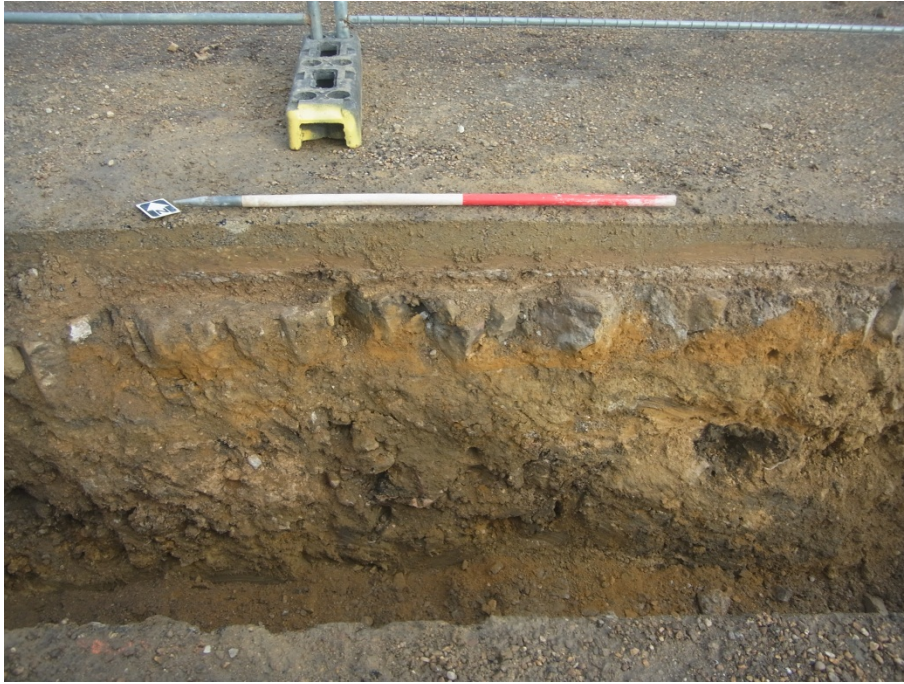
Section of Trench 5 including a potential limestone surface Fig 8

Trench 5 was located at the western side of Deene Hall and was aligned north-west to south-east. Its stratigraphy differed from the other trenches. The south-eastern part of the trench cut through 0.14m of modern tarmac and concrete which, in places, overlies the remnants of a limestone surface (502) set upon a near pure bed of orange sand 0.11m thick (503) (Fig 8). Below this there was a rubble layer (508) of a similar consistency to (203) which extended down to the base of the trench. The north-western end of the trench followed the eastern side of an existing road. Here a layer of black loamy topsoil (510), 0.15m thick overlies an orangey layer of silty clay subsoil (511). Below this there was the continuation of the rubble spread (508) which became thinner as it becomes more distant from Deene Hall. This layer was underlain by natural clay mixed with Cornbrash limestone (509).

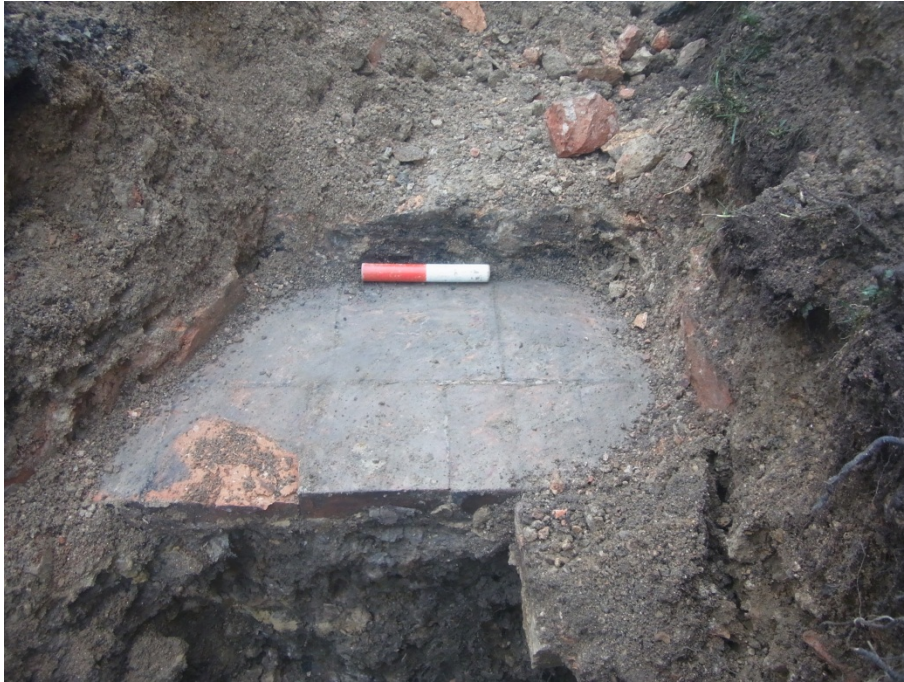
Paviour brick surface Fig 9

North of wall [507], just below the layer of tarmac the remains of a Pavioir brick surface was uncovered (Fig 9).

The sample brick from the surface is 175mm square and 50mm thick (7 inches x 2 inches). It is mould made with hard fine sandy pale red clay with frequent ironstone and gravel inclusions up to 10mm long (Fig 14). The top of the brick is slightly rough to the touch as the overlying surface (Fig 9) protected it from wear.

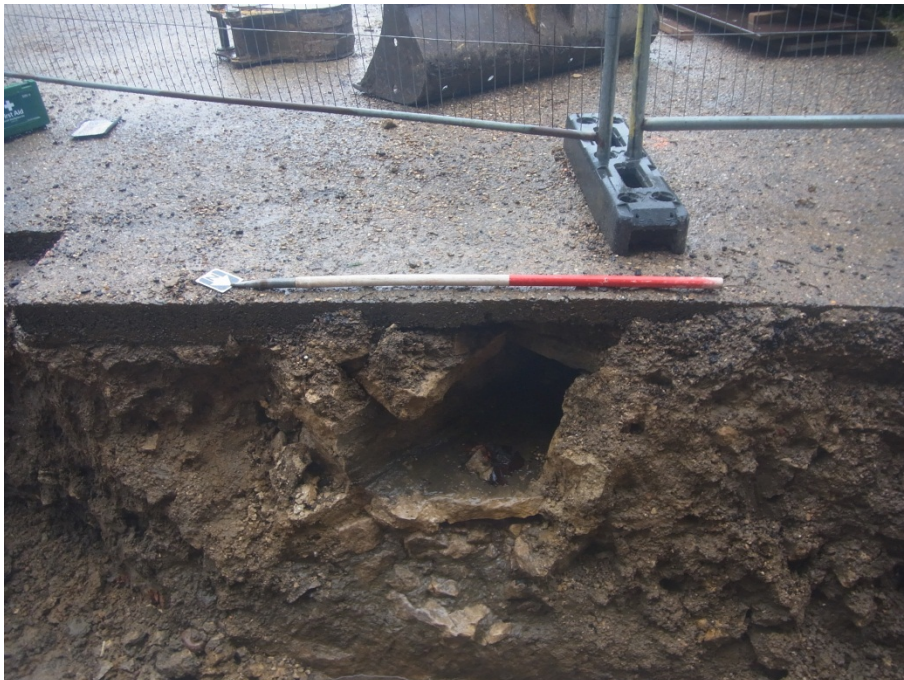
Stone-lined drain within Trench 7 Fig 10

An undated stone-lined drain which was still directing water was present in Trenches 7 and 8 (Fig 10).

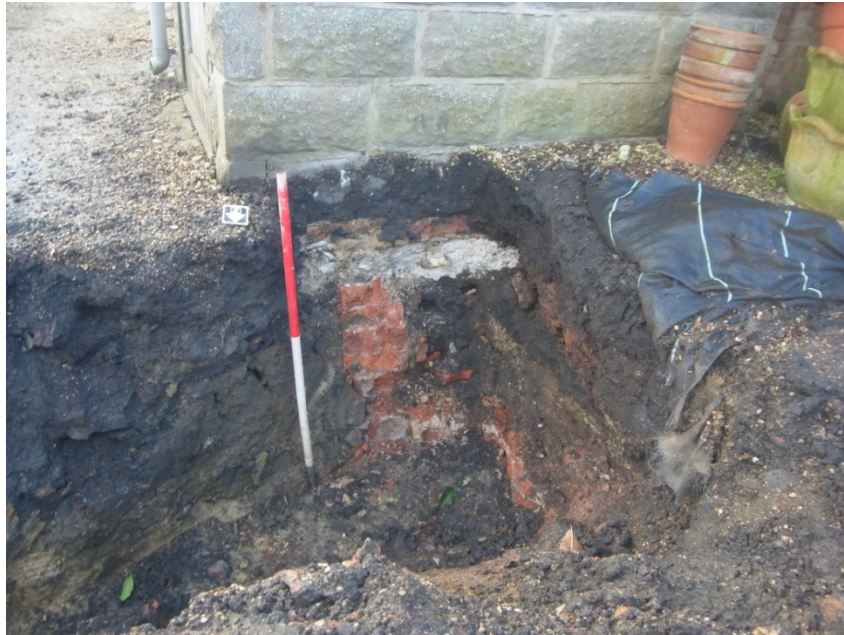
Stoke house remains within trench 10 Fig 11

The remnants of a Victorian stoke house were uncovered within Trench 10, beneath a modern concrete boiler house. This would have been used to heat up the large glasshouses that were located within the walled kitchen garden (Fig 11).

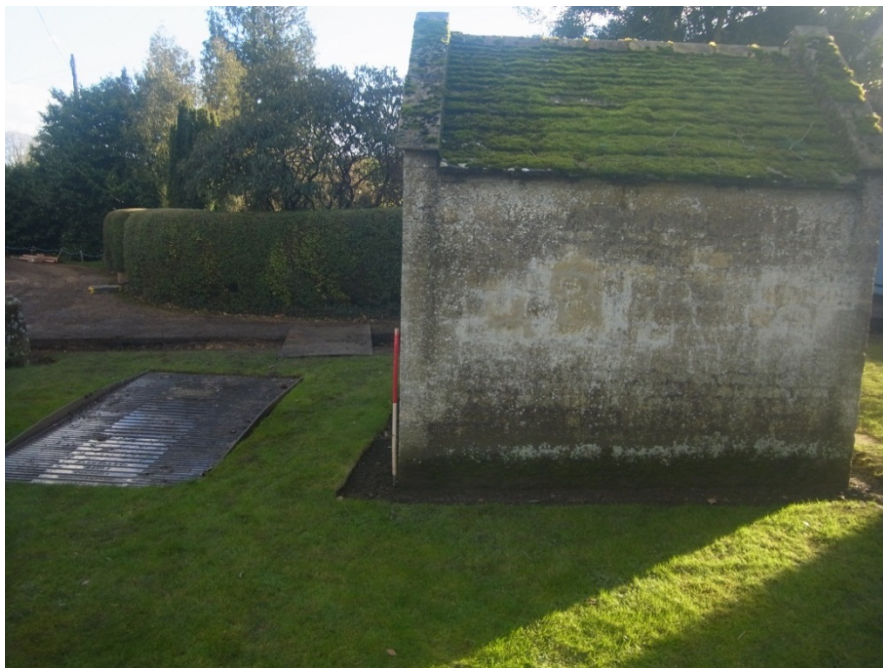
Weigh station house and platform Fig 12

Trench 9 uncovered a limestone gravel path leading from the weigh station located north of the trench. The weigh station is a small limestone building with a slate roof (Fig 12). A sign over the entrance door indicated that the estate had a licence to sell game. Outside the window of this structure, there is a metal plate on the ground which would have been used to weigh livestock, it is cast iron and inscribed with 'Barwell & Co, Eagle Foundry, Northampton, 1836'. This pathway might have led to the southern part of the cottage which used to operate as a slaughter house.

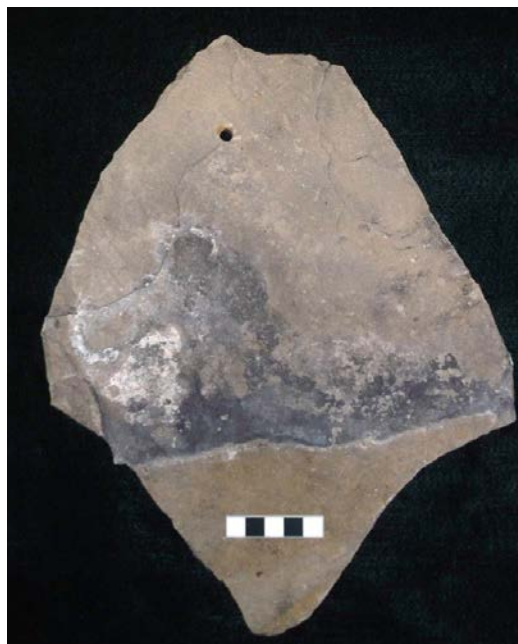
One almost complete roof tile and half of another were collected as the best surviving samples. Both tiles have been burnt both sides. The material is most likely Groby or Swithland slate from north-west Leicestershire, quarried until the 19th century when cheaper Welsh slate brought about a permanent decline in the industry (Ramsey 2007).

The almost complete tile is diamond-shaped, 315mm long, 245mm wide in the middle and 12mm thick, with a peghole, 7mm in diameter near the top. The bottom half of the tile has had both sides cut with a slight concave arc down to a point, probably for reuse from an original possibly damaged rectangular tile (Fig 13). The other tile was originally rectangular, 225mm wide and 10mm thick, cut cleanly in half with the bottom half surviving.

Slate roof tile (scale 50mm) Fig 13

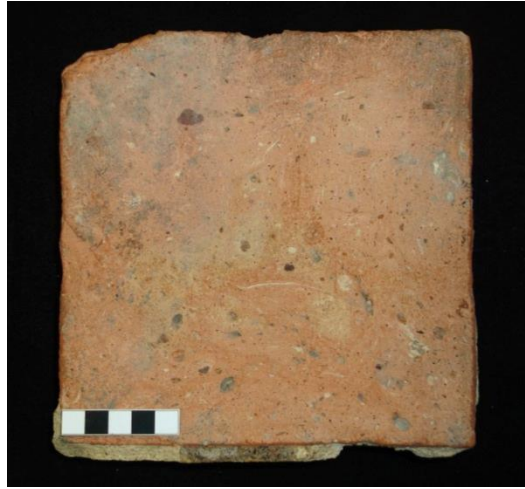
The base of the brick has the remains of grey mortar with an aggregate of large (10mm) white, black and brown stone. One of the sides has the remains of fine white mortar and another has a layer of hard grey Portland cement, 7mm thick, with a vertical line indicating where two other bricks had been laid adjacent to overlap.

Paviour brick (scale 50mm) Fig 14

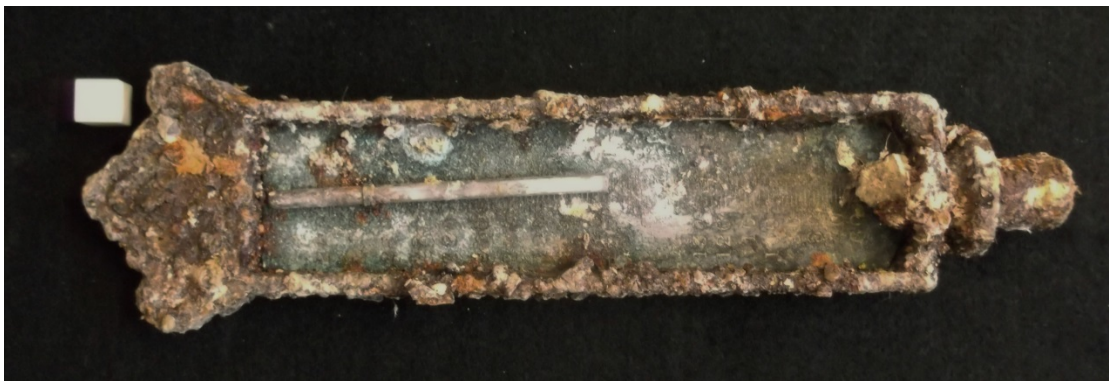
This iron thermometer case is 230mm long, 45mm wide and 15mm thick (Fig 15). The top expands into three decorative lobes, 5mm thick, widening to 63mm, the centre lobe has a banner which holds a maker's name or symbol and initials above. The base of the recess expands into a cone 30mm in diameter and 18mm deep with a ring 5mm thick and 30mm in diameter below to hold the glass inside the 18mm tall and 15mm wide cylindrical base, where remnant glass is still poking out.

The shallow recess, 10mm deep and 153mm long, holds the still partially surviving glass thermometer. The recess was lined with copper plate carrying the graduated scale which had a range from 60° to 260° F (Fahrenheit).

This would have been a thermometer for specialised use, requiring monitoring of very high temperatures, in a boiler for a laundry or greenhouse, or for jam making perhaps.

Iron thermometer case, top to the left (scale 10mm) Fig 15

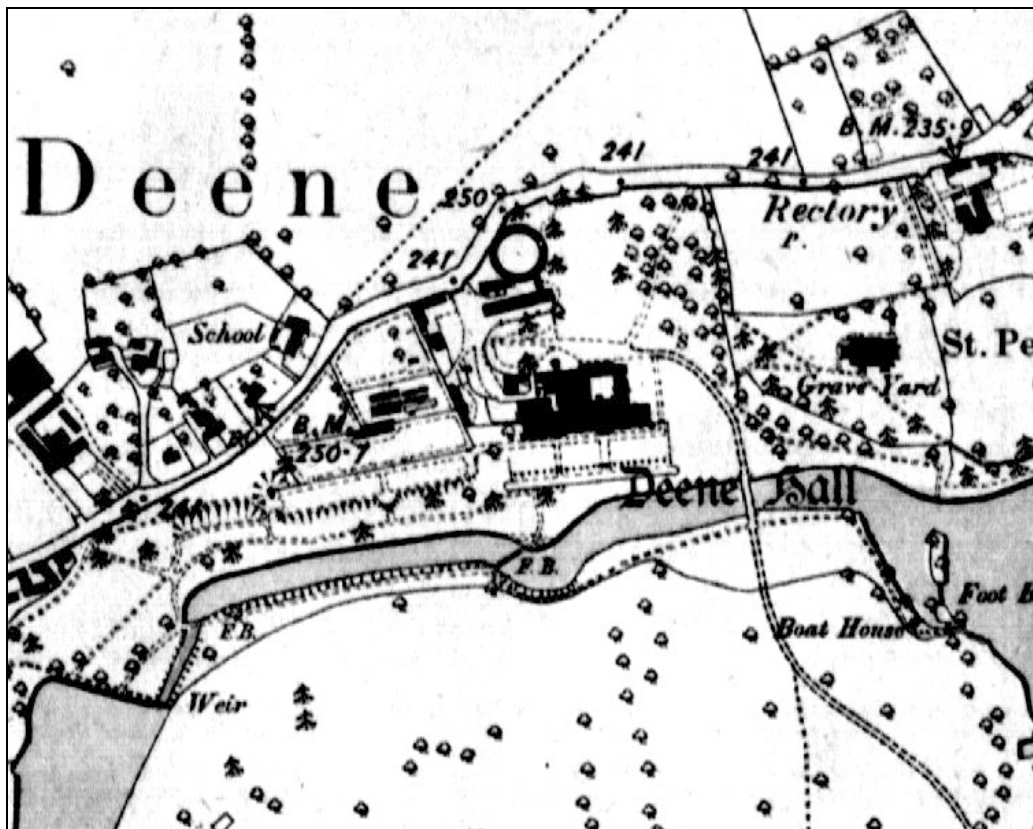
Extract from First Edition Ordnance Survey map, 1886, showing the 19th-century layout of the house Fig 16

A concentration of archaeological features was located in the southern portion of the site, located within the courtyard of Deene Hall. This consisted of a number of walls mostly constructed of limestone with some red brick walls also present. These are likely to be the remains of the large building that is marked out on the 1886 Ordnance Survey map, the 18th-century laundry house and Victorian ballroom that was demolished after a successful appeal to the House of Lords in 1984 (Fig 16).
