**Archaeological watching brief  
at Saxon House, Bakewell Road  
Orton Southgate  
Peterborough  
March 2016**

Planning reference: 15/01155/FUL

Report No. 16/59

© MOLA Northampton  
Project Manager: Anthony Maull  
Site Code: PSH16  
NGR: TL 13971 94739

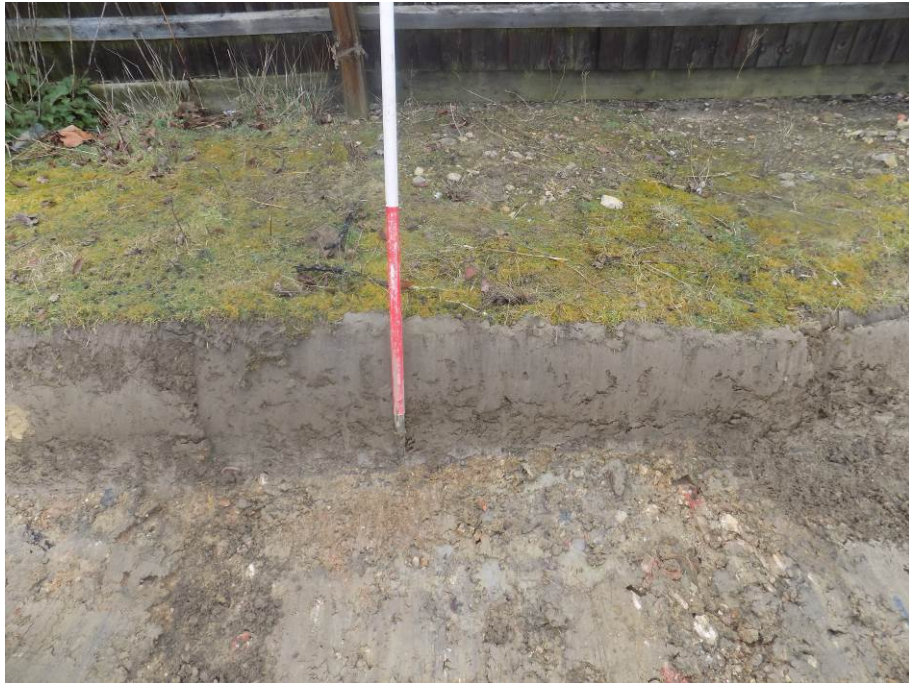
Stripped area section at northern edge of site Fig 3

The extreme northern and southern edges of the development area were outside the gravelled area, and could potentially reveal undisturbed ground; however, no topsoil was discerned and only made ground and re-deposited clays were observed down to the formation level. At the northern edge of the area possible topsoil, c0.30m thick, of mid brown-grey clay was observed, however, this overlay modern made ground (Fig 3) and should be considered as entirely re-deposited in nature. A layer, c0.30m thick, of mixed mid brown and grey clay was observed at the southern edge of the site, this overlay redeposited clays.

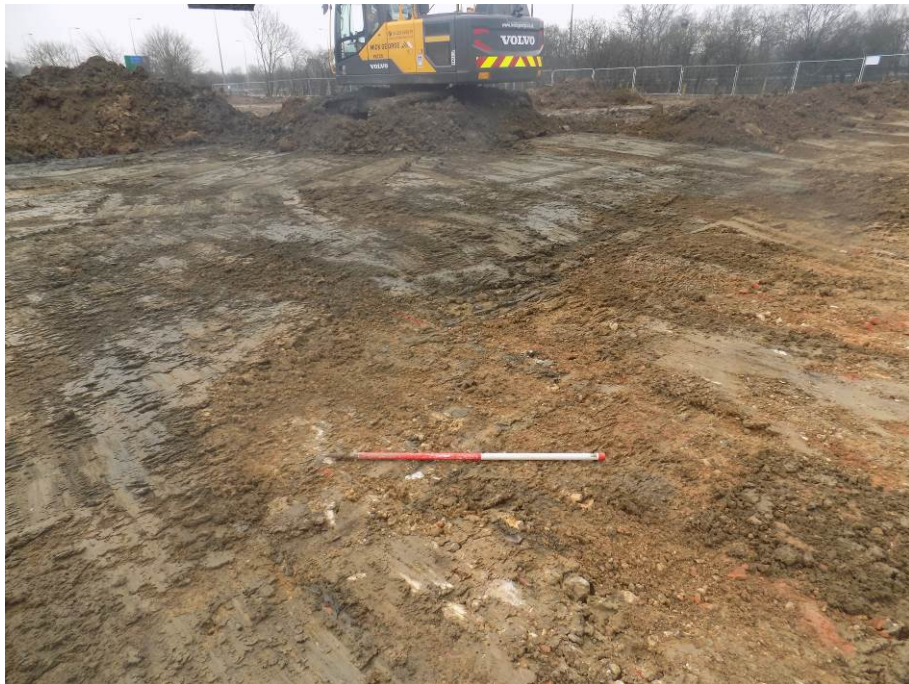
General view showing stripped area, looking south-west Fig 4

The majority of the groundworks within the development area revealed no topsoil to be present, with the majority of the area being a pre-existing gravel surface temporary car park; with the gravel layer being between 0.20m to 0.60m in thickness (Figs 3-6).

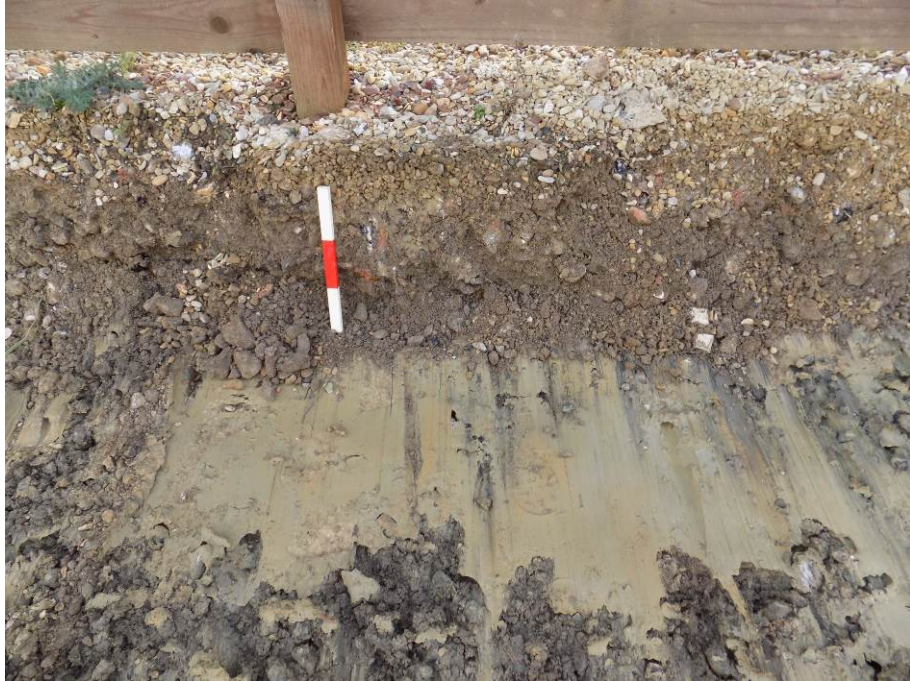
Fig 5

Section in existing gravel layer

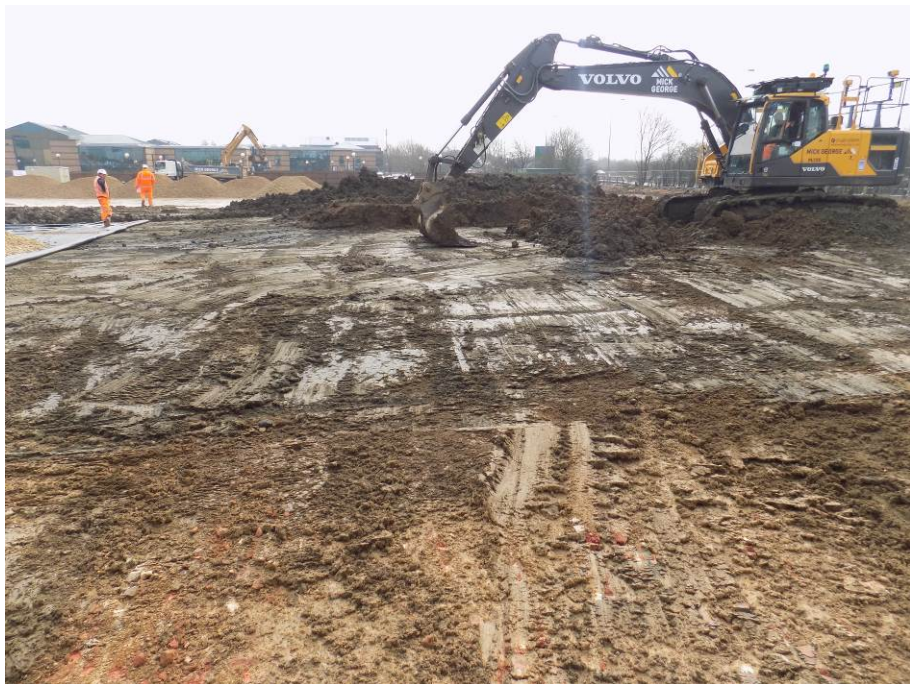
Fig 6

General shot showing stripped area, looking south
