**Archaeological observation, investigation, recording
and analysis of land on the Fosse Way at
Syston, Leicestershire
March 2015 and January-March 2016**

Report No 16/66

Event No: X.A111.2014

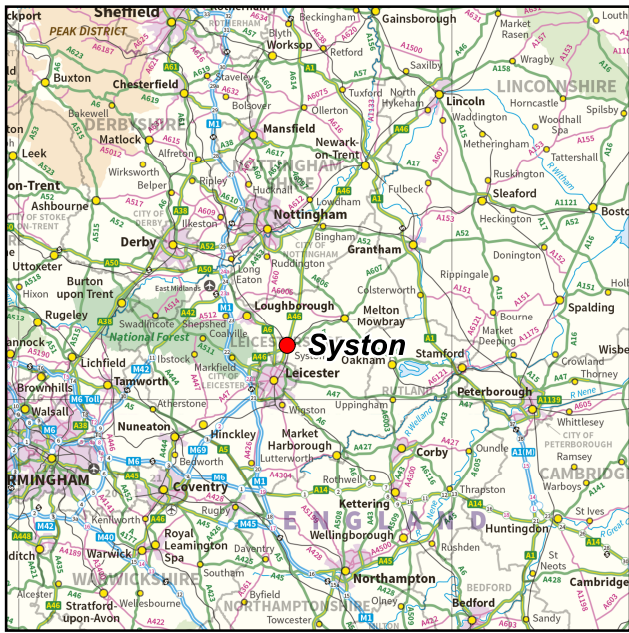
Site location, culvert and test pit location Fig 1

Syston is a village on the north outskirts of Leicester and south-west of Melton Mowbray (Fig 1). Culverts 2a and 3 lie 420m and 480m south respectively of Lewin's Bridge, north of Syston near the River Wreake. The development area, subject to archaeological mitigation, comprises the existing culvert structures underlying the Fosse Way road.

MOLA Northampton had been commissioned by Leicestershire County Council, to carry out a programme of observation, investigation, recording, analysis and publication on groundworks associated with the replacement of flood culverts 2a and 3 on the Fosse Way at Syston, Leicestershire (NGR SK 6210 1251 and SK 6208 1244; Fig 1).

On 10 March 2015, the observation area comprised a small test pit (TP 2), 3.1m long by 0.7m wide by 2.5m deep (Figs 1,3) excavated within the road corridor just to the north of the northernmost drainage culvert (Culvert 2a). The test pit was excavated using a 360° mechanical excavator fitted with a c0.7m bladed bucket.

Test pit 2 (Section 3 and Figs 1, 3, 4) was excavated to a depth of c2.5m where the natural substrate, consisting of a layer of grey alluvial clay (206) at least 1m deep was encountered.

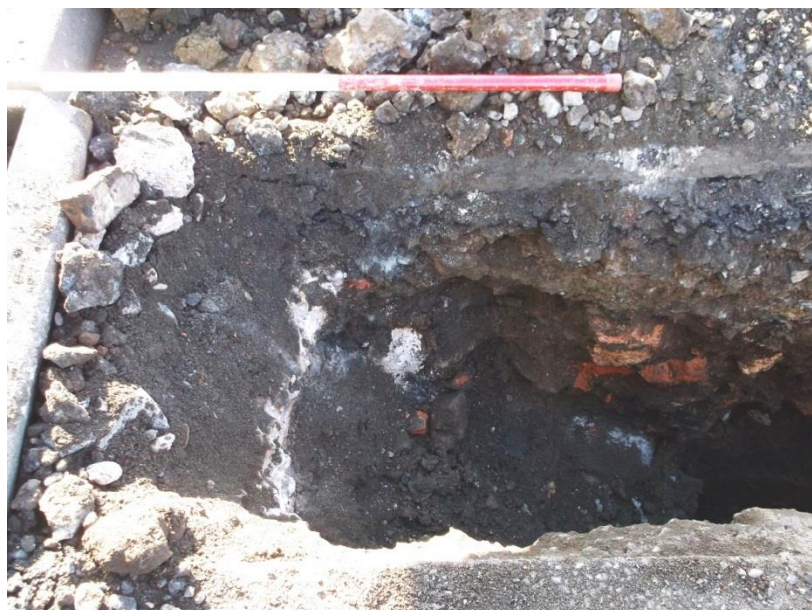
Test Pit 2, section showing modern road build-up (204), looking south Fig 4

Overlying (206) was a 0.5m thick layer of compacted grey brown silty clay (205), above which was a c0.5m deep layer of dark grey-brown silty loam with numerous fragments of modern bricks, fire bricks and small to large fragments of blast furnace slag and clinker (204) which appeared to be the foundation layer for the overlying layers of modern road material.

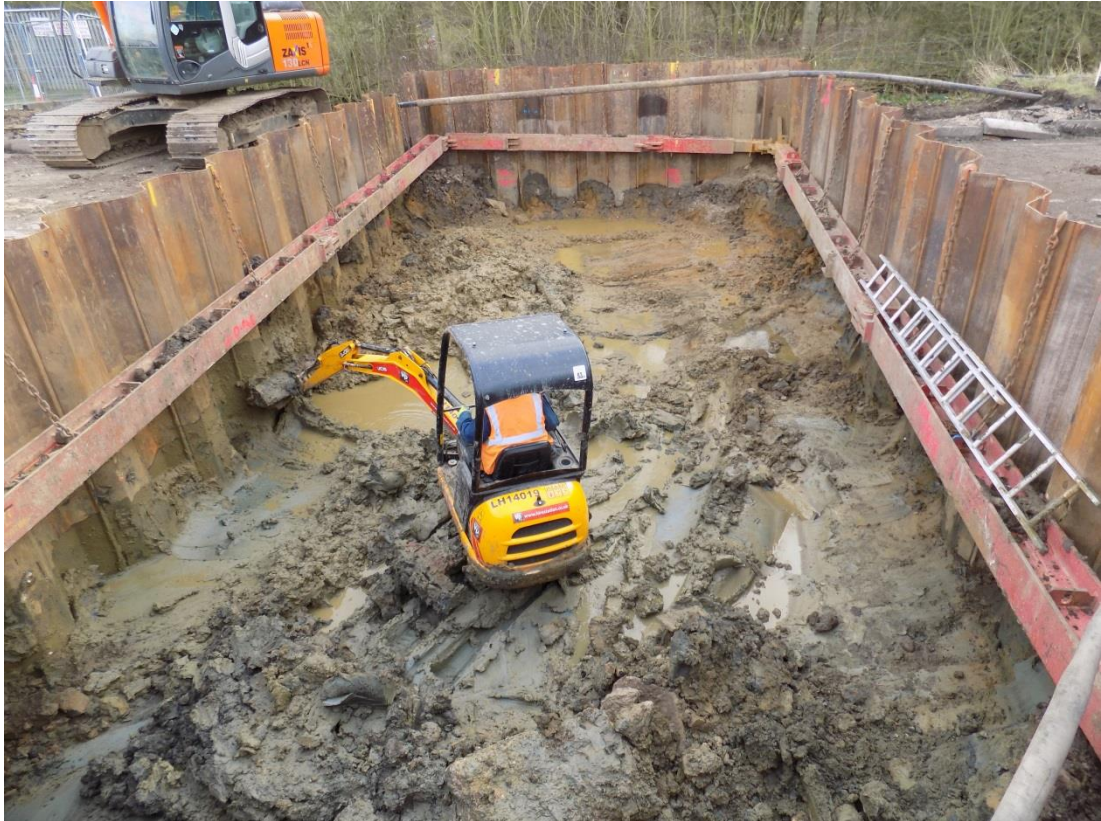
Northern culvert (Culvert 2a), looking east Fig 5

The natural substrate consisted of mid-grey alluvial clay (401) and was observed within the western half of the trench floor, at a depth of c2m below the surface of the modern road surface. In the eastern half of the trench floor a layer of orange-brown clay and gravel (402) was observed (Fig 5). It is uncertain whether or not this layer is part of the natural substrate or whether it represents a layer of build-up material; in appearance, it is very similar to a layer observed in the Culvert 3 trench which may have been part of an agger (see below).

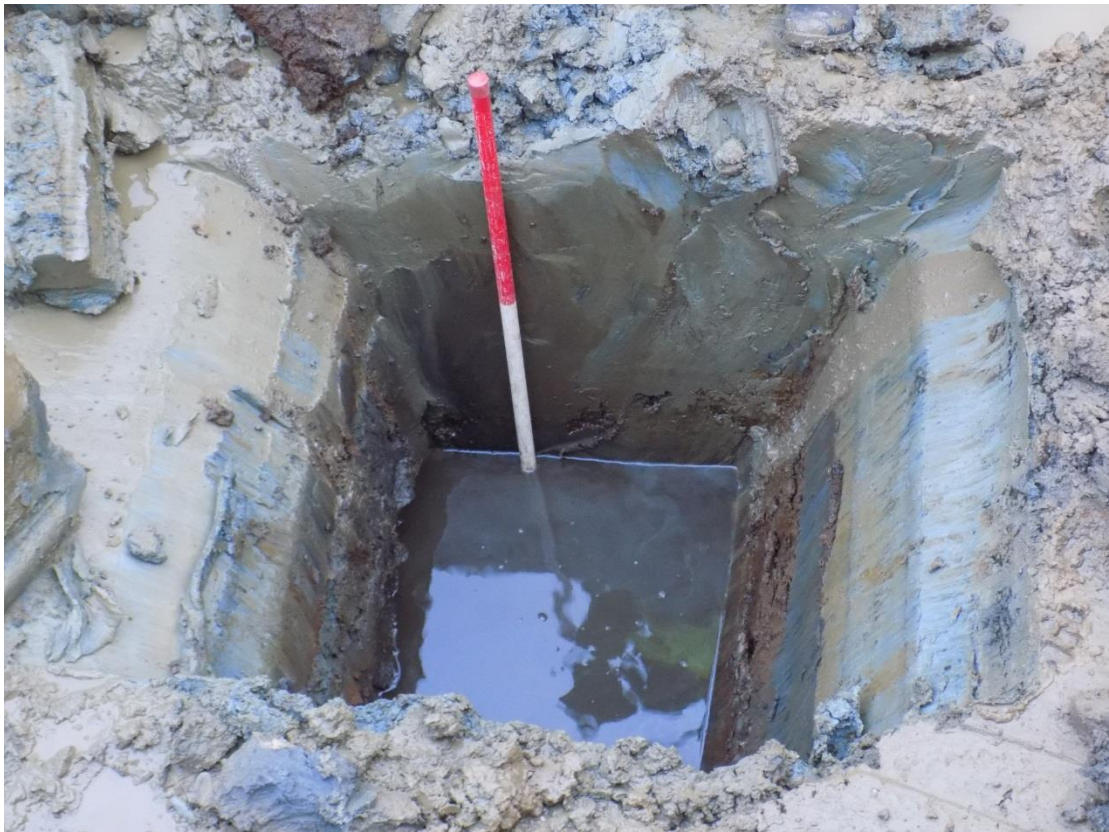
Northern culvert (Culvert 2a), sondage in trench floor, looking north Fig 6

A small sondage (Fig 6) measuring 1m long by 1m wide by c0.8m deep was machine excavated in approximately the mid-point of the trench floor. At the base of the sondage was a layer of dark grey silty clay (405) at least 0.1m deep, this was overlain by a c0.2m deep layer of mid-brown sandy clay (404), which was overlain by a c0.2m deep layer of blue-grey clay (403), overlying this was a 0.3m deep layer of grey alluvial clay (401), seen throughout the western half of the trench floor.

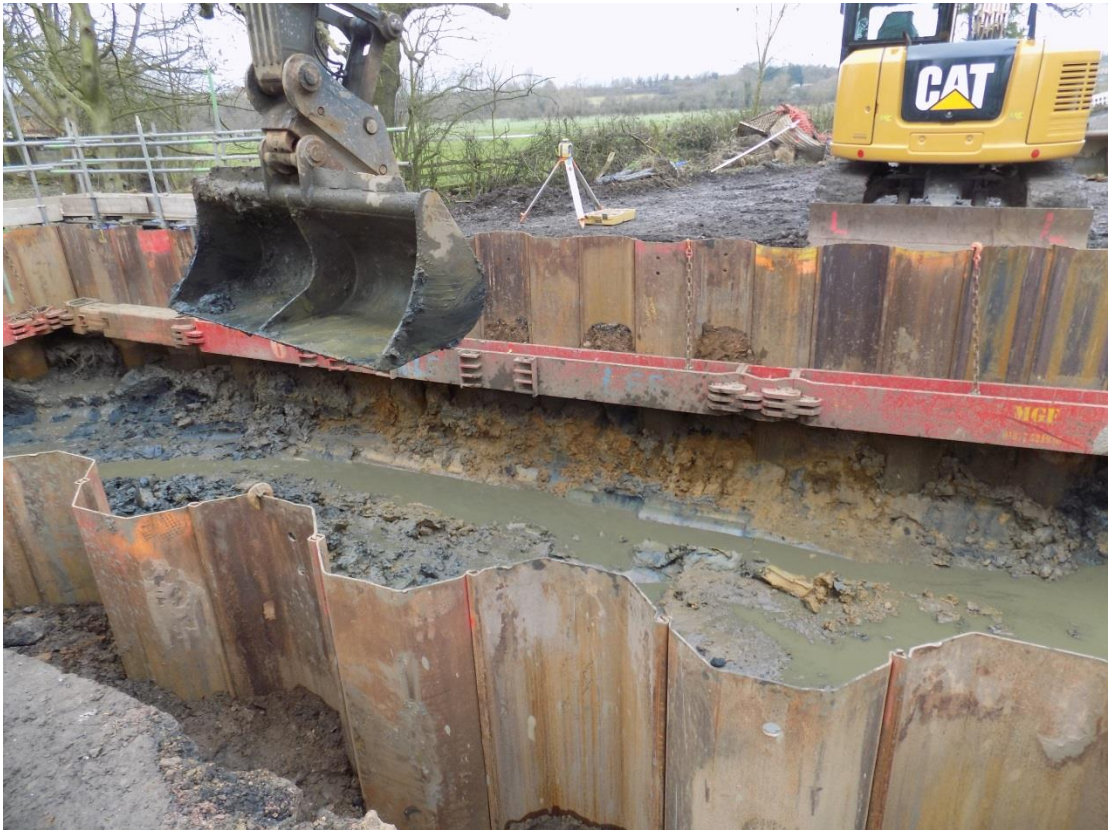
Southern culvert (Culvert 3), possible agger in section, looking north-west Fig 7

A c7.0m wide layer, (301), was observed in the central part of the northern and southern sections of the culvert trench, at c1.0m to c2.0m below the modern road surface down to the formation level; comprising mid orange-brown clay containing some gravel and occasional large fragments of stone. It is possible that this layer is the natural substrate within this trench; alternatively however, the layer could be materials deposited in order to build up the road. Layer (301) appeared to have a slightly raised profile towards the centre of the section, with it sloping off to the east and west of the trench, where layers of dark grey silty-clay were observed (302, 303). This had the appearance and form of an agger, with adjacent roadside ditches; however, no dating was recovered (Figs 1, 7, 8).

A fairly substantial layer of mid orange-brown mixed clay with occasional stones (301) was observed in the southern culvert (Fig 1) and appeared in the section to have a slightly raised profile to a height of c1m from the base of the trench at formation level; with it sloping down to the eastern and western edges of the trench, where layers of blue-grey clays were observed with a width of c3-4m (Fig 8). These possible ditches along with the profile of the material in section are indicative of a possible 'agger' with roadside ditches. The possible agger was observed as a very much reduced structure within the northern culvert and was only partially visible within the pipe diversion trench, though this was perhaps due to this trench having not been excavated to the same depths as the culverts; evidence for the agger was not observed in either test pit.

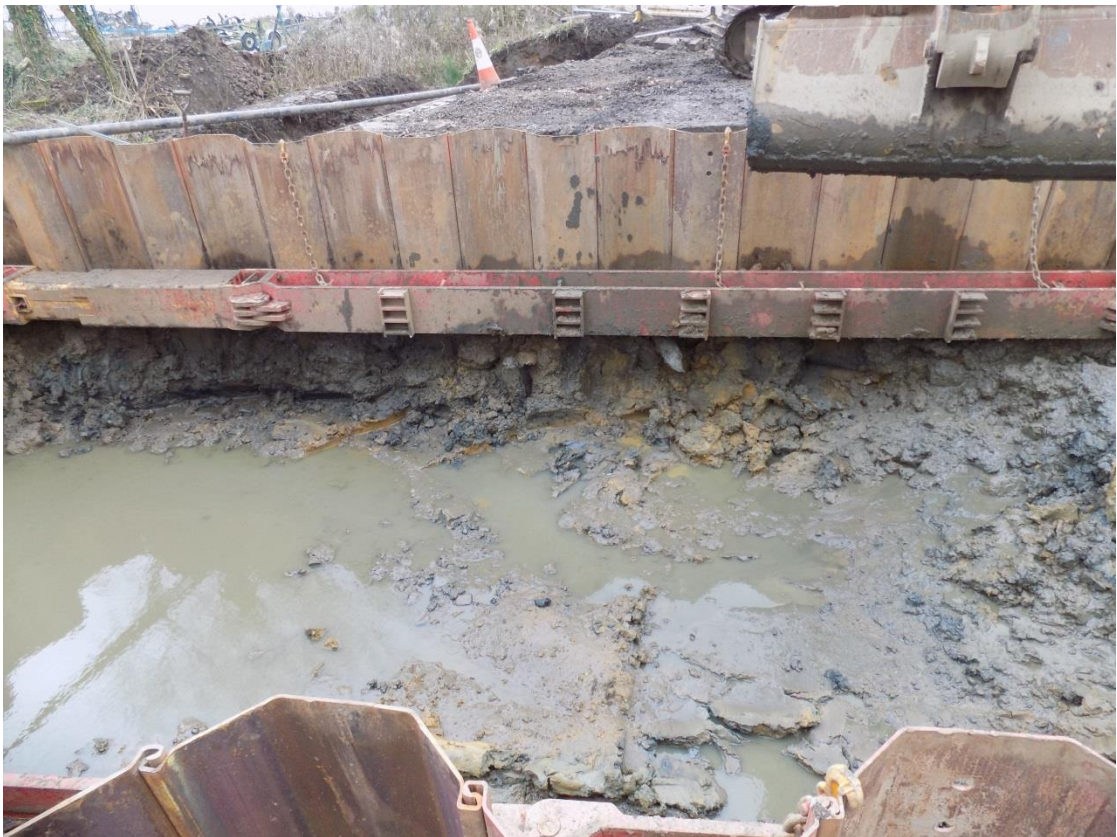
Southern culvert (Culvert 3), timber posts in section, looking south Fig 8

During the watching brief a total of eight wooden posts were observed *in situ* (Figs 8 and 9), and four posts were recovered for further examination.

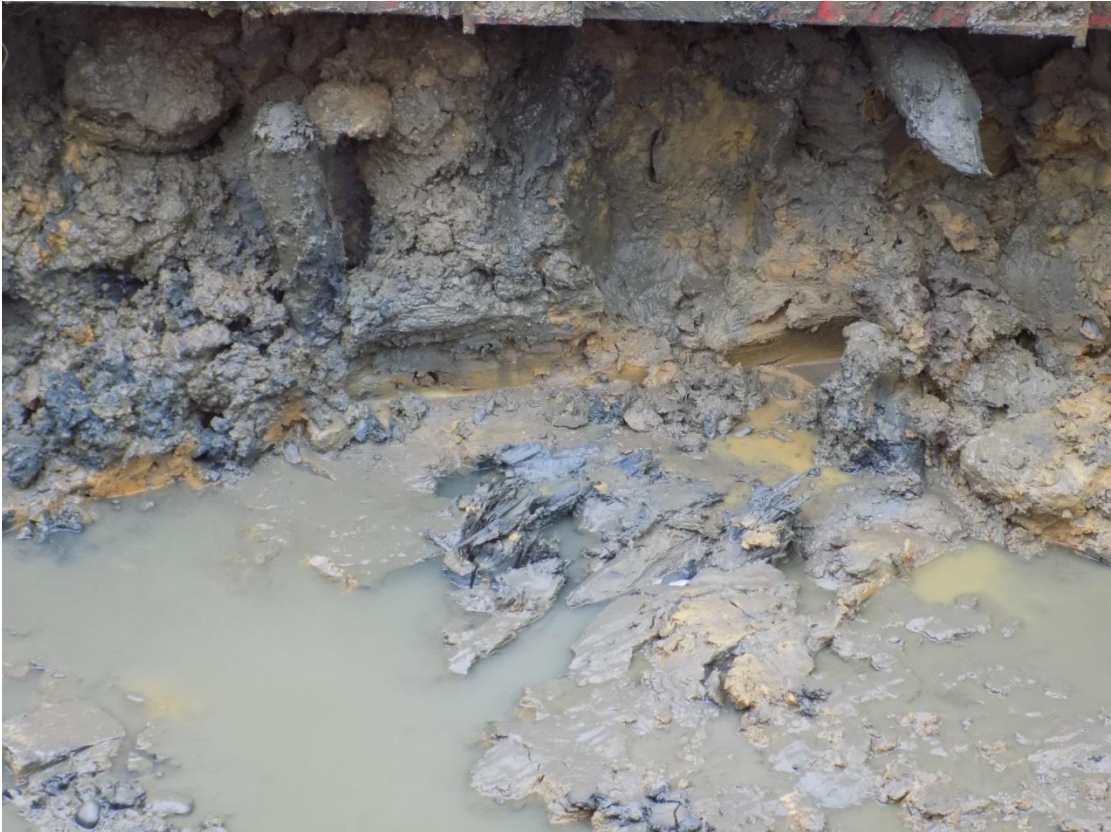
Fig 9

Southern culvert (Culvert 3), timber posts (close up), looking south

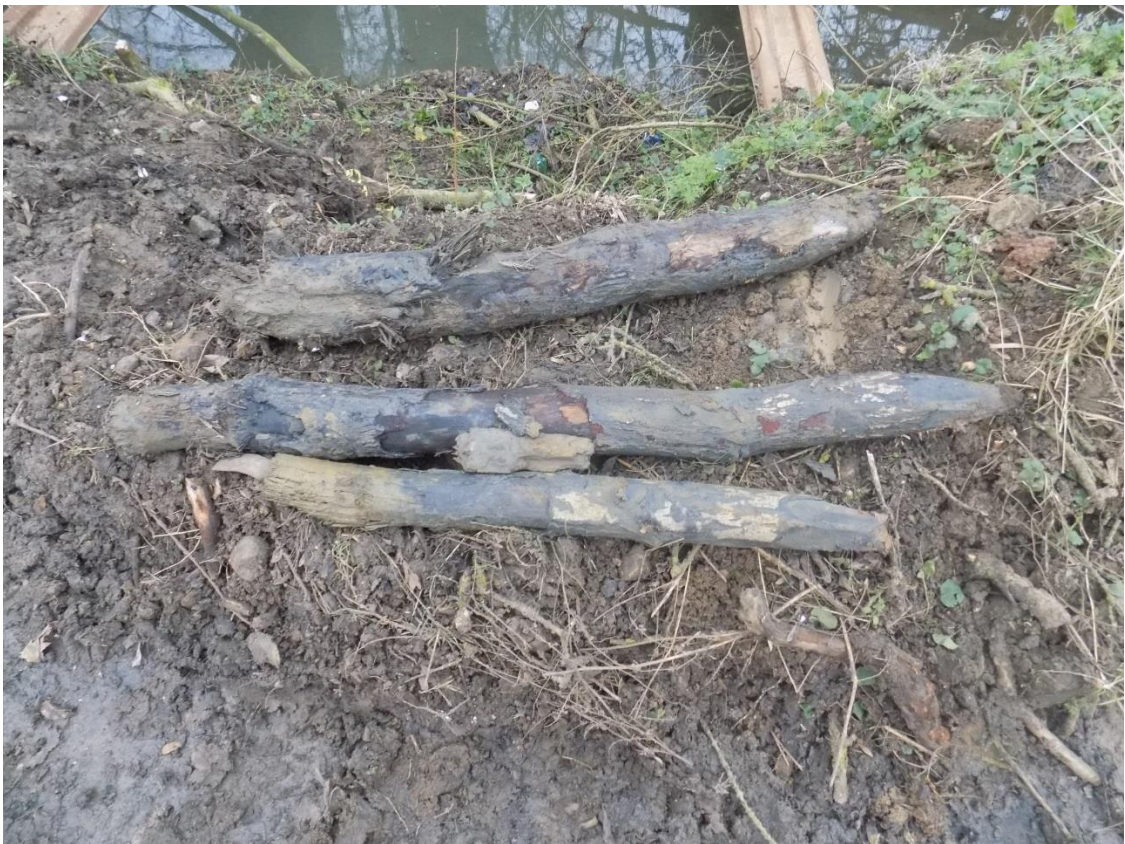
Fig 10

Timber posts recovered from the southern culvert trench (Culvert 3)

A series of vertical timber posts consisting of c 1m long timbers, all with the bark still in place and sharpened to a point at one end, were observed mostly still *in situ* close to the north section of the trench, though several were observed across the width of the trench (Figs 8, 9). They appeared to have been driven into the layer of orange-brown clay and gravel (301); several of the timbers were retained for analysis (Fig 10 and 13).

The recovered examples are all roundwood posts, 110-150mm diameter, possibly of birch, judging by the bark. Each post had been sharpened to a point at one end, leaving a series of flat facets from 150mm to 250mm long. The length of these flat facets suggests that they were not hand cut with an axe or adze, and they were most probably cut with a powered saw (Fig 14), which would imply that the posts are of relatively modern date (Figs 10 and 13). The lack of mineralisation of the wood may also support this interpretation.

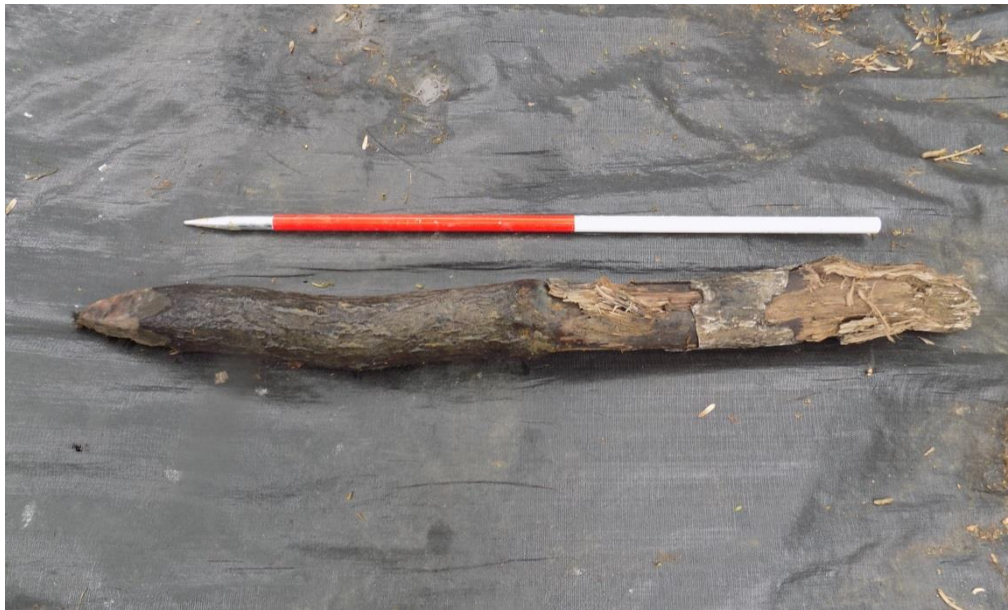
Example of timber post Fig 13

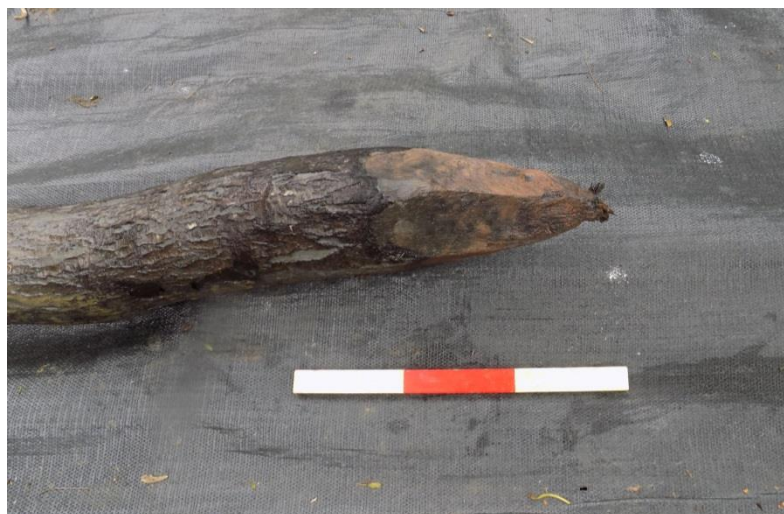
Example of sharpened point Fig 14
