**Archaeological excavation on land at  
Much Park Street car park, Coventry  
West Midlands  
2014-15**

Report no. 16/71

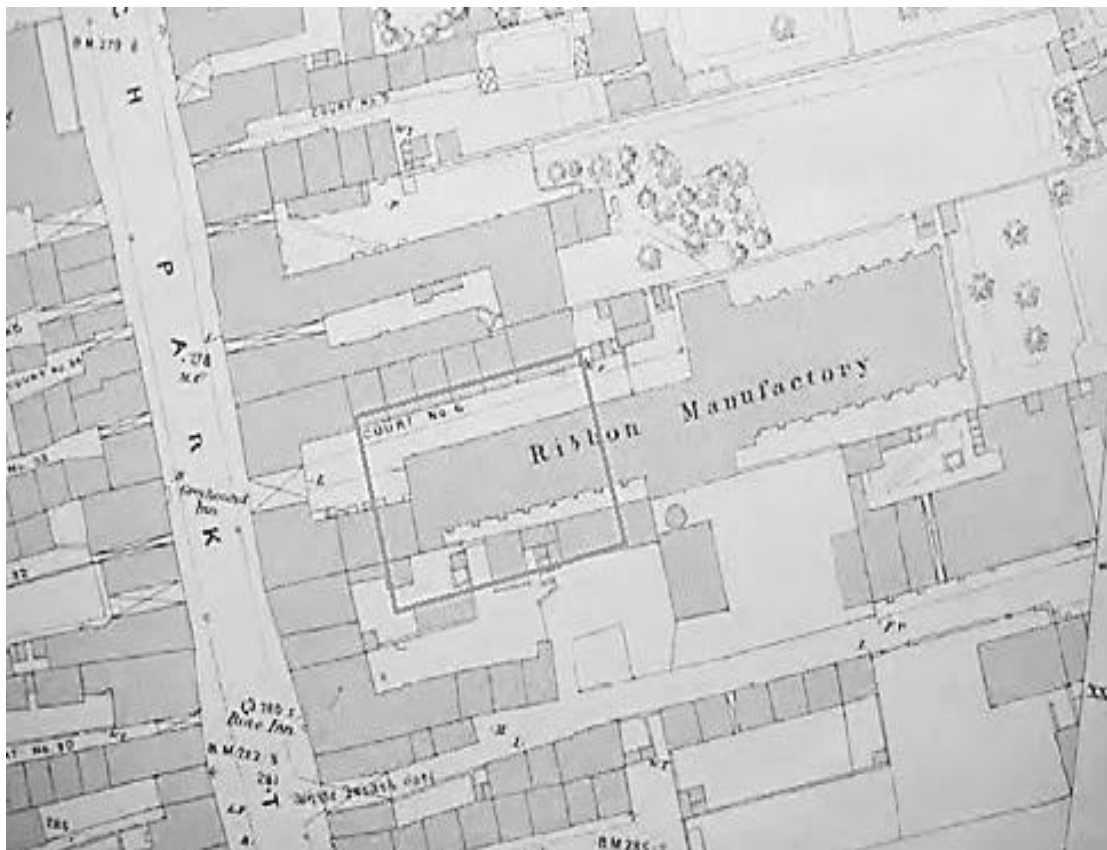
First edition 25" OS map, 1888 Fig 9

Ordnance Survey maps dated between 1888 and 1962 show the central part of the site remained dominated by the factory, Court 6 (Providence Place) and associated buildings (Figs 9-10).

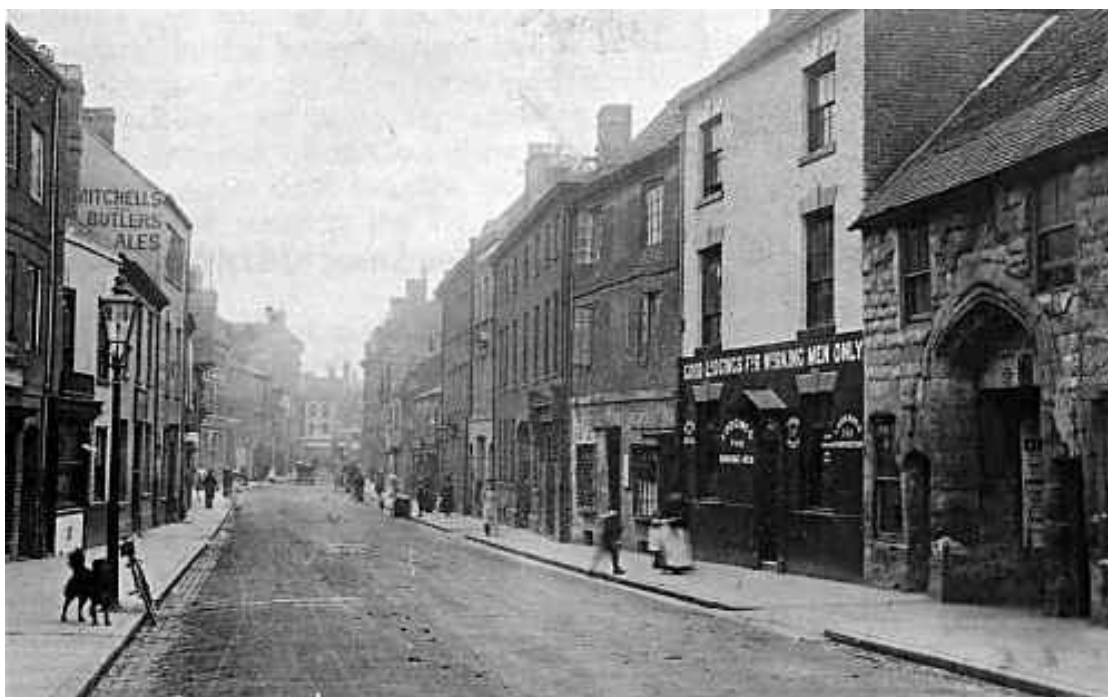
Much Park Street, 1912 Fig 11

A photograph of Much Park Street from 1912 views the street from opposite Whitefriars Gatehouse looking north (Fig 11).

On the frontage, three buildings along from the gatehouse, the factory building can be seen with two rows of windows for light and an archway with a dropped kerb for street access to Providence Place (Fig 11).

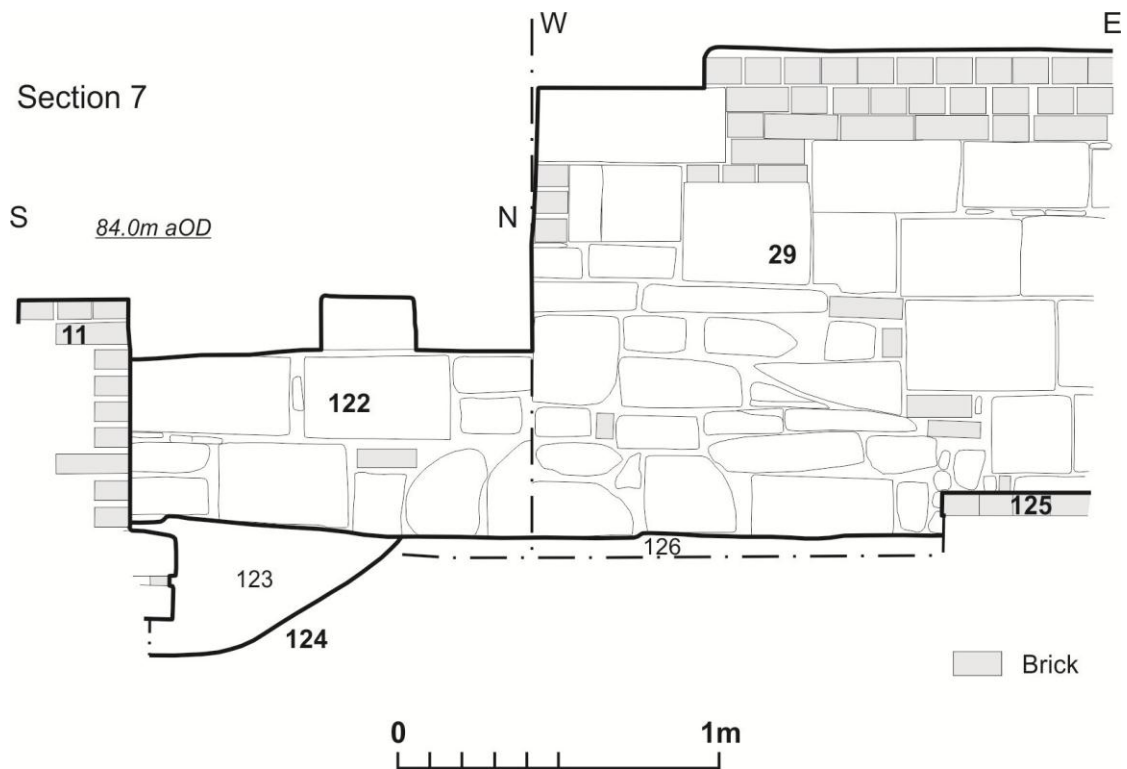
Truncated pit [124], Section 7 Fig 13

Evidence of this comes from a circular pit [124] that was heavily truncated by a stone ashlar block wall [122] to the west and brick wall [11] to the south (Fig 13). With approximately only one quarter of the whole pit visible, it was at least 0.80m long by 0.30m wide and 0.40m deep with a wide bowl-shaped profile onto a flat base. It had been cut into the natural (126) with a fill of mid brownish-grey silty sand and produced a single rim sherd of Coventry A ware with a date ranging between the 12th and 14th centuries.

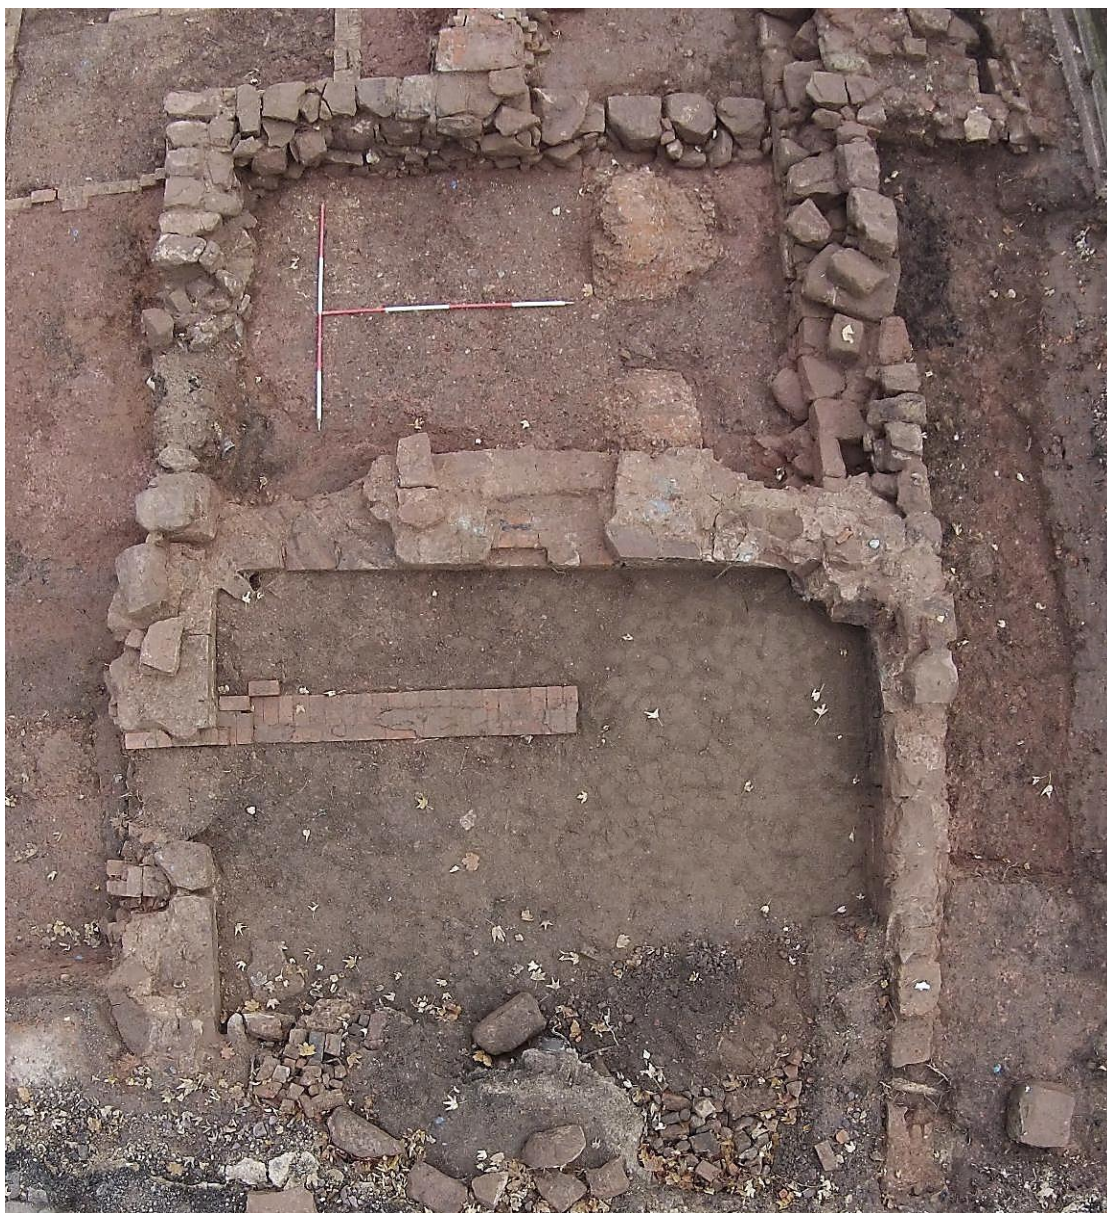
Building [139] and undercroft [138], looking east Fig 14

Building [139] consisted of two sandstone walls [63] and [64] aligned east-north-east to west-south-west and north-north-west to south-south-east with boundary wall [65] forming the south wall. The walls were keyed into each other at the time of construction and survived to a height of 84.71 aOD with the uppermost course forming a level surface from which a timber frame could have been built (Figs 12 and 14).

During the later 14th century the possible timber-framed building was replaced by an ashlar block sandstone-built vaulted cellar or undercroft [138] (Fig 14). It almost completely occupied the footprint of the earlier building and would have presumably joined onto the rear of a timber-framed building fronting Much Park Street similar to those found during excavations at the Stone House (ECT464).

The north wall [61] of the undercroft was 7.40m long by 0.75m wide with a springer halfway along its length and had two possible doorways. The original doorway [145] was 2.40m from the western end of the wall with an opening 0.80m wide, and was observed during the watching brief. This doorway towards the western end, however, is likely to be a later addition with brickwork present below the sandstone door jamb (Fig 14).

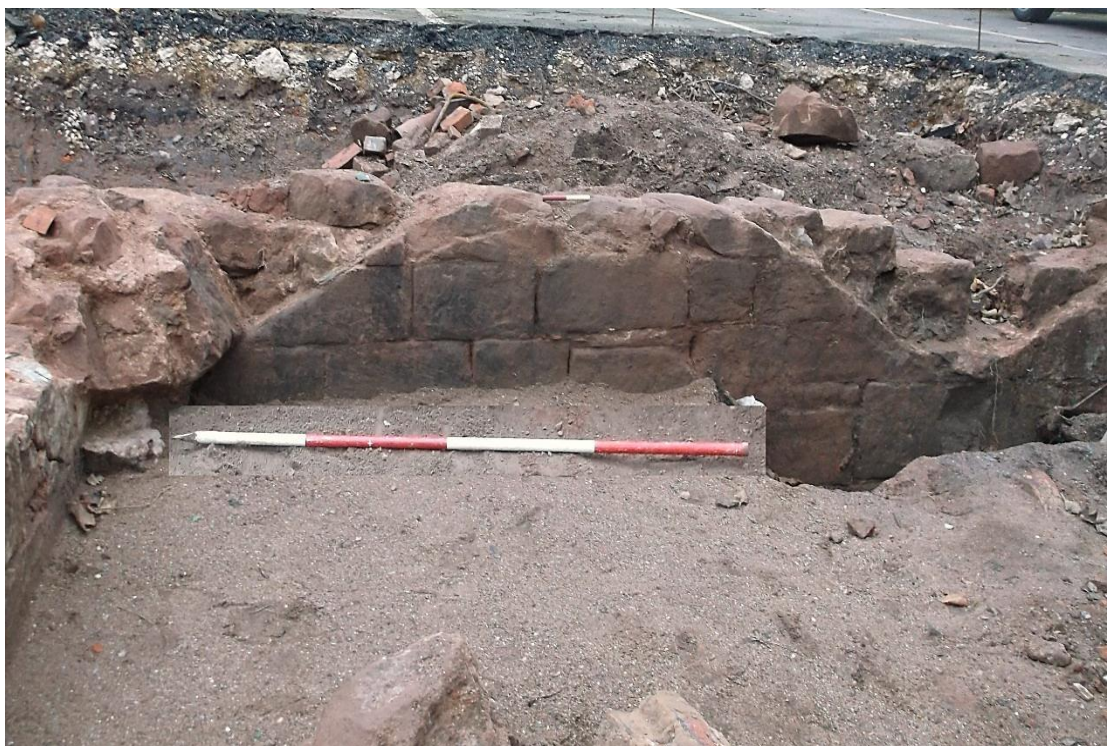
Wall [60] with V-shaped sockets to support the vaulting, looking south Fig 15

The wide V-shaped sockets in wall [60] were used to support the vault with the springers set at the base of the V. The springers were better preserved on the south-east corner and mid-way along the north wall [61].

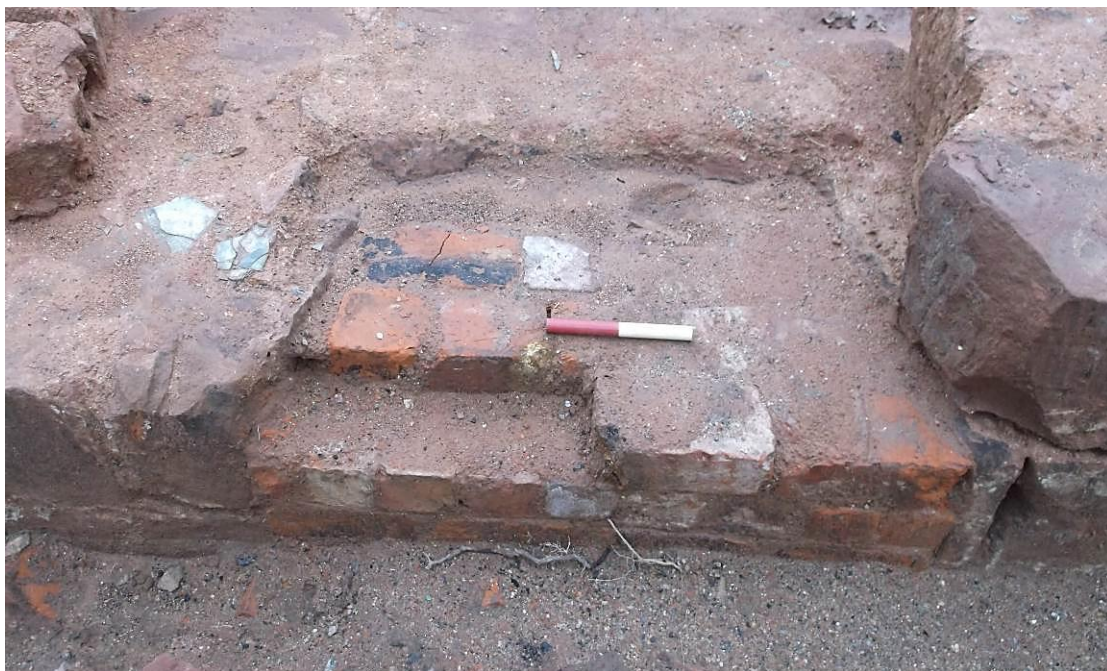
Undercroft skylight [141], looking east Fig 16

Wall [62] was 5.0m long x 0.70m wide, it was constructed in the same method as wall [60] and formed the east end to the building with a skylight [141] located centrally along its length (Fig 16). The skylight opening into the undercroft was 1.0m wide and set 0.50m into the wall letting natural light into the building and suggesting it was below ground level. Later in the 19th century, brick had been used to block off the skylight.

Other modifications included a single skin central wall dividing the east from west and the blocking up of skylight [141] (Fig 16).

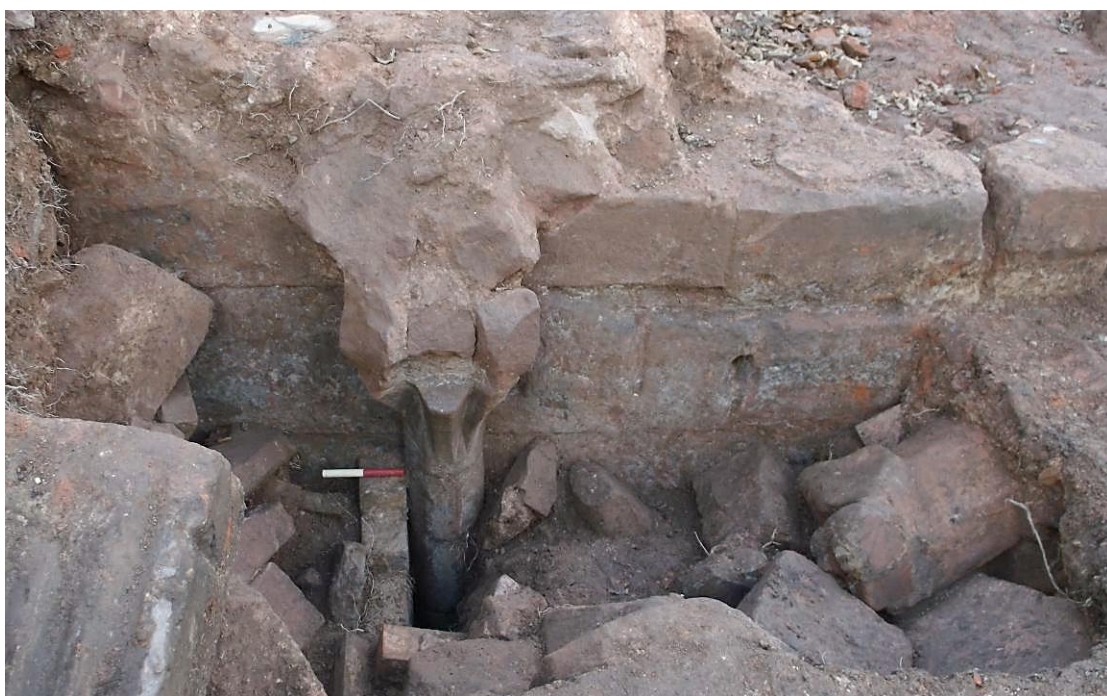
Springer set into north wall [61], looking north Fig 17

The springers [142] for the vaulted ceiling survived on the north-east and south-east corners as well as half way along the length of the undercroft north and south walls. They sat on applied or engaged chamfered columns (Fig 17) and split into three ribs to support the vaulting. Two ceiling bosses were found within the backfill of the cellar (Figs 35-36).

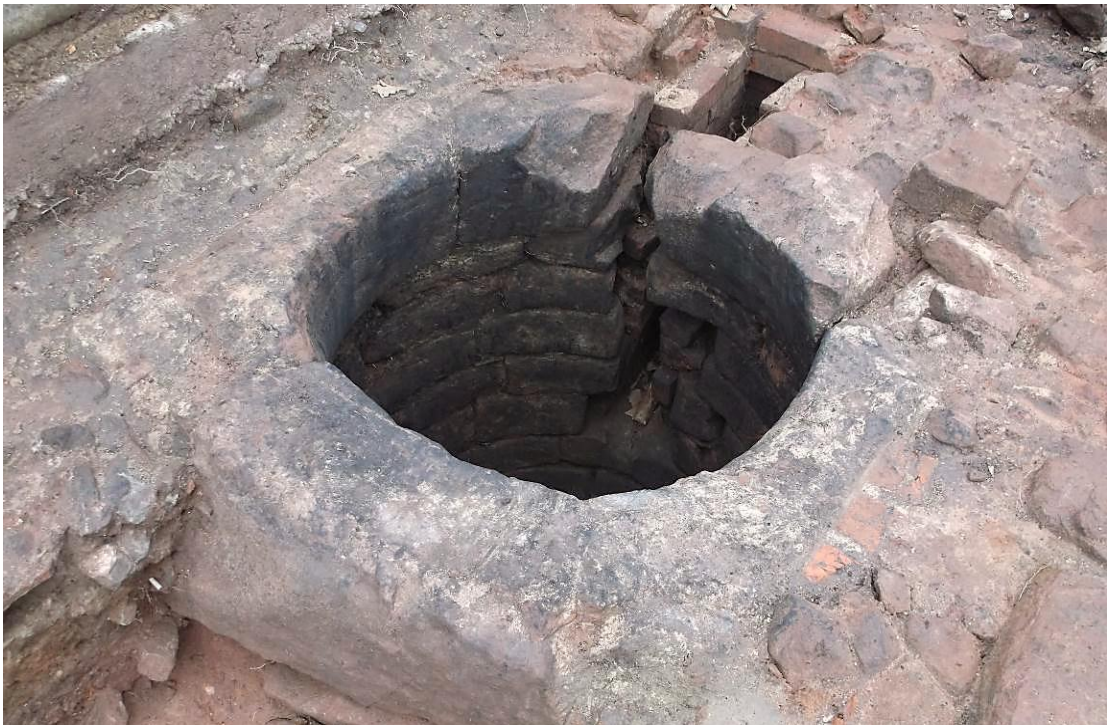
Well [66], looking south Fig 18

The top of well [66] was 1.30m by 1.30m square and constructed of large sandstone blocks up to 700x400x500mm, the internal edge had been carved to form a rough circle with a 0.90m diameter. The lower courses were smaller blocks of sandstone no larger than 450x300mm with no obvious bonding material (Fig 18).

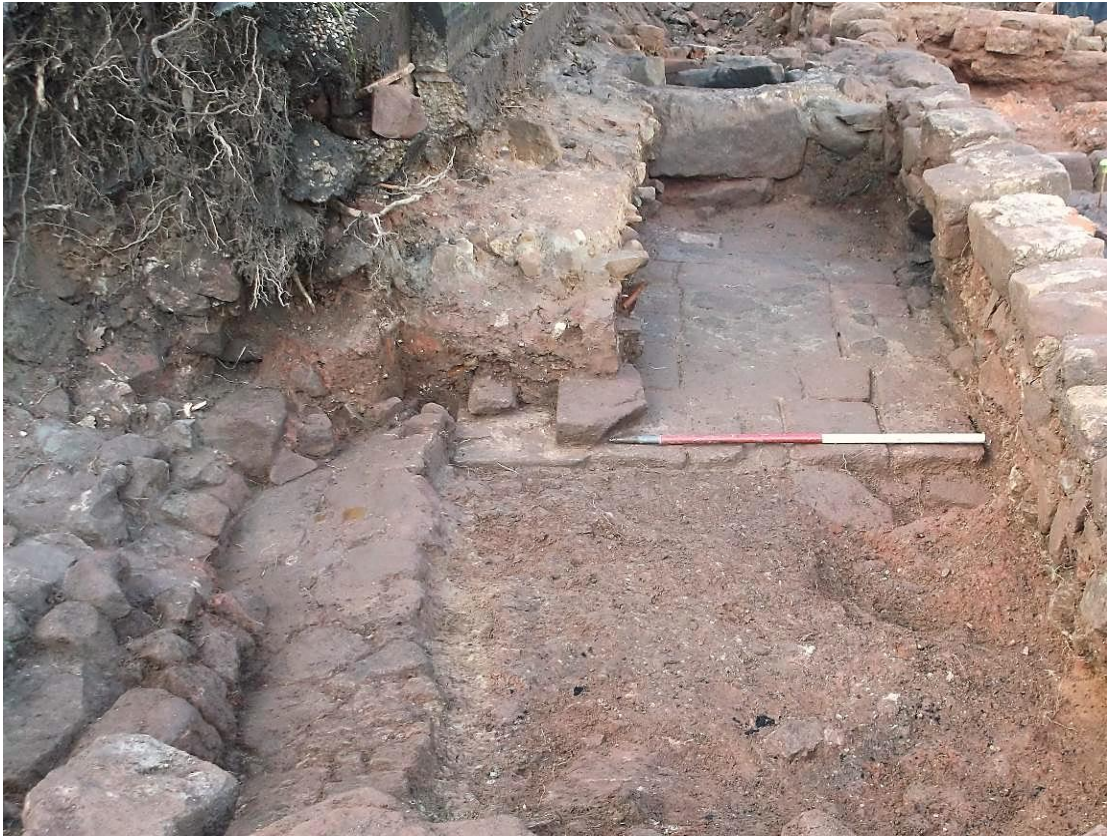
Flagstone yard [87] and well [66], looking west-south-west Fig 19

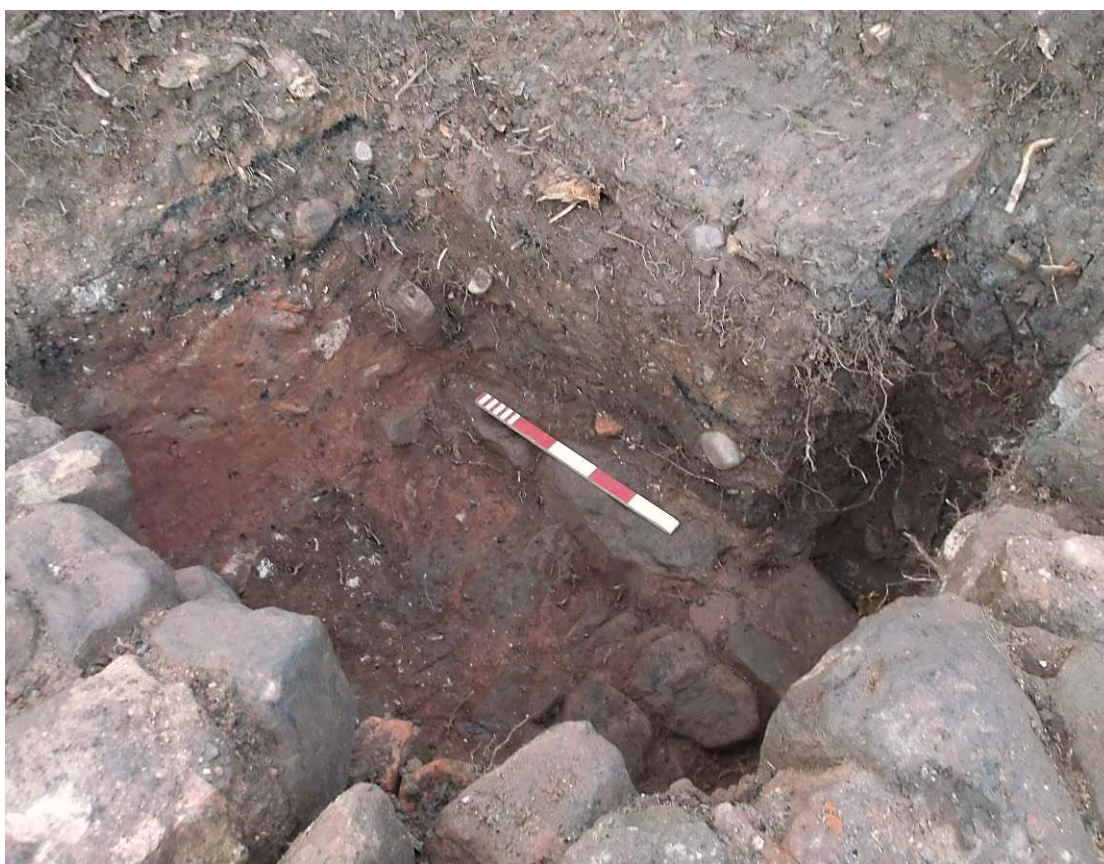
Wall [129] in TP1, looking north-west Fig 21

Medieval sandstone walls aligned east-north-east to west-south-west were present in TP1 and in the extension to TP2. Both were of a similar construction with wall [129] being 1.20m to the north and 2.0m to the west of wall [98]. Wall [129] was 2.50m long by 0.25m wide with a single course of roughly squared sandstone blocks 0.30m long by 0.25m wide by 0.20m thick bonded with reddish-brown clay (Fig 21). Only a 0.50m length of wall [98] was visible in TP2s extension where it was a single course 0.40m wide and 0.12m thick. They probably represent the remains of outbuildings on the plot of land during the 15th century.

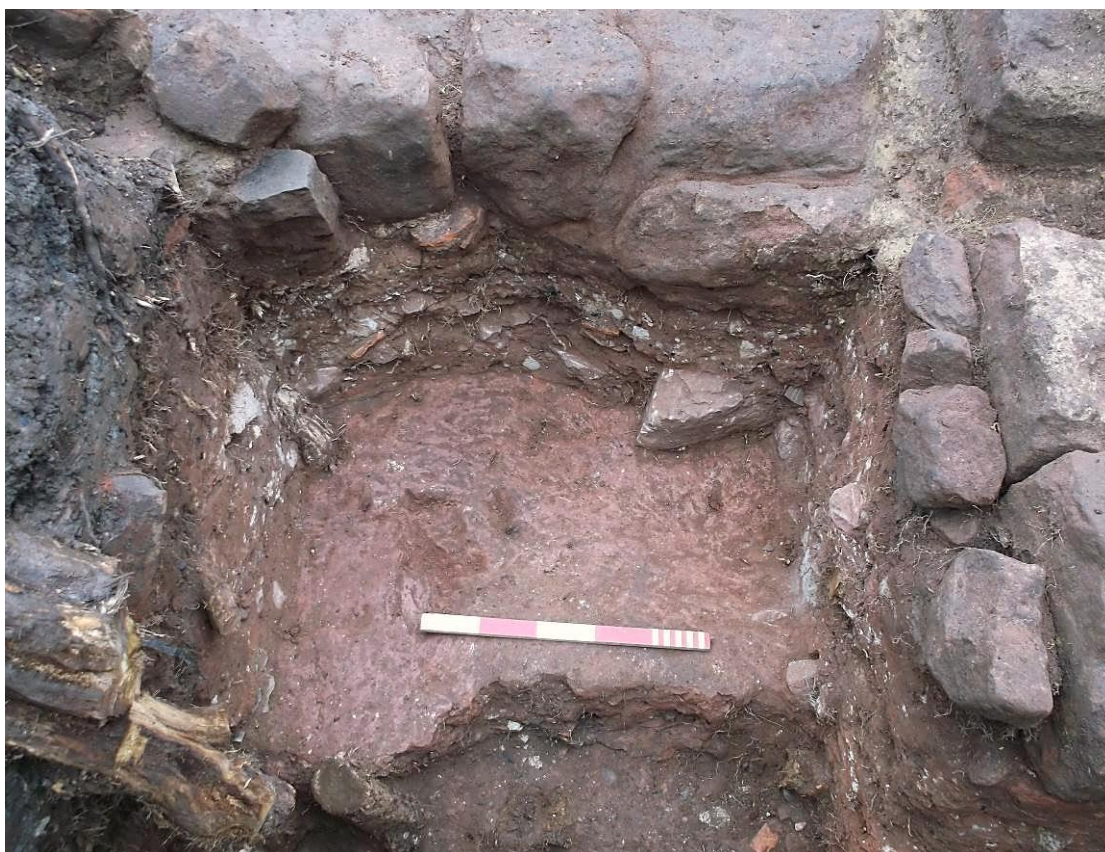
Clay floor (47) in TP3, looking south-east Fig 22

Test pits 3 and 4 to the east revealed a possible medieval clay floor. Layer (46) was mid grey-brown sandy clay with frequent sandstone fragments that was excavated to 0.10m and contained medieval pottery (Fig 22). It was overlain by a reddish-brown clay floor surface (47) that was 0.13m thick and potentially covered an area 6.0m long by 1.50m wide. It had been truncated on its northern edge by the modern car park wall that has removed any evidence of an associated structure.

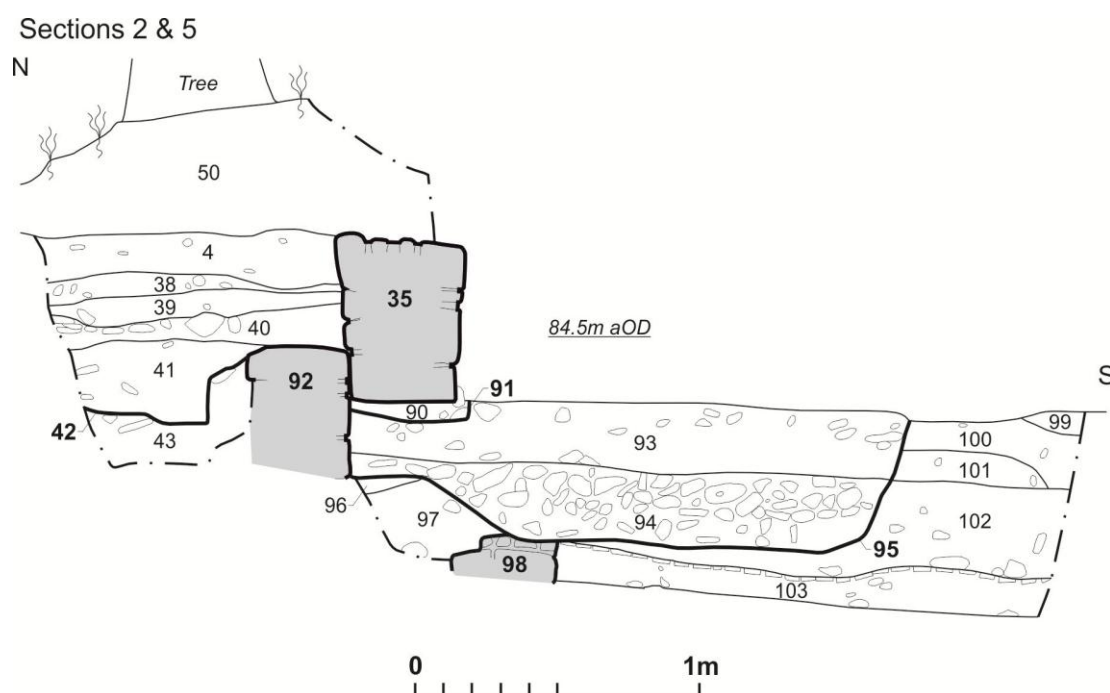
TP2, Sections 2 and 5 Fig 23

A segment of ditch or a large pit [95] aligned north-north-east to west-south-west truncated the re-deposited layers and contained demolition deposits with pottery dating to the 17th or 18th centuries (Fig 23). It had a U-shaped profile with a wide flat base and was 11.0m long by 1.40m wide by 0.50m deep. The lower fill (94) contained a large quantity of small irregular sandstone fragments, broken tile and the occasional cobble stones and was overlain by greyish-brown silty sand (93) that had a small quantity of demolition material present.

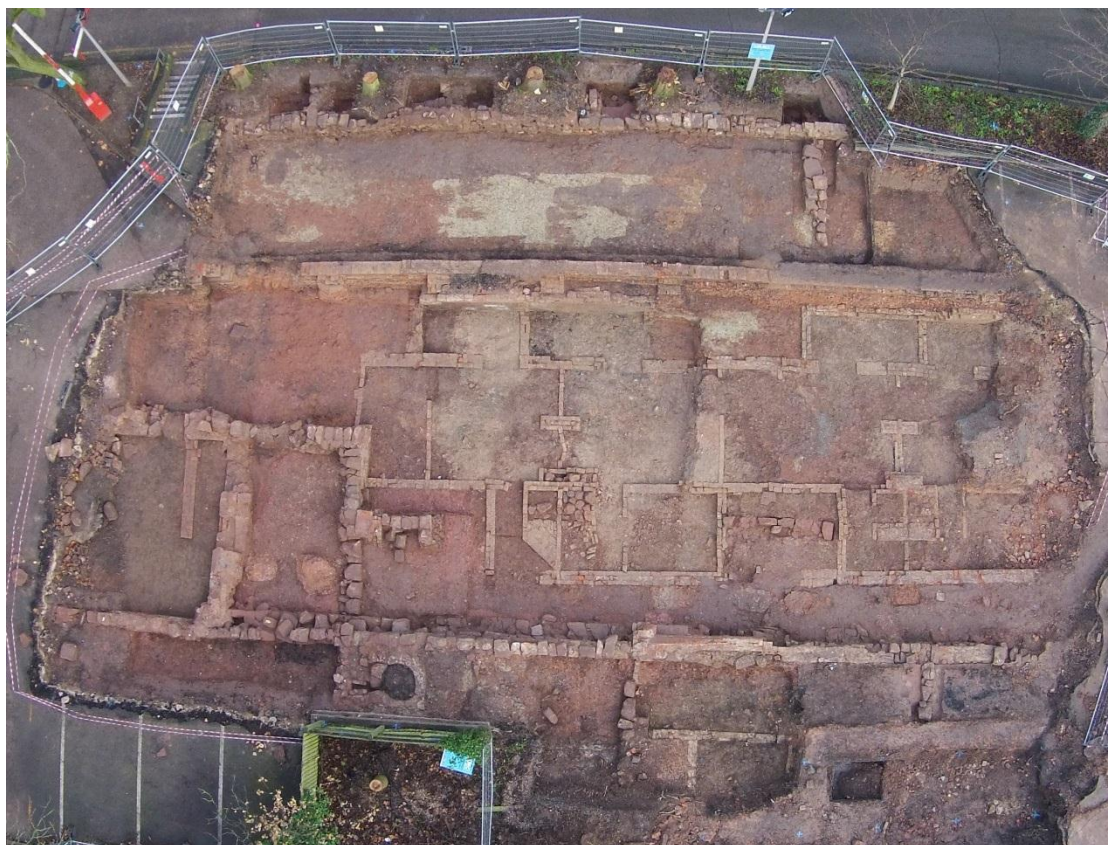
Aerial view of site, orientated towards north Fig 24

The building was located on the south side of Providence Place and was constructed from handmade, unfrogged orangey-red brick that were 240mm long by 110mm wide by 70mm thick bonded with a pale yellow-brown sandy mortar. Aligned east-north-east to west-south-west, the building was 68.0m long and at only 8.50m wide, it was possibly respecting the original long and narrow medieval burgage plot by reusing boundary wall [65] (Fig 24).

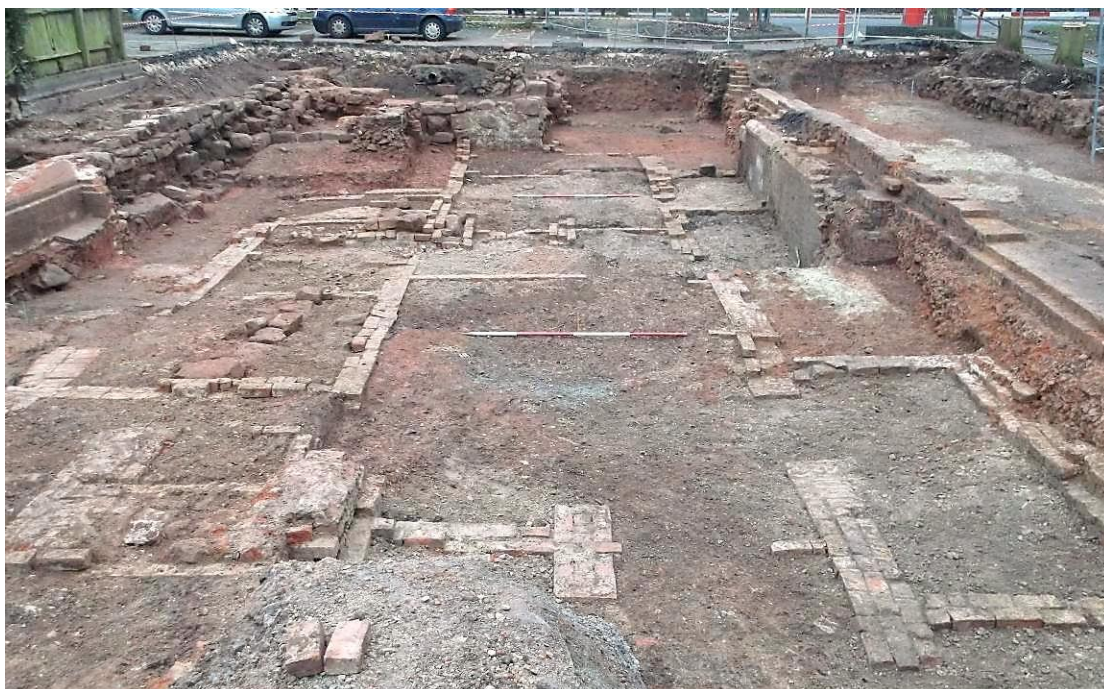
Structure [5] storerooms, looking west Fig 25

Wall [10] formed the southern division constructed from two skins of brickwork 0.28m wide, alternating courses between stretchers and mixed stretchers and headers, similar to a Common bond. Four doorways, 0.60m wide, were present along the length of the wall giving access to individual rooms. Responding wall [11], to the north, was of a heavier construction being three skins, 0.36m wide, which alternated between courses of stretchers on a mixed stretcher and header course. Three doorways, 1.0m wide, were present along the length of wall [11], giving access to rooms on the north side of the basement (Fig 25).

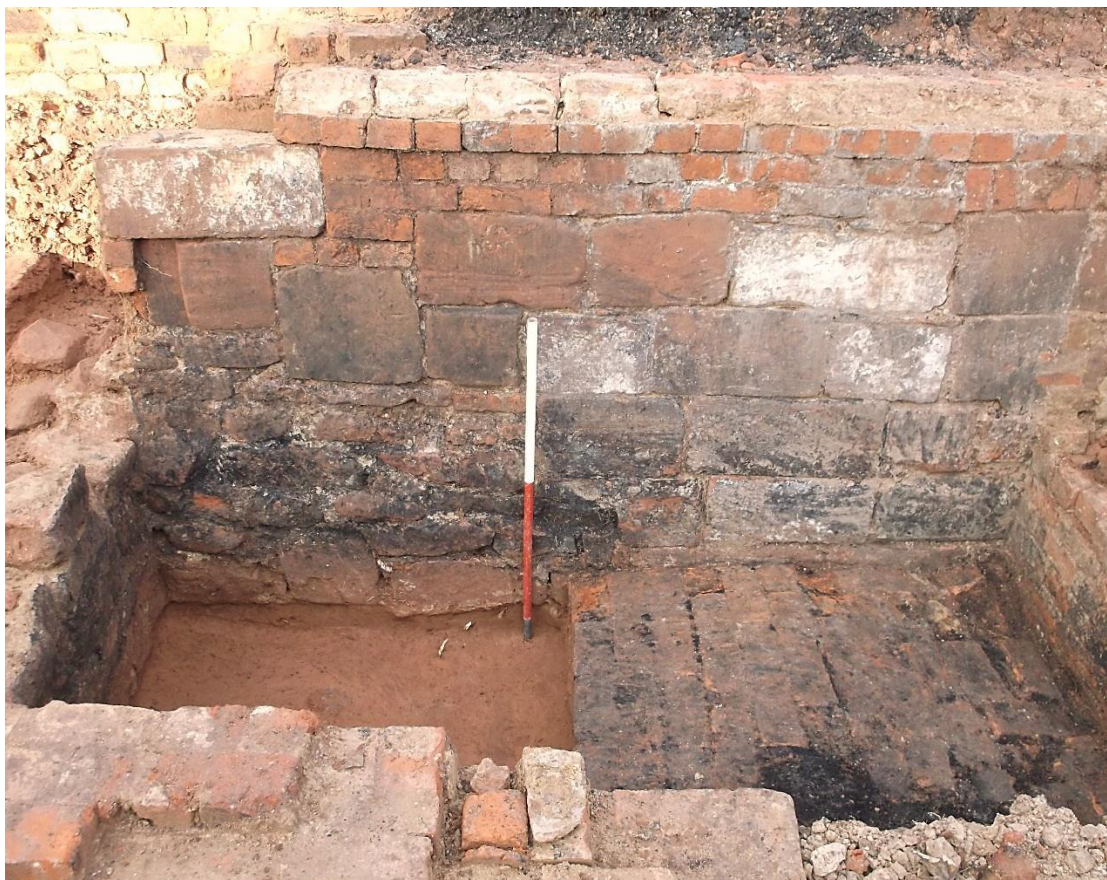
Wall [29] and brick floor [125], looking north-north-west Fig 26

A hand-dug excavation was undertaken in a storeroom in the north-west corner of the basement to identify what appeared to be a medieval ashlar sandstone wall. Wall [29], aligned east-north-east to west-south-west along the inside of wall [6], was 7.0m long and 0.65m wide. The lower courses were constructed from reused medieval ashlar and rough sandstone that had 19th-century brick infill above smaller blocks to

level the course. Three courses of brickwork were set onto the sandstone forming a possible supporting section of wall for northern façade [6] (Fig 26).

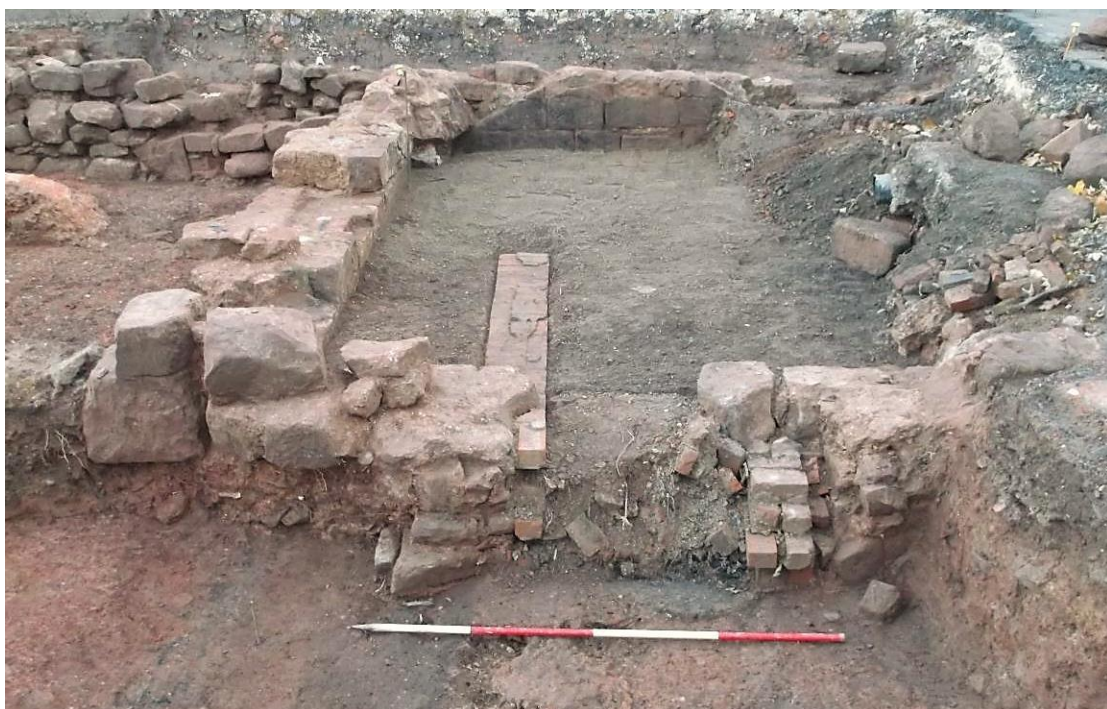
19th century doorway into undercroft, looking south-east Fig 27

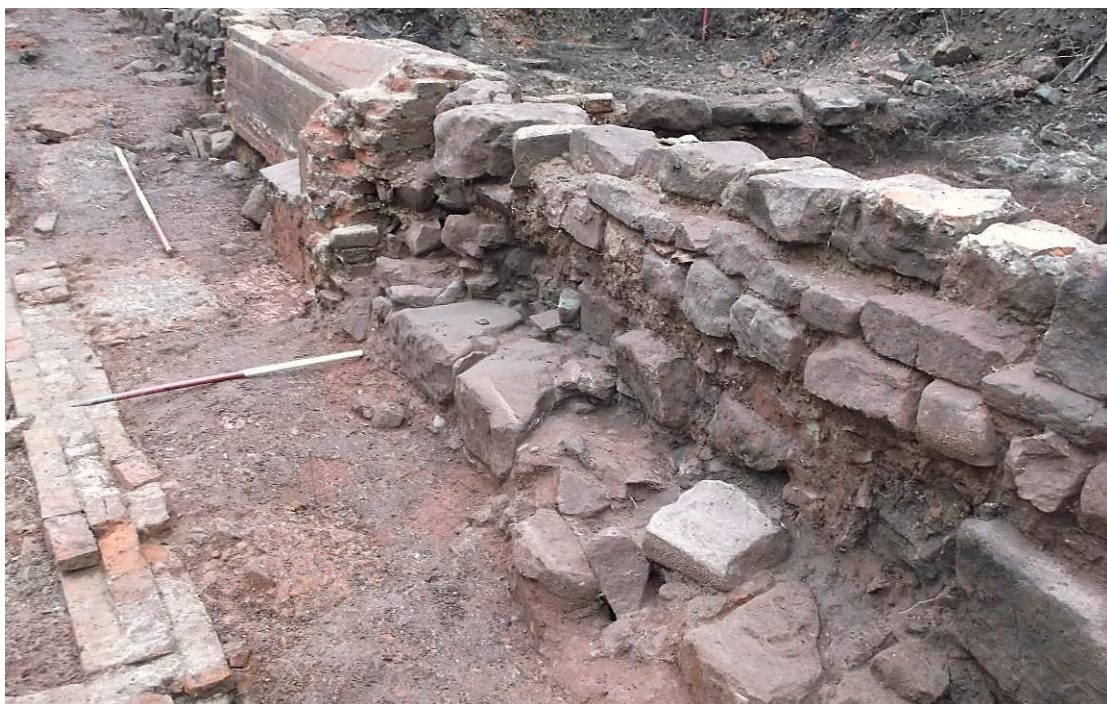
Boundary wall [65] overlain by wall [143], looking east Fig 28

The boundary wall [65] to the south of the factory appeared to be partially buried beneath mixed sandy clay soil (151) that was up to 0.30m thick (Figs 12 and 28). The boundary was reinstated by the construction of wall [143], with reused medieval sandstone blocks, that was 0.50m wide and varied in height along the length of site. The sandstone was all roughly-faced into rectangular blocks of stone between 300x300x250mm, up to 600x400x450mm in size. Brick inserts and sections of wall had replaced part of the sandstone wall, indicating continuous use and modification through to the 20th century.

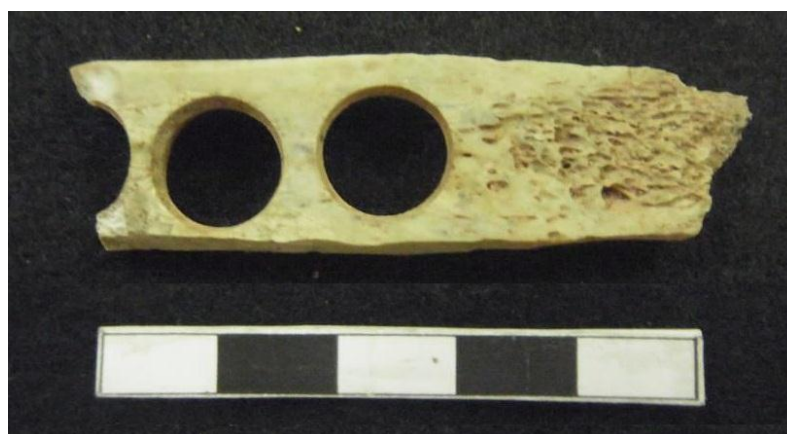
Bone working debris, (SF 7) Fig 31

A strip of long bone (Fig 31) with two circular perforations and part of a third cut into it was recovered from layer [114] over flagstone surface [87] (Fig 18 and 19). The holes measure 10mm in diameter and 4-5mm high, they have been drilled from both sides of the bone, resulting in a concentric median ridge on the internal edge. These strips are often interpreted as the by-product of button making (cf. Geddes and

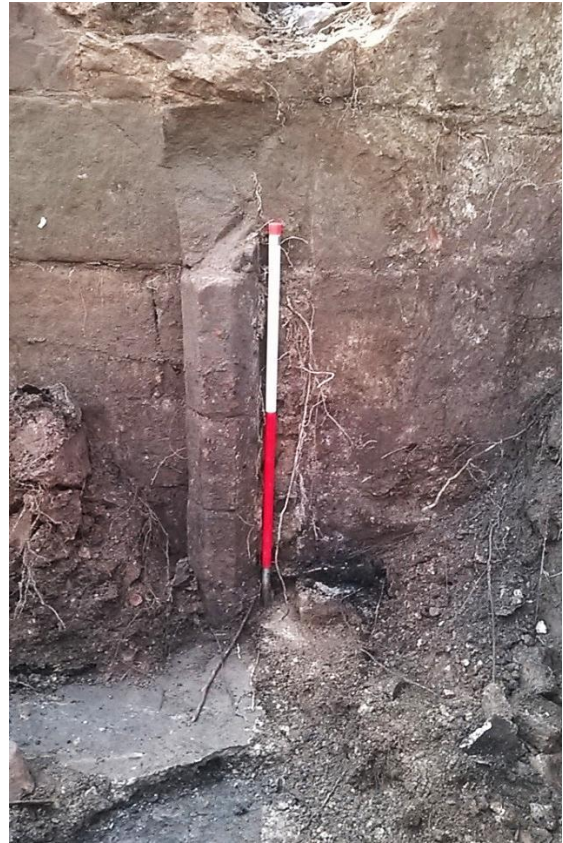
Column on wall [60], looking south Fig 33

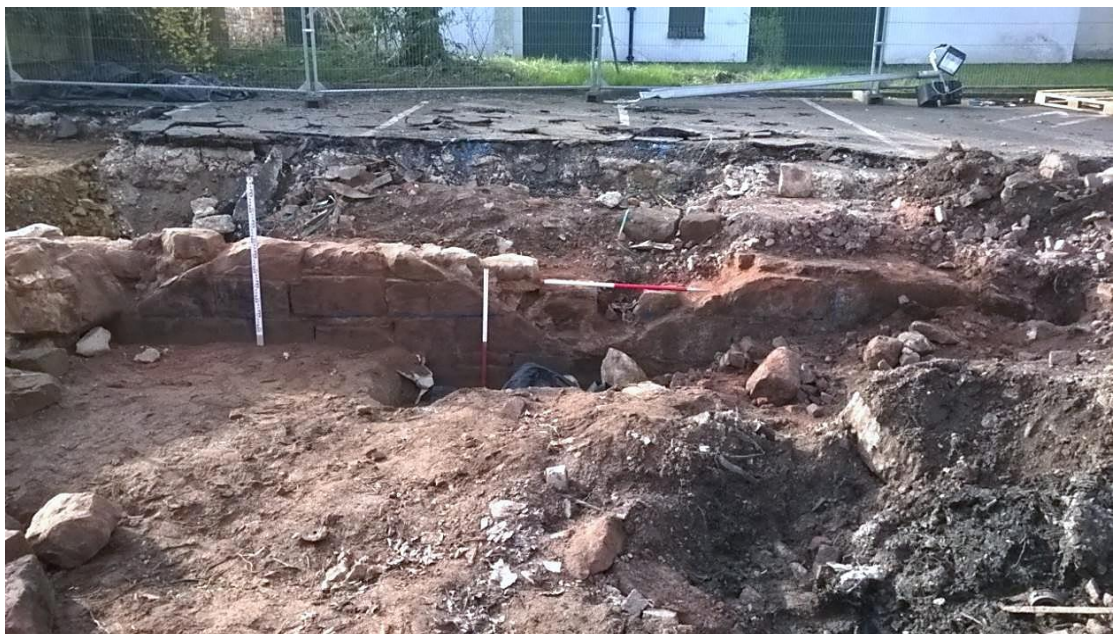
Undercrofts [138] wall [60], looking south-east Fig 34

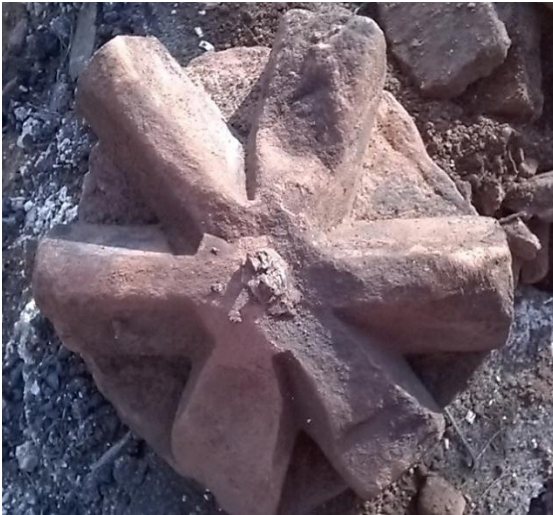
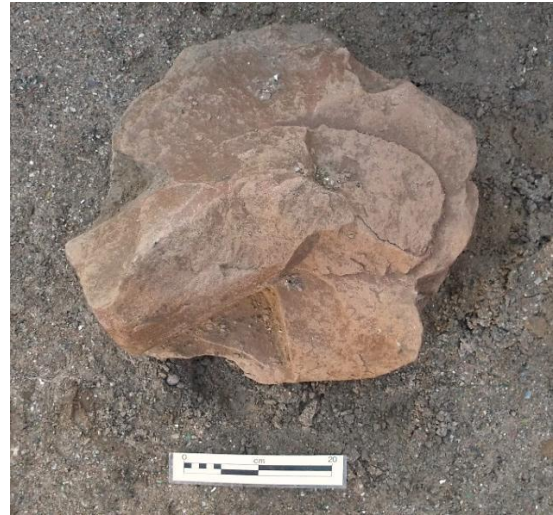
Ceiling bosses from rubble backfill of [138] Figs 35 and 36
