**Archaeological observation, investigation
recording and analysis of land at
Bentley's Farm Bungalow, Helmdon Road,
Sulgrave, Northamptonshire
May 2016**

Report No 16/87

Archaeological observation, investigation, recording and analysis was carried out by MOLA Northampton, during construction work on land at Bentley's Farm Bungalow, Helmdon Road, Sulgrave, Northamptonshire. Remnant medieval ridge and furrow was observed on the site together with features associated with the former farmyard and buildings.

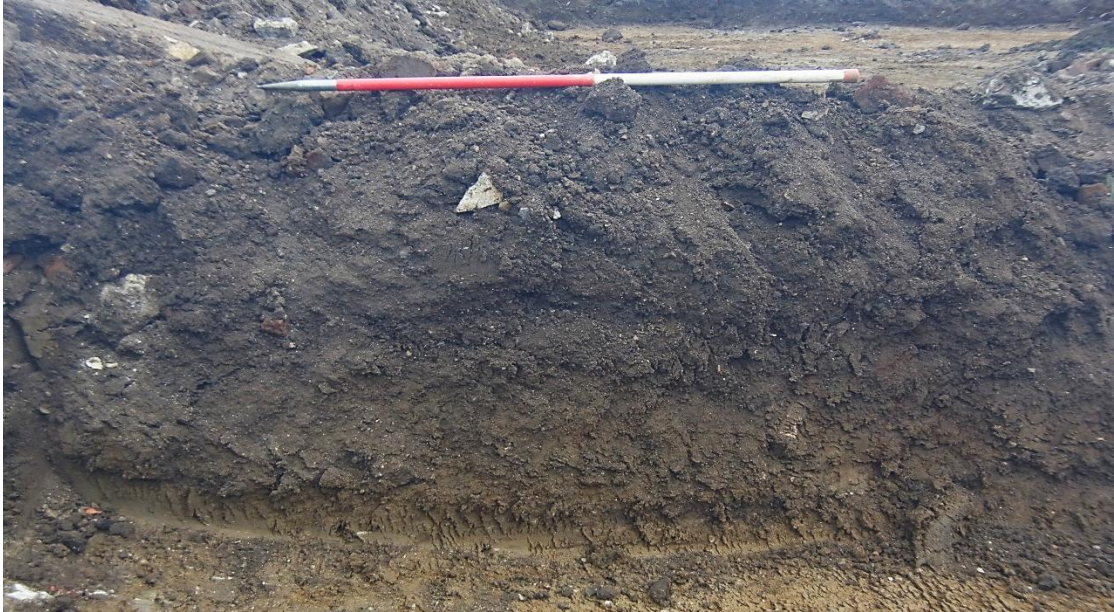
Stratification within Area 2, made up ground, looking east Fig 4

Area 2 and 3 had a layer of make-up material (10) sealing the subsoil; this was between c.0.40m deep and c.0.60m in Area 2 and c.1.20m deep in Area 3. The layer was dark grey- brown silty clay which included fragments of brick, slate roof tile and post-medieval blue transfer print pottery, none were collected (Fig 4).

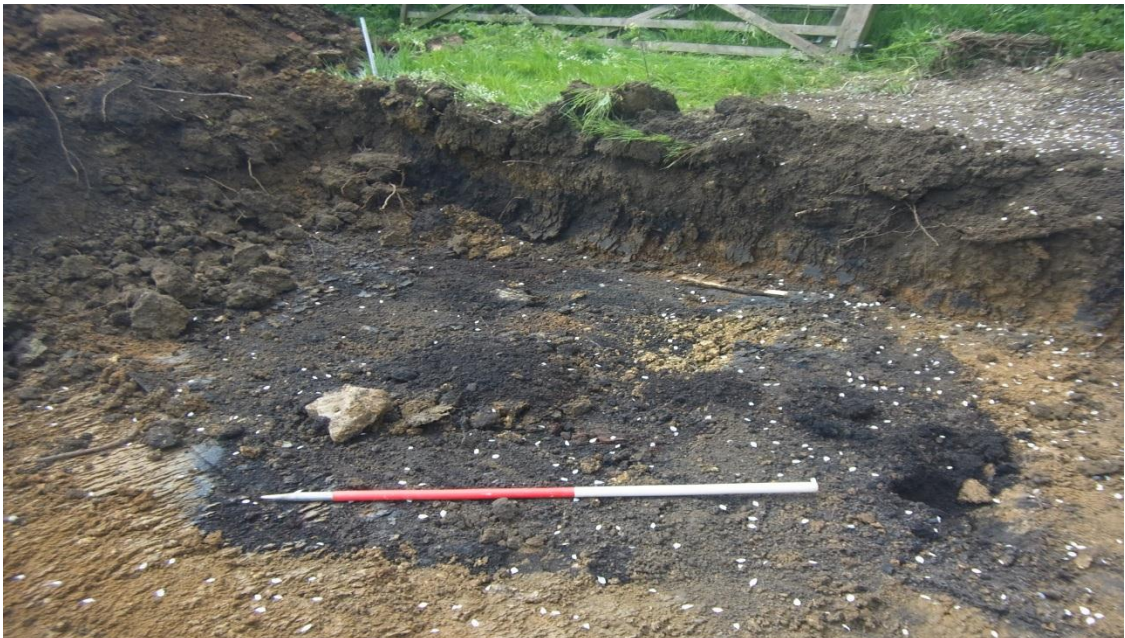
Modern pit [5], looking south-west Fig 5

The area was a wide L-shape 13m by 11m at the widest point. Towards the south-west corner of the area was a modern rectangular pit [5], which was cut through the subsoil and contained very dark blue-black silty sand with 20% large charcoal chunks, and a geological test pit.

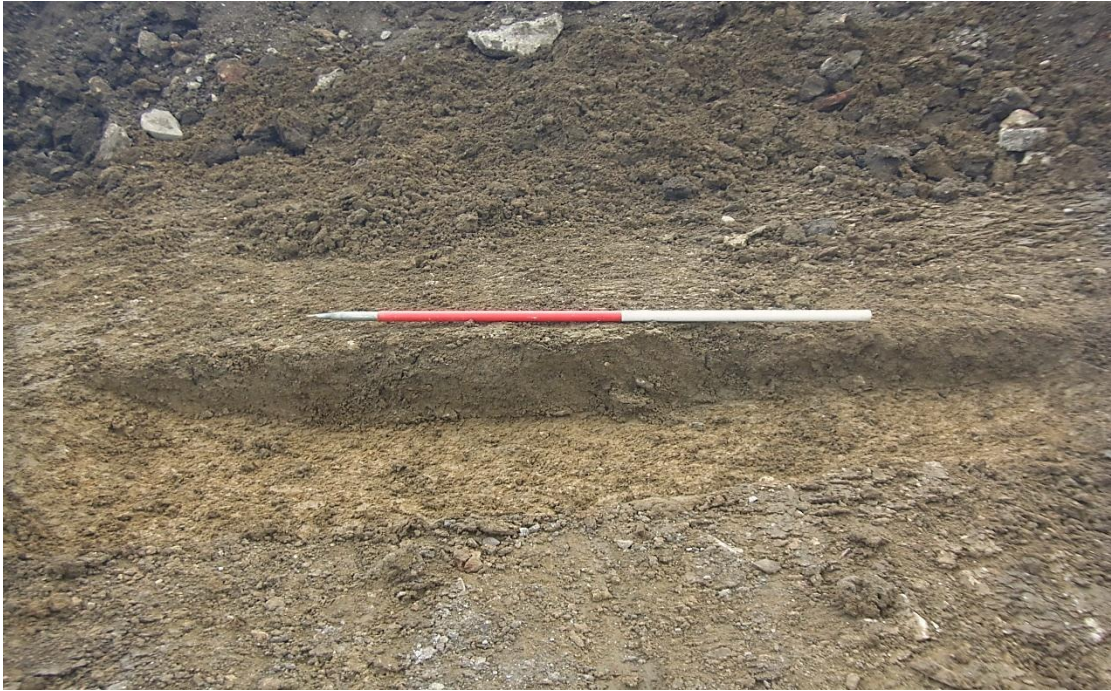
Furrow [7], looking south Fig 6

Area 2 was 14.50 long and 12m wide at its widest point. Three furrows were present within this area, aligned north-west to south-east. Furrow [7] was 2m wide and 0.16m deep with gentle sloping sides and a broad flat base (Fig 6). It was filled with light to med brown-grey silty clay and contained 1% small stones. The furrows were 5.5m apart, and can only be seen in Area 2.

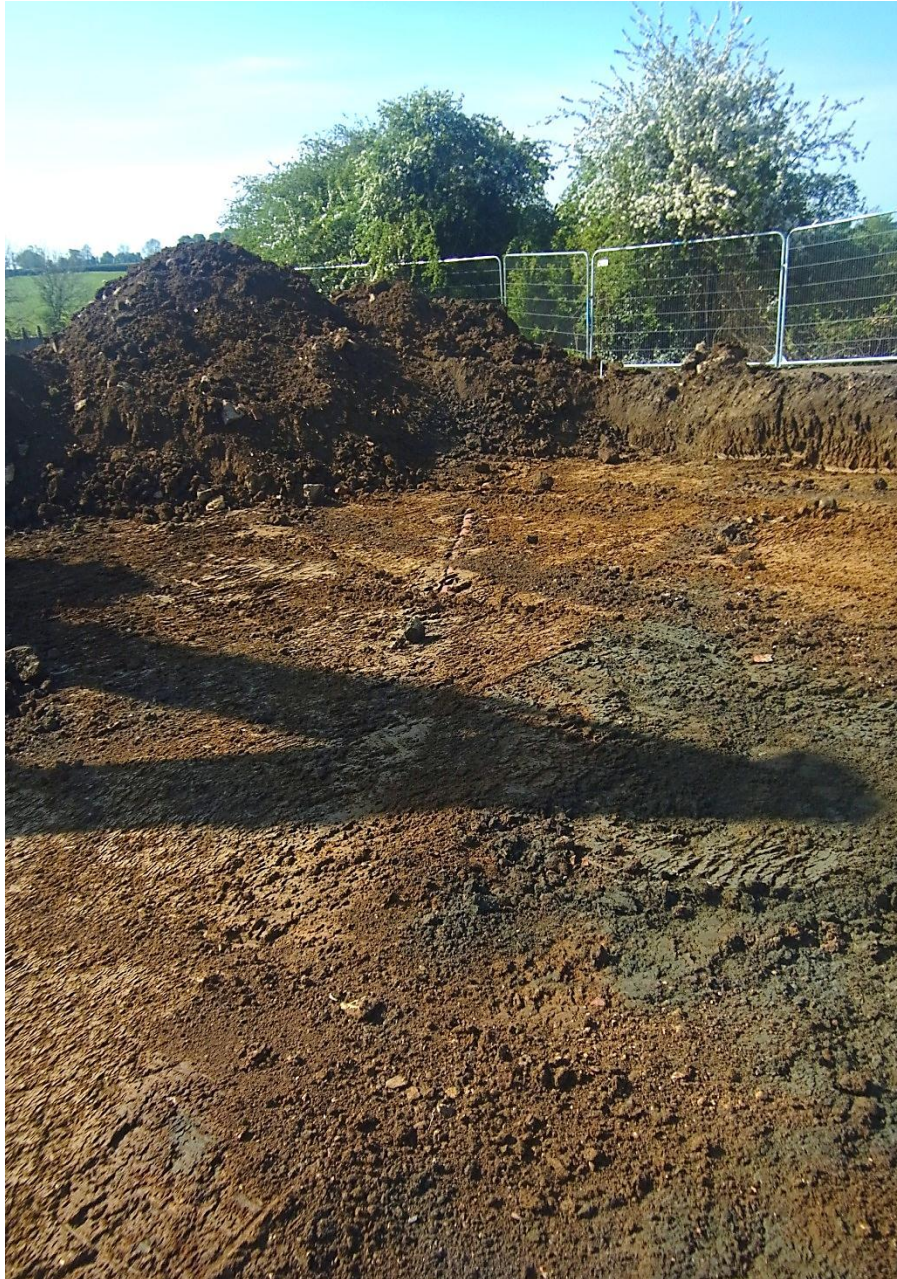
Fig 7

The furrow was cut by a later land-drain that was aligned north-east to south-west across Area 2 and was being fed from the circular soakaway in north-east of the area. The soakaway was circular in plan, c.1.0m in diameter and was constructed from unfrosted red brick and surrounded on the surface by the concrete that was present when the barn was in use. Furrow [7] was cut by a later small pond [9] irregular in plan with uneven sides and base and was filled with a light to med grey-blue-green silty sandy clay with 30% rooting, very cassy in colour and smell.

General view of Area 2 featuring furrows, drain and pond, looking south-west

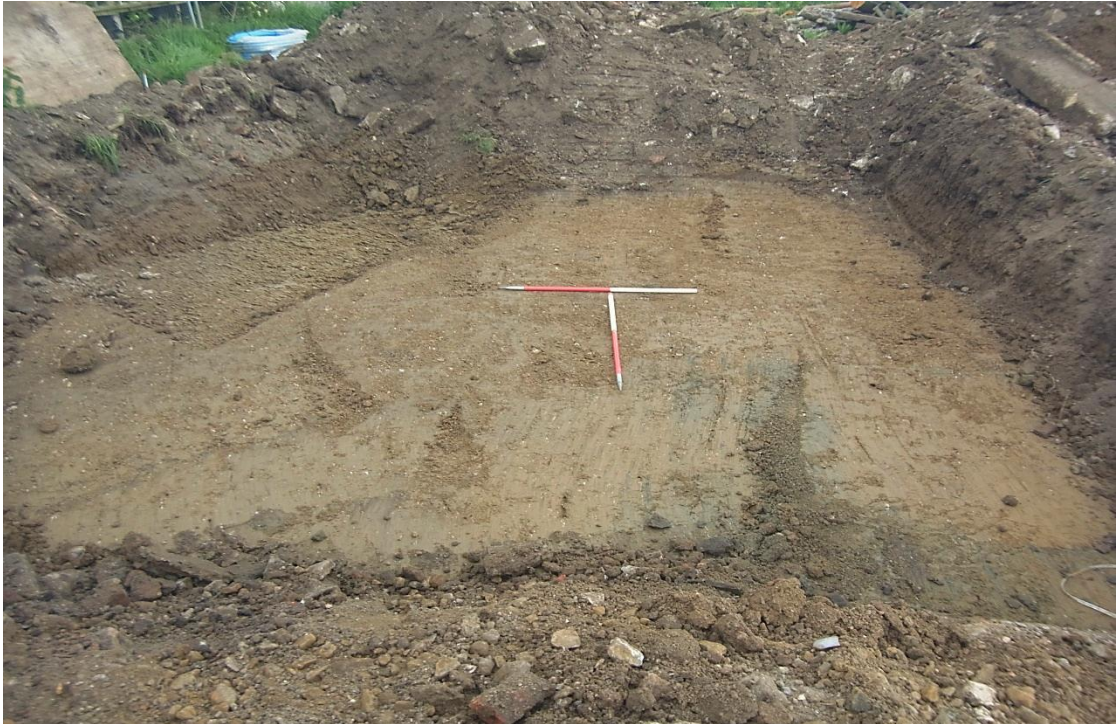
Area 3 general view, looking south Fig 8

The carport area was rectangular, 8m long by 7.5m wide. Natural was seen in the western side of the area at the depth of 1.2m, which dropped to 1.40m to the south-east. No features were present within this area.
