**Archaeological observation, investigation
and recording of land at Nottinghams
Baldock Road, Cottered
Hertfordshire
May 2016**

Report No 16/107

Author: Tim Sharman

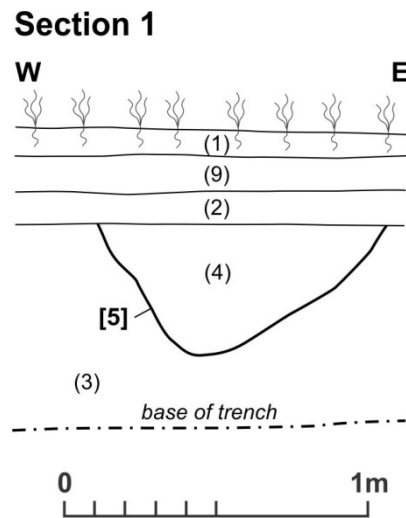
Within the northernmost footing trench, a possible linear ditch of unknown length [5] was noted running in a north to south direction (Figs 2, 3 and 4). The ditch was 0.95m wide by 0.45m deep with a V-shaped profile. The western side of the ditch sloped more steeply than on the east. The fill (4) consisted of a yellow-brown sandy clay loam with occasional flint pebbles. No dating evidence was recovered from the ditch fill.

Section across ditch [005] Fig 3

The observation work identified a possible small ditch [5] of unknown date running beneath the western extension of the northernmost barn. No artifacts or dating evidence was recovered from this feature. The brick footings and brick-lined drain appear to post-date the fire of 1879 which destroyed the stables leading to their rebuilding soon after.

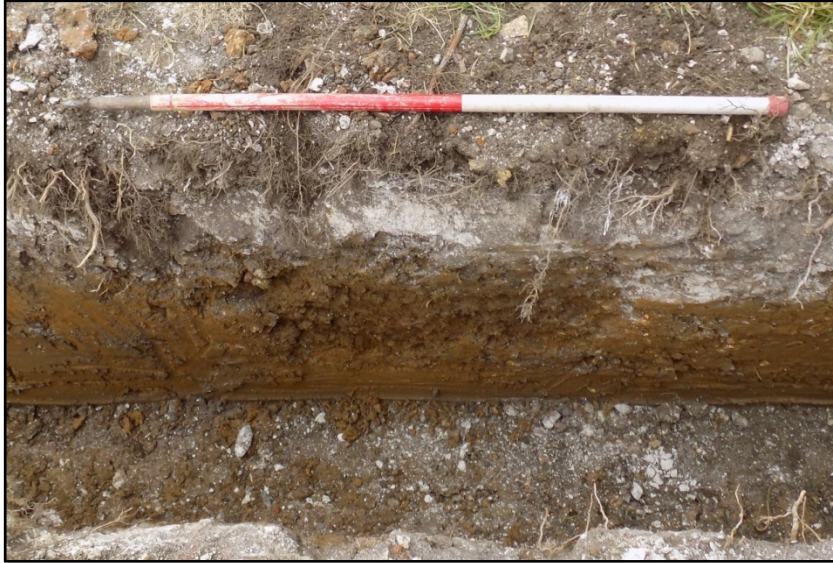
Ditch [5], looking north Fig 4

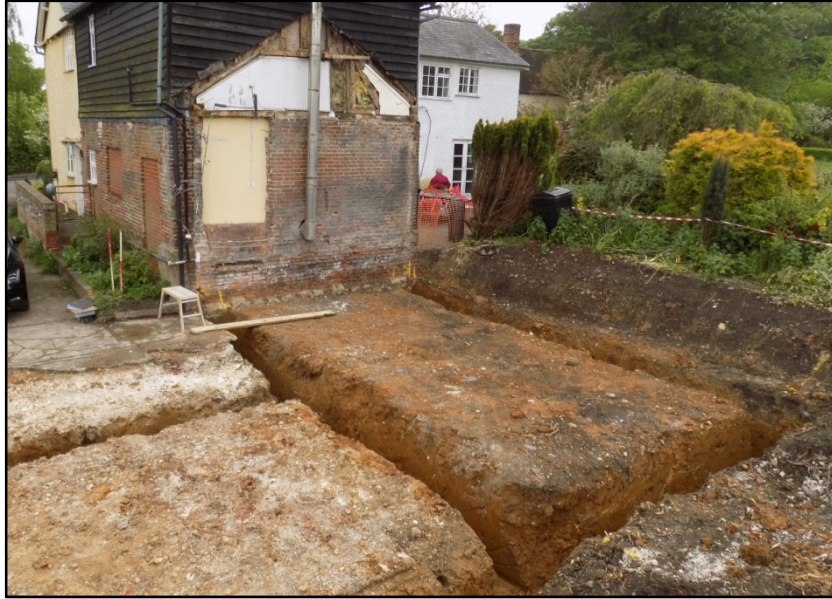
clay containing a higher concentration of flint inclusions was noted, which would appear to have been a slightly more “gravelly” form of the natural substrate. No subsoil or topsoil was extant within any of the trenches, however, immediately to the south of the observation area, a layer of subsoil (2) and topsoil (1) was noted within the edge of the adjacent garden which had been scraped at an angle of approximately 45° prior to the excavation of the footings trenches (Fig 5).

Southern part of site, looking south-east Fig 5

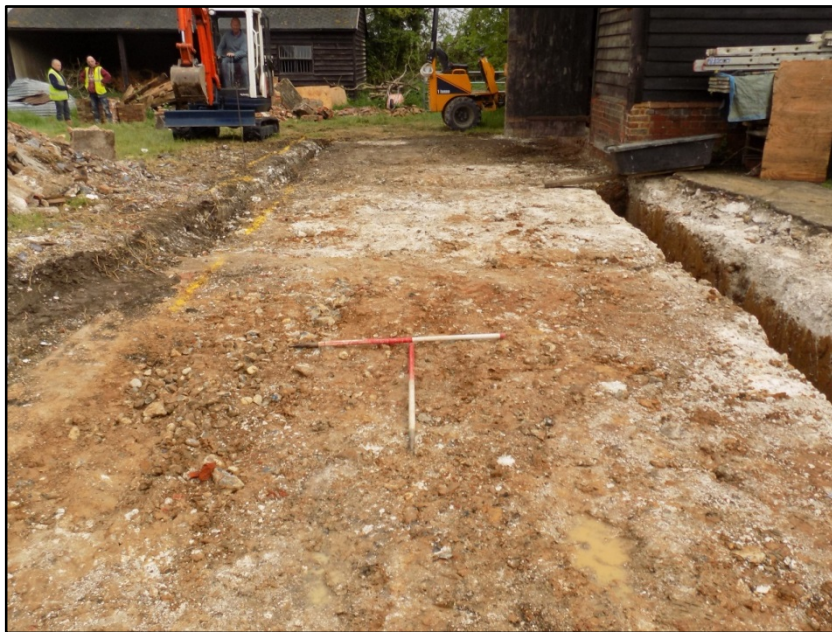
Two former floor layers were noted within the footprint of the former stable block (Figs 6 & 7). The lowest, (8), consisted of a layer of flint nodules and chalk rubble which had been placed directly above the natural clay (3). The uppermost layer (9) consisted of a compacted layer of grey-white chalk rubble with a few tiny pebble inclusions. Within the former stable block, layer (9) appears to have been directly overlain by the modern layer of concrete which had been recently removed during the demolition of the building. Layers (8) and (9) also appear to have underlain the layer of modern concrete which was extant throughout the stable yard (Fig 7).

Layer (8) with overlying layer (9) partly removed, looking north Fig 6

The flint layer (8) may have been a sub-base for the rammed chalk floor (9) which appears to have been spread throughout the area of the stables and stable yard prior to the construction of modern concrete floors and surfaces throughout the buildings and stable yard respectively.

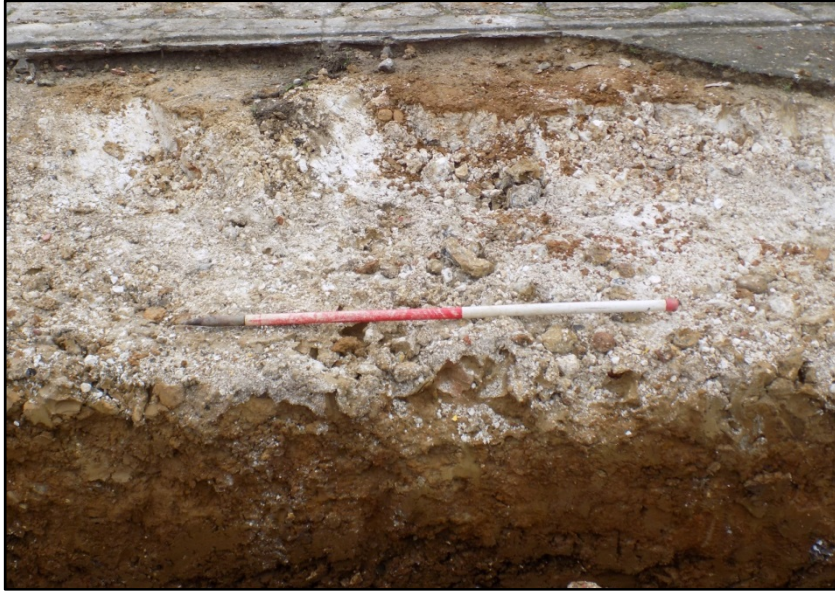
Late post-medieval surface (9) beneath modern concrete, looking east Fig 7

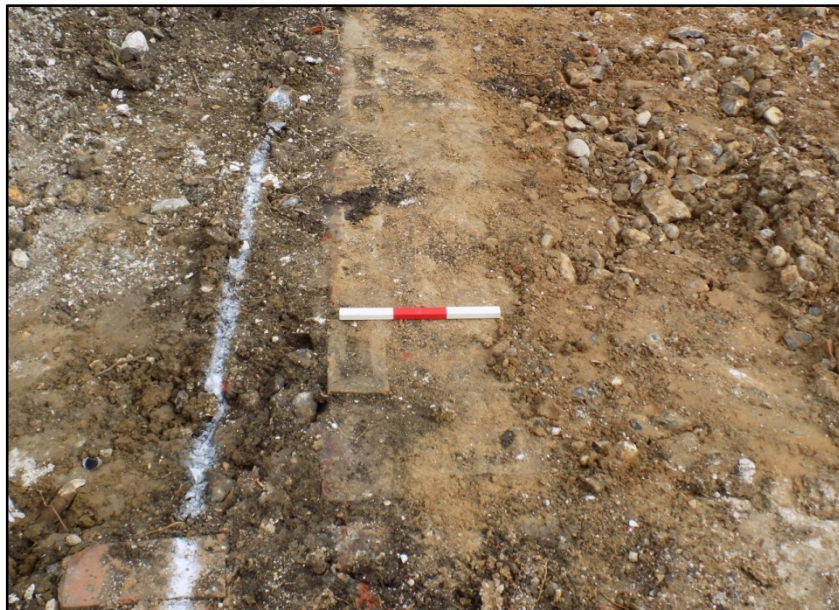
The brick footings of the former stables (Fig 8) were noted to be still *in situ* at least two brick courses deep. They were a mixture of frogged and un-frogged bricks and following the same alignment as the machine-cut footings for the new building, particularly on the western and southern sides. The brick footings for the cross-walls of the former stables were also visible (Fig 9) and did not appear to have cut through the former floor layers (8) and (9), suggesting that the earlier stable floor was constructed just after the walls.

Western side of site, brick footings and flint floor foundations, looking north Fig 8

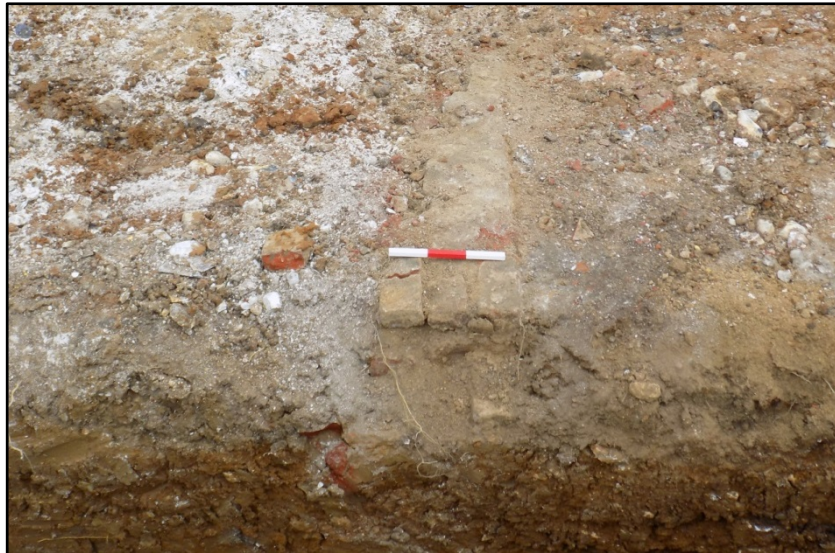
Footings of former stable cross-wall, looking east Fig 9

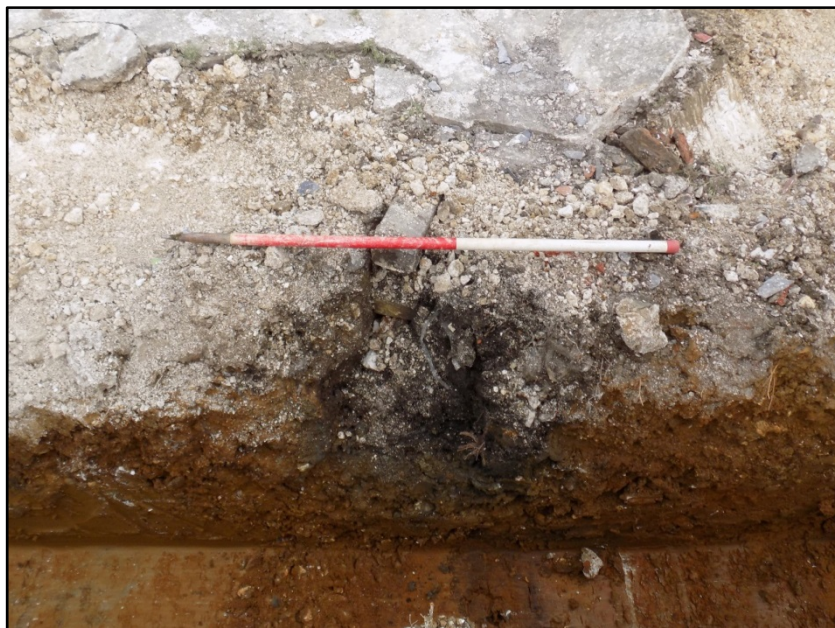
Just to the east of the eastern wall of the former stables and half way along its length was a vertical, brick-lined drain [7] (Fig 10). A channel set within the modern concrete of the stable yard fed into the drain, suggesting it had been in use until the recent demolition of the stables. The fill (6) consisted of a dark grey silt with modern inclusions such as plastic litter.

Drain [7] looking east Fig 10
