**Archaeological observation, investigation and
recording of land at The Old Manor House,
Cholesbury Lane, Cholesbury, Buckinghamshire
June 2016**

Report No 16/108

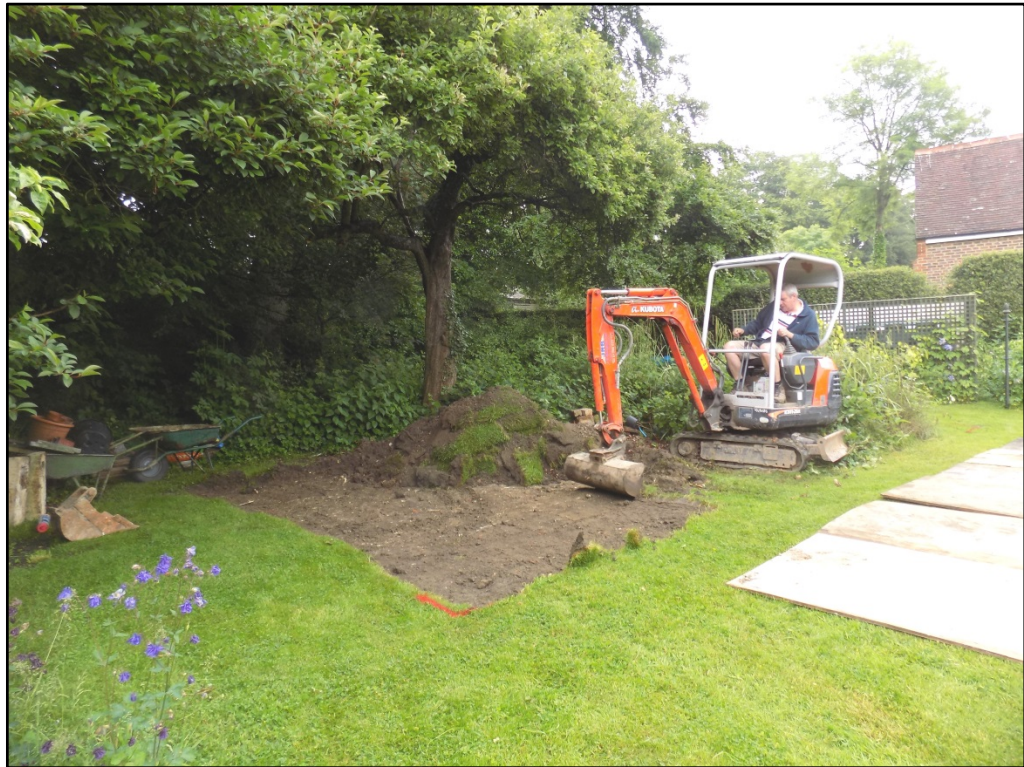
Front Cover: Stripping turf, western part of observation area, looking north east

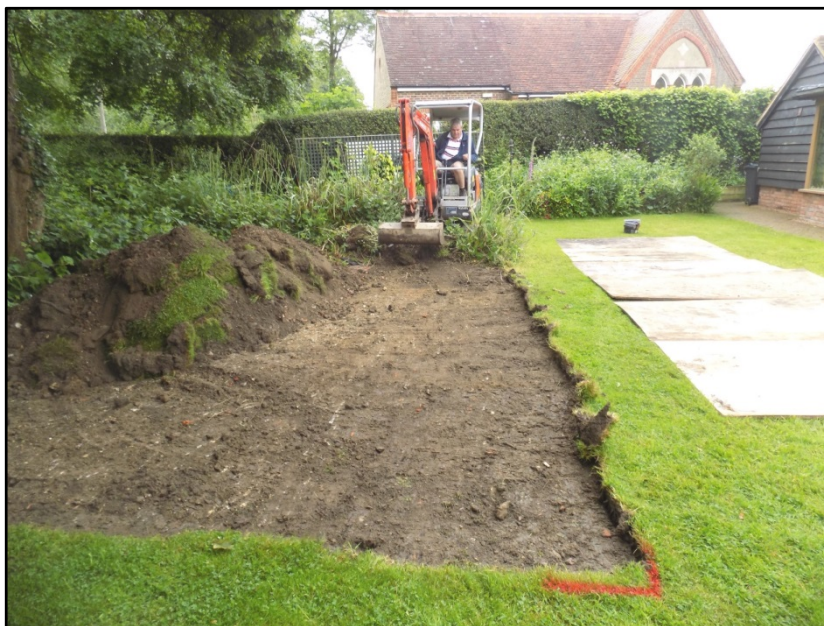
Observation area, layer (2) during turf removal, looking east Fig 3

Due to the shallow nature of the excavated trench, the natural substrate was not observed. At the western end of the observation area, a layer of firm dark yellow-brown sandy clay loam (2) of unknown depth with frequent inclusions of coal, post-medieval and modern brick, tile, glass and pottery (not retained) was noted (Fig 3). Overlying this was a thin layer of topsoil (1) consisting of loose dark grey-brown loam with occasional small pebble inclusions. Layer (2) was not visible at the eastern end of the observation area due to the shallower nature of the excavation work and modern disturbances (see below).
