**Archaeological test pit investigation
at the former Castle House
Marefair, Northampton
May 2016**

Report No. 16/112

PROJECT DETAILS		OASIS molanort1-255947	
Project title	Archaeological test pit investigation at the former Castle House, Marefair, Northampton, May 2016		
MOLA Northampton was commissioned by Northamptonshire County Council to carry out an archaeological test pit investigation on land at the former Castle House, Marefair, Northampton. A total of five test pits were excavated, three lay within the footprint of the former building with the remaining two located in a courtyard area to the north with the aim of identifying the extent of the modern truncation and if any archaeological deposit survived on the site. Only truncation of the natural substratum was observed within the footprint of the former building, however the courtyard test pits revealed a buried medieval wall, pits, garden soils and an 19th-century building beneath up to 3.0m of overburden.			
Project type	Archaeological test pit investigation

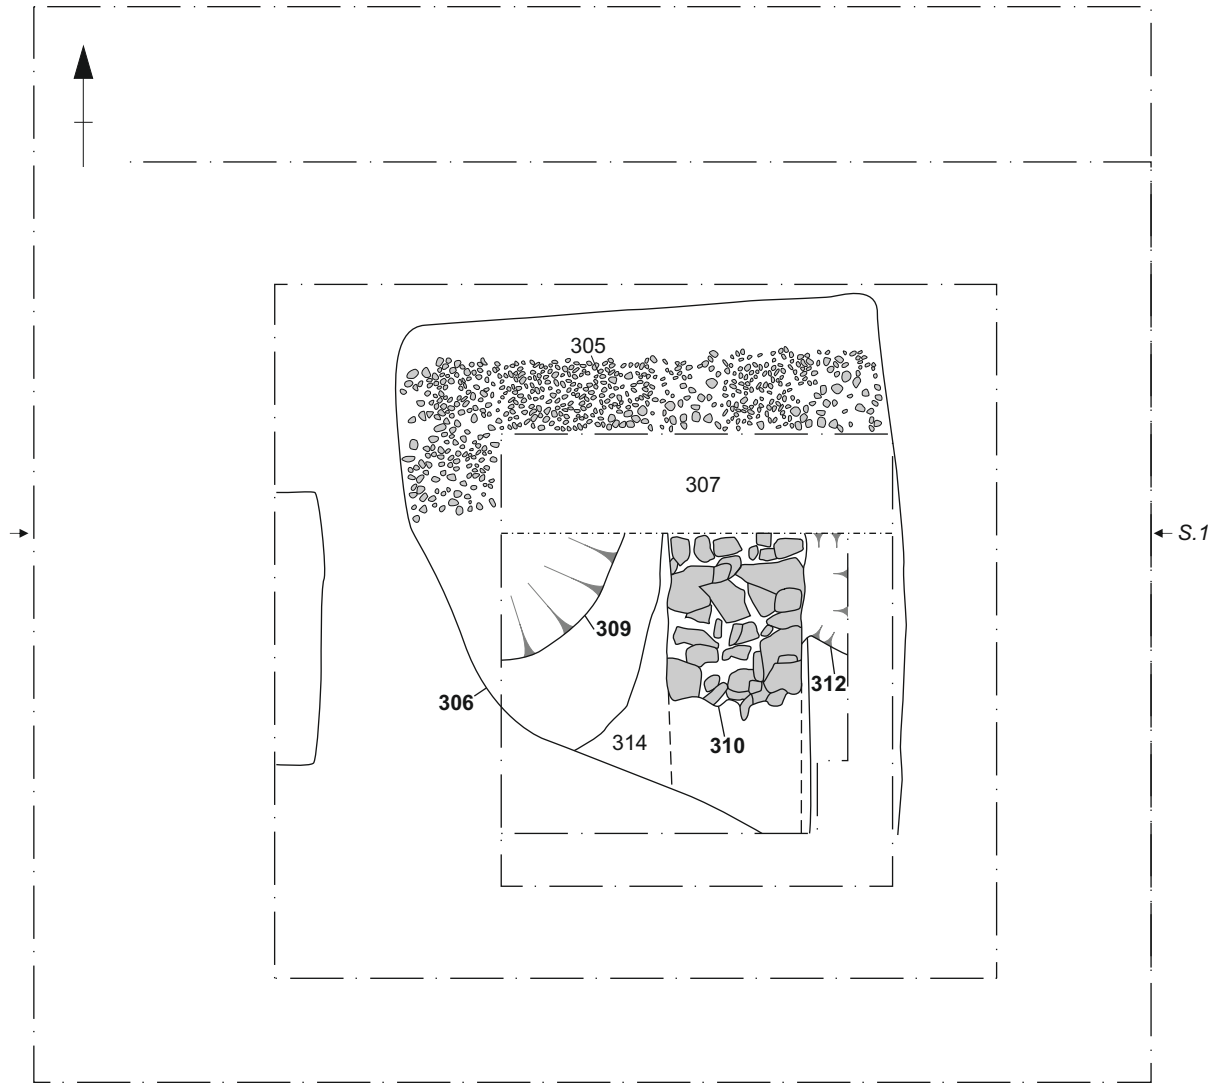
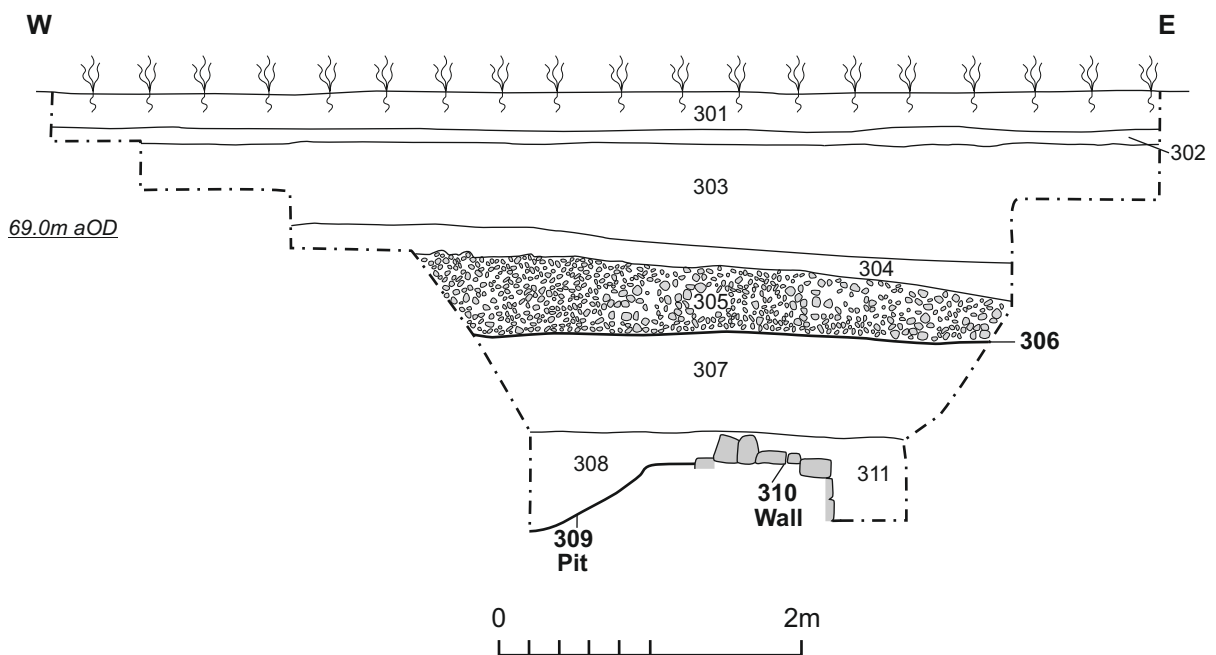
Test Pit 3, section and plan Fig 8

Section 1

Test Pit 3 was located in the south-west area of the yard. There was a ridge of natural geology (313) at 67.84m above Ordnance Datum, comprising reddish-brown clay with frequent ironstone fragments. The natural had been cut by a circular pit [309], in the north-west corner of the test pit, with approximately a quarter of the pit visible. Pit [309] had a wide bowl-shaped profile. It was excavated to a depth of 0.80m where the edge of the pit extended beyond the test pit. The fill of mid grey-brown silty sandy clay (308) contained frequent small ironstone fragments and produced pottery dated to the 12th century (Fig 7, left side).

Wall [310] was 1.30m long by 0.80m wide, aligned north to south and was constructed from irregularly shaped ironstone fragments that were roughly coursed. The east side of the wall was visible in pit [312] and continued below the excavated depth of 0.70m (Fig 9). A layer of dark grey sandy soil (314) around the wall contained pottery dating from the mid-13th century and may indicate a date when the structure was in use.

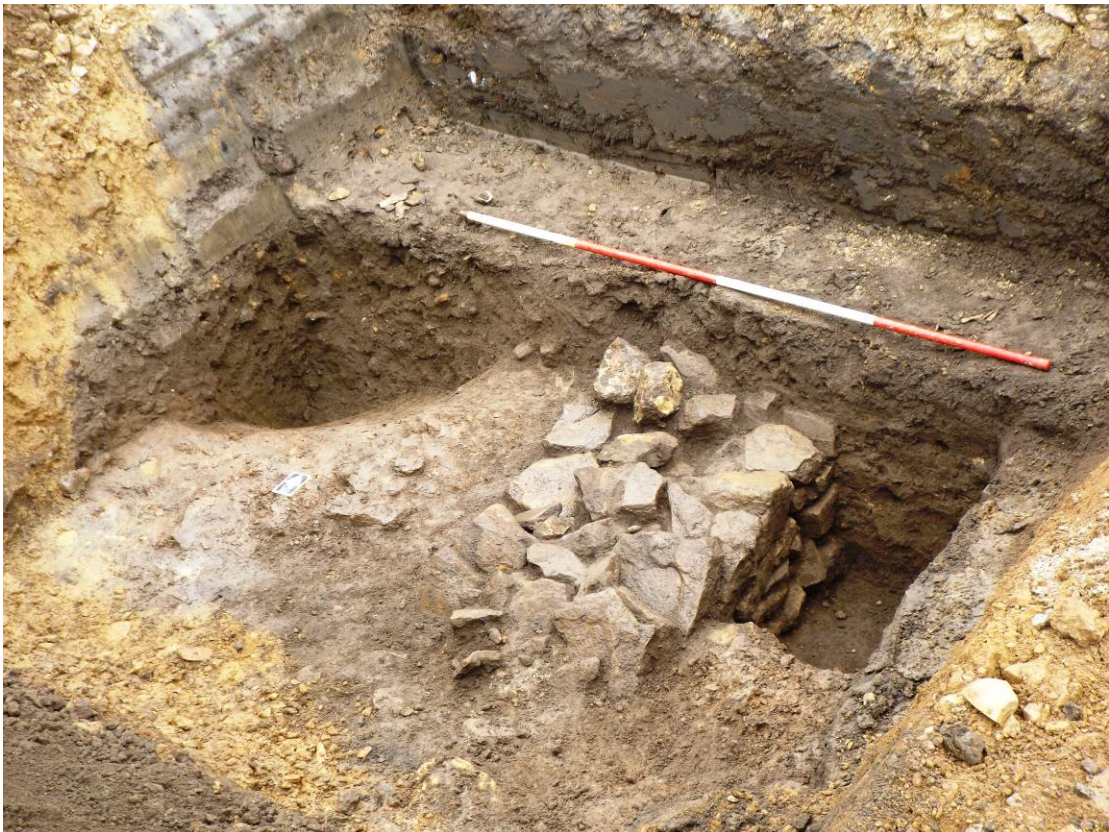
Fig 9

Pit [309], wall [310] and pit [312], looking north-west

A second pit [312], in the north-east corner of the trench, had only its southern edge visible (Fig 9). The western edge was truncated by wall [310] that also cut the eastern edge of pit [309]. Pit [312] had a near vertical edge, visible to a depth of 0.75m, and had a fill of grey-brown silty sandy clay (311). The proximity of the pit to the test pit edge prevented further excavation, but auguring established that it had an overall depth of 1.60m. Pottery dating from the 12th century was recovered from the feature.

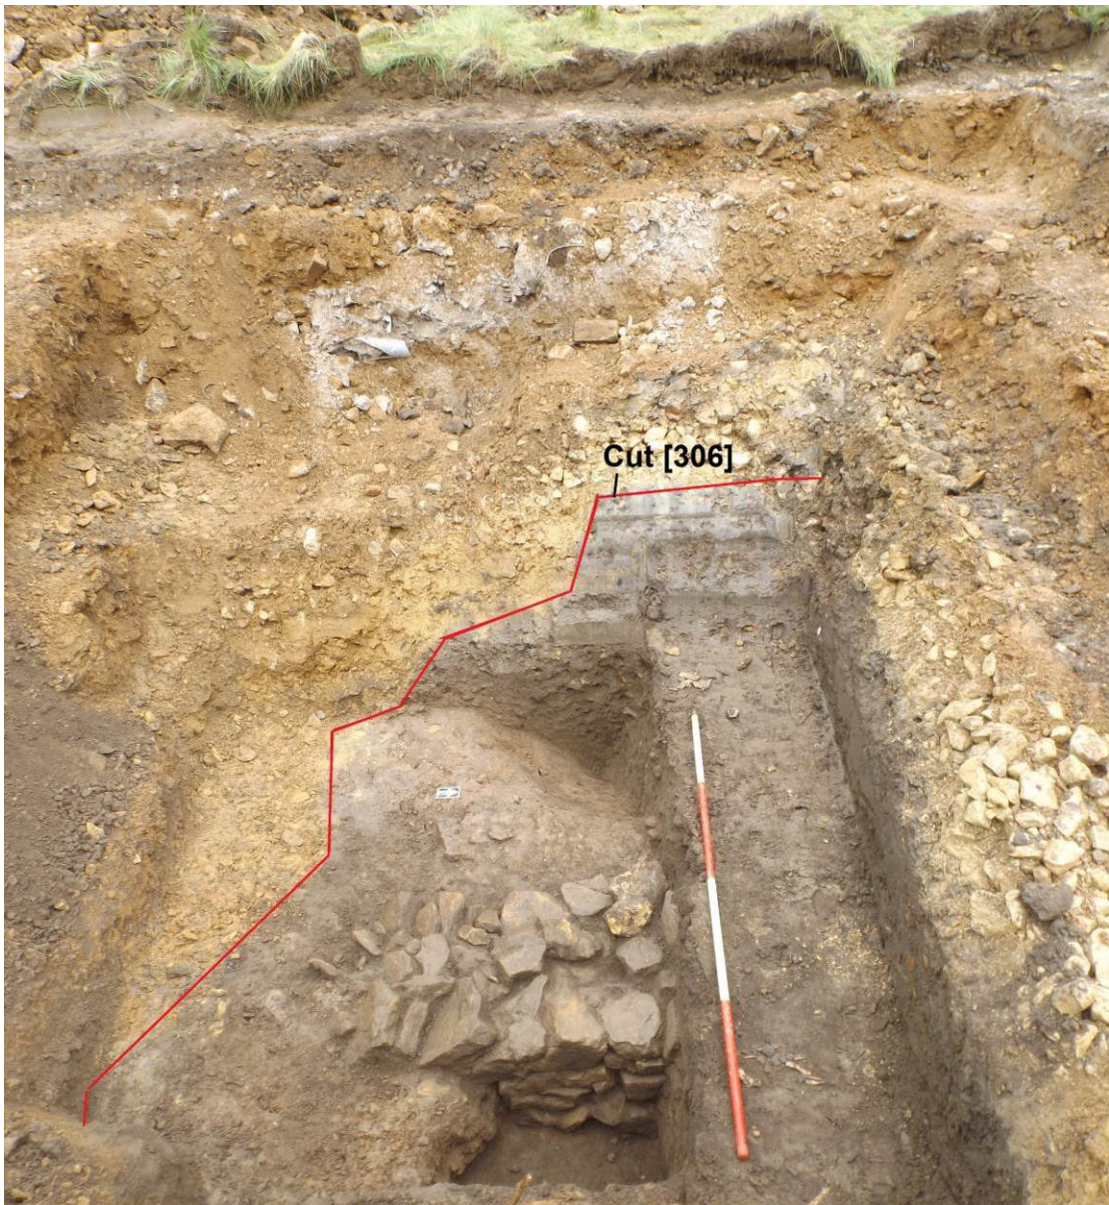
Fig 10

Modern truncation [306], looking west

to the late 15th century. The soil layer had been truncated vertically by modern demolition deposits that cut sharply down from north to south [306] that has been infilled with layers of orangey-brown stone, sand and concrete rubble (302-305) that were seen cutting the base of the test pit on its southern edge (Fig 10).

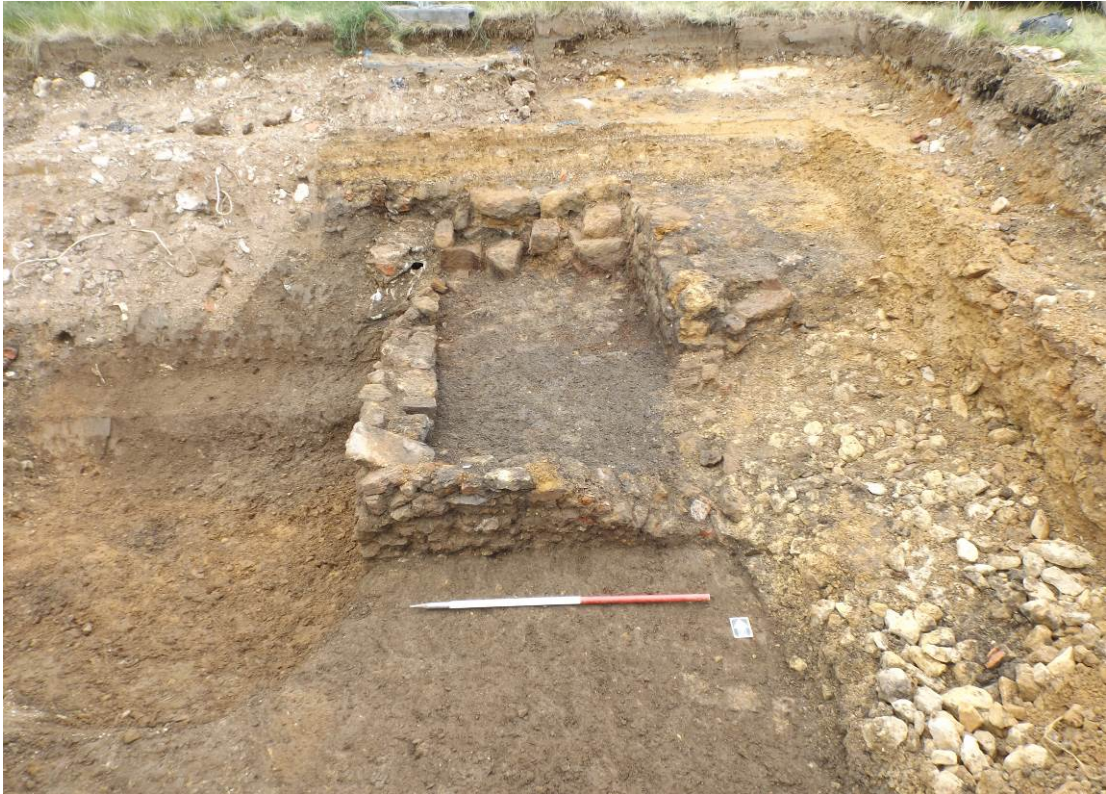
Fig 11

19th-century building in Test Pit 2, looking north

There was a garden soil (212), 0.40m thick, of dark grey sandy clay loam, similar to soil horizon (314) in Test Pit 3, which contained pottery dating to the 13th century (Fig 11). The geological horizon lay immediately below at 68.39m aOD, no archaeological features were revealed.

In the north-east edge of Test Pit 2 was a corner of a building constructed from ironstone blocks that cut the medieval garden soils and could be part of the structure shown on the 1847 map (Fig 5) on the northern edge of the site. The building consisted of two main walls [208] and [209] that had two smaller walls [211] and [210] forming a rectangular structure, possibly a lean-to on the south-west corner of the main building that was 3.0m long by 2.0m wide (Figs 11 and 12). This was sealed beneath demolition deposits 1.20m thick overlain by topsoil 0.25m thick.

Wall [208], aligned east to west, was partially beneath the northern edge of the test pit. It was constructed from roughly-faced and squared ironstone fragments that ranged between 250mm long by 200mm wide by 150mm high up to 400mm long by 300mm wide by 300mm high and was roughly horizontally-coursed. The wall was visible for 1.31m but had been cut by a modern pipe at its western end. The eastern end formed a corner to wall [209] which was aligned north to south that was 3.0m long by 0.60m wide and survived over five courses high, continuing below the level of excavation. Constructed using the same materials and prepared in the same style, wall [209] was bonded together using a hard sandy cement-based mortar.

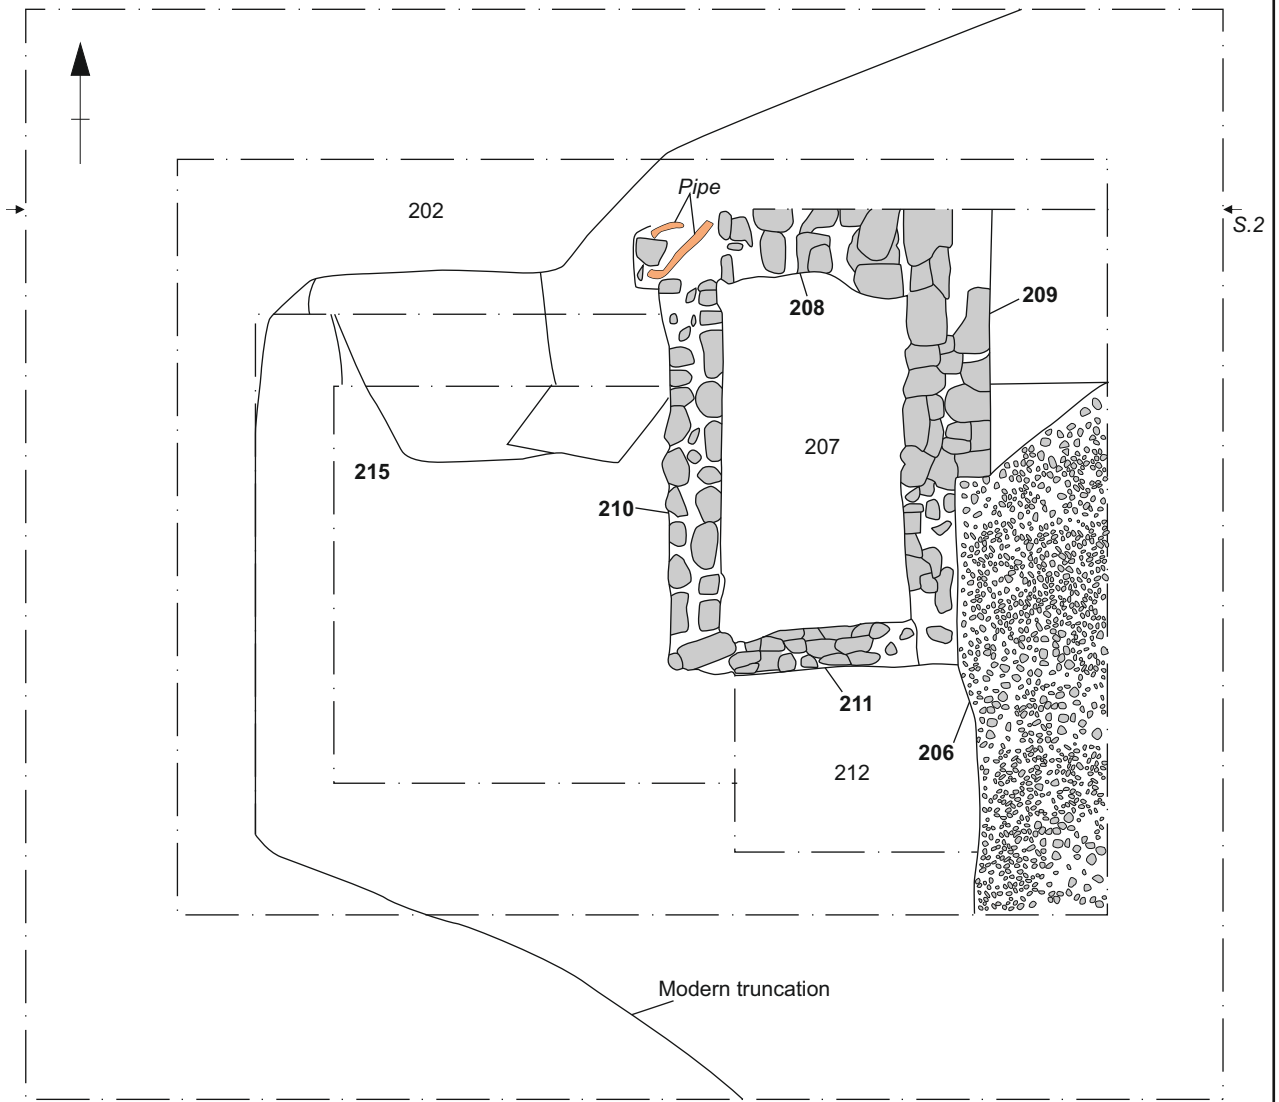
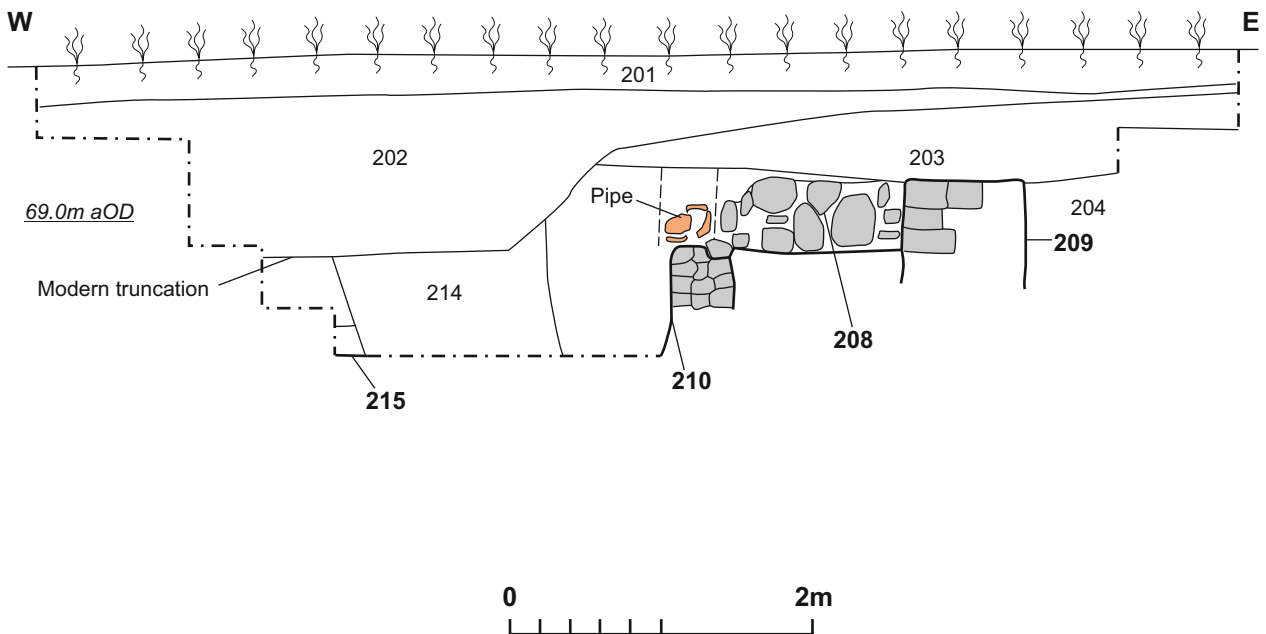
Test Pit 2

Section 2

Walls [211] and [210] formed the opposing sides to the building, constructed from smaller ironstone fragments with frequent broken brick that appeared tacked on to the main walls, likely at a later date. Wall [211] formed the south wall of the building, was 0.38m wide and aligned east to west. It was roughly constructed but the south face was well made indicating it was likely to be seen from outside. Wall [210], aligned north to south, was 0.40m wide and survived to seven courses high (Fig 13). The building was filled by mixed dark-grey silty clay (207) that contained 19th-century stoneware pottery sherds.

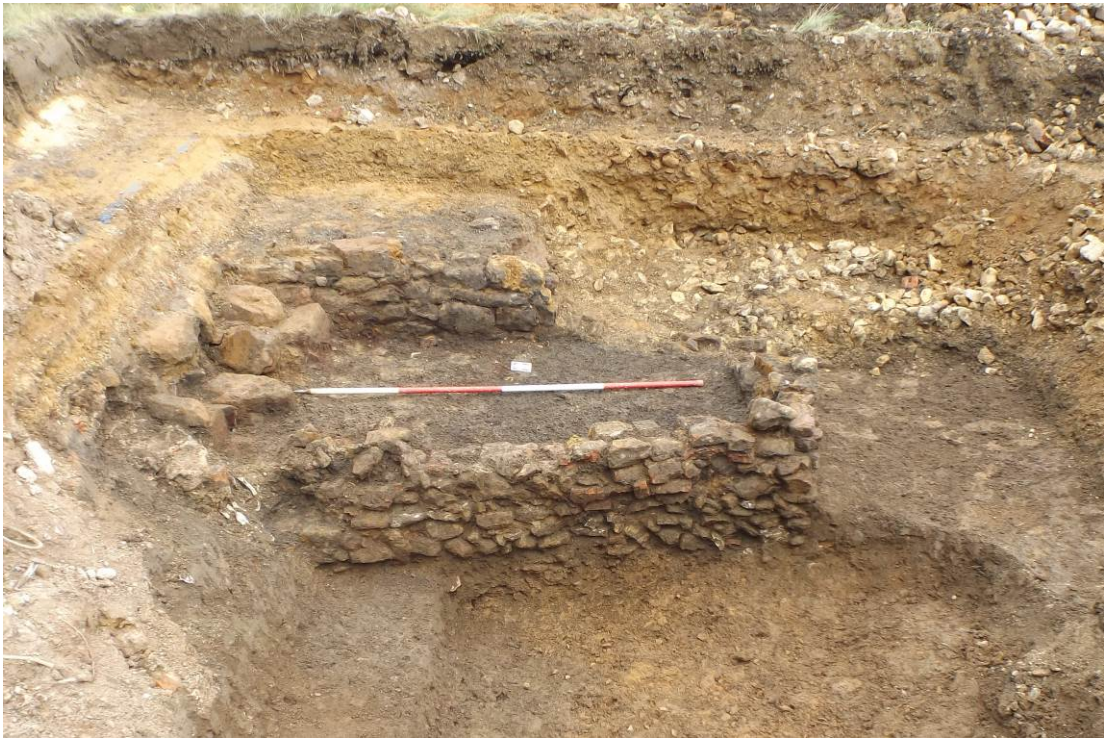
Fig 13

Walls [210] and [209], looking east

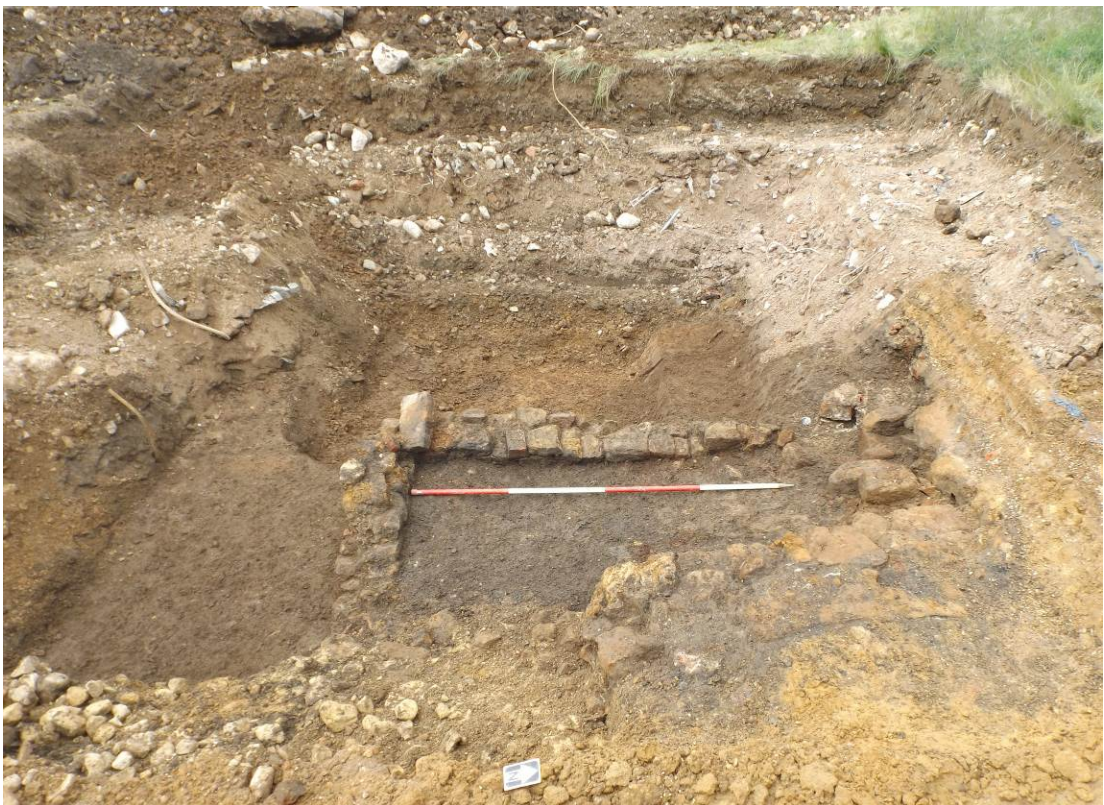
Fig 14

Modern truncation in Test Pit 2, looking west

The south-eastern corner of the building has been truncated by a large modern pit [206] that was filled with building stone. The western edge of the test pit contained modern demolition deposits from the former Castle House building that were still visible in the base of the test pit at a depth of 2.0m (Fig 14).

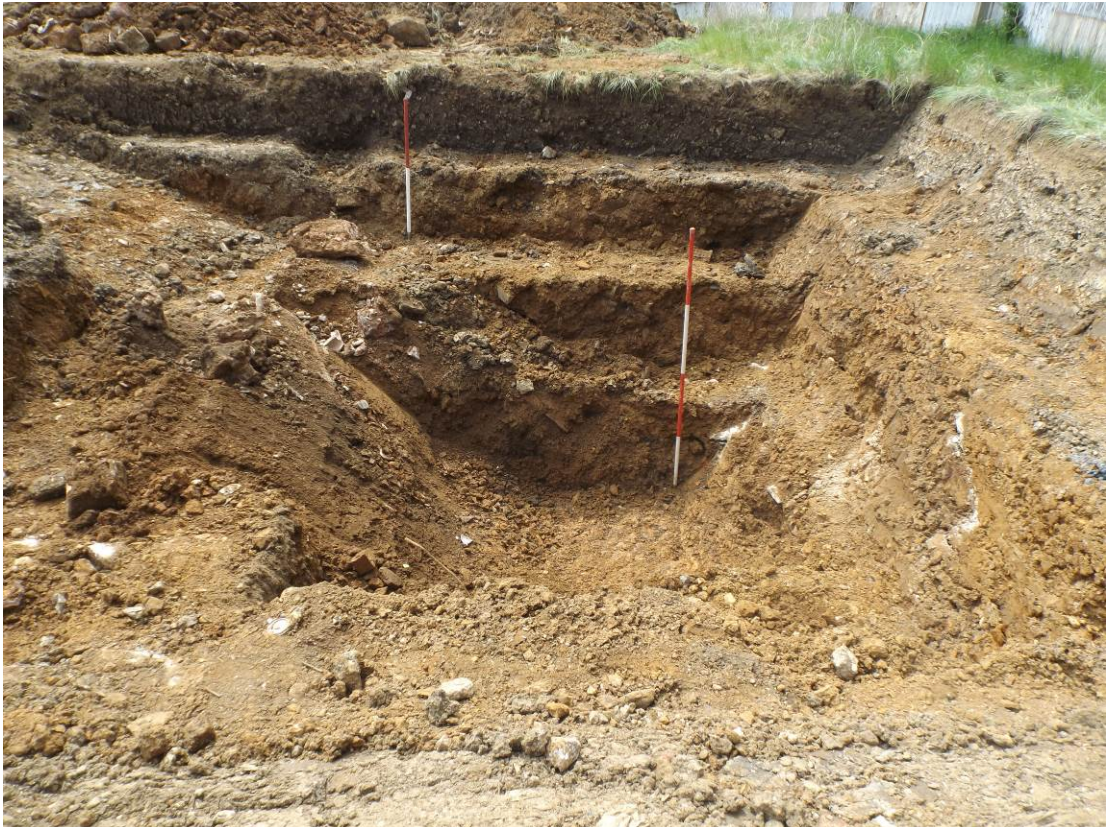
Fig 15

Test Pit 1, looking south

Test Pit 1, located in the north-east corner of the site, encountered undisturbed ironstone deposits (104) at 66.73m above Ordnance Datum. The natural geology was overlain by a demolition deposit (103) that consisted of large broken concrete fragments, reinforced concrete, brick and metal within a sandy matrix that was 1.80m thick. The demolition deposit was overlain by mixed grey-brown clay (102) that also contained broken brick and concrete, covering the area to a depth of 0.50m thick. The topsoil overlay this and was 0.30m thick (Fig 15).

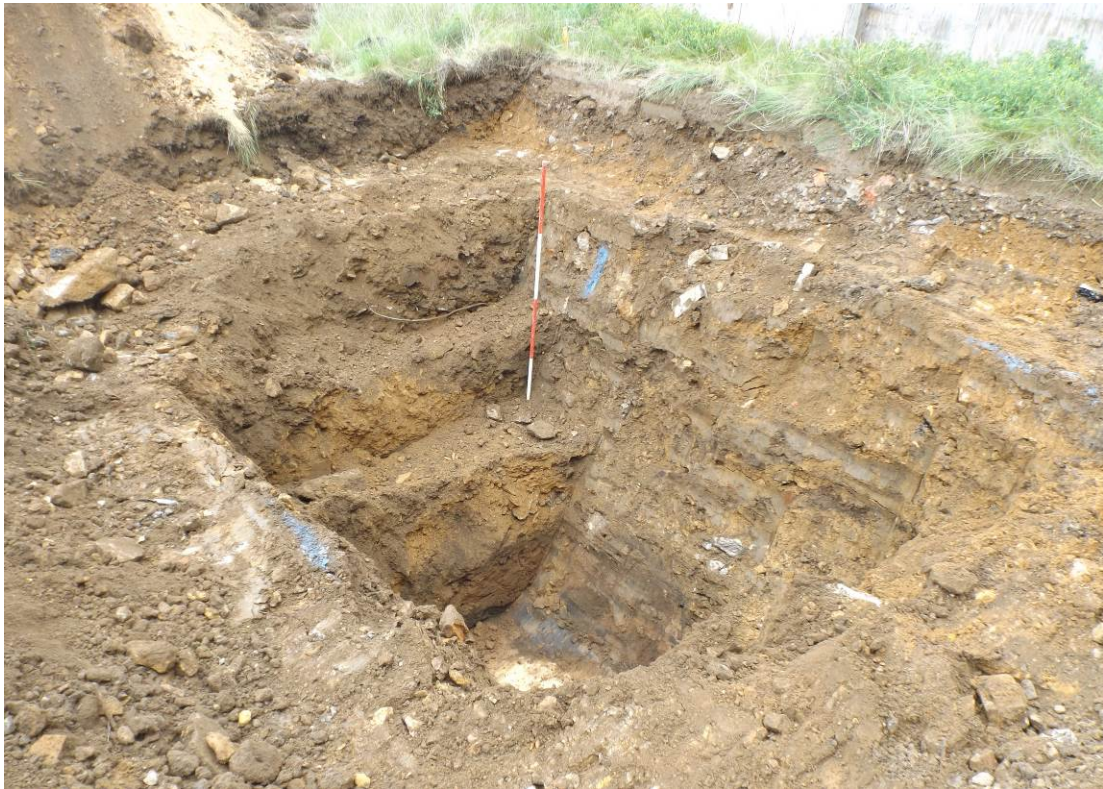
Fig 16

Test Pit 4, looking north-west

Test Pit 4, located in the north-east corner of the site (Fig 6), was excavated to 66.88m above Ordnance Datum where the natural geology was pale yellow-brown sands (405). The sand was overlain by dark grey silty clay (404) that contained brick fragments and was 0.55m thick. Overlying the clay was a mixed demolition layer (403) that was very loose rubble with ironstone fragments, broken concrete slabs, metal struts and bricks that was up to 2.0m thick.

Sealing the rubble was a layer of dark grey silty clay (402) that contained building stone and brick fragments that was 0.40m thick. The topsoil that covered the area was mid grey sandy clay (401) that was 0.25m thick (Fig 16). The test pit had an overall depth of 3.38m, a large concrete block on the southern edge and the proximity to the fence line prevented a wider area being opened up.

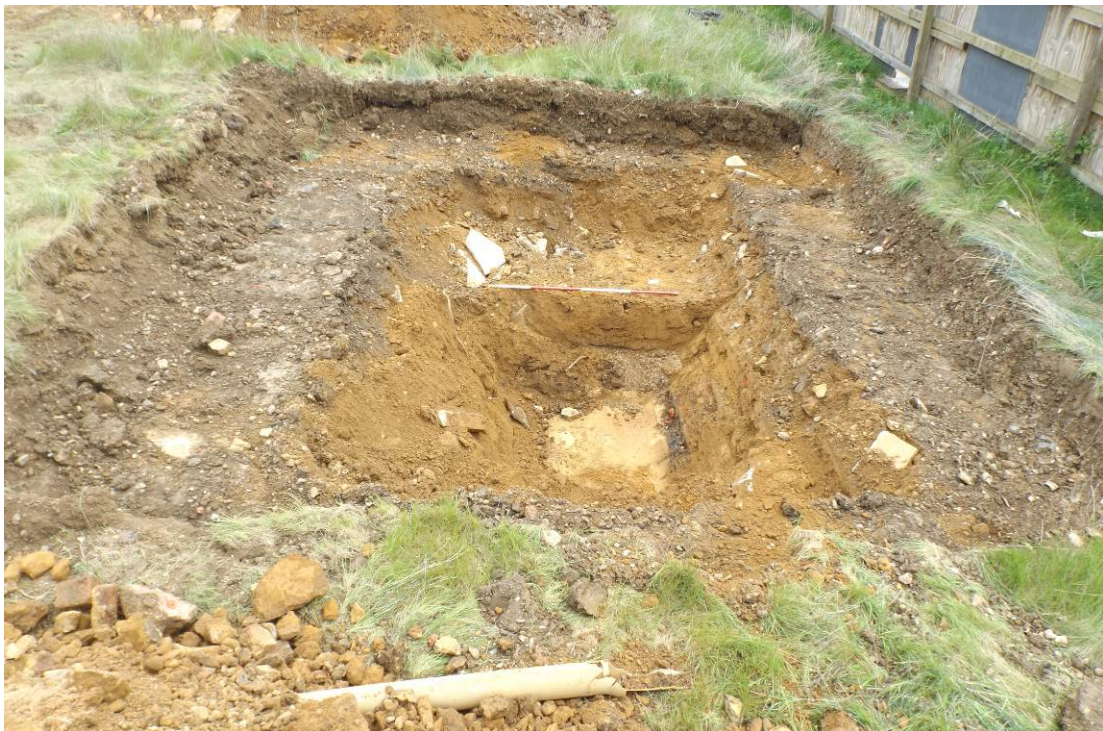
Fig 17

Test Pit 5, looking west

Test Pit 5 located along the southern boundary of the site was excavated to 66.70m above Ordnance Datum, where the natural geology (505) was pale yellow-brown and orange sand (Fig 17).

The natural was overlain by a demolition deposit (504) that was dark grey silty clay with frequent brick fragments, plastic pipe and scrap metal that was 0.30m thick.

Overlying the clay was a rubble demolition deposit (503) that contained concrete rubble, slabs, and broken brick and reinforced concrete fragments. The rubble deposit was up to 1.50m thick and was overlain by a layer of stoney dark grey clay (502) that was 0.60m thick with frequent brick fragments throughout. The mid grey sandy clay topsoil (501) present over the area was 0.12m thick.

The test pit was excavated to a depth of 2.55m below the current ground surface. Through the centre of the test pit, aligned north to south, was a gravel filled service trench that prevented further expansion of the test pit to the east.
