**Historic Building Recording of a Barn at  
Stoneleigh Farm, Upper Boddington  
Northamptonshire  
August 2016**

**Report No. 16/151**

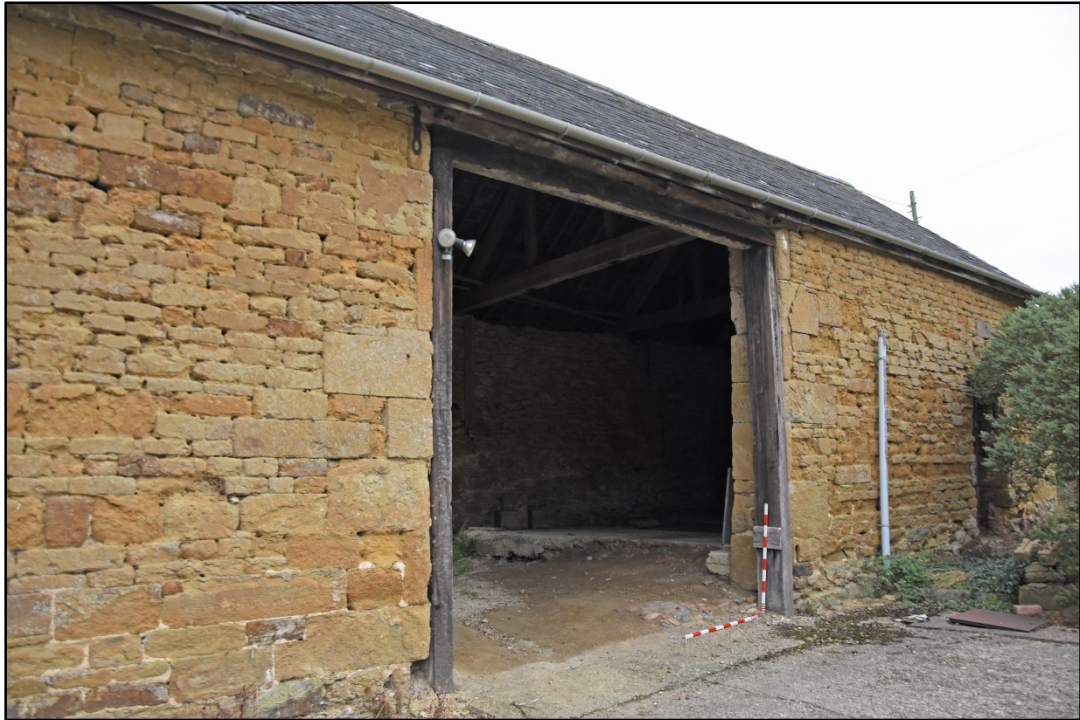
The central doorway Fig 10

The primary entrance to the barn is via a full-height double doorway, c3.7m in width, located roughly central to the east elevation (Fig 10). The door opening is lined with large, shaped, stone blocks and contains a black-painted timber frame and lintel. The doorway was fully open with no doors surviving. Interestingly the frame shows no evidence of having supported hinges or any other door mechanism; the jambs are smooth with no peg or screw holes visible. Some remnant iron work remains *in situ* on the lintel, above each jamb. This comprises a cast iron pivot ring or gudgeon flanked by a pair of cast-iron hoops, one with an attached iron strap. The pivot rings do not appear to be substantial enough to support a door of the size needed to close the opening and the modern concrete yard surface has removed any evidence of former pivot posts if there were any. A tall, narrow ventilation slot is located to the south of the doorway, its jambs splayed inwards.

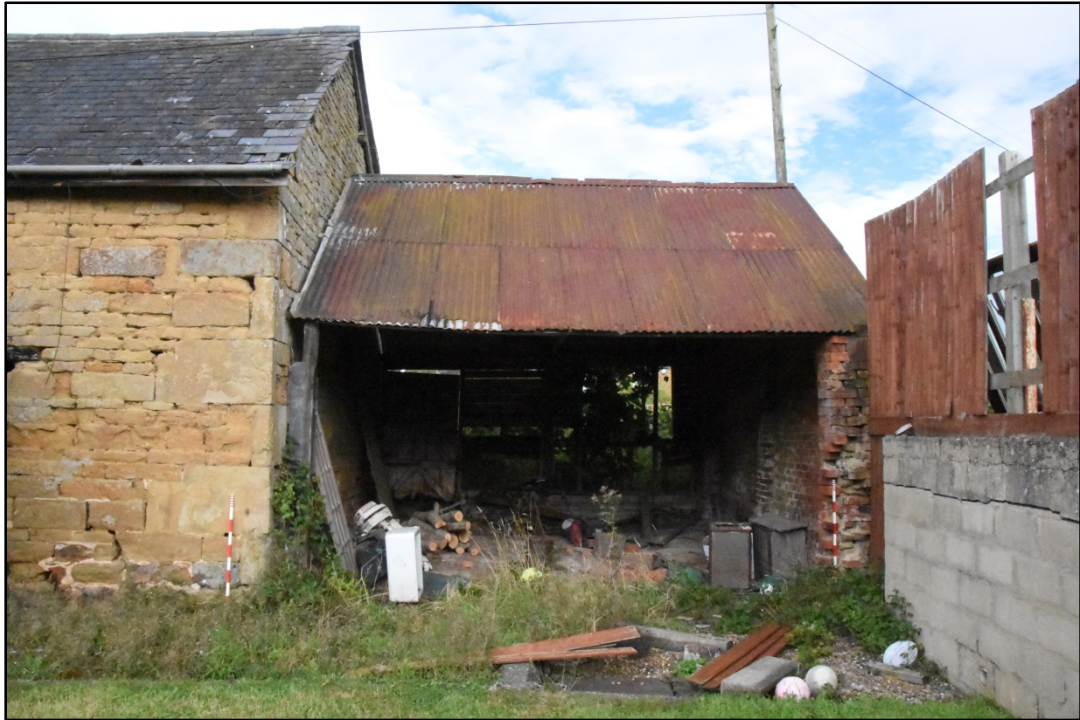
The extension, looking north-west Fig 12

Built against the north gable elevation, the extension is a simple structure on a roughly square plan measuring 5.5m in width and breadth (Figs 5 and 12). It is open-fronted to the east and has a gable roof of corrugated sheets to a height of 4.7m. The timberwork which supports the roof frame is embedded into the north wall of the barn (Fig 38). To the north is a gable wall of red bricks in English Garden Wall bond, comprising projecting piers central to the wall and at the ends, with a projecting plinth at the base, spanning between the piers (Fig 39). The brickwork of the southern pier is in particularly poor condition with many of the bricks having fallen away. Several bonding timbers, lengths of machine-sawn pine, have been embedded in the wall above the piers, level with the wall plate, and below the two purlins. The brickwork of the piers and plinth differs in appearance from those which make up the bulk of the elevation, being of a darker red colour, mixed with occasional blue-black bricks, in contrast to the surrounding paler pink - red bricks. The upper part of the westernmost pier has been rebuilt. It is possible that this elevation was formerly not fully enclosed, allowing access through this wall into the northern part of the property.

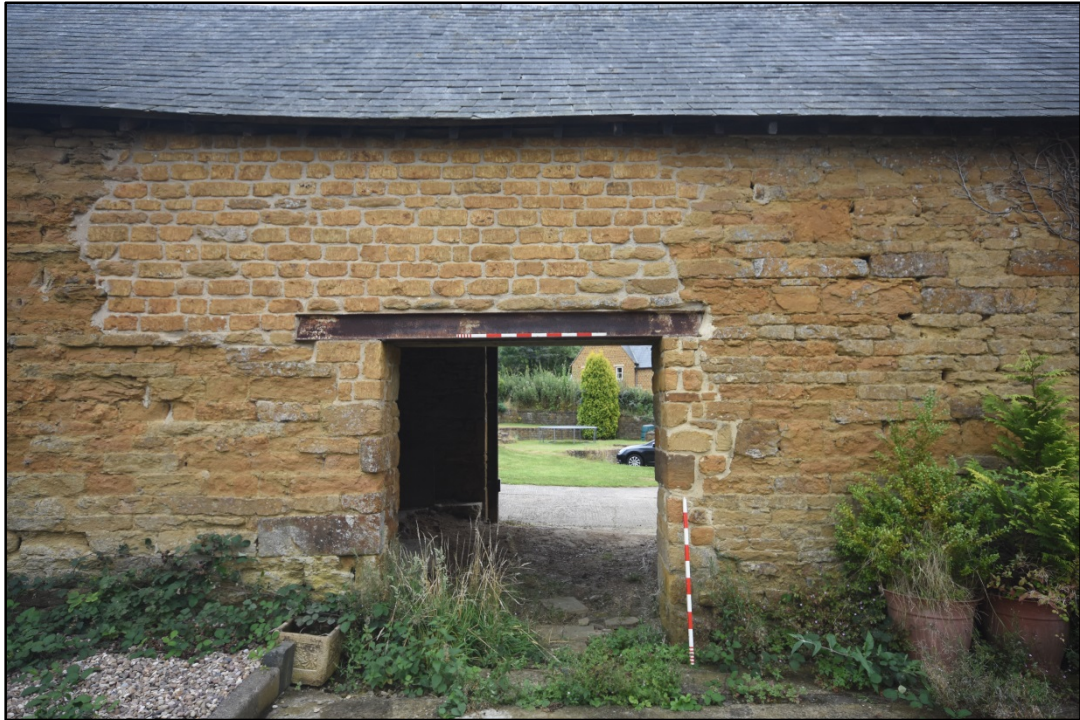
The reduced doorway and area of repair Fig 14

Opposing the main doorway is a smaller, almost square door which allows access to the room from the north-west (Figs 14 and 32). The opening is 1.9m in width and it is evident that it was formerly a full-height opening which has been reduced. As part of this work, the southern door jamb appears to have been completely re-built or re-faced, with some minor work also having been carried out to the northern jamb. The door lintel is formed of a pair of C-beam RSJs and a timber beam. Above this, the former opening is blocked in coursed stone rubble with cement mortar. On the inner face of the wall, this is confined to the width of the door but on the outer face it encompasses a wider area of repair and re-facing. A similar, though more crudely executed, repair or re-facing is visible externally at the north end of the west elevation.

The reduction and repair work carried out to the western central doorway appears to be relatively modern; the stonework is more sympathetic than other changes, though a cement mortar was utilised.

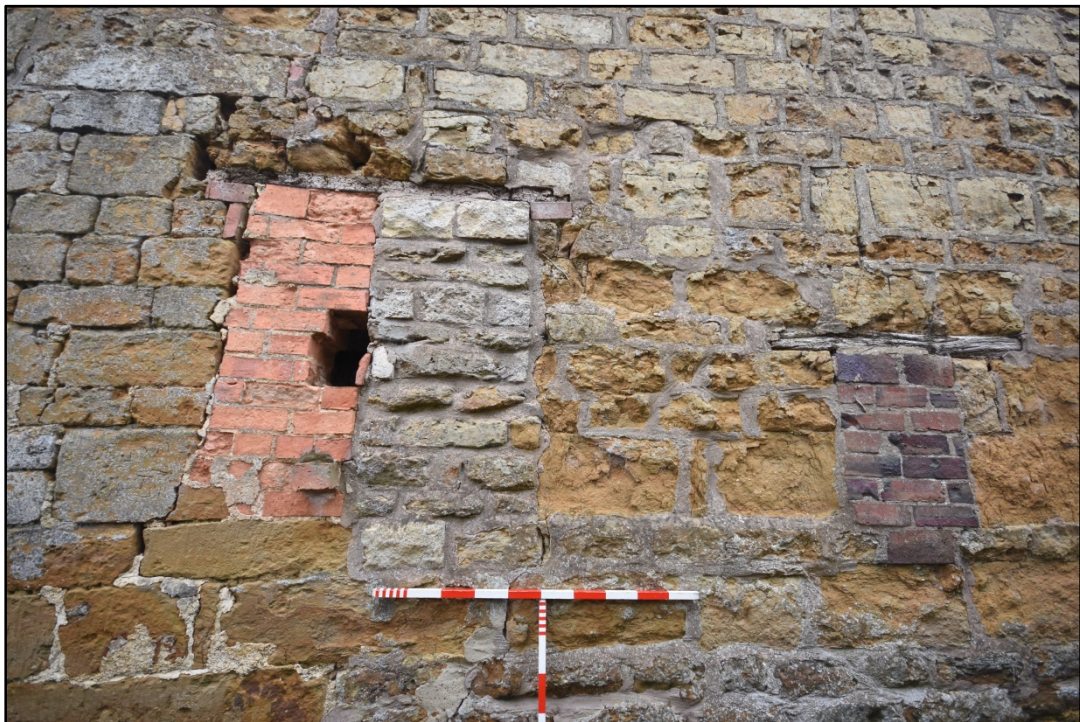
Detail of the blocked windows of the south elevation Fig 19

A small cupboard has been created within a former window opening in the south wall (Fig 21). The window has a timber lintel and has been blocked externally with blue-purple bricks bearing horizontal skintling marks from their manufacturing process (Fig 19). The cupboard has a simple hinged door of planks, flush with the wall surface, with strap hinges connecting to the wooden frame. Adjacent to the cupboard is a square window. The window opening has been blocked in two separate phases, the first halved the opening vertically using rubble with cement mortar, and the second phase fully blocked the remainder of the opening with red brick, at the same time repairing and replacing parts of the stonework at the jambs (Figs 19 and 21).

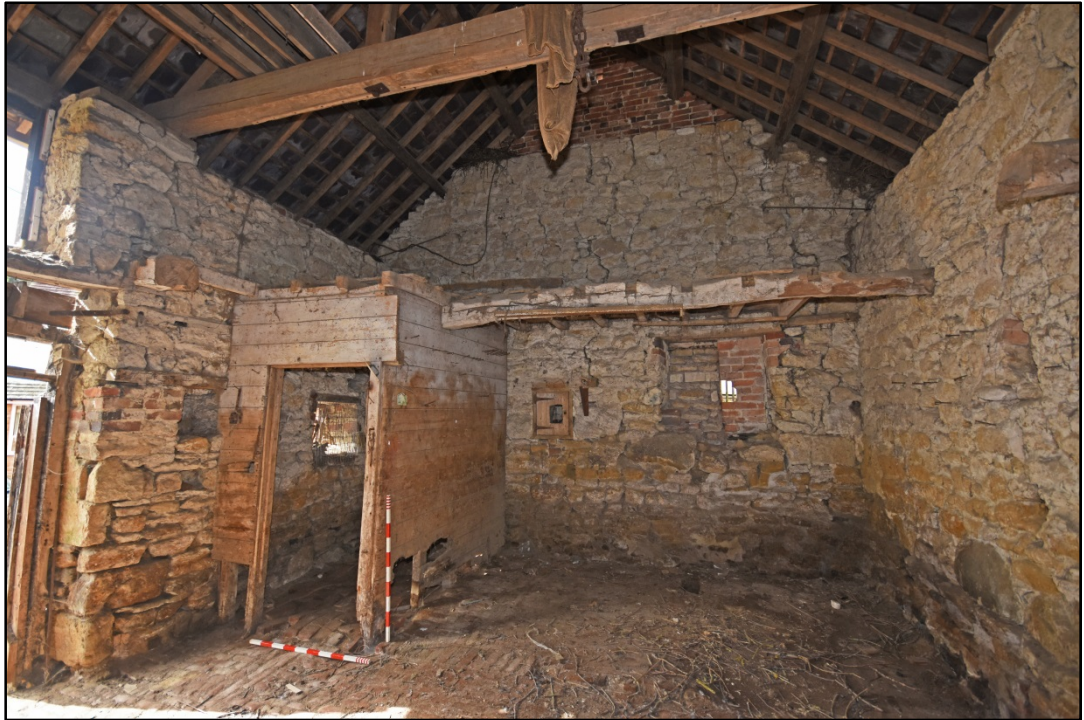
Room 1, looking south-west Fig 20

the wall (Fig 20). It is possible that the partition formerly fully encompassed the southern end of the room. The remains of a truncated post can be seen a short distance to the west of the store, in line with the end of the room (Fig 5). A timber beam spans between the east and west walls of the barn, central to the small room, and carries joists for a mezzanine floor. The floor has been largely removed, exposing defunct joist slots. The eastern end of the beam, which passes over the store room, has crudely-shaped chamfered stops on the underside edge. After it passes out from the store room, the beam is reduced in size with the underside being hand hewn (Figs 24 and 25). The fitting for a strip light remains on the underside of the beam. The truncated ends of two more beams remain *in situ*, projecting from the east and west walls (Figs 23 and 26). The surviving beam and the beam ends are equally spaced and it is likely that the mezzanine floor formerly spanned the full extent of the room.

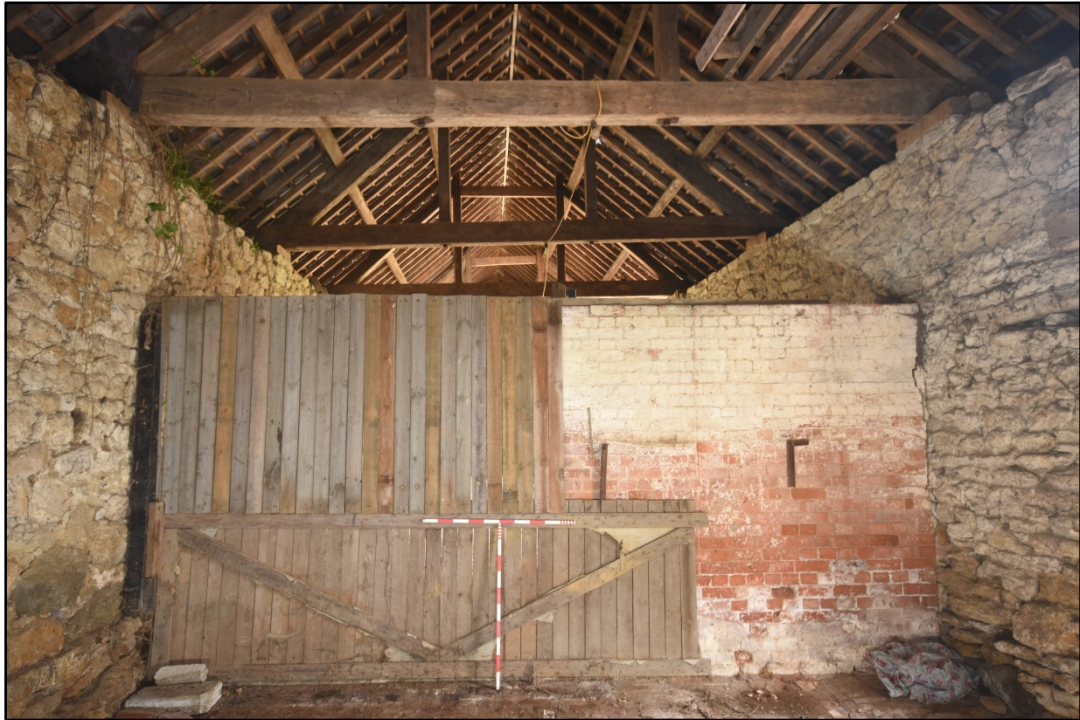
The brick and timber partition, looking north-east Fig 28

The room is enclosed from the main barn space (Room 2) by a brick and timber partition, c2.4m in height (Figs 28 and 29). It fully spans between the east and west walls but is not keyed into them. The eastern half of the partition is constructed of red brick in English bond and the remainder is formed up upright planks nailed to horizontal rails, with diagonal bracing on the southern face.

The barn has been re-roofed, likely in the mid to late 19th century, in a style typical of the period, utilising pine and Welsh Slate. The brick partition between Rooms 1 and 2 is likely a 20th-century addition and has been cut short and partly replaced with planks. The concrete flooring and manger at the north end of the barn are of a mid-20th-century date and it is likely that the brick partition is contemporary with this work. The date of the small store room within Room 1 is uncertain, though again it could be contemporary with the mid-20th-century conversion of the building, or it could perhaps be of an earlier, 19th-century date. The brick flooring within this room is indicative of a pre-20th-century date and extends the length of the former mezzanine floor level indicated by the truncated beams in the east and west walls, stopping at the later brick partition wall.

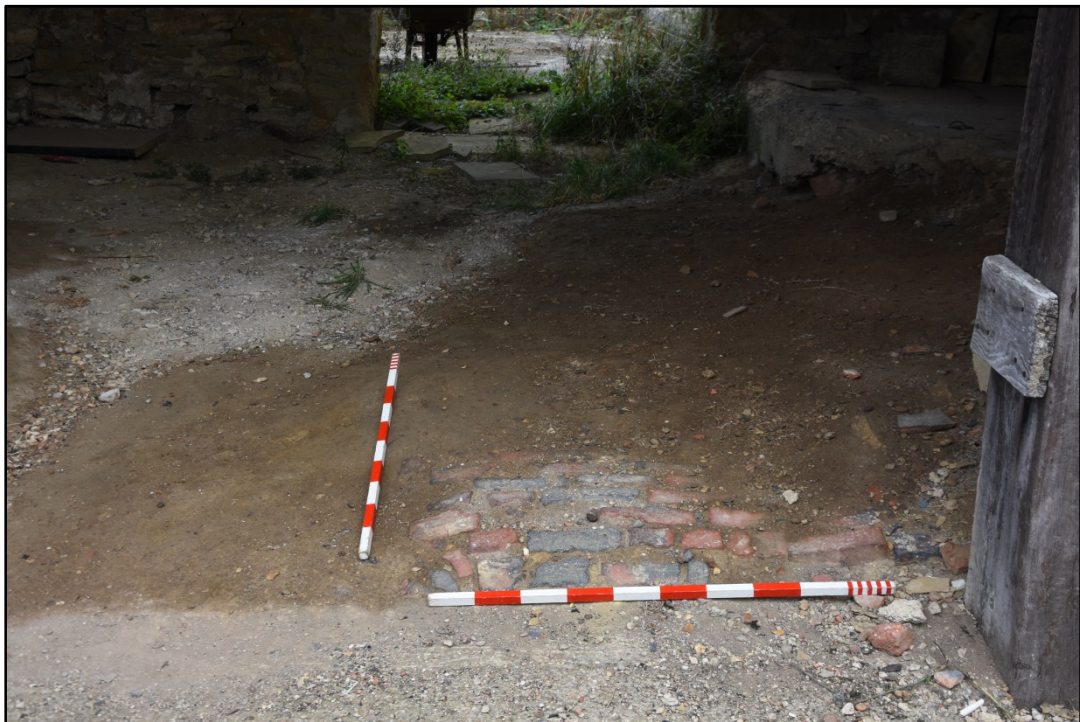
Remnants of a brick floor surface within the central eastern doorway Fig 31

The larger part of the room has a compacted earth floor, no longer level, which slopes down to the main doorway. A small patch of brick floor surface remains *in-situ* adjacent to the door; this flooring scheme likely formerly covered the central part of the room, between the opposing doors of the east and west walls (Fig 31).

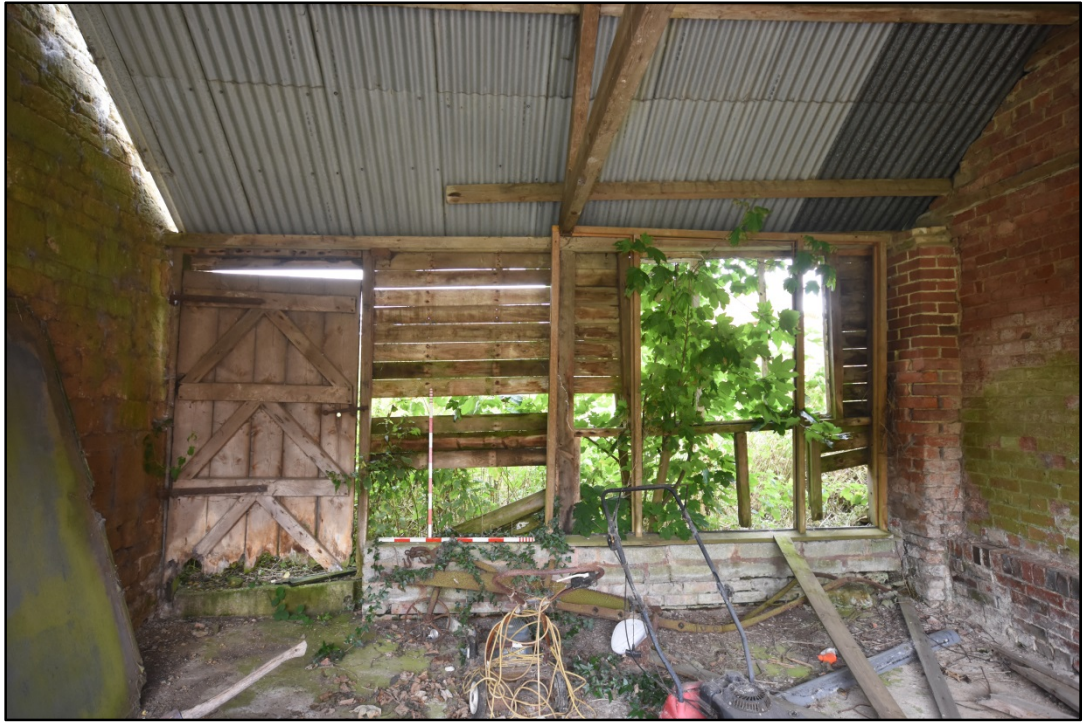
The west wall of the extension Fig 40

The west wall comprises a brick and breezeblock dwarf wall carrying a lightweight frame of pine with plank cladding (Fig 40). A wooden door of planks with diagonal bracing is located in the south-west corner of the room.

The structure was found to be in a fairly poor condition, with much of the light wooden frame of the western wall detached from its primary supports and with much of the plank cladding missing. Vegetation from the overgrown area to the north had begun to push through this wall into the room.

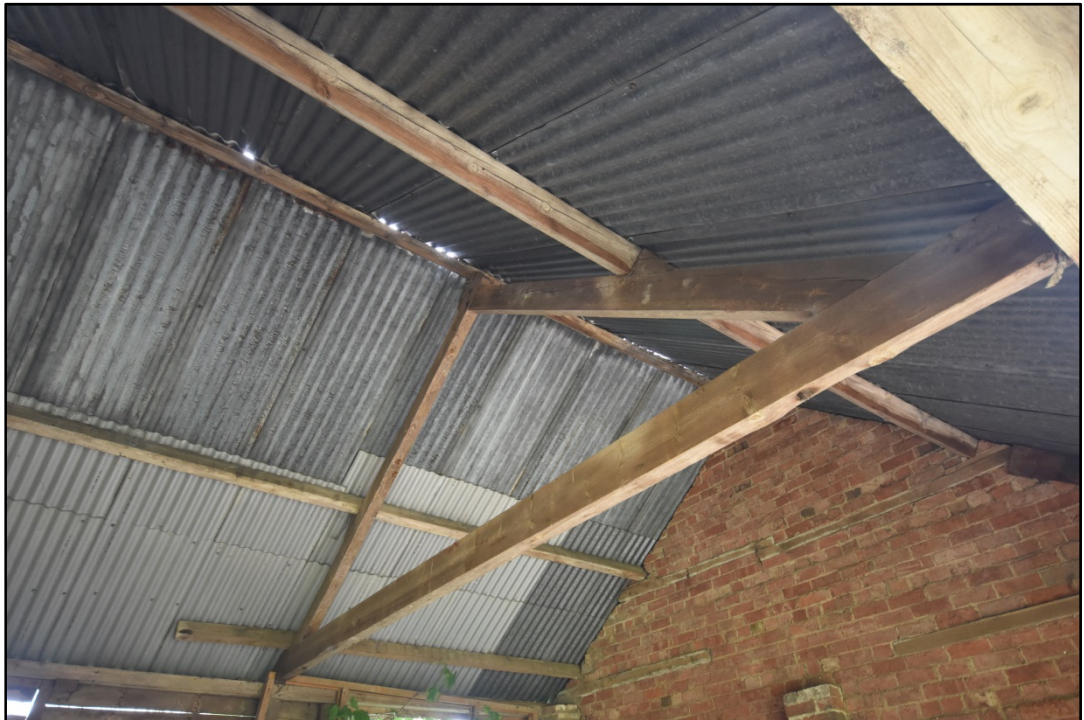
The extension roof support Fig 41

The roof of overlapping corrugated sheets is supported by a central collar truss, with rafters and a ridge plate supported between the crossed rafters (Fig 41). The floor is poured concrete.
