Phase 2 trial trench evaluation on land at Nursery Bungalow, West Street Buckingham, Buckinghamshire November 2016

Report No. 16/205

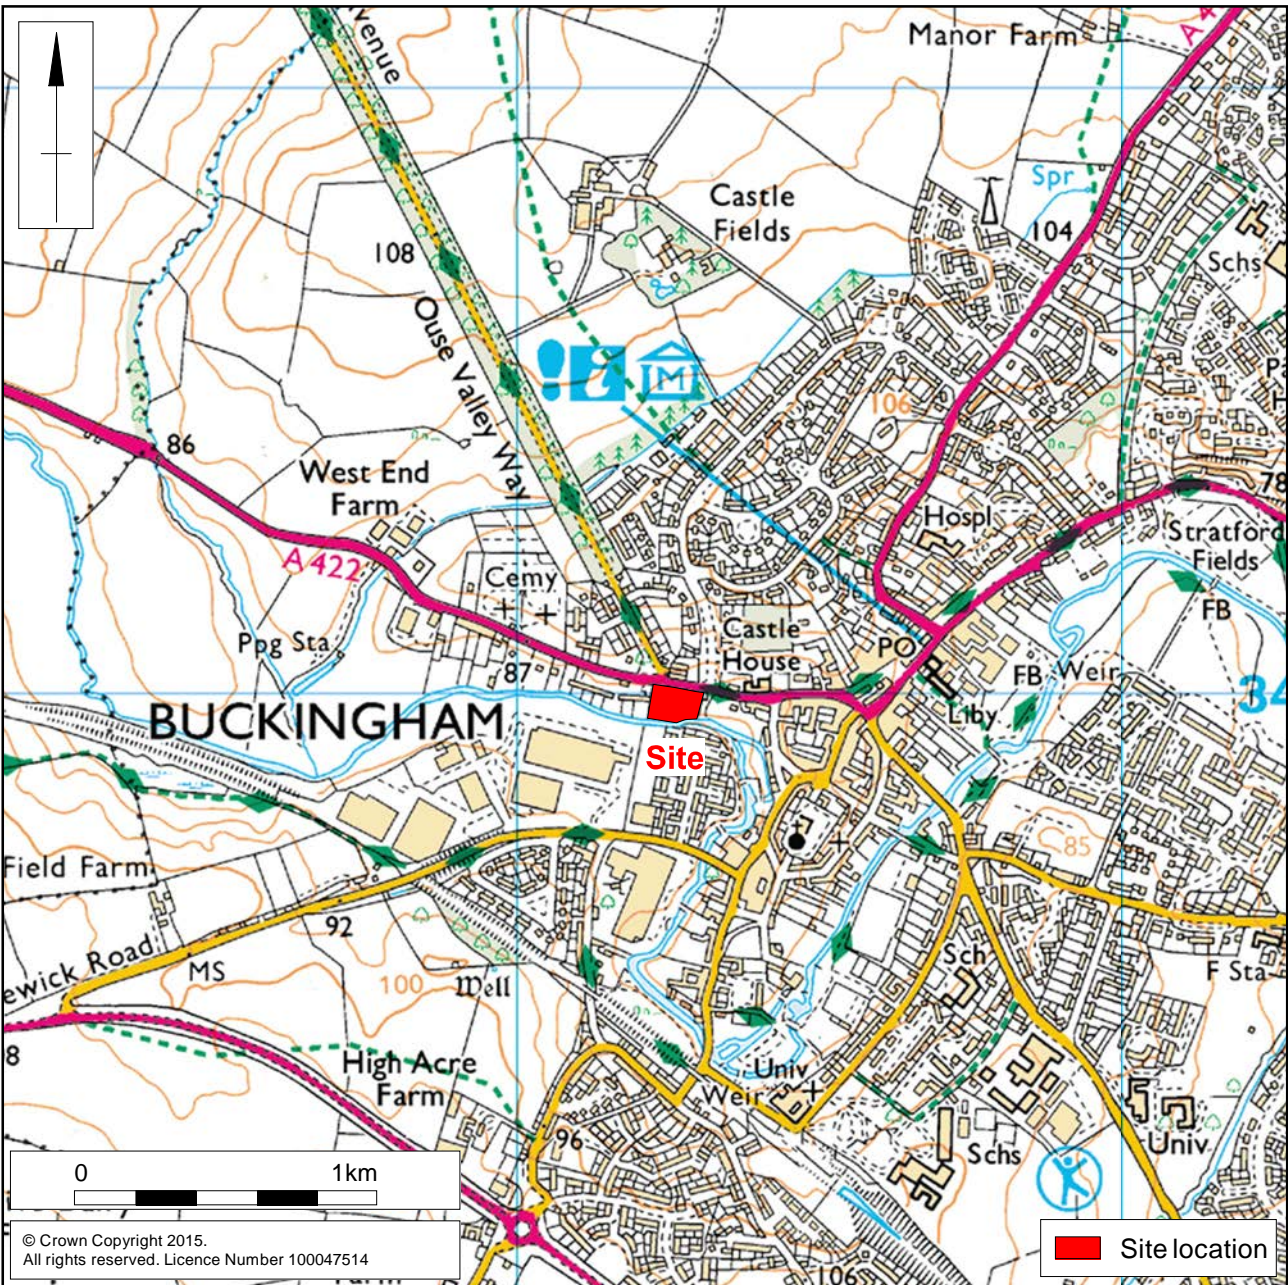
Site Location Fig 1

Scale 1:25,000

In November 2016, MOLA (Museum of London Archaeology) was commissioned by Neil Tanner Associates to undertake the second phase of archaeological trial trench evaluation on land at Nursery Bungalow, West Street, Buckingham, Buckinghamshire (NGR SP 69280 33987, Fig 1). The work was undertaken in advance of proposed residential development as requested by Buckinghamshire County Archaeological Service.

The development area occupies approximately 0.35ha of garden and a small scale derelict nursery located on the west side of Buckingham. The site is bounded to the north by West Street, the River Great Ouse to the south and housing to the west and east (Fig 1).

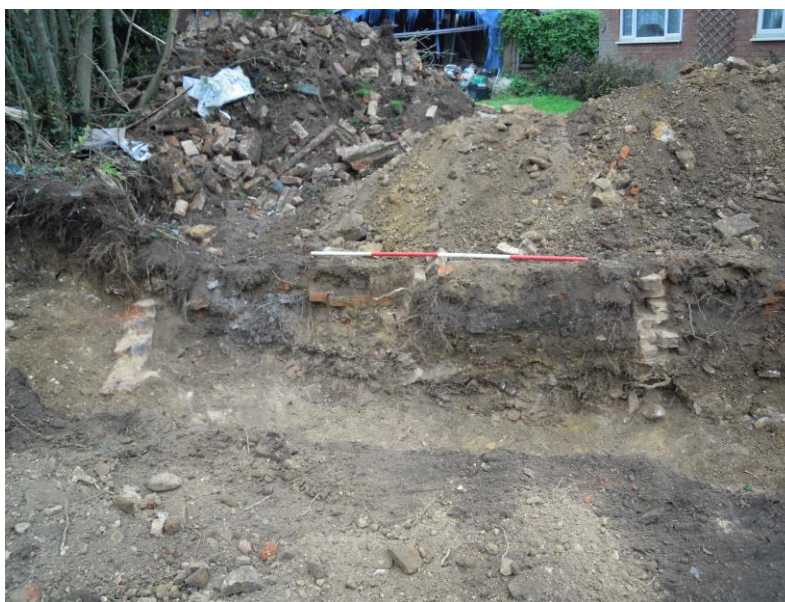
Trench 5, former nursery structure, looking east Fig 3

No archaeological features or deposits were identified within the three trenches. However, within Trenches 4 and 5 remnant foundations were observed of former buildings associated with the nursery (Fig 3). The areas of these buildings had been terraced and the level of the natural geology reduced.

Trench 3 was the only trench to reveal undisturbed natural geology. Trenches 4 and 5 showed clear signs of terracing for the nursery buildings that once stood and occupied a large part of the northern development area, likely removing any potential archaeological features.

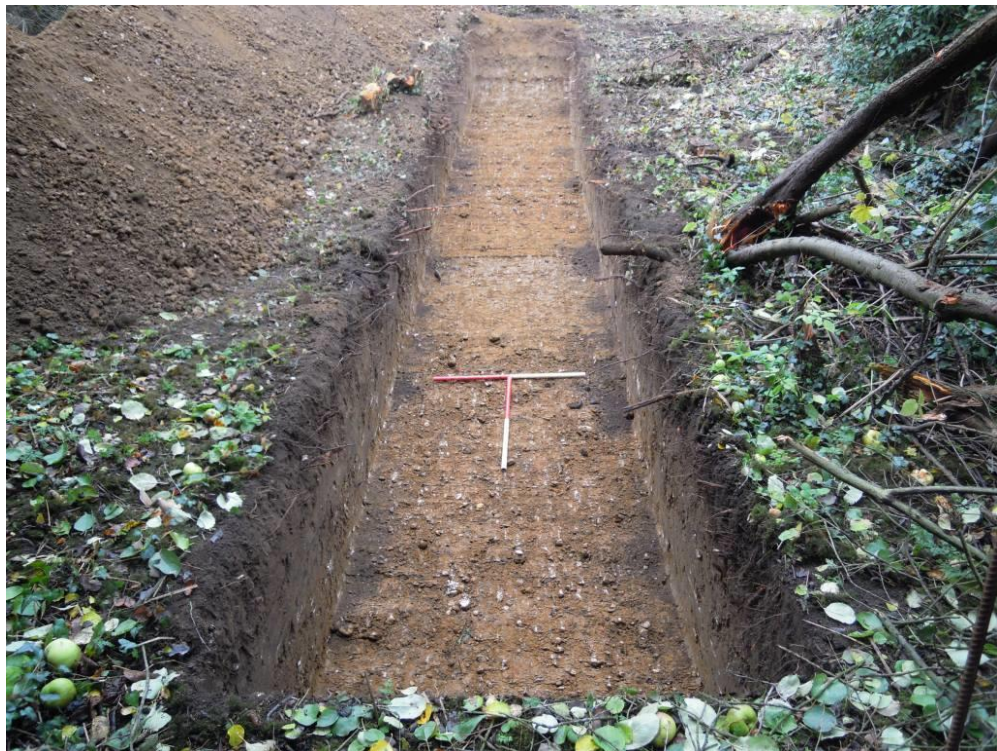
Trench 3, Looking north

Trench No	Length, width & alignment	NGR	Surface height	Depth & height of natural
3	15m x 1.80m N-S	469261 234006	82.86m aOD	81.86m aOD
Context	Context type Feature & type	Description	Dimensions	Artefacts/ Samples
301	Topsoil	Dark brown loam.	0.50m thick	-
302	Subsoil	Mid orange-brown sandy clay	0.50m thick	-
303	Natural	mid orange-brown sandy-clayey with mixed sized limestone pieces		-

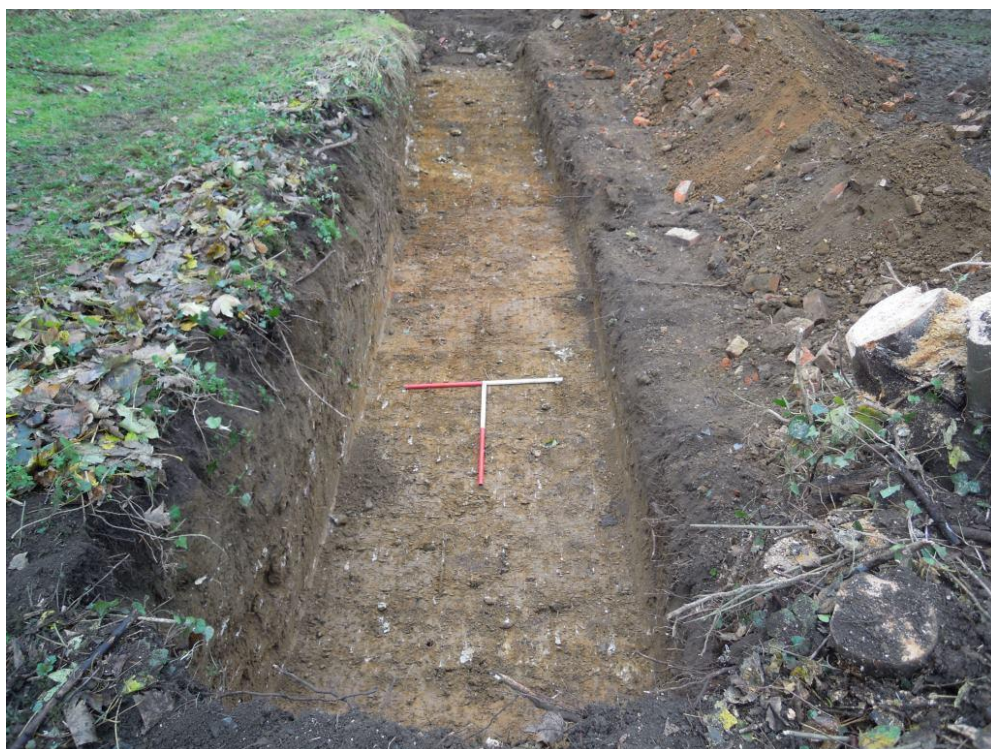
Trench 4, looking east

Trench No	Length, width & alignment	NGR	Surface height	Depth & height of natural
4	15m x 1.80m E-W	469264 234004	82.63m aOD	81.63m aOD
Context	Context type Feature & type	Description	Dimensions	Artefacts/ Samples
401	Topsoil	Dark brown loam	0.40m thick	-
402	Subsoil	Mid orange-brown sandy-clay	0.60m thick	-
403	Mixed natural	Mid brown sandy-clay	0.30m thick	-
404	Natural	mid orange-brown sandy-clayey with mixed sized limestone pieces.	1.20m wide 0.15m deep	-

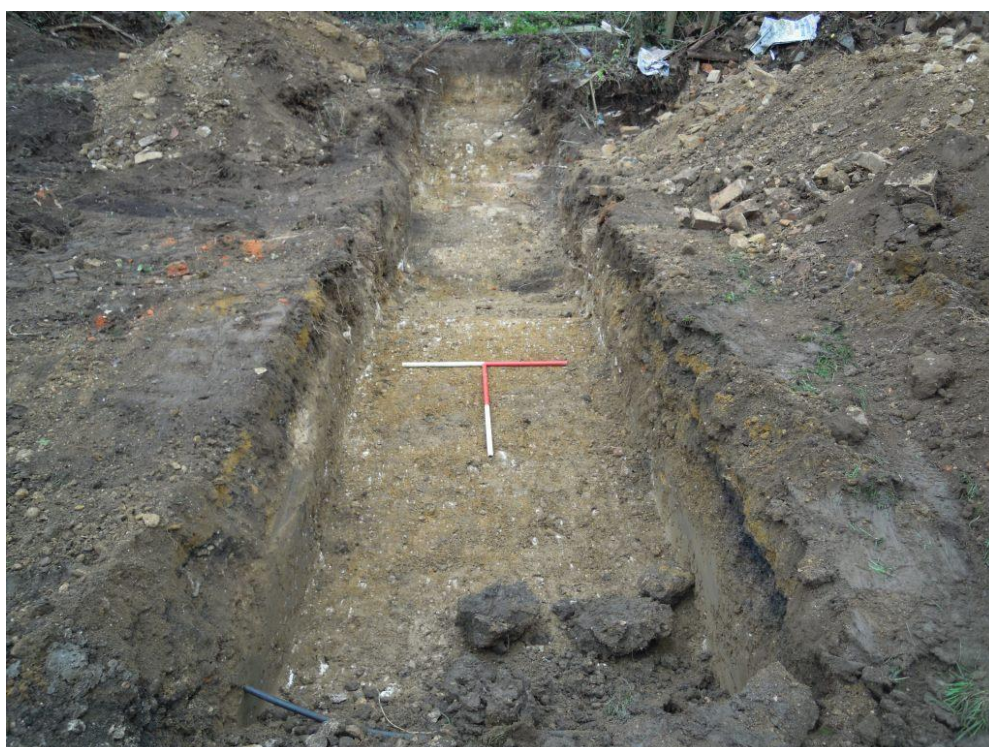
Trench 5, looking north-east

Trench No	Length, width & alignment	NGR	Surface height	Depth & height of natural
5	15m x 1.80m N-S	469288 234005	82.91m aOD	82.36m aOD
<i>Context</i>	<i>Context type Feature & type</i>	<i>Description</i>	<i>Dimensions</i>	<i>Artefacts/ Samples</i>
501	Topsoil	Dark grey-brown loam	0.25m thick	-
502	Subsoil	Mid orange-brown sandy-clay.	0.30m thick	-
503	Natural	mid orange-brown sandy-clayey with mixed sized limestone pieces.	-	-
504	Wall	Modern brick wall foundation	-	-
505	Fill	Mixed modern material between walls 504 and 506	0.60m thick	-
506	Wall	Modern brick wall foundation	-	-
507	Modern levelling layer	Dark red sand.	0.13m thick	-
508	Modern levelling layer.	Black ashy layer.	0.10m thick	-
509	Modern levelling layer.	Compacted sand and gravels.	0.20m thick	-
510	Alluvial deposits	Dark brown silty clay.	0.25m thick	-
