**Historic Building Recording at
Greenfield Lodge, Strixton
Northamptonshire
January 2017**

Report No. 17/09

PROJECT DETAILS		OASIS molanort1-275106
Project title	Historic Building Recording at Greenfield Lodge, Strixton, Northamptonshire, January 2017	
Short description	<p><i>MOLA (Museum of London Archaeology) carried out a programme of historic building recording of buildings at Greenfield Lodge, Strixton, Northamptonshire. The site is an agricultural complex comprised of a Grade II Listed mid-19th-century farmhouse with associated contemporary and later ranges of barns, stables, sheds, and outbuildings. A linear stable range was found to predate the Farmhouse, likely dating to the late 18th or early 19th century and was re-modelled and re-roofed as part of a wider phase of renovation works at that time of the construction of the Farmhouse in 1848. A two-storey outbuilding or extension to the Farmhouse had a domestic use and contained a bread oven and fireplace.</i></p>	
Project type	Historic England Level 2, Historic Building Recording

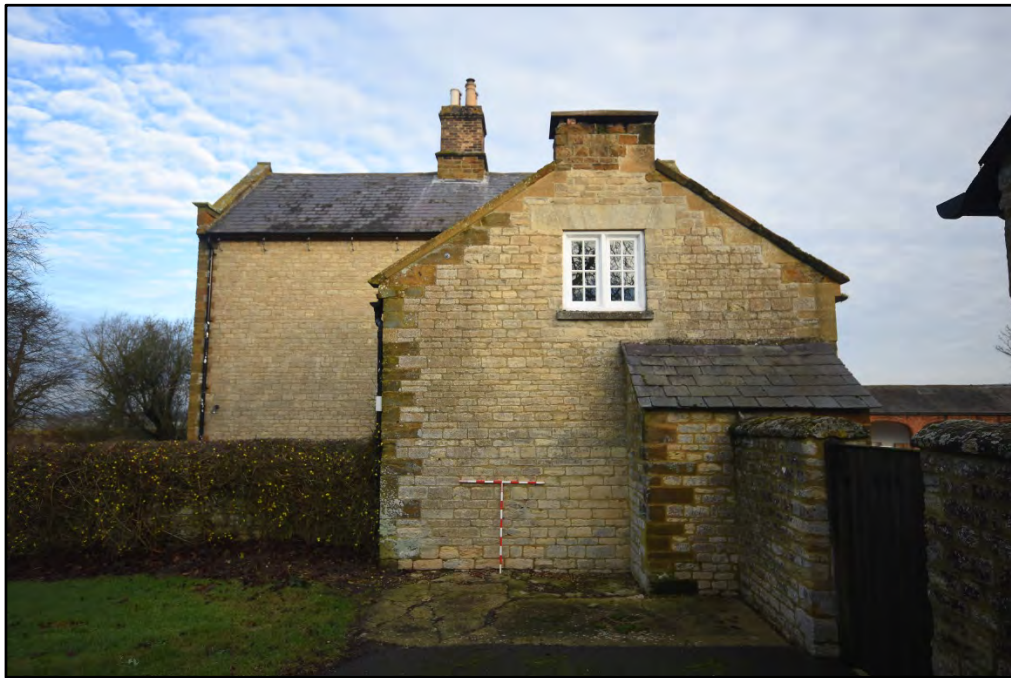
The primary building material is shaped limestone rubble in alternating courses of square and thin blocks. The quoins and the detailing around the door and windows are of dark red, brown bedded sandstone.

The south elevation of the outbuilding Fig 9

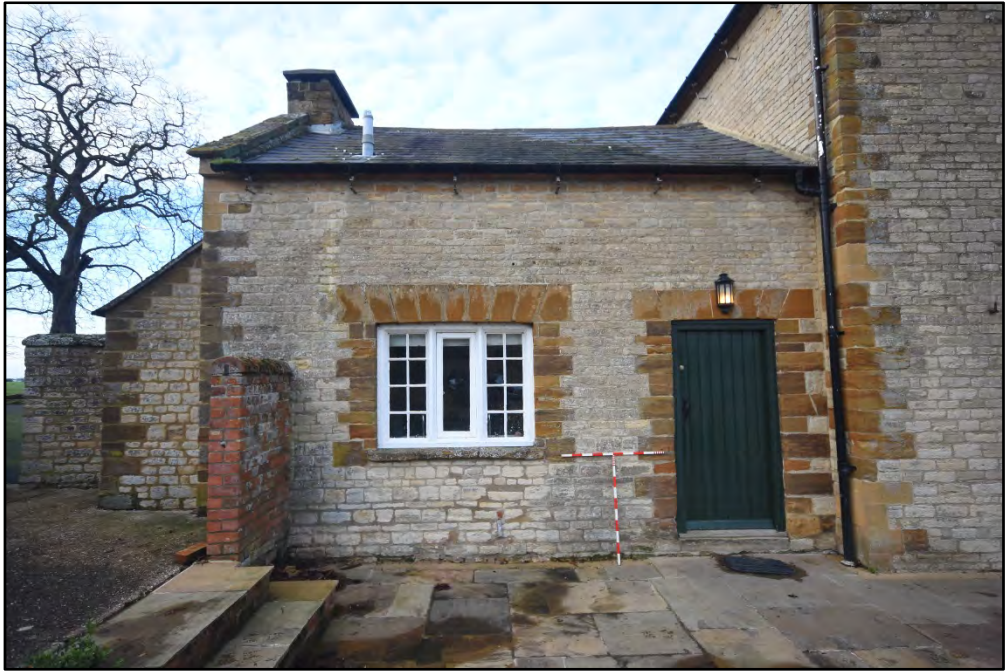
The only external access is via a single-width doorway in the east elevation. The door has a flat stone lintel with modern electric light over and the door surround is of stone blocks. The green painted door consists externally of thin beaded planks with horizontal plank bracing internally. It is secured by a modern yale lock and has an antique thumb latch. The door is hinged on the north side by two internal strap hinges and swings into the room. The door surround is splayed on the inner face.

The east elevation Fig 10

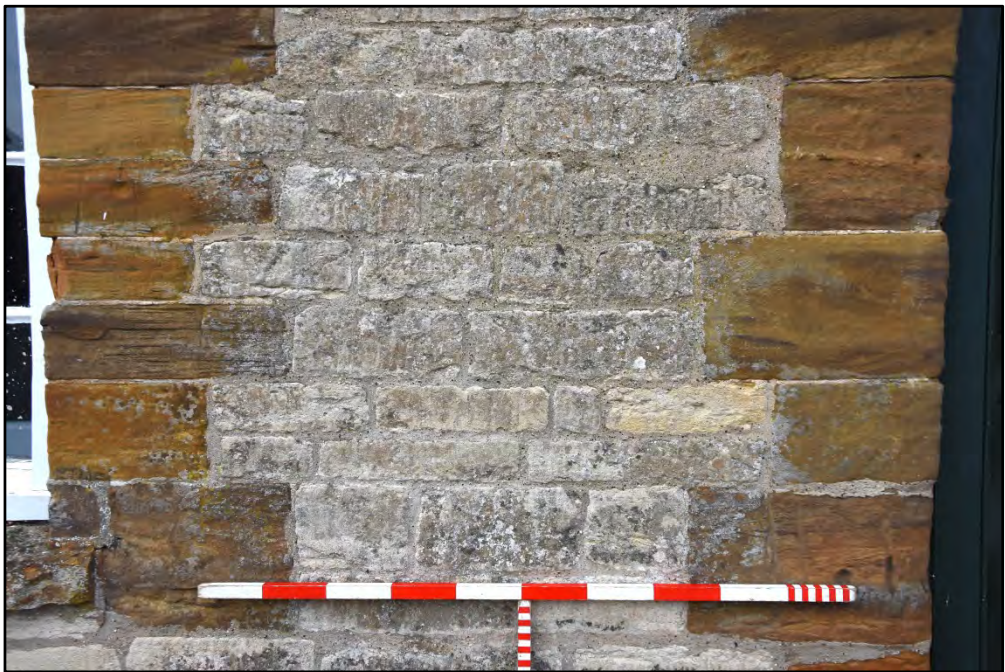
Detail of the fabric Fig 11

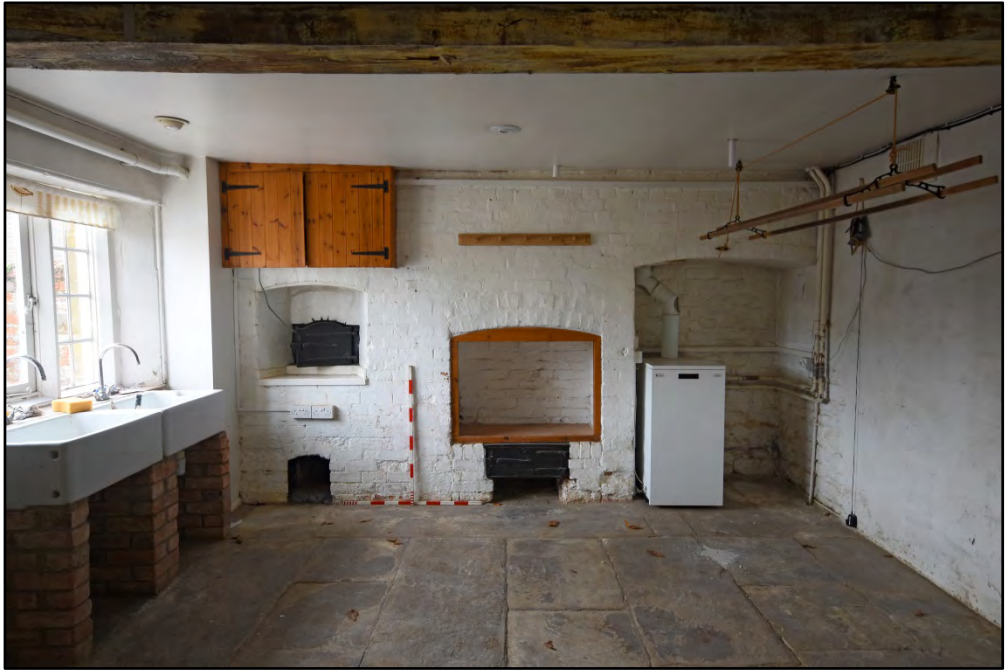
At ground floor level the outbuilding comprises a single, roughly square room, fairly plain, with a fire opening, an oven, and a tall, arched recess in the western wall. The recess, located in the west corner of the room, is formed by the projection into the room of the brick-built fireplace and oven. The brickwork projects above the recess and forms an arched roof through which an opening has been created to allow for the insertion of a flue for a modern oil fired boiler. The fireplace comprises a wide opening with a shallow arched lintel. Below the opening is a narrow flue with a cast iron hinged door. A manufacturer's stamp *Mills & Co Wellingborough* can be seen on the door.

The outbuilding, ground floor, looking west Fig 12

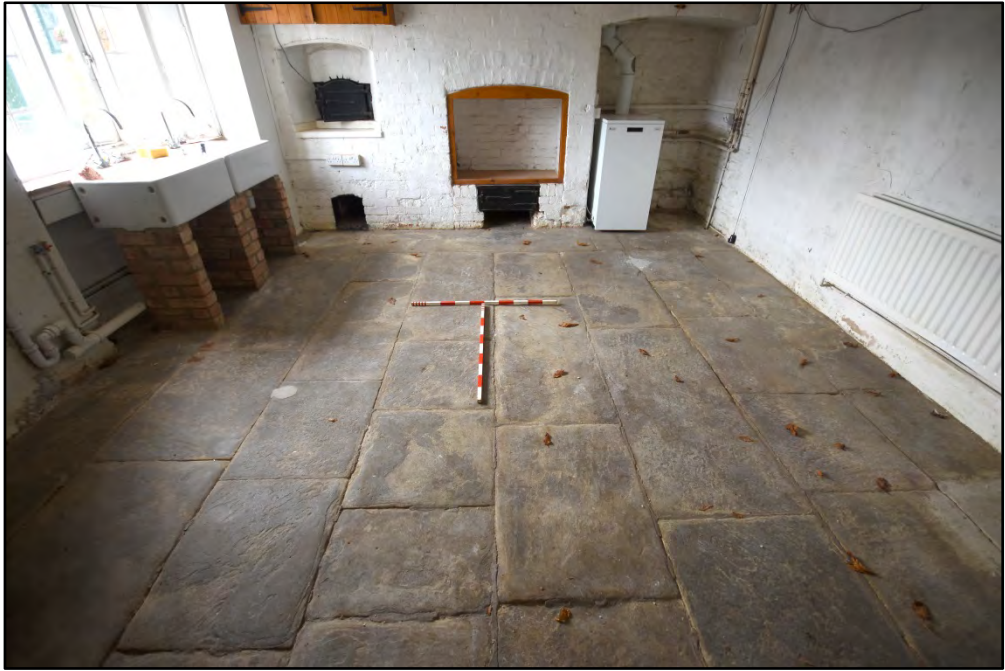
The room has a well-made floor of tightly fitted flagstones. The stones are shaped to fit into the window recess and the deeper recess in the south wall. The stones also change direction and size to fit around the brickwork of the south wall, thus indicating that these are contemporary features of the room. The flags display expected weathering but are otherwise in a very good condition.

The flagstone floor Fig 14

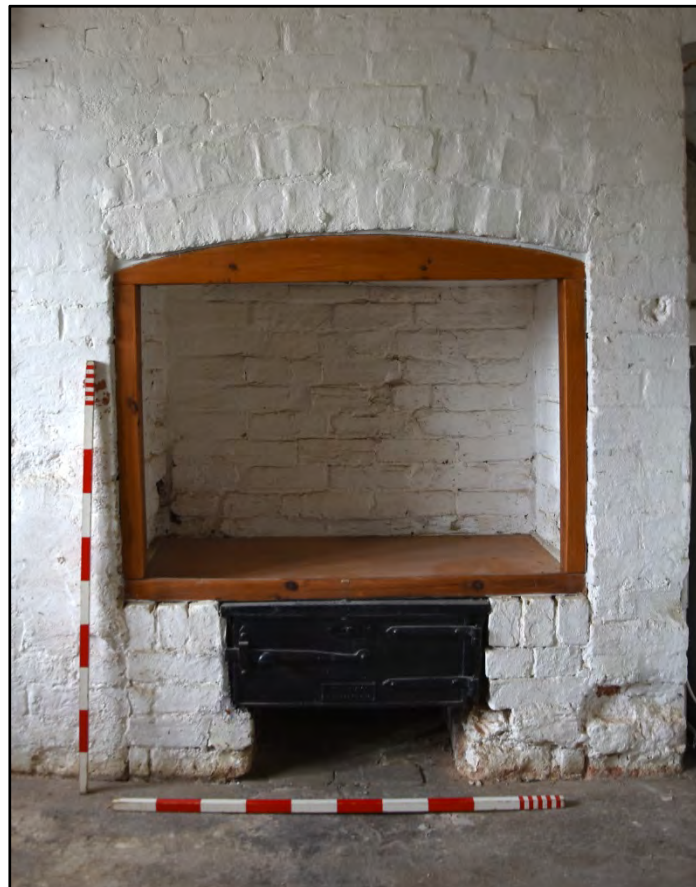
The fireplace Fig 15

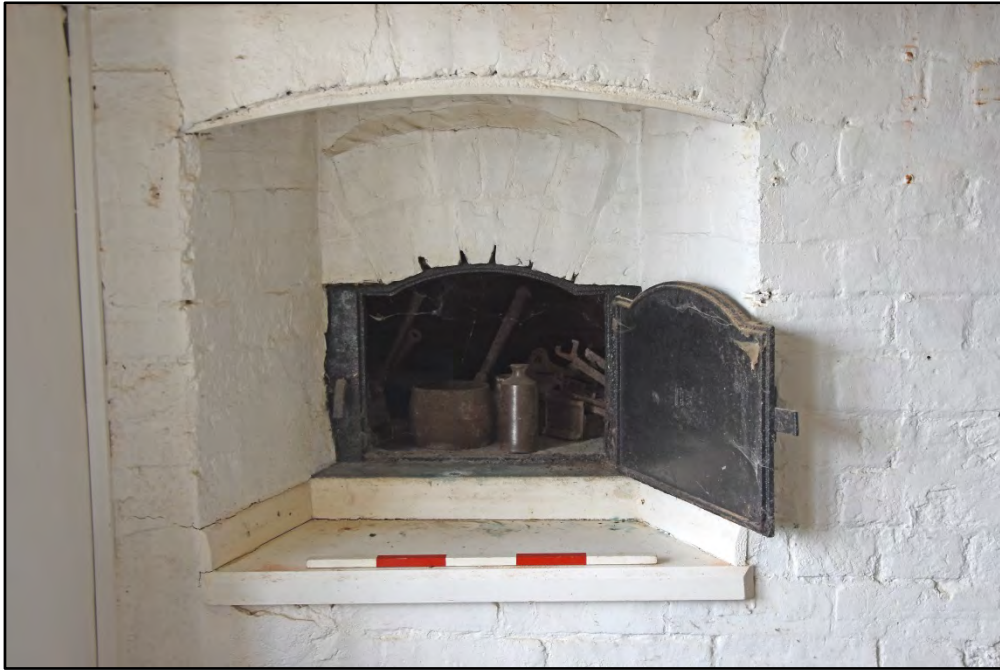
The oven, possibly a bread oven, has a splayed, arched opening and can be closed by a cast-iron hinged door. No manufacturer's stamp was visible but the door is of a very similar design to that of the fireplace. The number 16 is cast into the inner face of the door. The oven widens out from the door and projects south through the gable wall and into the small structure built against the wall. It is fully lined in brick and has a gently arched brick ceiling. At floor level below the oven is a small flue which projects into the wall and upwards to meet the oven, allowing for the ash and burnt material which would drop through the grated oven base to be cleared out. At the time of survey the oven contained a variety of antique bottles, containers and kitchen utensils. A modern electrical cupboard has been built onto the brick wall, above the oven. In the south-east corner of the room, adjacent to the oven, modern water pipes have been partly boxed in.

The oven Fig 16

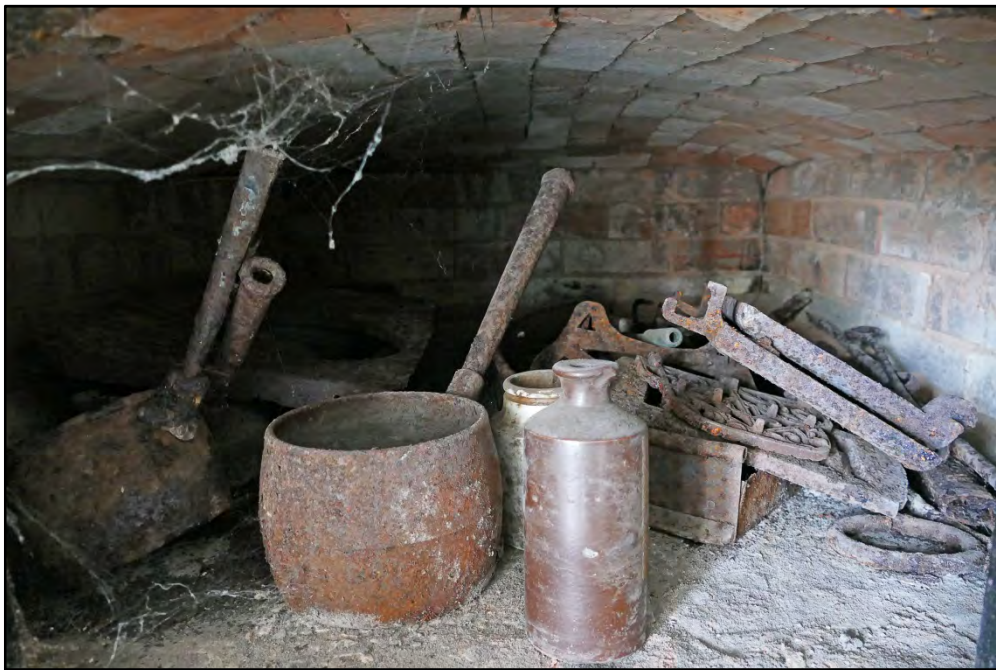
The interior of the oven, containing antique cookware and a stoneware ink bottle Fig 17

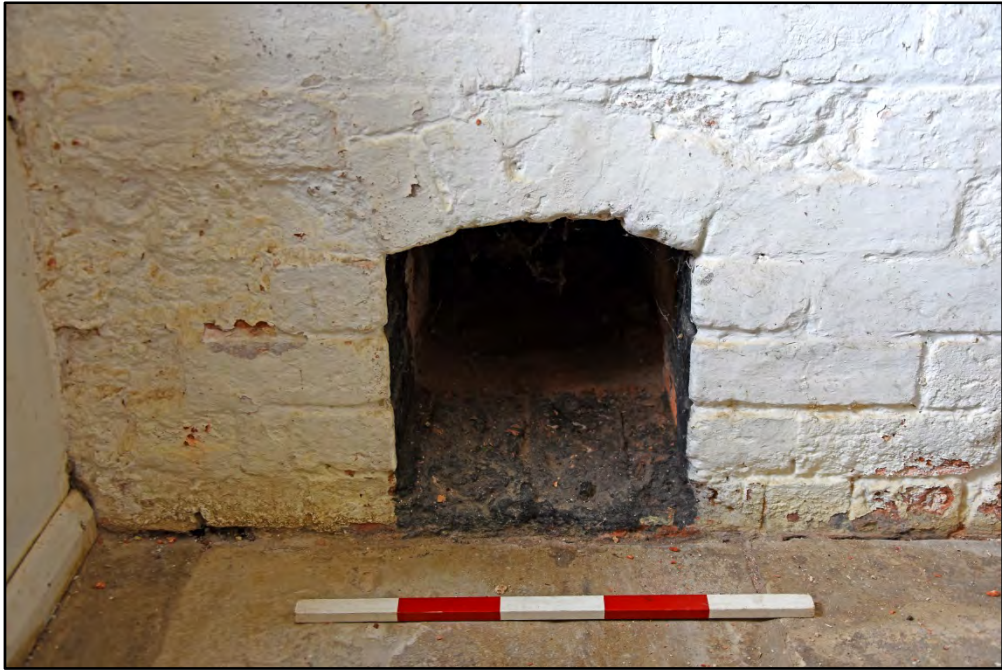
The flue below the oven Fig 18

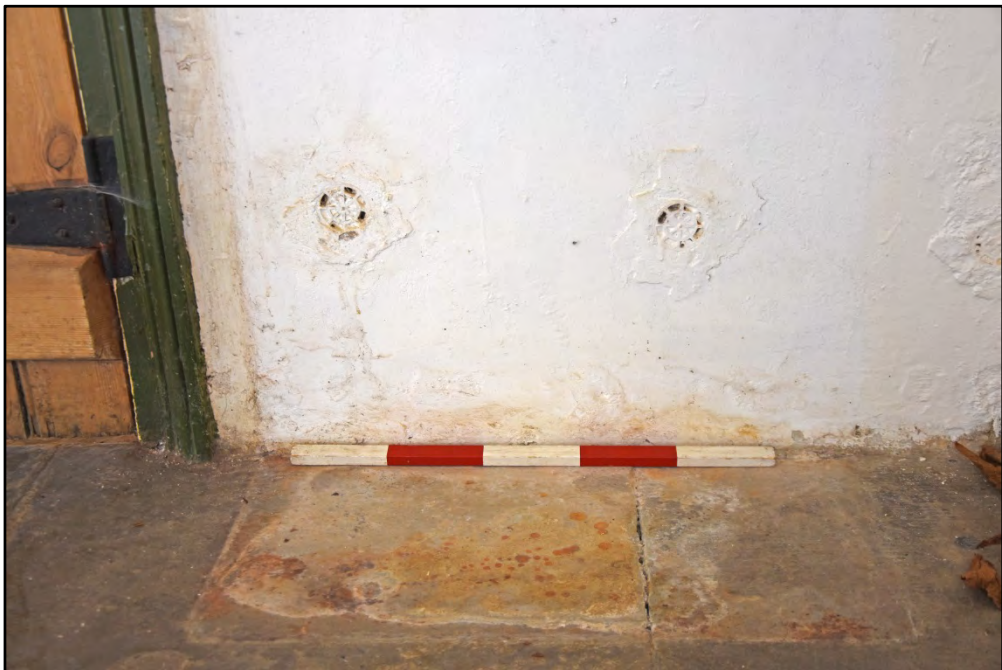
Detail of inserted vents in the north wall Fig 19

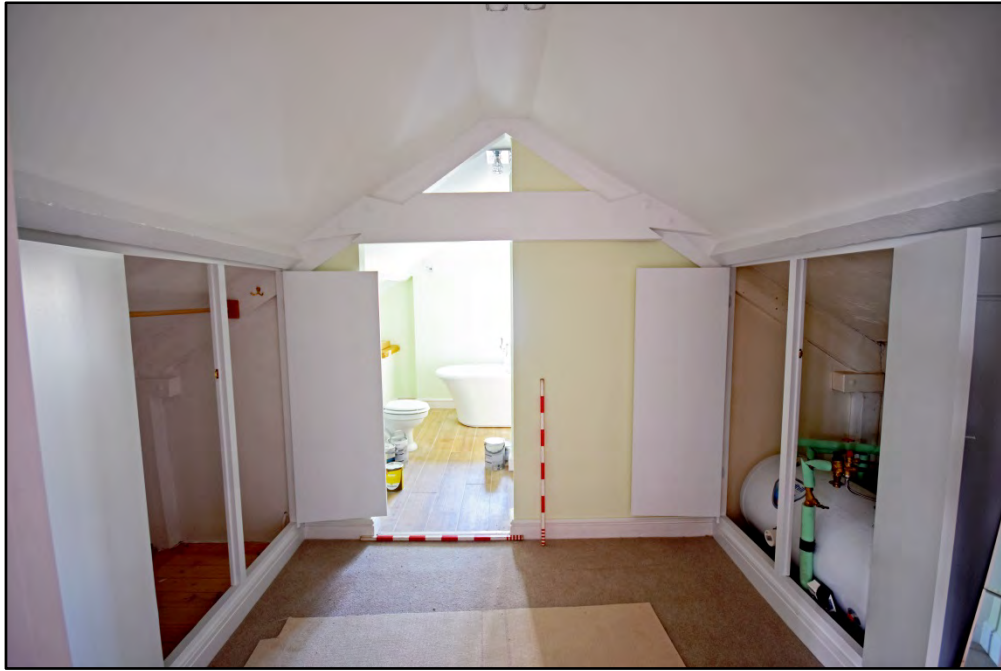
The two rooms are separated by a central truss of principal rafters joined together by a brace which is partly jointed to each rafter and secured by bolts. The distal end of each rafter rests atop a vertical post which in turn descends to the floor and connects to the east and west ends of the central beam. Purlins span the full length of the room, one at each span and are trenched into each rafter.

The first floor, looking west, showing the central truss Fig 20

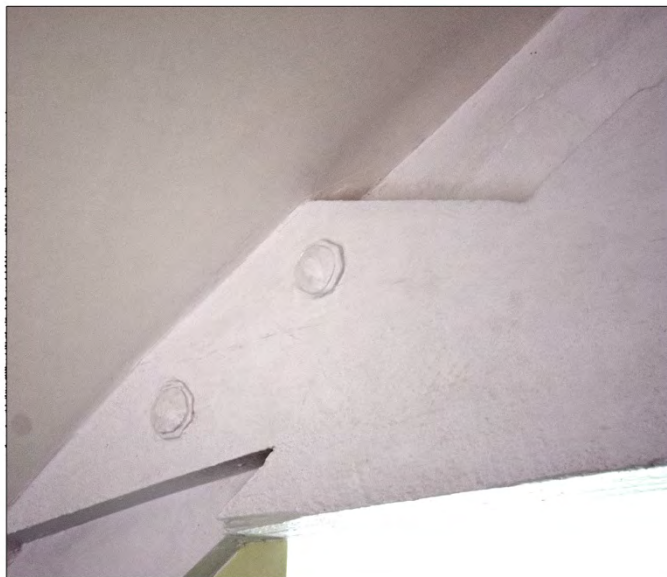
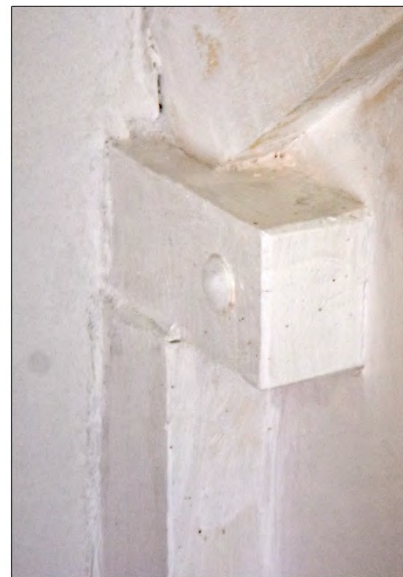
Detail of the truss joinery Fig 21

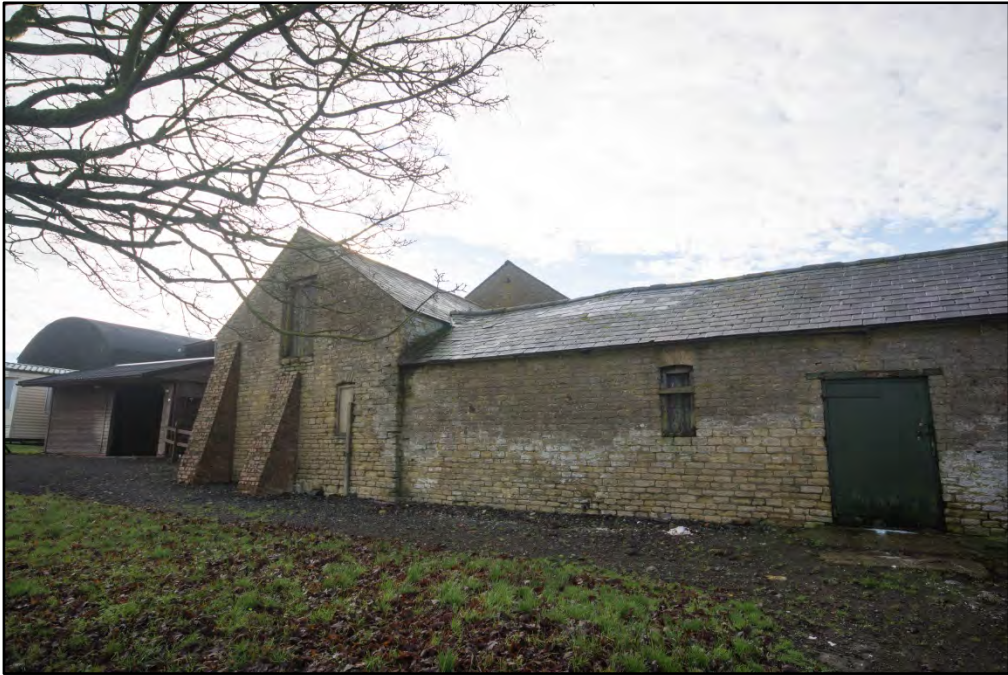
Viewed from the north the range presents a fairly featureless continuous stone wall which is clearly of a single phase. The fabric and construction are the same as that of the eastern range which the stable range joins. The Stable range is slightly offset from the northern wall of the east range but the walls are keyed into each other.

The north elevation of the Stable range and the eastern range Fig 25

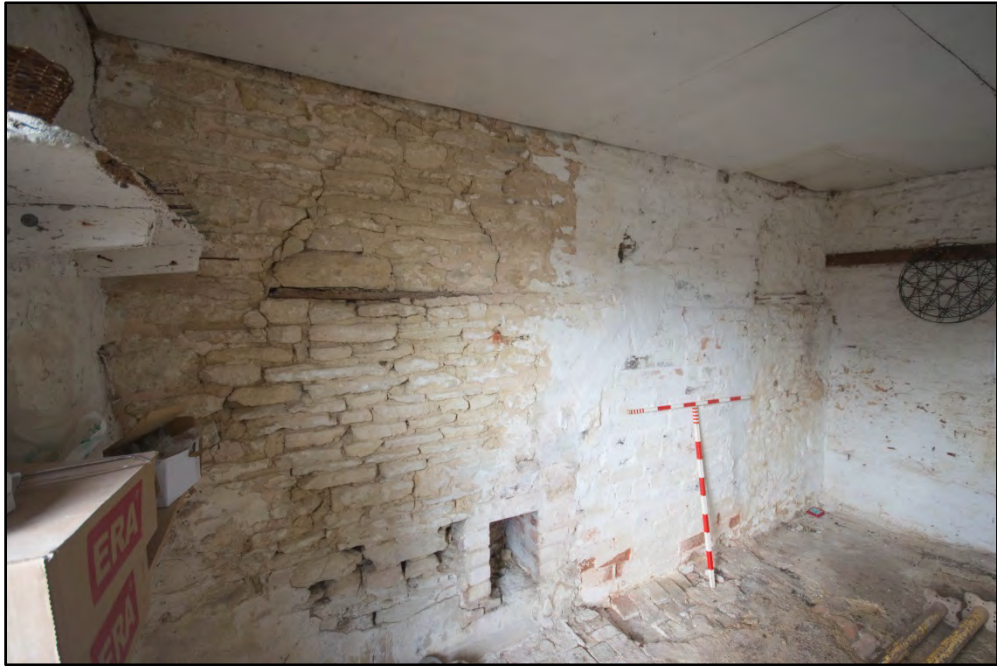
Room 1 is fully enclosed and fully stone-built. The room is accessed from the east through a single-width door of beaded planks with internal horizontal bracing, and with cast iron door furniture. The lintel, externally, is formed of angled, shaped stones. The room has seen use as a store room and formerly had a fireplace in the western wall which had been blocked in brick. A long bonding timber has been inserted into the wall

above the former fireplace to mitigate against deterioration of the wall fabric in this area. The brick blocking forms a square shape around the former fireplace and picks out the angled flue. A small brick flue has been created at ground level adjacent to the blocked fireplace. Externally, the brick-built chimney flue has a rectangular profile with a buff terracotta crown-style chimney pot. The room's concrete floor has deteriorated in places and it is clear that it has been laid over an earlier brick floor surface. A small window is built into the north wall.

Room 1, showing blocked fireplace and adjacent flue Fig 29

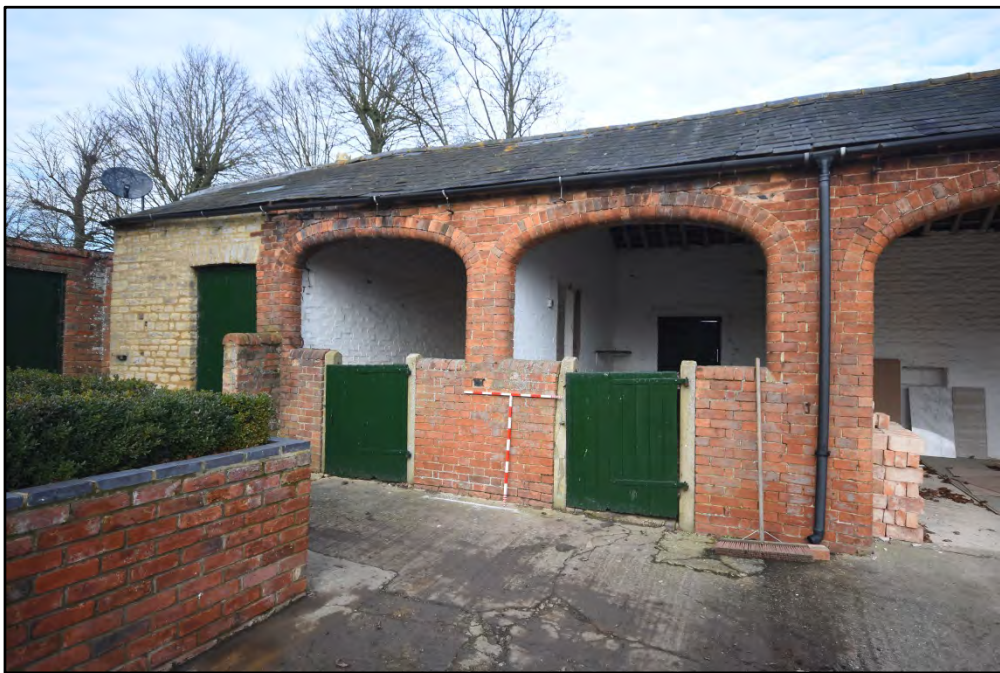
Rooms 2 and 3 are semi enclosed with dwarf walls between the brick columns, between which are short doors. Room 3 has a door in its north wall which allows access from the yard to the land at the north of the building. This is a full height door, in the prevalent style, being formed of beaded planks with horizontal bracing. A cat hole is located towards the base of the door with a wooden shutter on chains. The jambs are of red brick indicating that this is a later insertion, contemporary with the remodelling of the building. Three modern steel shelves are installed adjacent to the door. The western room is plain with no surviving fittings. There is a small window with steel grate located within a slightly splayed recess in the north wall. The rooms are accessible to each other by a doorway built into the partitioning wall. The rooms both brick floors and the brickwork continue through the doorway, indicating that it is not a later insertion.

The semi-enclosed rooms at the west of the Stable range Fig 30

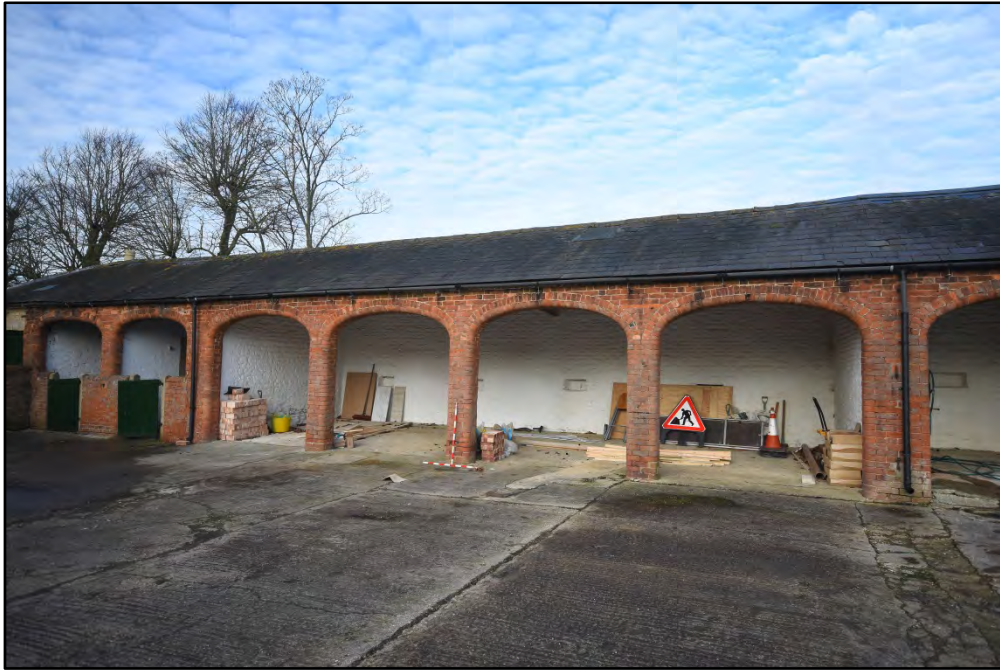
Room 4 is the largest room and has a rectangular plan c11.5m x 4.5m with four arched openings over three brick columns. It is clear that a trough formerly spanned the length of the room and is now evident only as a continuous narrow scar in the floor with matching scars in the east and west walls. The room is plain with few features of its former stable function visible. Four rectangular niches, each c0.5m in width, with a wood lintel above each one are built at regular intervals into the north wall. The niches are plain with no associated fixtures or fittings. Three king post trusses cross the room, each one embedded between the stones of the north wall and the bricks of the south wall.

General view of room 4, looking north-west Fig 33

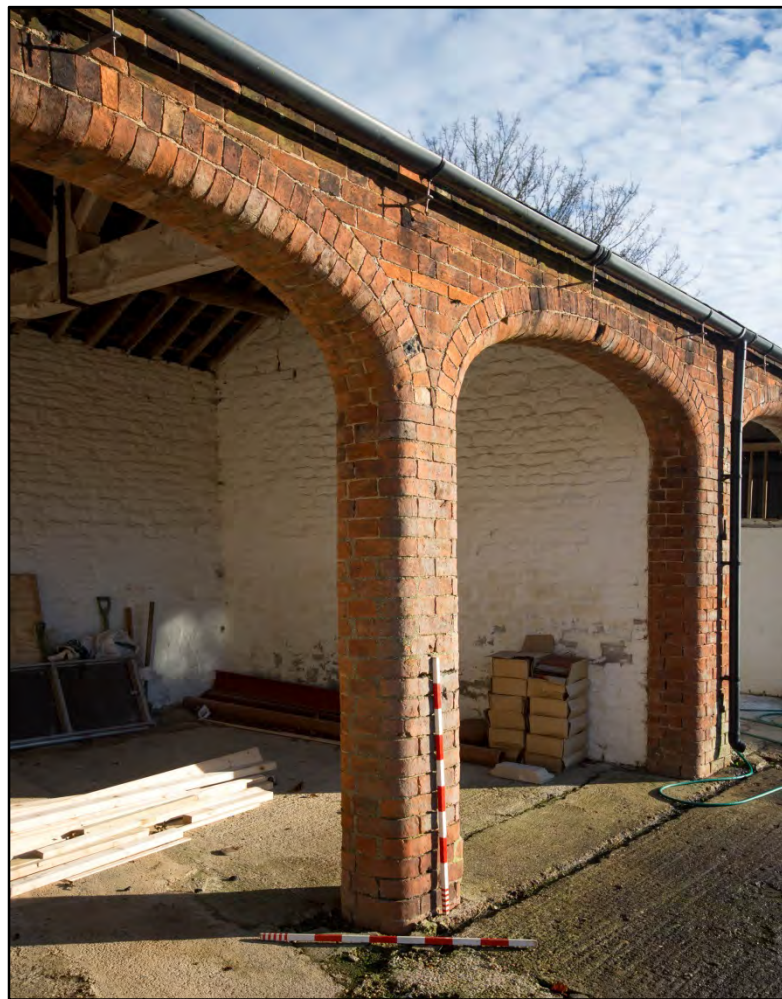
Detail of the brick columns and arched openings Fig 36

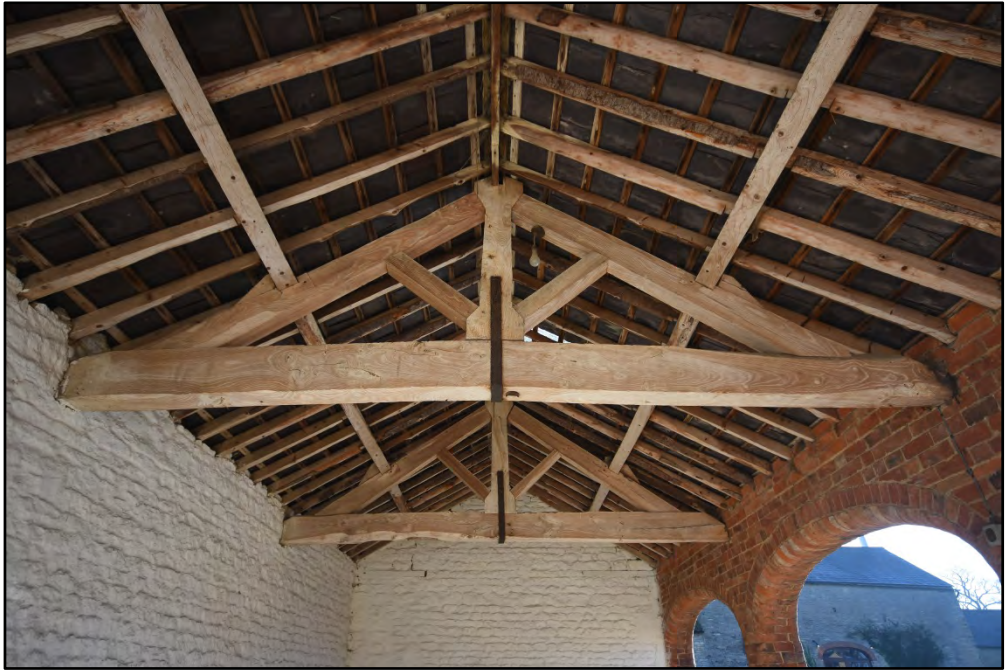
The king post trusses, looking east Fig 37

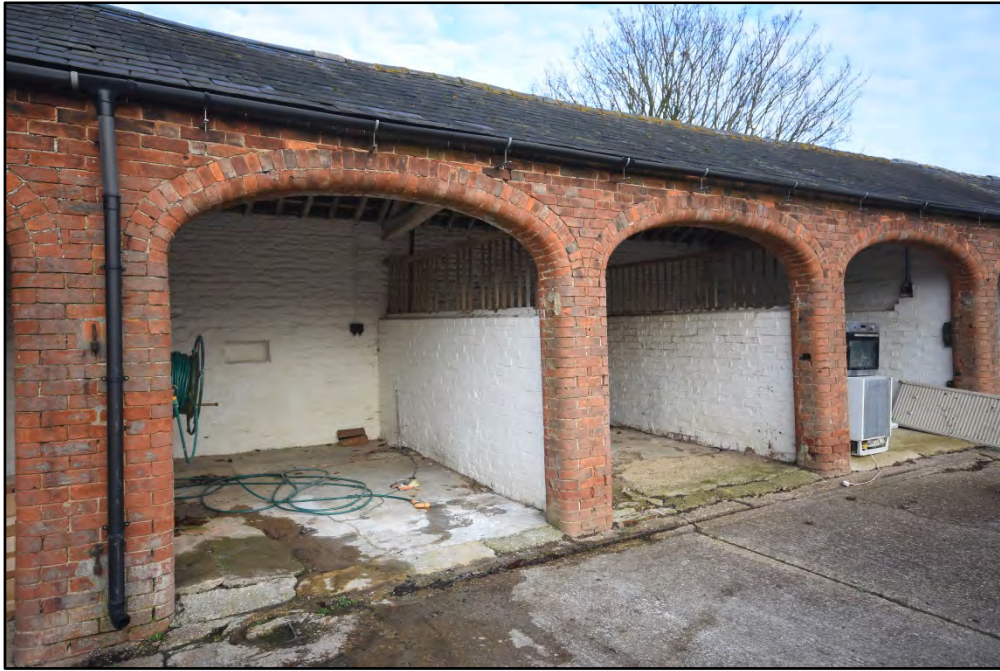
Rooms 5-8 are mid 19th-century subdivisions of a former room of similar dimensions to Room 4. Each is accessed through an arched opening and each room is separated from its neighbour by brick dwarf walls. The inward facing walls are painted white. A doorway the north wall of Room 9 allows access between the courtyard and the garden at the north of the farm. The adjacent three bays are former stable rooms though no stable furniture remained within the rooms. The brick partitions between the rooms are half-height walls and each has a wooden louvered panel across the top. The rooms have concrete floors with and the scar of former troughs can be seen at the rear of each room.

Rooms 5-7 Fig 39

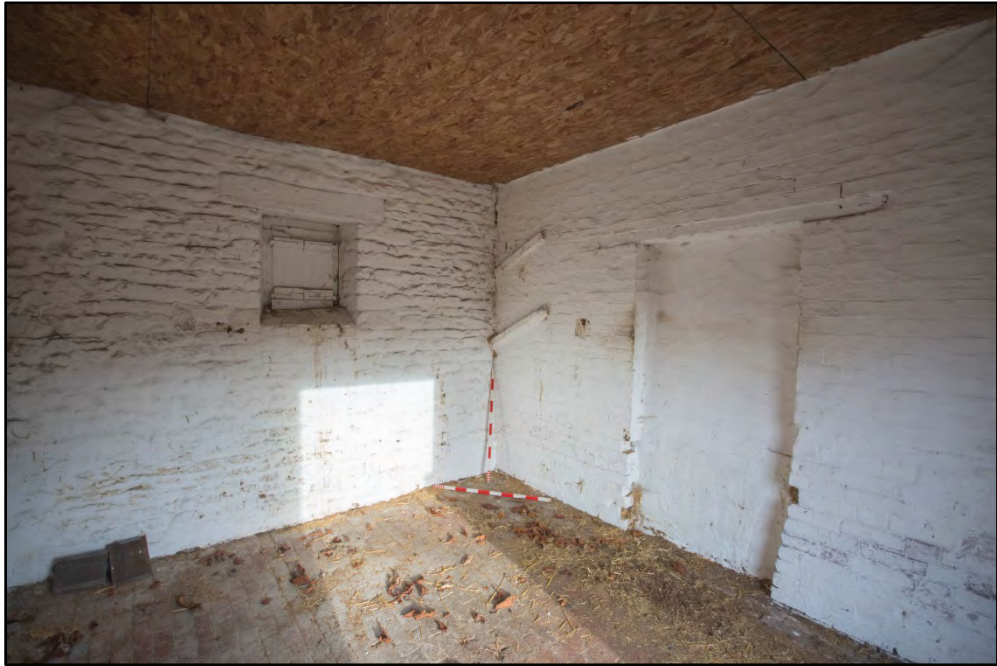
Rooms 9 and 10 are fully enclosed rooms, each with a top and bottom opening stable door, and separated from each other by a brick partition wall. The brickwork is not keyed into the stone walls at the north and south. The walls of the western room are painted white and the lower portion of the walls of the eastern room are painted black. A door formerly between the two rooms was blocked in brick and plastered over.

Room 9, showing blocked door to room 10 Fig 41

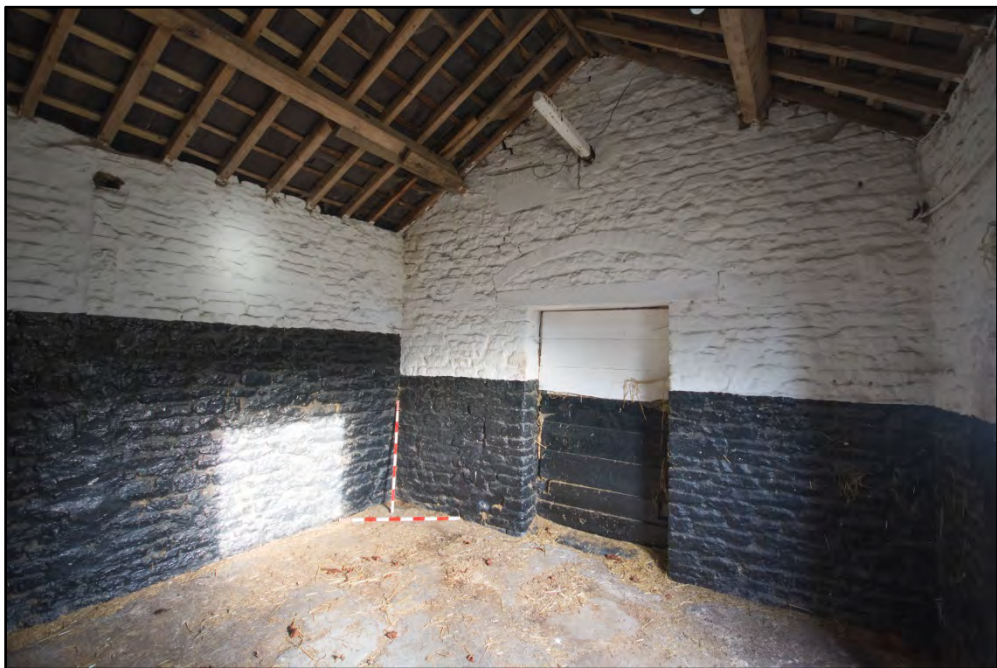
Similarly, another door, this one boarded over, formerly allowed access into the eastern range. Above the door's timber lintel is a brick relieving arch, contrasting with the stone wall. A small square window with hinged wooden shutters looks north from the westerly room. The window has a thick wooden lintel over and a wooden frame within a splayed opening. Both rooms have a brick floor. Externally, the door openings are plain with stone lintels. The lintel and top part of the eastern door have been replaced with the work carried out in a similar style as the original.

Room 10, showing blocked door to the eastern range Fig 42
