# Historic building recording of the Boathouse at Wicksteed Park, Kettering Northamptonshire

Report No. 17/58

*MOLA (Museum of London Archaeology) carried out historic building recording of the Boathouse at Wicksteed Park. This pre-fabricated concrete building dated to the earliest years of the park in the 1920s and was a simple, practical structure, built to accommodate boats for use on the adjacent lake. Unfortunately the building was damaged by a fire in November 2016 and it was determined that it should be demolished and replaced. This survey provides a record of the structure prior to demolition.*

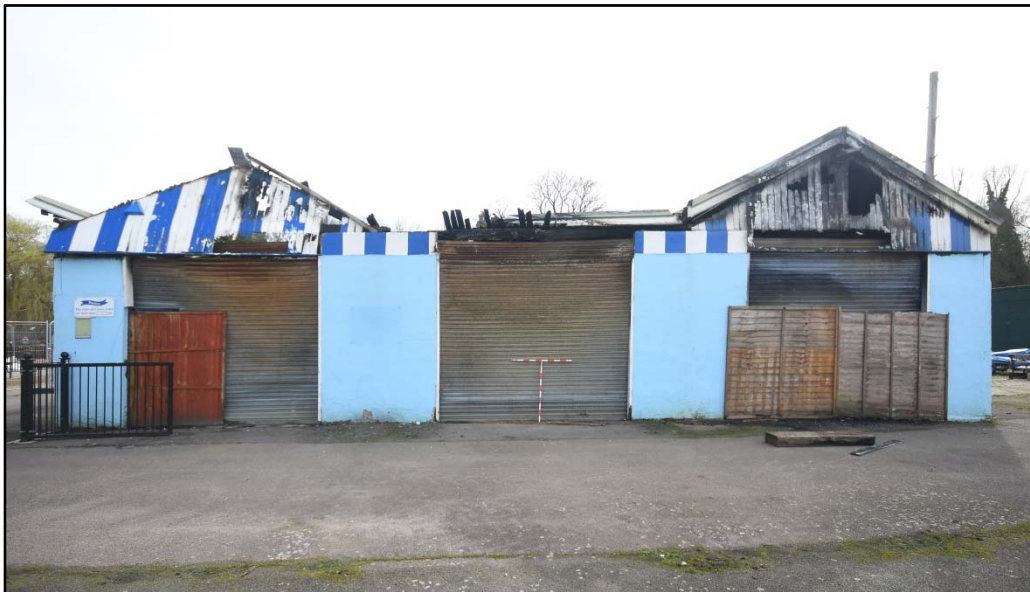
The west elevation Fig 8

The boathouse had three large doorways, equally spaced across its west elevation, each with a roller door fully enclosing the openings (Figs 8 & 16). The doorways were square, each measuring 3m x 3m, with 100mm wooden jambs. The roller mechanisms were installed internally within the building and were manually operated by means of chains and cogwheels (Fig 17). The mechanisms were fixed to L-section beams attached to the jambs. The boathouse doorways were originally enclosed by wooden sliding doors which can be seen on a historic photograph of the building (Fig 5). These doors were in pairs, sliding outwards from the openings. It appears that the central door was mounted externally and the flanking doors were installed internally, in order to accommodate the openings of all three pairs.

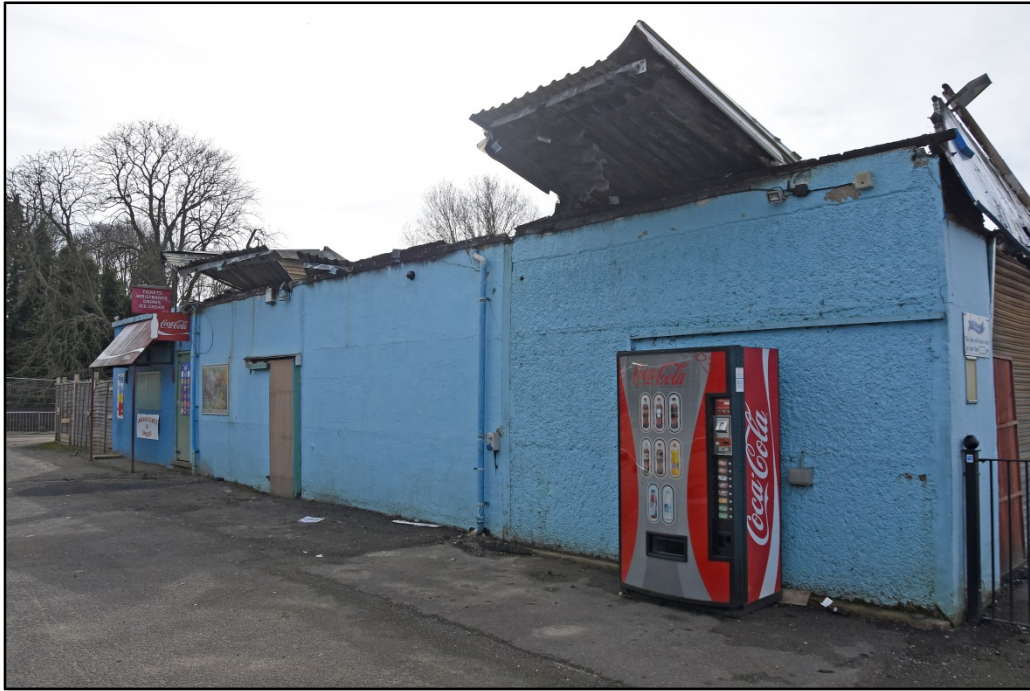
The north elevation, looking south-east Fig 13

The boathouse was a single-storey structure of three bays, positioned parallel to the lake's edge. It was a relatively simple and practical structure, well-suited to its original function. A number of smaller buildings were built against the rear of the boathouse. These were extant from the 1960s but are not depicted on Ordnance Survey mapping of the 1990s. A modern, single-storey, breeze-block shop extension was built against the north-east corner of the boathouse, with serving window and door facing to the north (Figs 12 & 13). A small shed was formerly located adjacent to the north-west corner of the boathouse and is visible on a historic photograph (Fig 5). This building is not shown on 1920s Ordnance Survey mapping (Fig 4). The Ordnance Survey map of 1968 (not reproduced) depicts an extension to the boathouse on its north-western corner; however it is depicted as being part of the building rather than a disconnected adjacent building. It is likely that the small shed seen on the historic photograph was replaced prior to 1968 with an extension which was demolished by the time of this survey. The external elevation in this area of the boathouse has a rough render which is different to the smoother render seen elsewhere (Fig 13).

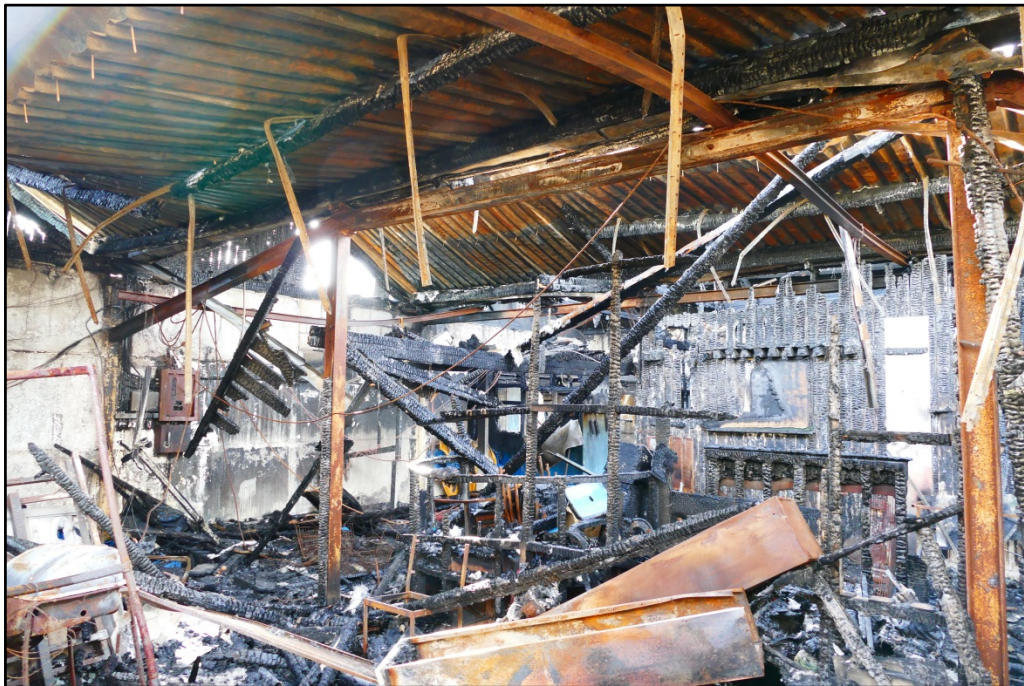
The interior, prior to clearing and making safe Fig 14

An electrical fire on 15th November 2016 caused severe damage to the building, gutting the interior and destroying most of the roof structure. The walls, being constructed of concrete, interspersed by steel beams, remained largely intact.

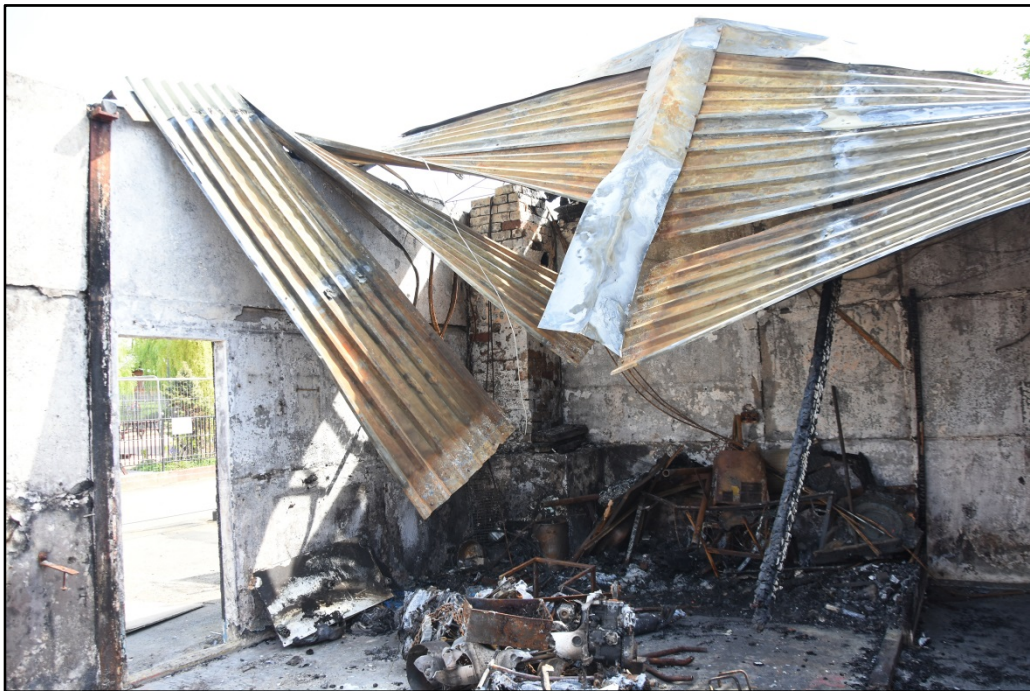
The north-east area of the boathouse, with chimney stack in the corner Fig 18

A brick chimney survived in the north-east corner of the boathouse and its tall flue is visible on a historic photograph of the building (Figs 5 & 18). No fire opening or fireplace was visible. The chimney stack had a rectangular section measuring 0.7m x 0.6m and was wider at the base. The floor of the north-eastern corner of the boathouse, a space measuring 3.5m x 4m, is raised 1" above the surrounding floor level (Fig 29).

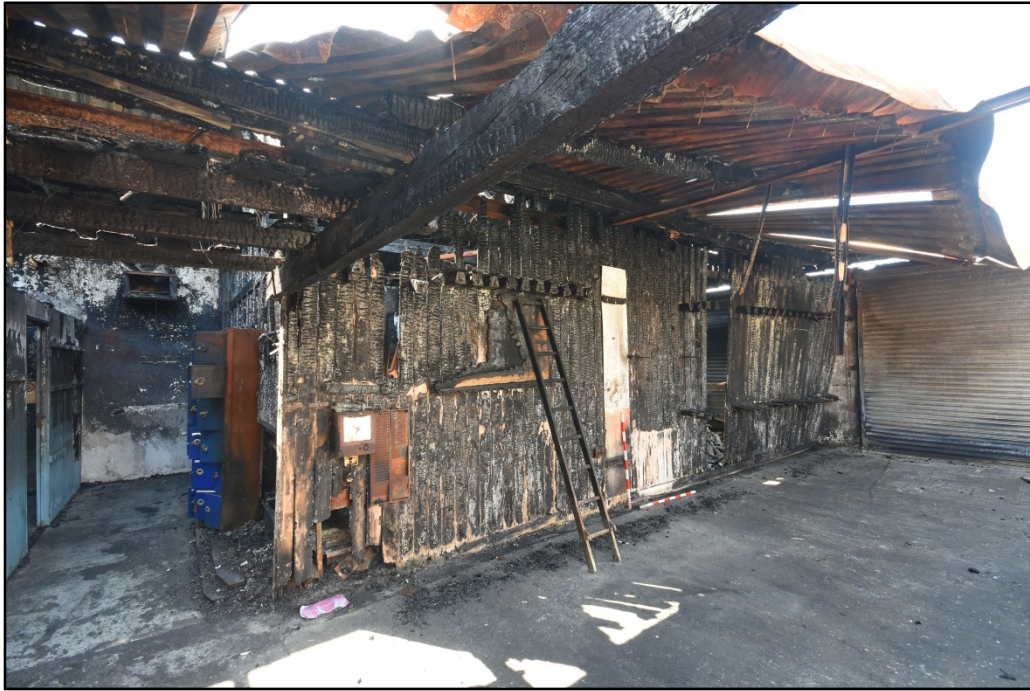
The north wall of the maintenance room, showing projecting supports Fig 19

Two rooms survived within the boathouse, both within the southern bay (Figs 19-23). A small room occupied the eastern end of the bay and possibly functioned as an office. The remainder of the bay comprised a single room, separated by the smaller room by a narrow passage which contained lockers. This room was perhaps used for boat maintenance and contained work benches, tools and paint tins. The internal walls were formed by timber beams between the RSJs, clad with wood planks. A historic photograph of building shows a chimney projecting from the roof of this room (Fig 6). Two rows of closely spaced supports, likely former oar-racks, projected from the north face of the interior wall of the larger room (Fig 19).

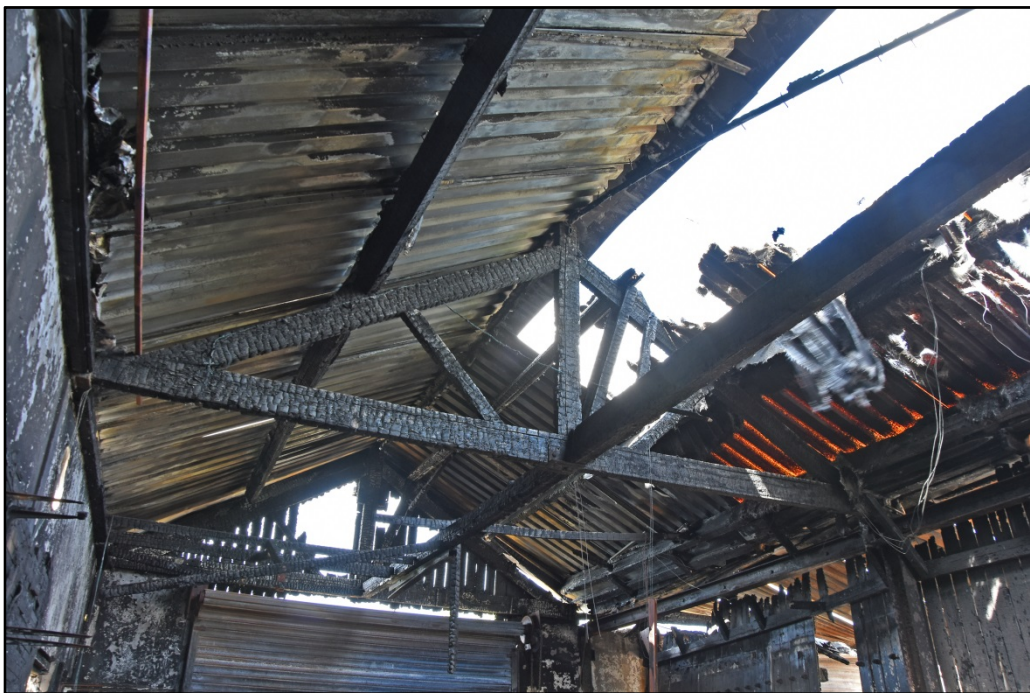
Detail of the roof trusses Fig 24

The roof structure was comprised of king-post and braced trusses carried over timber plates supported at eaves level over the steel posts (Figs 24 & 25). These posts, I-section RSJs, are embedded in the walls and are free standing within the building, with steel beams spanning between them supporting the roof valleys and trusses (Fig 26).

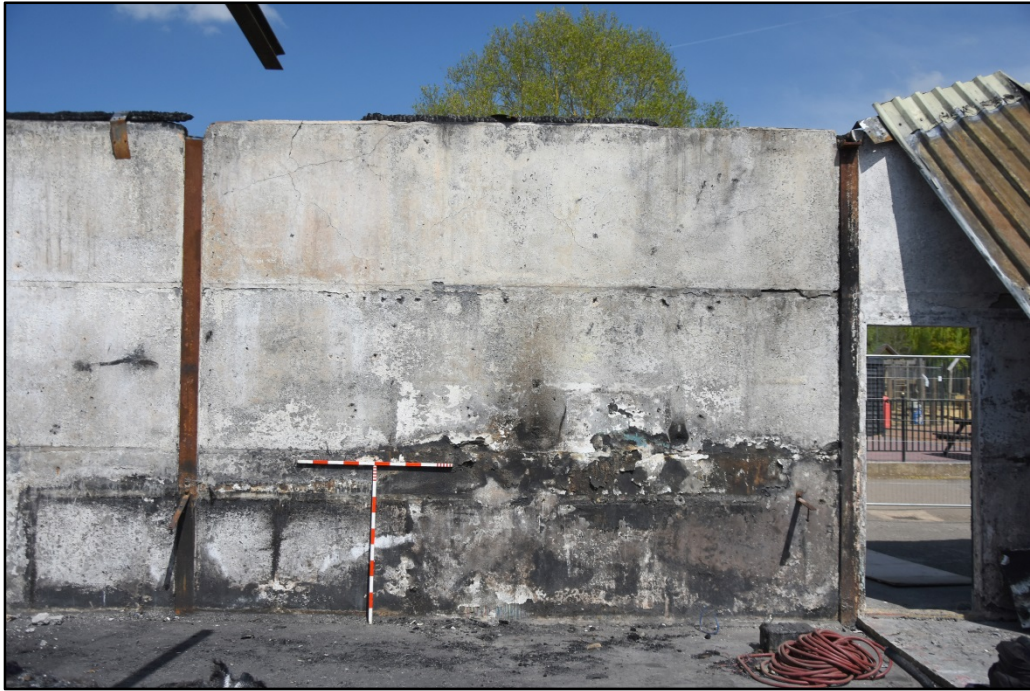
Detail of the concrete panel and steel beam construction Fig 27

The boathouse had a rectangular plan, measuring 15m x 12.8m, and was constructed primarily of precast concrete panels separated by steel I-section RSJs (Rolled Steel Joist) that supported the roof (Fig 29). The concrete panels were generally of an equal size, each measuring 2.5m x 1m (Fig 27). The boathouse walls were painted blue at the time of this survey, however it appears from historic photographs that the walls were initially unpainted and left their natural grey colour.

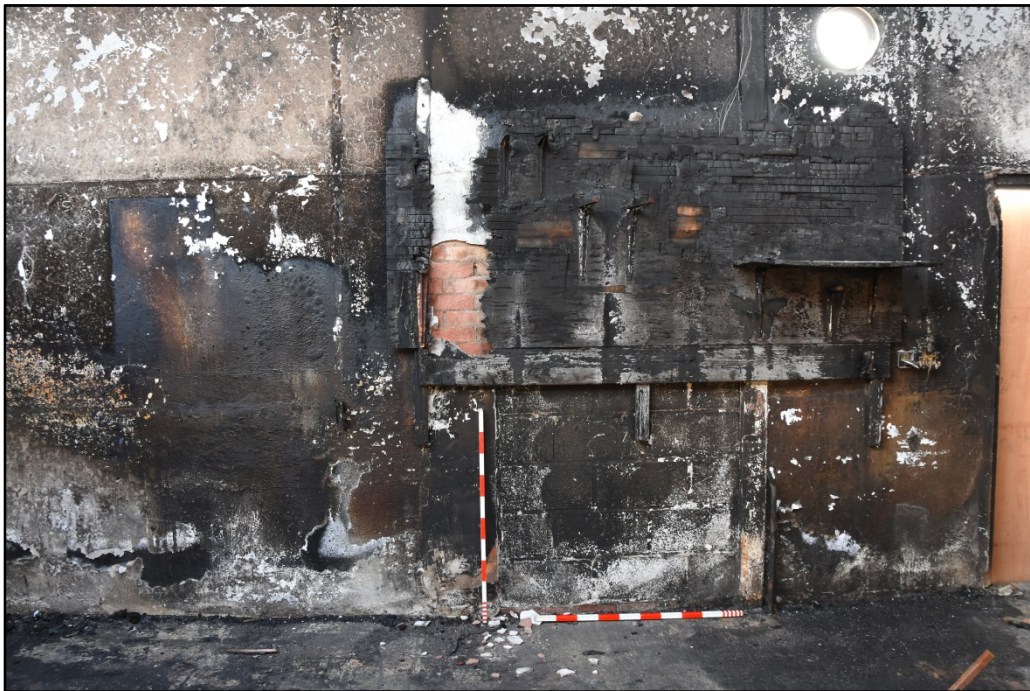
Breeze block and brick blocking of former door in the south elevation Fig 28

Two blocked door openings were noted on the south elevation (Fig 29). One of these doors, blocked in brick, is visible on a historic photograph of the boathouse and formerly opened into an enclosure of the children's zoo area. It is unclear when this door ceased to be used and was blocked but it is likely to have been an original feature of the building. The second doorway in the same elevation is blocked with breeze blocks, with a short panel of brickwork adjacent (Fig 28). It is unknown when this door was functional. In the same elevation was an existing doorway, still open at the time of survey. A sliding door was located on the north elevation.
