**Archaeological observation, investigation and
recording at the church of St Botolph,
Slapton, Northamptonshire
December 2016**

Report No 17/73

Archaeological observation, investigation and recording were carried out by MOLA (Museum of London Archaeology), during groundwork on land at the church of St Botolph, Slapton, Northamptonshire. During the course of the work, the stone footings for the tower and the north aisle of the church were revealed.

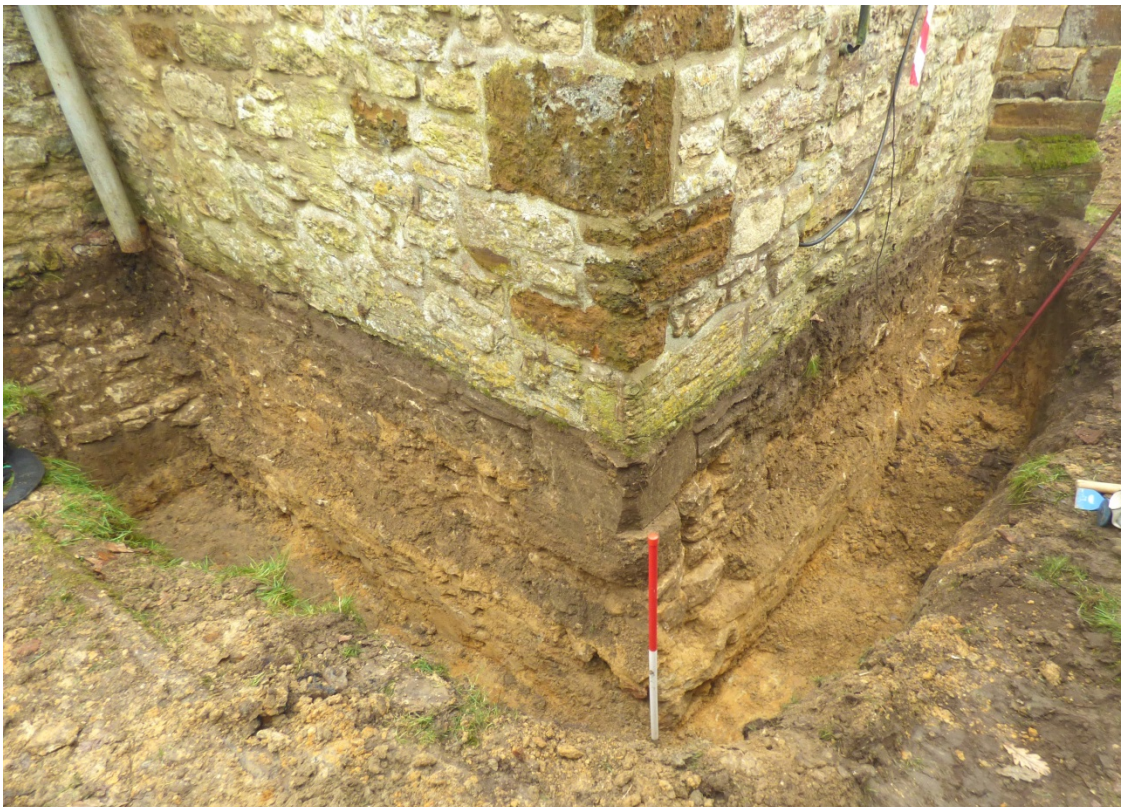
Footings of north-western corner of tower, looking south-east Fig 4

The medieval wall footings of the tower were exposed below ground surface (Fig 4). It consisted of approximately nine courses of roughly dressed limestone blocks c1m deep with a 0.25m offset on the lowermost courses which rested directly on the natural layer (003).

The medieval footings of the nave were exposed below ground surface (Figs 4, 5) and consisted of six courses of roughly dressed medium-sized limestone blocks c0.6m deep with large limestone or ironstone blocks at the north-west corner. The lowermost courses of the footings were offset from the wall by a width of 0.25m. Beneath the lowermost footing course, was a 0.32m deep layer of grey-brown sandy loam with charcoal flecks and small stone inclusions (004).

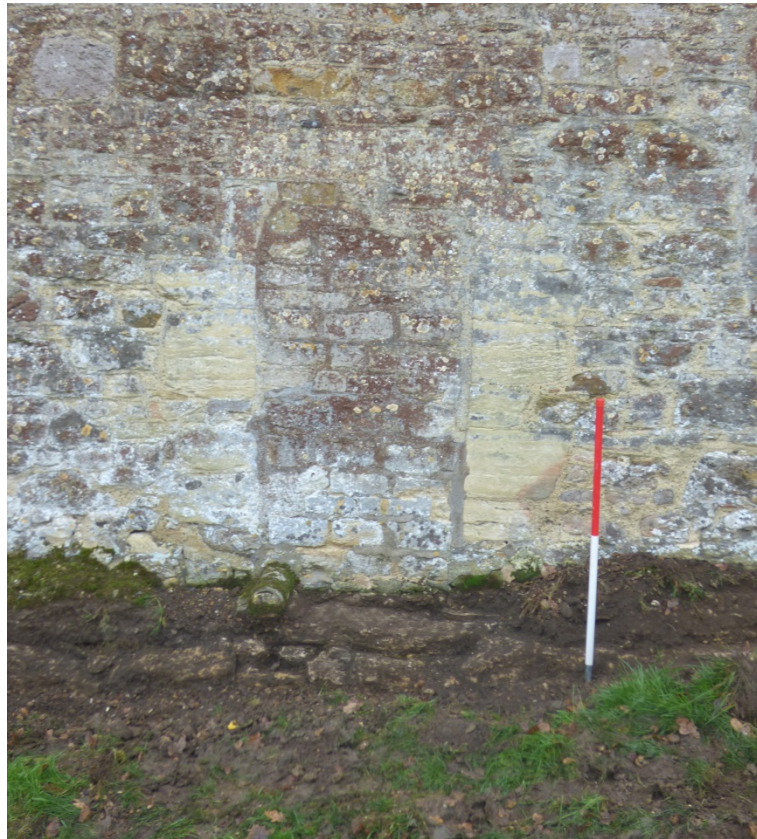
Blocked doorway, north wall of nave, looking south Fig 7

During the observation work an opportunity was taken to record a blocked doorway on the north wall of the nave (Figs 7, 8). Externally the doorway measured 1.7m high by 0.84 wide and internally it measured 2.2m high by 0.94m wide. The external stone door frame had been removed and the void between had been filled with coursed limestone blocks.

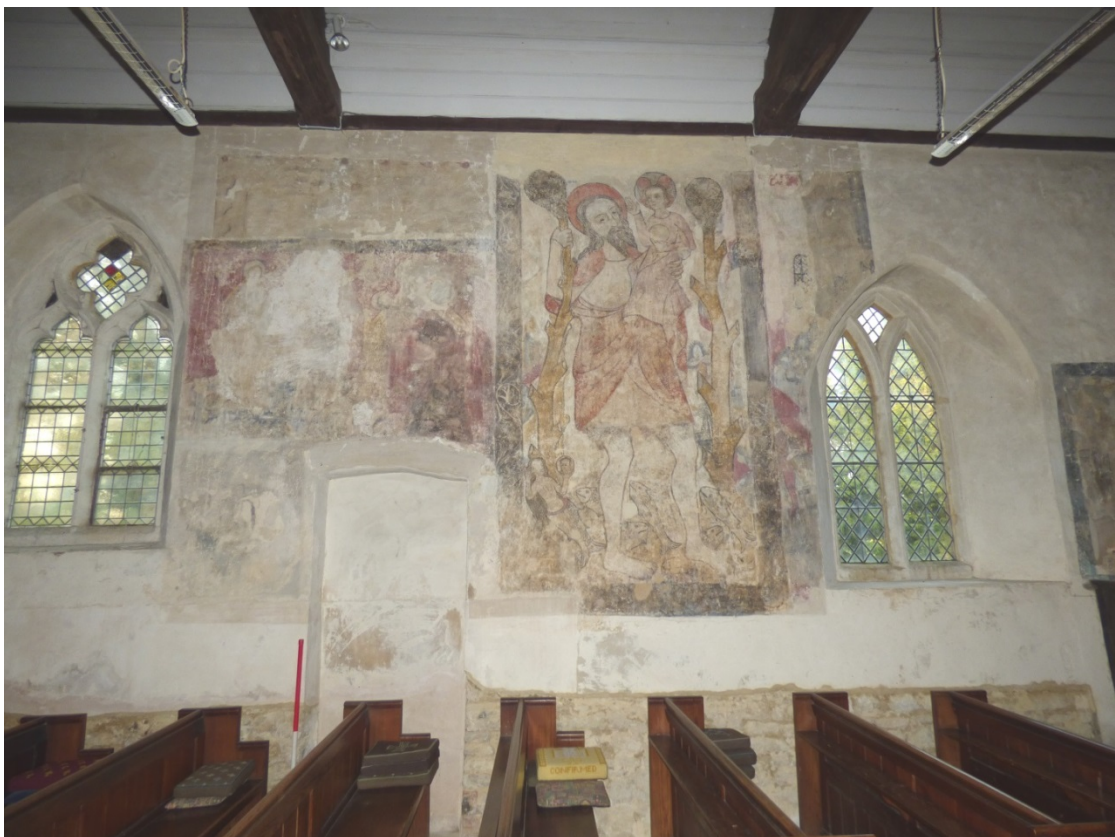
Blocked doorway and wall painting showing St Christopher, looking north Fig 8

The interior contains some notable late medieval wall paintings all of which had been covered in limewash at the time of the Reformation until their rediscovery in the late 19th century. The largest of the wall paintings (located on the north wall of the nave) depicts a towering St Christopher with Christ child on his shoulder (Fig 8). In the south chapel is a painting showing St Eloi shoeing a horse, by removing a leg and leaving the horse supported by scaffolding. In 1875-83, the church was largely restored by William White. The work included a rebuild of the tower.
