**Historic building recording
and archaeological observation at
the Northampton Museum & Art Gallery
and the Old Gaol, Northampton
Northamptonshire**

Report No. 17/107

Historic building recording and archaeological observation at the Northampton Museum & Art Gallery and the Old Gaol, Northampton Northamptonshire

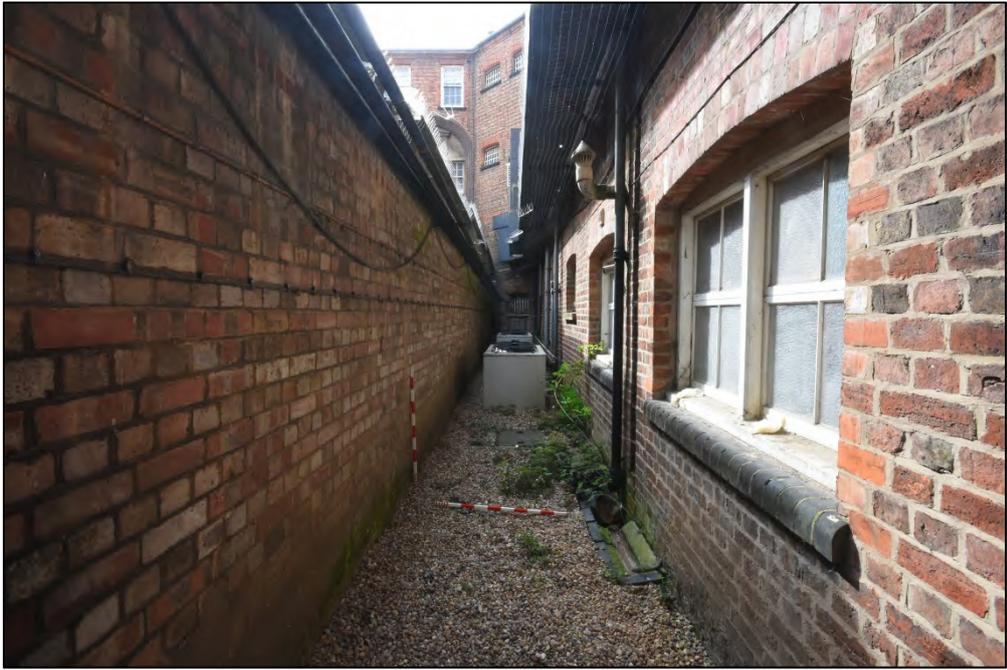
The alleyway at the east of the museum, looking west Fig 28

A narrow alleyway, nicknamed by staff as 'pigeon alley', is formed between the south wall of the east gaol wing and the elevated access corridor (Figs 28-29). The alleyway is accessible only from the museum basement and it provides access to a pair large modern ground-mounted air conditioning units. At first floor level, above the alleyway are external air-conditioning flues.

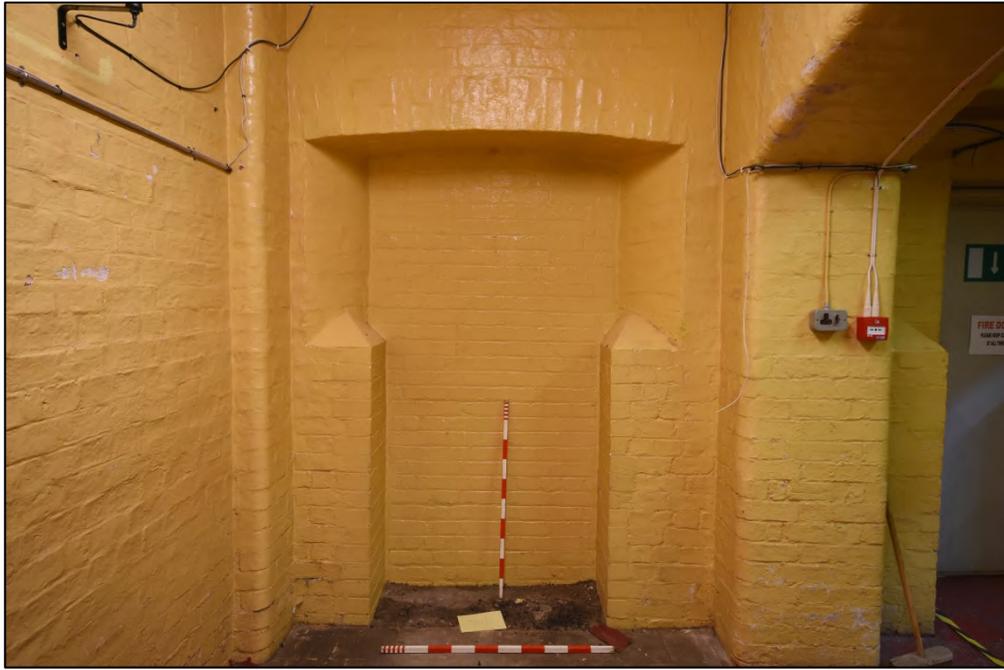
Example of the blocked doorways, showing the shouldered jambs Fig 42

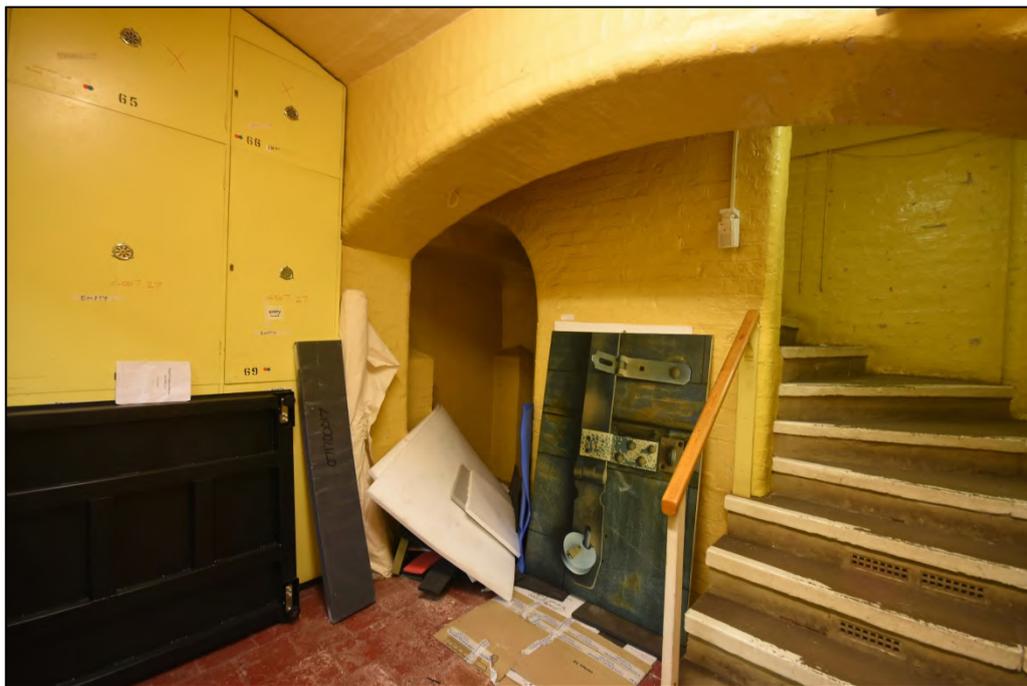
The basement stair, showing the awkward arrangement of this feature Fig 43

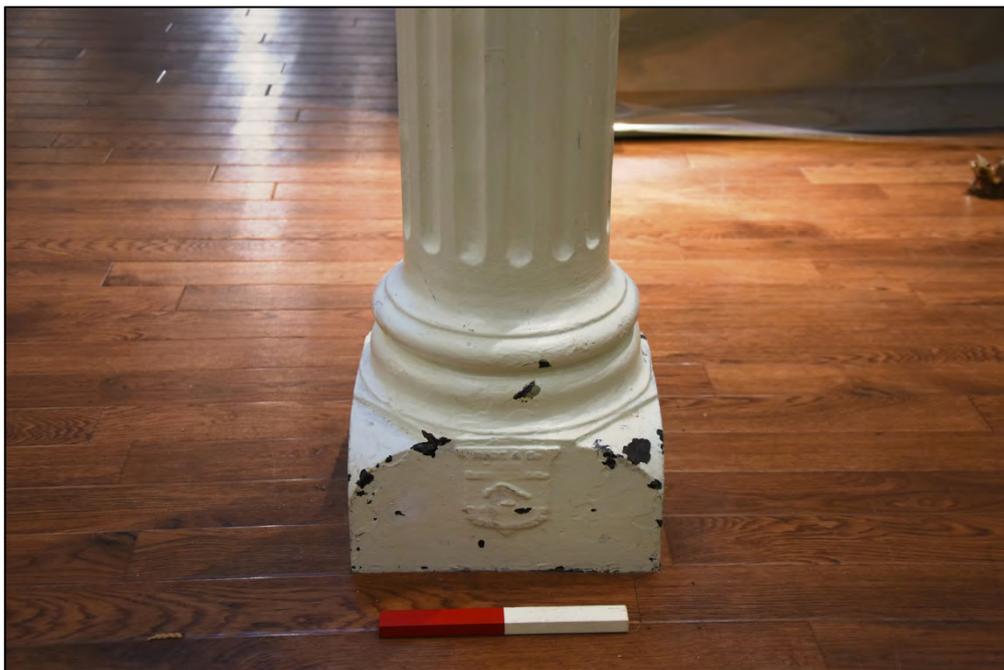
Detail of column base, showing the mark of the Eagle Foundry Fig 45

Two white painted cast iron columns rise from floor to ceiling. The columns are fluted and rise from toroidal column bases on inverted cushion plinths (Fig 45). At the apex are simple bell capitals (Fig 46). The columns support the underside of an iron or steel beam which spans the width of the room. Foundry marks, largely illegible due to heavy paint, are located on the plinths and are identified as the Eagle badge of the Rice & Co. Ironfounders of Northampton. The Eagle Foundry was located on the Phipps Brewery premises on Bridge Street. The foundry had been purchased by Sir Pickering Phipps Rice in the 1860s and produced a range of domestic, commercial and industrial components including fire goods, railings, grates and lamp-posts. The columns are simple and elegant but are somewhat lost in the room as they blend in with the overall plain white colour scheme.

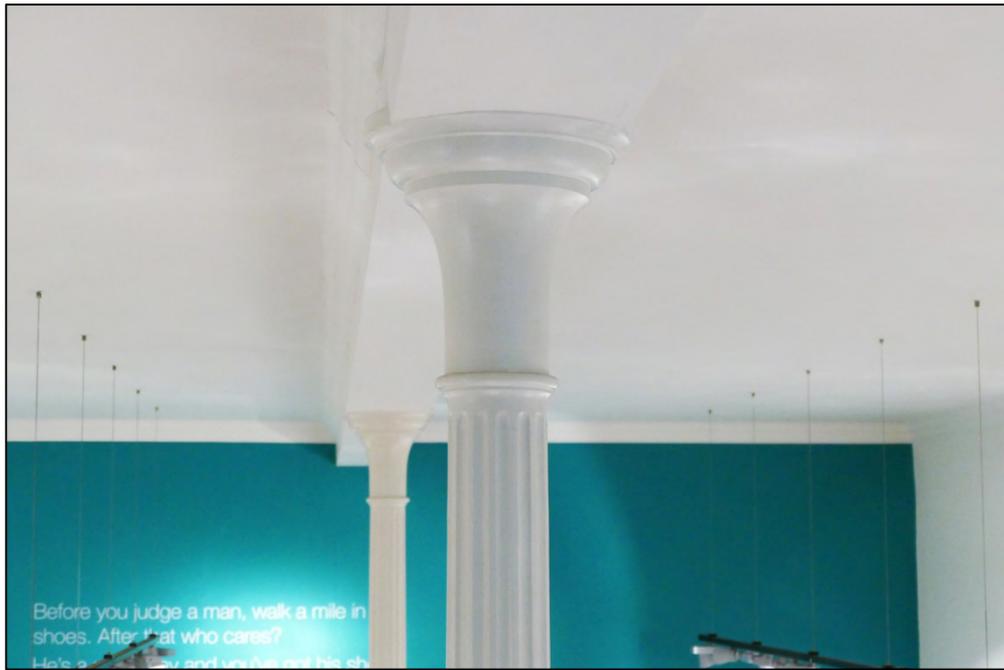
Detail of column crowns Fig 46

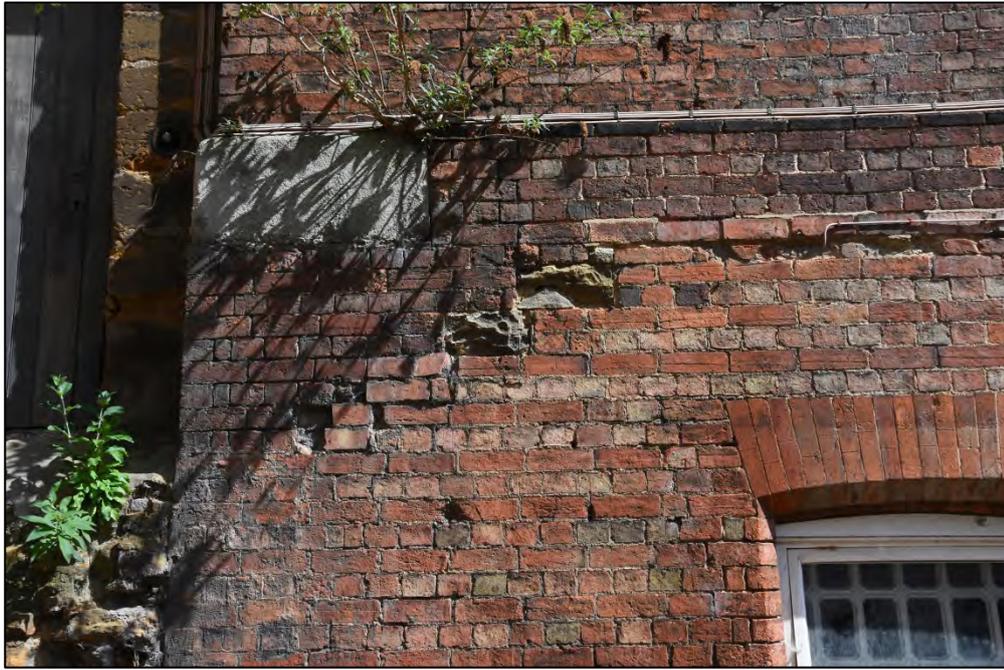
Detail of former steps to the hanging shed and platform Fig 62

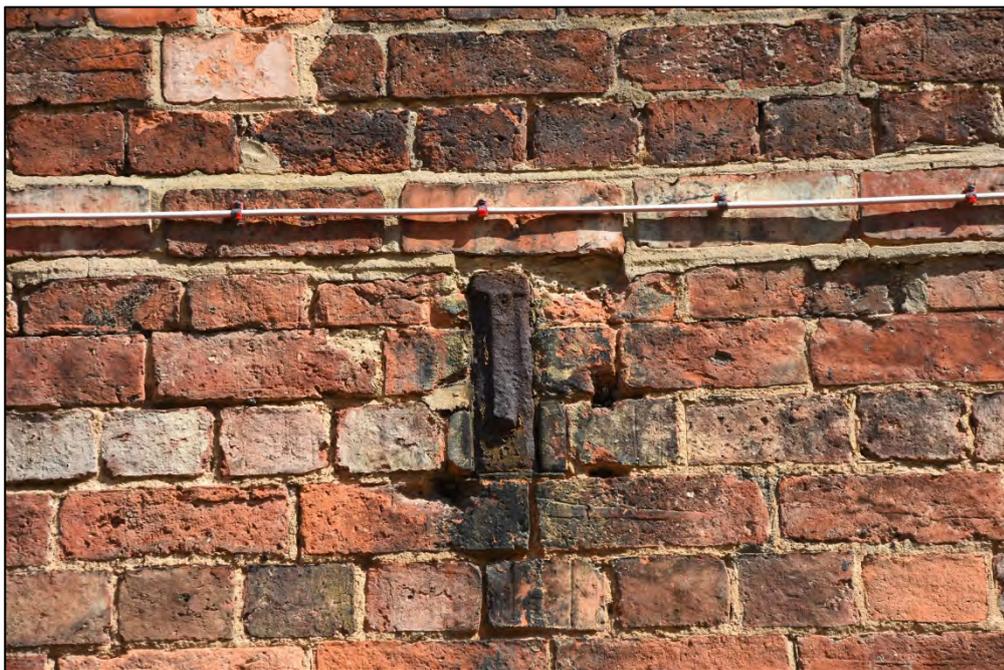
Detail of truncated supporting bracket for the former elevated platform Fig 63

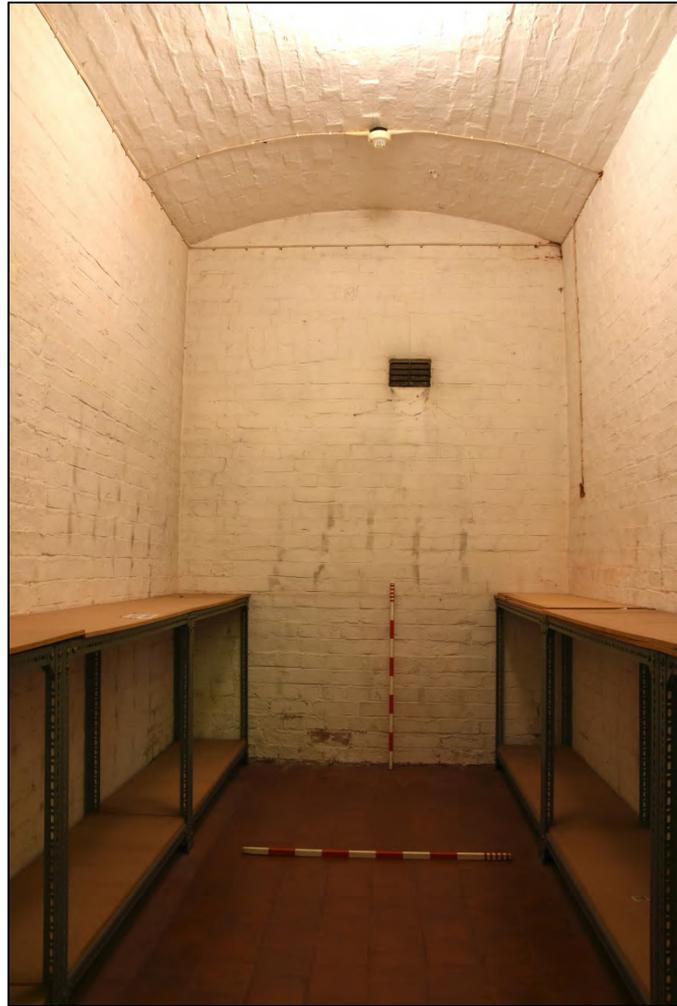
Former cell, now a strong room. Note blocked window at the rear wall Fig 74

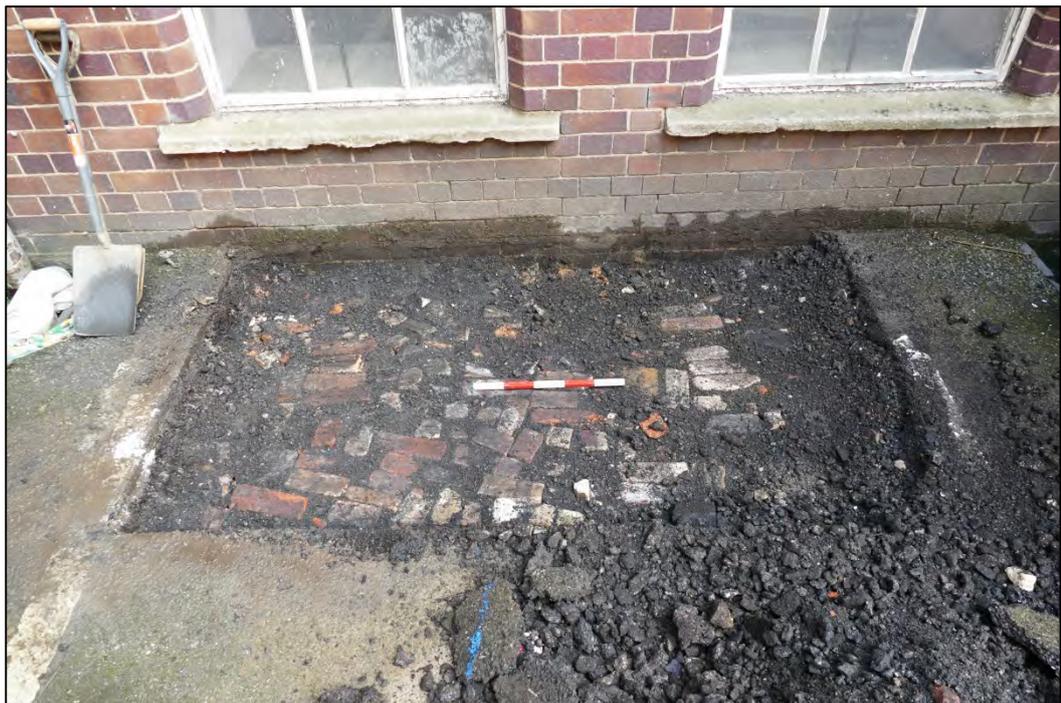
Foundation trench 1, the brick levelling layer Fig 141

This was located at the junction of the Council offices building and the overhead access corridor/ cycle sheds and was positioned against the western wall of the Council offices in order to determine the depth of its foundations (Figs 141, 152). The trench was hand excavated to a depth of 1.5m but failed to find the wall foundations and was subsequently re-excavated by machine.

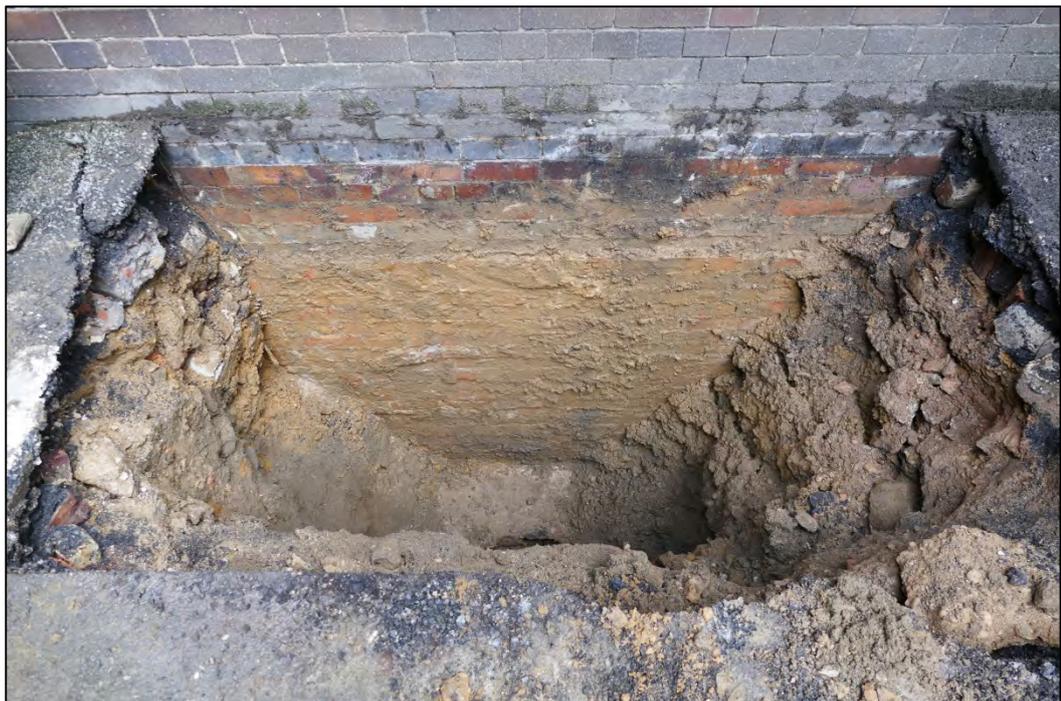
Foundation trench 1, showing the exposed foundations Fig 143

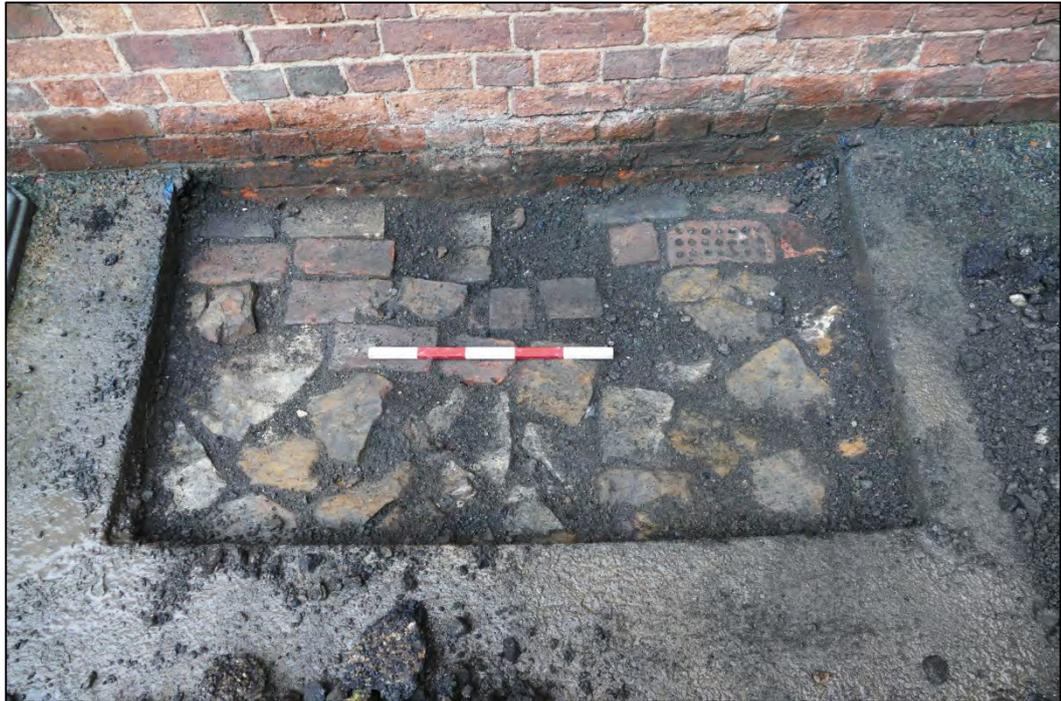
Foundation trench 2, showing the brick and stone levelling layer Fig 144

The tarmac surface was found to be 100mm in thickness and overlay a mixed brick and stone levelling layer of a single brick thickness, comprising a mix of unfrogged and perforated bricks and sandstone and ironstone. The removal of this layer revealed a ceramic drain, no longer in use, which appears to have connected to downpipes a short distance to the north of the trench. This feature was initially left *in situ* and the excavation stepped to avoid it but was later removed and will be reinstated. The drain was within a 600mm thick layer of mid-yellow-brown sandy gravel hardcore containing frequent building rubble and 19th and 20th-century domestic debris.

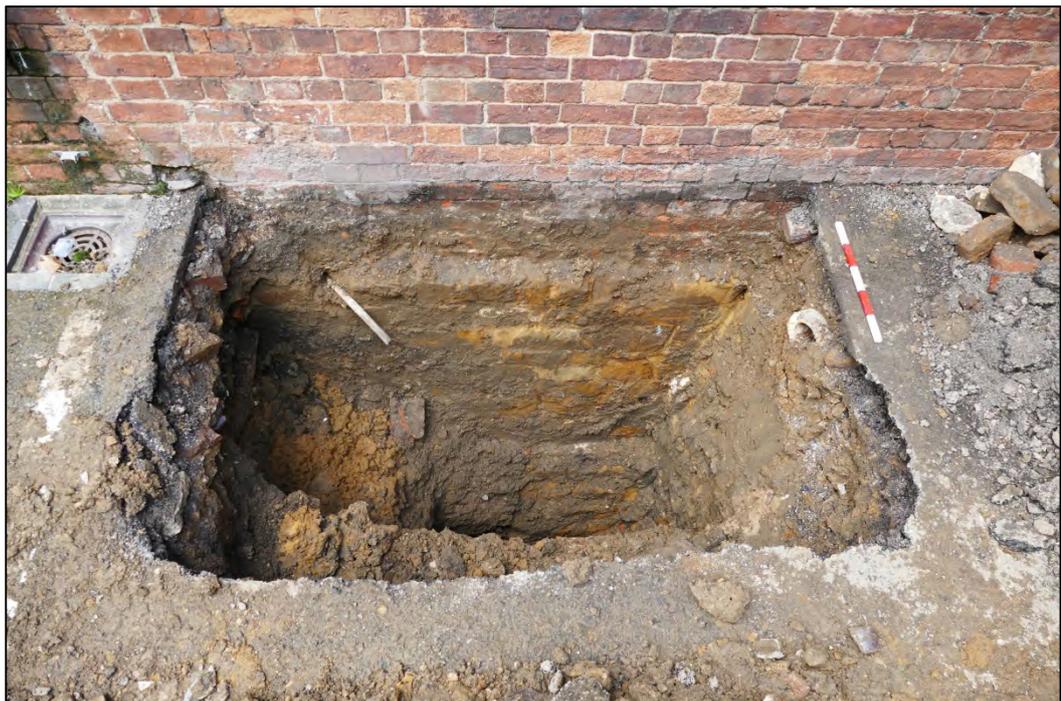
The brickwork of the gaol wall extended downward to a depth of c400mm where it was found to overlay a coursed stone wall of shaped Northampton Sand and Ironstone rubble (Fig 145). The stonework is lipped outward and descends to c1.8m from the tarmac (nine courses of stone), whereupon it is battered outward in five courses, c0.9m total thickness. At the base of the batter was found a layer of concrete blinding, c100mm thick.

Foundation trench 2, showing the stone-built foundations Fig 145

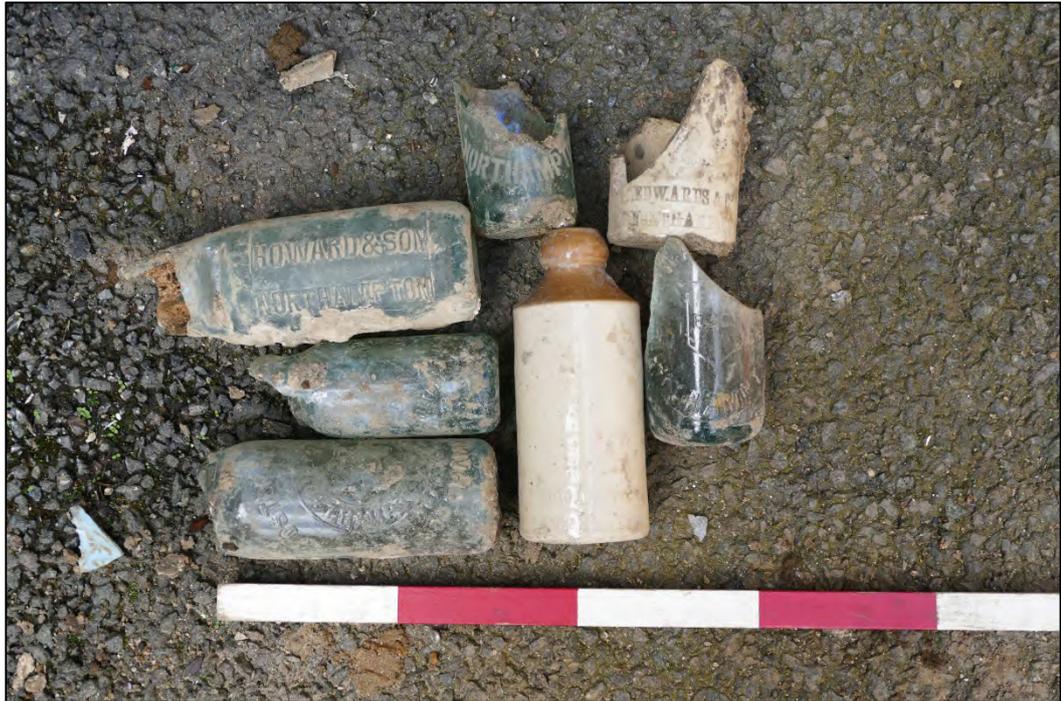
Examples of the bottles recovered from foundation trench 2 Fig 146

Below the hardcore was a fairly homogenous level of mid-grey-brown silt containing frequent broken bottles, fragments of brick and occasional animal bones and fragments of oyster shell. The bottles have been identified as Codd bottles, ranging from the mid-1880s to c1910 and were sourced from local mineral water manufacturer's including Foster and Lewis, Howard & Sons and Edwards & Co. Also present were stoneware ginger beer bottles, stamped Edwards & Co., also of a late 19th and early 20th-century date. A single diagnostic sherd of Cistercian ware-type pottery was recovered from this layer during the initial hand excavations and is described as follows:

Excavation adjacent to the gaol recovered a large number of codd bottles, these still being found at the very base of the foundations at a depth of 2.8m. Many of the bottles were labelled Edwards & Co. This company operated a mineral water factory in the basement of the former gaol between the years 1894-96, the operation then being passed on to Dilks and Co. The bottles were unlikely to have been manufactured on site but were probably stored here. The former Midland Temperance Hotel at the corner of Angel Street and Guildhall Road would quite likely have had a store of mineral water bottles. The presence of these bottles at such a depth and very close to the gaol walls provides conclusive evidence of a deep disturbance to the ground level in the gaol yard. While some disturbance to the yard occurred prior to the demolition of the terraces and erection of Council offices, it is very likely that most of the backfill and levelling layers relate to this period.

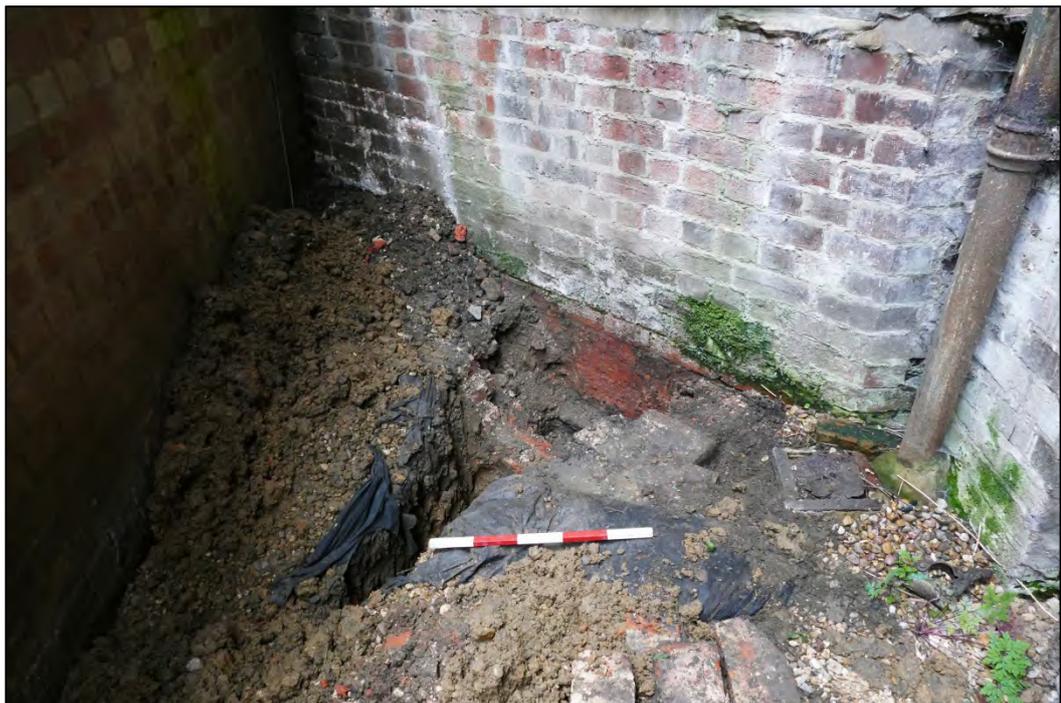
Foundation trench 3 Fig 147

This was hand excavated at the angled intersection of the two gaol wings, in the narrow alleyway formed between the gaol and the overhead access corridor/ cycle shed (Figs 147, 152). The alleyway is fully paved with loose gravel on Terram. This was pulled back to reveal a brick wall parallel to and at distance of 220mm from the gaol wall. The bricks, which were left *in situ*, were unfrogged red bricks and held together with a very strong mortar. Between the bricks and the main wall was a compact mid-grey sandy gravelly fill containing frequent fragments of building rubble and rubbish. A 2" diameter cast iron pipe was encountered at a depth of 400mm and likely connects to a cast iron pipe fixed to the wall nearby. This was left *in situ*. The sandy gravel fill continued to a depth of 500mm where it was found to overlie a flat concrete surface. It is likely that the brickwork forms a culvert or drainage inspection trench. It was decided to cease digging at the concrete surface and excavation continued at the south side of the culvert.

The brickwork was followed down to a depth of 0.8m through mid-grey-brown sandy silt with occasional fragments of brick and domestic debris. A brick surface or footing was found at a depth of 0.8m, abutting the brick culvert, with a straight edge to a flat surface of ironstone rubble (Figs 148, 152). Due to the lack of room in the trench area it was not possible to expand the excavation and investigate this feature.

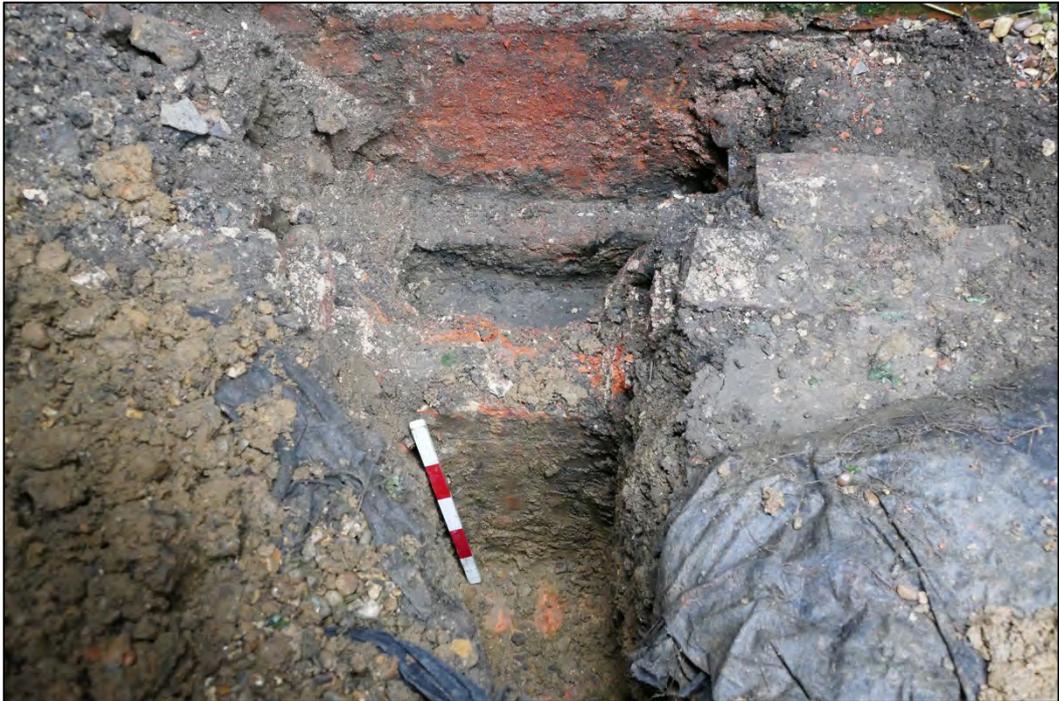
Foundation trench 3, showing the brick gully with pipe adjacent to the wall Fig 148

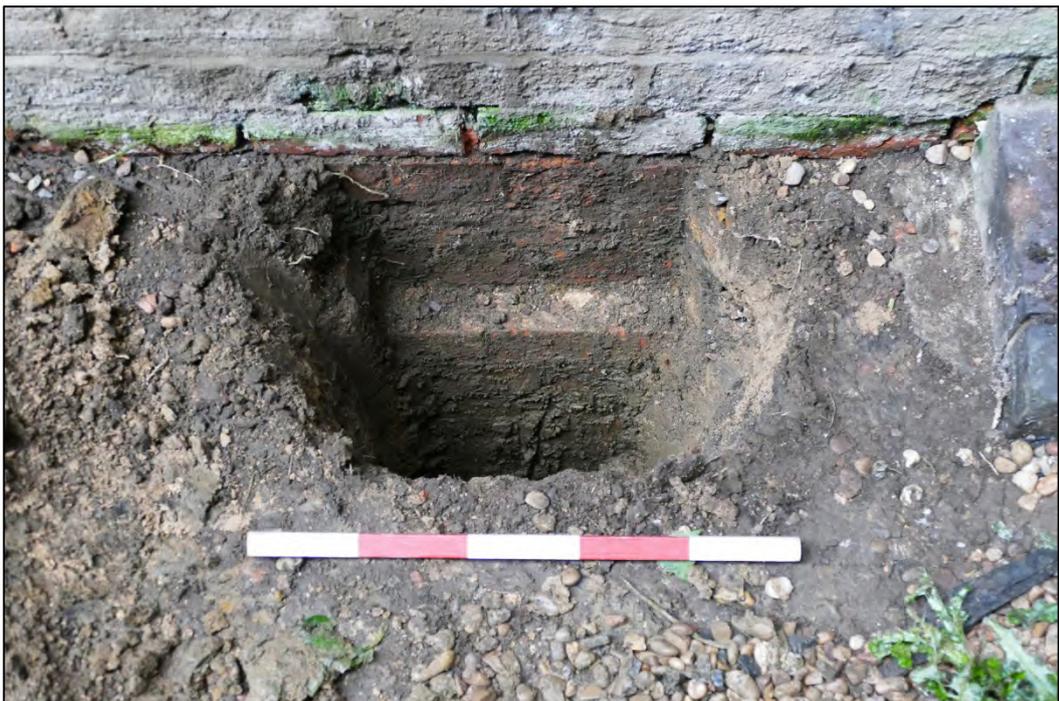
This trench was also excavated in the alleyway at its eastern end. Beneath the loose gravel on Terram was layer of c300mm thick layer of mixed sandy gravel with frequent brick fragments. This overlay grey-brown sandy silt with ironstone fragments, which continued to a depth of 1.5m (Fig 149).

Foundation trench 4 Fig 149

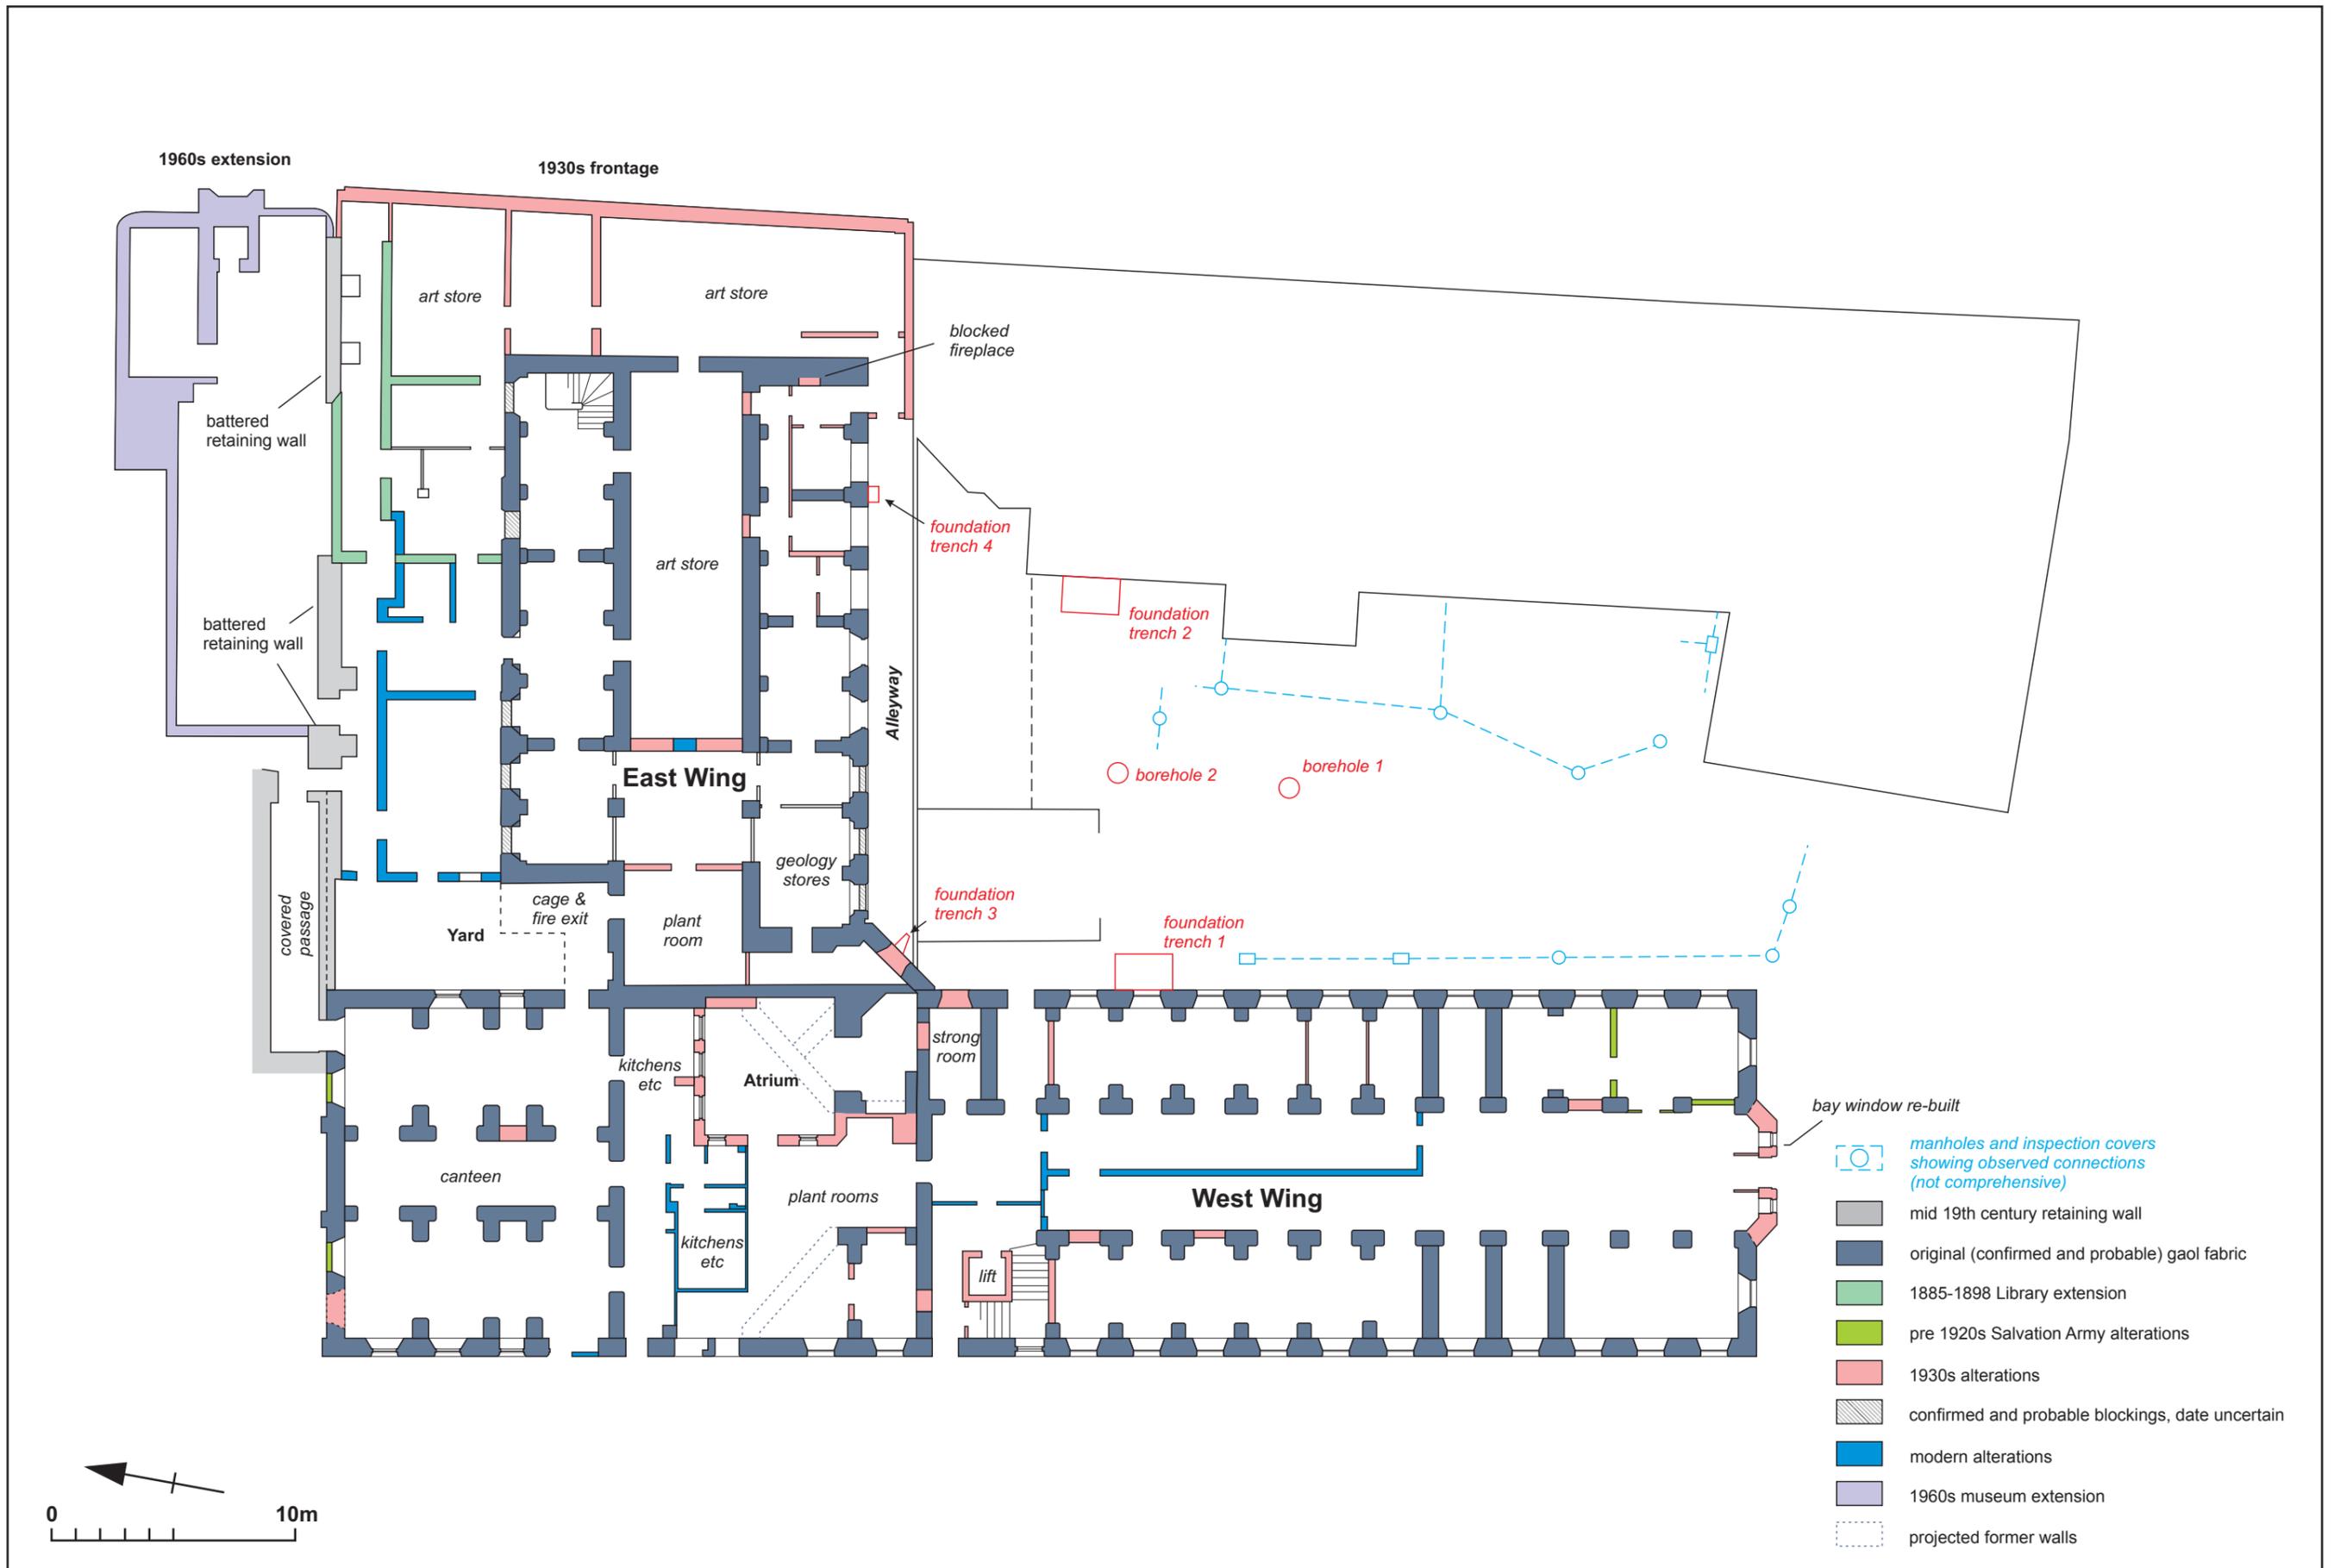
Phased plan of the lower ground floor, also showing areas of archaeological observation Fig 150

A series of boreholes and exploratory foundation trenches were excavated in the south-west parking area and in the alleyway between the overhead access corridor / cycle store and the east gaol wing (Figs 138, 150 and 152). The aim of these excavations was to investigate the underlying strata and to determine the depth and nature of the buildings' foundations.
