Archaeological observation, investigation and recording at the church of St George the Martyr Wootton, Northamptonshire

Report No 17/105

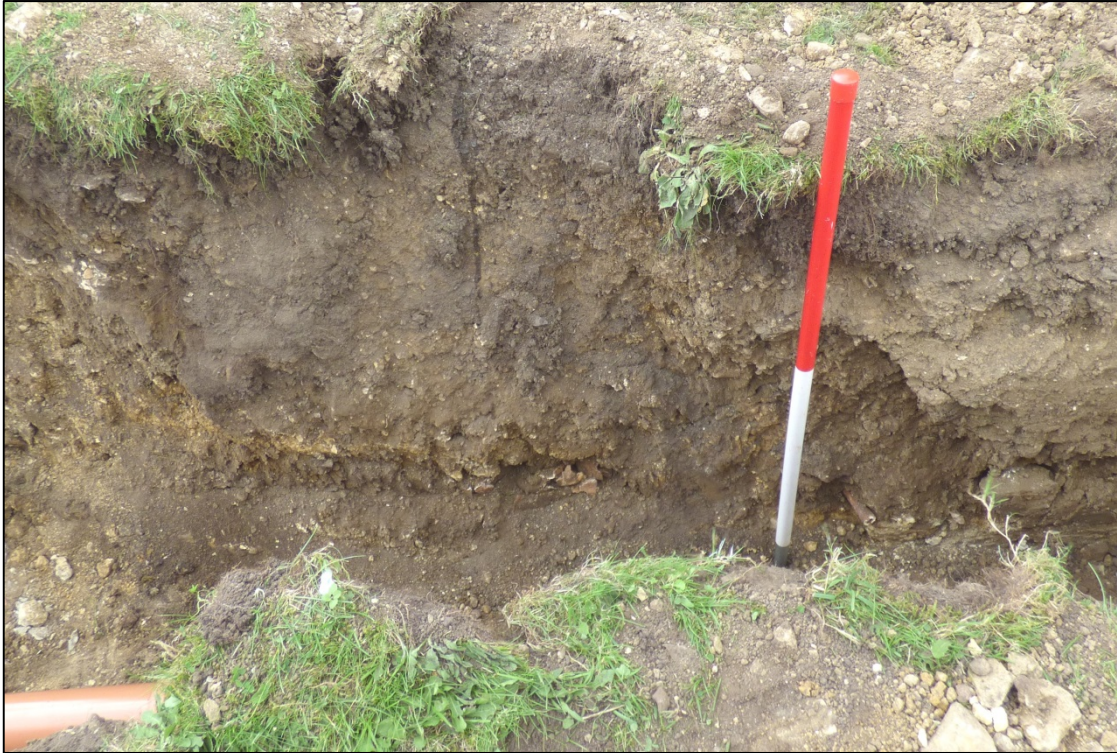
Grave cut [006], looking east Fig 4

Two grave cuts [006] and [008] were noted during the excavation of the service trench, at a depth of 1m (Figs 2 and 4). The fills (005) and (007) respectively, were similar and consisted of a mottled dark grey-brown, sandy loam with patches of red-brown sandy loam. Fragments of human bone were noted *in situ*. Within fill (005), the remains of a human skull were noted at the base of the grave cut (Fig 4).

Excavations within the churchyard revealed two grave cuts c1m below present ground level, possibly medieval in date, containing fragmentary human remains. At nearby Little Billing, late Saxon to modern burials at All Saints Church were found to survive largely between 1.1m and 1.3m below ground level (Chinnock 2014; Chinnock in press). A medieval or later date could therefore not be unreasonable to suggest at Wootton. Redeposited broken grave slabs were also noted within the service trench.

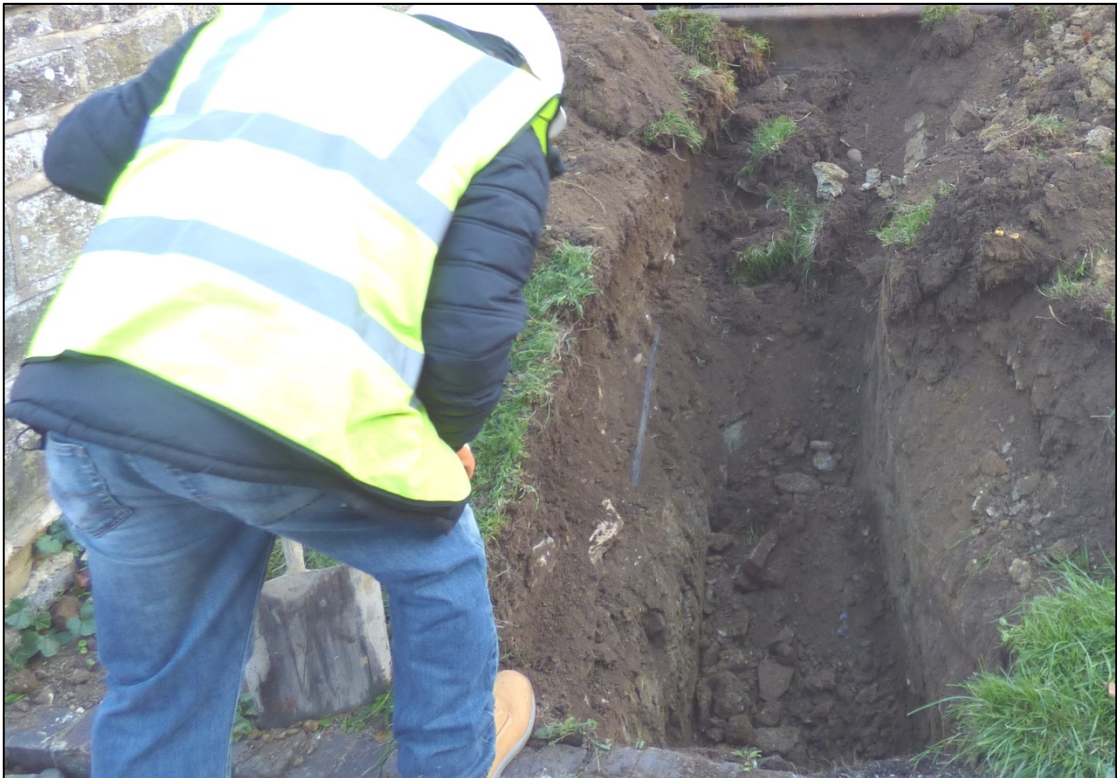
Layer of re-deposited, broken grave slabs (009), looking north Fig 5

Close to the southern end of the service trench a layer of re-deposited, broken grave slabs was noted (009) (Figs 2 and 5).

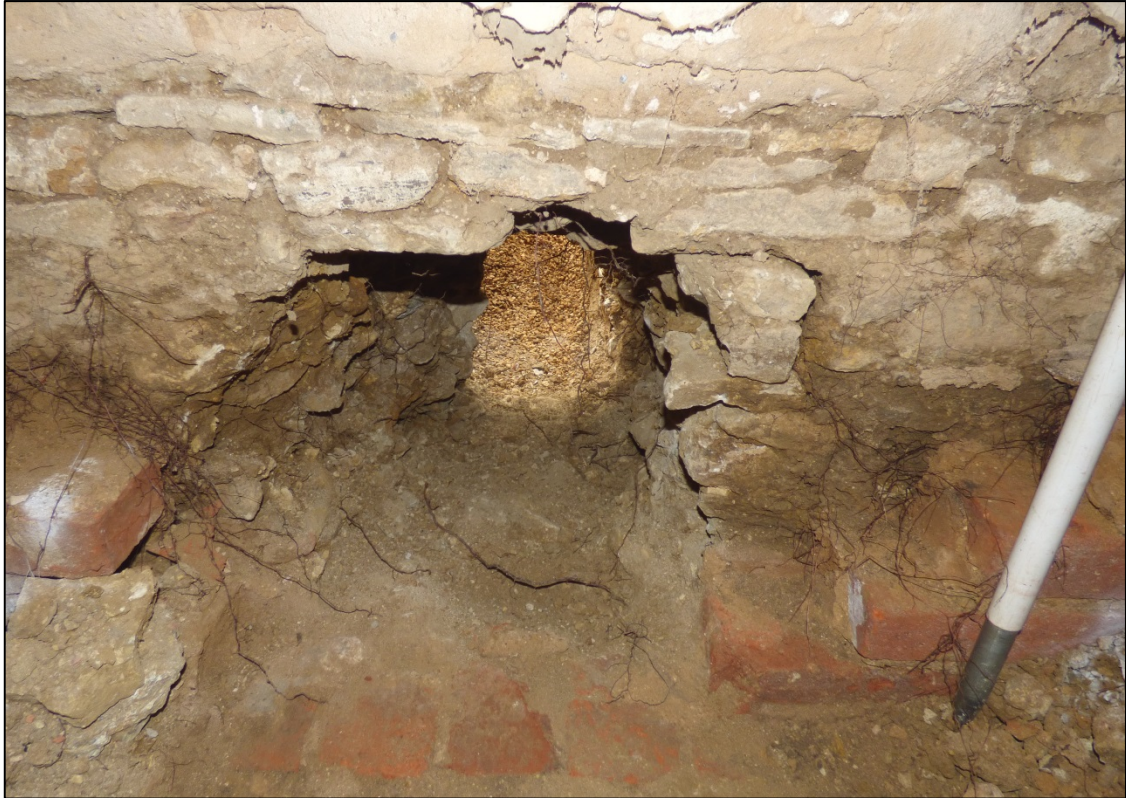
Access hole cut through north wall footings, looking north Fig 6

Within the church interior, at the western end of the nave and the north and south aisles, the pews and the underlying floor boards and supporting joists were removed. An access hole measuring 0.5m wide by 0.46m high was drilled through the footings of the north wall of the church approximately 0.6m to the east of the internal north-western corner of the church (Fig 6). The church wall footing was found to be 0.73m wide at this point. It was also noted that a c0.4m high, pre-modern (possibly 19th-century) brick offset had been constructed against the base of the north wall of the church (Figs 6, 9 and 10). The offset had been constructed to support the wooden floor joists on the north side of the church.

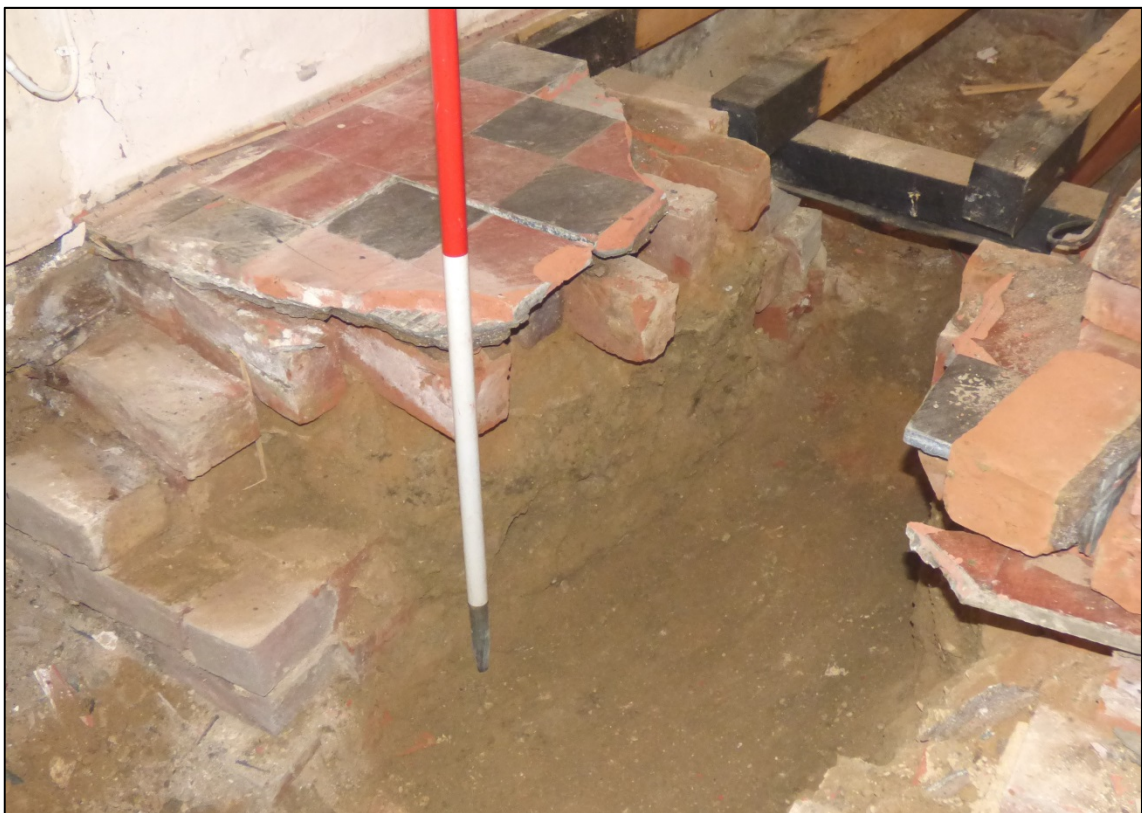
Section across southernmost brick pier, looking north-west Fig 7

From the new access hole in the north church wall, uPVC service pipes were laid in voids beneath the pews, across the width of the church in a north to south direction. The line of the service pipes cut across three 19th-century tiled walkways aligned east to west between the rows of pews. Three sections were cut across the walkways to provide access for the new service pipes. The walkways were revealed to be free standing, with linear brick piers for the timber floor joists (Fig 2). All three brick piers were c0.5m high, though with variable widths of 1.05m, 1.48m and 1.10m for the northern, central and southernmost piers respectively. The construction of the piers consisted of five courses of bricks with a brick capping upon which ceramic tiles had been laid. The cores of the piers were a compacted soil consisting mostly of a pale to mid-grey brown sandy loam with fragments of mortar and charcoal (Fig 7).

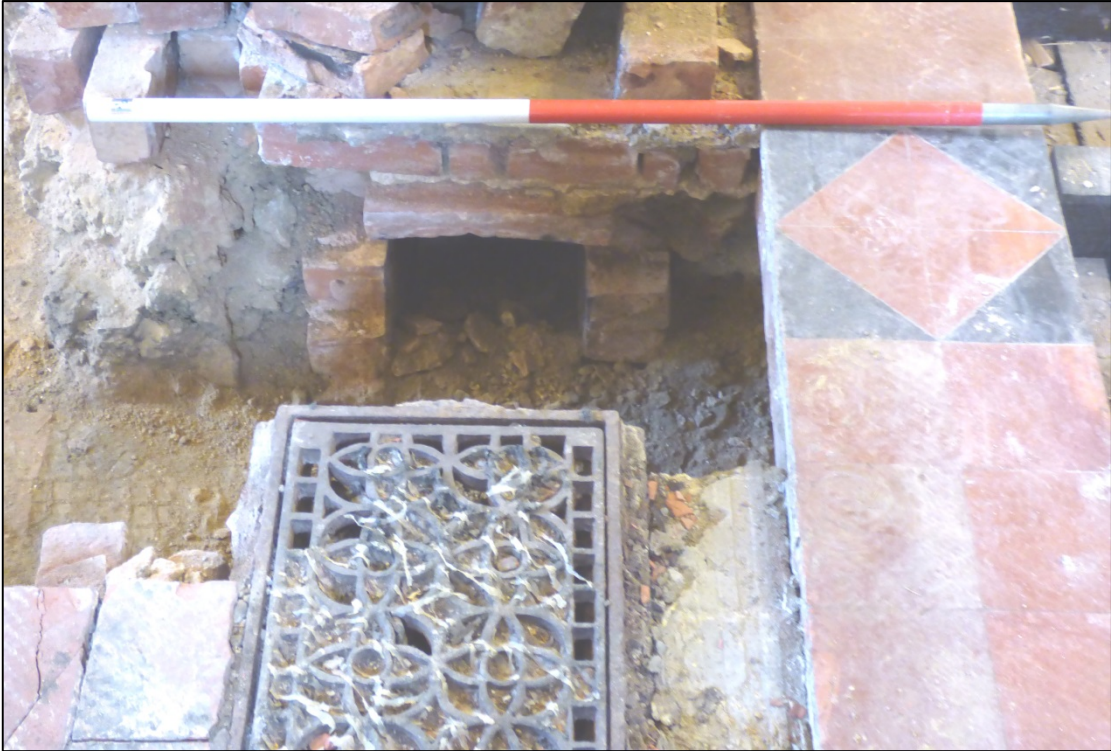
Victorian heating duct [010], looking east Fig 8

Running along the centre of the central brick pier, in an east to west direction was a brick-lined heating duct [010] (Fig 8). The duct was c0.4m high with an internal width of 0.26m and was capped with an iron lattice grate. Another duct [011] ran north-south towards a square hole in the north wall of the church (Fig 10), just to the east of the new access hole.

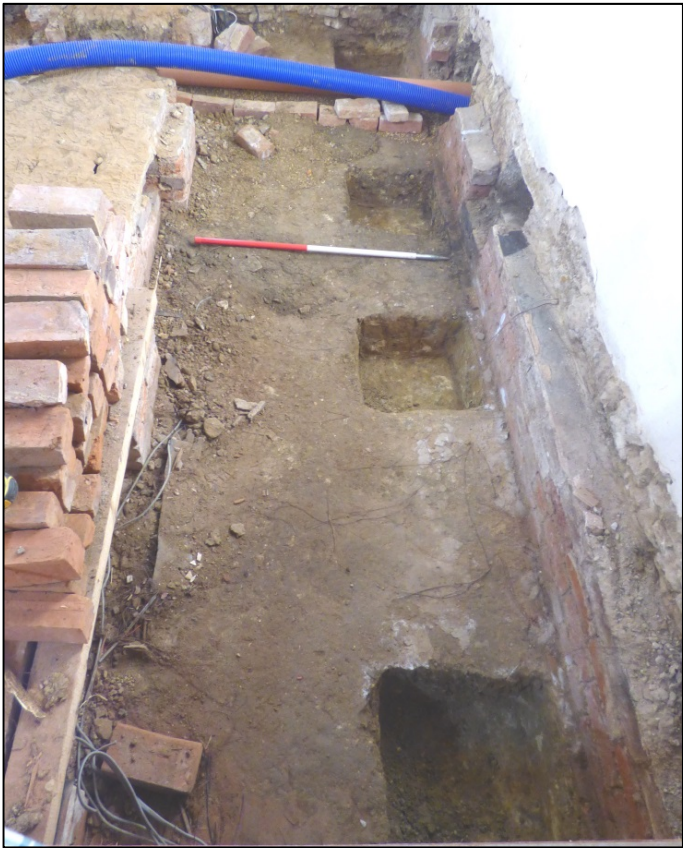
Stanchion trenches and [011], looking west Fig 9

Just inside the north wall of the church, four stanchion trenches were excavated. Each trench was 0.5m square by 0.2m deep. Some re-deposited human bones were noted within some of the trenches and were left *in situ* (Figs 9 and 10)
