**Archaeological observation, investigation, recording
analysis and publication of works at
4 Moor Cottages, Nags Head Lane
Hargrave
Northamptonshire**

Report No. 19/80

MOLA (Museum of London Archaeology) carried out a watching brief at 4 Moor Cottages during groundworks for residential re-development. No archaeological remains were found on the site which comprised of house footings and service trenches for a single residential building.

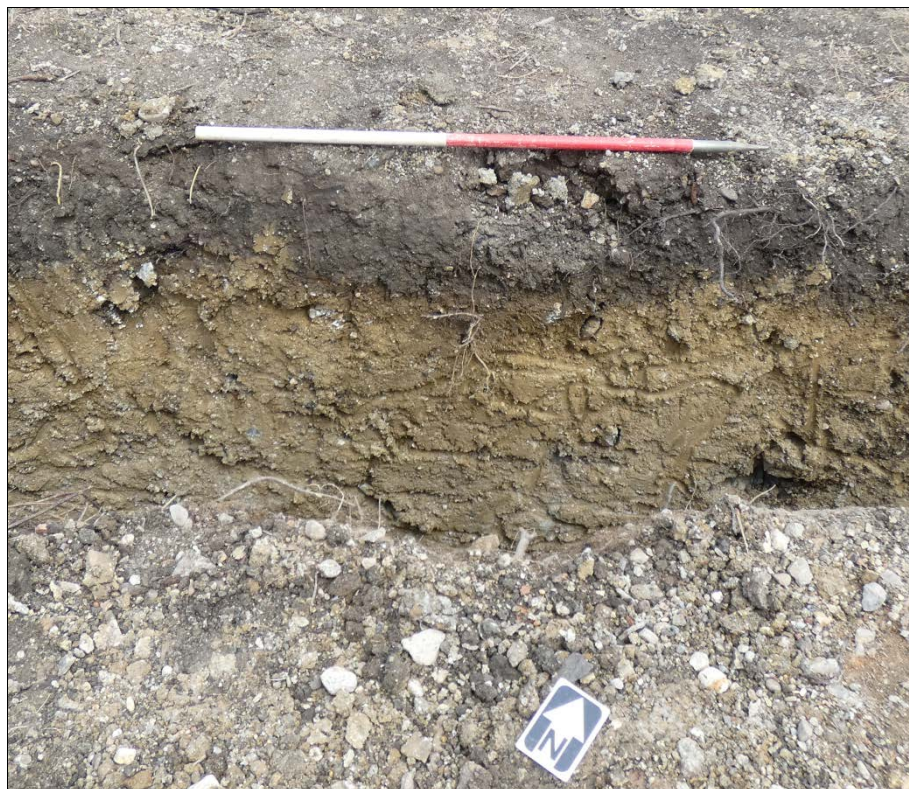
Site stratigraphy Fig 2

The general stratigraphic sequence recorded on site comprised layers of topsoil and subsoil overlaying the natural surface and in places, made ground relating to the former garage. The topsoil, a dark brown grey loamy silt with frequent stones was consistent across the site except where made ground was present with a depth of between 0.23 and 0.30m. The subsoil, a mid-brown silty clay varied in depth to a much greater degree measuring between 0.11m towards the northern end of the footings to 0.40m at the southern end where the ground rises. The natural substrate was a mid-brown-yellow chalky clay.
