**Archaeological observation, investigation, recording,
analysis and publication at St Margaret's Church,
Alderton, Northamptonshire
April 2022**

Report No.: 22/031

Author: Paul Thompson

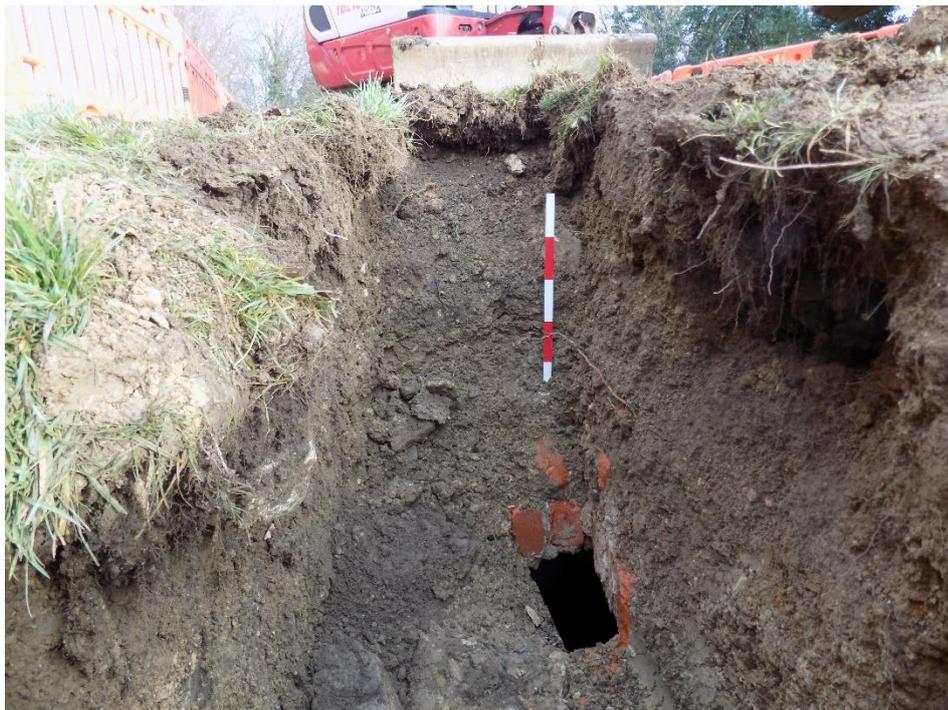
Burial Vault [1010], looking north-east Fig 3

Once subsoil [1010] was encountered, burials and two brick vaults were discovered [1011] and [1038]. Vault [1038] lay east of Burial 21 and west of Burial 25 and in line with vault [1011]. Both vaults were constructed from red brick and grey mortar. Within [1038] a body was visible with at least two coffin handles. The hole made by machine accidentally removing a brick, was easily made good by replacing the brick and covered up with spoil immediately and left without further disturbance. Burials were observed beneath the modern path tarmac but were left undisturbed in situ.

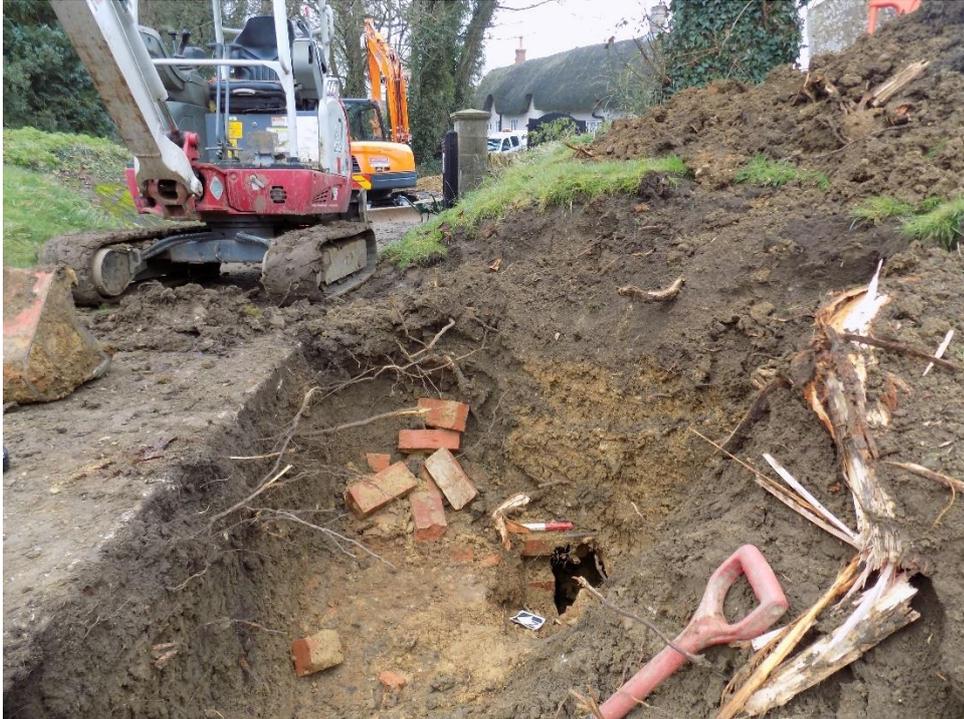
Burial Vault [1038], looking north-east Fig 4

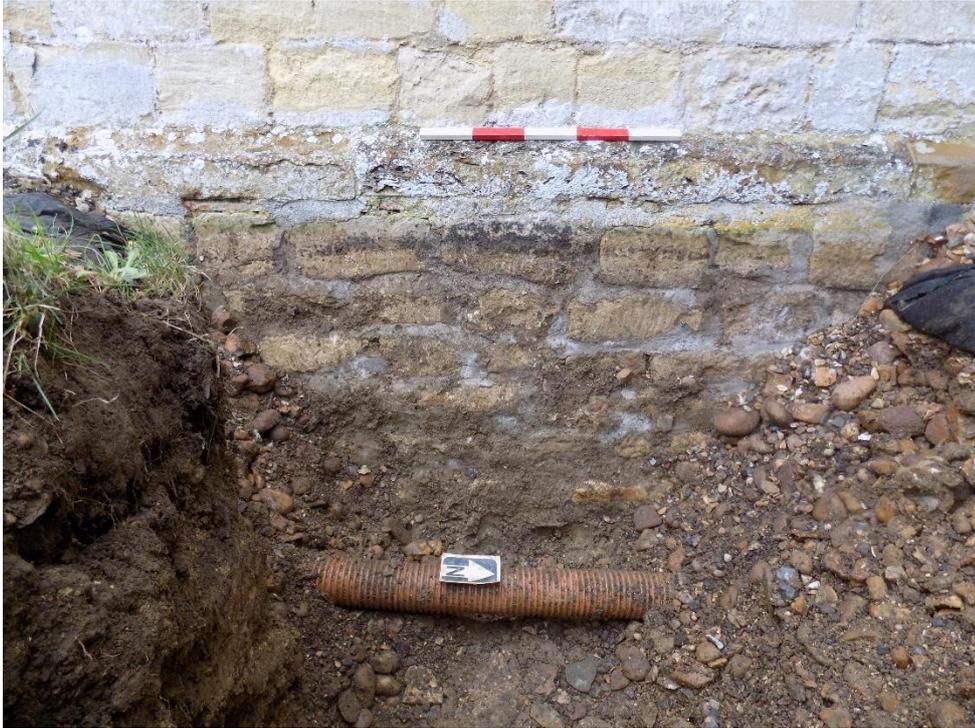
The southern church wall [1005/1025] with plastic pipe, looking west Fig 5

The church wall [1005] is built of a compact light yellow to brown limestone roughly hewn blocks. This was bonded with mortar [1006] of compact mid yellow to brown colour. The south-west corner of the church porch revealed a foundation [1012/1026] of 0.50m in depth exposed during excavation of the service trench in the east side and continuing beyond the limit of excavation. This wall foundation consists of an approximately east to west aligned wall of firm mid yellow brown limestone blocks and sandy clay bonding. The foundation [1012] lays above [1023]. The wall above this foundation has been removed. This may be a foundation wall for a church wall now demolished. Personal Communication with the Church Warden indicated that the church building extended further to the south.

The south-west part of the trench begun at the church wall [1005/1025] and was devoid of archaeology. Only a plastic service pipe [1003] (Fig 4) was found aligned with the church wall, below [1000], turf and topsoil. The backfill of the modern service [1003] comprised friable brown small, rounded pebbles. The cut for this service [1004] was aligned east-west with a 'U' shaped profile and fairly steep sides.

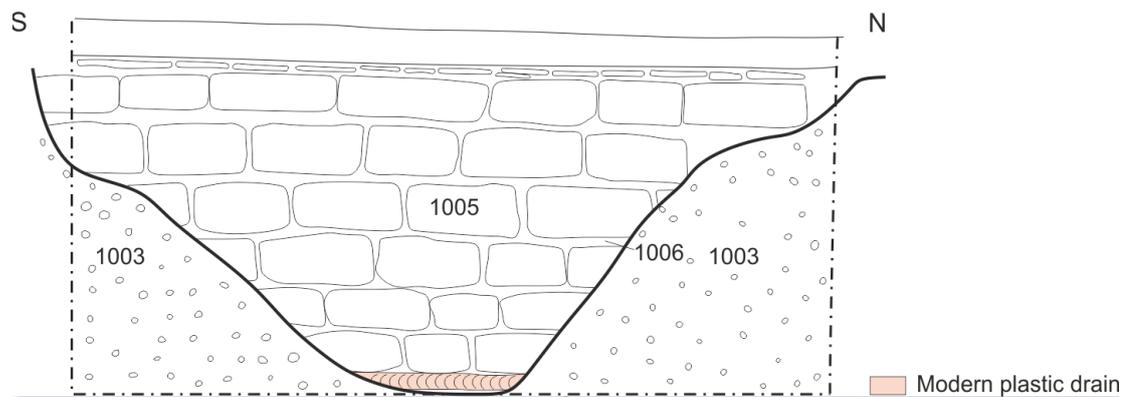
Section 1

The north-western section drawing of the new foul water trench, looking north-west
Fig 6

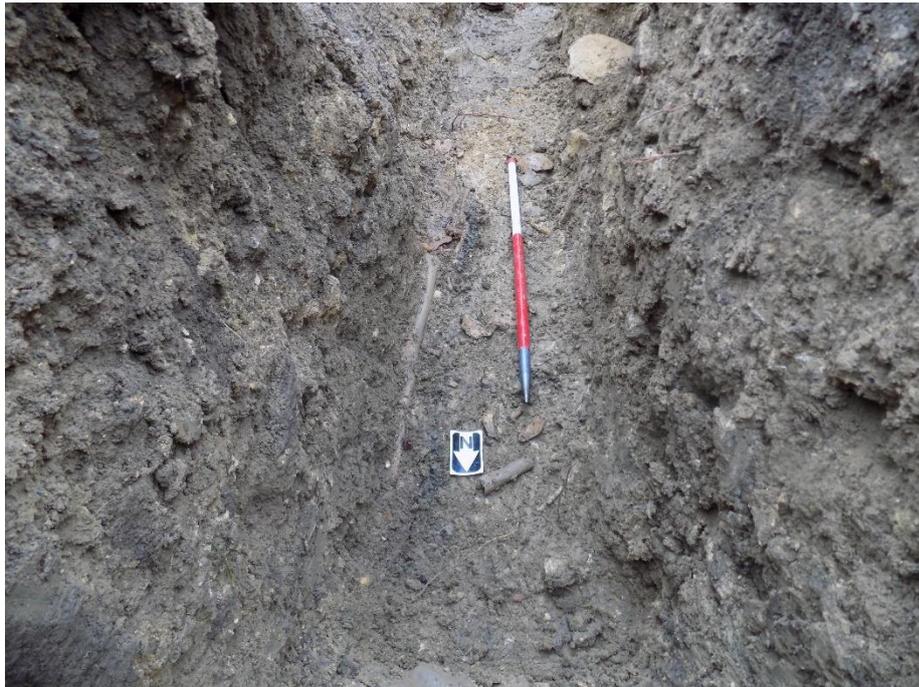
Burial 1, looking south, with the dark organic deposit and line of studs to the left of the scale and north arrow. Fig 7

Burial 1 (Fig 7) was an articulated skeleton lying supine of which the majority of the left side including the cranium and neck vertebrae were excavated from within the trench, the rest being beyond the limit of excavation. A line of studs and dark organic material lay to the immediate left of the skeleton indicating perhaps a coffin possibly covered in cloth secured by the studs. The cranium displayed slight damage from compaction, otherwise bone was in good condition.

Burial 1 was filled with [1013], (stratigraphically immediately below [1010]) a soft mid-grey silty clay with rare small pebbles and limestone fragments with diffuse rather than clear boundaries. This fill and those of all the burials are very similar since they are all in close proximity to each other. When overlapping, edges and clear cuts or boundaries between could not be ascertained. A sample was taken from this burial due to a concentration of metal studs which are discussed in Section 6 below.

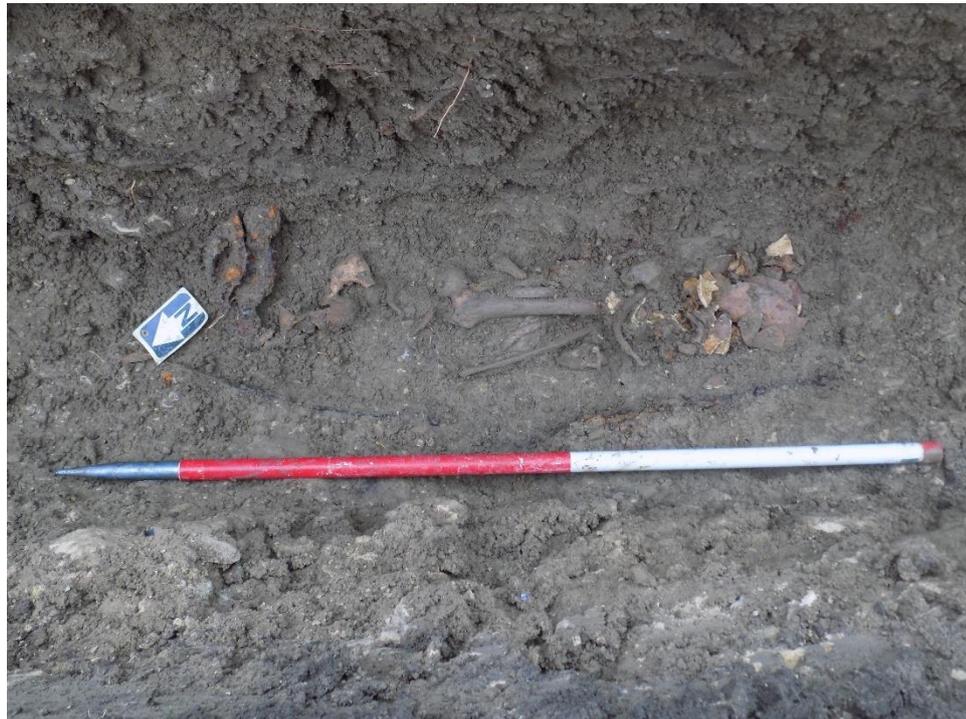
Burial 4, looking south-east, with the dark organic deposit and line of studs above the scale. Fig 8

Burial 4 (Fig 8) was located at the base of the trench, 0.75m below the ground surface. This individual, like Burial 1, was buried inside a wooden coffin potentially covered in cloth and secured with decorative nails or studs. The burial was articulated and supine although the bones appeared dis-articulated and broken, upon excavation. Curiously, many bones appeared to be absent from this burial.

Burial 4 was filled with [1014], (stratigraphically immediately below [1010] and possibly below [1002]) a soft mid-grey silty clay with rare small pebbles and limestone fragments with diffuse rather than clear boundaries, no clear grave cut could be seen. This fill and those of all the burials are very similar since they are all in close proximity to each other. When overlapping, edges and clear cuts or boundaries between could not be ascertained. A sample was taken from this burial due to a concentration of metal studs which are discussed in Section 6 below.

An iron buckle and coffin handles or fittings (SF14) were found on the left side of the inhumation. An iron nail (SF15) was located between the individuals' feet.

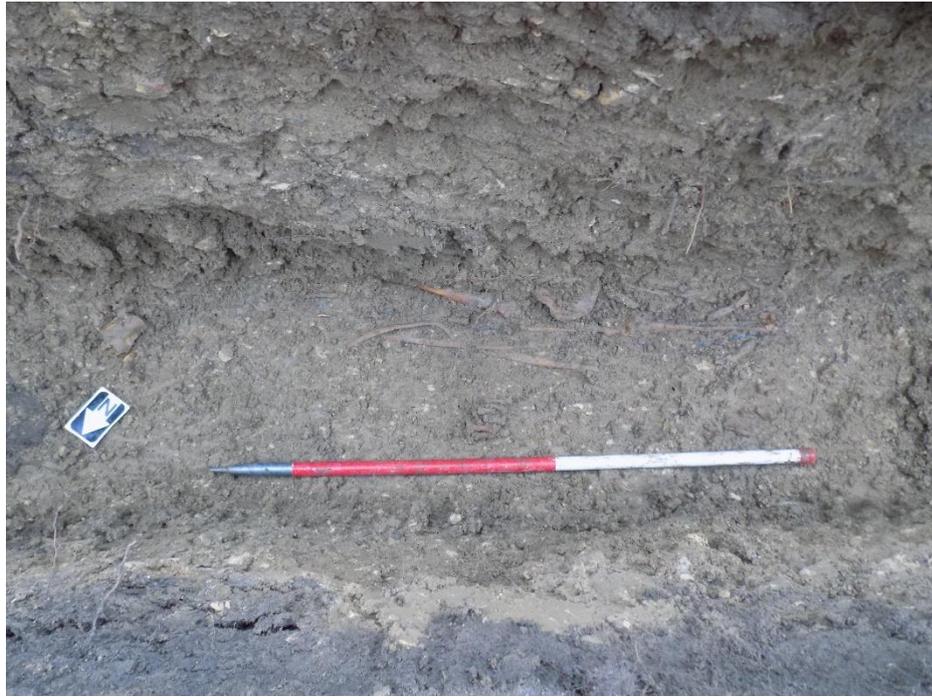
Burial 5, looking south-east. Fig 9

Burial 5 was an articulated skeleton of which the left half minus the cranium, maxilla and mandible (remained in situ beyond the limit of excavation) (Fig 9) was excavated. This individual was, like all of the excavated internments at St Margaret's churchyard laid south-west to north-east, supine but no evidence was found for a coffin. All bones were intact and in very good condition, possibly due to being protected by Burial 4 immediately above.

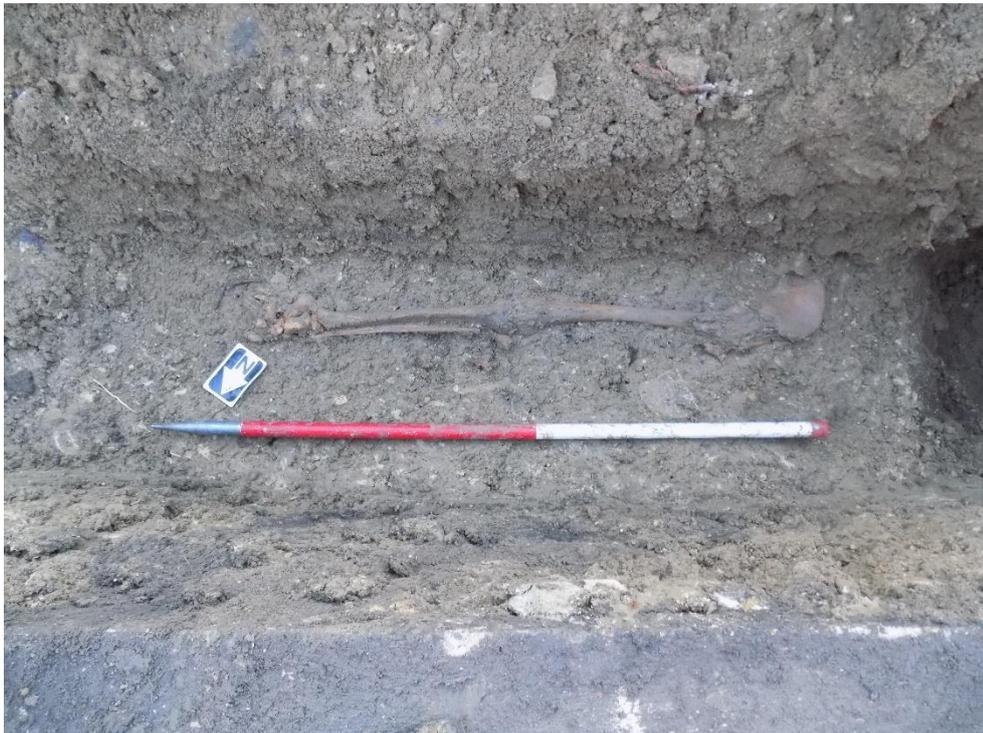
Burial 6, looking south-east. Fig 10

Burial 6 was an articulated skeleton of which, only the vertebrae from above pelvis to feet of the left hand side survived in good condition. The right side was evidently beyond the limit of excavation of the service trench (Fig 10). The head, torso and arms were missing. The individual was originally laid supine south-west to north-east however no indication of a coffin was found. Burial 6, 7 and 8 lay sequentially in the same location therefore it may be reasonable to assume these three burials were related to each other.

The fill of Burial 6 comprised of a soft mid grey silty clay [1021]. This had occasional small pebbles and limestone fragments with diffuse boundaries due to the close proximity of Burials 7 and 8. Potentially Burials 6, 7 and 8 all belong to the same family due to their stratigraphic sequence but absence of truncation.

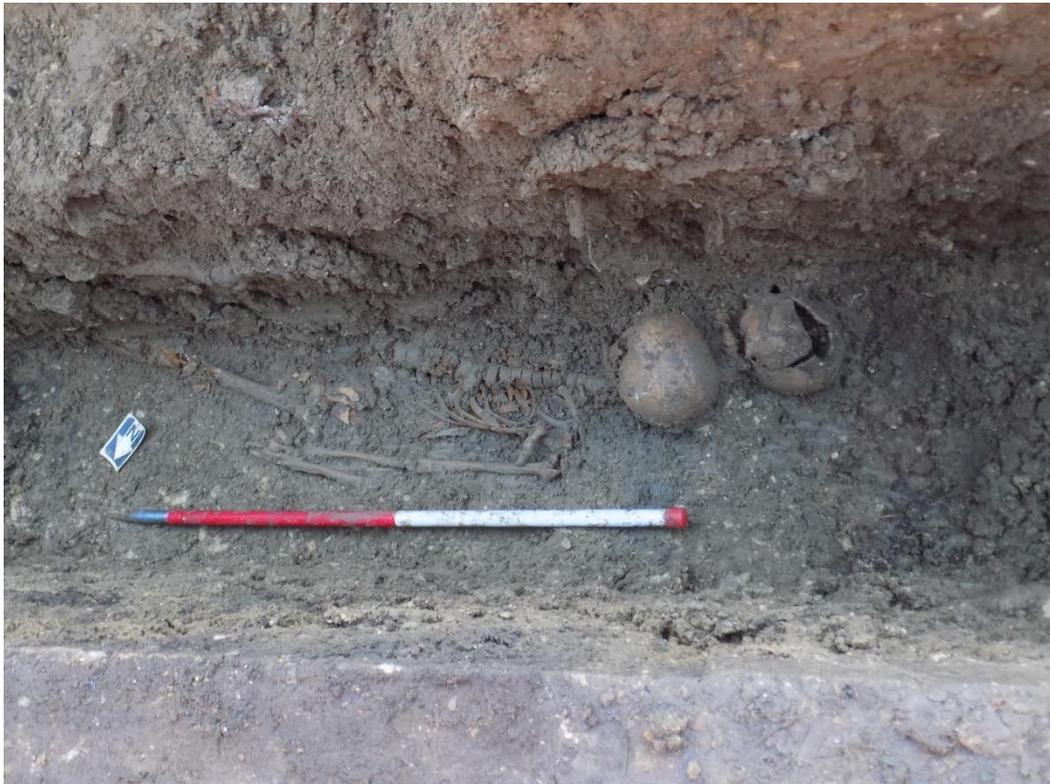
Burial 7, looking south-east. Fig 11

Burial 7 was an articulated skeleton laid supine south-west to north-east (Fig 11). Again, the left side was within the service trench excavation, on this occasion, including the cranium, maxilla and mandible. The pelvis was noticeably crushed and the individual was notable for an absence of teeth and no teeth sockets indicating an older individual. Burial 6, 7 and 8 lay sequentially in the same location therefore it may be reasonable to assume these three burials were related to each other.

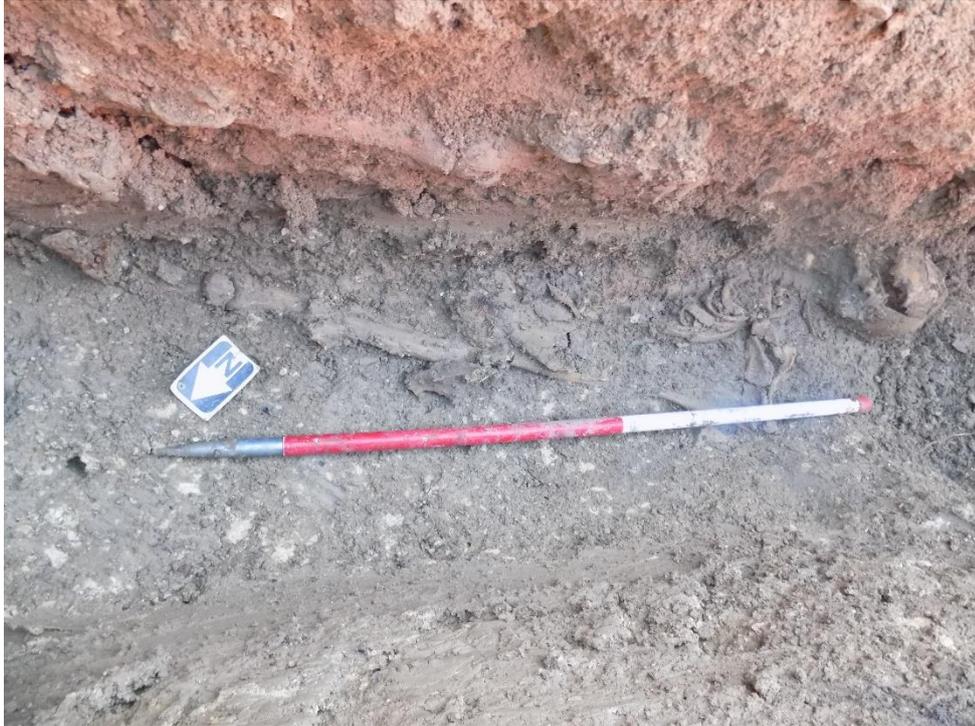
Burial 8, looking south-east. Fig 12

Approximately half of Burial 8 (Fig 12) lay beyond the limit of excavation. However, this articulated skeleton's left side survived intact and in good condition apart from the pelvis being crushed in situ, including the cranium, maxilla and mandible. No grave cut was visible, however the individual was laid supine orientated south-west to north-east. This was the primary inhumation interred in this plot with Burial 7 above and, Burial 6 above Burial 7. Burial 6, 7 and 8 lay sequentially in the same location therefore it may be reasonable to assume these three burials were related to each other.

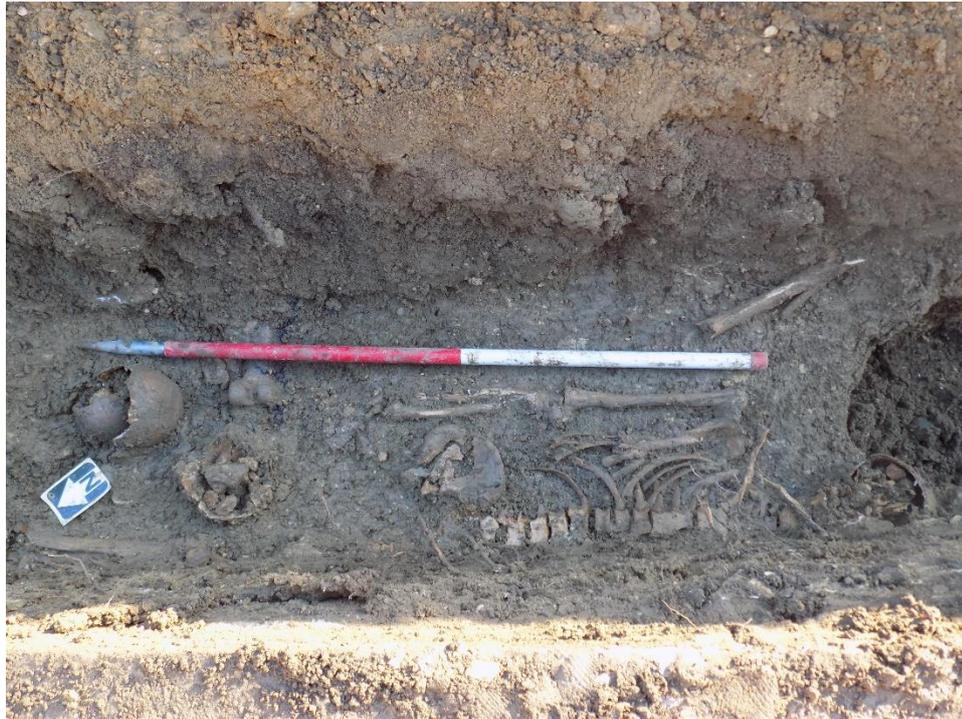
Burial 9, 10 and 11 looking south-east. Fig 13

Burial 9 (Fig 13) was an incomplete articulated skeleton lying north-east to south-west. No grave cut was visible, and the pelvis had been crushed and lay broken. The left side lay within the trench while the right side was beyond the limit of excavation. Burial 9 legs had been truncated by Burial 10 and the bones were absent.

Context [1015] is the fill of Burial 9 and comprised of soft mid grey silty clay with occasional pebbles and limestone fragments with diffuse boundaries due to being disturbed by Burial 10 and 11. A copper alloy shroud pin (SF1) was recovered from this fill on the north side of the maxilla. All of the burial backfill was remarkably similar.

Burial 11 (Fig 13), lay supine south-west to north-east and was an almost complete articulated skeleton although the right arm from shoulder lay beyond the limit of excavation. The grave cut [1032] was oval in plan shape, shallow with gently sloping concave sides. The grave cut into the natural geology (1024) comprising firm light yellow with white sandy clay and Limestone and chalk pieces. This was the only grave cut that was clearly visible, albeit at the base of the burial only around the feet, however the left big toe and the right foot below ankle were cut away or missing and had cut away the skull of Burial 13. Burial 11 has cut away the cranium of Burial 13.

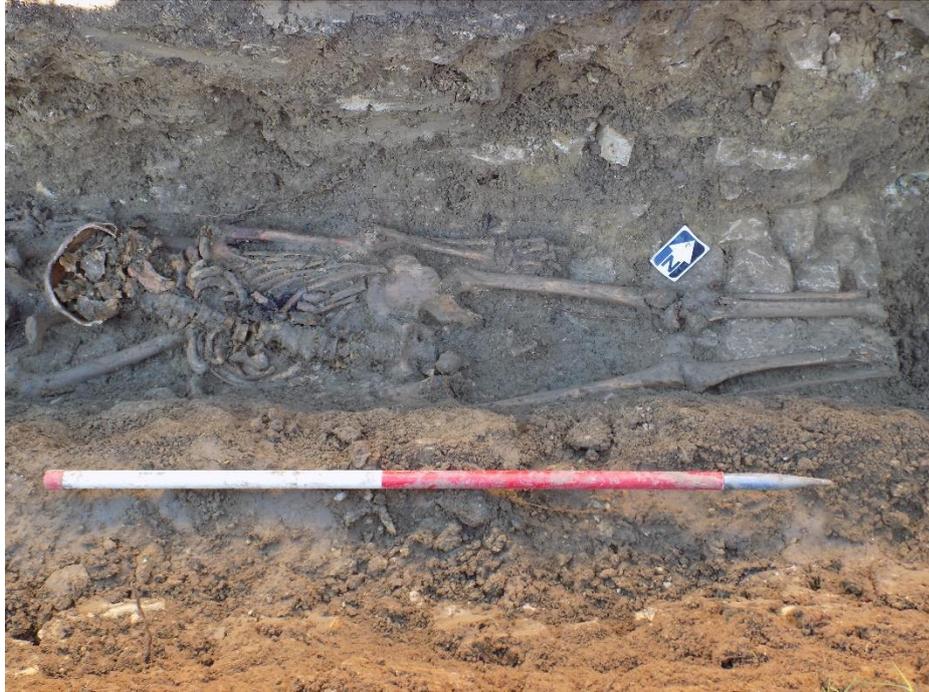
Burial 12 looking north-west. Fig 14

Burial 12 (Fig 14) was a nearly complete articulated skeleton laying supine, with cranium facing north, south-west to north-east. The only absent elements were the feet below the tarsal bones. The burials feet were probably truncated by pit [1020]. As the right arm is at the limit of the excavation no small finds of nails were located other than at the feet.

Context [1017] was the fill of Burial 12, comprising a soft mid grey silty clay with occasional small pebbles and limestone fragments with diffuse boundaries. This is similar to all of the burial fills encountered on this site. Burial 12 overlies Burial 13 with a similar fill and is cut by pit [1020] in the north-east. Five small finds (SF5, SF6, SF7, SF8 and SF9) comprising iron nails were found on the internments left side; at cranium, scapula, distal end of femur and tarsal bones of the ankle on both sides. The positions of the iron nails suggest the presence originally of a wooden coffin.

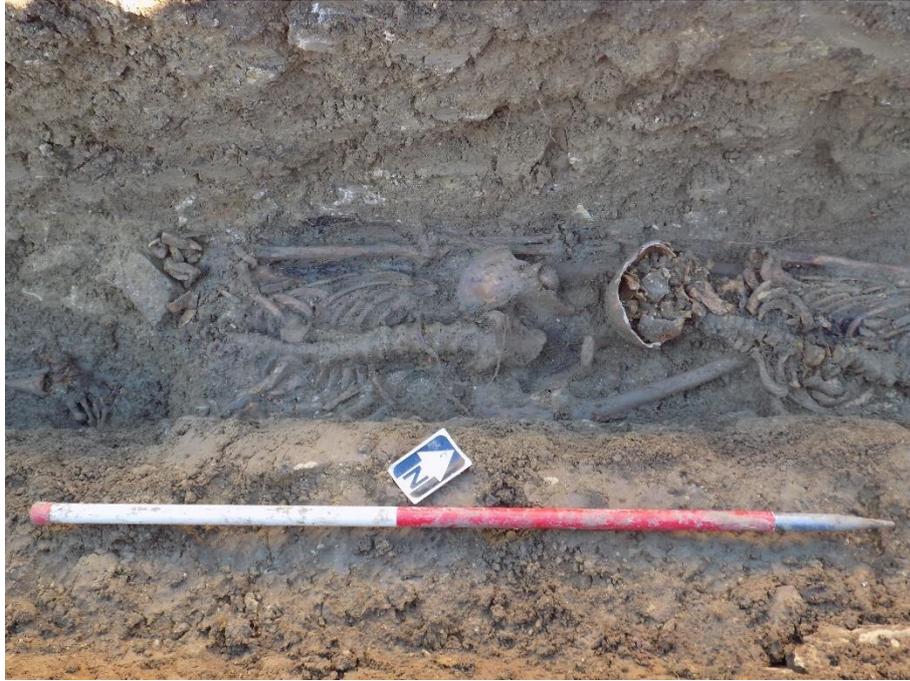
Burial 13 looking north-west, with Burial 12 on the right. Fig 15

Burial 13 (Fig 15) was an almost complete articulated skeleton with the exception of the cranium, maxilla and mandible elements. Burial 13 lay underneath Burial 12 stratigraphically and was also laid supine in a south-west to north-east direction. The cranium of Burial 12 lay on top of Burial 13 pelvis and Burial 13 cranium is absent, presumed truncated by Burial 11 which was buried at a greater depth. All remaining bones were in good condition and were still articulated in situ. Along the left arm, a dark organic line was visible, probably the last vestige of a wooden coffin, however so degraded that only a soil colour change survives.

The fill of Burial 13 was context [1018] comprising a soft mid grey silty clay with occasional small pebbles and limestone fragments with diffuse boundaries and noticeable root disturbance. This fill does appear to have been mixed with subsoil. Four small finds were encountered all comprising iron nails (SF10, SF11, SF12 and SF13).

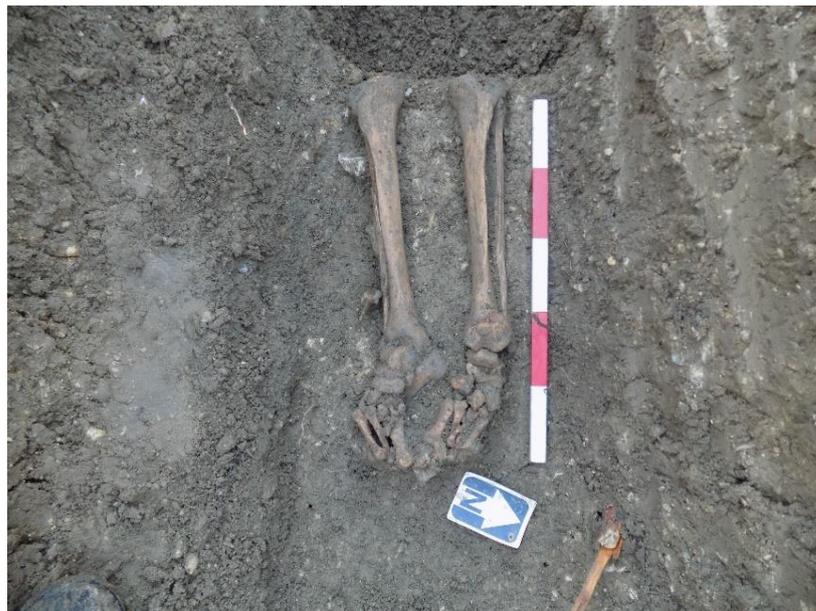
Burial 14 looking south-west. Fig 16

Burial 14 (Fig 16) consisted of articulated elements of only the Tibia, Fibula and below including all foot bones, aligned south-west to north-east and supine. The upper legs and above were presumably truncated by the pit [1020]. Surviving bones were in good condition, no finds interred with this burial were encountered.

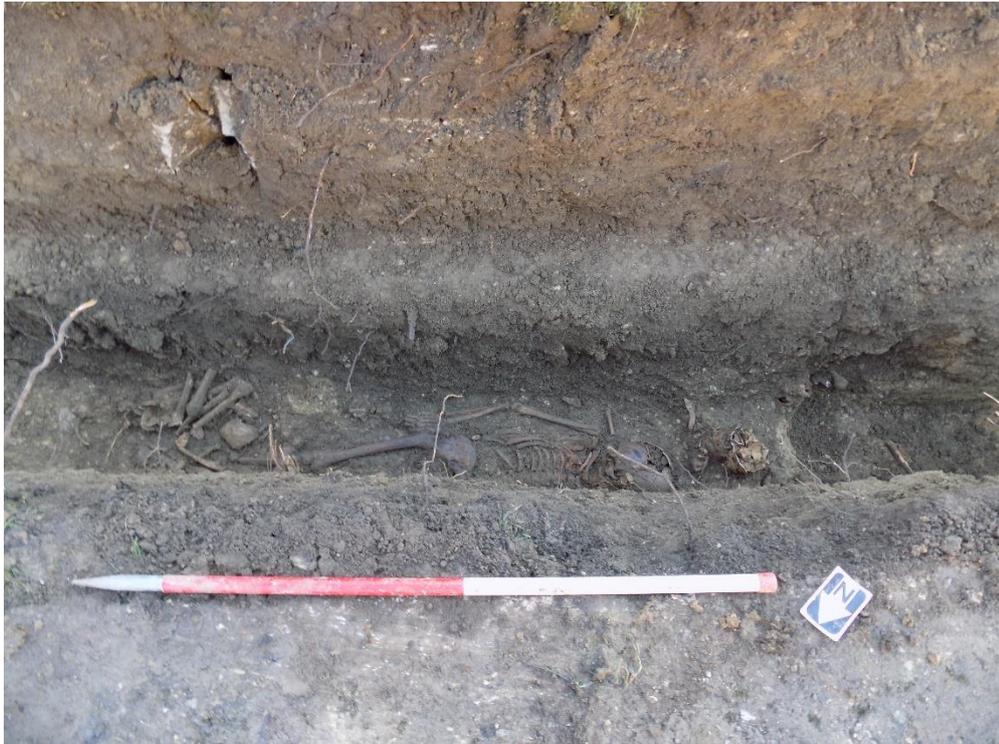
Burial 15 (right) and 16 (centre and left), looking south-east. Fig 17

Burial 15 (Fig 17) survived only as a supine, south-west to north-east, articulated cranium, maxilla, mandible, clavicle, scapula and neck vertebrae. Burial 15 had been truncated by the later Burial 16. Burial 15 probably overlay another burial which was not recorded as little was visible within the trench and the un-exposed burial lay beyond the depth of the trench.

Burial 16 (Fig 17) was an articulated skeleton with bones in good condition, laying supine orientated south-west to north-east and cut into Burial 15. The left arm from scapula lay beyond the limit of excavation, as did the left lower leg. The right leg has been truncated below the knee and a deposit of disarticulated human bones were laid in their place which included cranium fragments.

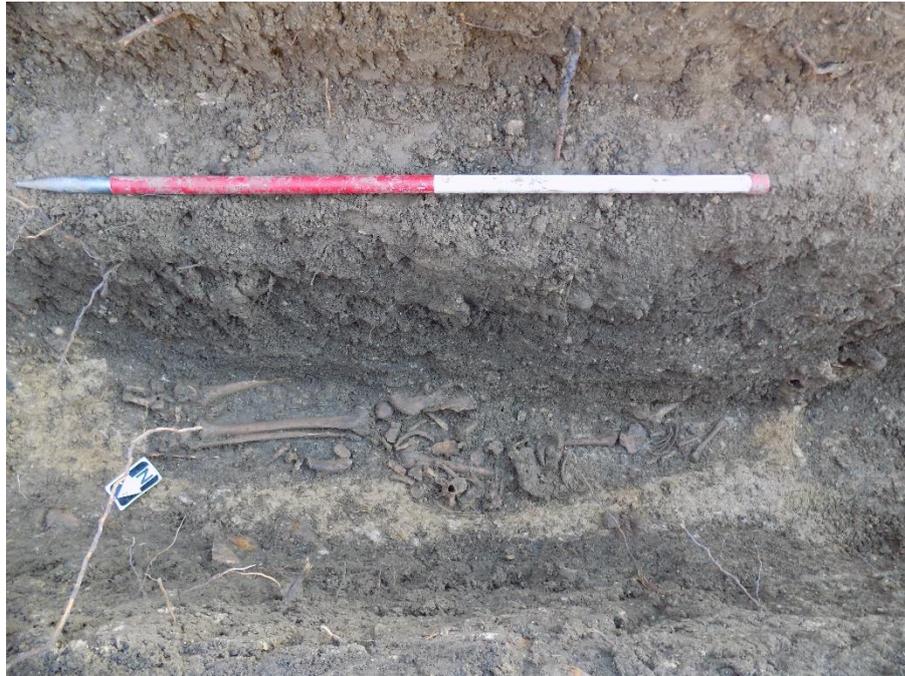
Burial 17 (right) and 18 (left), looking south-east. Fig 18

The fill (1033) of Burial 17 comprised soft mid grey silty clay with occasional small pebbles with limestone fragments and root disturbance with clear boundaries into the yellow natural geology (1024) after excavation becoming diffuse where it merged with fill (1035) of Burial 18. This fill was very similar to fill (1035) of Burial 18.

Burial 18 (Fig 18) was a non-articulated skeleton laying supine, south-west to north-east with bones in good condition, just not quite in the right place. The bones were disturbed although appeared to be in roughly the anatomically correct locations. Present were the mandible, some neck and lower vertebrae as well as left side ribs and some left arm bones and fingers. It is unclear if Burial 18 cuts or is cut by Burial 17 but both were overlain by Burial 16. The grave cut was only visible after bones had been fully exposed.

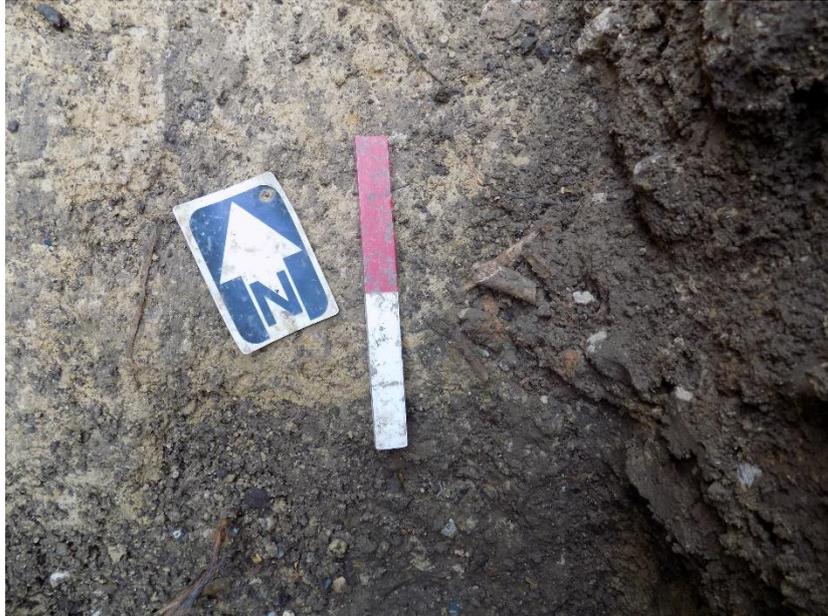
Burial 19, looking north-east. Fig 19

All that remained of Burial 19 (Fig 19) was an articulated left foot excavated from the side of the limit of excavation. It is probable that the remaining skeleton lies on the same alignment as all of the burials, south-west to north-east, immediately beyond the service trench, although the adjacent burial was disturbed with disarticulated bones from another burial.

The fill of Burial 19 [1027] comprised a soft mid grey silty clay with occasional small pebbles and limestone fragments with diffuse edges. The fill surrounds an excavated portion of this burial of which only the left foot bones remain within the excavated trench. In close proximity to the side of the excavated foot bones is an iron nail (SF19). No grave cut was visible.

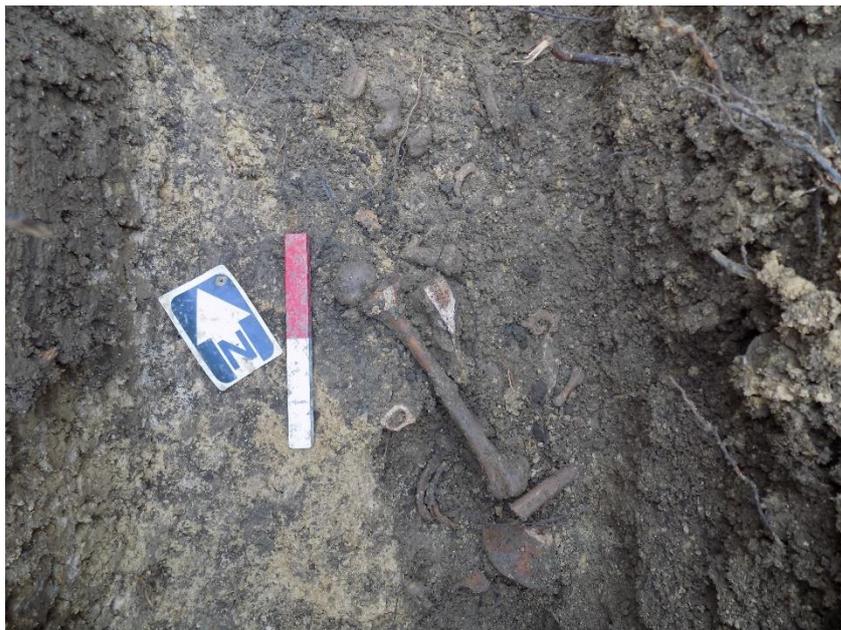
Burial 20, looking north-east. Fig 20

Burial 20 (Fig 20) was not articulated, aligned north to south and comprised a heavily disturbed group of human bones overlying Burial 23 and Burial 24. Not all bones were present from this deposit. Due to the disturbance the original alignment cannot be ascertained but is assumed to have been originally the same as all the other burials. No other finds were recovered. Potentially this represents an earlier internment disturbed by and re-interred following Burial 23 and 24.

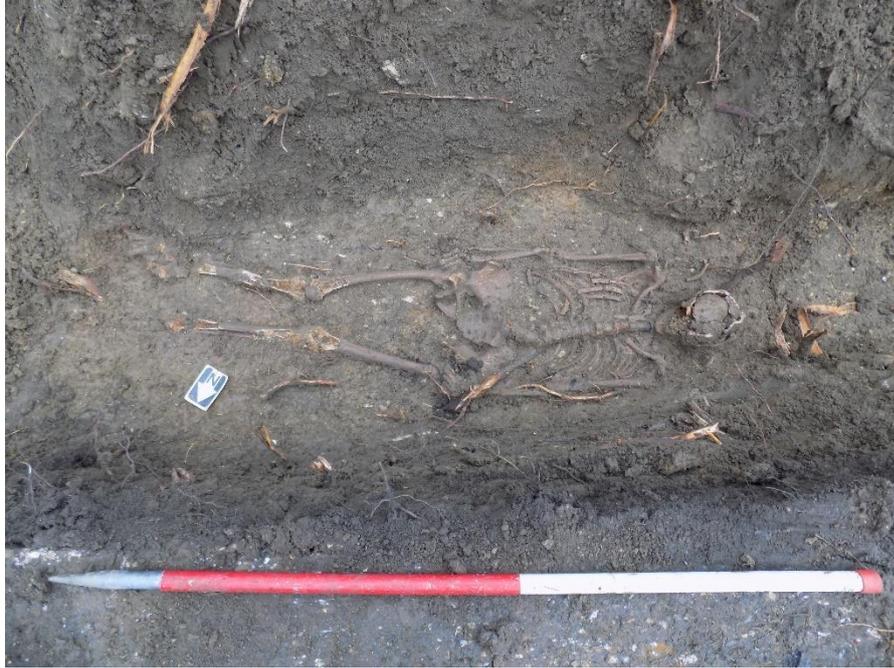
Burial 21, looking south-east. Fig 21

Burial 21 (Fig 21) was a supine articulated skeleton orientated south-west to north-east with some damage by machine excavation to the skull and legs at the knee. The left foot was missing and is assumed to have been pre-mortum. All other bones were otherwise present and in good condition.

The fill of Burial 21 [1028] comprised a soft mid grey silty clay with occasional small pebbles and limestone fragments with root disturbance and diffuse boundaries. This fill is similar to other burial fills on site. No visible grave cut present. Three iron nails (SF21, SF22 and SF23) were found by the legs of the internment, suggesting the presence of a coffin, and two copper alloy shroud pin fragments (SF20) was found next to the cranium on the right side. A fragment of metal wire was also found (SF24) in this burial.

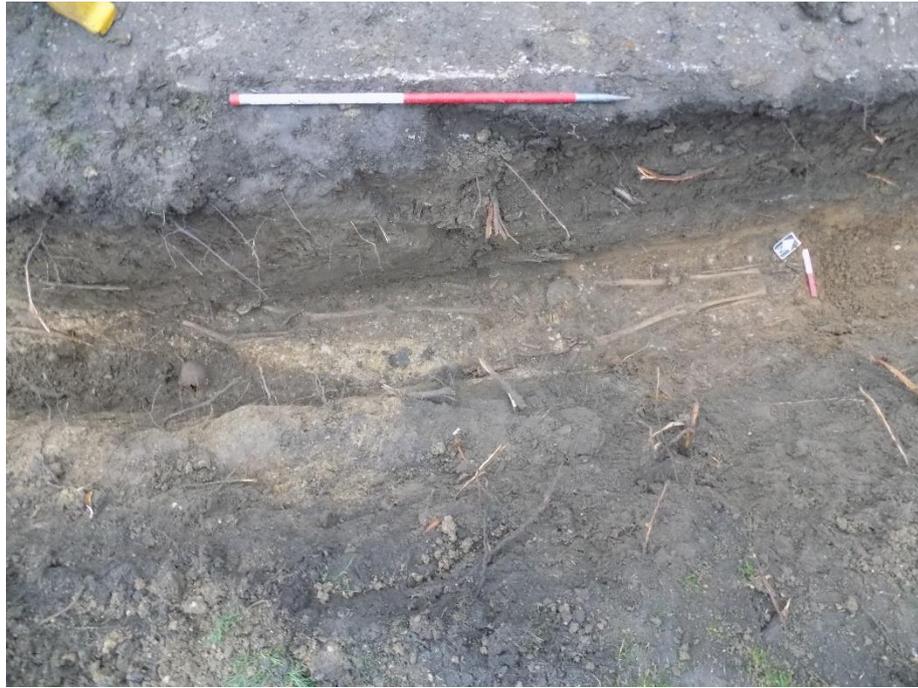
Burial 22 (right), Burial 23 (centre) and Burial 24 (left), looking north-west. Fig 22

Burial 22 (Fig 22) was a supine articulated skeleton orientated south-west to north-east. This burial had been truncated by another, later internment, Burial 23 to the south-east. The upper body from stomach area upwards has been truncated and is absent from the grave. Legs, forearms, hands, pelvis and some lower ribs are present. Bones are in good condition however the pelvis has been crushed.

Burial 23 (Fig 22) was an articulated supine internment orientated south-west to north-east with approximately half being within the service trench. Beyond the limit of excavation lay the skull, left arm and hand, majority of the vertebrae and rib cage and the left femur. The lower legs, right femur, right pelvis, right arm and some right-side ribs were excavated. Bones were in good condition. No grave cut was visible in plan or in section.

Burial 24 (Fig 22) was dis-articulated and had been heavily disturbed by both root disturbance and historic interference as parts of the body had been moved around and found in a miss-matched pile. This burial comprised both femurs, right pelvis, right arm, some right-side ribs and vertebrae from the centre of the spine only as well as the right collar bone and cranium with maxilla but missing mandible. Burial 24 was overlain by Burials 20 and 23. No grave cut was visible in plan or in section.

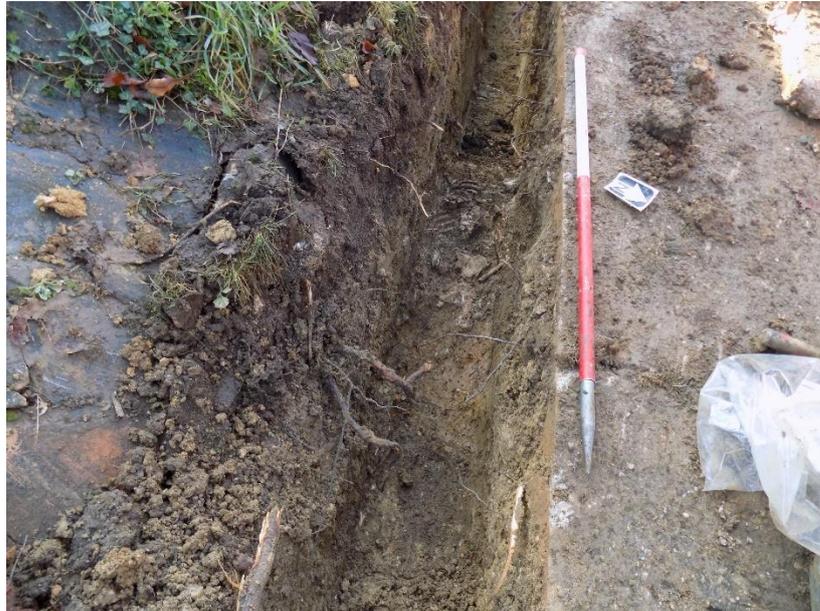
Burial 25, looking south-west. Fig 23

Burial 25 (Fig 23) comprised an incomplete yet articulated supine skeleton orientated north-east to south-west. The feet were left unexcavated as they were beyond the

limit of excavation as was the right femur below the ball joint. The skull and shoulder blades were missing although these bones may have been disturbed by root damage, due to close proximity to a large tree, however, this would not explain their complete absence. The pelvis, crushed, and the upper left femur were in situ and articulated to the pelvis. No grave cut was visible in plan or in section.
