**ORTON MEADOWS GOLF SHOP,  
HAM LANE,  
PETERBOROUGH,  
CAMBRIDGESHIRE**

***ARCHAEOLOGICAL MONITORING***

**APRIL 2015**

**PREPARED BY CHRISTER CARLSSON**

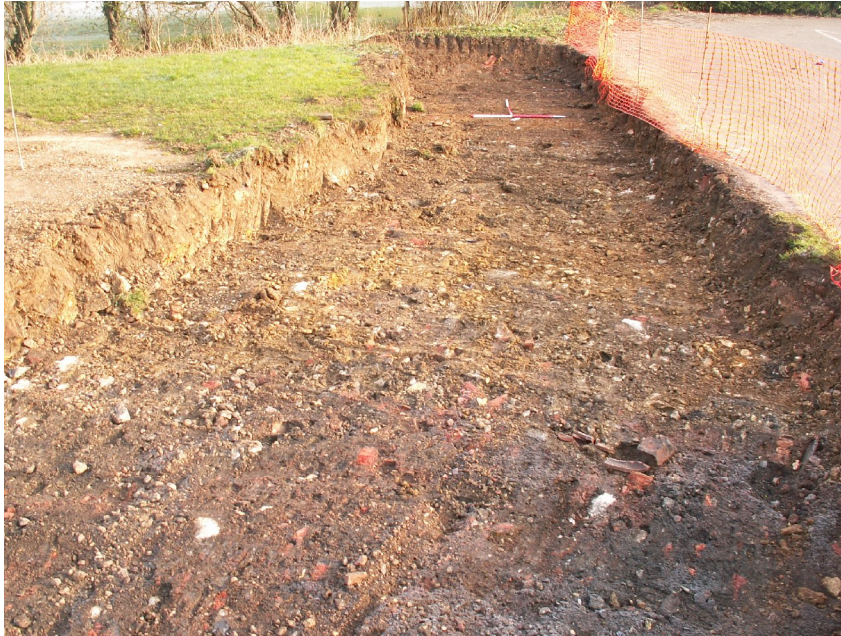
The development in Area 1 comprised the expansion of the existing car park towards northwest (Figure 4). The stratigraphy in this area was largely man-made and had a very modern character. The lowest deposit encountered was (102), consisting of yellow orange brick, mortar and small stones. This layer was a modern fill for the existing car park, but the bottom of the layer was not reached during the development. Therefore it was not possible to study any deeper stratigraphy within this area. Layer (102) was covered by (101), an up to 0.35m thick layer of dark brown, soft silty clay with occasional pieces of modern brick.

*Figure 4. Area 1 contained modern fills of brick and mortar (102) beneath the topsoil (101) in the expended car park.*

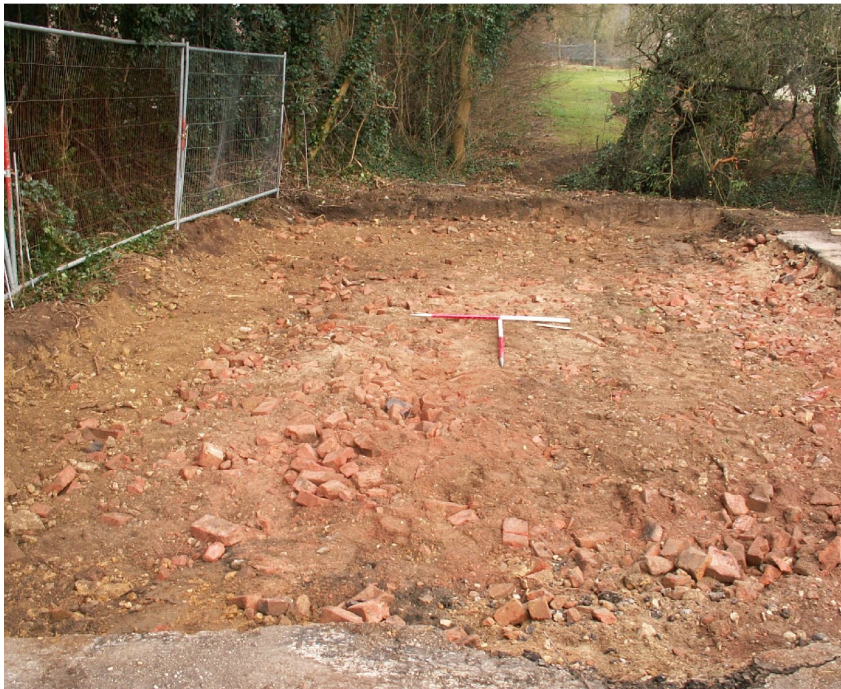
The development in Area 2 consisted of further expansion of the existing car park towards west (Figure 5). The lowest deposit encountered was (202) consisting of modern yellow orange brick, mortar and small stones. Layer (202) was a modern fill for the existing car park, but the bottom of this layer was not reached during the development. It was therefore not possible to study any deeper stratigraphy. Layer (202) was largely covered by (201), an up to 0.05m thick layer of black, solid Tarmac from the existing car park. It was only in the western end of Area 2 that Tarmac was not present.

*Figure 5. Area 2 contained modern fills of brick and mortar (202) beneath the expended car park.*

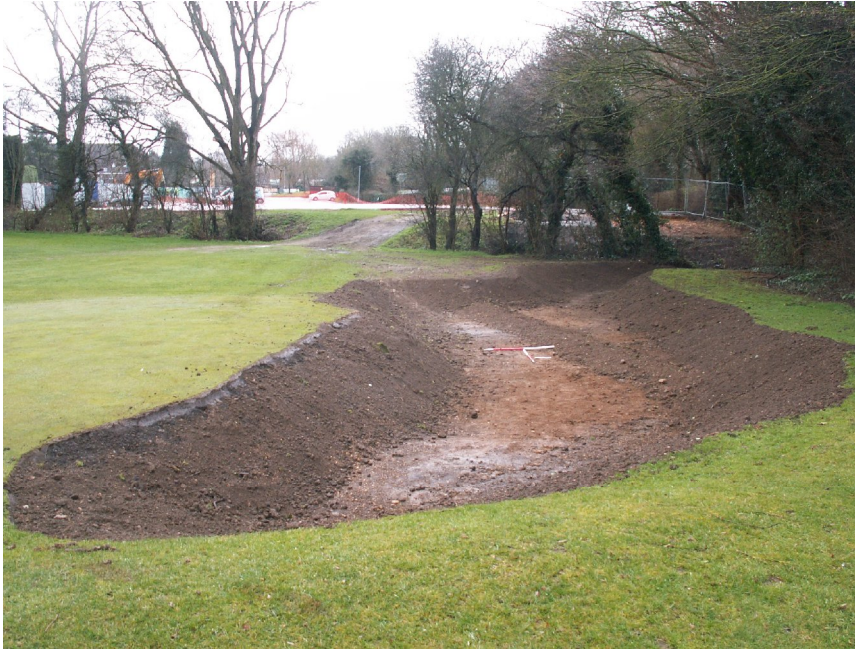
The development in Area 3 consisted entirely of a new Flood Storage area, which was opened up in the western part of the existing golf course (Figure 6). The stratigraphy in this area was simple and largely man-made. The lowest deposit encountered consisted of the natural ground of yellow sandy silt with occasional roots and small stones. Overlying the natural was (301), an up to 0.85m thick layer of dark brown, soft silty clay with occasional tree roots. This layer had entirely been brought into the site during landscaping works linked to the layout of the original golf course.

*Figure 6. Area 3 contained the new Flood Storage area in the existing golf course. A thick man-made layer of dark brown, silty clay (301) was covering the natural ground.*

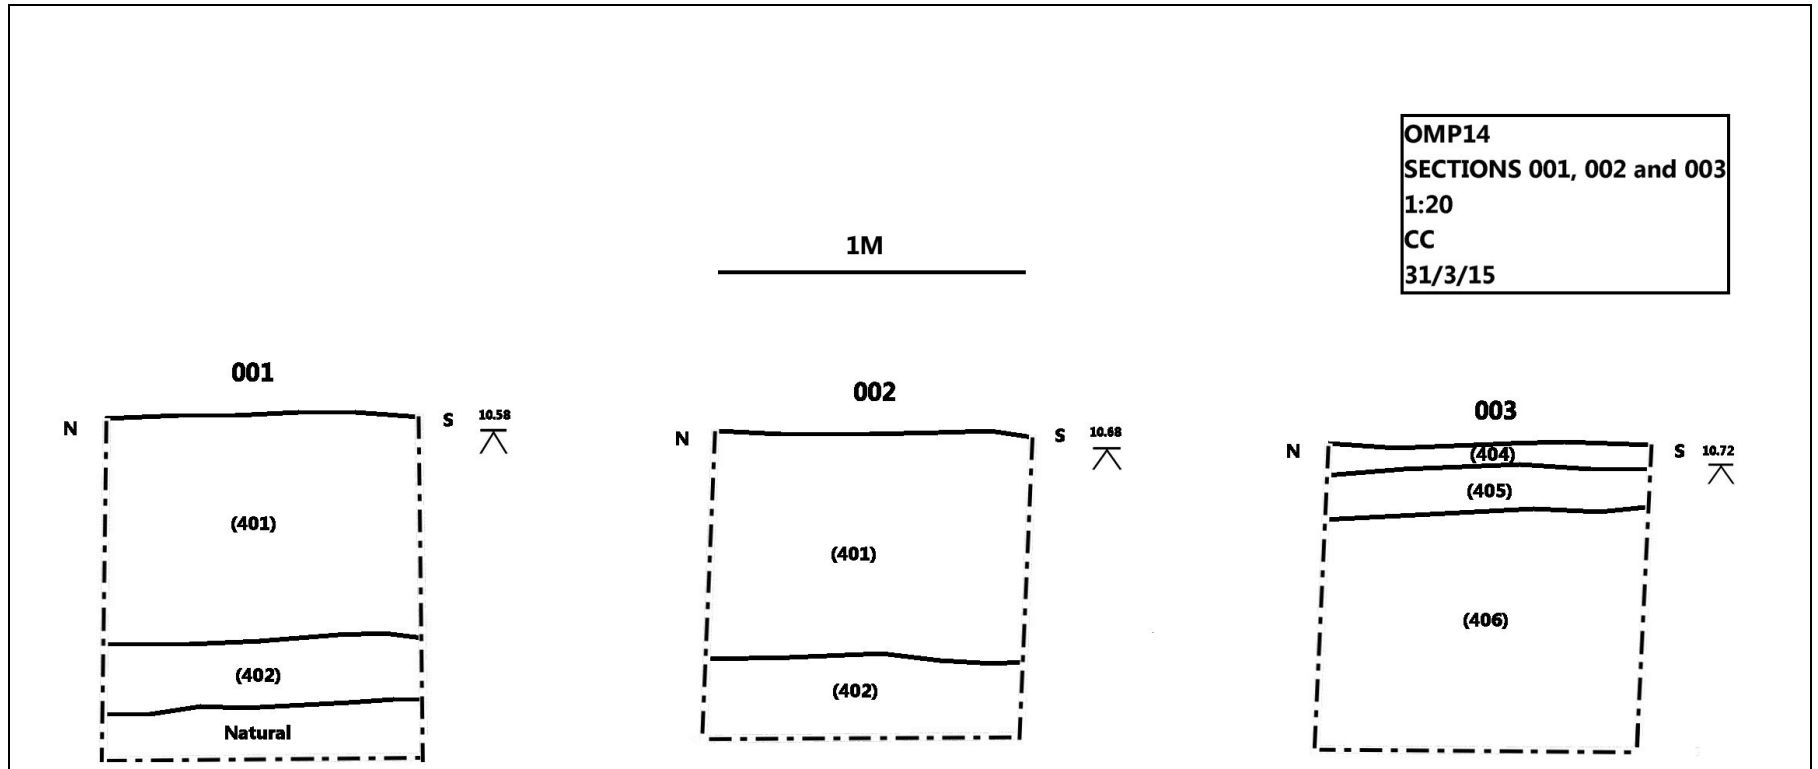
The first golf shop had been constructed on a thick bedding layer (401), which was entirely man-made and consisted of up to 0.75m thick yellow, packed gravel. This thick bedding layer was overlaying the original ground level (402), consisting of up to 0.21m thick dark brown, plastic silty clay, which had partly been polluted by oil. It is therefore likely that this surface had been exposed during the construction of the original golf shop. The lowest deposit encountered was the natural ground, which consisted of brown yellow sandy silt with occasional small stones.

The southern part of the new golf shop was stretching into the existing car park. The stratigraphy was therefore slightly different in this area, as the thick bedding layer of yellow gravel was missing completely. The uppermost deposit consisted instead of the up to 0.05m thick, black solid Tarmac (404). The Tarmac was resting on a, up to 0.15m thick, man-made plastic layer of orange yellow brick and mortar (405). This man-made fill for the existing car park was resting upon the original ground surface of dark brown, plastic silty clay, which had partly been polluted by oil (406). The natural ground was, however, not reached in the southern end of the new golf shop.
