10 CHURCH LANE, NEWTON BROMSWOLD, NORTHAMPTONSHIRE NGR REF: SP 99956 65905 ARCHAEOLOGY INPEPENPEN CONSULTANTS **ARCHAEOLOGICAL MONITORING** (OASIS ID: independ1-247074) **MARCH 2016** PREPARED BY CHRISTER CARLSSON

Summary

An archaeological monitoring was conducted by Independent Archaeology Consultants for the construction of a new garage, fencing and improved access drive at 10 Church Lane, Newton Bromswold, Northamptonshire. The development area contained a backfilled pond, with associated man made earth banks. The artificial bank contained Post Medieval pottery and the site, therefore, showed evidence of human activity from the 18th to the 20th century.

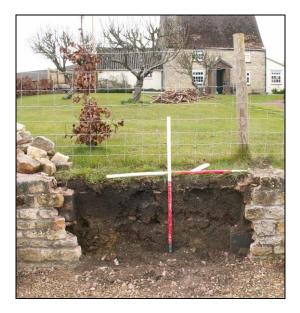
Figure 3. The deposits behind the modern retaining wall were about 0.60m thick, and were made up of modern garden soil.

- 6.1 The archaeological monitoring began with an investigation of the deposits behind the Modern retaining wall in the southern parts of the development area. This study showed that the new driveway would go on top of up to 0.60m thick deposits of Modern gardensoil. This soil had obviously been brought into the garden in order to reduce the slope towards Church Lane in the south.

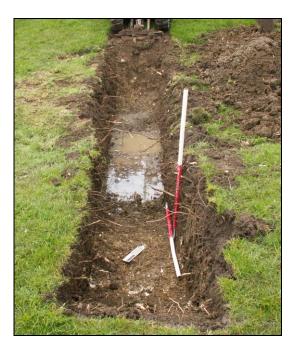
Figure 4. The test trench across the area for the new garage revealed a backfilled pond. The surrounding man made earth bank contained Red Earthenware sherds from the $18^{th}-20^{th}$ century.

- 6.2 The oldest deposit encountered during the fieldworks was the Natural ground. It consisted of yellow, hard clay with occasional limestones and roots. Cut into the Natural was the pond [103].

- 6.3 This pond was about 3.5m wide where it was visible in the N-S running testtrench, and the length can be estimated to about 7m from the surrounding earth bank. The pond had been backfilled and contained a very wet fill (102) of dark, soft clay with occasional limestones and roots. The bottom of the pond was not reached during the groundworks, as there was a risk this would cause instability in the new garage.

- 6.4 The surrounding earth bank (101) was up to 0.65m thick and were made of dark brown, soft silty clay with frequent roots from the surrounding trees. The

earth bank also contained a number of large stones and pieces of Red Earthenware.

7.1 The artefactual evidence from the site at 10 Church Lane in Newton Bromswold consisted to 100% of various pottery sherds. In the man made earth bank (101) five sherds of Red Earthenware (of which some showed traces of white glazing) were found. This pottery can entirely be dated to the 18th-20th century and indicates that the earth bank and the pond were constructed during the last two hundred years.
