**LAND AT VARITY HOUSE,
VICARAGE FARM ROAD,
FENGATE,
PETERBOROUGH,
CAMBRIDGESHIRE**

ARCHAEOLOGICAL EVALUATION

JULY 2017

PREPARED BY CHRISTER CARLSSON

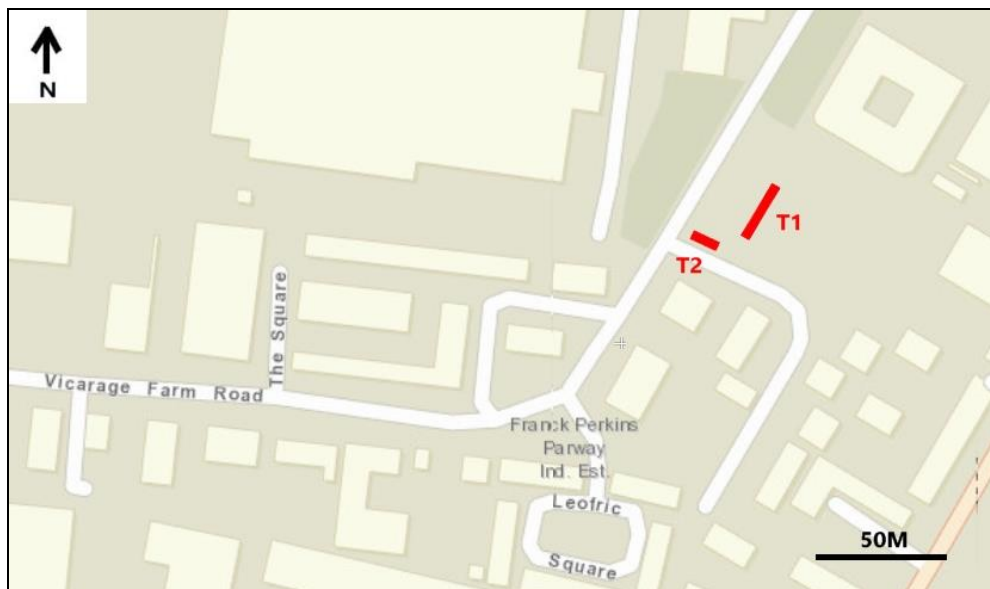
Figure 3. Site Outline and Trench Locations.

- 5.1.1 It was suggested that one 12m long machine cut trench, and one 22m long machine cut trench, both with a width of 2m, were going to be excavated under constant archaeological supervision using a flat bladed ditching bucket. Due to site constraints, however, both trenches were made slightly shorter. The shorter Trench 2 was eventually opened up over a distance of 10m while the longer Trench 1 was 20m long. The total length of trenching was therefore 30m, covering a total area of 60m² (Figure 3).

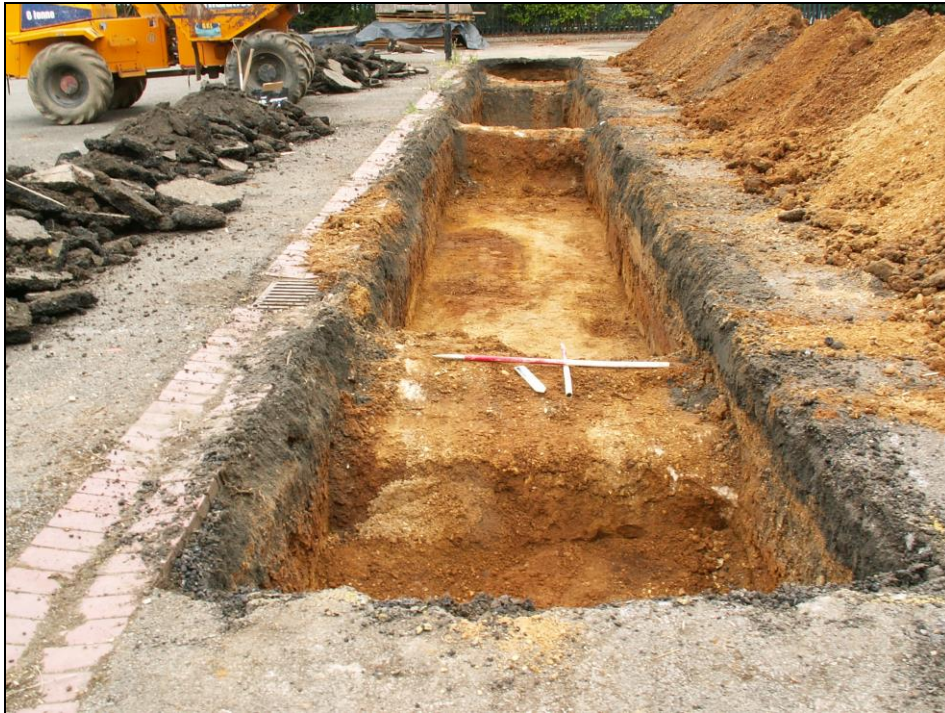
Figure 4. Trench 1. Overview. South west facing photo.

- 7.1 Trench 1 was 20m long, 2m wide and up to 1m deep. In an east-west direction across the trench there were three concrete tunnels with modern drainage pipes, causing the trench to be divided into three distinct parts (Figure 4).
- 7.2 The lowest level encountered in Trench 1 was the Natural deposits, which consisted of light yellow, soft sandy silt with occasional stones. Cut into the Natural deposits were two archaeological features; a kiln and a posthole.
- 7.3 The kiln [109] was located in the central parts of Trench 1, and had a north-south orientation. It was 3m long and up to 1m wide. It seemed to consist of two distinct parts; the actual kiln in the north and a possible stoke pit in the south. Even if the kiln could not be dated during this stage of fieldworks, as

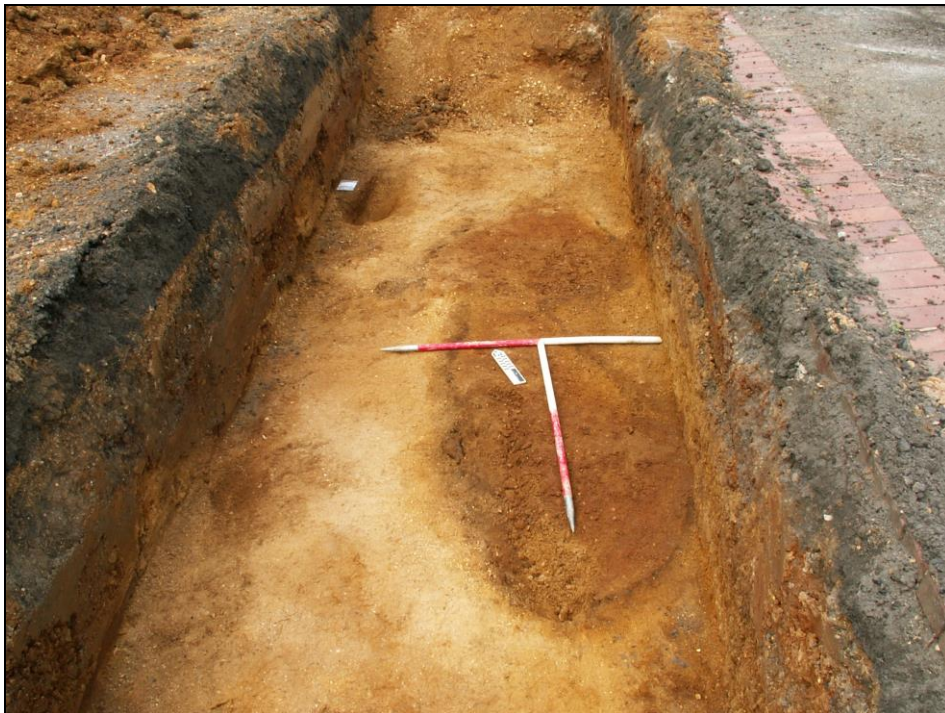
Figure 5. The kiln [109] in Trench 1 consisted of two distinct parts; a possible stoke pit in the south and the supposed kiln in the north. In the background can also be seen the posthole [106]. North east facing photo.

absolutely no finds were recovered from the feature, the shape and size of this kiln clearly resembles Roman and/or Medieval industrial kilns (Figure 5-6).

- 7.4 Both the kiln and the stoke pit appear to have the same fill on top, but the feature was not fully excavated during this step of fieldworks. The fill (107) consisted of light brown sandy silt. An environmental sample from this fill indicates that very little charred plant remains are present in the fill of the stoke pit. The kiln itself has, on the other hand, been left untouched, but was covered with geo-textile until a decision has been made whether further archaeological investigations will be needed in the area.

- 7.5 Surrounding the kiln was the lower part of the supposed kiln wall (108). It was clear that high temperatures have caused particles of sand and gravel to melt together in a fairly solid, blackish texture. Even though the whole stoke pit was not excavated during this stage of fieldworks a smaller section was dug through its southern end.

- 7.6 This section clearly showed that the surviving parts of the stoke pit had been dug into the Natural deposits, and that it had a rounded bottom and rounded sides that were up to 0.19m deep. However, since the central parts of the stoke pit were not reached it is possible that the stoke pit is actually slightly deeper in the centre.

- 9.4 The kiln at Varity House could not be dated more closely during this step of archaeological fieldworks, but it resembles Roman and/or Medieval industrial kilns. If this is indeed an old industrial kiln it will be of high archaeological significance, and should therefore be further investigated should it be threatened by the future development.

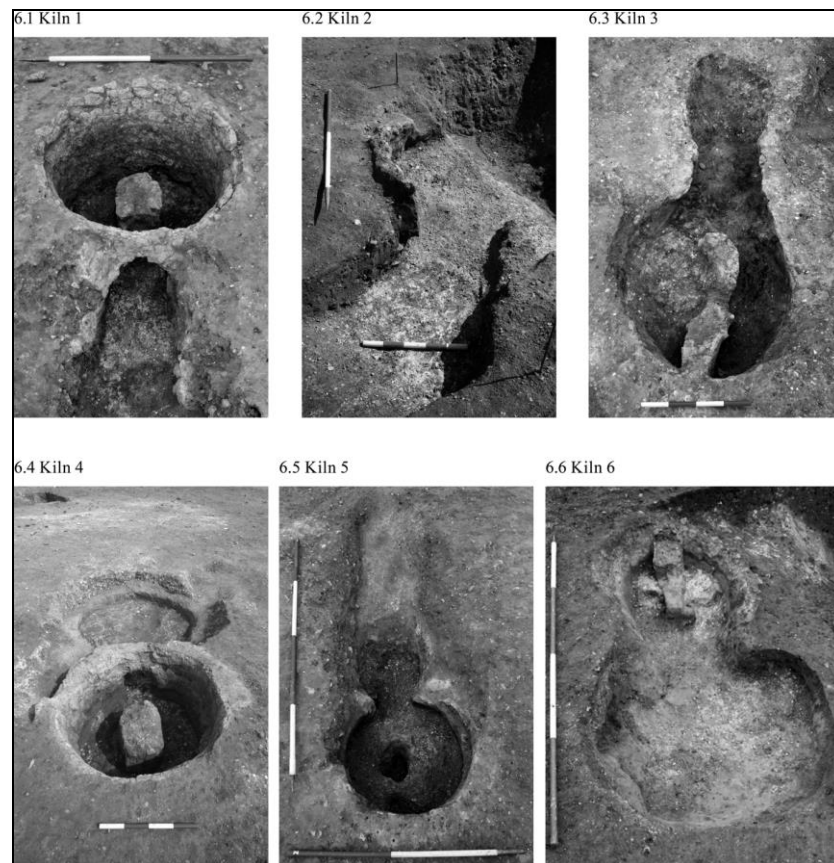
Figure 6. Photos from the article: Continental Potters? First-Century Roman Flagon Production at Duxford, Cambridgeshire. Cambridge University Press. Volume 47.

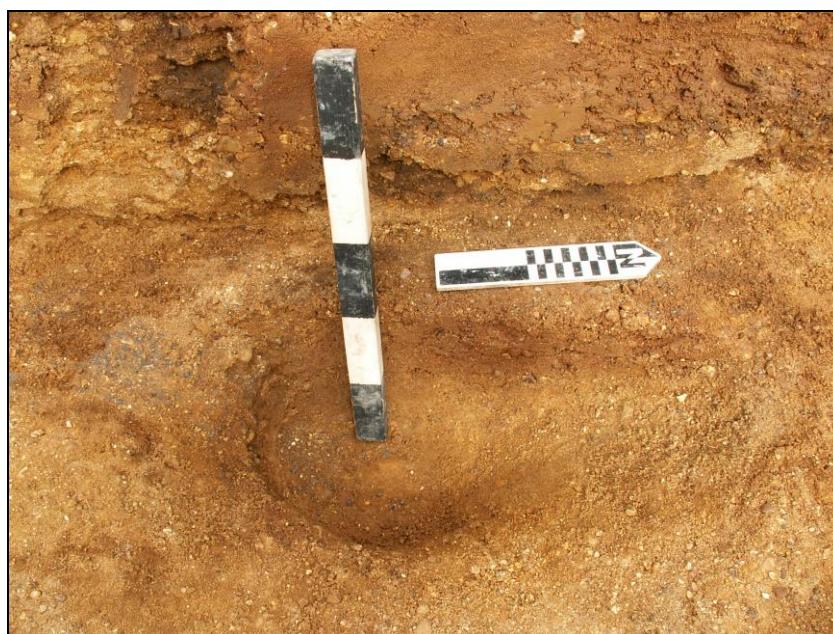
Figure 7. The posthole [106] was located ca 0.50m northeast of the supposed kiln. West facing photo.

- 7.7 Located about 0.50m northwest of the kiln was the supposed posthole [106] (Figure 7). The posthole was almost 0.50m wide, 0.20m deep and had a vertical side in the south, a more sloping side in the north, and a rounded bottom. It is presently unclear whether there is a connection between the kiln and this posthole. The posthole may belong to a structure associated with the kiln, but in order to fully understand the relationship between the two features larger areas needs to be opened up.

- 7.8 The posthole had a fill (105) consisting of light brown, soft sandy silt with inclusions of poorly preserved wood in the centre of the fill (Figure 7). The fact that wood was preserved may be an indication that the posthole is actually younger than the kiln, but the Fenland is well known for preserving old wooden structures.

- 9.2 The posthole contained poorly preserved wood, something which may indicate the posthole is fairly modern, but since the posthole and the kiln were both covered by thick silt deposits, and were showing up on a similar depth in the ground, they may very well be contemporary. The Fenland is famous for preserving old wooden structures due to the lack of oxygen in the ground.

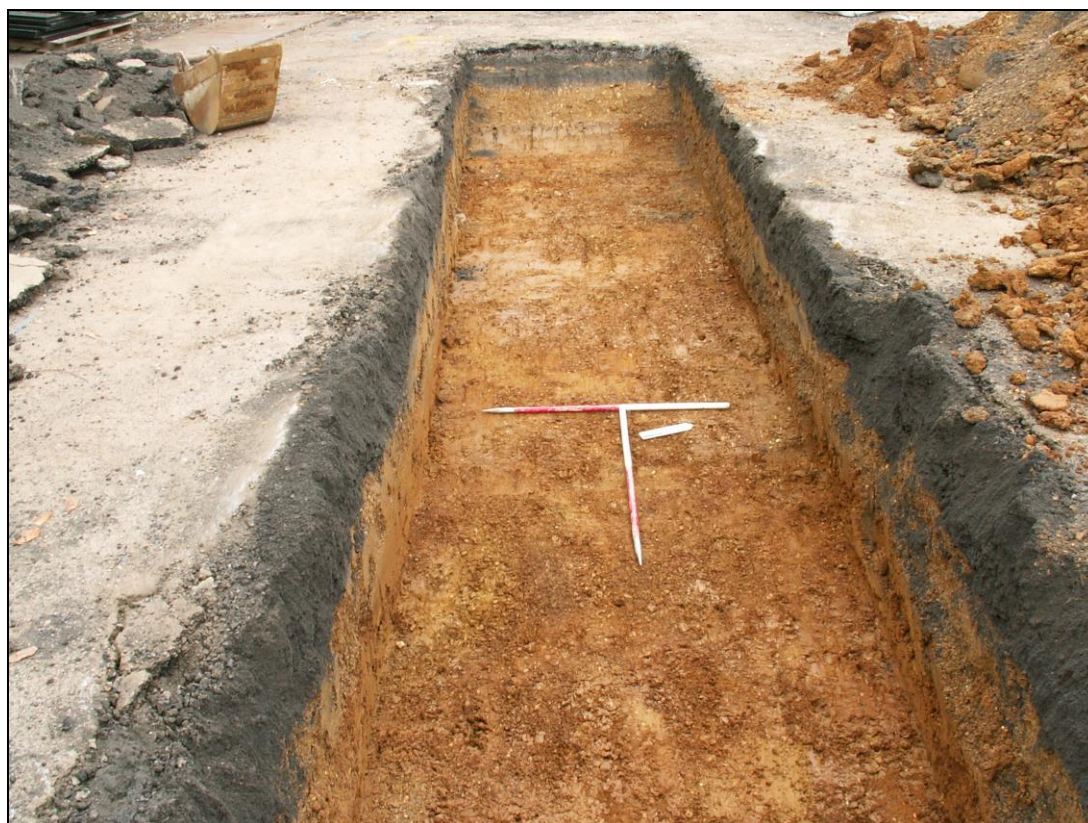
Figure 8. Trench 2. Overview. No archaeological features were being uncovered in the trench. North west facing photo.

- 7.11 Trench 2 was 10m long, 2m wide and up to 1m deep (Figure 8). The trench contained no archaeological features. The lowest level encountered was the Natural deposits, which consisted of light yellow, soft sandy silt with occasional stones.
- 7.12 Covering the Natural in Trench 2 was the 0.50m thick old ground horizon (204), which consisted of light brown, plastic sandy silt with frequent small stones.
- 7.13 The next level encountered in Trench 2 was the 0.20m thick modern fill (203), which consisted of yellow, softly packed gravel. This fill was in turn covered by the 0.20m thick fill (202) of grey, softly packed gravel. The uppermost fill in Trench 2 was the 0.10m thick, black, solid tarmac (101).
