**NEW LIDL STORE,  
1184 LINCOLN ROAD,  
PETERBOROUGH,  
CAMBRIDGESHIRE**

***ARCHAEOLOGICAL WATCHING BRIEF***  
**(OASIS ID: independ1-293498)**

**JULY 2017**

**PREPARED BY CHRISTER CARLSSON**

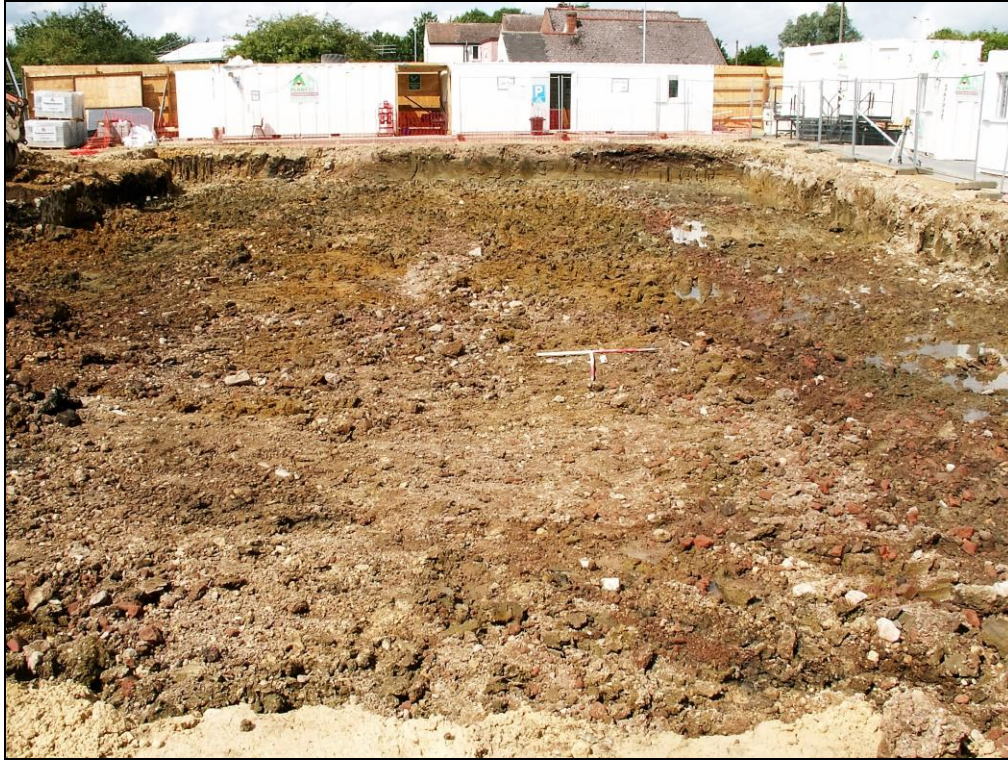
*Figure 4. Overview of the area facing north. The ground was showing clear signs of having been previously disturbed down to a depth of about 0.7m below the present ground level.*

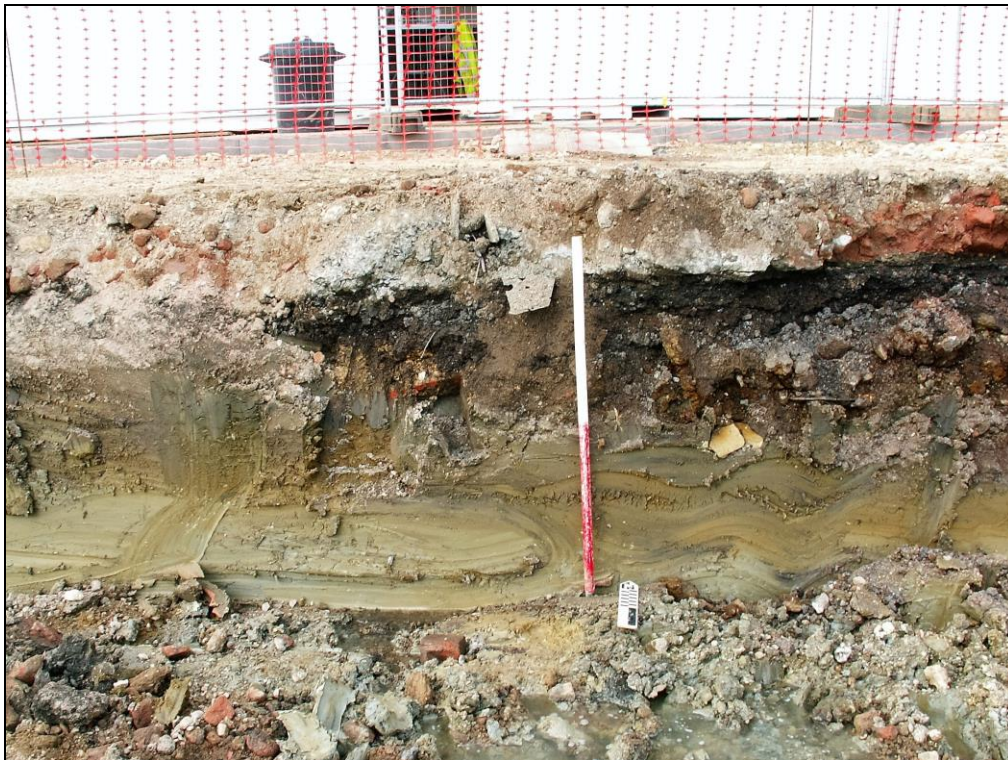
*Figure 5. A close-up photo of the northern section of the site. Modern bricks, concrete and other rubble can be seen on top of the natural clay.*

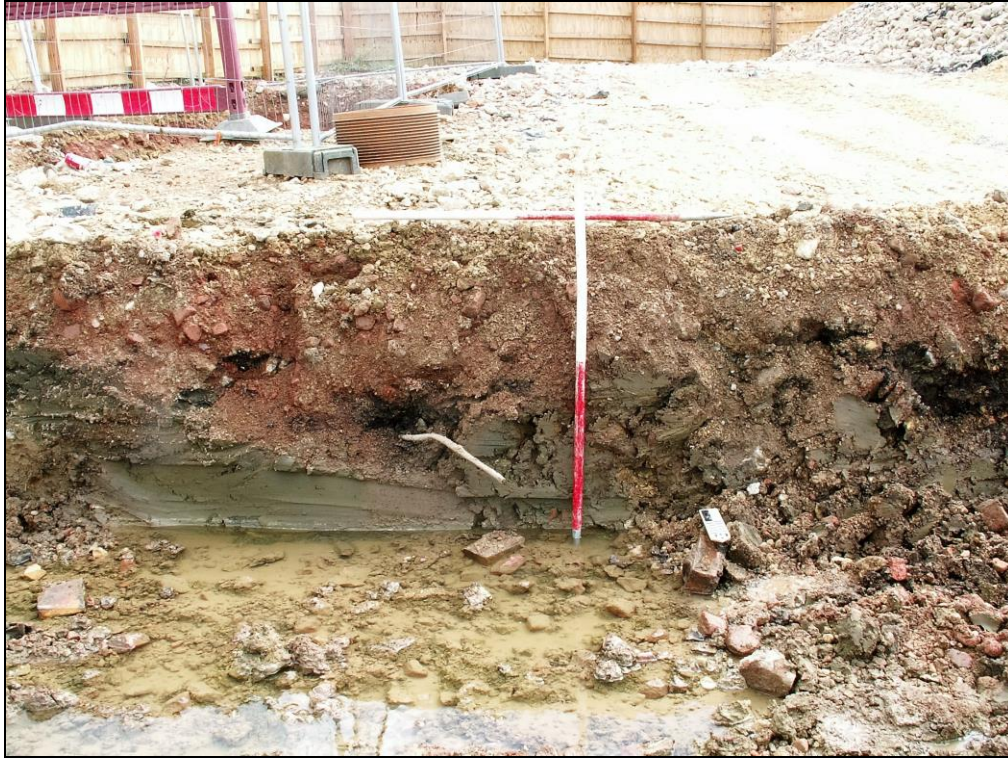
*Figure 6. The southern section of the site gave a similar impression as the north end of the site, with modern disturbance reaching deep down in the ground.*

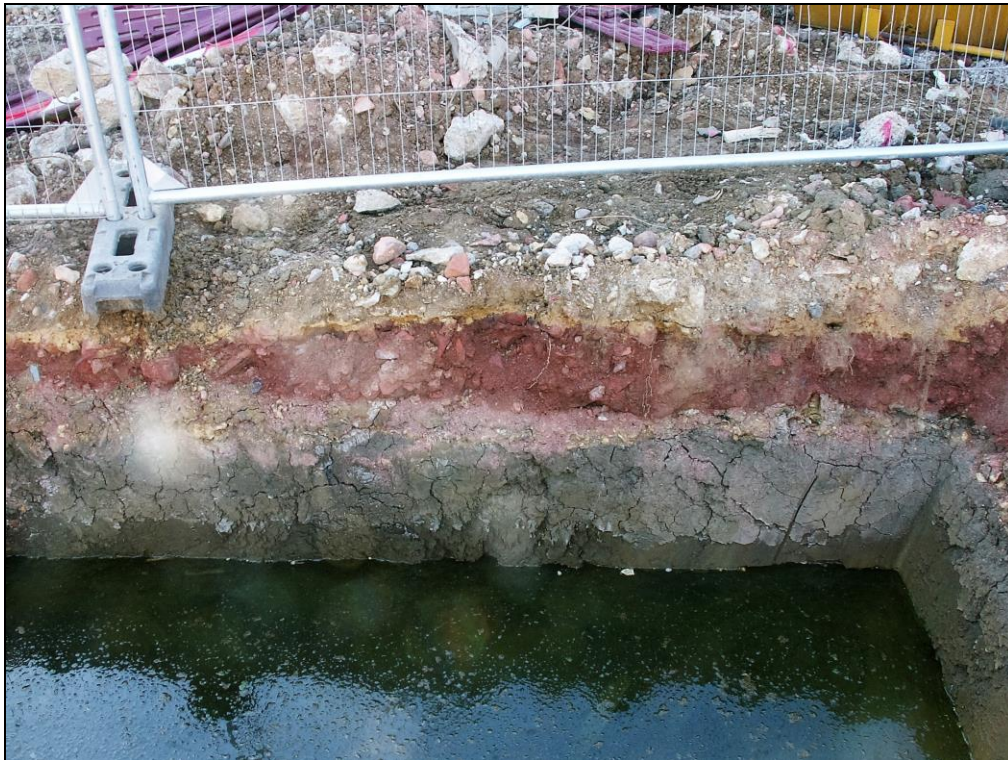
*Figure 7. In the hole for an old tank could be seen modern deposits sitting on top of a thin layer of preserved topsoil. No archaeological horizons could be identified in between the modern deposits and the topsoil.*

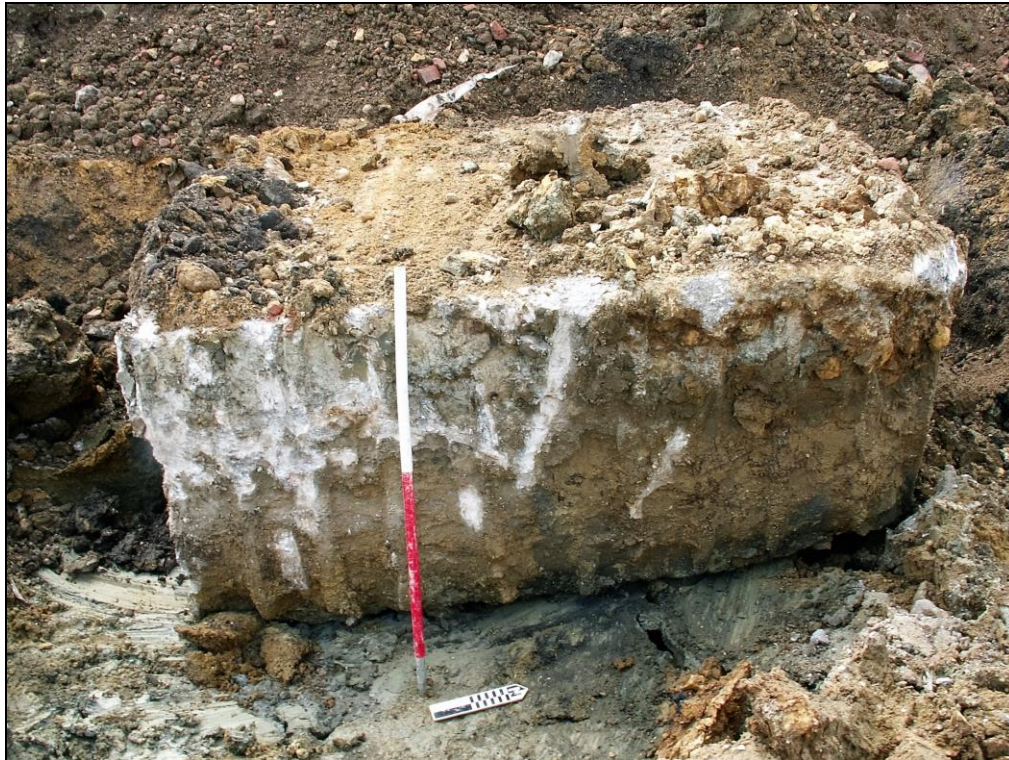
*Figure 8. Massive pieces of concrete from the demolished warehouse were sometimes reaching far into the natural deposits of the site.*

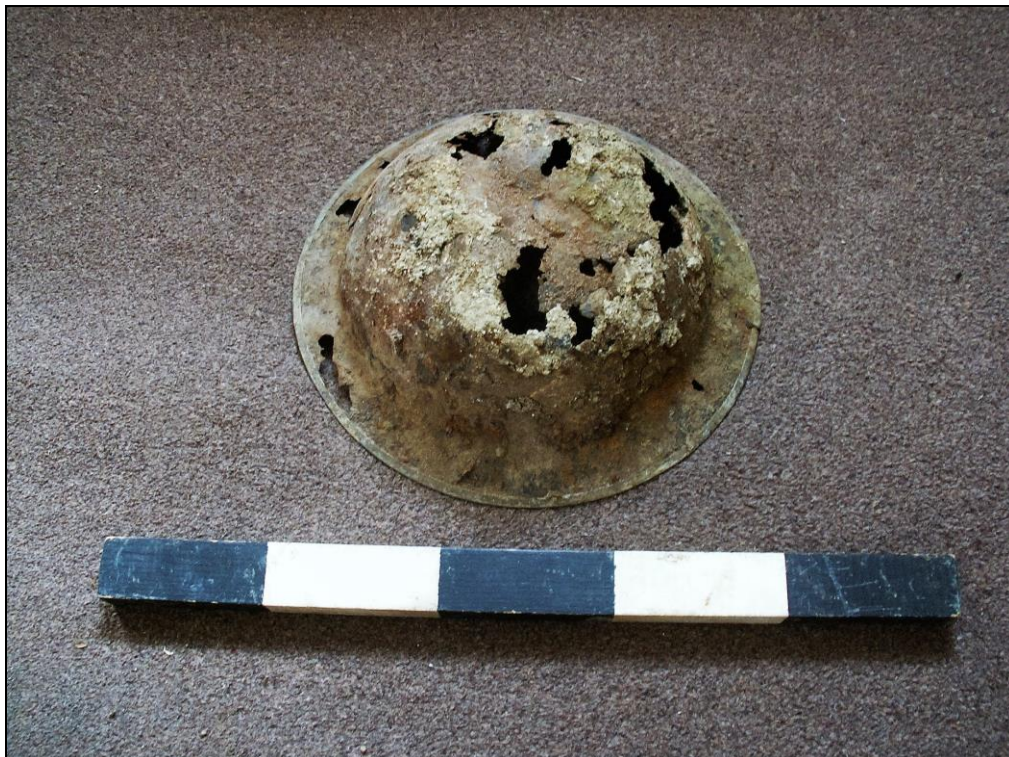
- 7.5 The uppermost deposit within the development area was a modern layer of mixed concrete, gravel, stones and bricks (101). This layer was clearly a modern fill created to support the demolished warehouse. A British military helmet from the Second World War was also collected from this layer. The helmet was a steel helmet of the model Mark II, a model that came into production in 1938.

*Figure 9. A poorly preserved British helmet from the Second World War was found in the context (101). It was a steel helmet of the model Mark II, which come into production from 1938 onwards.*

- 8.2 No artefacts of archaeological interest were for this reason uncovered during the investigation. A steel helmet from the Second World War was collected from the uppermost layer of the site, but might have ended up there with deposits that were brought into the site during the construction of the former warehouse.
