**MANOR FARM,  
Oundle Road,  
Chesterton,  
Cambridgeshire**

***ARCHAEOLOGICAL EVALUATION AND  
HISTORIC BUILDING RECORDING***

**SEPTEMBER 2018**

**PREPARED BY CHRISTER CARLSSON**

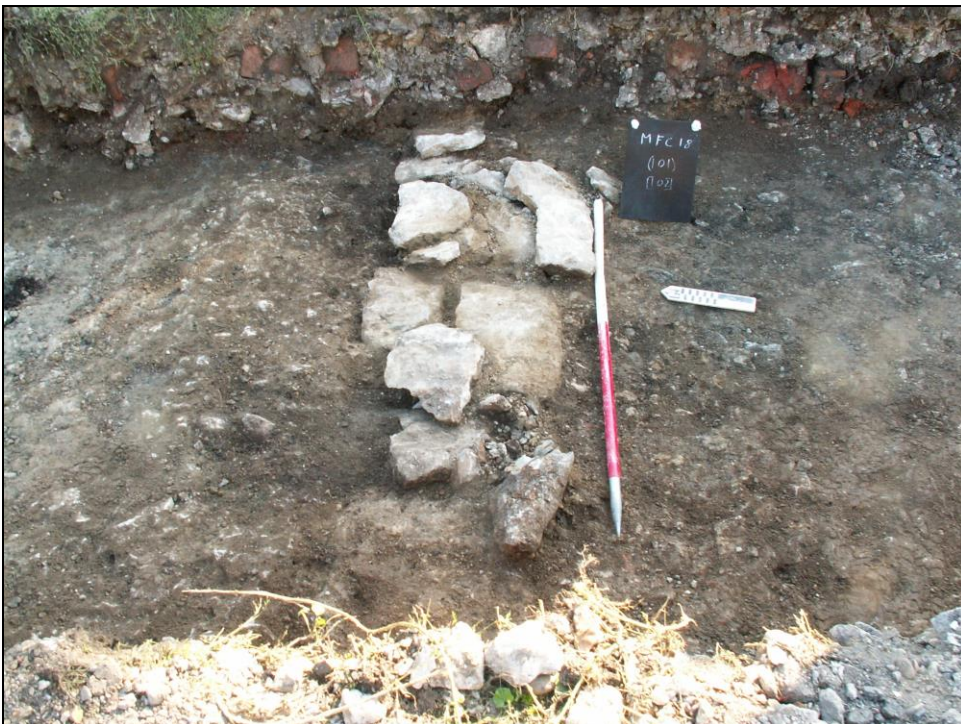
Figure 5. Stone wall foundation [102] in the southern part of Trench 1 was possibly from a former Post Medieval farm building within the area.

- 6.3 The wall foundation [102] was east-west orientated and was visible over the entire 2m wide trench. The wall was 0.52m wide and consisted of natural limestones in poorly preserved mortar (101). The wall foundation trench had been cut 0.20m into the ground from the bottom of Trench 1.

- 6.4 A single sherd of glazed redware from the period ca 1600-1800 AD was found beneath one of the foundation stones in wall (101) and can possibly date the structure to that period.

- 6.6 It is possible that the two parallel walls belonged to the same building, as the building material and the distance between the two walls of about 7m gives this structure a similar size as the two preserved historic barns that are still standing east and west of Trench 1.
