**LAND ADJACENT TO MOORLANDS FARM,  
119 HIGH STREET,  
ARLESEY,  
BEDFORDSHIRE**

***ARCHAEOLOGICAL EVALUATION***

**NOVEMBER 2018**

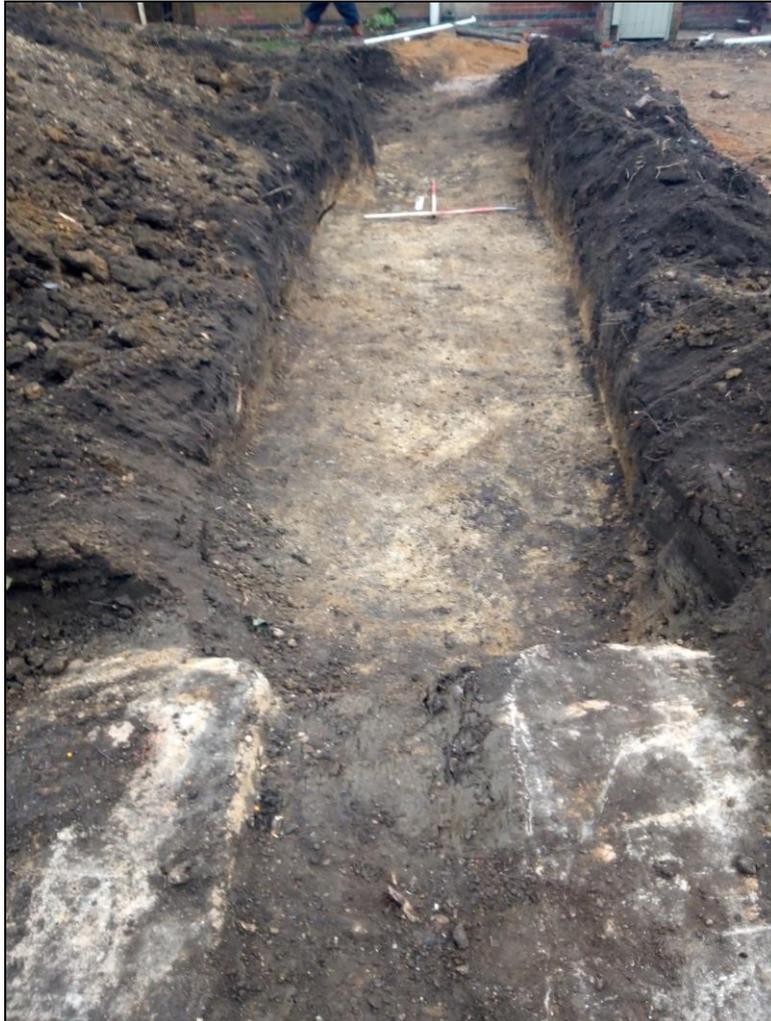
*Figure 4. Trench 1 from north. Overview photo.*

- 7.1 Trench 1 was north-south orientated, 11m long and 2m wide. It was excavated to a depth of about 0.60m below the present ground surface. The Natural deposits consisted of West Melbury Marly Chalk Formations. The trench had two modern concrete foundations (103) and (104), with a thickness of 0.48m

each, in its northern end, but contained otherwise no features of archaeological interest (Figure 4).

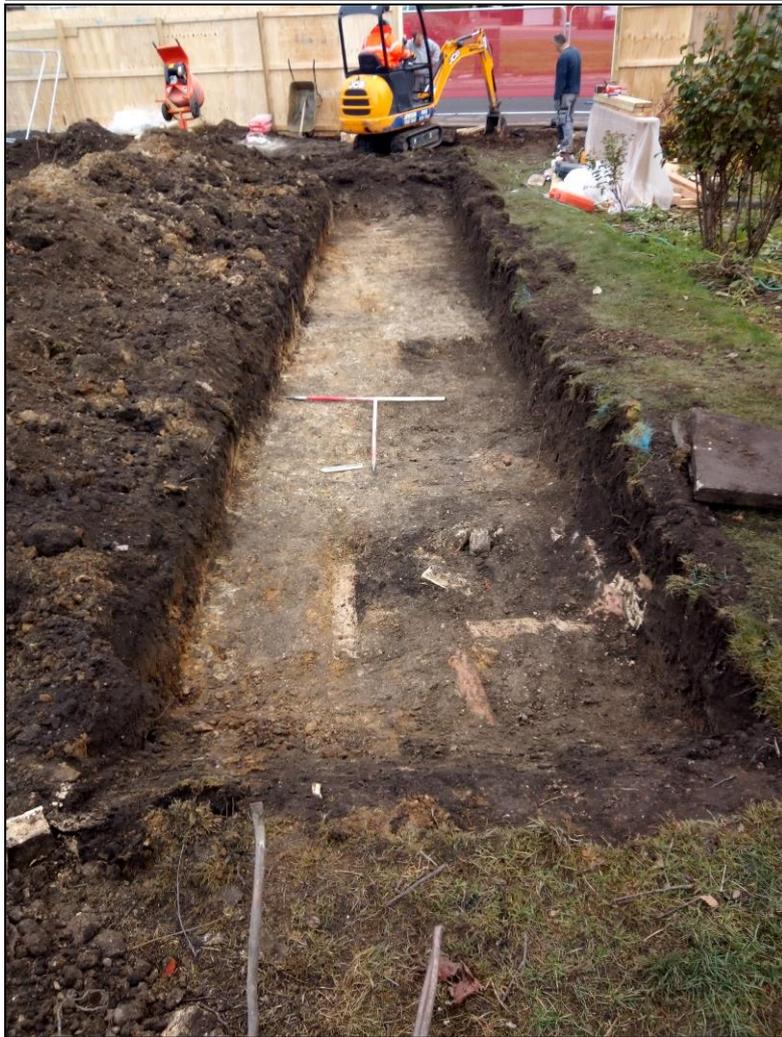
*Figure 5. Trench 2 from west. Overview photo.*

- 7.5 Trench 2 was east-west orientated, 11m long and 2m wide. It was excavated to a depth of about 0.70m below the present ground surface. The Natural deposits consisted of West Melbury Marly Chalk Formations. The trench had a modern concrete soakaway in its western part and a Post medieval drainage ditch was running along the south section of the trench before it disappeared into the section of the trench (Figure 5).

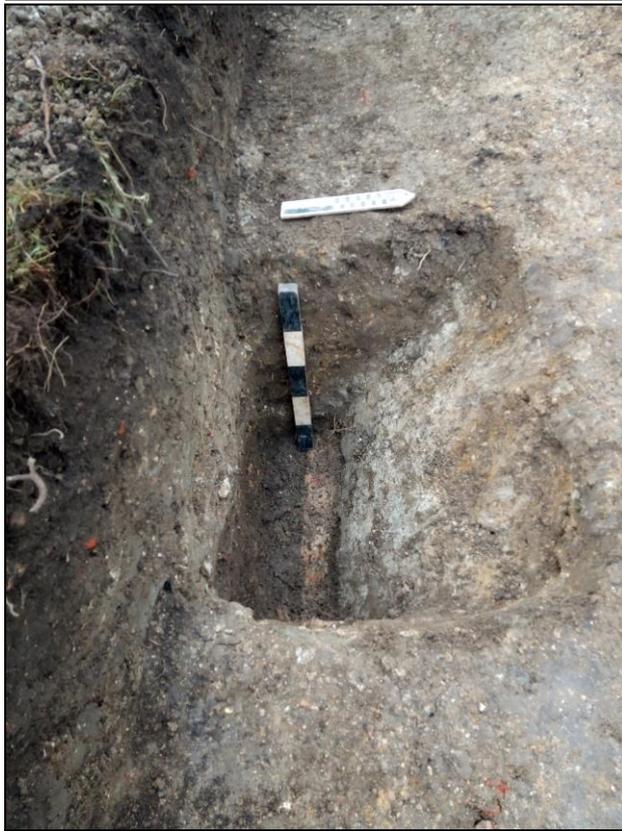
Figure 6. The section through ditch [203] in Trench 2.

- 7.6 The drainage ditch [203] had a V-shaped cut and was up to 0.55m deep. At the bottom it had occasional Victorian bricks that had probably been deliberately placed in the ditch for drainage purposes. These bricks dated the ditch to the Victoria period as the earliest. The ditch's single fill (204) consisted of light grey, plastic silty clay with occasional inclusions of crushed bricks and mortar. The ditch was visible over a distance of 6.2m before it disappeared into the south section of Trench 2. For this reason the full width of the ditch was not seen. The excavated slot through the ditch was 0.75m long and 0.70m wide (Figure 6).
