**WHITELAND BARN,  
SULEHAY ROAD,  
YARWELL,  
NORTHAMPTONSHIRE**

***HISTORIC BUILDING RECORDING LEVEL 2***

**JUNE 2020**

**PREPARED BY CHRISTER CARLSSON**

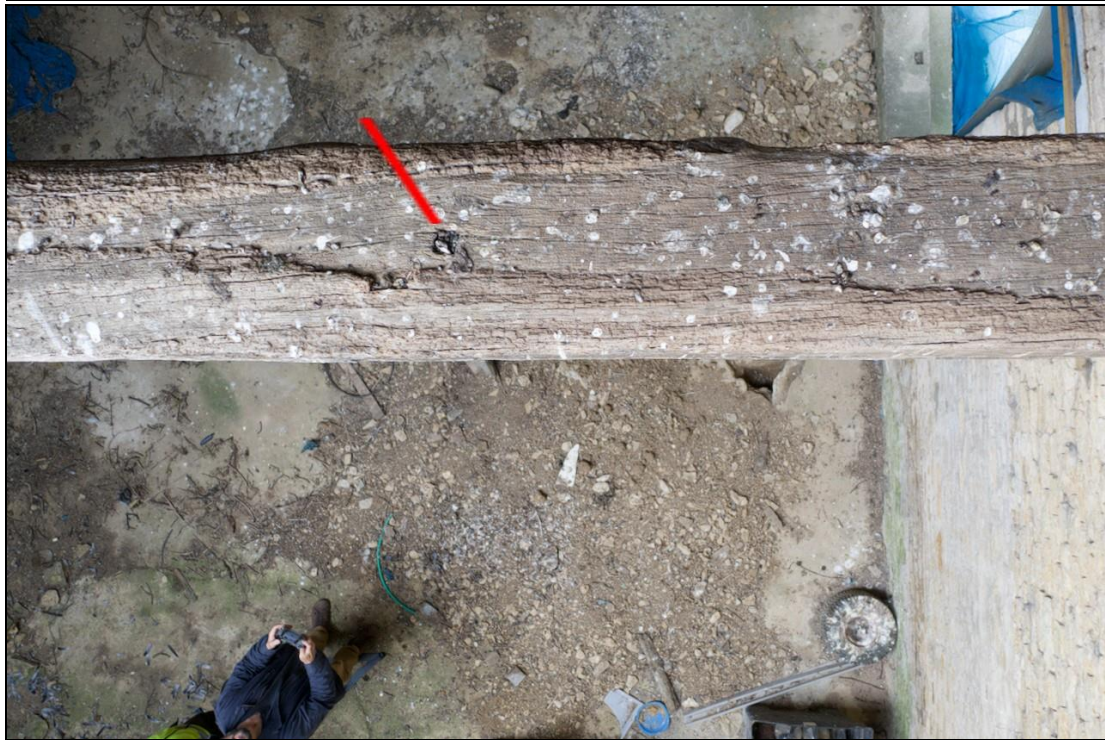
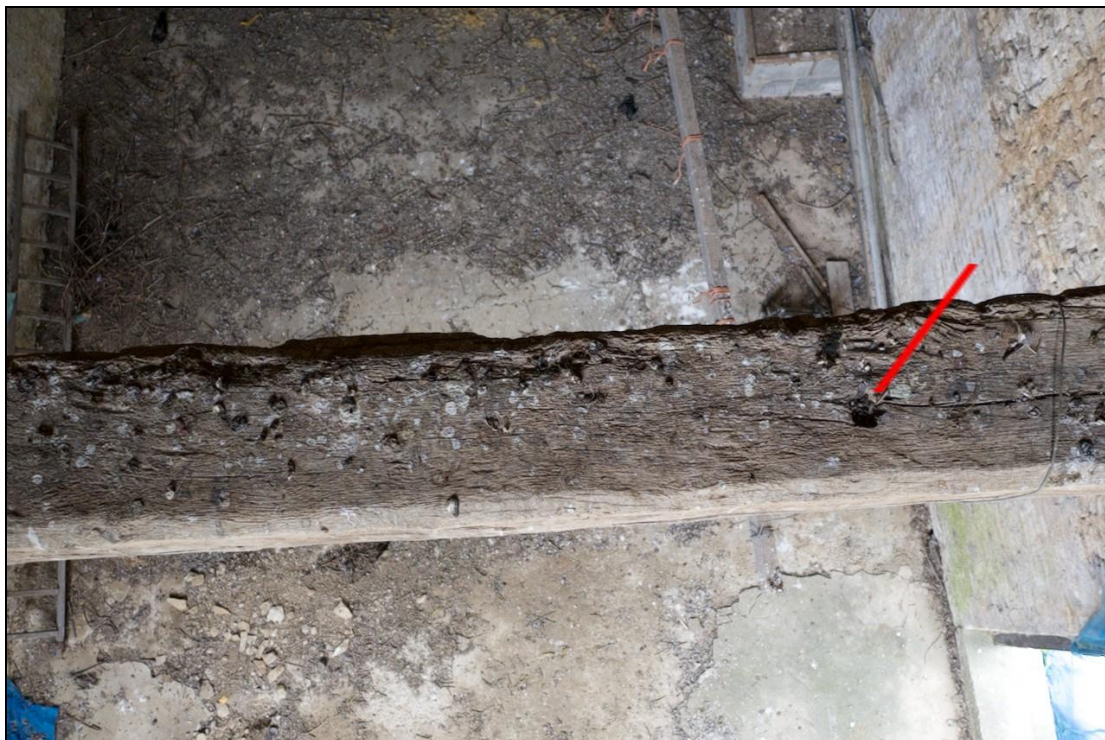
- 6.13 During the investigation of the main barn a flying drone was used in order to get closer to structures and details located high up inside the barn. Through this technique it was possible to take photos of the upper sides of all the trusses, and a few squared and round holes, that did not fit in with the present roof design, were identified in this way. This may be an indication that the beams have been re-used in the barn, and that they originally come from another building (See drone photos below).

*Drone photos from inside the main barn. Holes were identified on the upper sides of the wooden trusses, indicating that the beams may have been re-used in the barn.*

- 7.3 Due to the use of a flying drone it was possible to take photos of the upper sides of the trusses. It then became clear that the trusses had a number of circular and squared holes, that did not fit in with the present roof structure. This is another indication that the roof of the main barn has been altered at some point. It remains unclear whether the original trusses have used when this alteration was carried out, or if old wooden beams have been brought in from elsewhere. Because of the unexplained holes in the trusses, however, it is possible that they were in fact brought in from another building.

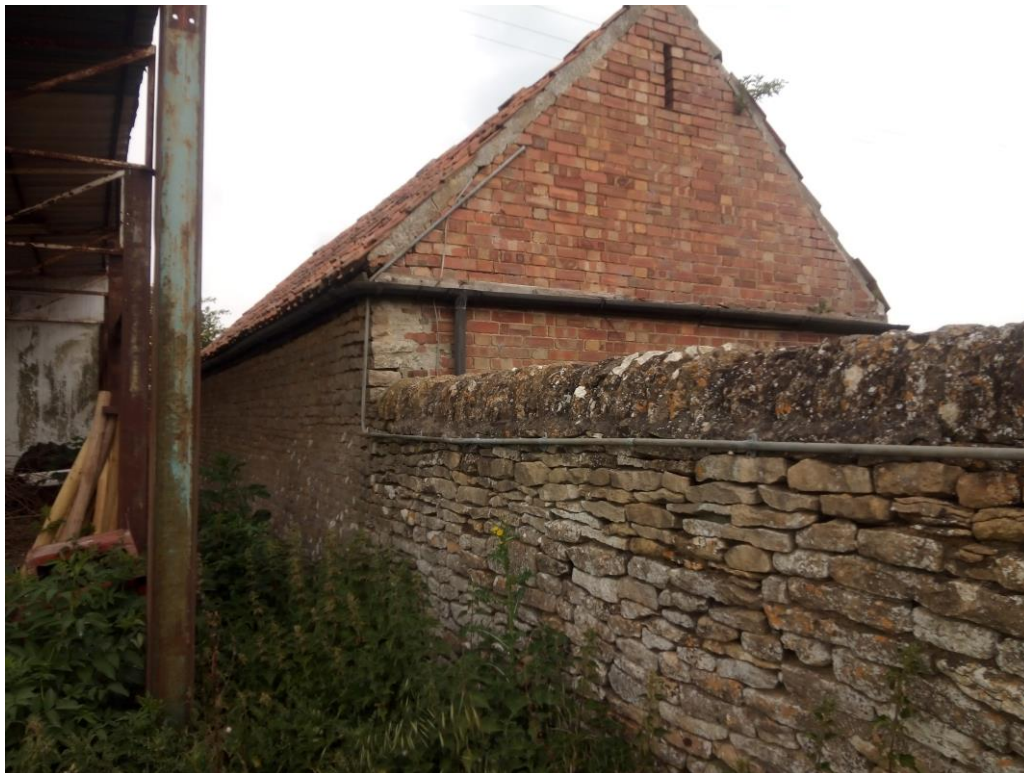
*Figure 13. The old enclosure wall continued into the brick building in the southern part of the site. This suggests that the brick structure is of a later date.*

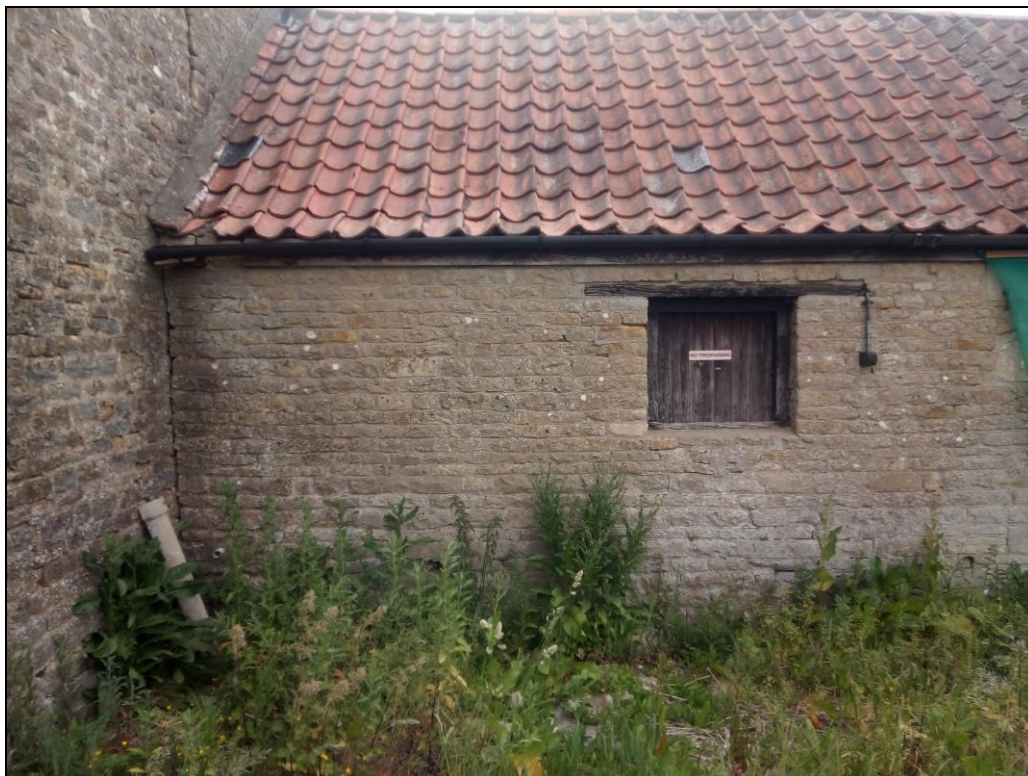
- 6.16 Even if the whole eastern range may be dated to the second part of the 19<sup>th</sup> century the oldest part of the range consisted of a 4m x 4.5m large, and almost quadratic, stone room. It is likely that this room is the first attempt to build a range along the eastern part of the site, and the room is of a higher architectural quality than the rest of the eastern range. For some reason the rest of the range is built in a less accurate way, as if the original plans were altered during the construction (Figure 15).

*Figure 15. This stone extension of the original barn was possibly built during the later part of the 19<sup>th</sup> century. Photo from west.*

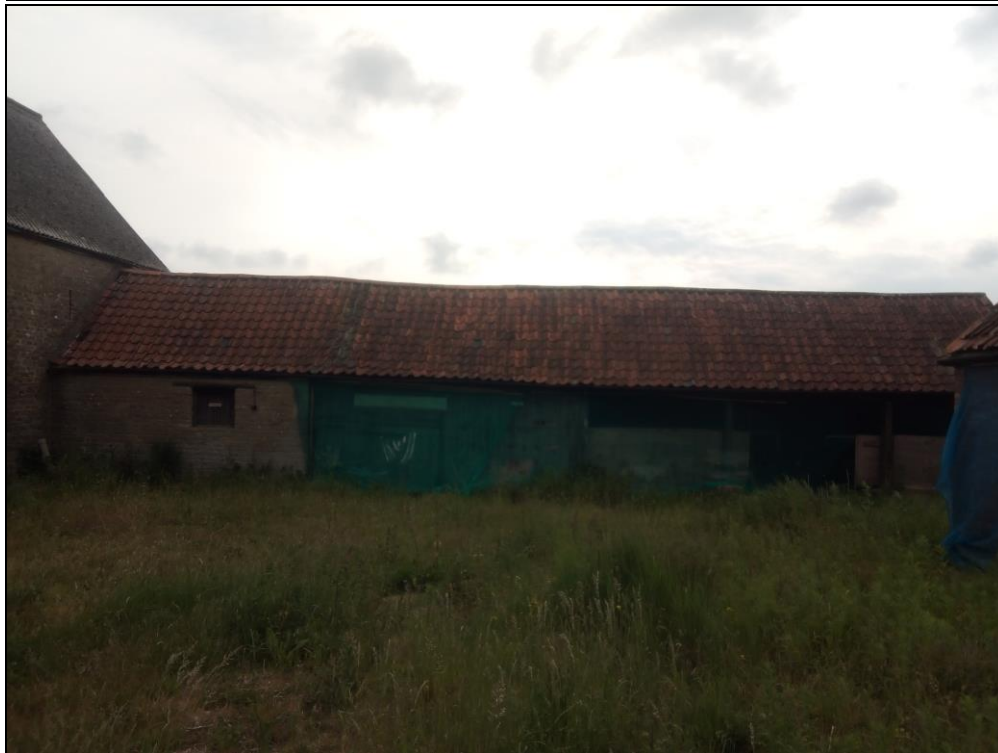
*Figure 16. A partly wooden animal shed had been preserved along the original enclosure wall. The structure likely dates from before the year 1900. Photo from west.*

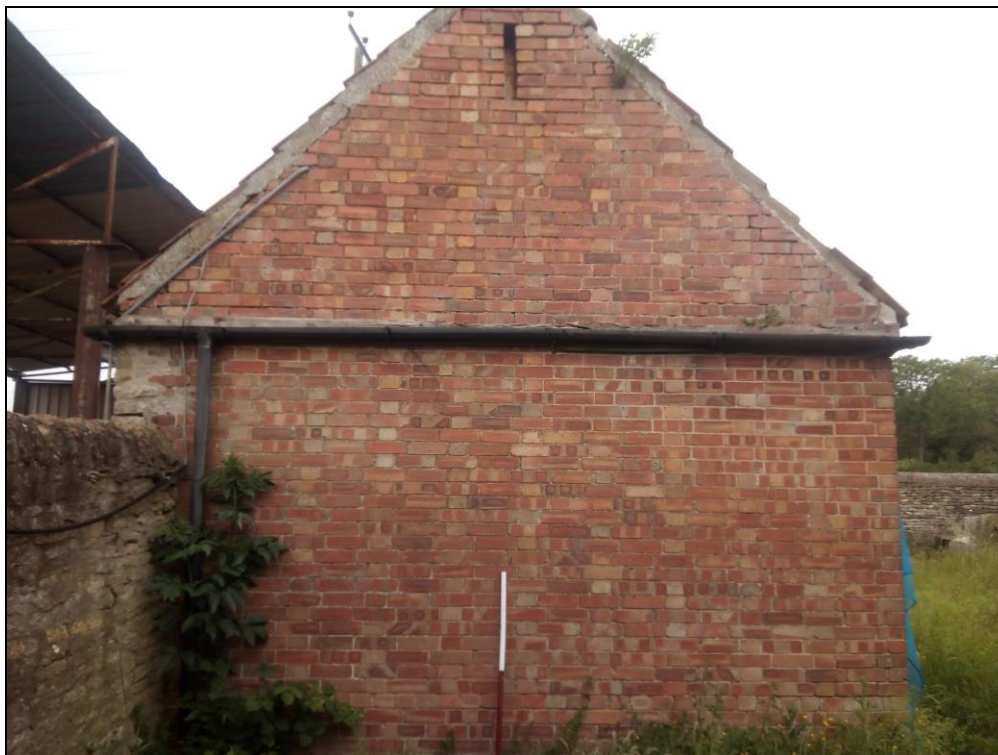
- 6.19 The brick animal shed along the southern side of the barn yard was the only structure within the site that was made of bricks (Figure 17). The structure is not shown on the earliest maps of the site, but first appears on the 1901 OS map. This indicates that it is the youngest structure within the site. The northern and eastern walls of the building were entirely built of machine-made bricks, while the southern and western walls were partly consisting of the older stone enclosure wall that once surrounded the site.

*Figure 17. This brick structure along the southern side of the barn yard was the youngest building within the site, and is first showing on the 1901 OS map. Photo from east.*

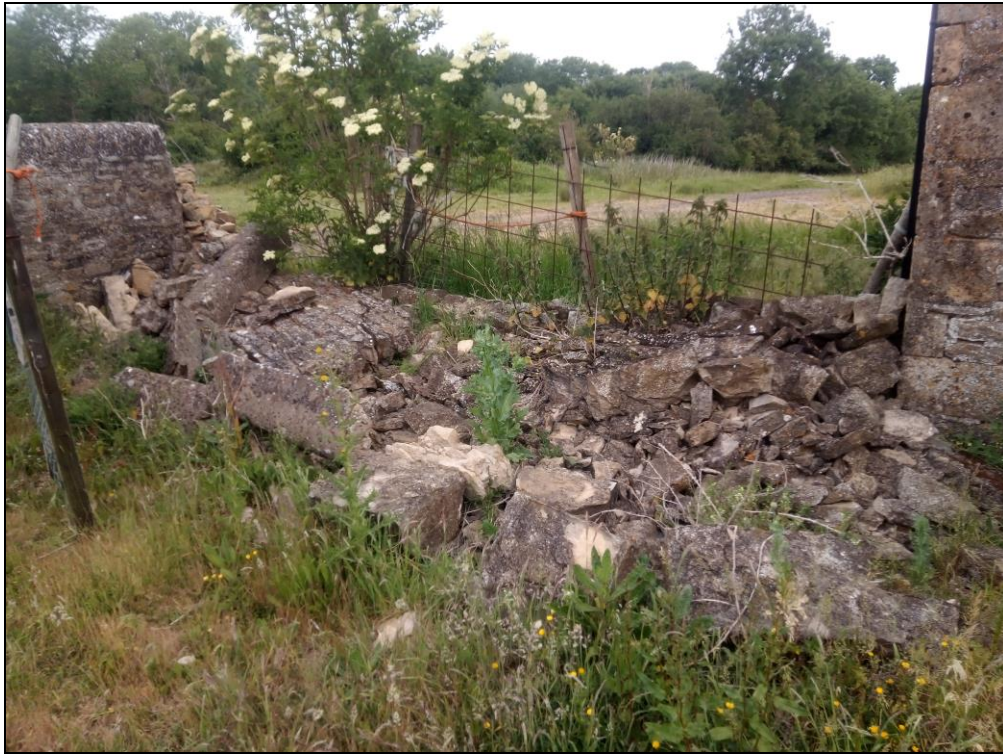
- 6.22 An up to 1.5m high and 0.5m wide enclosure wall was still visible along the western and southern sides of the barn yard. This wall is likely to be an original feature, which once surrounded the whole site in the 19<sup>th</sup> century. A wall is shown in this location on some of the earliest maps of the barn complex.
- 6.23 The animal sheds in east the south had been built up against this wall, so the enclosure wall filled the purpose of being an outer wall in these later structures (Figure 9-13). A part of the enclosure wall has recently collapsed in the north west corner of the site. This break showed that the wall had been constructed of natural stones from the area, which had been mixed with a yellow lime mortar (Figure 18).

*Figure 18. A part of the old stone enclosure wall had collapsed in the north west corner of the site. Photo from south east.*

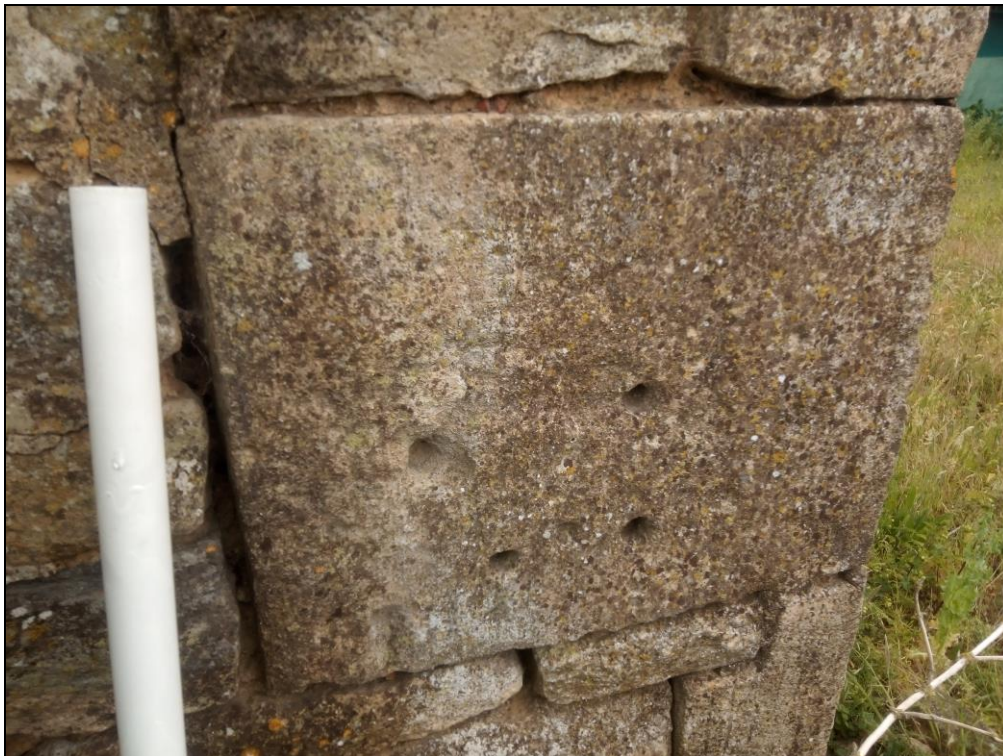
been re-used in the barn, and may therefore come from another building, as at least one of the stones had strange looking holes in the surface (Figure 19).

*Figure 19. The original barn from the 19<sup>th</sup> century contained a few re-used stones. This particular stone could be from an older church or farm building in the area. Photo from west.*

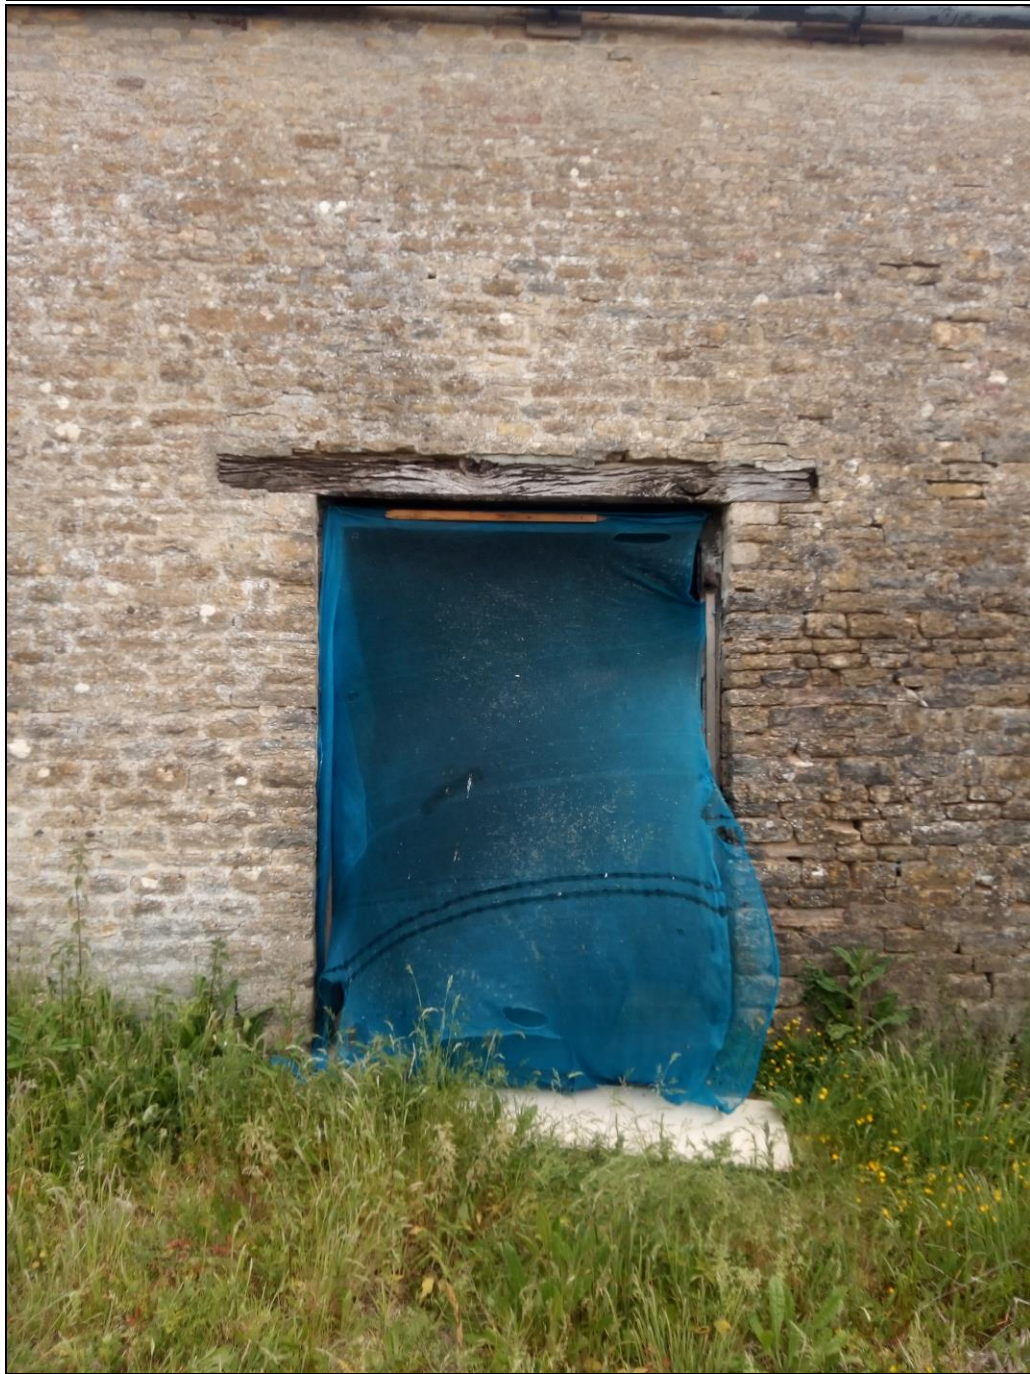
- 6.9 There are a number of openings in the outer stone walls of the barn; windows and doors as well as loading hatches. In the south wall the original door of the barn is located. It is about 1.5m wide, 3m high and has a wooden lintel which appears to be original (Figure 20).

*Figure 20. The main door leading into the 19<sup>th</sup> century barn. Photo from south.*

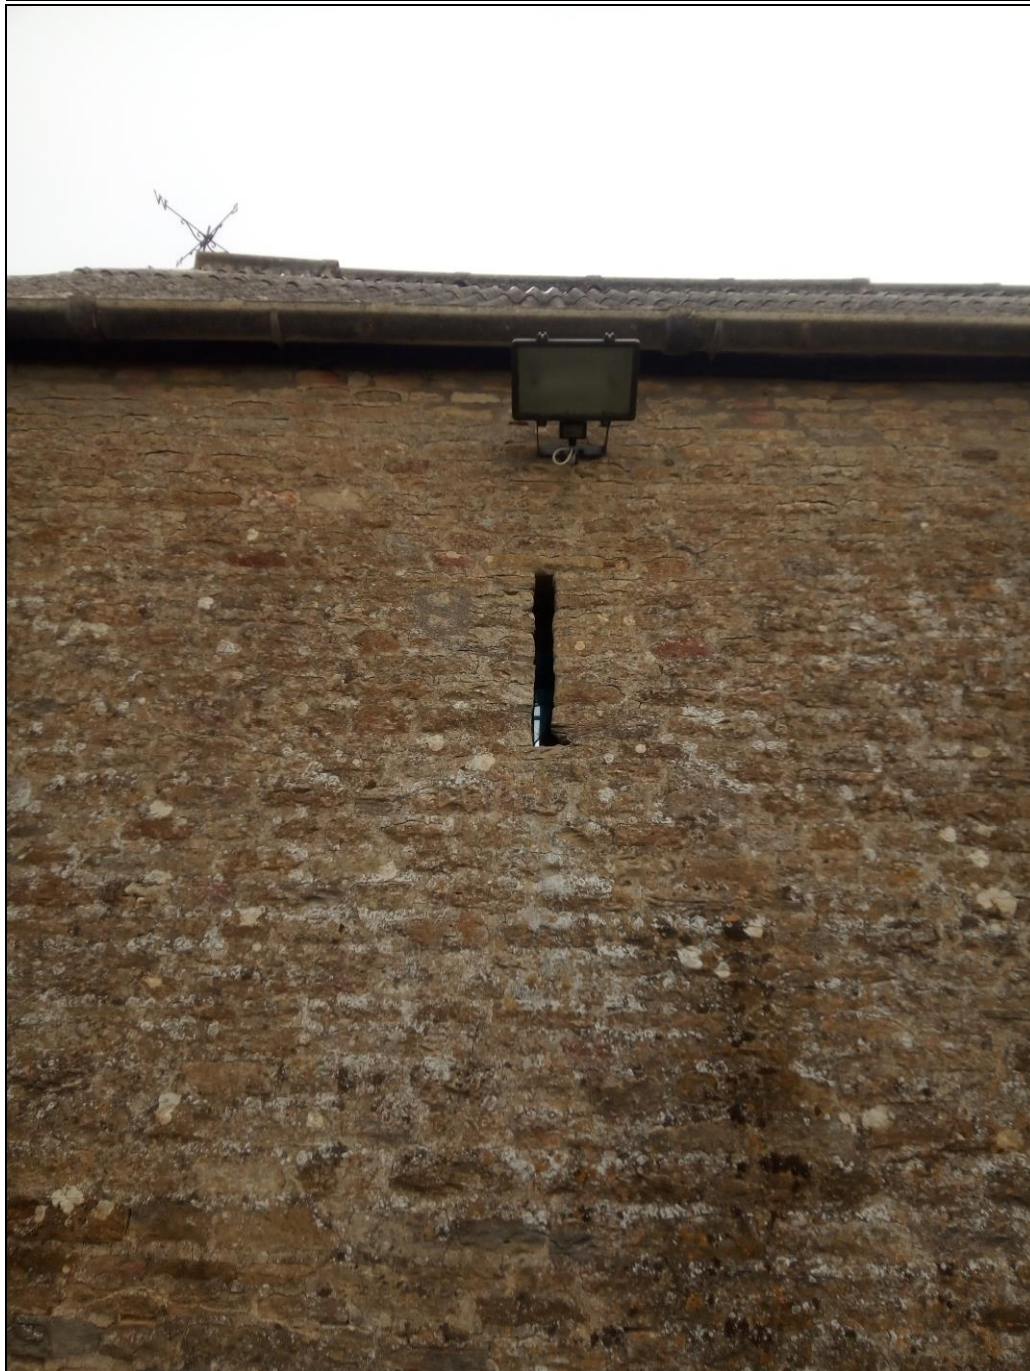
- 6.10 In the south wall there are also two ventilation holes, or narrow windows, with a design that goes back to much earlier architectural traditions in the way they remind of arrow slits in medieval castles (Figure 21).

*Figure 21. The narrow ventilation windows in the 19<sup>th</sup> century barn are based on a much older design, and almost reminds of arrow slits in medieval castles. Photo from south.*

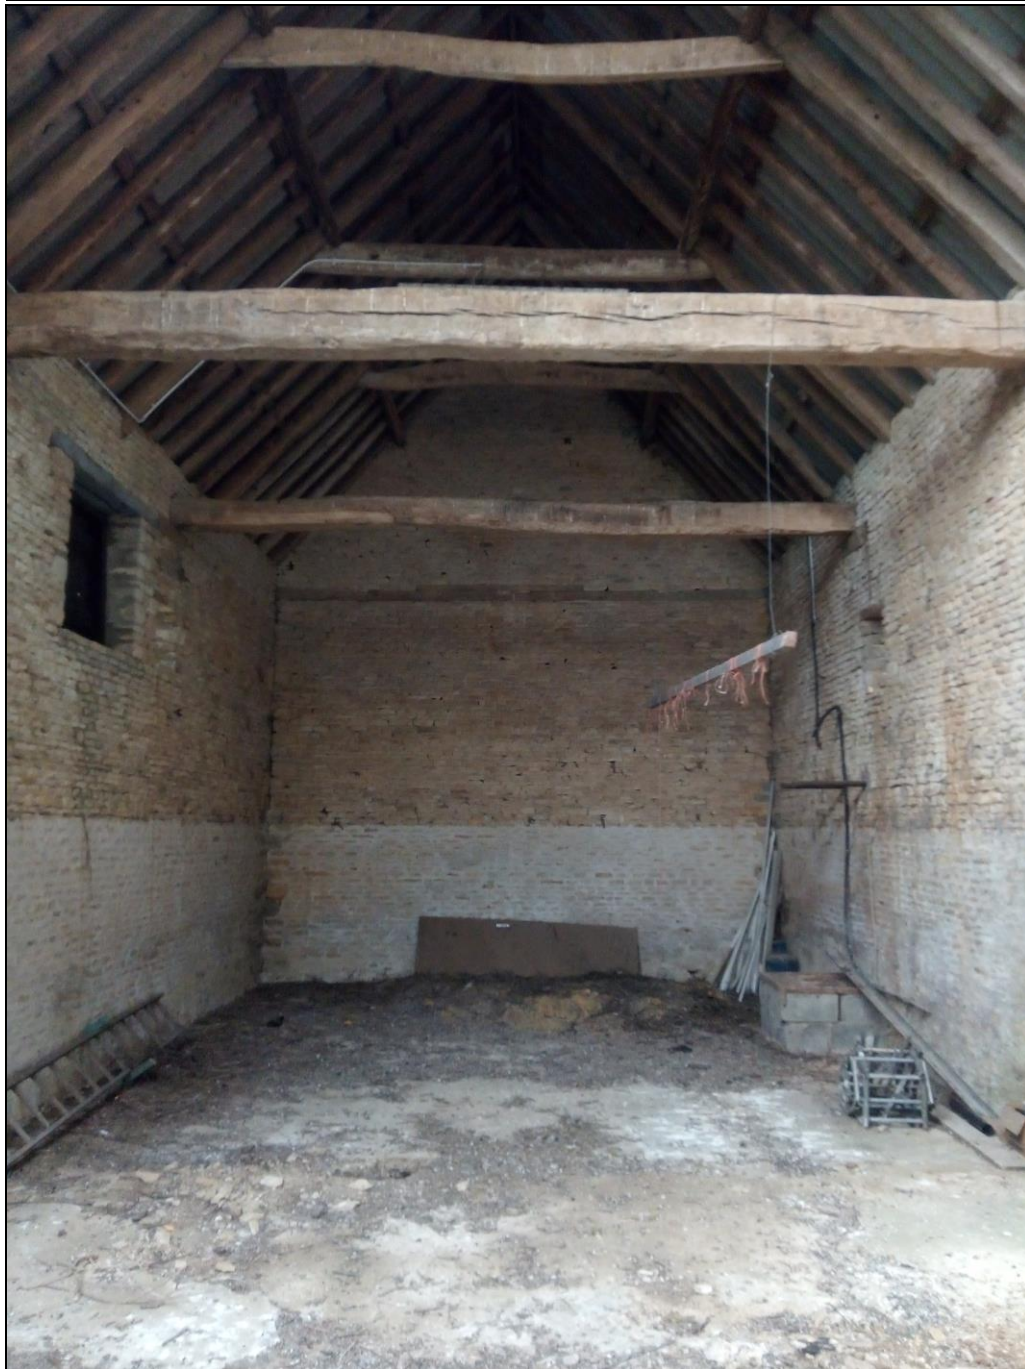
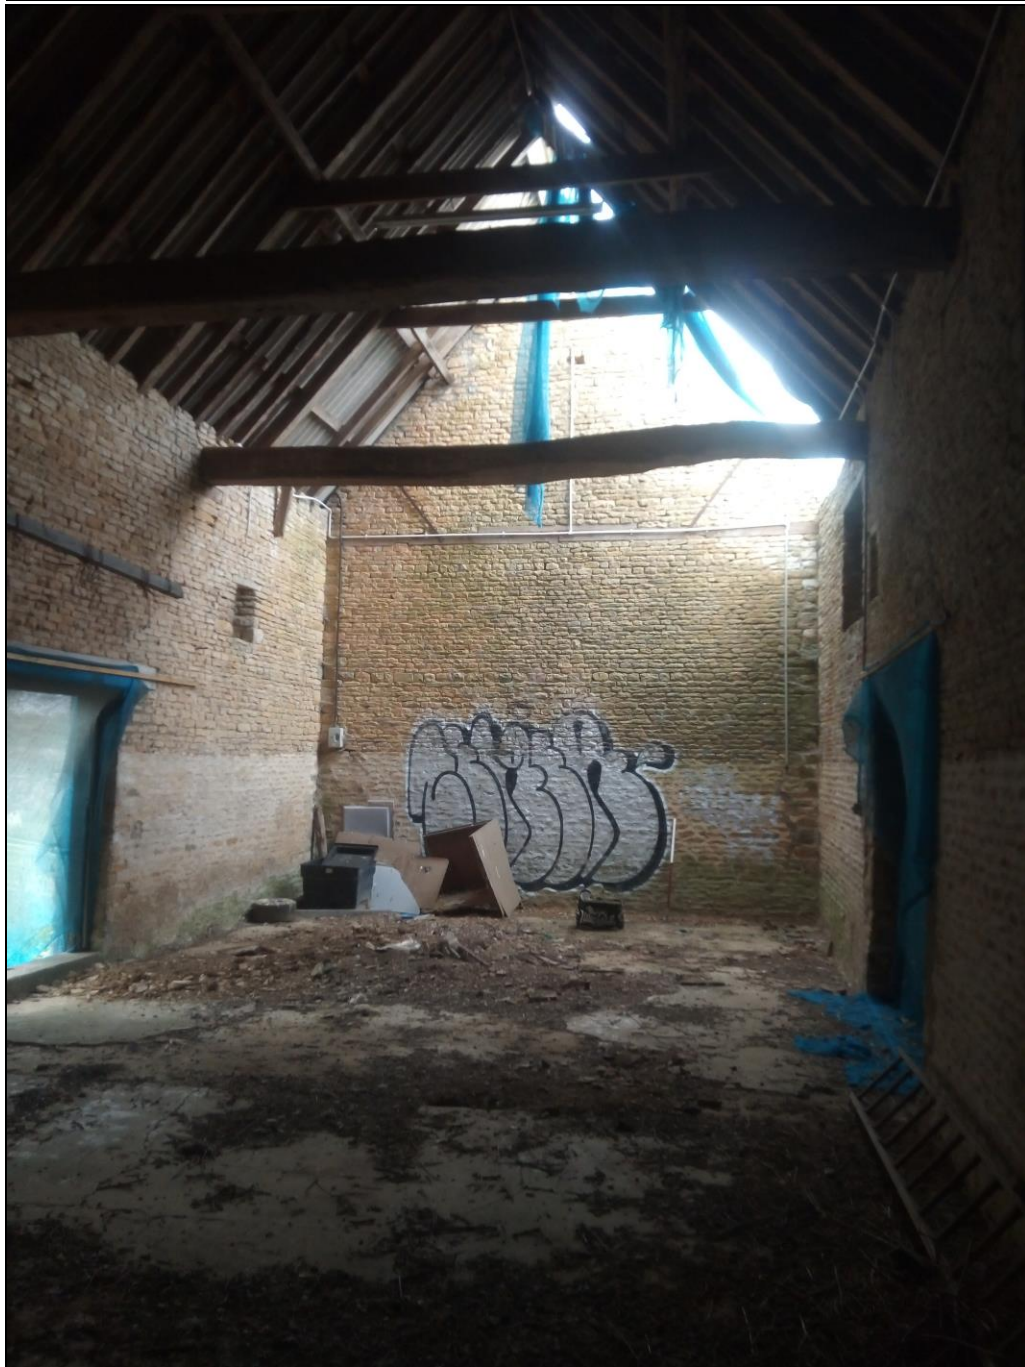
- 6.12 Internally the main barn had a secondary concrete floor of 20<sup>th</sup> century design. There were traces of a thin layer of plaster along all walls inside the barn. This layer stretched up to about 2m on all walls around the entire structure. Modern graffiti could also be seen on some walls (Figures 22 and 23).

*Figure 22. The interior of the 19<sup>th</sup> century barn consisted of one large room. Photo from west.*

*Figure 23. The interior of the 19<sup>th</sup> century barn. Photo from east.*

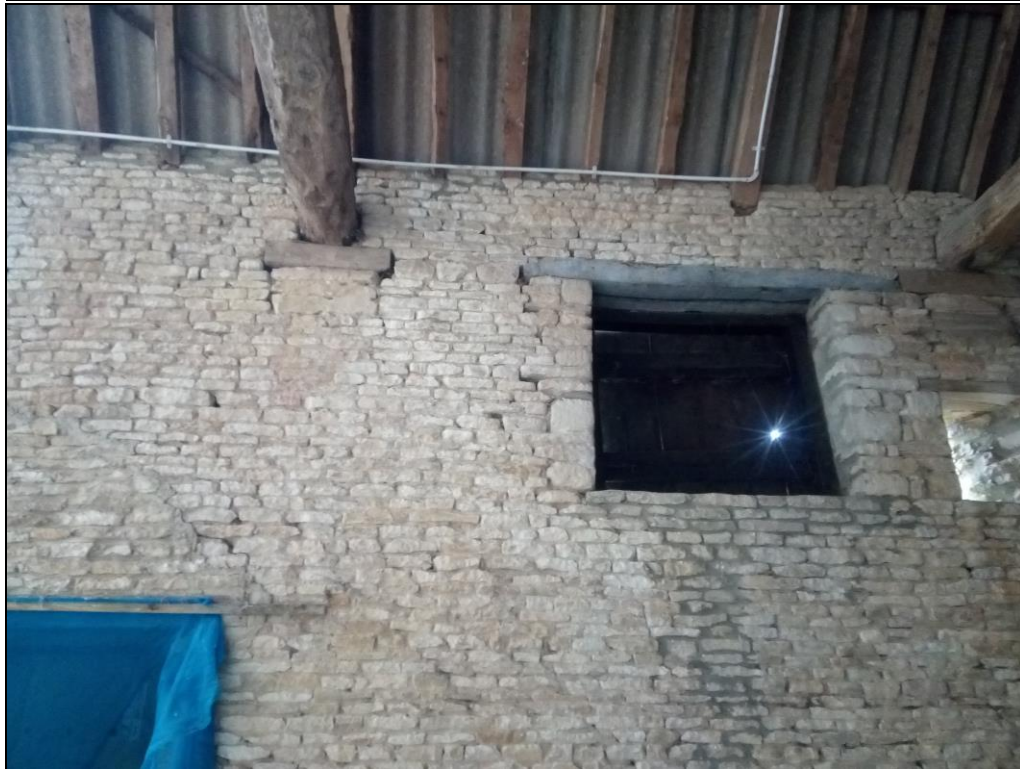
- 6.14 The fact that the original beam slots for the trusses had been blocked up throughout the barn, and that all trusses had been moved upwards by ca 0.5m, is a further proof that the original roof design of the main barn has been altered at some point (Figures 24 and 25).

*Figure 24. The wooden trusses of the 19<sup>th</sup> century barn had at some point been replaced, or at least moved upwards by ca 0.5m, as the blocked up original beam slots were visible throughout the barn. Photo from south.*

- 7.2 Internally the barn complex had preserved a large number of interesting features, such as doors, windows and wooden roof beams. It became clear that the roof structure of the original barn in the north must have been altered at some point. The original beam slots in the outer stone walls of the main barn had been blocked up, and the trusses moved upwards by ca 0.5m.

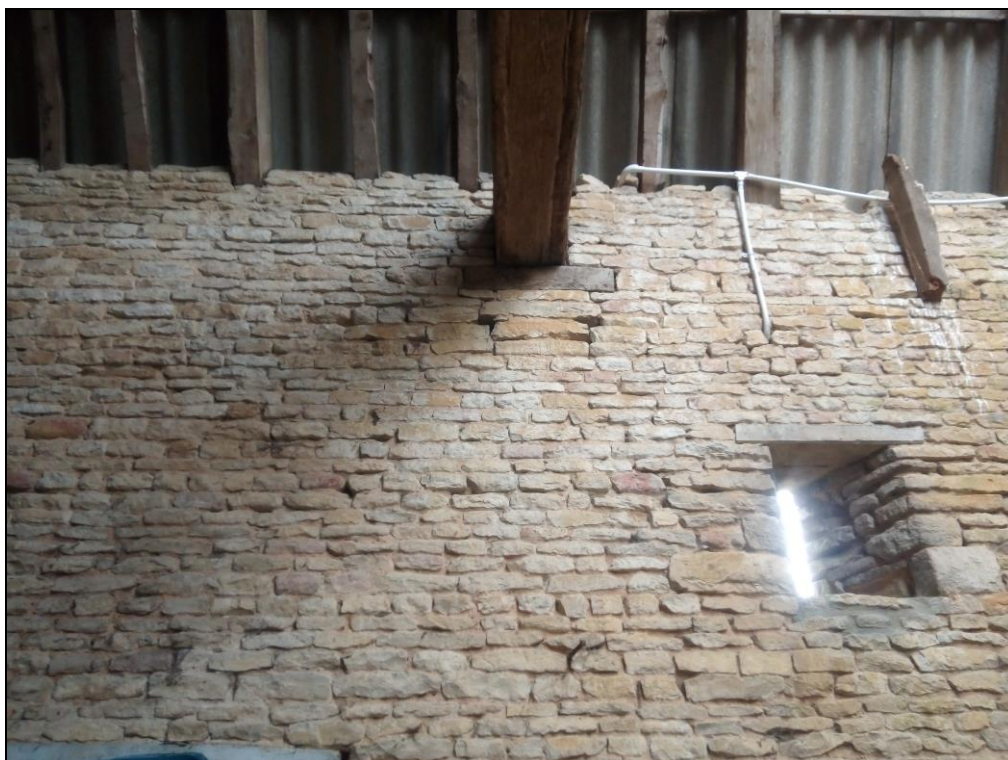
*Figure 25. Another blocked up original beam slot in the 19<sup>th</sup> century barn. Photo from north.*

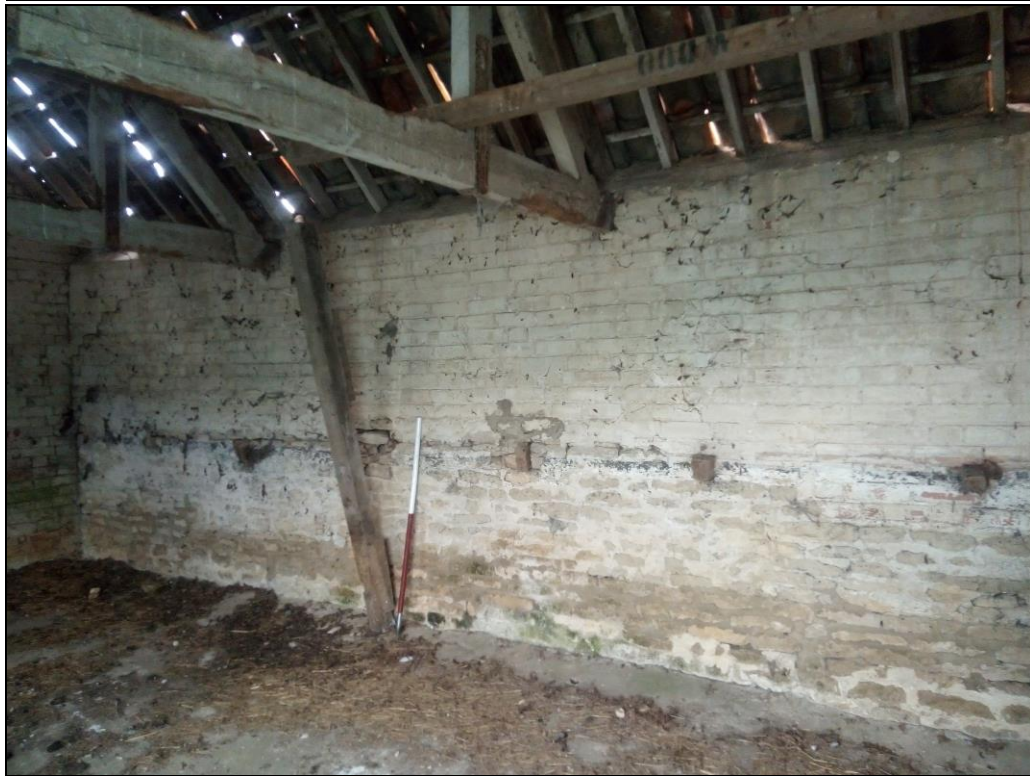
- 6.21 Internally the brick building had preserved wooden feeding racks for animals along the southern wall (partly taken away), and the wooden roof beams seems entirely to be from the time of the erection around the year 1900. Modern graffiti could be seen on some of the walls (Figure 26-31).

*Figure 28. A wooden feeding rack had once been located along the southern wall of the brick animal shed, but its beam had been cut at some point. Photo from northwest.*

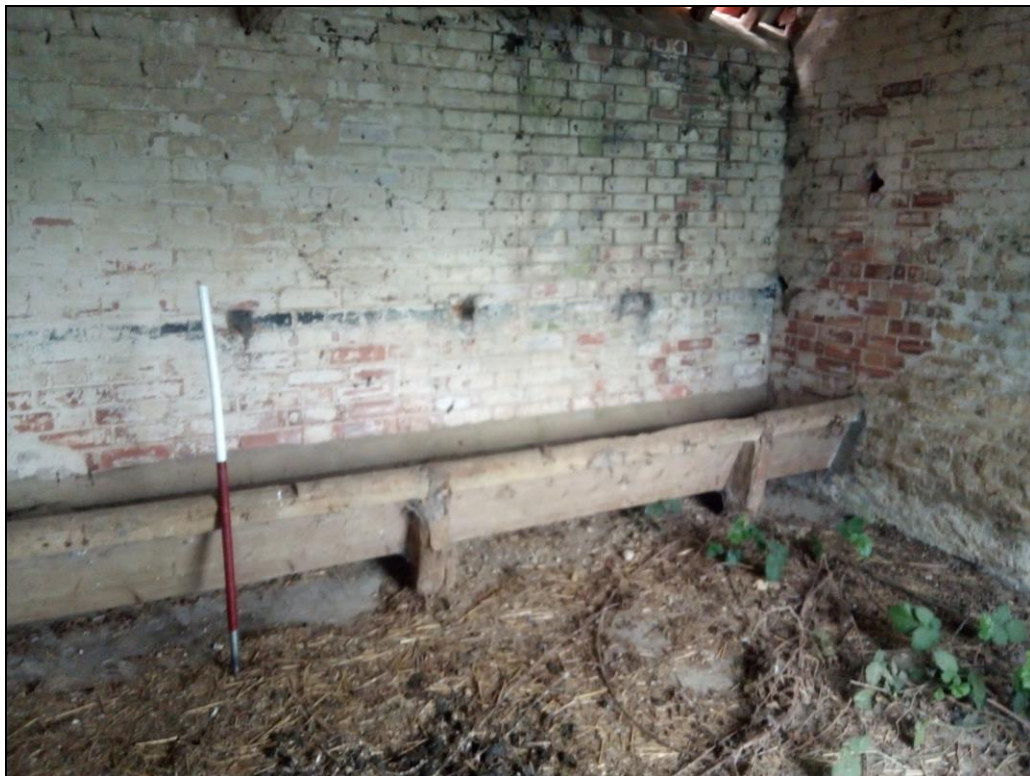
*Figure 29. In the western part of the brick animal shed the wooden feeding rack was still intact. Photo from northeast.*

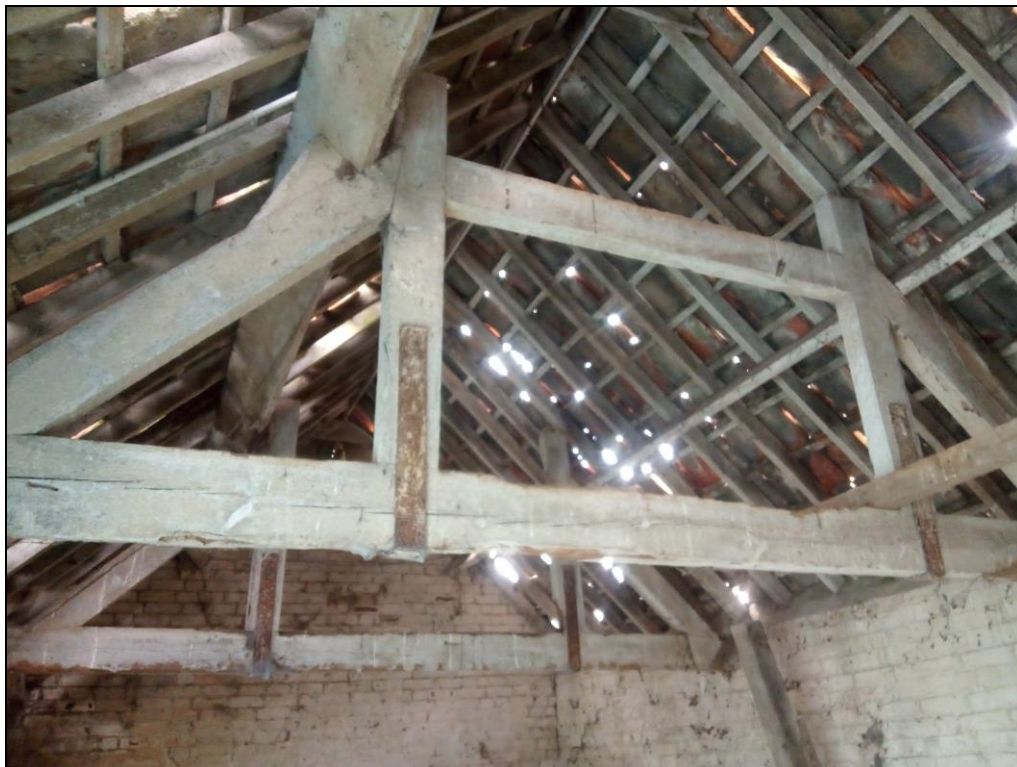
Figure 31. The wooden beams in the roof construction of the brick animal shed. Photo from west.

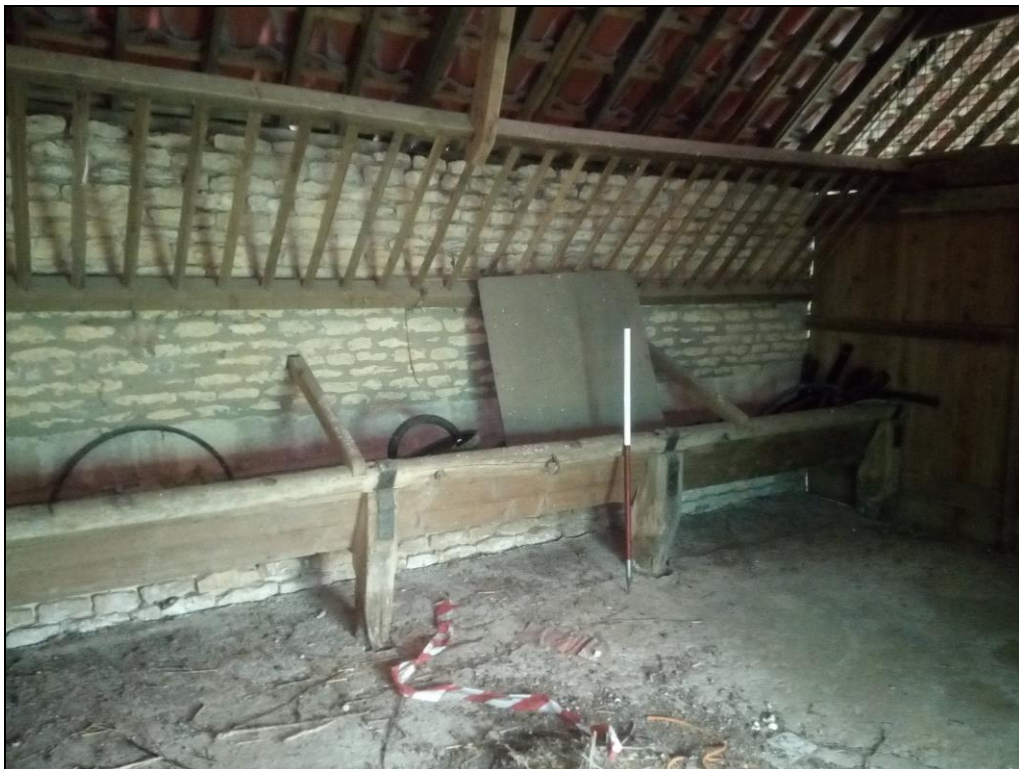
- 6.18 Internally the building has been divided in two parts by a thin wooden plank wall, which runs in an east-west direct through the centre of the structure. The building has clearly filled the function of being an animal shed as wooden feeding racks were at the time of the investigation preserved along the entire length of the building (even if parts were missing). The whole range has a 20<sup>th</sup> century concrete floor and the wooden beams in the roof construction appear to be original (Figures 32-36).

Figure 33. Interior of the partly wooden animal shed along the eastern enclosure wall. A wooden feeding rack was still in place. Photo from northwest.
