HOME FARM,
HIGH STREET,
KETTON,
RUTLAND

## ARCHAEOLOGICAL EVALUATION

**MARCH 2021**

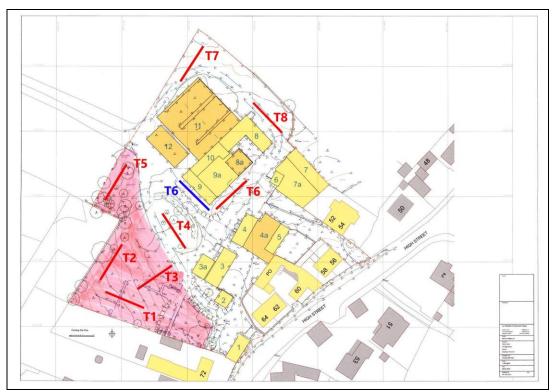
Figure 3. The Trench Locations at Home Farm, Ketton. The blue Trench 6 shows the new location of this trench in comparison to its original red location.

- 5.1.1 It was suggested that eight 25m long machine cut trenches, both with a width of 2m, were going to be excavated under constant archaeological supervision using a flat bladed ditching bucket. The total suggested length of trenching was therefore 200m and the trenches were going to cover a total area of 400m². Trench 6 had, however, to be moved slightly due to a previously unknown high voltage cable in the ground (Figure 3).

7.11 Trench 6 was northwest-southeast orientated, and was originally planned to be 25m long and 2m wide like all other trenches within the site. The trench had, however, to be moved slightly due to the presence of a previously unknown high voltage cable in the ground. Trench 6 was therefore made 25m long, 1m wide and up to 1m deep (Figure 9).

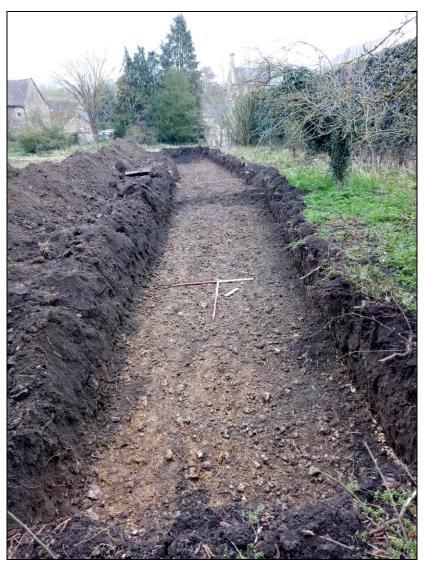
Figure 4. Trench 1. Overview. Photo from northwest.

- 7.1 Trench 1 was northwest-southeast orientated, 25m long, 2m wide and up to 0.70m deep (Figure 4). The Natural deposits consisted of compact yellow-white limestone. No archaeological features were identified as cutting into the Natural, but a few pockets of Subsoil could be seen as shallow depressions in the Natural. These pockets were investigated and turned out to contain medium sized stones and pieces of china dating from the 20<sup>th</sup> century. They were not seen as actual archaeological features but shallow impressions linked to garden activity in the former allotments in the western parts of the site.

- 7.2 The Natural was overlaid by the up to 0.50m thick Subsoil (102) of light brown, soft silty clay. One sherd of medieval pottery was collected from the subsoil. The uppermost deposit in Trench 1 was the up to 0.20m thick Topsoil (101) of dark brown, soft silty clay. Parts of the Topsoil had most likely been brought into the former allotments in this area of the site and contained frequent crushed demolition material.

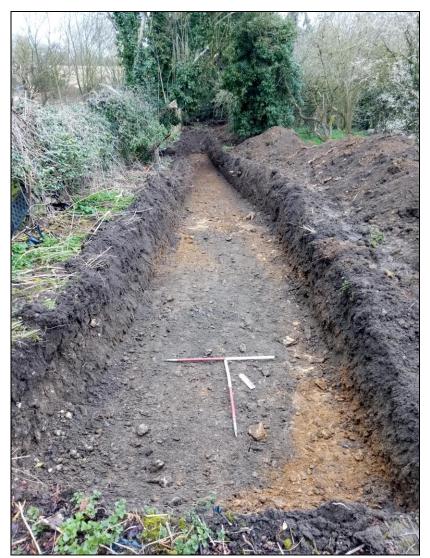
Figure 5. Trench 2. Overview. Photo from southwest.

- 7.3 Trench 2 was northeast-southwest orientated, 25m long, 2m wide and up to 0.70m deep (Figure 5). The Natural deposits consisted of compact yellow-orange limestone. No archaeological features were identified as cutting into the Natural, but a few pockets of Subsoil could be seen as shallow depressions in the Natural. These pockets were investigated and turned out to contain medium sized stones and pieces of china dating from the 20<sup>th</sup> century. They were not seen as actual archaeological features but shallow impressions linked to garden activity in the former allotments in the western parts of the site.
- 7.4 The Natural was overlaid by the up to 0.50m thick Subsoil (202) of light brown, soft silty clay. The uppermost deposit in Trench 2 was the up to 0.20m thick Topsoil (201) of dark brown, soft silty clay. Parts of the Topsoil had

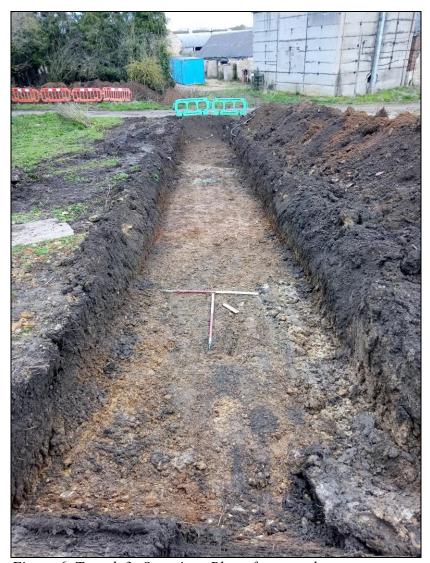
Figure 6. Trench 3. Overview. Photo from southwest.

- 7.5 Trench 3 was northeast-southwest orientated, 25m long, 2m wide and up to 0.70m deep (Figure 6). The Natural deposits consisted of compact yellow-orange limestone. No archaeological features were identified as cutting into the Natural.
- 7.6 The Natural was overlaid by the up to 0.50m thick Subsoil (302) of light brown, soft silty clay. The uppermost deposit in Trench 3 was the up to 0.20m thick Topsoil (301) of dark brown, soft silty clay. Parts of the Topsoil had most likely been brought into the former allotments in this area of the site and contained frequent crushed demolition material.

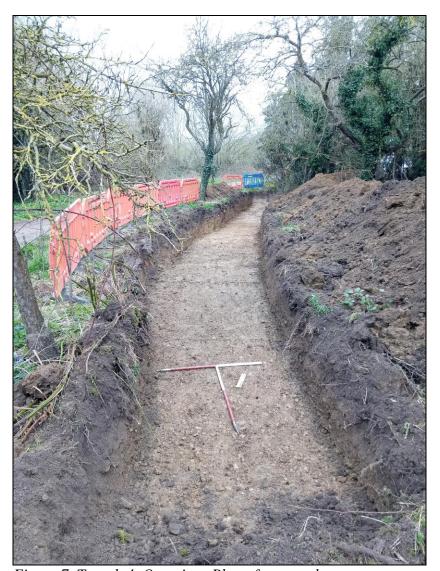
Figure 7. Trench 4. Overview. Photo from southeast.

- 7.7 Trench 4 was northwest-southeast orientated, 25m long, 2m wide and up to 0.70m deep (Figure 7). The Natural deposits consisted of compact yellow-white limestone, with a higher concentration of silt in the northern end of the trench. No archaeological features were identified as cutting into the Natural.
- 7.8 The Natural was overlaid by the up to 0.50m thick Subsoil (402) of light brown, soft silty clay. The uppermost deposit in Trench 4 was the up to 0.20m thick Topsoil (401) of dark brown, soft silty clay. The Topsoil contained frequent crushed demolition material.

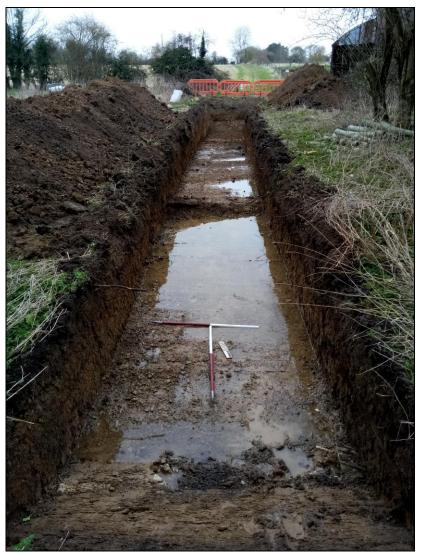
Figure 8. Trench 5. Overview. Photo from southwest.

- 7.9 Trench 5 was northeast-southwest orientated, 25m long, 2m wide and up to 1.50m deep (Figure 8). The reason for the considerable depth was an attempt to test the underlying geology of the site. The Natural deposits consisted of compact yellow-orange gravel and limestone. No archaeological features were identified as cutting into the Natural.
- 7.10 The Natural was overlaid by the up to 0.70m thick Subsoil (502) of light brown, soft silty clay. The uppermost deposit in Trench 5 was the up to 0.50m thick Topsoil (501) of dark brown, soft silty clay. The Topsoil contained frequent crushed demolition material.

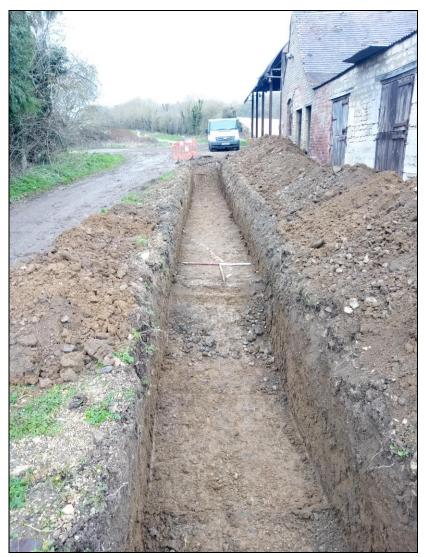
Figure 9. Trench 6. Overview. Photo from southeast.

- 7.12 The Natural deposits consisted of compact yellow-orange gravel and limestone. No archaeological features were identified as cutting into the Natural.
- 7.13 The Natural was overlaid by the up to 0.30m thick Subsoil (602) of light brown, soft silty clay. The uppermost deposit in Trench 6 was the up to 0.70m thick Topsoil (601) of dark brown, soft silty clay. The Topsoil contained frequent crushed demolition material.

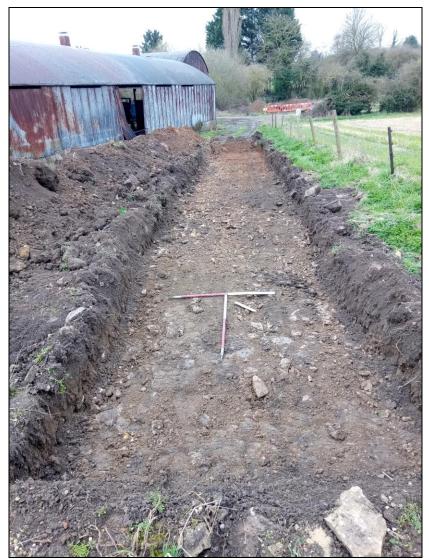
Figure 10. Trench 7. Overview. Photo from northeast.

- 7.14 Trench 7 northeast-southwest was orientated, 25m long, 2m wide and up to 0.40m deep (Figure 10). The Natural deposits consisted of compact yellow-white limestone. No archaeological features were identified as cutting into the Natural.
- 7.15 The Natural was overlaid by the up to 0.10m thick Subsoil (702) of light brown, soft silty clay. The uppermost deposit in Trench 7 was the up to 0.30m thick Topsoil (701) of dark brown, soft silty clay. The Topsoil contained frequent crushed demolition material.

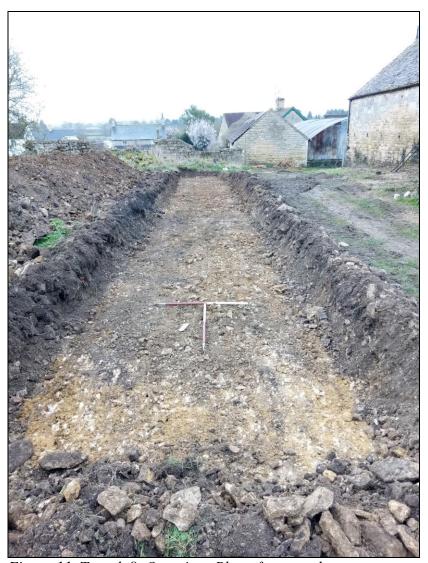
Figure 11. Trench 8. Overview. Photo from northwest.

- 7.16 Trench 8 was northwest-southeast orientated, 25m long, 2wide and up to 0.50m deep (Figure 11). The Natural deposits consisted of compact yellow-white limestone. No archaeological features were identified as cutting into the Natural.
- 7.17 The Natural was overlaid by the up to 0.10m thick Subsoil (802) of light brown, soft silty clay. The uppermost deposit in Trench 8 was the up to 0.40m thick Topsoil (801) of dark brown, soft silty clay. The Topsoil contained frequent crushed demolition material.
