**BEALINGS,
CHURCH ROAD,
STANSTED,
ESSEX**

PLANNING REF: UTT/20/2612/FUL

ARCHAEOLOGICAL EVALUATION

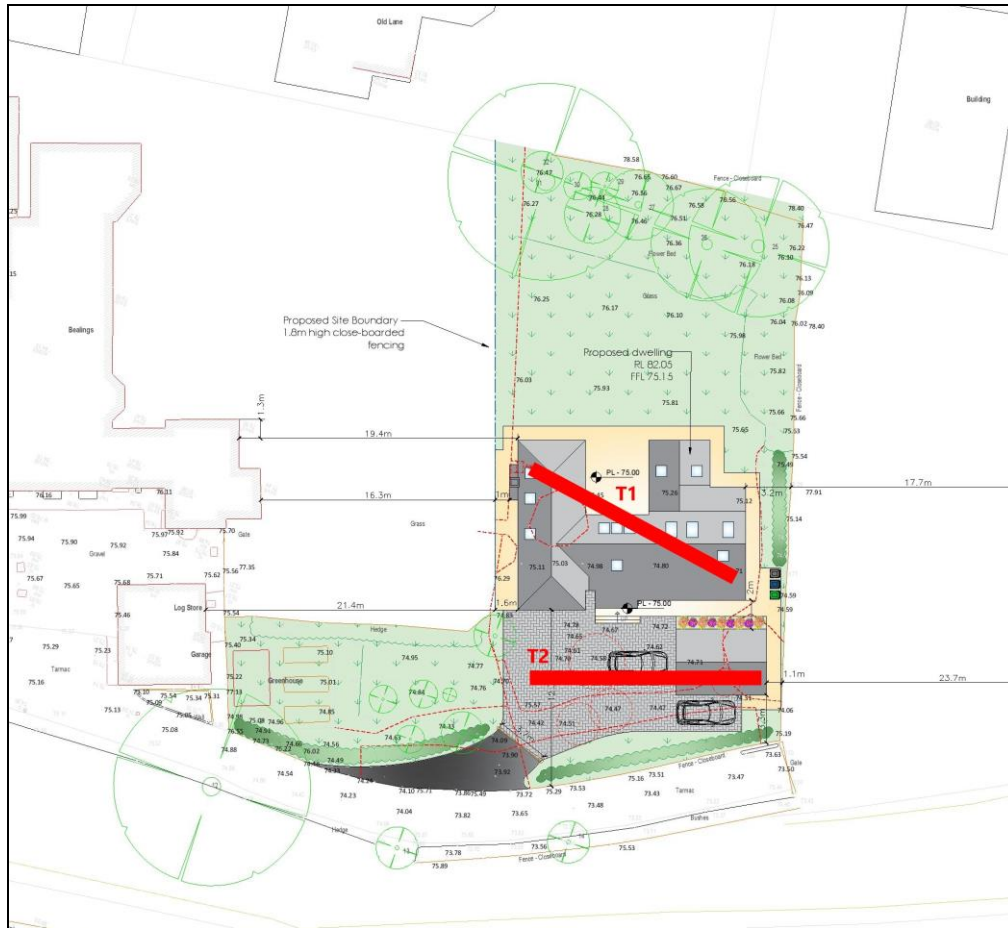
Trench Locations

Based on the layout of the site it was proposed that two evaluation trenches would be opened up across the site. It was suggested that both trenches were going to be 16m long and 1.8m wide. The trenches were opened up under constant archaeological supervision using a flat bladed ditching bucket fitted on a tracked machine. The total length of trenching was therefore 32m, totalling 58m², or ca. 4% of the 1455m² large development area.

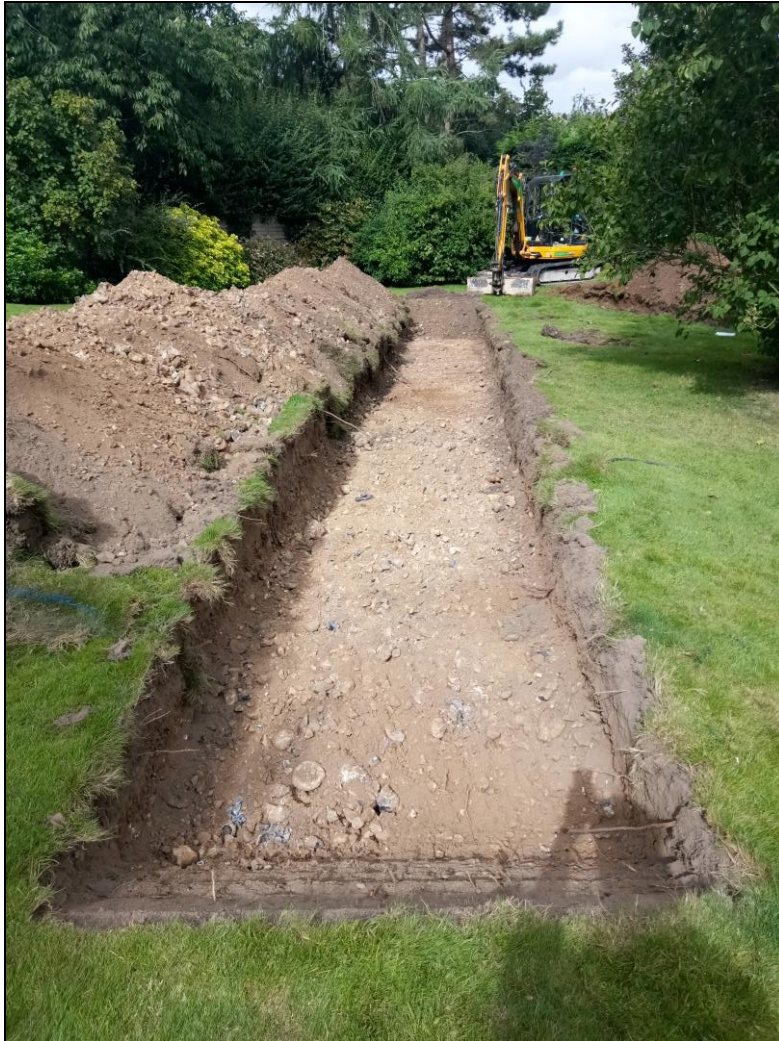
- 7.1 Trench 1 was 16m long and 1.8m wide and had a northwest-southeast orientation (Photo 1). The Natural consisted of yellow-white, semi compact gravel with frequent flint. No archaeological features were seen cutting in to the natural deposits.
- 7.2 Overlying the Natural was the up to 0.40m thick subsoil (102) of light brown, soft silty clay. The uppermost deposit in Trench 1 consisted of up to 0.30m thick garden soil of dark brown, soft silty clay (101).

Photo 1: Overview of Trench 1 from north west.

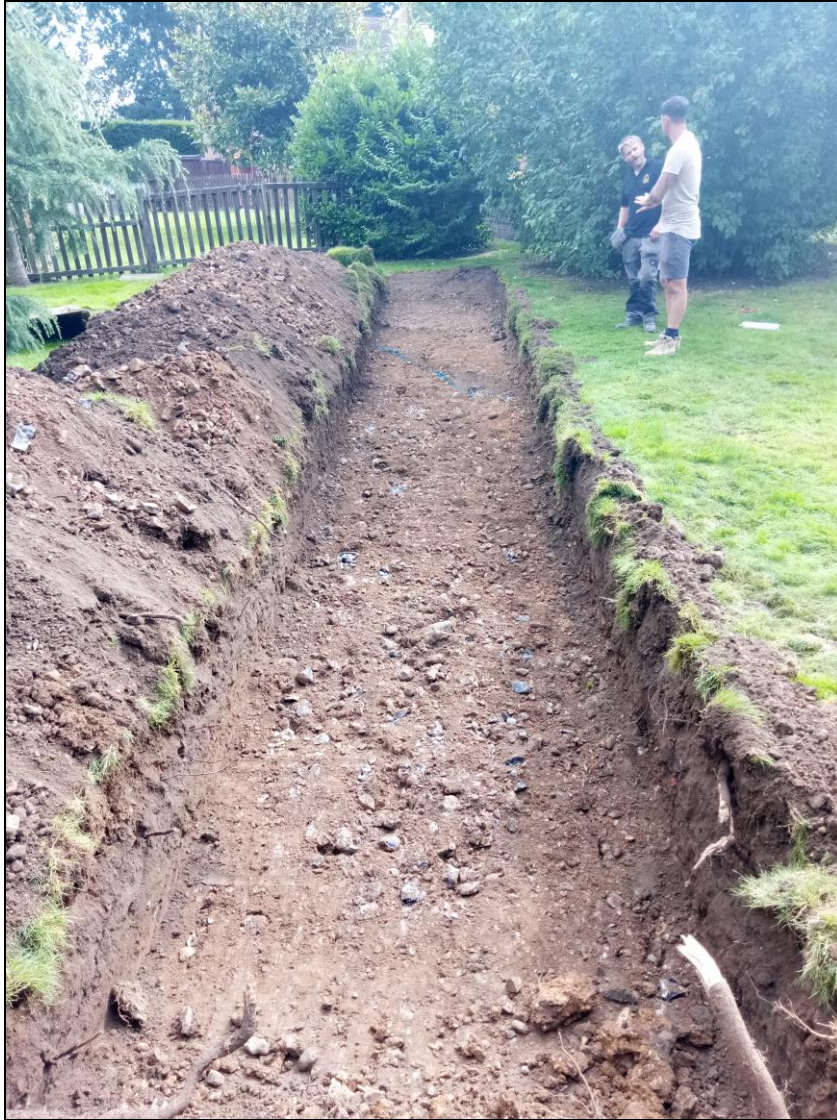
- 7.3 Trench 2 was 16m long and 1.8m wide and had an east-west orientation (Photo 2). The Natural consisted of yellow-white, semi compact gravel with frequent flint. No archaeological features were seen cutting in to the natural deposits.
- 7.4 Overlying the Natural was the up to 0.30m thick subsoil (202) of light brown, soft silty clay. The uppermost deposit in Trench 2 consisted of up to 0.25m thick garden soil of dark brown, soft silty clay (201).

Photo 2: Overview of Trench 2 from west.
