**Land South of Dean Road, Ferryhill,
County Durham
Archaeological Evaluation**

Author	J. Scott & J. McKelvey
Commissioned by	Gleeson Homes
Project Number	AD379
OASIS Number	adarchae1-503842
Date	September 2021

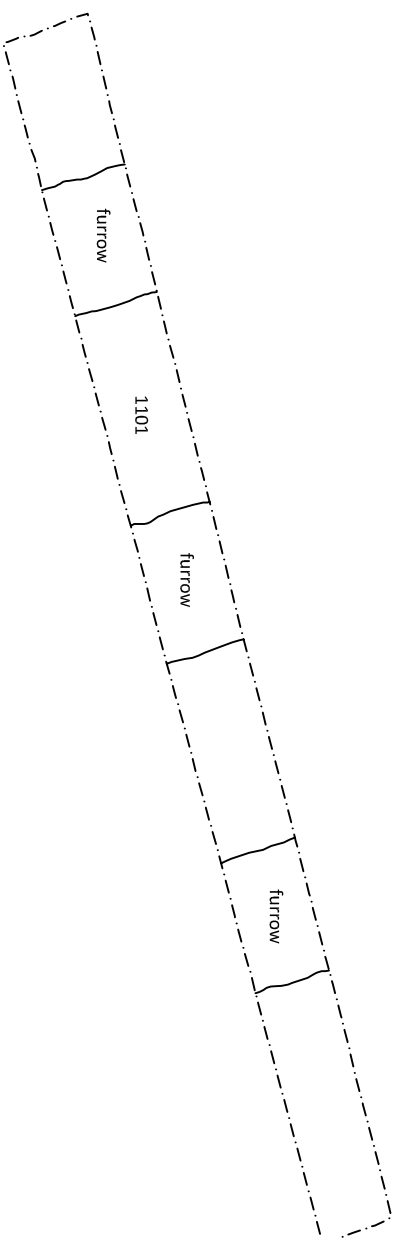
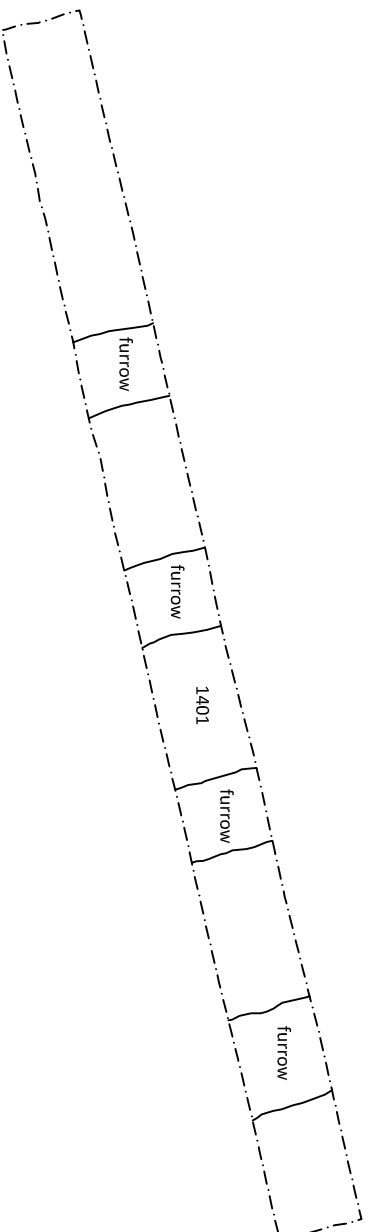
Figure 3: Plans of Trenches 11 and 14

5.9.1 Trench 11, which was 25m by 1.8m in size, was oriented ENE-WSW and located in the central area of the field. The natural subsoil (1102) consisting of a yellow clay was located at a depth of 0.31m BGL (122.79m AOD) and was overlain by a grey loam topsoil (1100), 0.31m in depth. Three 2.5m wide NNW-SSE furrows filled with a brown sandy clay ploughsoil (1101) were located, with a wavelength of 6m.

5.12.1 Trench 14, which was 25m by 1.8m in size, was oriented ENE-WSW and located in the central area of the field. The natural subsoil (1402) consisting of a yellow clay was located at a depth of 0.31m BGL (120.66m AOD) and was overlain by a grey loam topsoil (1400), 0.31m in depth. Four 1.5-2m wide NNW-SSE furrows filled with a brown sandy clay ploughsoil (1401) were located, with a wavelength of 4-5m.

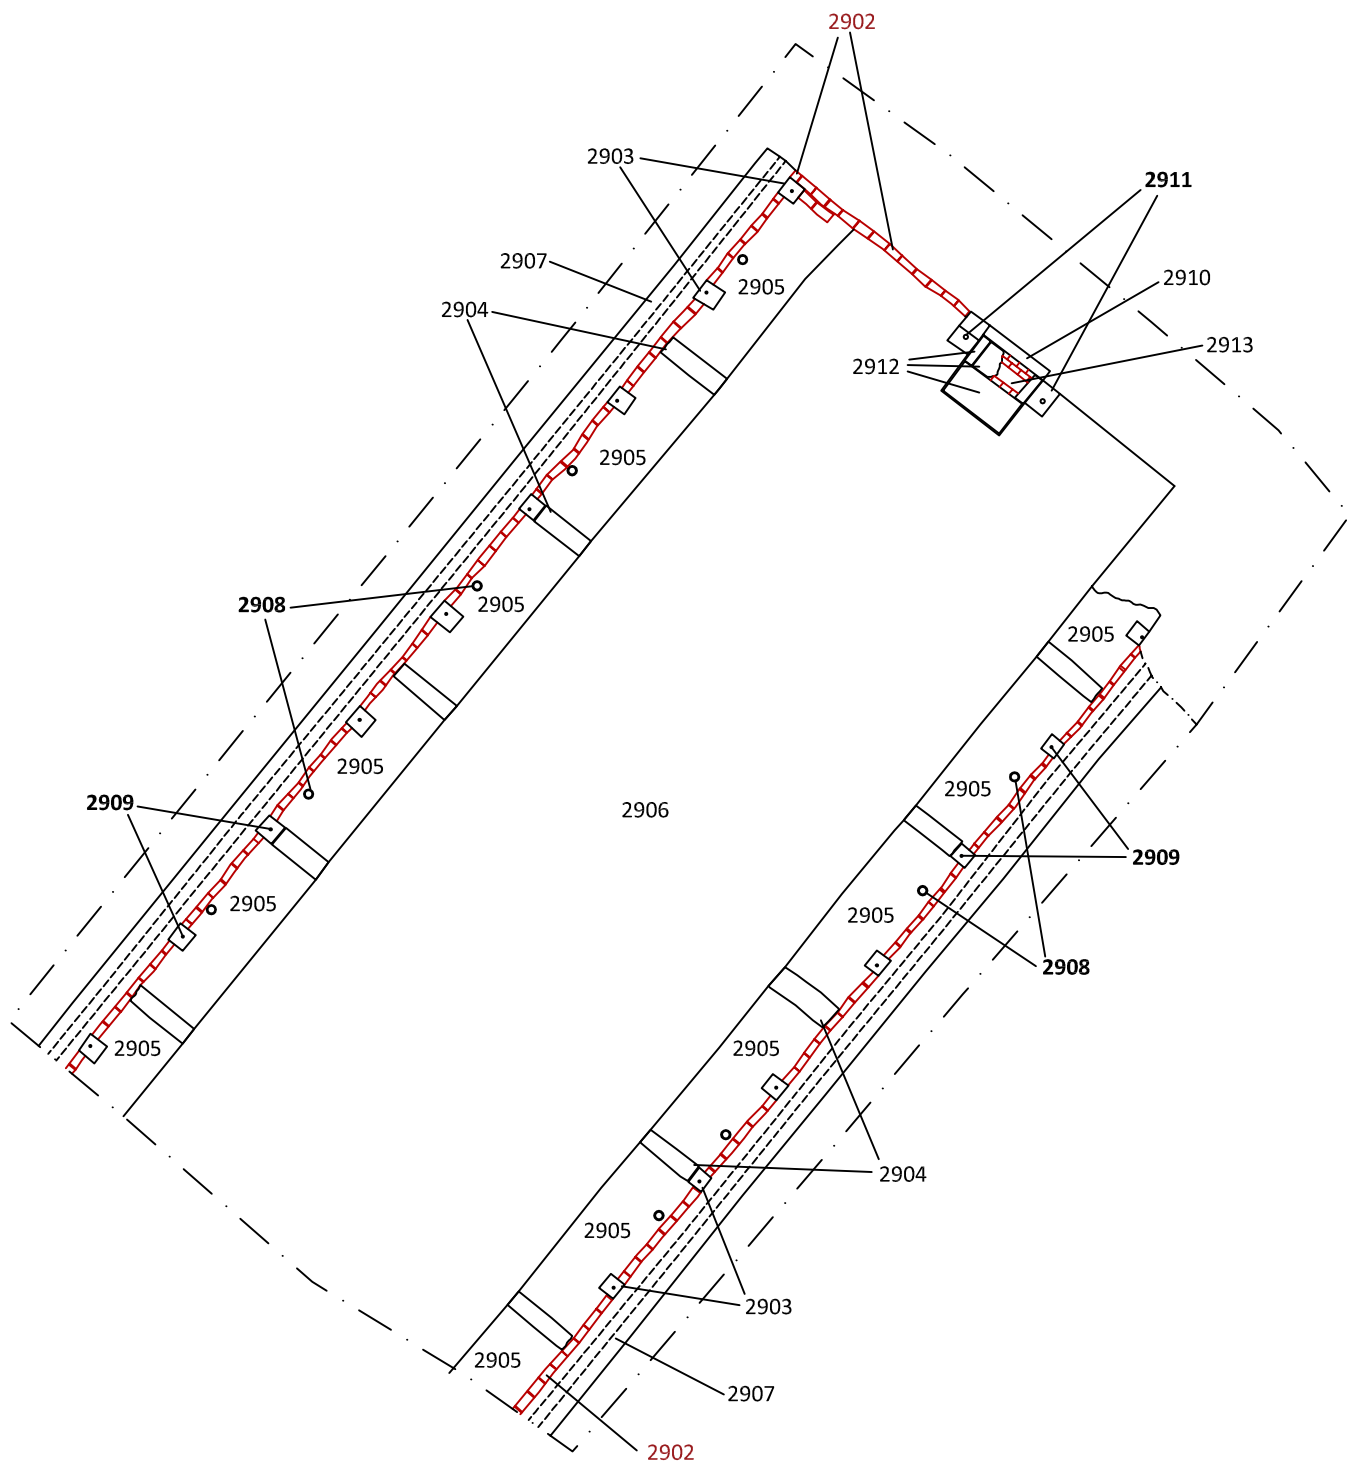
Figure 7: Trench 29 overall plan

located towards the south of Field 2a. Grey-brown loam topsoil (2900) and turf was stripped off to a building platform of red-brick and concrete construction (Plate 8). To the sides of the platform natural subsoil (2901) consisting of yellow clay was exposed at 0.28m BGL (124.45m AOD).

5.22.2 The building platform exposed formed the north-eastern end of a larger structure running back to the south-west (Plate 8). Its construction comprised an outer frame of low red-brick walls (2902). The walls running along the long axes of the structure (NW and SE facing edges) were a maximum of three courses built in stretcher bond (Plate 9). The wall of the north-east facing elevation (postulated to be the front of the building) was built in English-garden-wall one and five bond (five stretcher courses to each header course) and extended deeper below the ground surface to make up a total of nine courses before being founded on a rough poured concrete footing (2914) (Plate 13). Set within the brick walls (2902) along the two long axes of the larger structure (NW and SE facing edges) were a series of pre-cast concrete blocks (2903) roughly 25cm square (ten inches) spaced evenly, roughly 1.82m apart (six feet) (Plate 10). Each of these blocks showed evidence of corroded metal fixing points (2909) within it. Between the blocks (2903) and sometimes coinciding with them (behind) were a series of short pre-cast concrete beams (2904) spaced evenly roughly 2.75m apart (nine feet) (Plate 10). The area between the blocks and beams and the outer brick walls was filled with poured concrete (2905) (Plate 9). Between the beams and set within the areas of poured concrete large diameter (10cm or 4 inch) ceramic waste pipes (2908) were set suggesting that the original structure contained a number of W/Cs (Plate 11). The central portion of the platform (between the beams and poured concrete areas) was formed by a single pre-cast concrete slab (2906) roughly 5.48m wide (eighteen feet). Set centrally within the NE facing short axis of the building (postulated to be the front) a pre-cast concrete doorstep (2910) broke the line of the red-brick wall (2902) level with the internal floor level of the central slab (2906) (Plate 12). To either side of this poured concrete pads held metal post holes (2911) presumably associated with the door into the building. Behind this doorway within the building a section of the main slab (2906) was absent revealing a brick-built substructure (2913) covered with cast concrete slabs (2912) presumably forming an access to services etc. below the building (Plate 12). To either side of the long axes of the larger structure, exterior to the building, smooth straight drainage channels had been formed of poured concrete (2907).

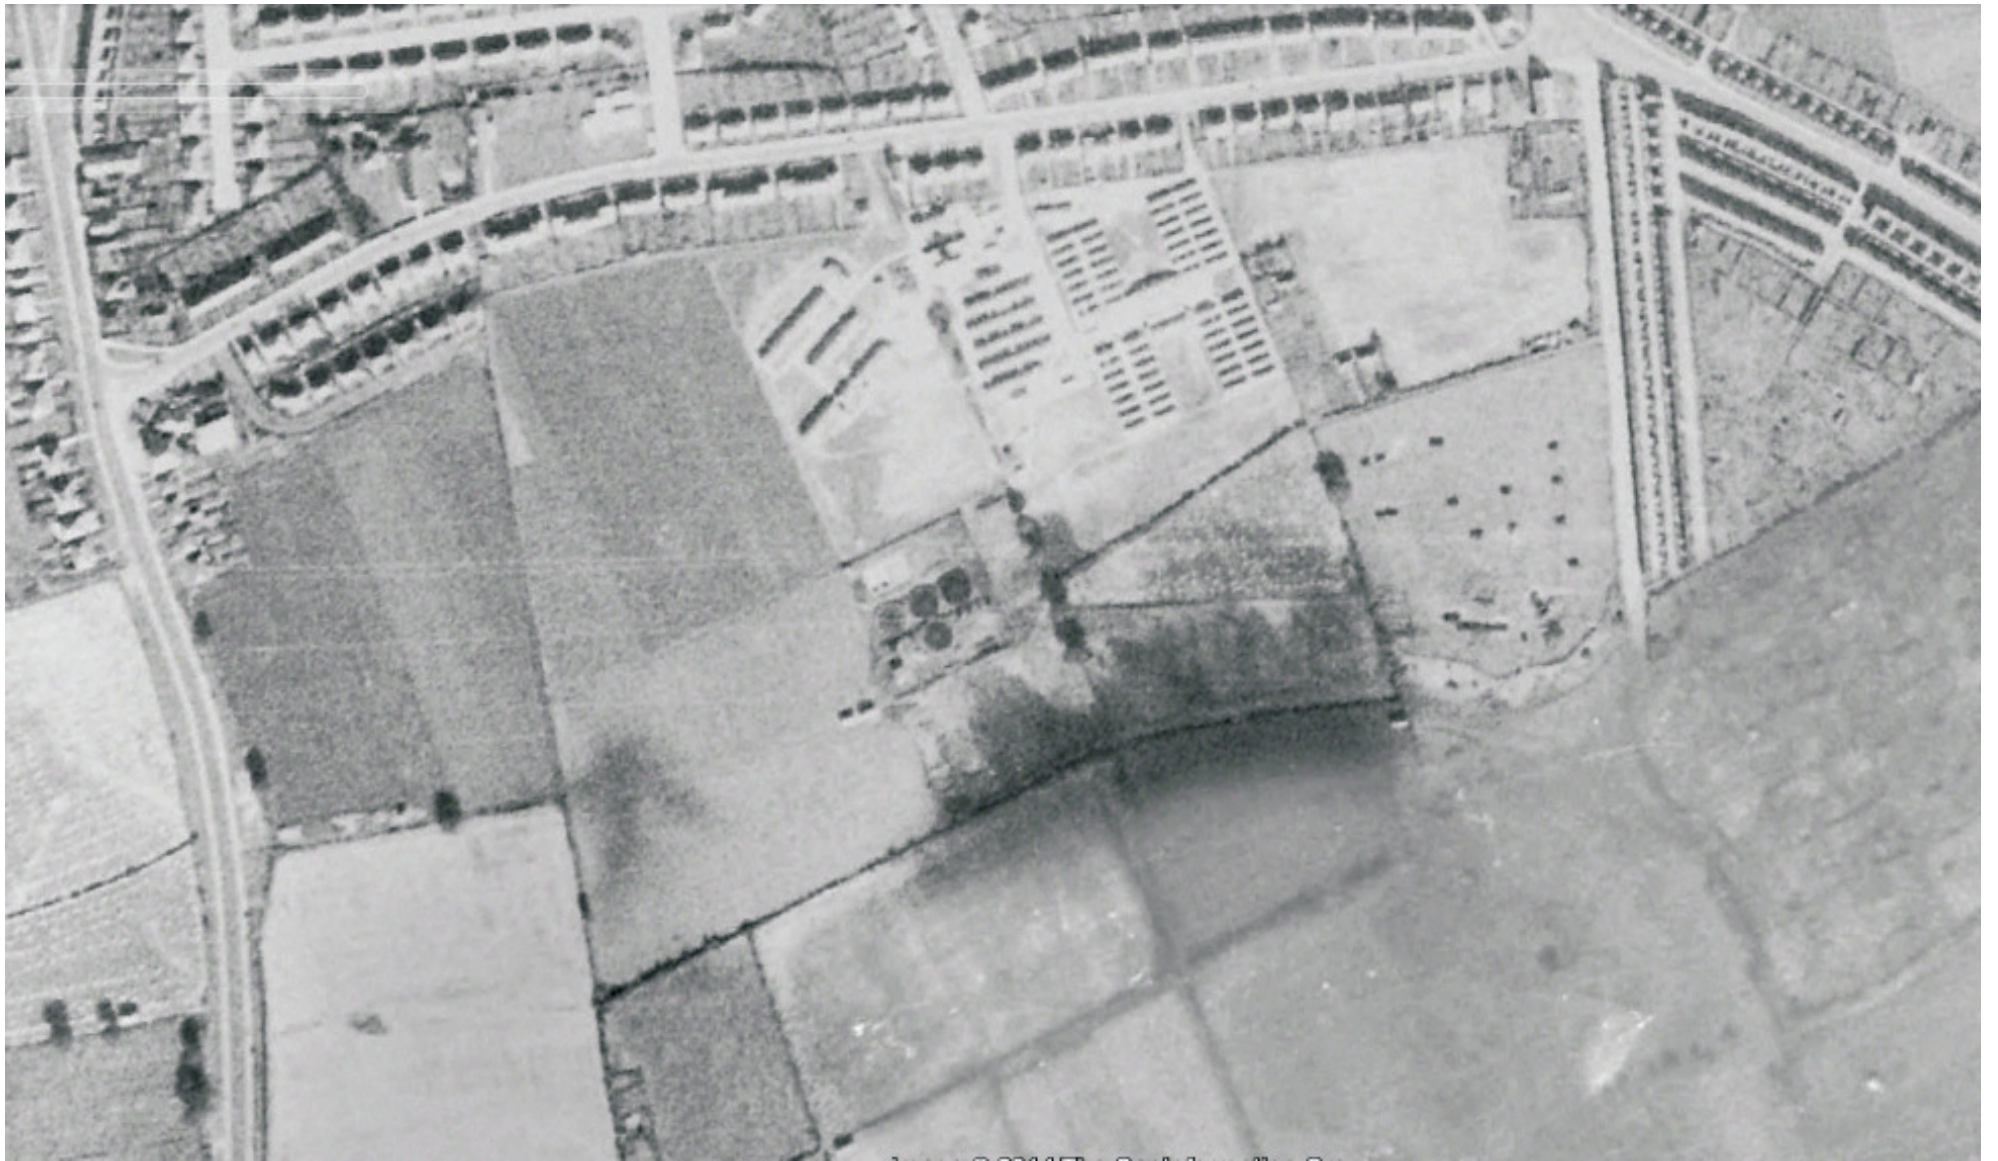
Figure 9: Aerial photograph c. 1945

2.4 An aerial photograph from 1945 shows in addition to the sewage works a series of small evenly spaced structures in the north-eastern field of the site representing the western part of a WWII era camp to provide accommodation for men conscripted to work as miners. Three long thin buildings (last depicted on the 1951 OS map) can be seen running north-east to south-west with areas of hard-standing around them. The sewage work is depicted on mapping until recent times.

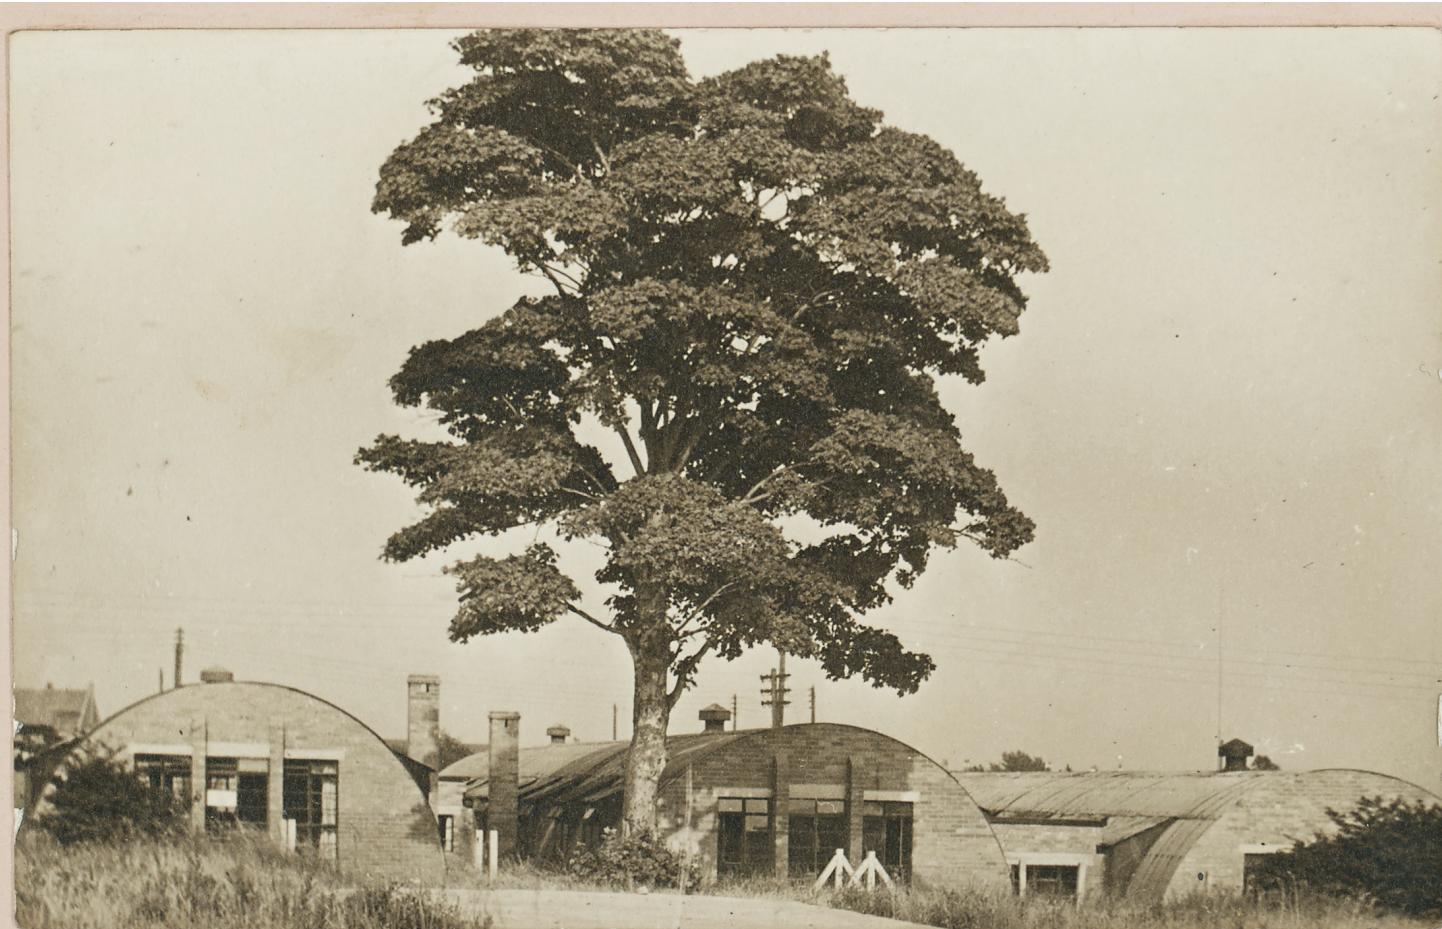
Figure 10: Historic photograph

25. Portion of Miners' Hostel, Dean Road, Ferryhill, erected under the Bevin Scheme in 1943, partially occupied now by Polish and Lithuanian mine workers.

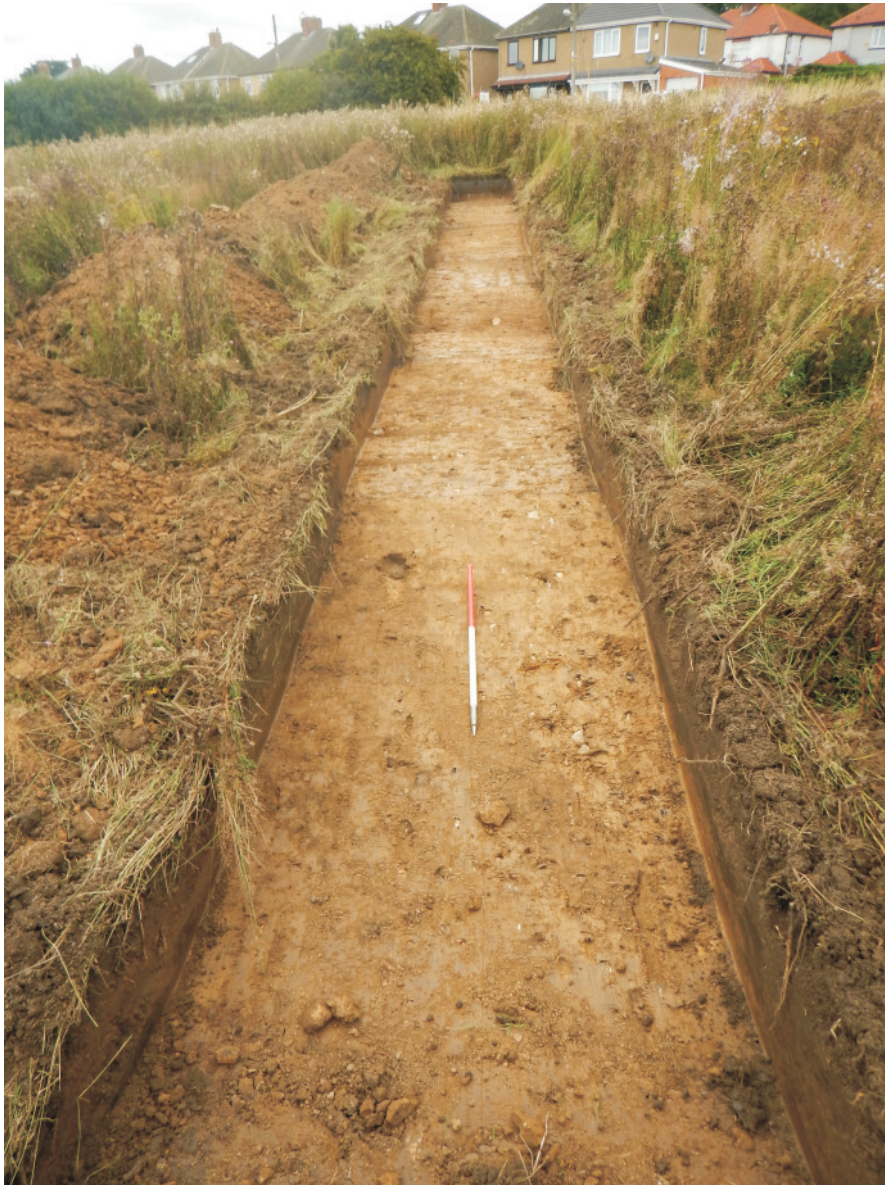
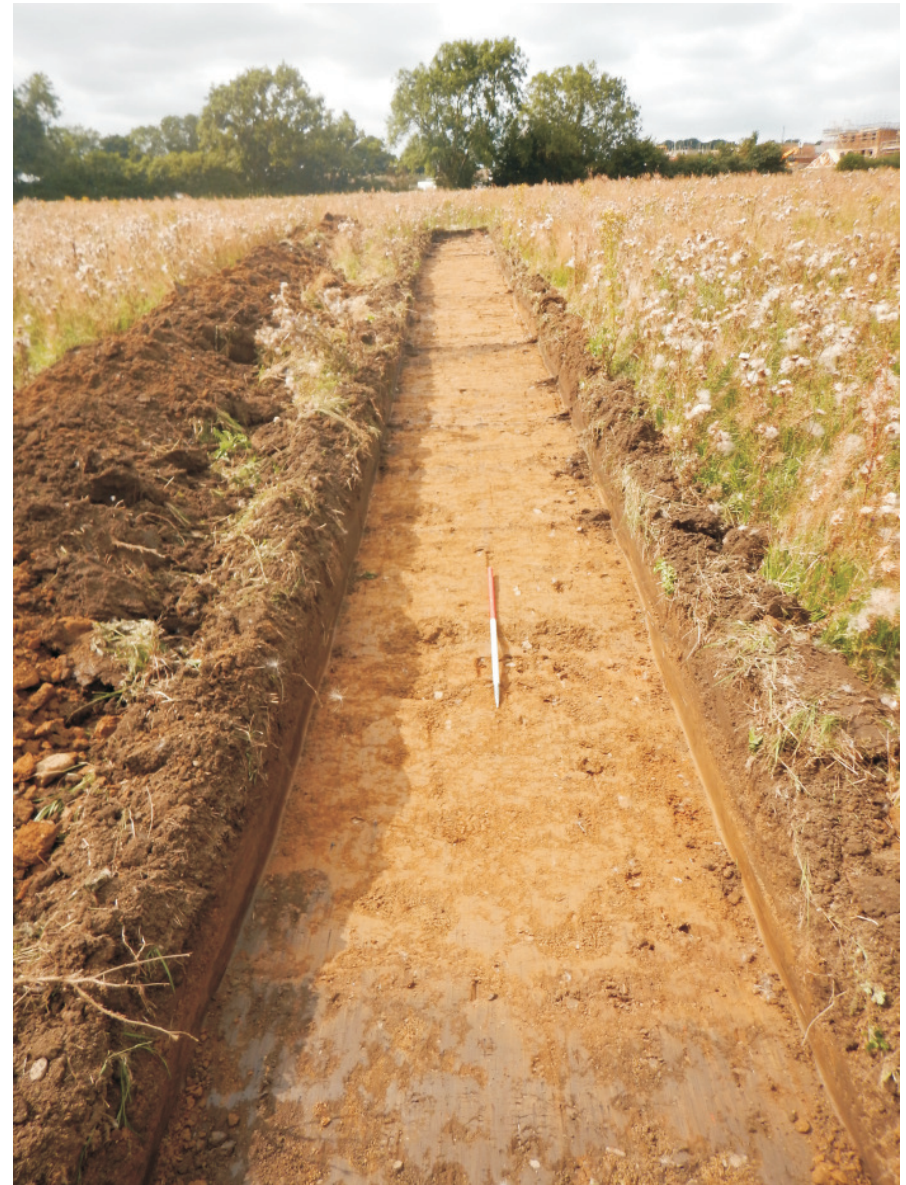
Plate 1: Trench 5 looking NW and Trench 21 looking W

5.3.1 Trench 5, which was 25m by 1.8m in size, was oriented north-west/south-east and located in the north-western corner of the field. The natural subsoil (502) consisting of a yellow clay was located at a depth of 0.35m BGL (129.08m AOD) and was overlain by a grey loam topsoil (500), 0.35m in depth. Three 2m wide east-west furrows filled with a brown sandy clay ploughsoil (501) were located, with a wavelength of 6-7m.

5.19.1 Trench 21, which was 25m by 1.8m in size, was oriented east-west and located in the southern area of the field. The natural subsoil (2101) consisting of a yellow sandy clay was located at a depth of 0.29m BGL (116.76m AOD) and was overlain by a grey loam topsoil (2100), 0.29m in depth.
