THORNTON ABBEY, NORTH LINCOLNSHIRE

HISTORICAL, ARCHAEOLOGICAL AND ARCHITECTURAL INVESTIGATIONS

Research Department Report Series 100-2010

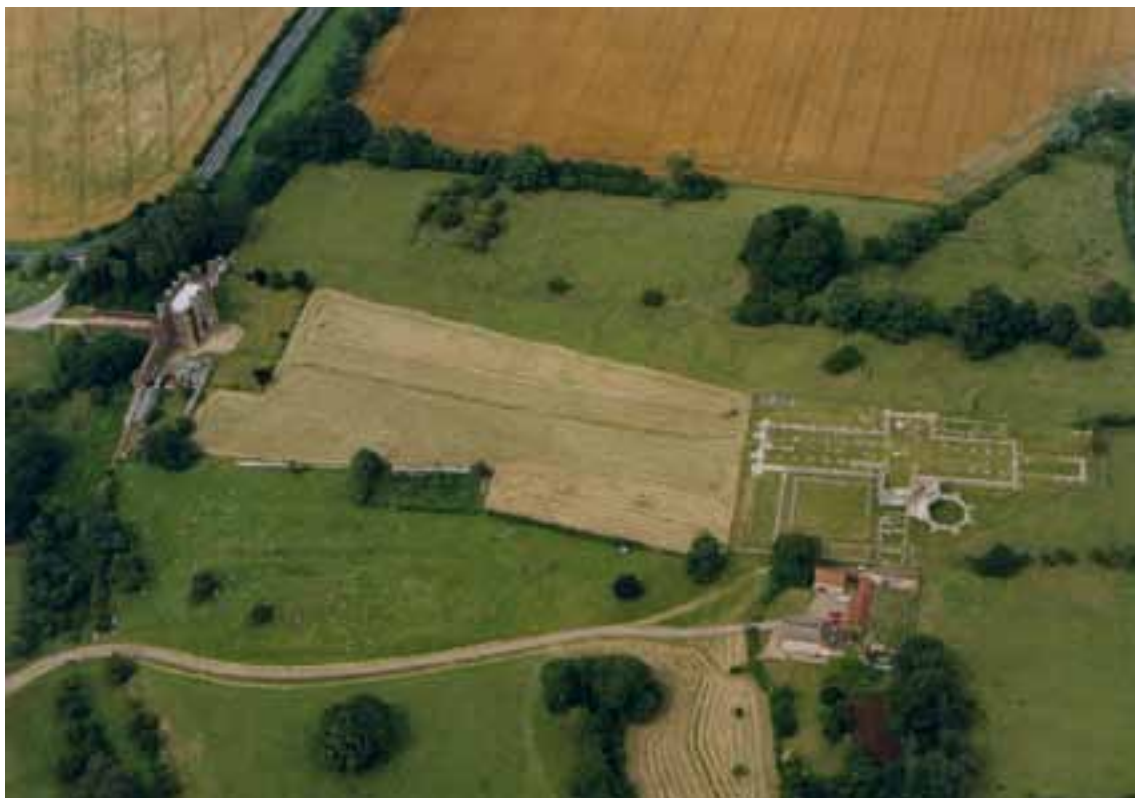
Figure 2. Oblique aerial photograph of the core of the monastic complex taken 19 July 1999, looking north, showing Abbot's Lodge Farm towards the bottom right corner and the late 14th-century gatehouse towards the left-hand side. The earthworks in the pasture between the gatehouse and the ruins of the claustral buildings, including most of those surveyed in 2007, are obscured by cut hay. The land parcel called North Bail in the Thornton Chronicle corresponds to the field containing a ripe cereal crop, at the top of the frame. English Heritage NMR index number TAI118/38, accession number 17295-09.

The abbey's entire precinct, together with College Bridge, a medieval stone bridge which lies just outside the precinct to the north, and an elaborate complex of medieval fishponds located immediately to the south, are designated a scheduled ancient monument (RSM number 13377), while the gatehouse and the ruins (and excavated foundations) of the claustral buildings have been in state guardianship since 1938. The core of the site remains under pasture, allowing extensive and complex earthworks to survive here, particularly between the gatehouse and the remains of the claustral buildings (Figure 2).

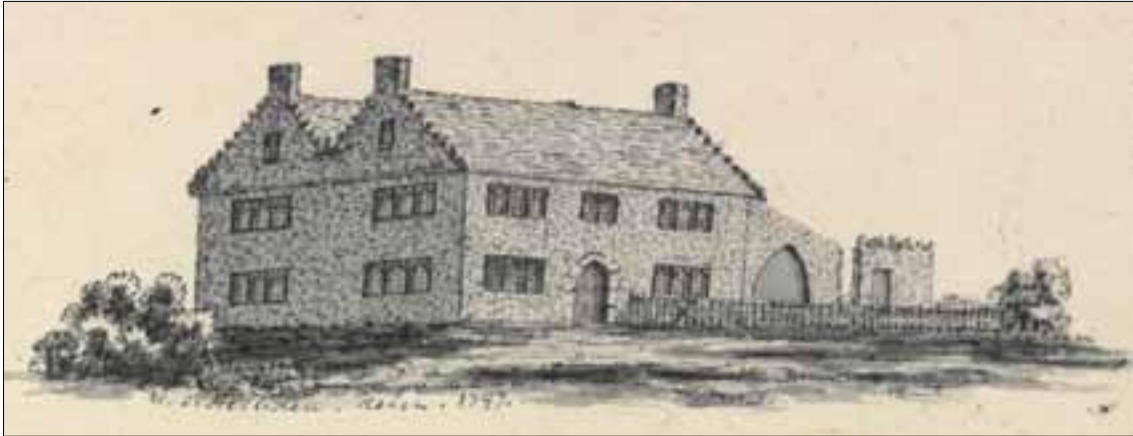
Figure 6. Pencil sketch dated 1787, showing 'Abbot's Lodge' (probably the 'New Hall' built in 1313). The building was remodelled in the 17th century, probably to house Lady Anne Skinner (died 1707). Reproduced by kind permission of Lincolnshire Archives (YARB/11/2/4).

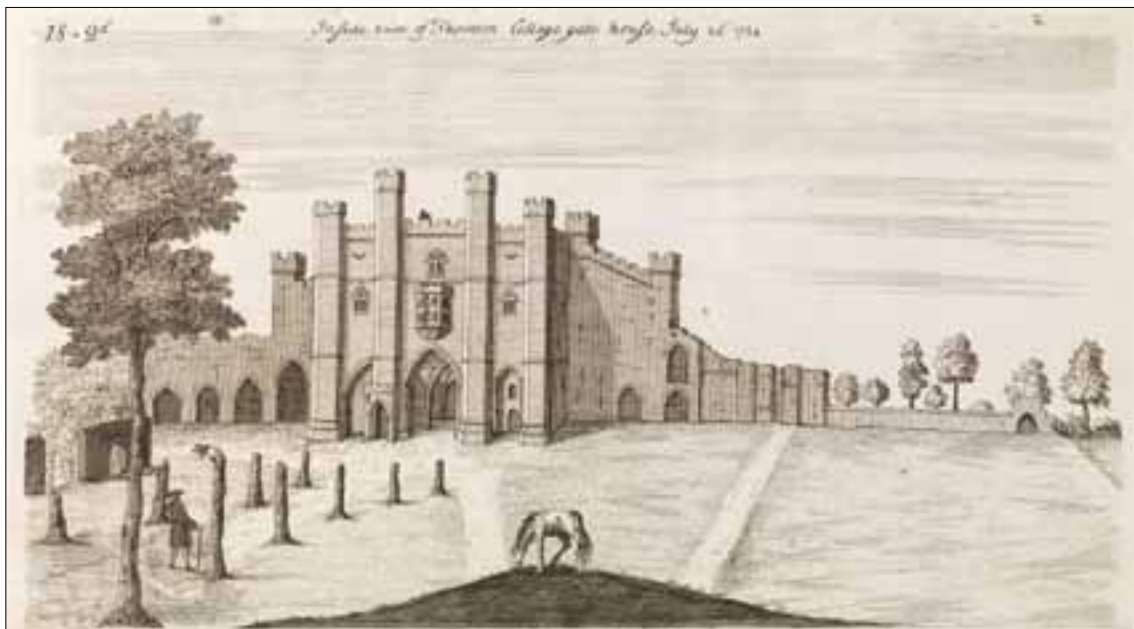
Figure 7. William Stukeley's 1724 engraving of the rear of the gatehouse, showing the remains of an avenue of trees. Note the gateway partly hidden by the intact tree; this is also visible, from the opposite side, on later depictions (see Figures 11-12) (reproduced from a print owned by Mr J Farrow; see also Lincolnshire Archives YARB/11/2/4).

In 1720, Sir Robert Sutton, of Kelham in Nottinghamshire, purchased the estate from the Skinner family. A 1724 engraving by Stukeley (Figure 7) is the earliest of a wealth of depictions of the abbey compiled by successive Lords Yarborough in a scrap-book between the 1850s and early 1900s (Lincolnshire Archives YARB/11/2/4). It shows the rear of the abbey gatehouse, approached by three broad, straight, parallel paths that can all be identified on the ground as earthworks. A mound in the foreground, to

From the current, truncated western end of wall **e**, another stretch of wall, also a later addition, runs northwards parallel to the flanking wing of the gatehouse and then, formerly, turned an obtuse angle to meet the flanking wing, as shown on Stukeley's etching of 1724, Nattes' painting of 1797, Rhodes and Watkins' etching of 1832 and Wallis' plan of 1870 (see Figures 7, 11, 12 and 14). It survives to a maximum height of 2.7m and is made of materials similar to - and possibly reused from - the earlier wall, but lacks a plinth. As mentioned in Section 4.2, the obtuse angle was later deliberately replicated in the design of the 1900 custodian's cottage, giving the cottage its rhomboid plan. The eastern wall of the cottage, though doubtless refurbished, retains the same superficial appearance as the rest of the earlier wall. The foundations of the stretch running to the flanking wing were exposed during excavations in advance of the laying of services to a new visitor facility in 2007 (Atkins 2010, 27-30). Mid-way along this stretch, a broad gateway (which seems to have been blocked by 1797) with a more ornate pedestrian gate (**f**) a few metres to its west, is shown from the north on Stukeley's depiction and from the south on the others; only the narrow pedestrian gate is shown on Wallis' 1870 plan. As described in Section 4.2, the gateway and adjoining stretch of wall were demolished in 1900 to make way for the custodian's cottage, with the position of the gateway, and to some extent its style, carefully reflected in the design of the cottage's front door. The style of the earlier doorway, which is depicted in some detail on the 1832 etching, with hints of other features visible on Nattes' 1797 watercolour, suggests a late medieval origin: it has a pointed arch and at least two levels of plinth on the flanking buttresses. Coppack (1991, 40) interprets this as part of a ruined structure, but even the closest examination of the post-medieval depictions leaves some uncertainty as to whether there was anything more here more than a gateway, albeit one that has undergone modifications.

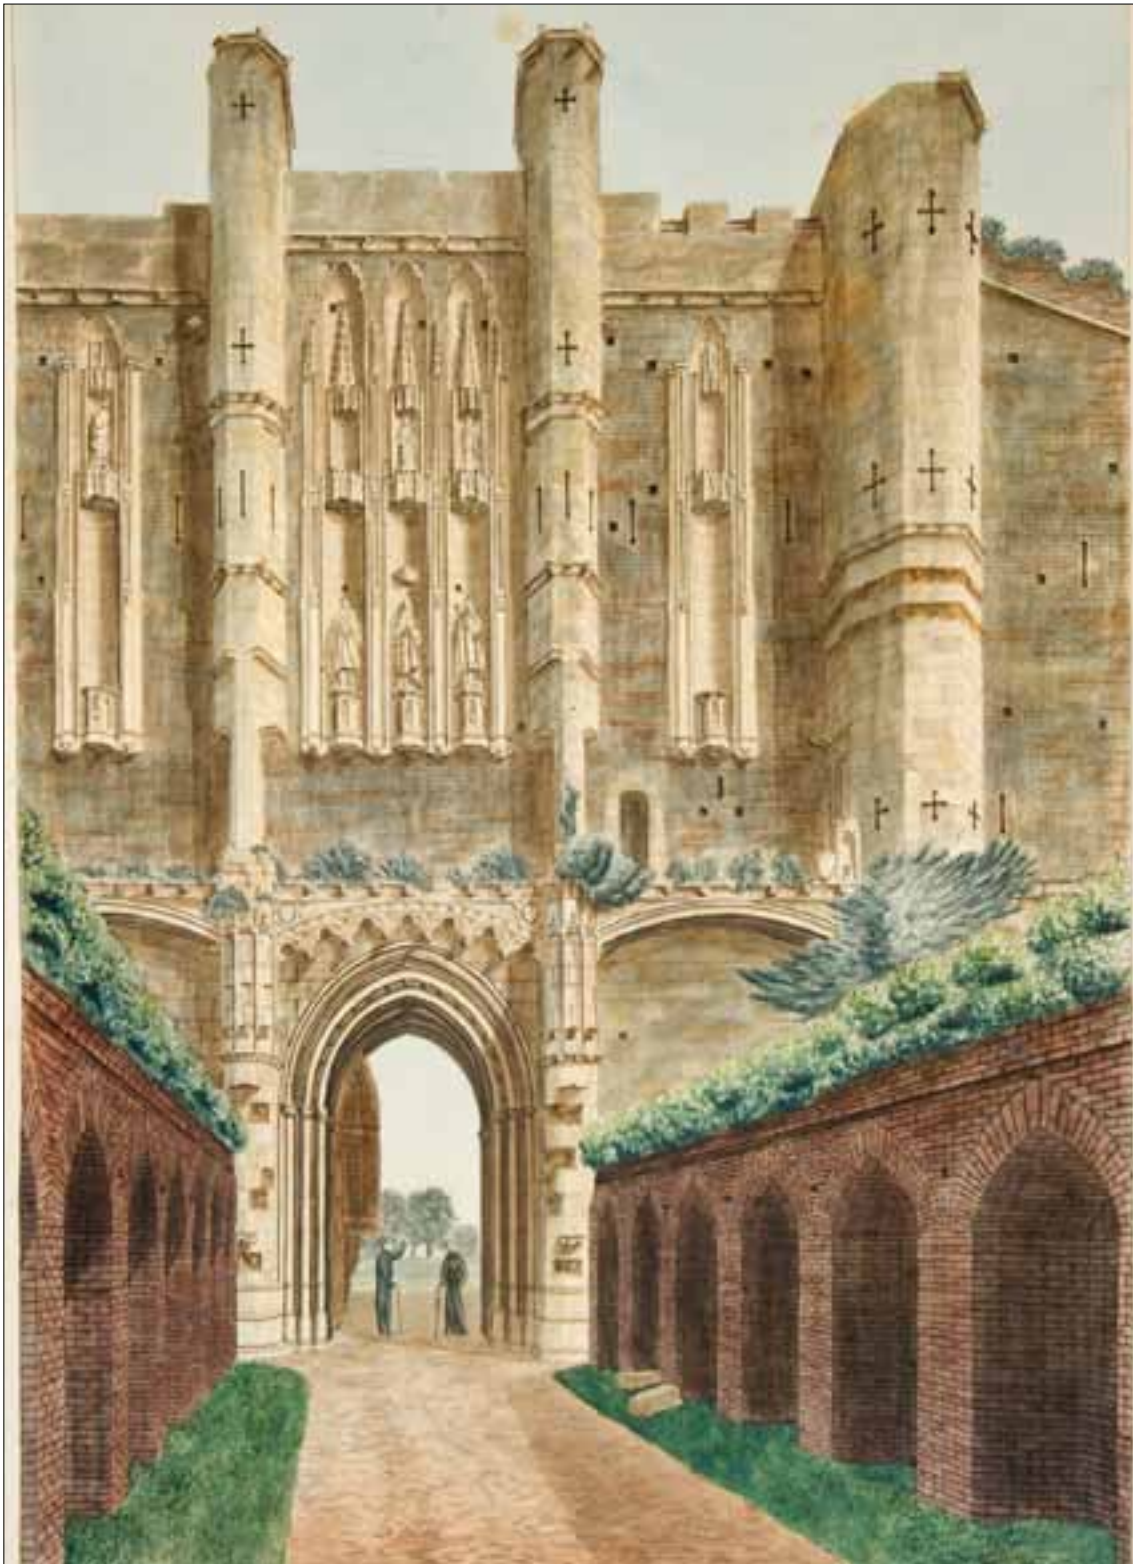
Figure 9. William Fowler's March 1818 hand-tinted engraving of the front of the gatehouse, based on an earlier painting by his son Joseph. Comparison with the same view today shows that little has been altered since the first Lord Yarborough acquired the site in 1816. Fowler collection, volumes 3 and 4, Lincolnshire Museum Service archive at Normanby Hall. Reproduced by permission of North Lincolnshire Museums Service

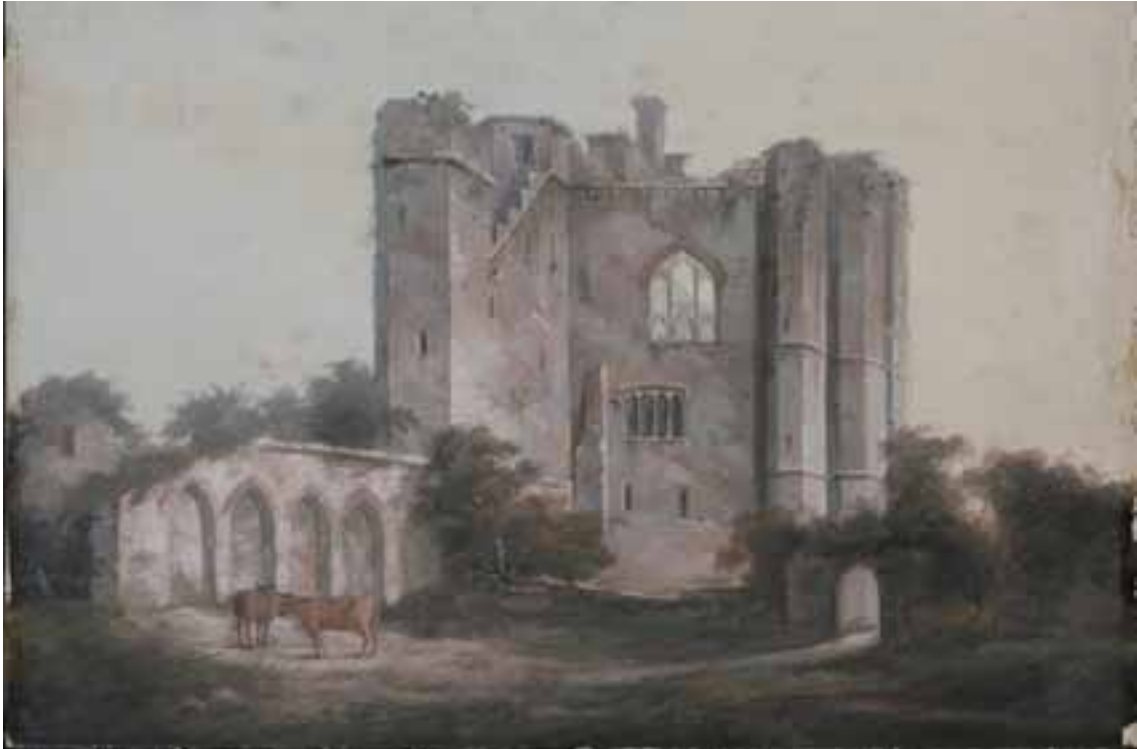
Figure 11. Watercolour of 1797 by John Claude Nattes of the rear of the gatehouse, showing, in the foreground, a pedestrian gateway whose position corresponds, more or less, to the front door of the custodian's cottage built in 1900.

In 1792, George Uppleby of Barrow Hall bought the property. In 1797, John Claude Nattes painted three watercolours of the gatehouse and one of the chapter house as part of a series on the buildings of Lincolnshire commissioned by Sir Joseph Banks (see Figures 11, 21 and 24). The paintings give a good impression of the decay of the buildings; the gatehouse evidently lacked both its roof and its second (timber) floor at that date

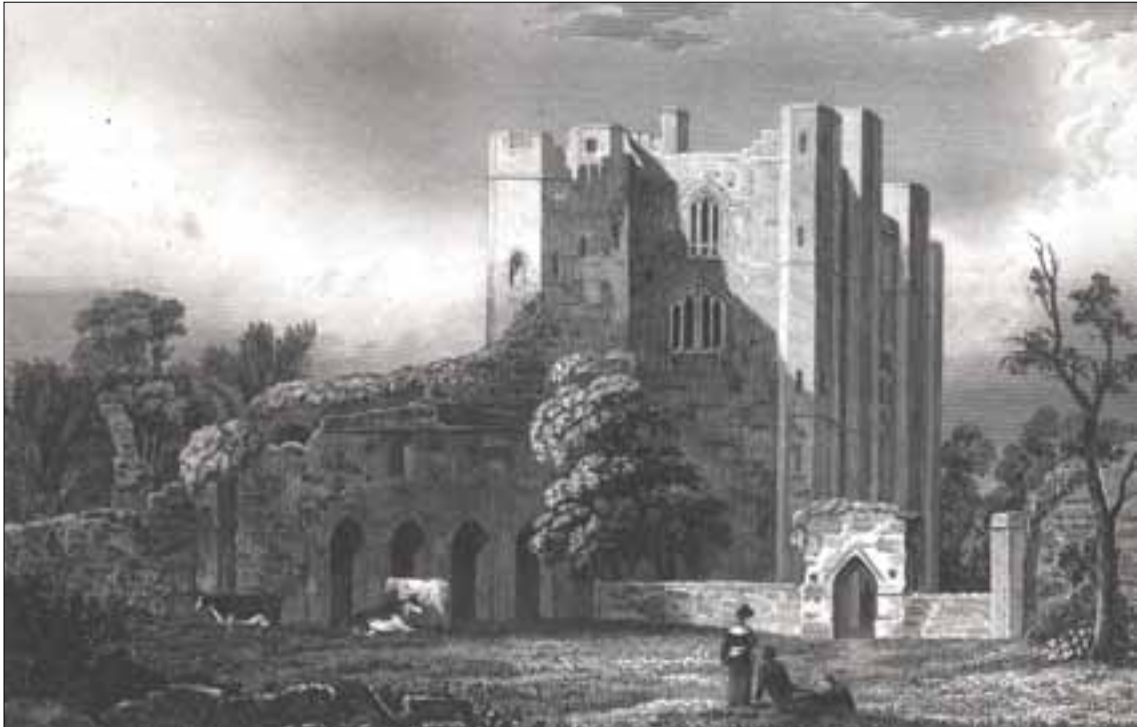
Figure 12. Rhodes and Watkins' 1832 engraving, showing the rear of the gatehouse from a perspective similar to that of Nattes' 1797 watercolour.

An 1832 engraving shows details of the rear of the gatehouse and adjoining boundary wall, including a pedestrian gateway through the stretch of wall later destroyed by the insertion of the custodian's cottage in 1900 (Rhodes and Watkins 1832; Figure 12). This view had been painted from roughly the same standpoint by Nattes in 1797, but showing the boundary wall and gateway partly covered in ivy, suggesting that the first Lord Yarborough's conservation work in the early 1830s was extended to all the monastic ruins. A carriage gate a few metres to the east of the pedestrian gate, which appears on Stukeley's 1724 depiction, is shown blocked on the 1832 engraving and probably on the 1797 painting, though it is barely discernible on the painting. Coppack (1991, 40) describes the masonry as representing 'a ruinous structure', but while Nattes' watercolour hints tantalisingly at details not shown on the later engraving, the depictions give no clear indication that the stonework was part of an actual building.

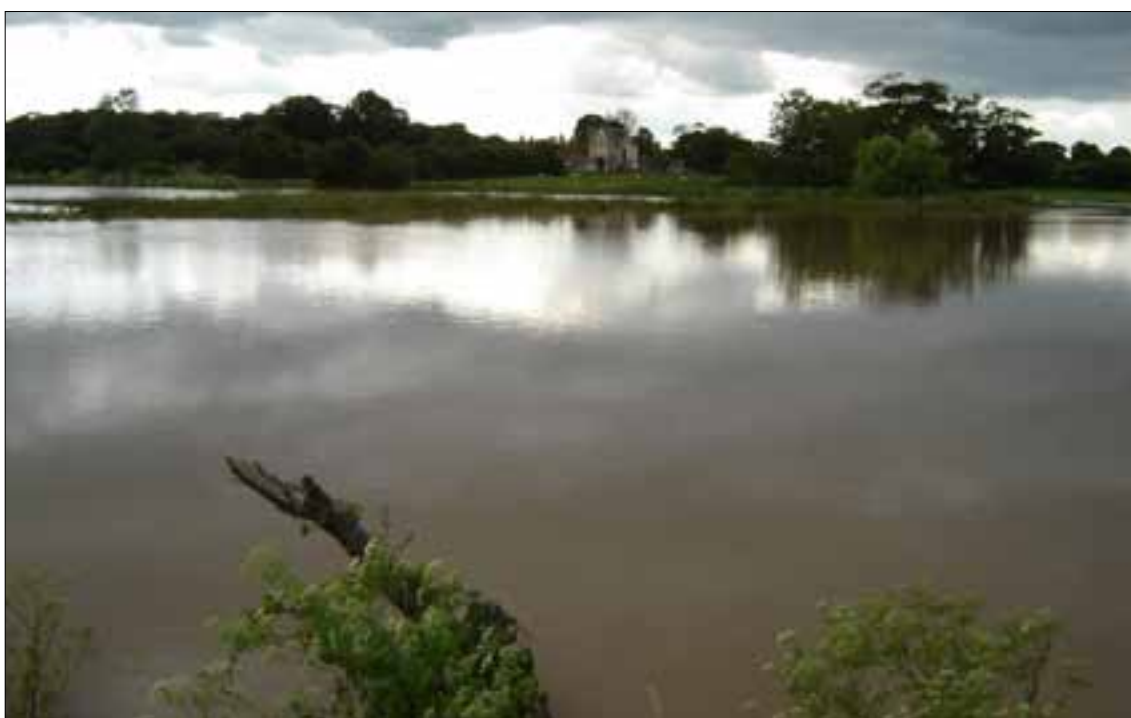
Figure 19. The chapter house, seen from the north-east across the flooded Skitter Beck on 26 June 2007. The floodwaters were held back by the substantial earthen bank south-east of College Bridge, which carries the modern road across the valley and may once have acted as a dam as well as a causeway (see Figure 3). Photograph by Keith Miller.

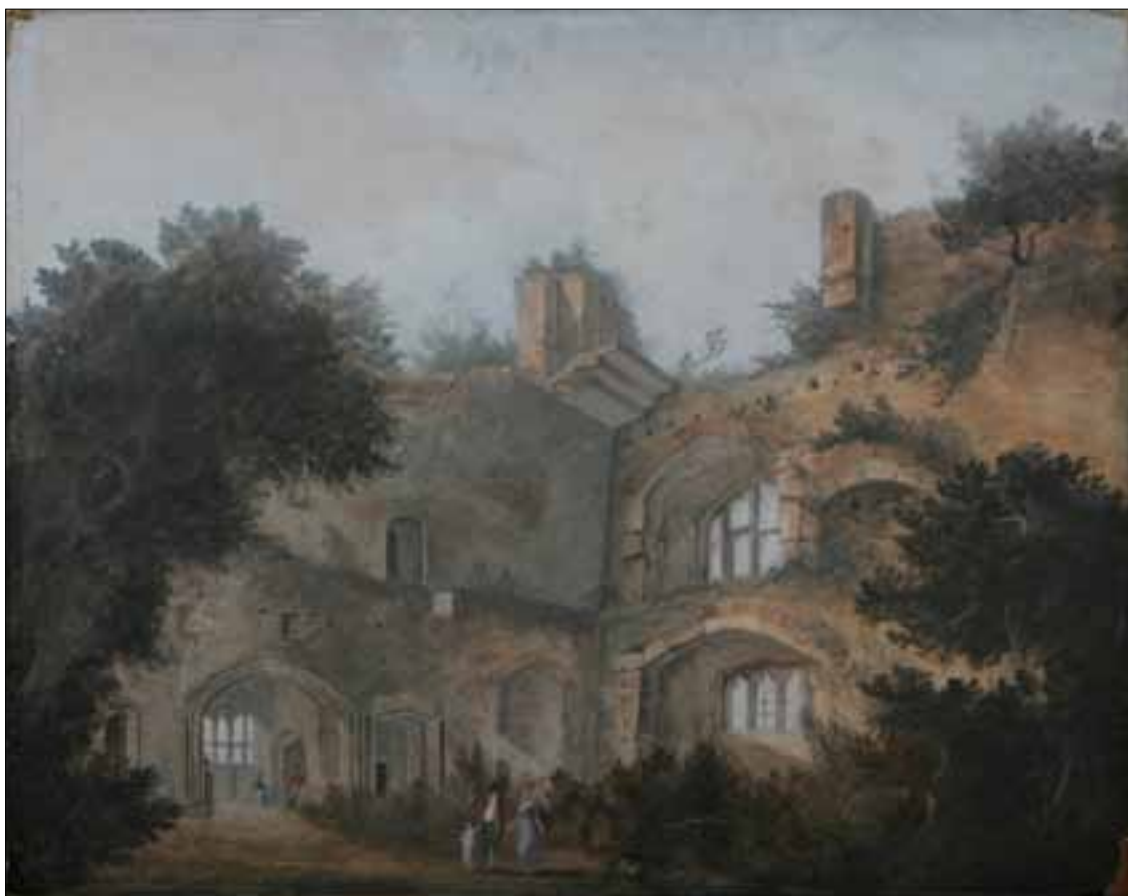
Figure 21. Watercolour of 1797 by John Claude Nattes, showing the first and second floors of the interior of the gatehouse, seen from the north-west.

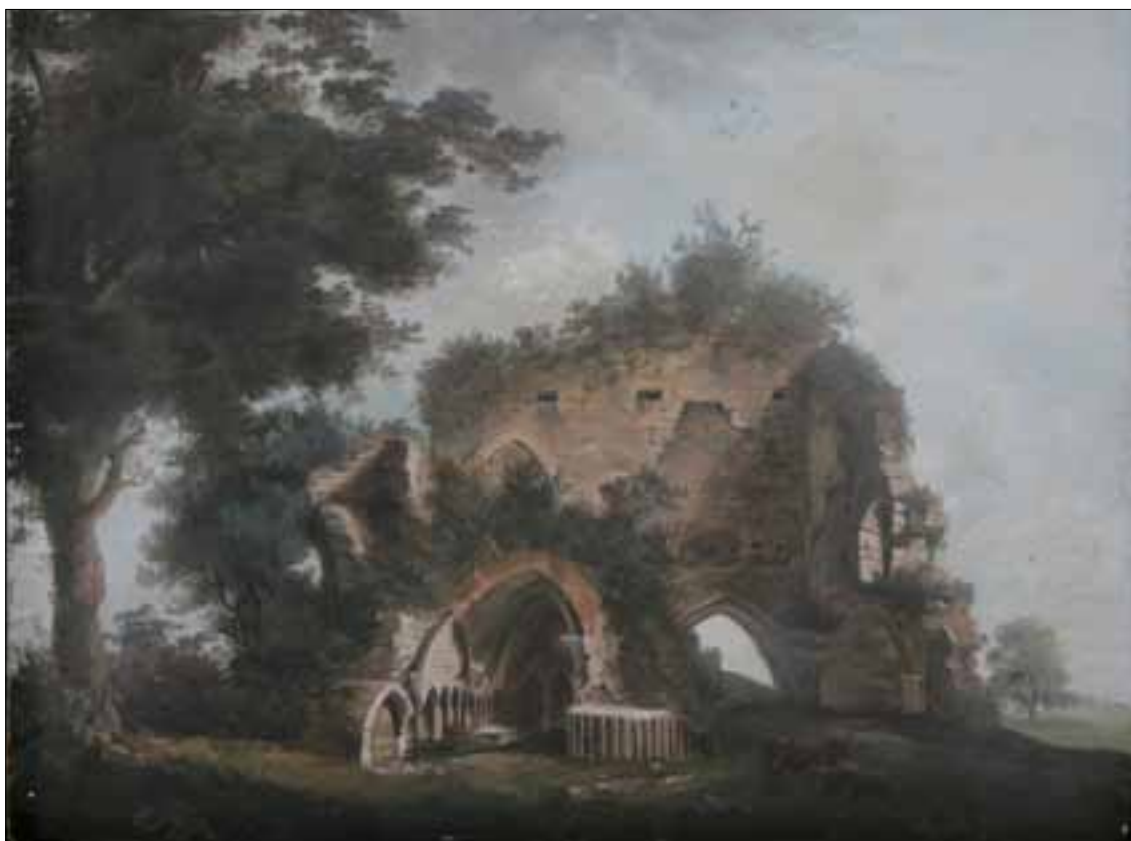
Figure 24. Watercolour of 1797 by John Claude Nattes, showing the ruins of the chapter house from the west. Note the depth of collapsed material.

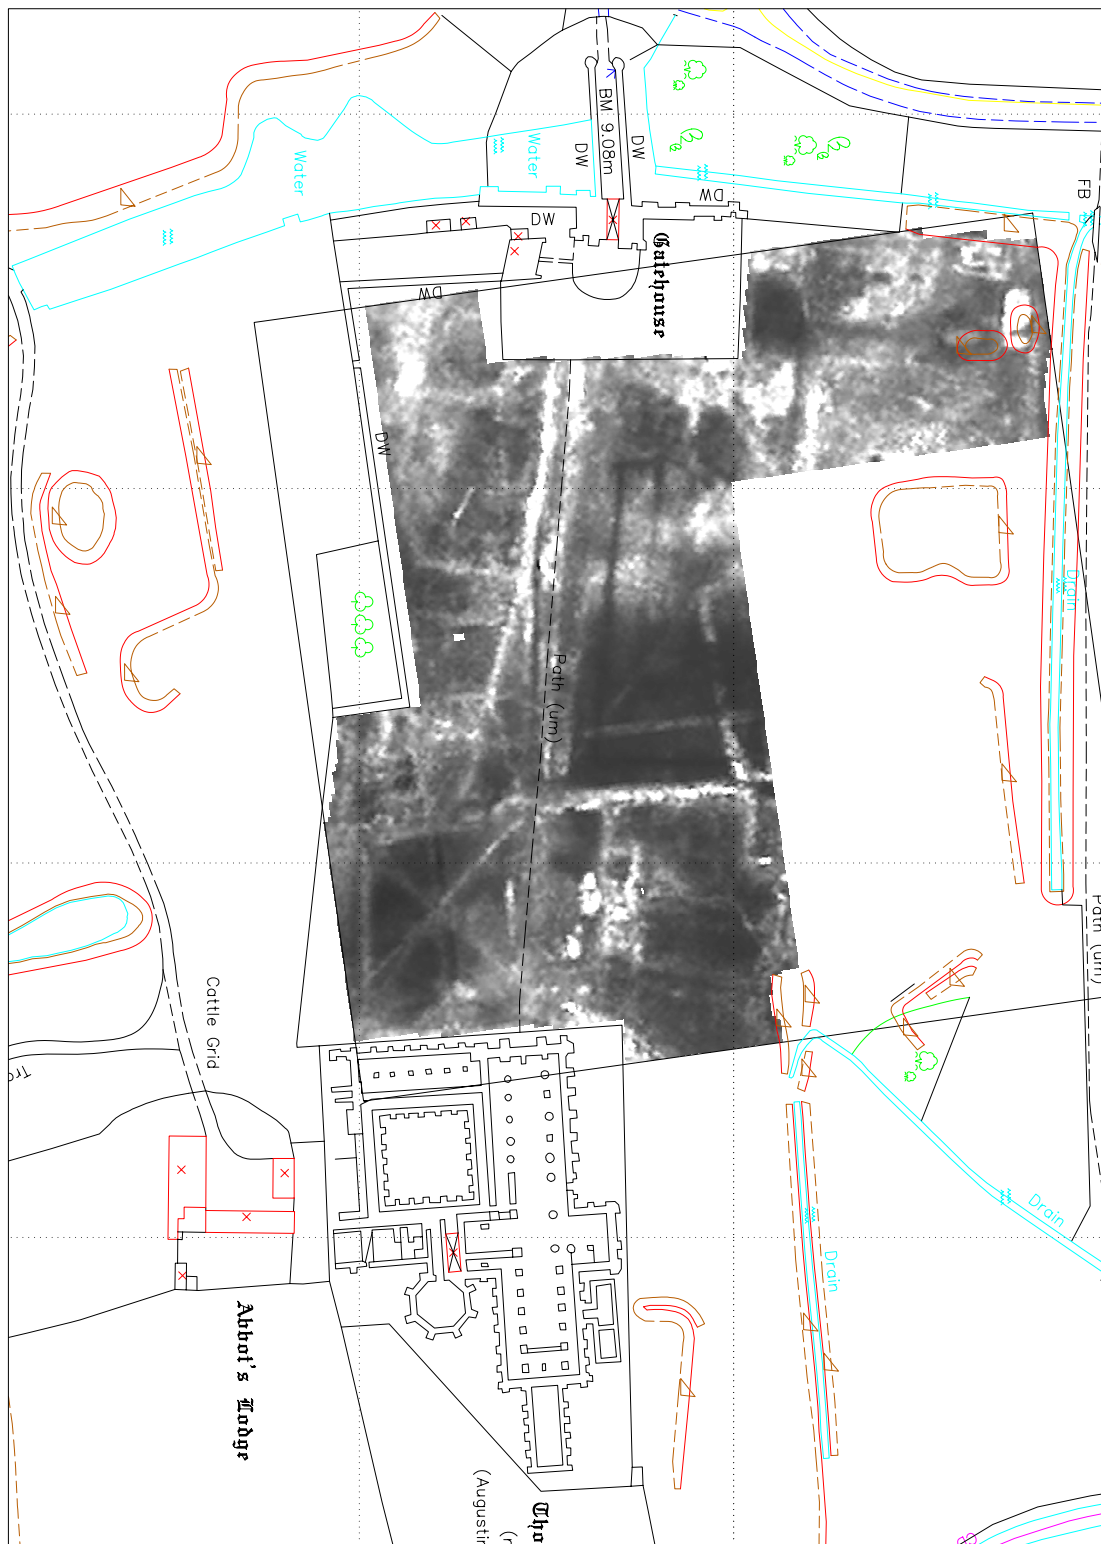
Figure 27. Earth resistance survey data, reduced from original plot at 1:1,250 scale.

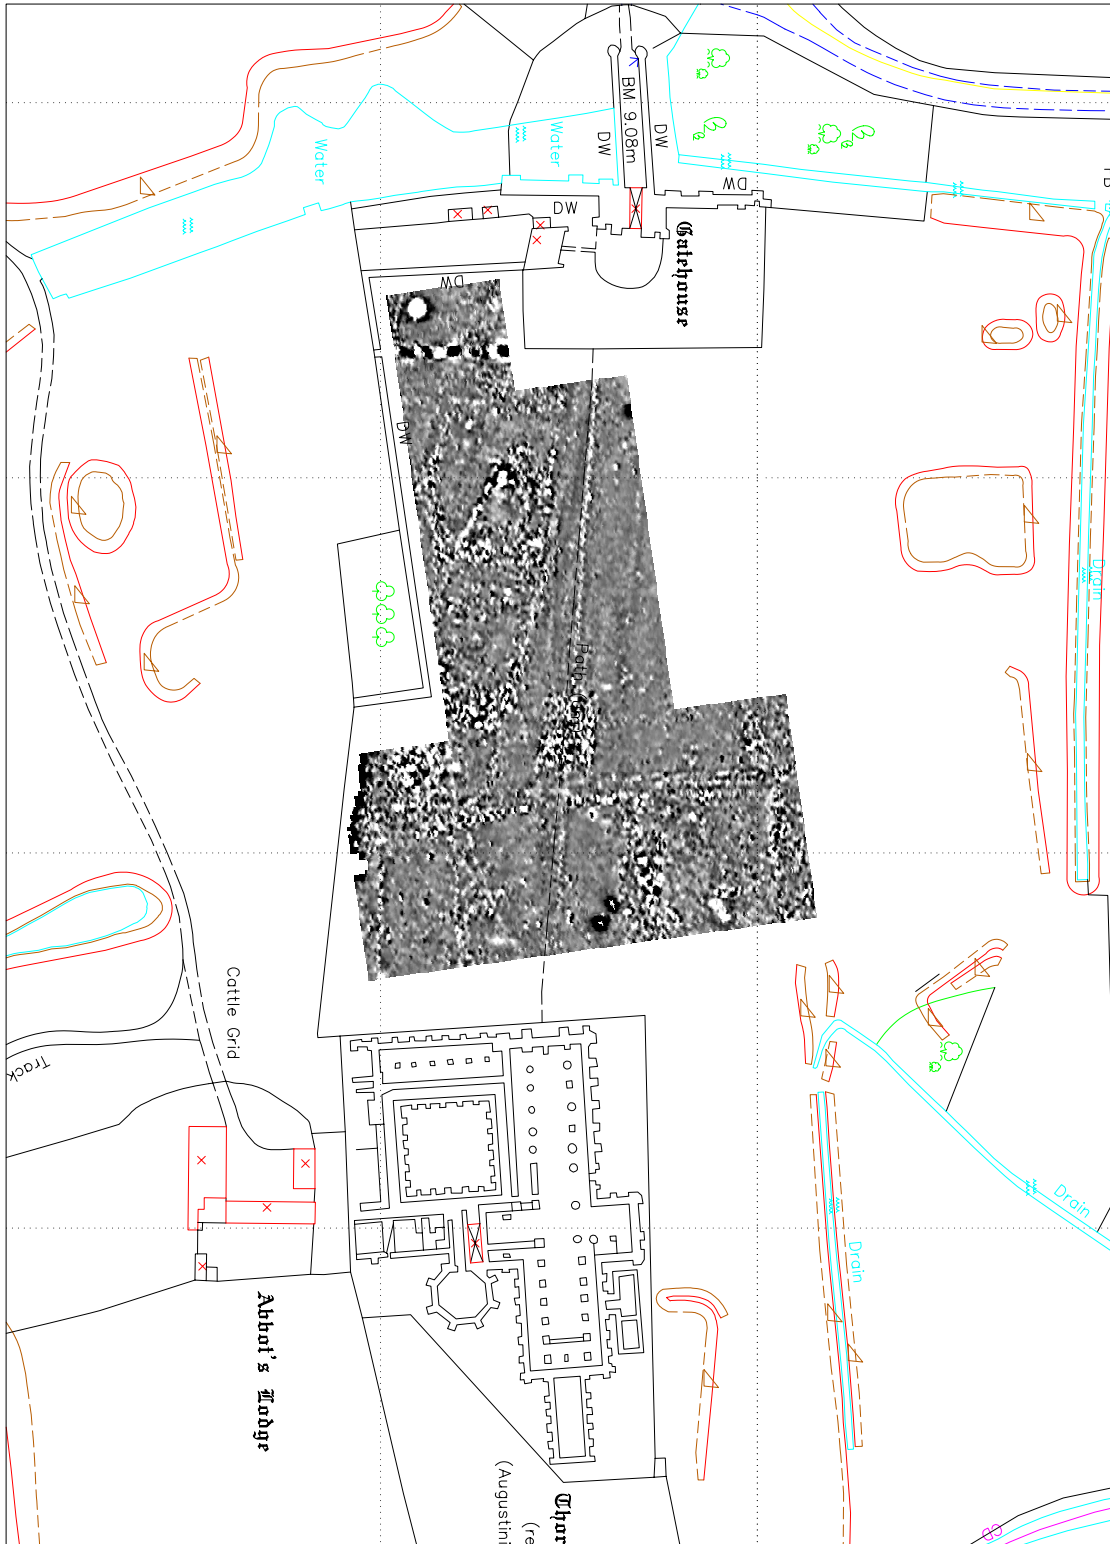
Figure 29. Magnetic survey data, reduced from original plot at 1:1,250 scale.

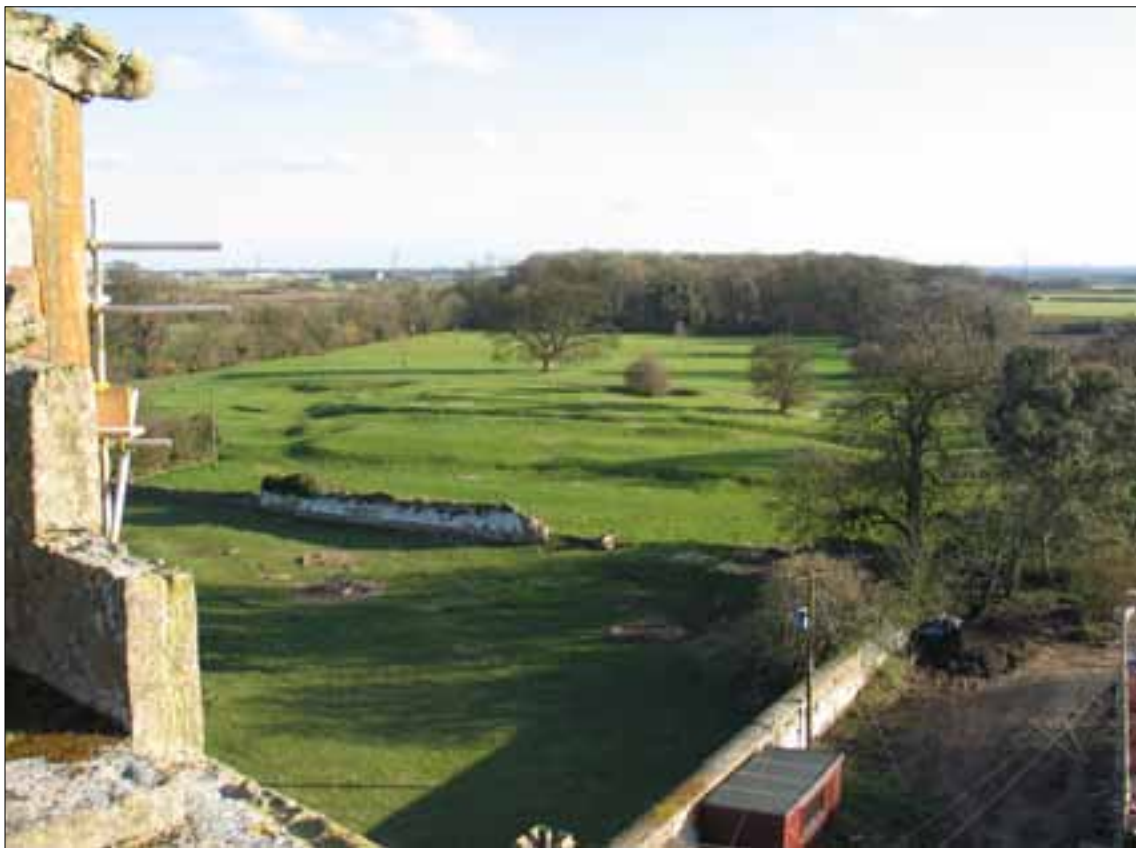
Figure 31. View of part of wall (**e**) and the earthworks beyond it (to its south), seen from the roof of the gatehouse.

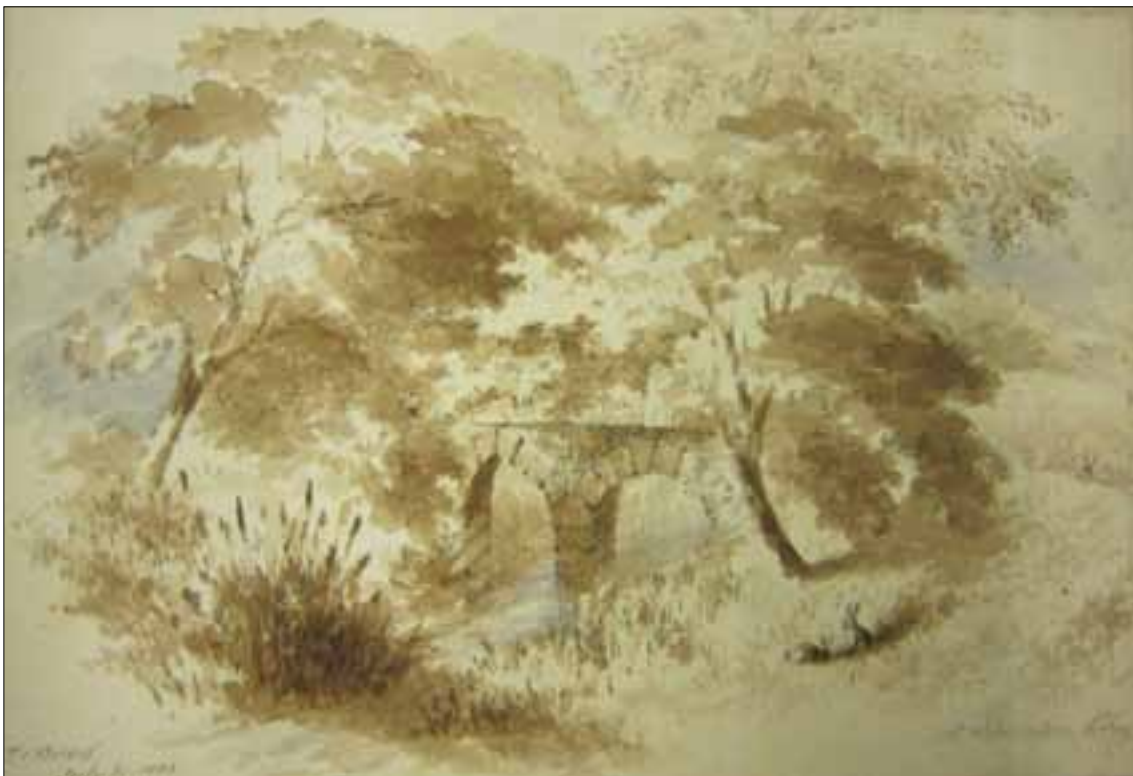
*Figure 32. Watercolour view of the west side of the fine, two-span, 14th-century bridge across water channel (**u1**), painted in July 1883 and pasted into the Yarborough scrap-book (Lincolnshire Archives YARB/11/2/4). Note that the standing water is today retained by material blocking the channel to the east, concealing two more courses of stonework and giving the bridge a rather squatter appearance than the painting shows that it once had. Reproduced by kind permission of Lincolnshire Archives.*

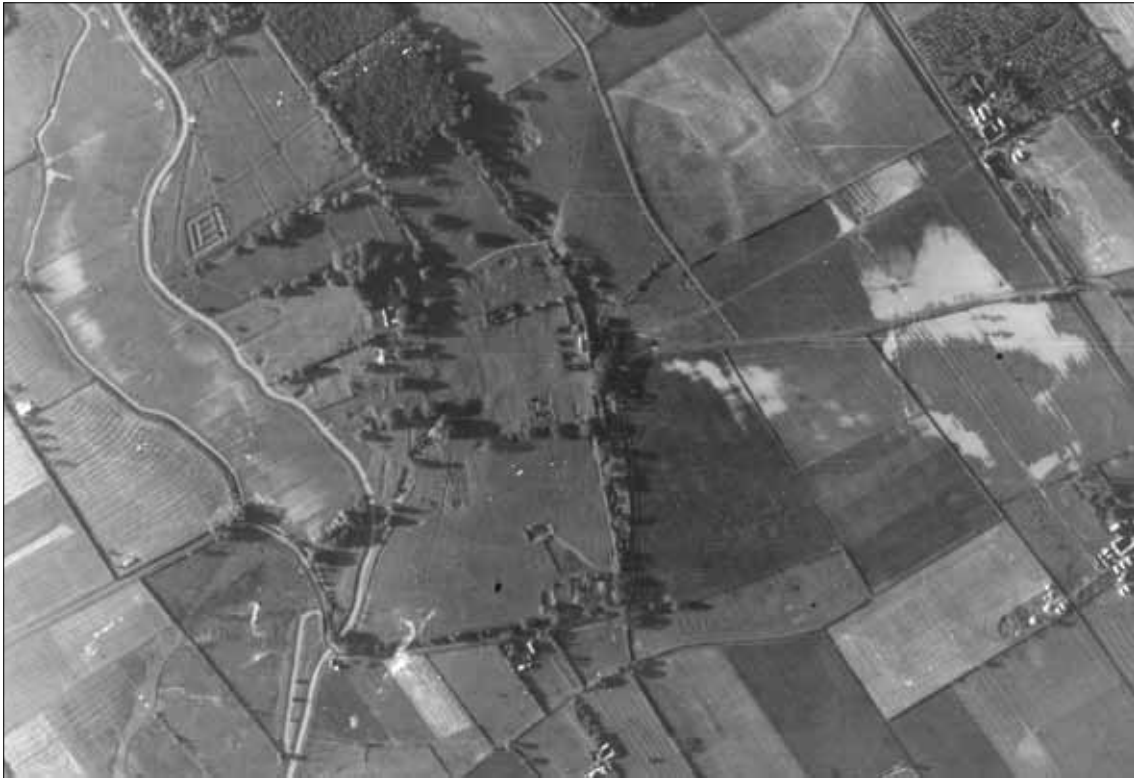
Figure 33. Extract from RAF vertical aerial photograph taken 21 September 1946 (RAF/CPE/UK/11748, frame 4047). Note the widespread ridge and furrow and the well-preserved water meadows north-west of the abbey, subsequently ploughed out.

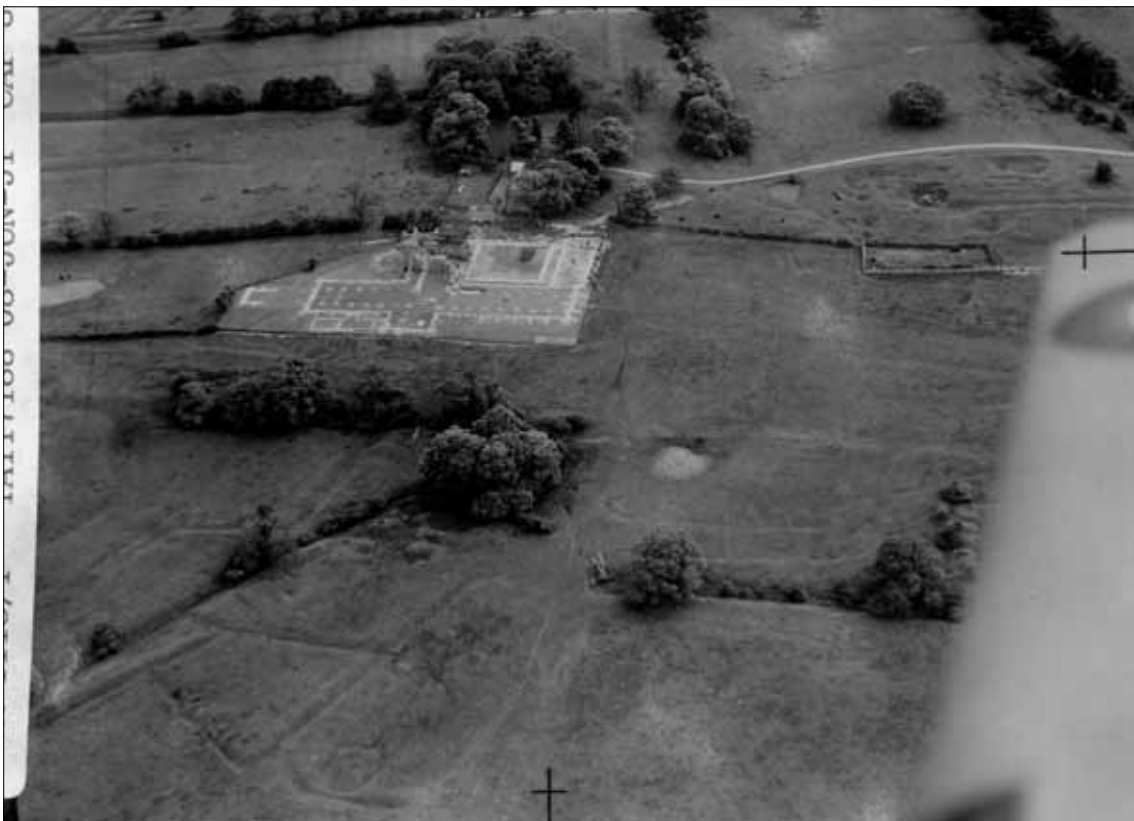
Figure 34. Extract from CUCAP oblique aerial photograph taken 8 June 1951 (CAP8022/73) showing extant earthworks in North Bail which were subsequently ploughed out.

The archaeological features mentioned above are visible as earthworks on the earliest available aerial photographs, which predate the onset of modern ploughing in the North Bail; some features are clearer subsequently as cropmarks. The earliest are RAF vertical photographs taken on 21 September 1946 (RAF 1946; Figure 33). Taken in the autumn, the picture quality is sharp (although marred by a number of horizontal scratches and minor print blemishes), with good contrast, aiding the identification of cropmarks and earthworks. The majority of features were mapped from a stereo pair of these photographs. At this date, the whole abbey precinct appears to have been under pasture, with the earthwork remains in the North Bail consequently well preserved. Additional detail of earthwork features in the south-east corner of the field is discernible on specialist oblique photographs taken by Cambridge University Committee for Aerial Photography in 1948 and 1951 (CUCAP 1948; 1951; Figure 34).

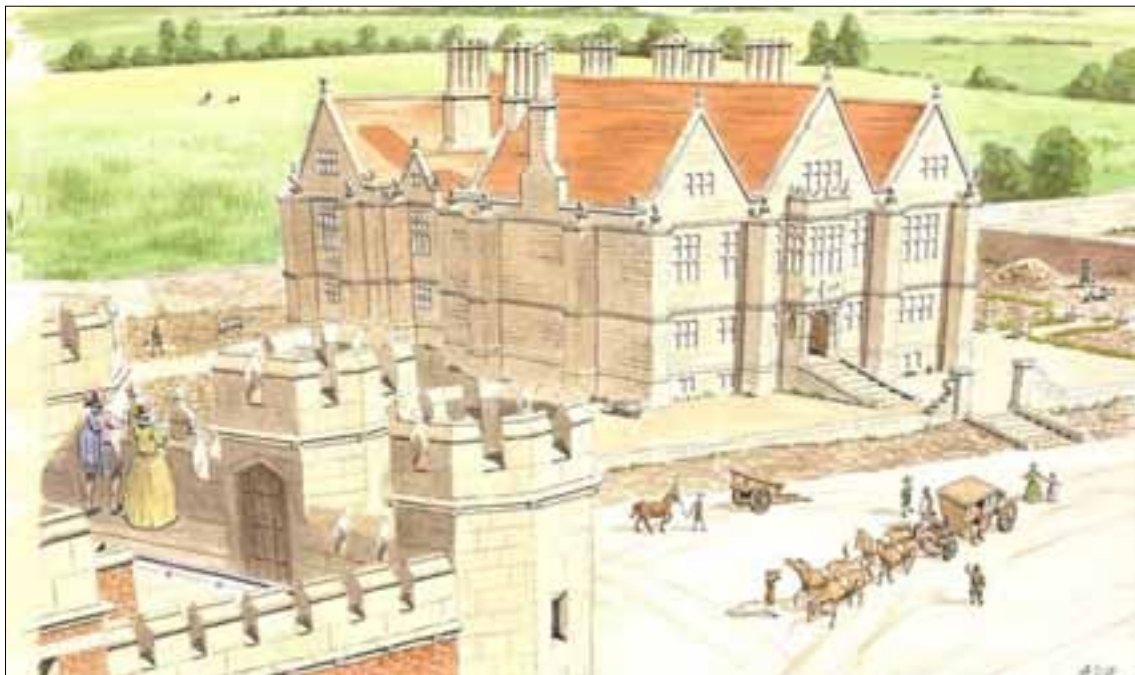
Figure 36. Reconstruction of Sir Vincent Skinner's house of about 1607 (by Gill Atherton).

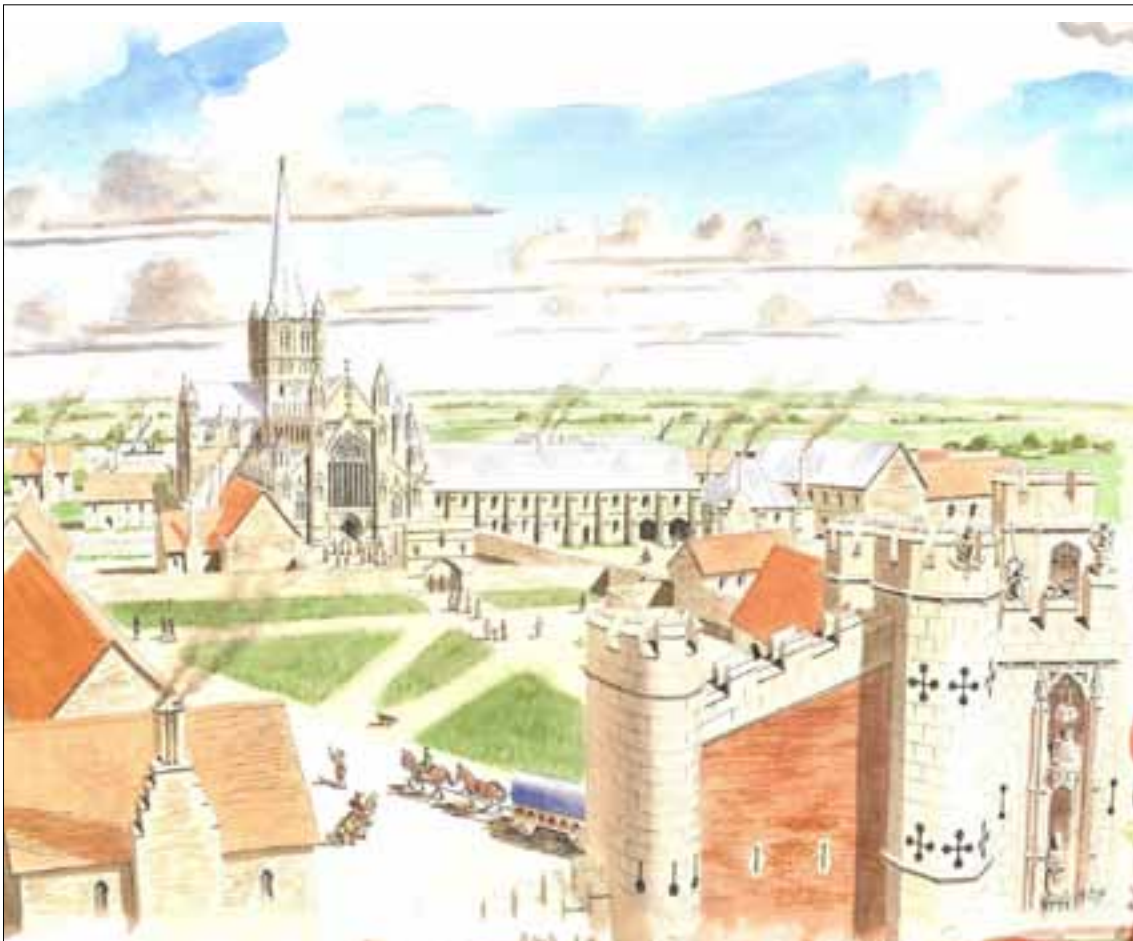
Figure 37. Reconstruction of abbey at the end of the 14th century (by Gill Atherton). Note that the depiction of unrendered brick on the gatehouse is now known to be misleading.
