# PRINCE EDWARD'S BASTION, CHATHAM LINES, KENT TOPOGRAPHIC SURVEY REPORT

**Topographic Survey Report**

NGR: TQ 7646 6878

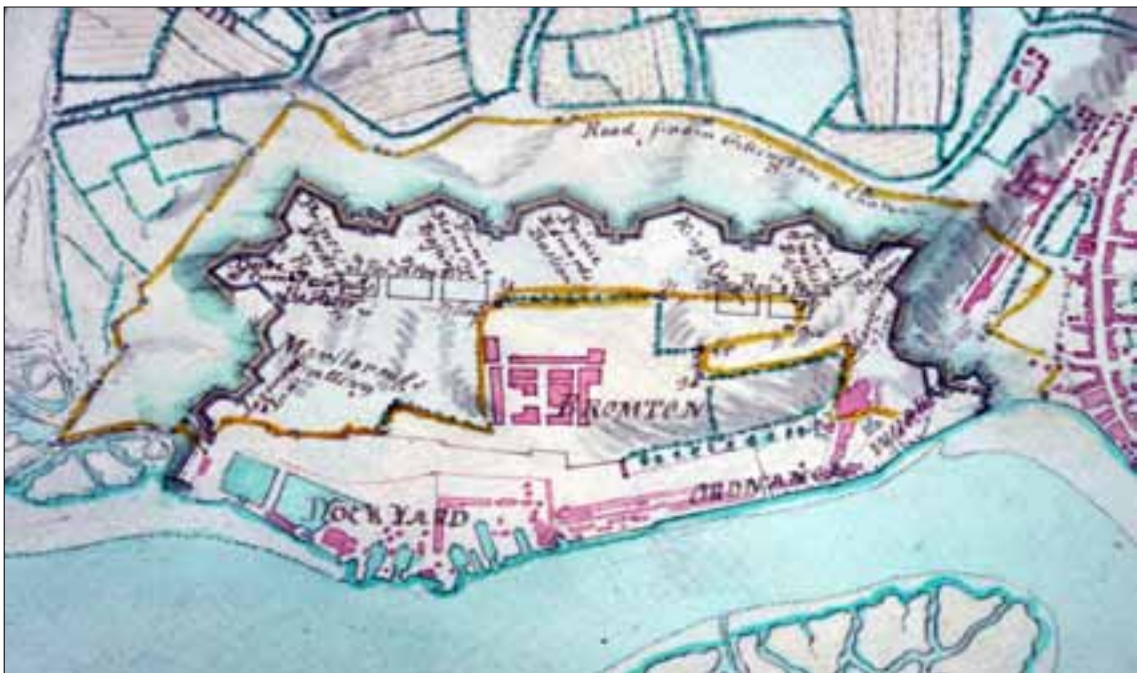
Figure 2 – Detail from a plan of the River Medway showing 'the new line at Chatham and the Fortifications Adjacent', undated (1756-7), north to bottom left (The National Archive UK (TNA UK) MPH 1154).

The early form of these defences is shown in Figure 2. The four bastions at the centre of the fortifications show clearly and beyond these, land was bought and cleared to form a field of fire that was the start of the area now known as the Great Lines. Brompton is the civilian settlement where many of the dockyard workers lived and this was brought within the defences. Not shown in the survey are the first infantry barracks of 1757, built to hold the garrison of troops to defend Chatham, which helps to date the map. In the next period of warfare and invasion threat, the American Revolutionary War (1778-83), the lines were considerably enhanced by the addition of redoubts behind the rampart at their northern and southern ends, but they remained mainly earthwork constructions.

The general plan form of the lines around Prince Edward's Bastion, with four-sided bastions linked by curtains, is that of the original construction shown on the 1756/7 plan (Figure 2). It seems that there was always a centrally placed sallyport on each of the curtains that appear to have originally been fairly simple gaps in the rampart with defensive earthworks behind to control access. There must also have been some form of causeway or bridge crossing the ditch at each sallyport.

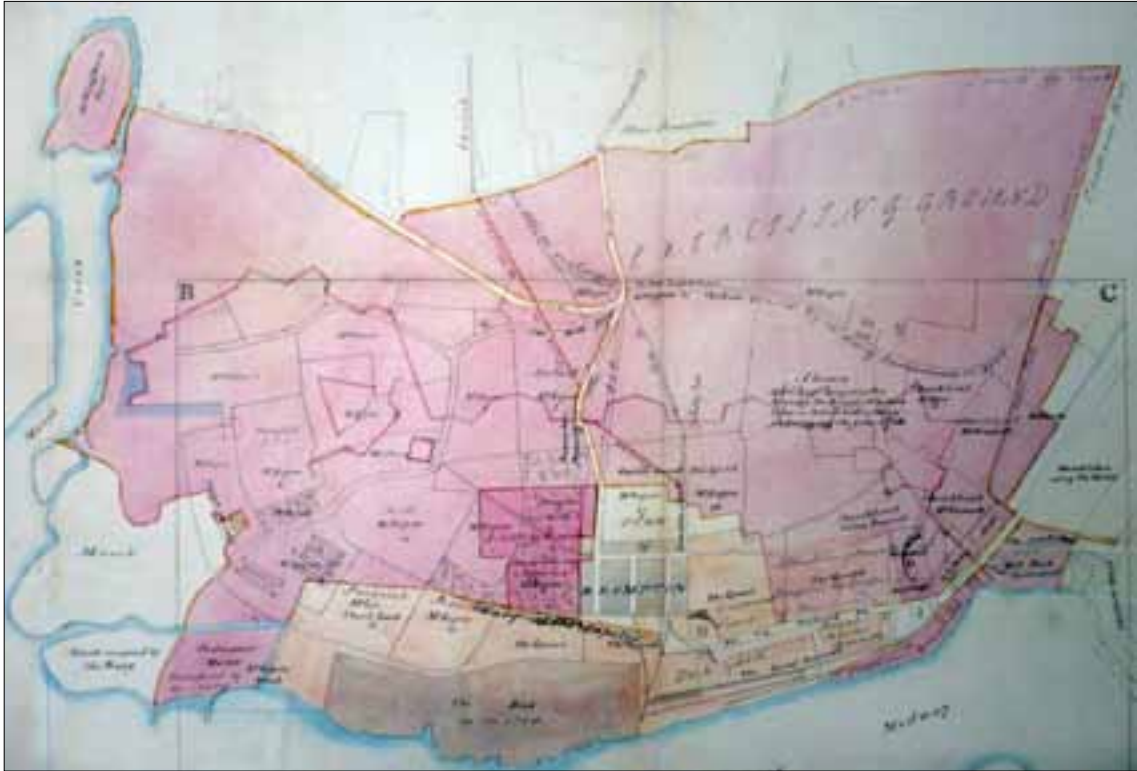
Figure 3 – An 1821 plan of the lines overlaid upon a copy of a survey of 1708, north to bottom left (TNA UK MFQ 1/1280/10).

A plan of 1821 (Figure 3 and Figure 11) shows the outline of the lines by the end of the Napoleonic era (Phase 3 below). Its main interest though is perhaps the underlying plan, a copy of a survey of the dockyard and surrounding lands undertaken in 1708 'in order to make a design for fortifying the same'. It therefore gives a 'before and after' view and the farms and fields bought in order to construct the lines, with named owners, can clearly be seen, as well as the size of the dockyard in the early 18<sup>th</sup> and early 19<sup>th</sup> centuries.

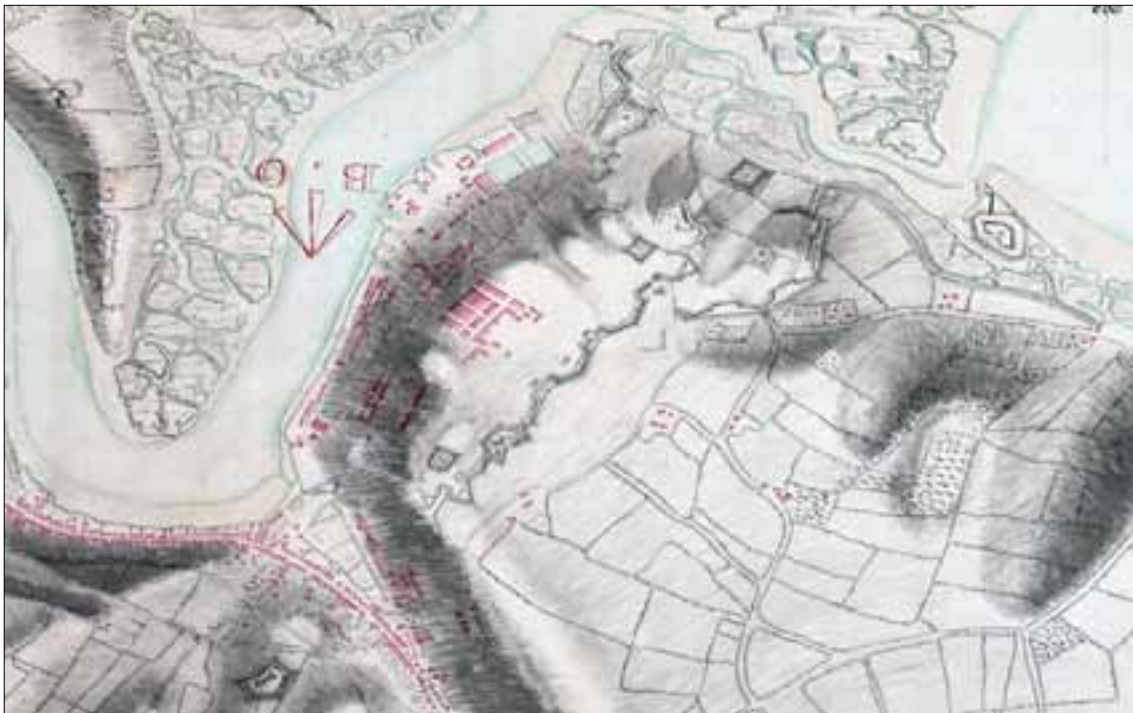
Figure 5 – Detail from a plan of 1779 showing the lines 'as they are to be restored this year' (TNA UK MPH1/358).

also an 'outward expansion of the defences' (Saunders 1989, 121, 122). This can be seen in the intended changes shown on the plans of 1779 (Figure 5) and 1783 (Figure 7), though they were not all implemented immediately. Initially the lines were enhanced at each end, and two redoubts (Townshend to the north and Amherst to the south) were constructed behind these improved defences. Few of the planned advanced works were built at this time though. An insert on the 1779 plan (Figure 6) shows that it was also intended to change the profile of the ramparts, though it is hard to be sure if this was carried out. However, the plan of 1783 shows a terre-plein running right around the bastions and curtains in contrast to the earlier plans, which suggests that the ramparts were rebuilt, confirmed by Debbeig's reports to the Board of Ordnance (Kendall, pers comm). The 1779 plan shows that the terre-plein was to be gained by ramps roughly half way along each bastion face and though these do not appear on the 1783 plan this may be due to simplification. The building shown within Prince Edward's Bastion in 1779 does not appear in 1783 but it is shown on a plan of 1786 (Royal Engineers 1987) together with two smaller buildings to either side. It is hard to see why a building would be shown on a plan of intended works to the lines if it were not already in existence so it could be that the omission from the 1783 plan may also be due to simplification.

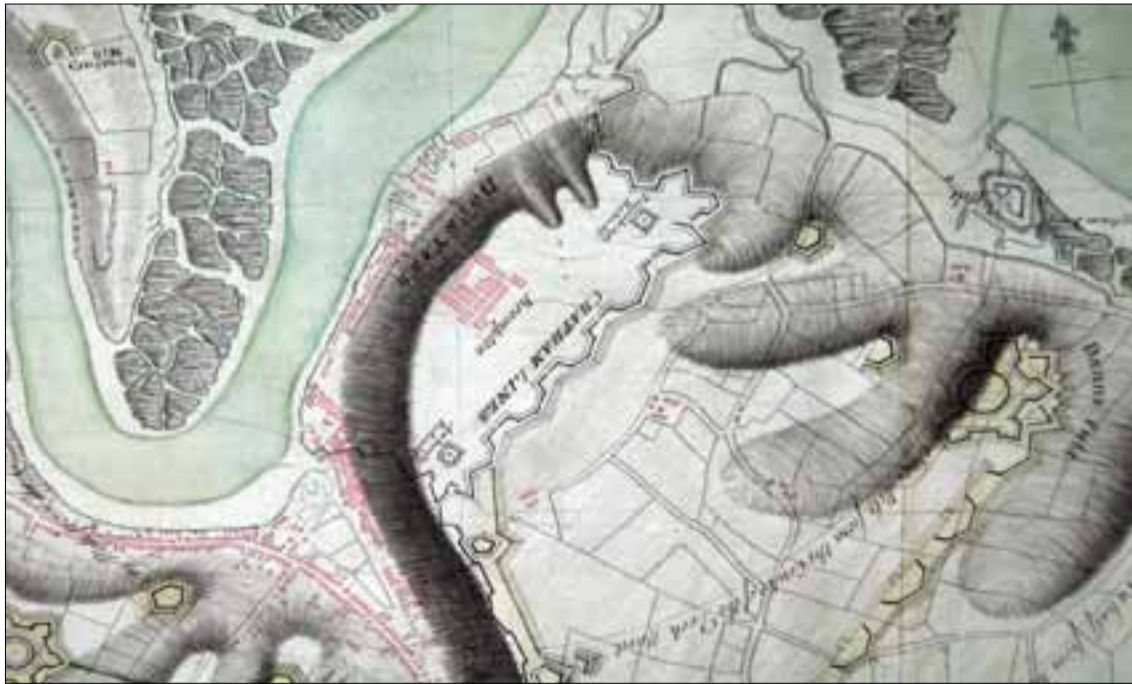
Figure 7 – Detail from a plan of 1783 showing 'the country two miles each way from the centre of Chatham dockyard'. The yellow shaded defences were planned but never built (TNA UK MPH 11296).

The 1879 map (Figure 13) only shows a marked distinction between the terre-plein and banquette along the curtains rather than right around bastion as implied by the sections shown on the 1779 map (Figure 6) and the plan of 1783 (Figure 7). If this is correct and originally the banquette ran right around the bastion then the terre-plein had probably been raised and broadened. If this was for military reasons, such as to allow for larger guns, then this would be the most likely context (but see Phase 4 below). The broad platform within the south angle of the bastion is all that remains of this feature.

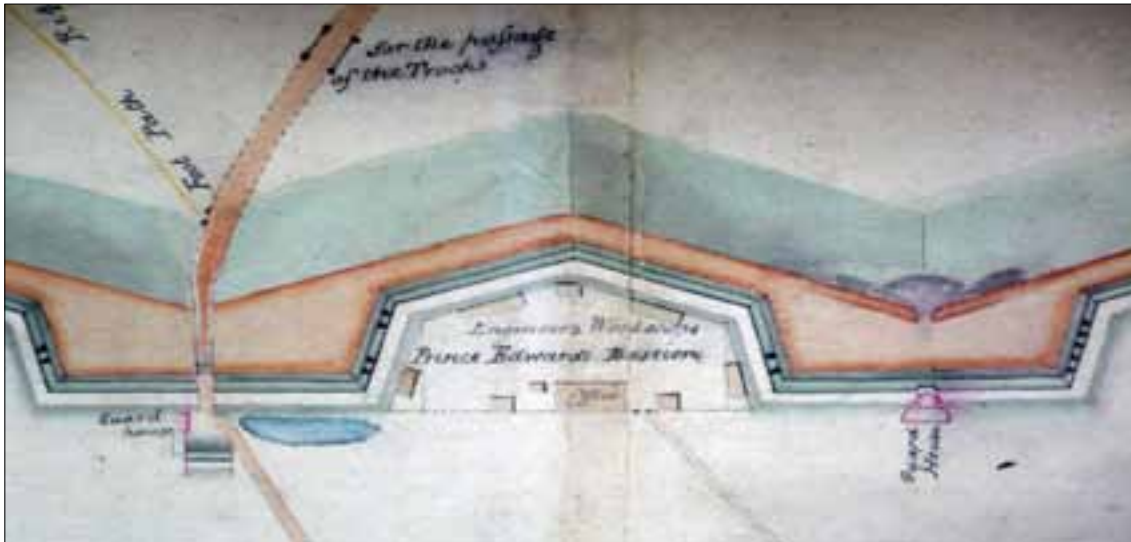
Figure 8 – Detail from ‘Plan shewing the boundary of the ordnance lands at Chatham...’, 1806, north to bottom left (TNA UK MR 1/81516).

By 1806 (Figure 8), and probably by 1804 (if the information in Figure 10 is correct), the rear face of the parapet, the scarp and the counterscarp had all been steepened and revetted in brick and embrasures inserted into the rampart. The sallyports, being weak points, were strengthened. That to the south consisted of an arched gateway through a continuous rampart with a substantial brick-built guardhouse behind to prevent direct access to the parade beyond. That to the north appears not to have had an archway and may have been larger. The guardhouse here was set off on the north side of the road but a wall and a dogleg in the road again prevented direct access through the gate. The approaches were reinforced by opening out the ditches in front of the curtain, which had previously followed the rampart more closely (compare Figure 4 with Figure 8), allowing more effective flanking fire from the bastion faces to either side. The sally-ports would have been approached via causeways with drawbridges, probably of wood, immediately in front of the ramparts. This was clearly the case to the north of Prince Edward's Bastion but no drawbridge or causeway is shown to the south (see Figures 8 and 10).

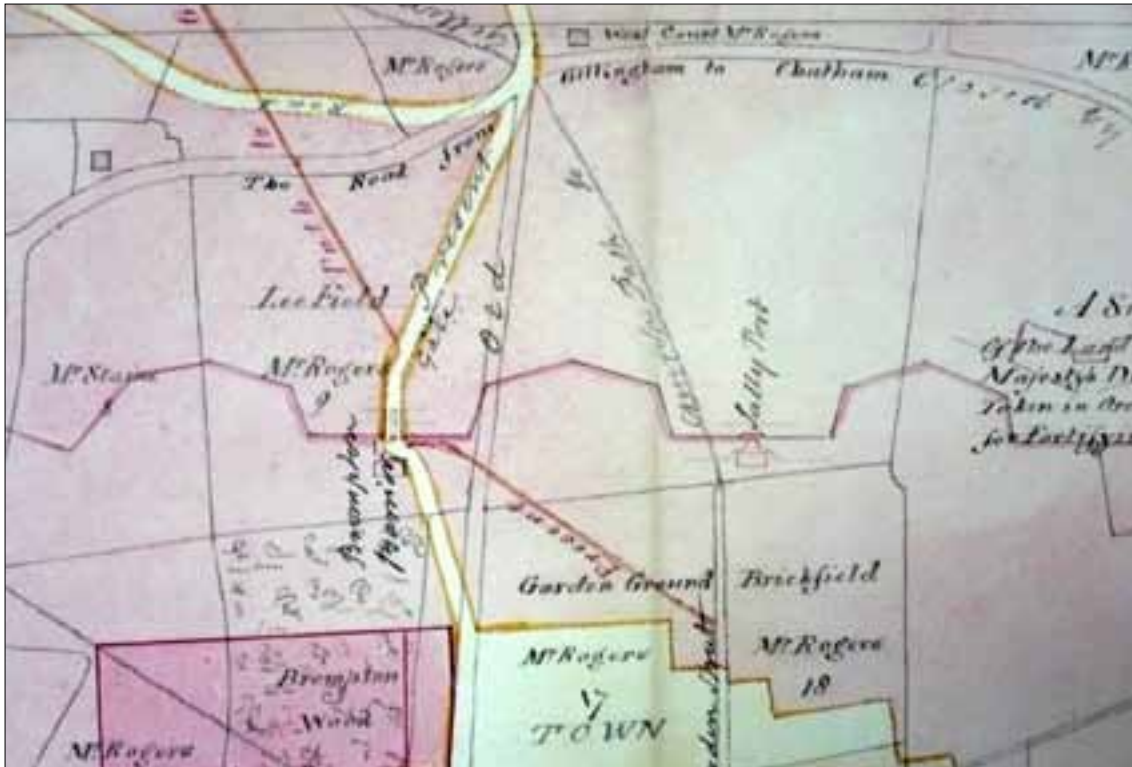
Figure 11 – Detail from a plan of the lines in 1821 (Figure 3), north to bottom left (TNA UK MFQ 111280/10).

Some of these features and changes are more accurately located on another plan of 1821 (Figure 11). For example, this latter plan shows that West Court was actually located directly in front of Prince Edward's Bastion rather than in front of the sallyport to the north of it. This plan also shows that this sallyport was known as 'Brompton Barrier', though the name may be a later addition, and that to the south was formally called 'Sally Port' by this time.

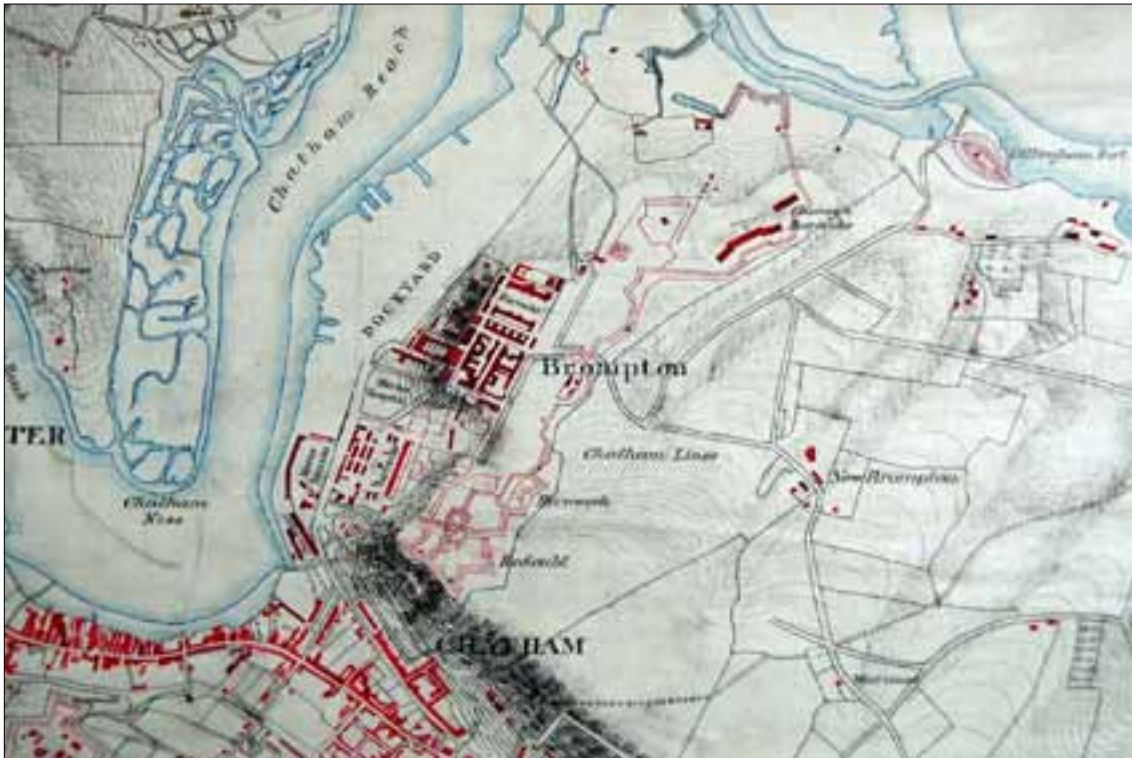
Figure 12 – Detail from an unpublished 1860 Ordnance Survey map compiled as part of the process of creating the first edition 6" to 1 mile series, not to scale (TNA UK MR 111276).

The first large scale Ordnance Survey (OS) map of the lines is a version compiled from 'candidates' for the first edition 6" to 1 mile map of Kent in 1860 (Figure 12). As such it is a pre-publication version and is interesting in that it uses contours to show the topography very clearly. The lines are shown in red; Prince Edward's Bastion is immediately below 'Brompton'. It can be seen to be the only bastion housing any buildings and they appear to be arranged roughly as they were in 1806, though there is no building inside the south flank.

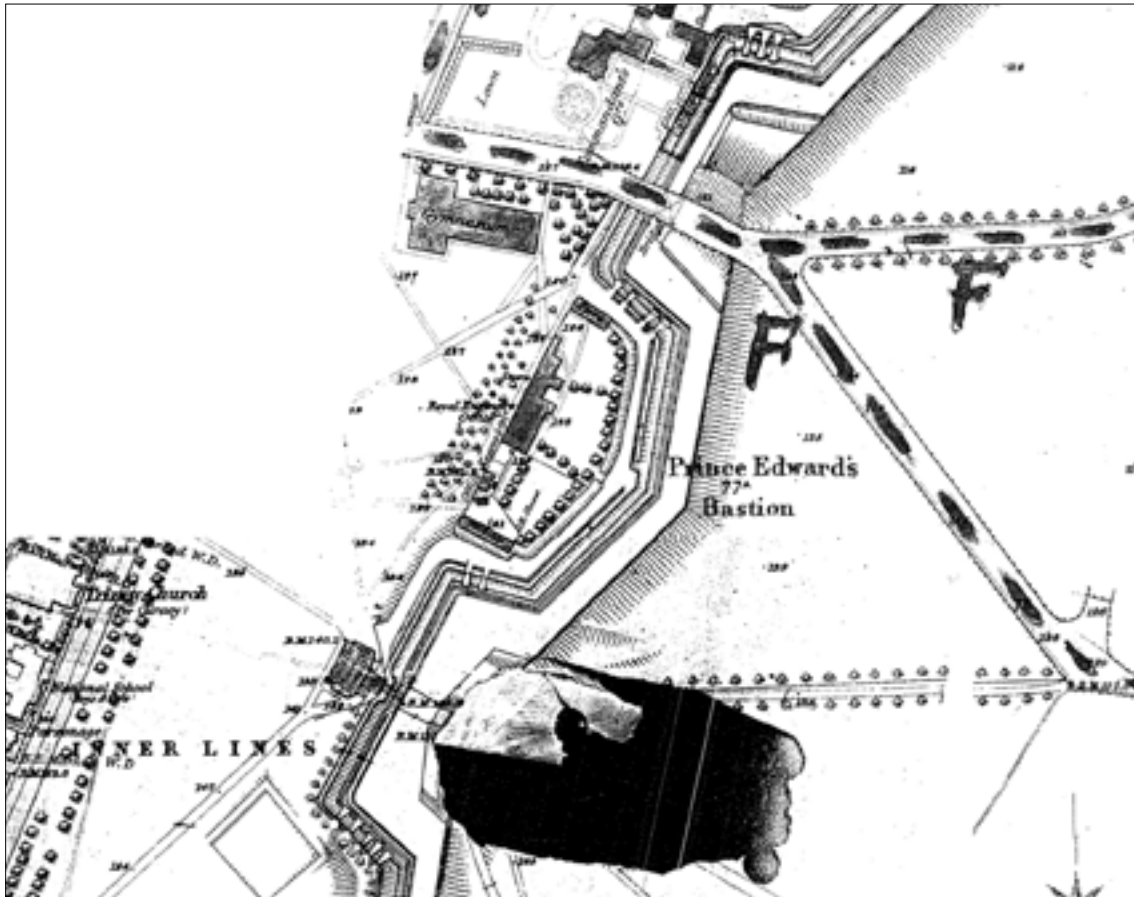
The 'War Department' 25" to 1 mile map of 1879 (Figure 13) shows several buildings within the bastion including two stores, the 'Royal Engineers Office', another office, a workshop and an earth closet (toilet). These were enclosed by a walled compound within the bastion that separated them from the open ground to the west. Numerous paths radiated out from the buildings suggesting that they were well used. The store to the north appears to be the same as that of 1806, and there had been some

The 1879 map also shows the form of the rampart at this time. A talus ran up to a terre-plein around the whole of the rampart apart from at the corner of the north curtain and bastion flank; several paths ran towards this area so it may have been the main access point up onto the rampart. No glacis is shown around the guardhouse behind the southern sallyport and it is possible that the terre-plein here was retained by splayed walls. The terre-plein was rather variable in width. It was quite broad behind the south curtain, widening significantly at the corner with the south flank, behind which it was also quite broad, and had been broader as it had been cut into to allow for the construction of the 'workshop' building. Around the face of the bastion the terre-plein was narrower, though it broadened a little at the salient where there may have been ramped access from the garden/yard within the bastion. It also broadened out somewhat behind the north flank where it was again cut into by one of the 'store' buildings. Behind the north curtain the talus was not visible and the terre-plein appeared to be much narrower than elsewhere, perhaps being retained by a wall. A banquette ran around the entire rampart behind the parapet revetment, with narrow breaks at the embrasures. There were six of these, four (arranged in two pairs) in the north flank

Figure 13 - Detail from an Ordnance Survey 25" to 1 mile 'War Department' map of 1879, not to scale (TNA UK WO 32/18207)

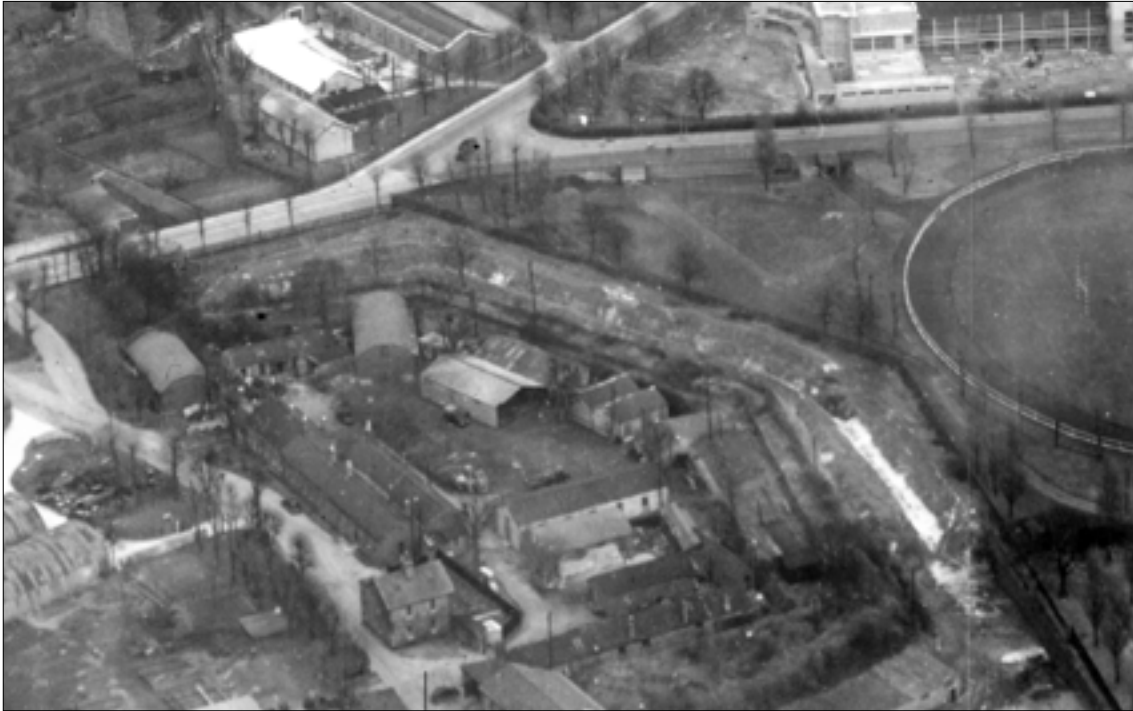
Figure 18 - Prince Edward's Bastion from the southwest (extract from RAF 30015 PFFO-0079 TQ 7668/3 4 February 1948 English Heritage (NMR) RAF Photography)

The infill and 'V' ditch appear to stop rather abruptly 20m or more before the south end of the bastion face; the revetment wall of the counterscarp can be seen in the bottom right corner of Figure 18. Within this low area was a large shed built against the south flank of the bastion, just visible in Figure 18, which was shown on the 1932 OS map. It can be seen in Figure 19 that the low area around the side of the south flank was relatively restricted. To the south, a strip perhaps 20-30m wide immediately north of Sally Port Gardens, had been partially filled in and a building constructed upon it. This

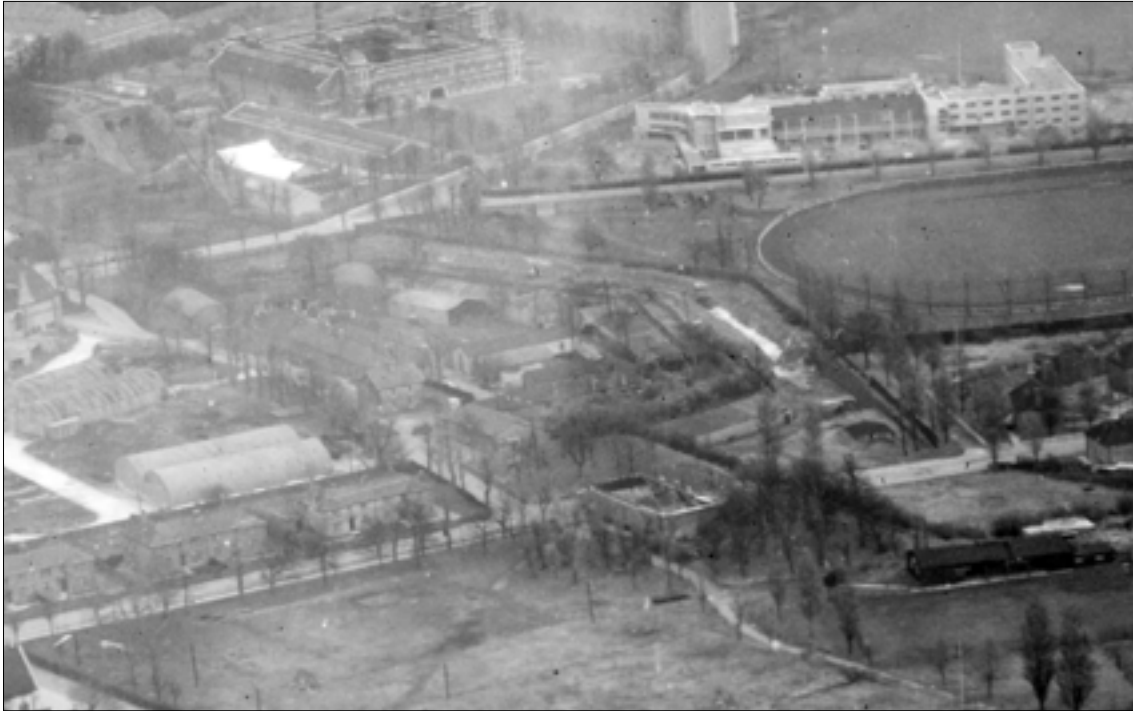
Figure 19 - Prince Edward's Bastion from the west (extract from RAF 30015 PFFO-0078 TQ 7668/2 4 February 1948 English Heritage (NMR) RAF Photography)

may be remains of the structure shown within the ditch on the 1879 map, though hints of a track suggested that the slope up to Sally Port had been graded. The building on the raised area appears to be a temporary shed and was not shown on the 1932 OS map or the 1950 aerial photograph. The area to the south of Sally Port appears to be completely filled and levelled, though not built upon. As noted above there is no firm evidence for any infilling of the ditch prior to the Second World War and it therefore seems likely that much of the ditch was filled during construction of the war-time defences.

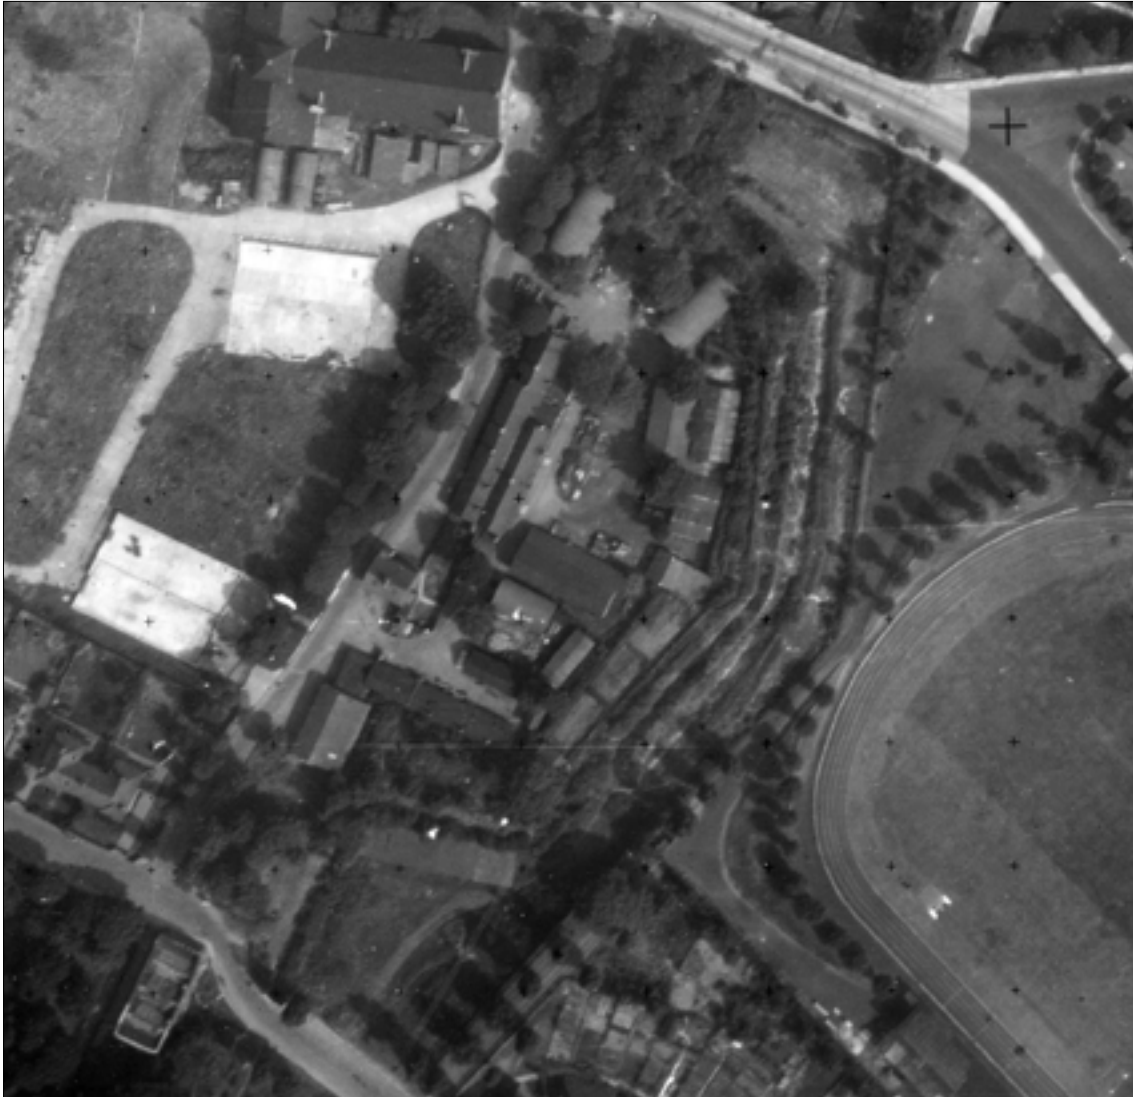
Figure 20 – A vertical aerial photograph of Prince Edward's Bastion in 1950, north to top (extract from RAF/58/550, frame 5204 14 August 1950 English Heritage (NMR) RAF Photography)

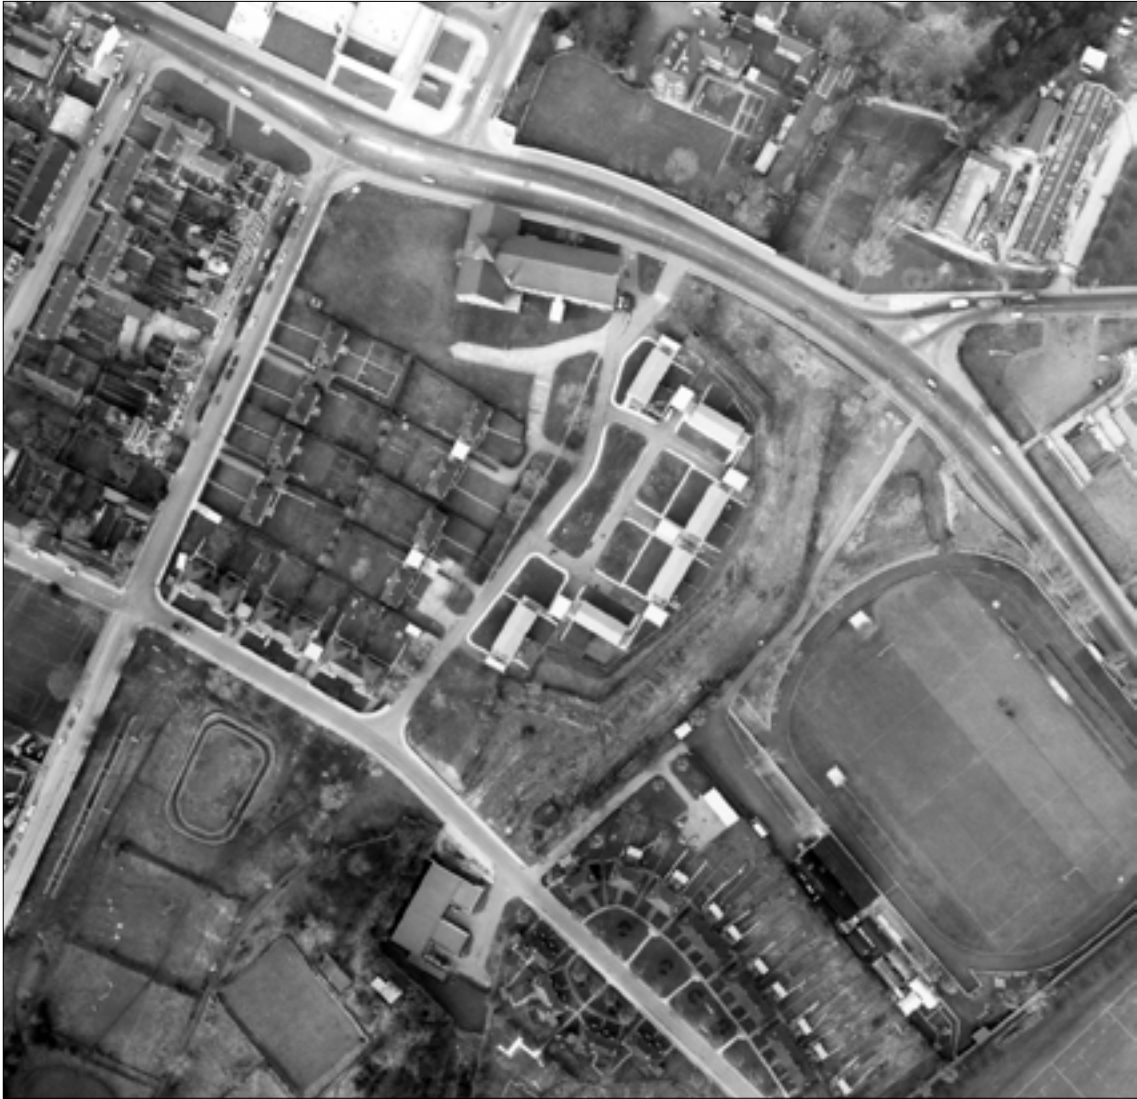
demolished and replaced by a small housing estate for married military personnel. This seems to have taken place in or very shortly before 1968 as an aerial photograph from this year (Figure 21) shows the new buildings and road layout, including the straightening of Sally Port/Sally Port Gardens, all of which appear to be recent. The guardhouse had also been removed by this time, although apparently not so recently. This aerial photograph also shows damage to the north face of the bastion and evidence of earth-moving work in the form of tracks and scrapes marks within the ditch, suggesting that much of the damage visible today may have occurred at this time.

Figure 21 – Vertical aerial photograph showing the bastion shortly after the construction of the housing estate, north to top (extract from OS/68004, frame 211 | February 1968 © Crown copyright. Ordnance Survey)

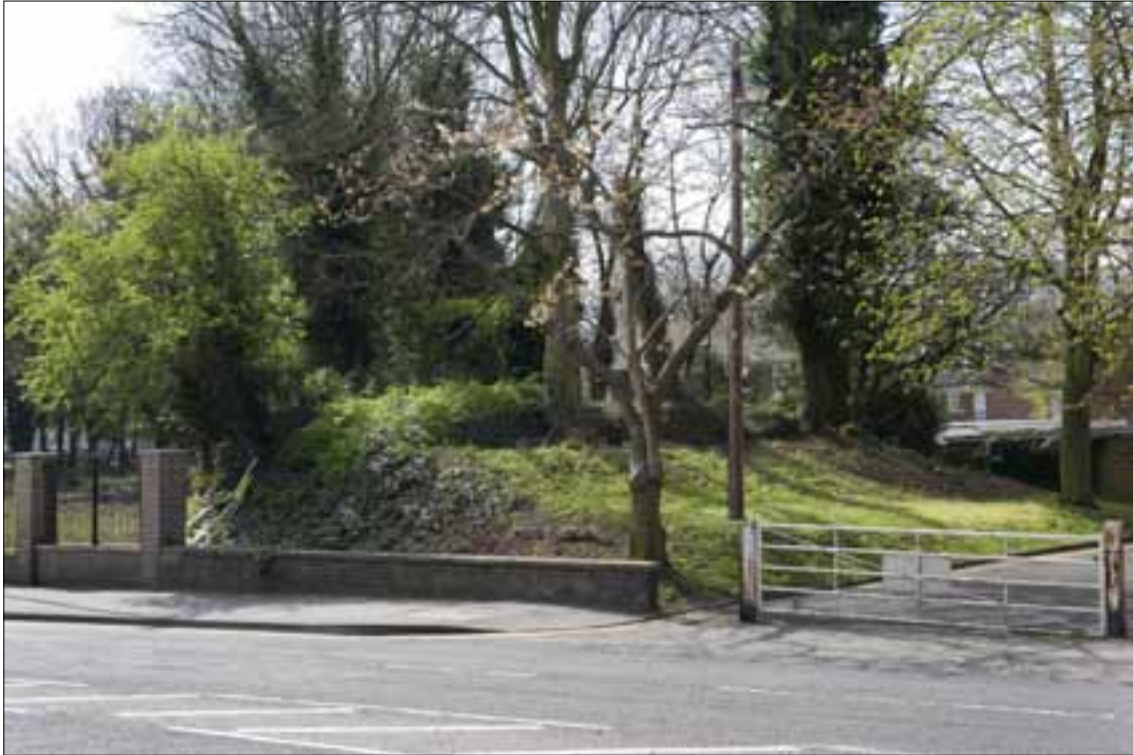
The remaining section of the north curtain [A], which runs towards Prince Henry's Bastion, retained at least part of the terre-plein, banquette and rear revetment of the parapet though this had lost its upper courses (see Figure 22). The terre-plein appeared to be rather narrow and the talus quite steep, probably preserving the Napoleonic form of the rampart here. It is possible that the terre-plein was originally retained by a wall which may have collapsed or been removed, but it is also possible that the rear of the work here had been truncated somewhat by the widening of Inner Lines. The rampart here was significantly lower than the south curtain [G] and it is possible that the surrounding ground level had been raised, probably by road improvements. There was no evidence of the scarp revetment and the rampart had either been cut back or eroded several metres; probably the latter as there was considerable evidence of damage by tree-fall and active erosion sites. The side facing Wood Street had clearly been cut back quite recently, presumably when the road was widened and this had a much more uniform appearance than that of the scarp.

Figure 22 - The north curtain from the rear, looking SSE (© English Heritage DP 119304 Steve Cole).

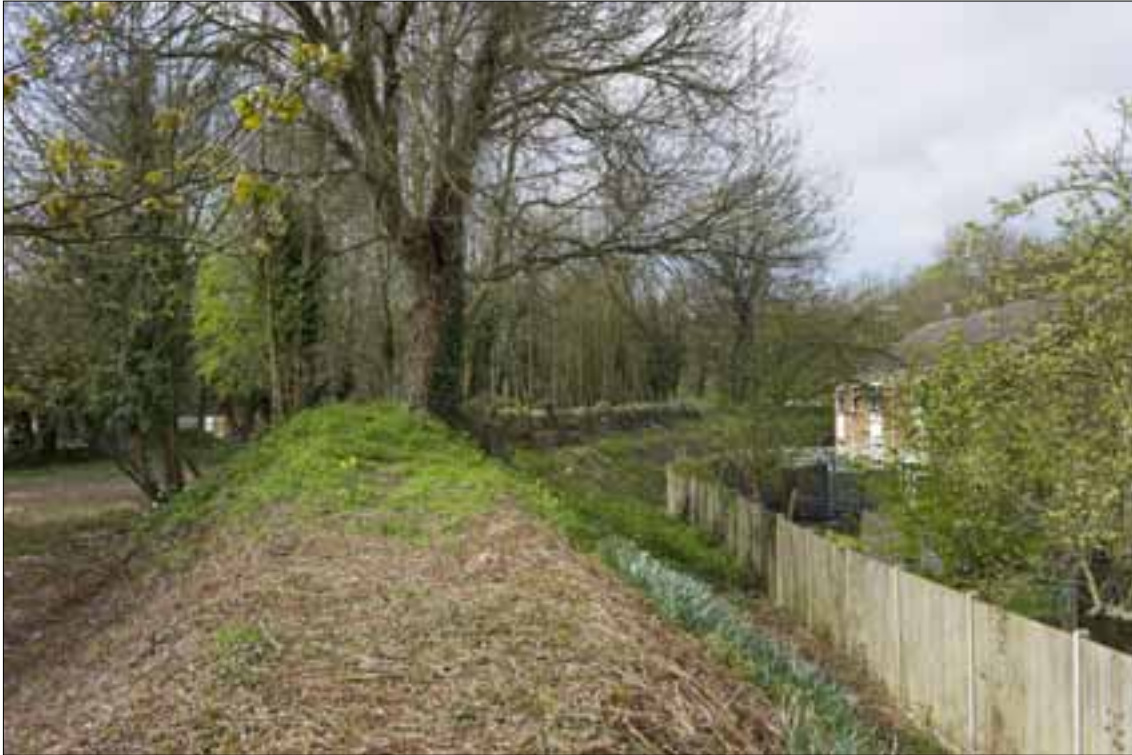
The north face of the bastion [C] was the most severely damaged section. Only a rough bank that was lower and narrower than elsewhere remained. The rear rampart elements had all been removed and there was no sign of the scarp revetment. At its southern end where it approached the salient the top of the bank rose significantly towards the point where the rear revetment could once again be clearly seen (Figure 23).

Figure 23 - The salient from the north (© English Heritage DPI 19293 Steve Cole)

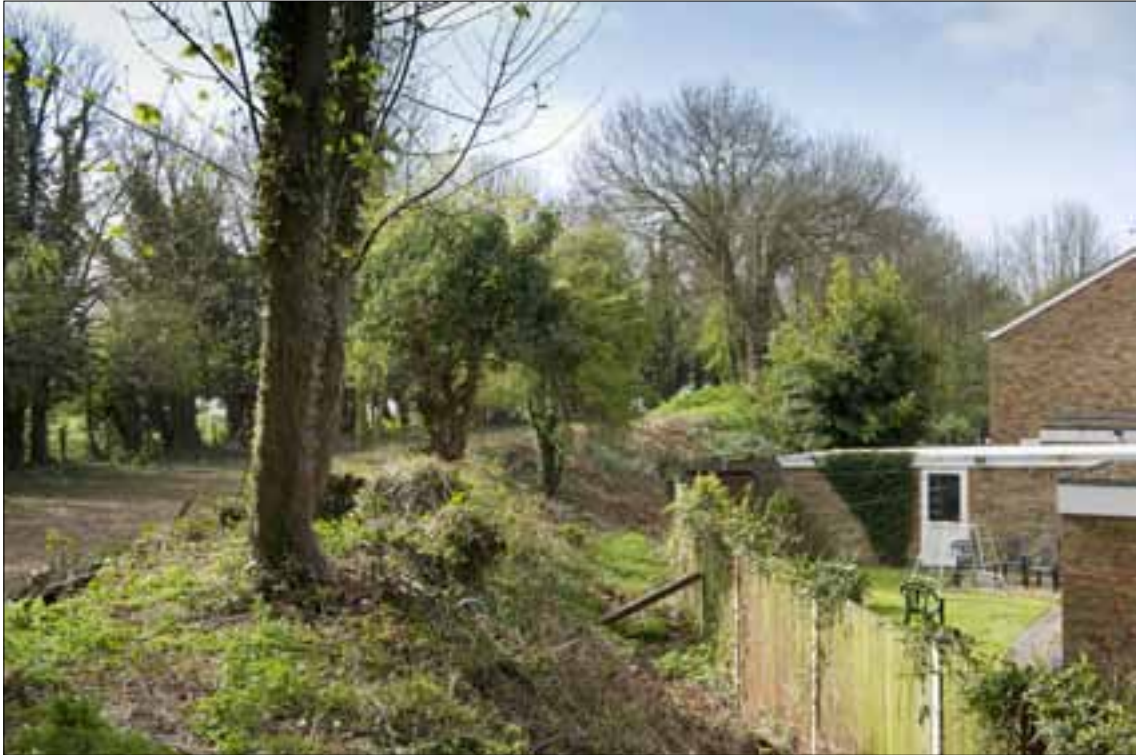
This section of the bastion projected forward from a line reflecting the south face and had a distinct change of angle about halfway along its length (see Figure 24). The plan form seen today is not original, which is shown on the 1932 OS map (Figure 17) and on aerial photographs as late as 1950 (Figure 20). The changed alignment is still not shown on modern OS mapping but is visible on the aerial photograph of 1968 (Figure 21), at which time the damage looked recent, and probably associated with the construction of the new housing within the bastion. It is therefore highly unlikely that much of this part of the rampart remains undisturbed. Towards the north end of this section part of the front face of the rampart had been severely damaged and was collapsing at the time of

Figure 24 - Looking south along the north face (© English Heritage DPI 19291 Steve Cole)

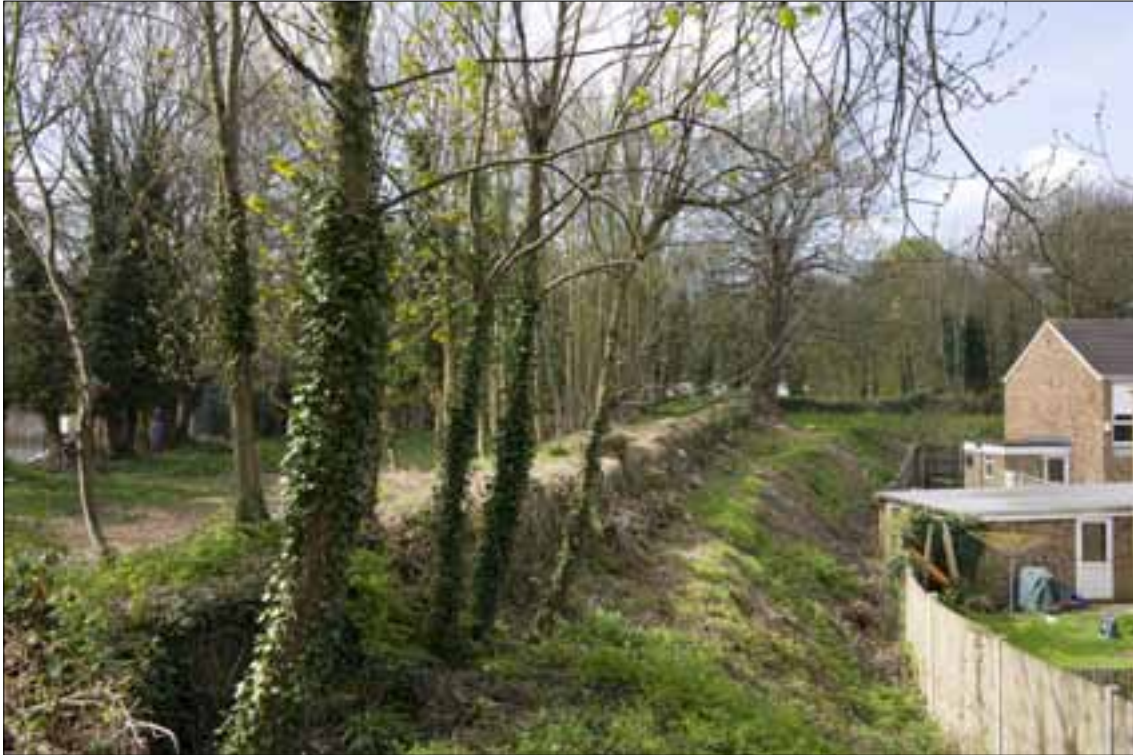
The salient [D] and south face of the bastion [E] were both in fair condition. The parapet revetment remained along this entire section, including part of the small rear projection just north of the salient, first shown on the 1879 map, though most of the rear elements had been removed (see Figure 25). There were no traces of the scarp revetment along the front of this section and the rampart had probably been cut back several metres as indicated by the 1968 aerial photograph (Figure 21) but there was no major damage as seen on the north curtain and flank.

Figure 25 - Looking southwest from the salient along the south face (© English Heritage DPI 19295 Steve Cole)

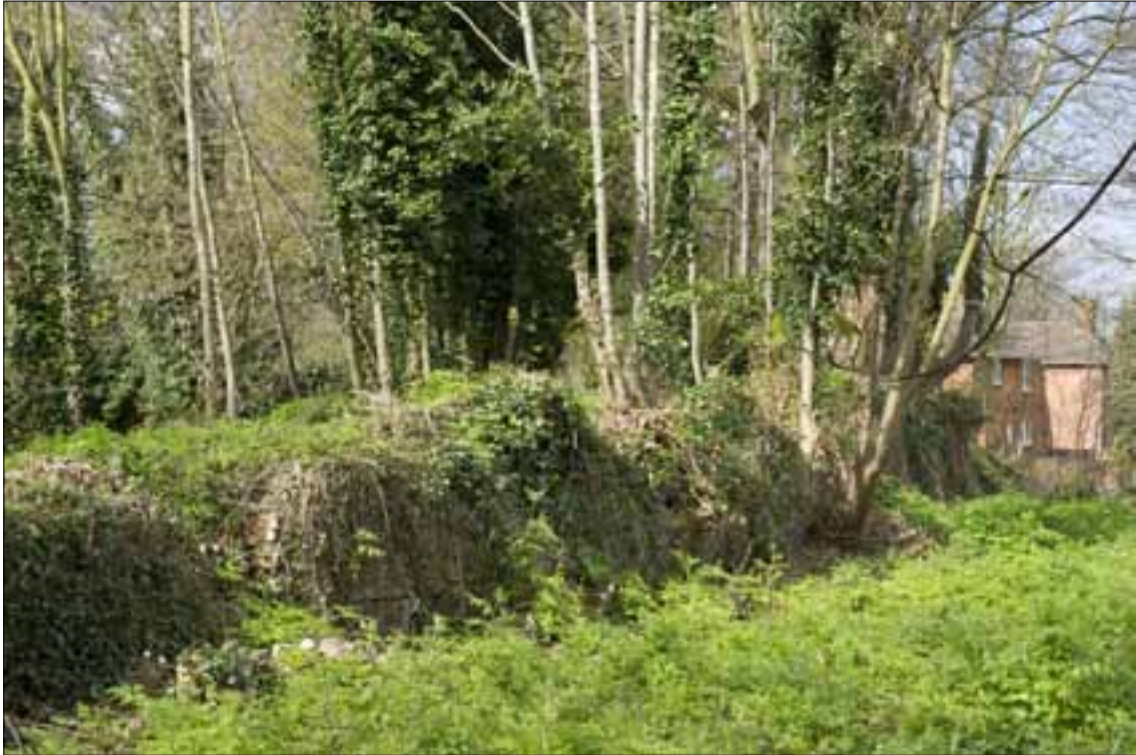
The south flank of the bastion [F] was also in reasonable condition. The revetment of the parapet remained and connected with that of the face. Although it had been damaged by vegetation growth (see Figure 26), one embrasure and part of a second could be seen at its west end where it reached a height of about 1.5m. This was in contrast to the lower revetment (about 1.0m) seen elsewhere and may give an indication of the original height of the parapet, though the north curtain was rather higher and so it may be the result of rising rampart levels to accommodate the rising terrain.

Figure 26 – The parapet revetment along the south flank, from the east (© English Heritage DPI 19301 Steve Cole). The gap visible to the left is damage rather than an embrasure.

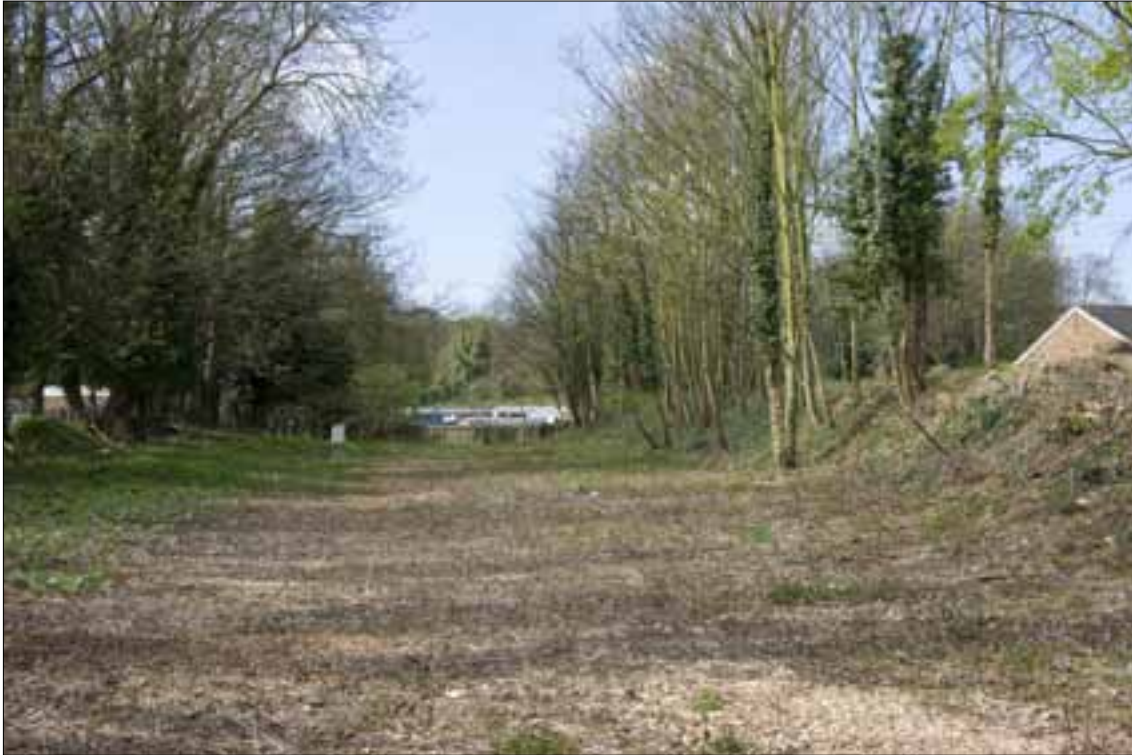
Figure 27 – looking southwest along the filled ditch from the salient (© English Heritage DPI 19298 Steve Cole)
