# WINDSOR CASTLE GOVERNOR'S HOUSE (NORMAN GATE, SOUTH TOWER, FIRST FLOOR) SURVEY RECORD AND INTERPRETATION OF A MEDIEVAL TILED FLOOR

## ARCHAEOLOGICAL REPORT

**PART OF PROJECT 600 – WINDSOR CASTLE ROUND  
TOWER AND FIRE PROJECT ASSESSMENT**

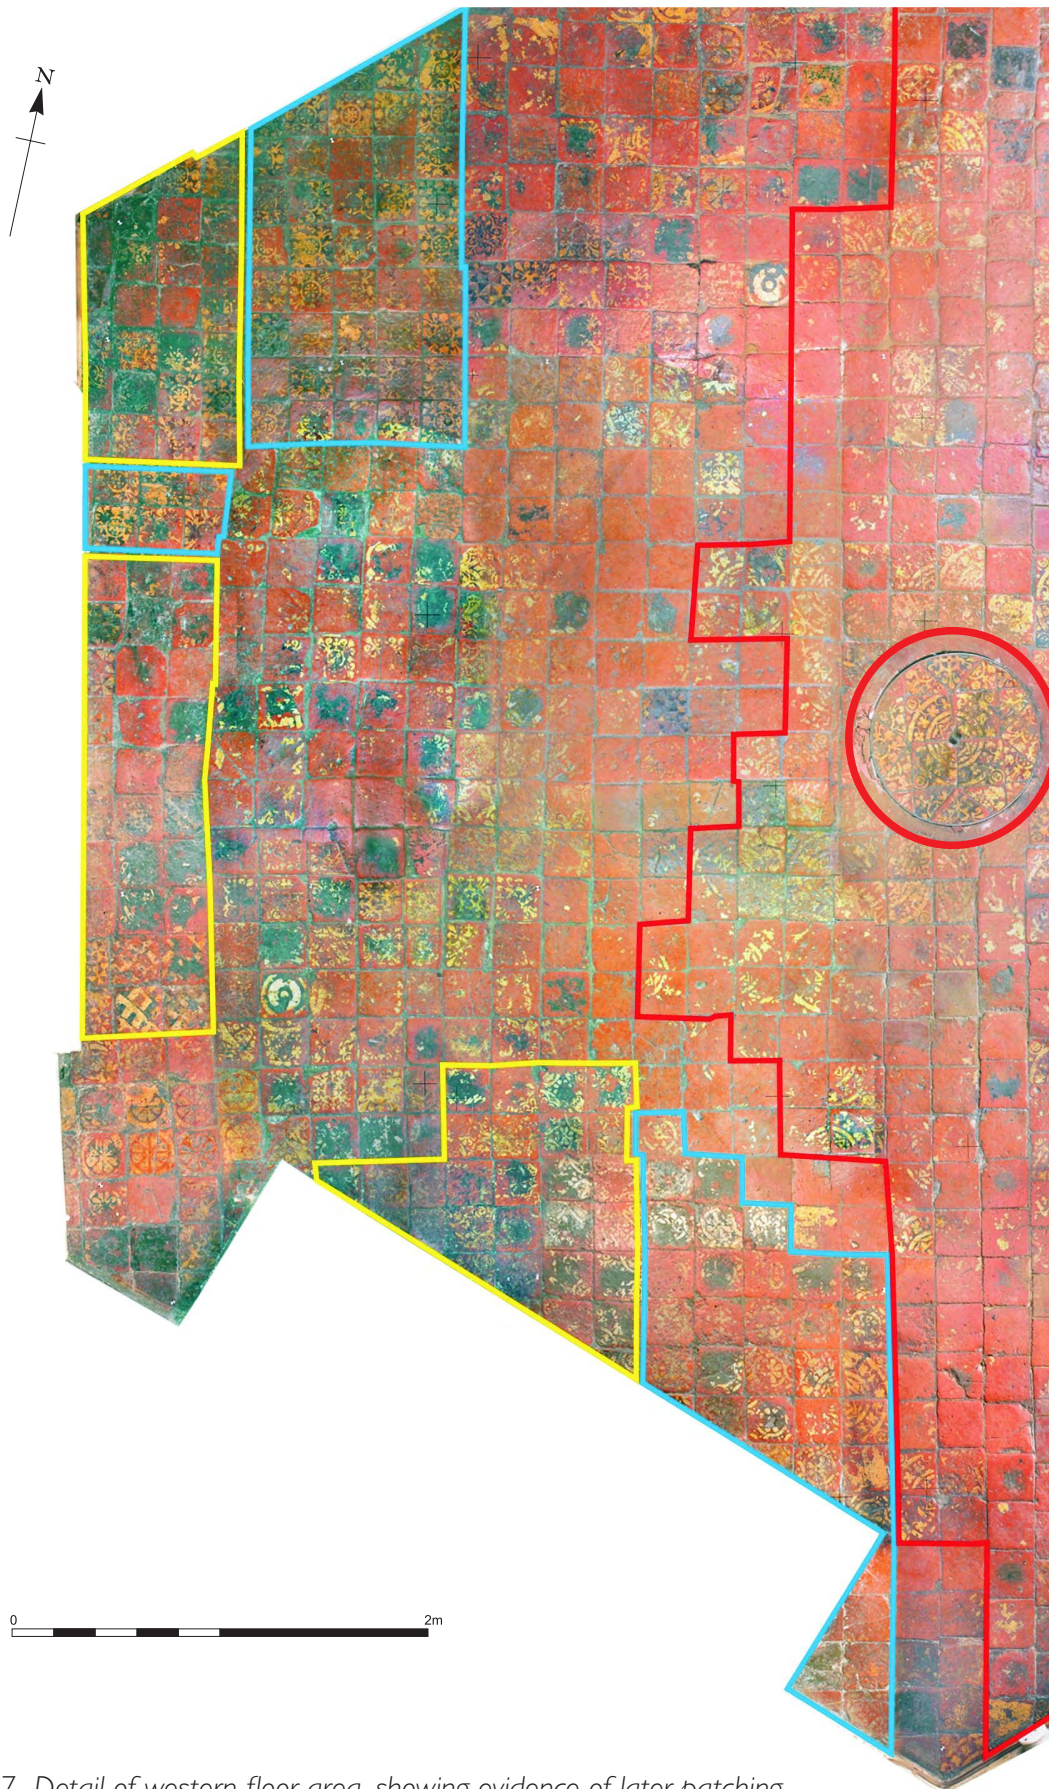
Figure 7 Detail of western floor area, showing evidence of later patching.

In the north-west area tiles with design 19 probably represent one area of contemporary patching, whilst the area in front of the fire with designs 4 and 24 represent another. Two separate areas of the floor have a nine tile design made up of a central ‘Westminster’ tile (design 2) surrounded by eight Penn tiles (design 14); presumably both were installed at the same time.

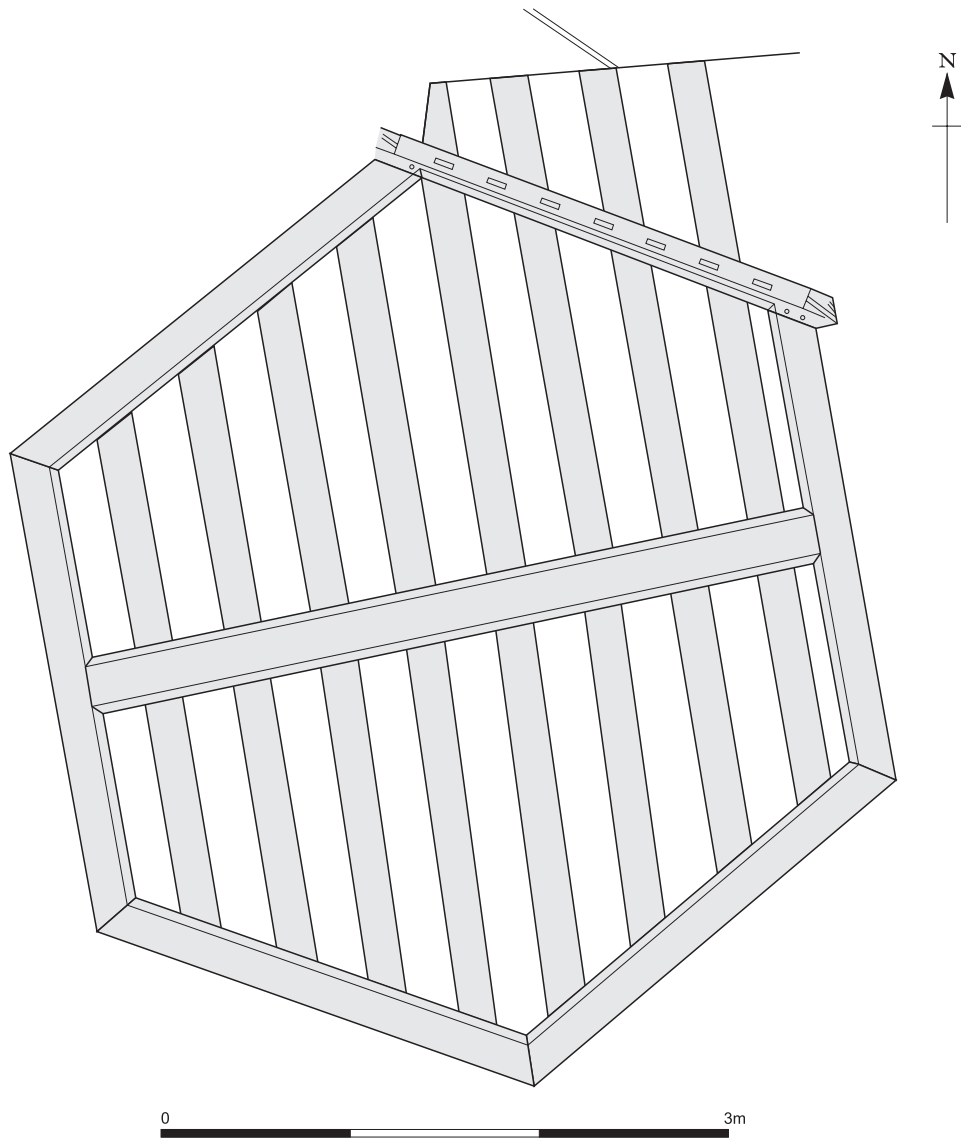
Figure 8 Reflected plan of ceiling joists, showing chamfered edges and empty mortices for screen across entrance. (After John Pigeon).
