Centre for Archaeology Report 37/2004

**Tree-Ring Analysis of Oak Timbers from Dartmouth Castle,
Near Dartmouth, Devon**

Ian Tyers

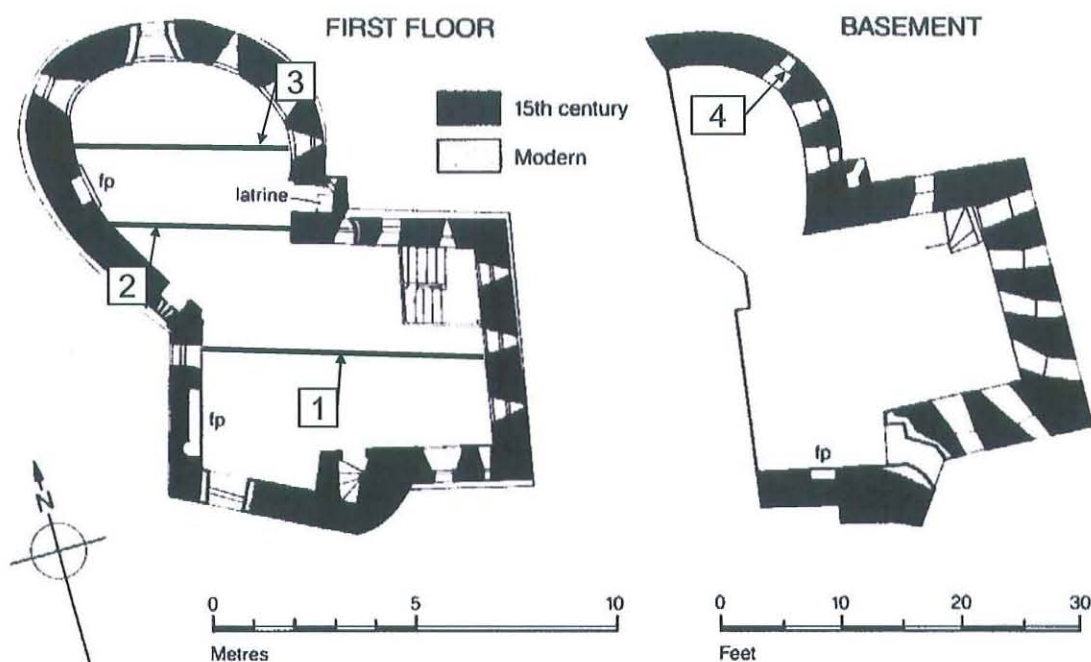
Figure 3 Plan of the basement and first floor ceiling of Dartmouth Castle, nr Dartmouth, Devon. The labelled arrows indicate the approximate locations of the sampled timbers (figure based upon English Heritage 1983, 7)

In between the assessment and the sampling Rob Harding from the EH regional office had been able to supply diagrams showing some of the repairs that had been undertaken on various occasions in the twentieth century. Once at the Old Castle with these plans, it became apparent that the ground-floor ceiling timbers which had been assessed as suitable on the first visit had been strengthened with steel bars and resin. As a result these timbers could not be sampled. The basement ceiling had been repaired with re-used softwood beams and had already been eliminated at assessment. This left the first-floor ceiling. This consists of just three visible beams running roughly east-west (Fig 3). One of these is in the round tower, one on the square tower, and one is in both. All three timbers were selected for sampling. The only other timber structure for which sampling was requested consists of multiple sills, posts, and lintels around a hole through which a defensive chain could be raised across the estuary. This structure could not be assessed on the original visit because of the number of visitors (it is normally inaccessible to visitors) and, when it was accessed for sampling it was found to be much less suitable than had been hoped. One sample was attempted from one of the three lintels. The samples were numbered 1-4 (Table 1; Fig 3).

KEY for Table 1 See Fig 3 for sample locations. The timber from which sample 4 was taken is embedded in the wall and its cross-section dimensions could not be measured. Total rings = all measured rings. Sapwood rings: H/S heartwood/sapwood boundary, ARW = average ring width of the measured rings

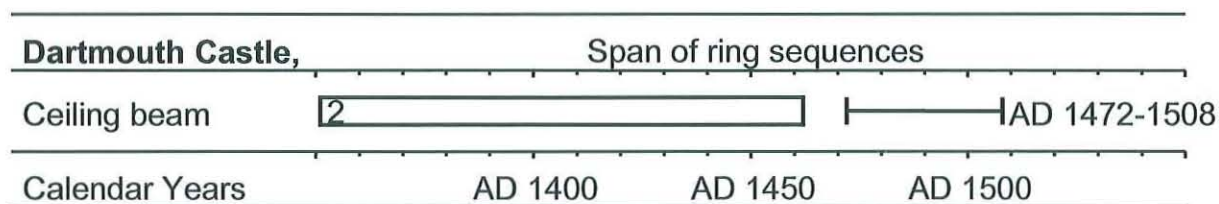
Figure 4 Bar diagram showing the chronological position of the dated timber from Dartmouth Castle, nr Dartmouth, Devon. The estimated felling period for the sample is also shown

The 112-year sequence from sample DARTMOUTH2 is dated AD 1351 to AD 1462 inclusive. It is complete to the heartwood/sapwood boundary. Adding the minimum and maximum expected number of sapwood rings to the date of the heartwood/sapwood boundary on this sample suggests it was felled between AD 1472 and AD 1508 (Fig 4; Table 1).
